REPORT NUMBER: SNCAP-CAL-99-7

**NEW CAR ASSESSMENT PROGRAM  
SIDE IMPACT TEST**

**VOLKSWAGEN DE MEXICO S.A. DE C.V.  
1999 VOLKSWAGEN NEW BEETLE  
2-DOOR COUPE**

**FINAL REPORT**

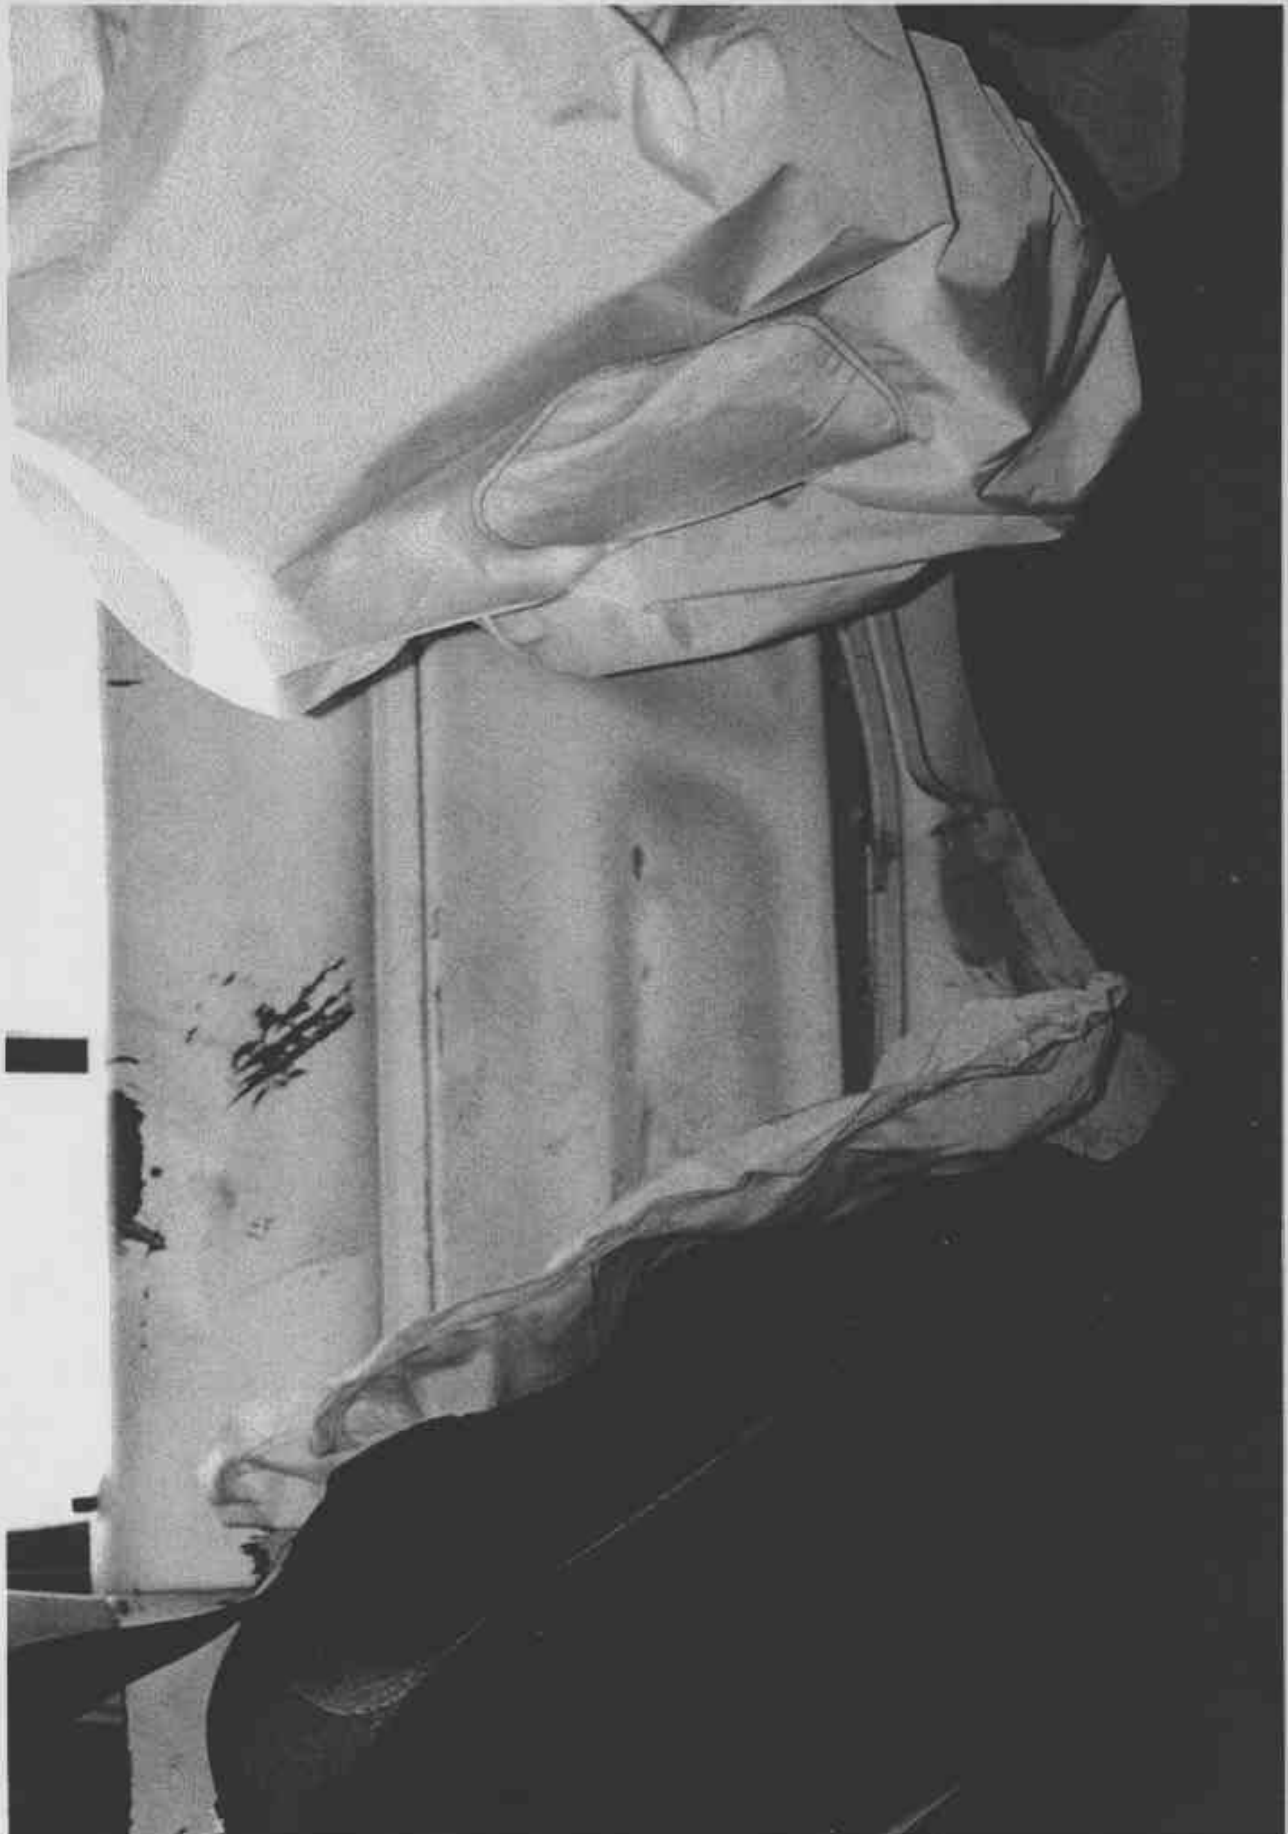
Figure A-26 POST-TEST INTERIOR OF FRONT DOOR SHOWING SID IMPACT LOCATIONS

The back of the head to the headrest. The side of the head to the left shoulder. The top of the head to the top of the door panel.

Upper Torso: Side airbag and door trim panel

Left Knee: Door trim panel
