REPORT NUMBER: SNCAP-CAL-00-3

**NEW CAR ASSESSMENT PROGRAM  
SIDE IMPACT TEST**

HONDA OF AMERICA MANUFACTURING, INC.  
2000 HONDA ACCORD  
4-DOOR SEDAN

NHTSA NUMBER: MY5301

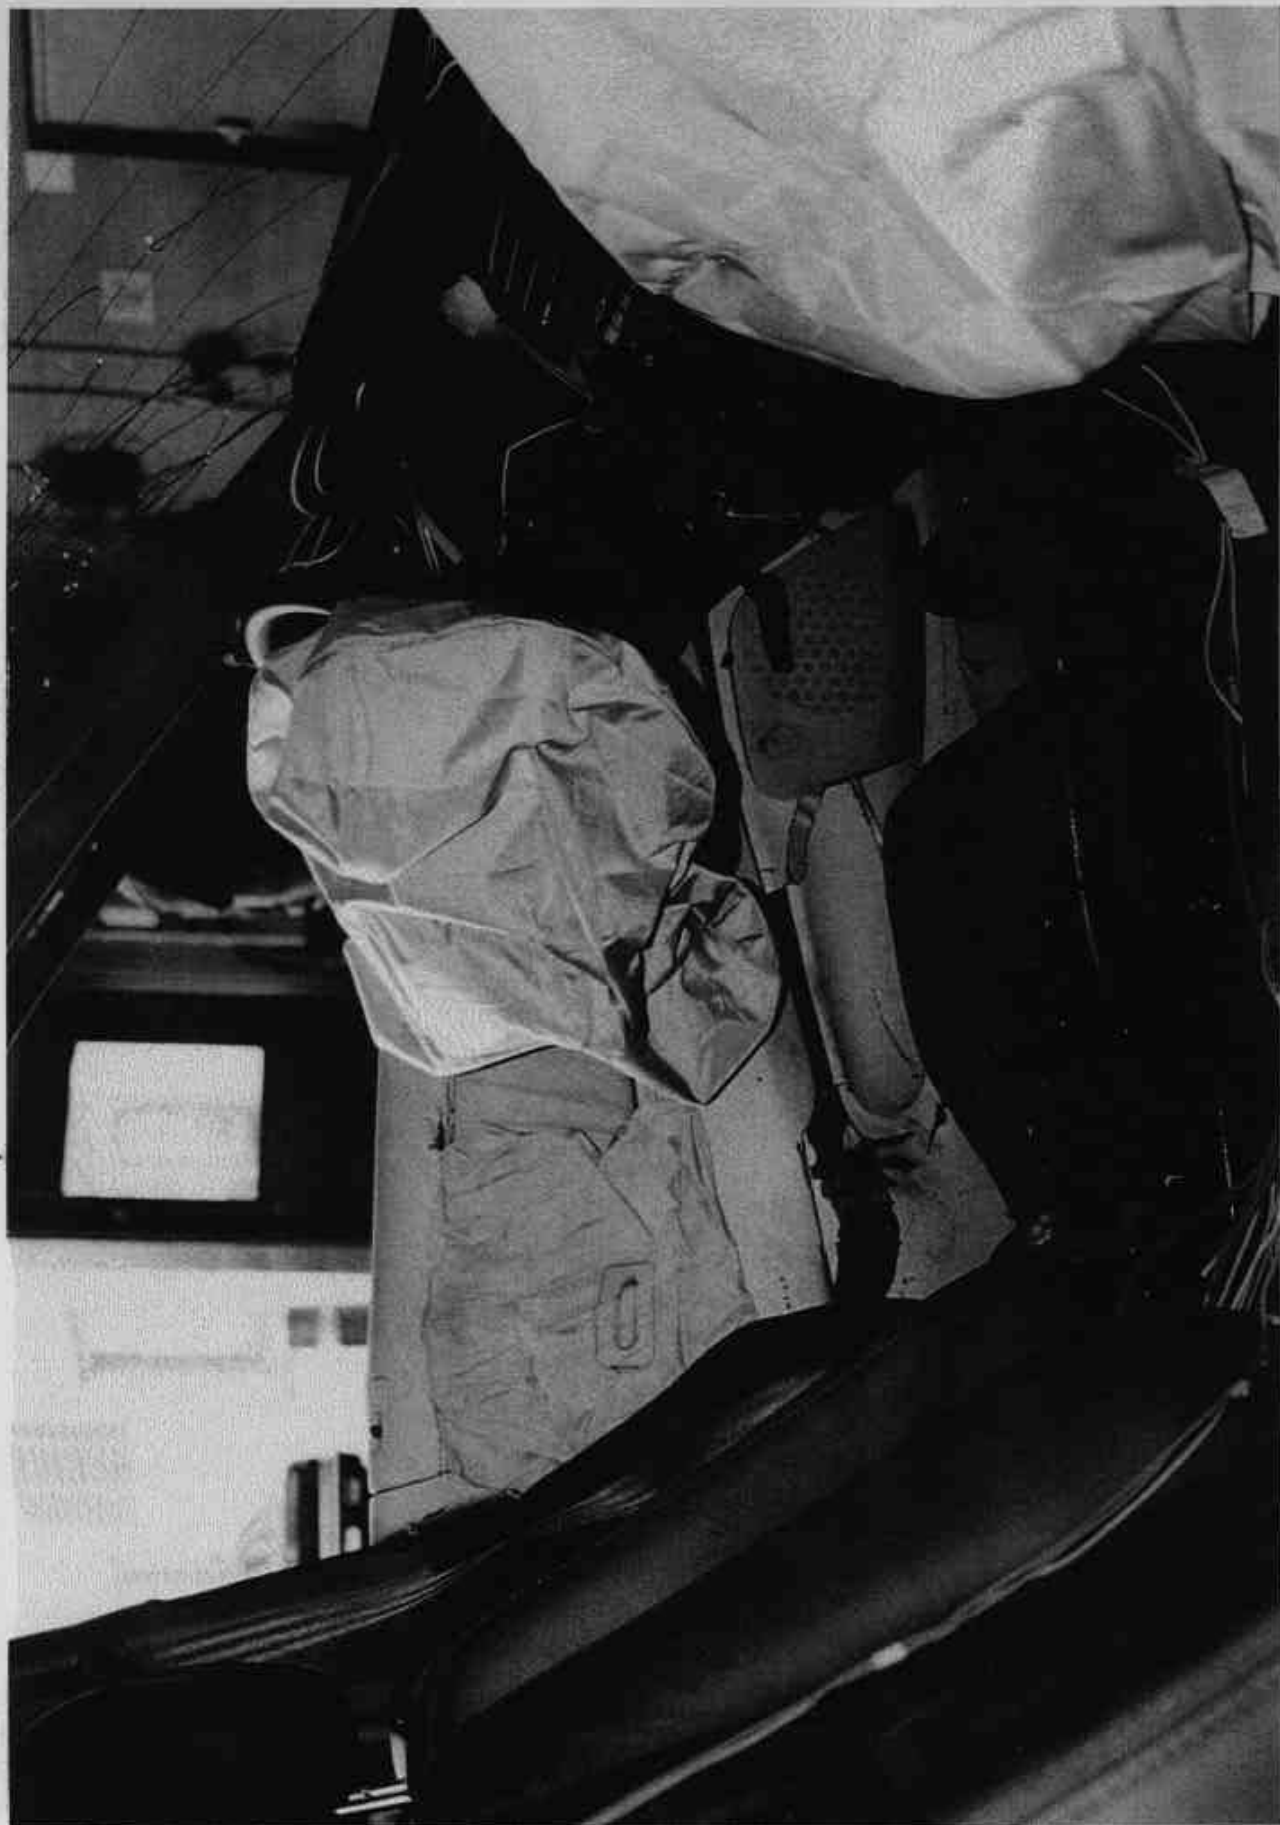
Figure A-26 POST-TEST INTERIOR OF FRONT DOOR SHOWING SID IMPACT LOCATIONS
