REPORT NO.: 214-MGA-2000-02  
SAFETY COMPLIANCE TESTING FOR FMVSS NO. 214  
"SIDE IMPACT PROTECTION"

Nissan Motor Company  
2000 Nissan Frontier Pickup  
NHTSA NO: CY5200

MGA RESEARCH CORPORATION  
5000 WARREN ROAD  
BURLINGTON, WI 53105

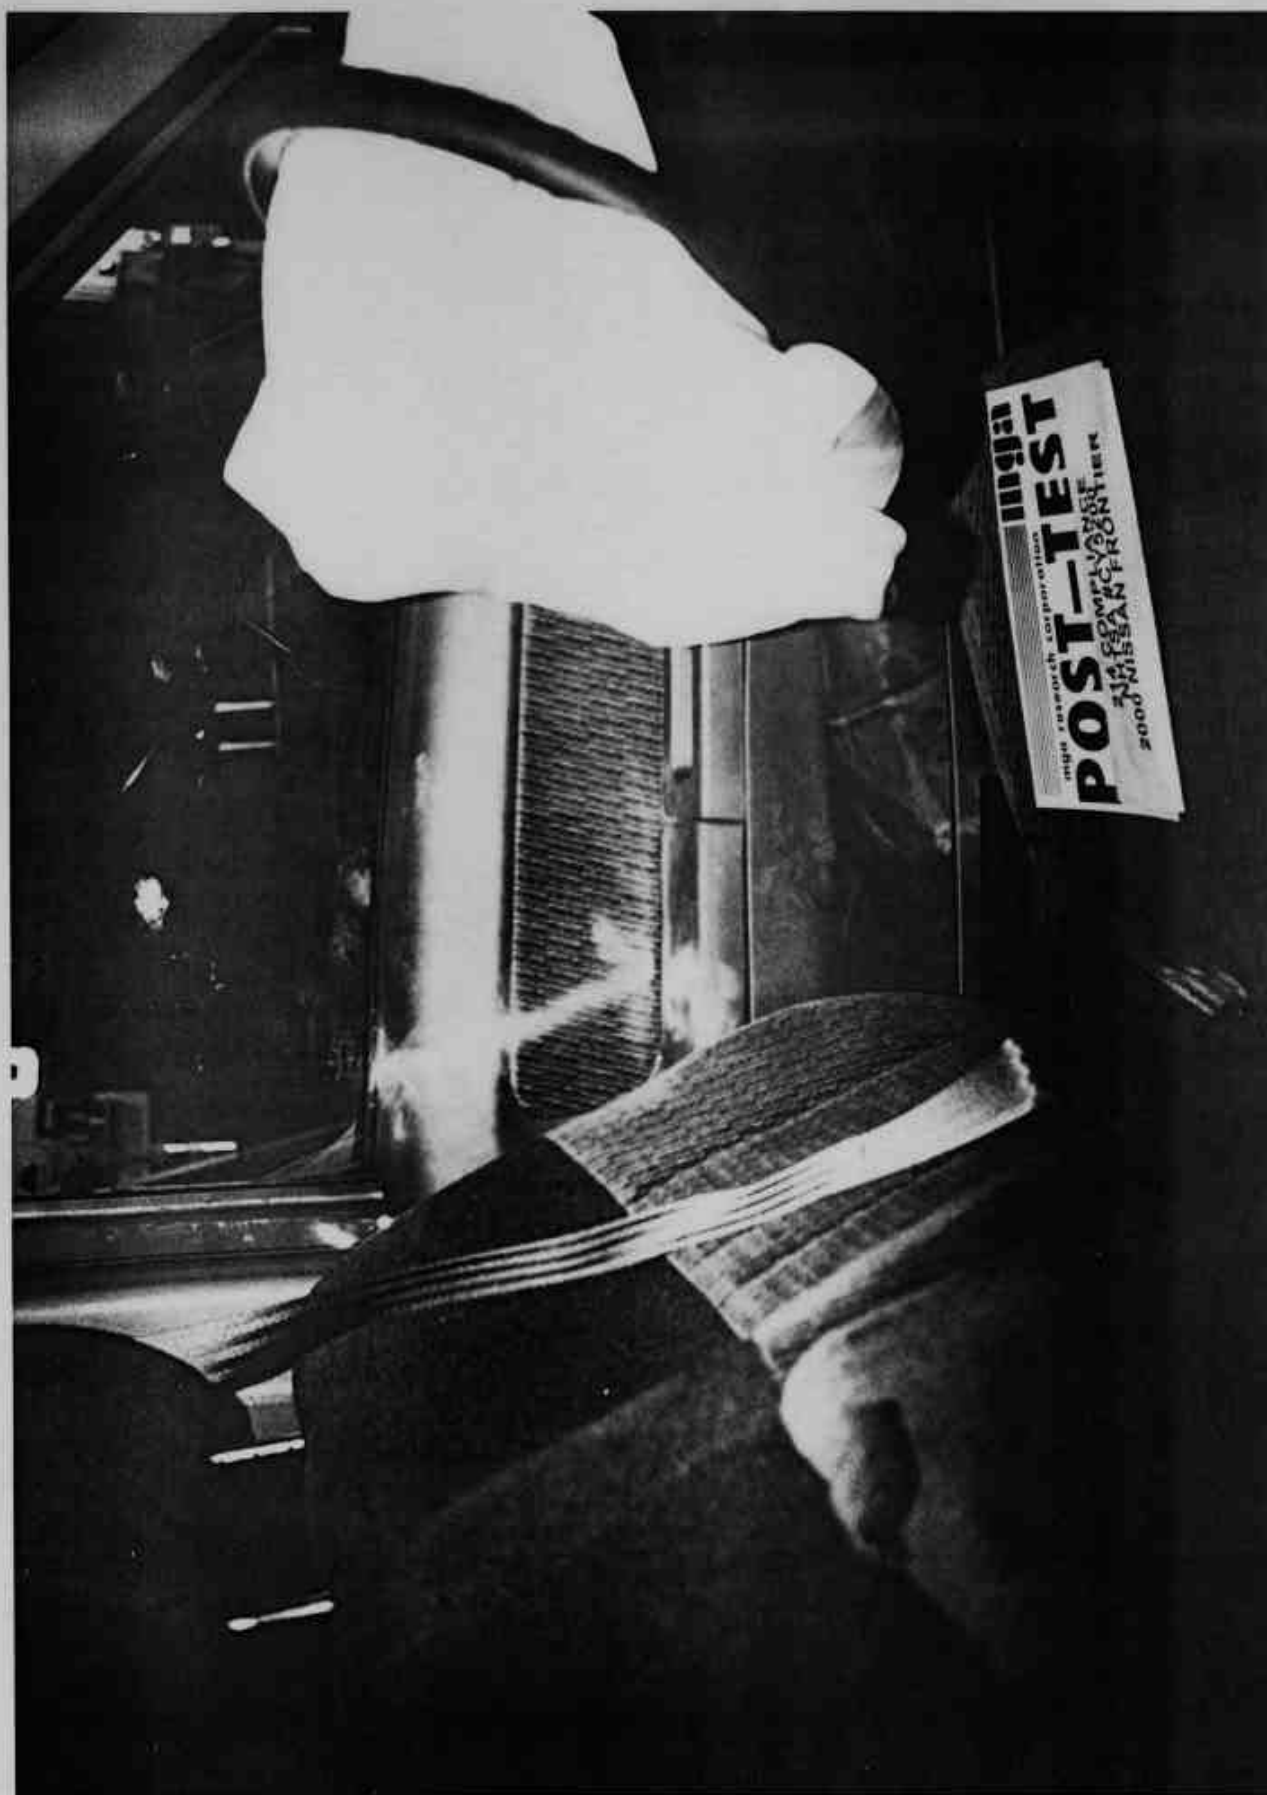
Photo No. A-28 - Post-Test Driver Dummy Contact

| | <u>DRIVER</u> | <u>LEFT REAR SID</u> |
|---|---|---|
| Arm | <u>to door panel</u> | <u>NA</u> |
| Pelvis | <u>to door panel</u> | <u>NA</u> |
| Left Knee | <u>to door panel</u> | <u>NA</u> |

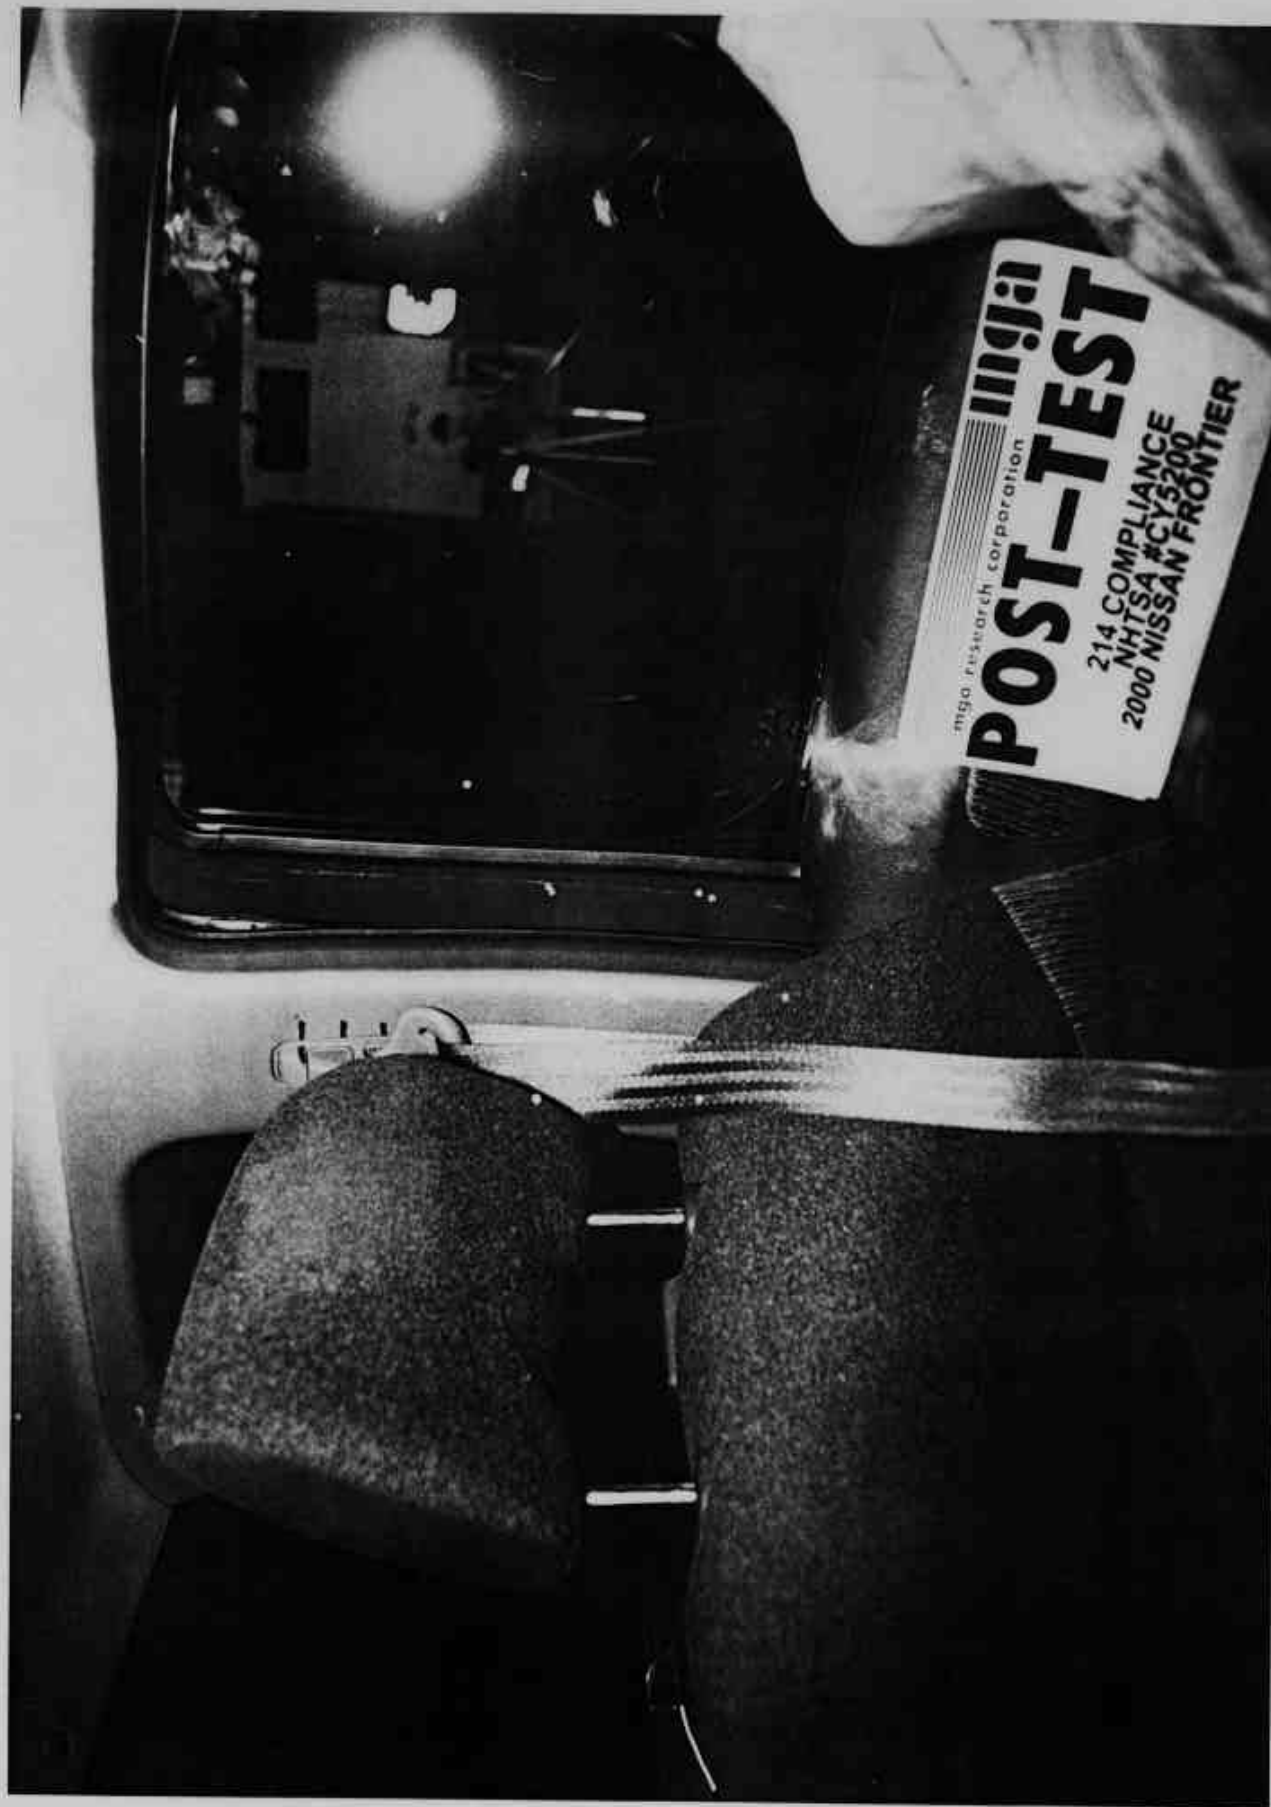
Photo No. A-29 - Post-Test Driver Dummy Head Contact

| | <u>DRIVER</u> | <u>LEFT REAR SID</u> |
|---|---|---|
| Head | <u>to side window &amp; shoulder belt</u> | <u>NA</u> |
