REPORT NUMBER: 301-CAL-99-07

**SAFETY COMPLIANCE TESTING FOR FMVSS 301  
FUEL SYSTEM INTEGRITY**

Hyundai Motor Company  
1999 Hyundai Sonata  
4 door sedan

**FINAL REPORT**

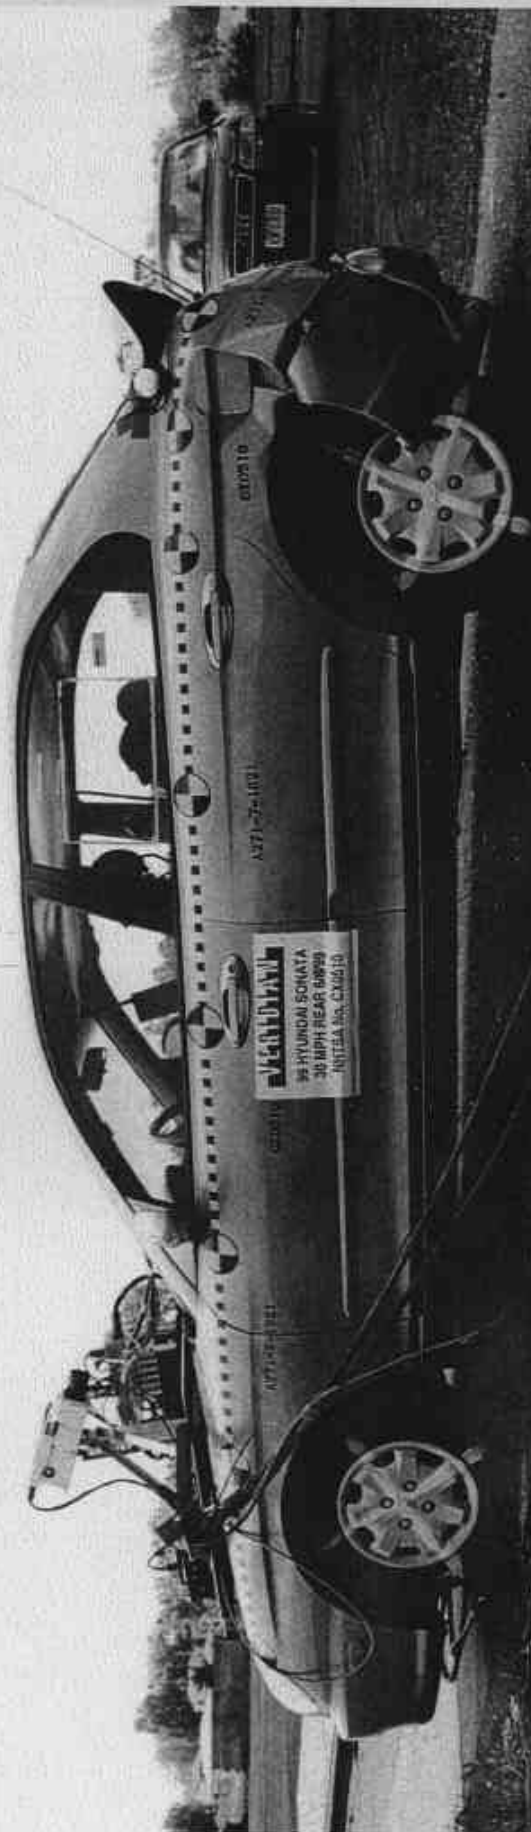
Figure A-4 POST-TEST LEFT SIDE VIEW

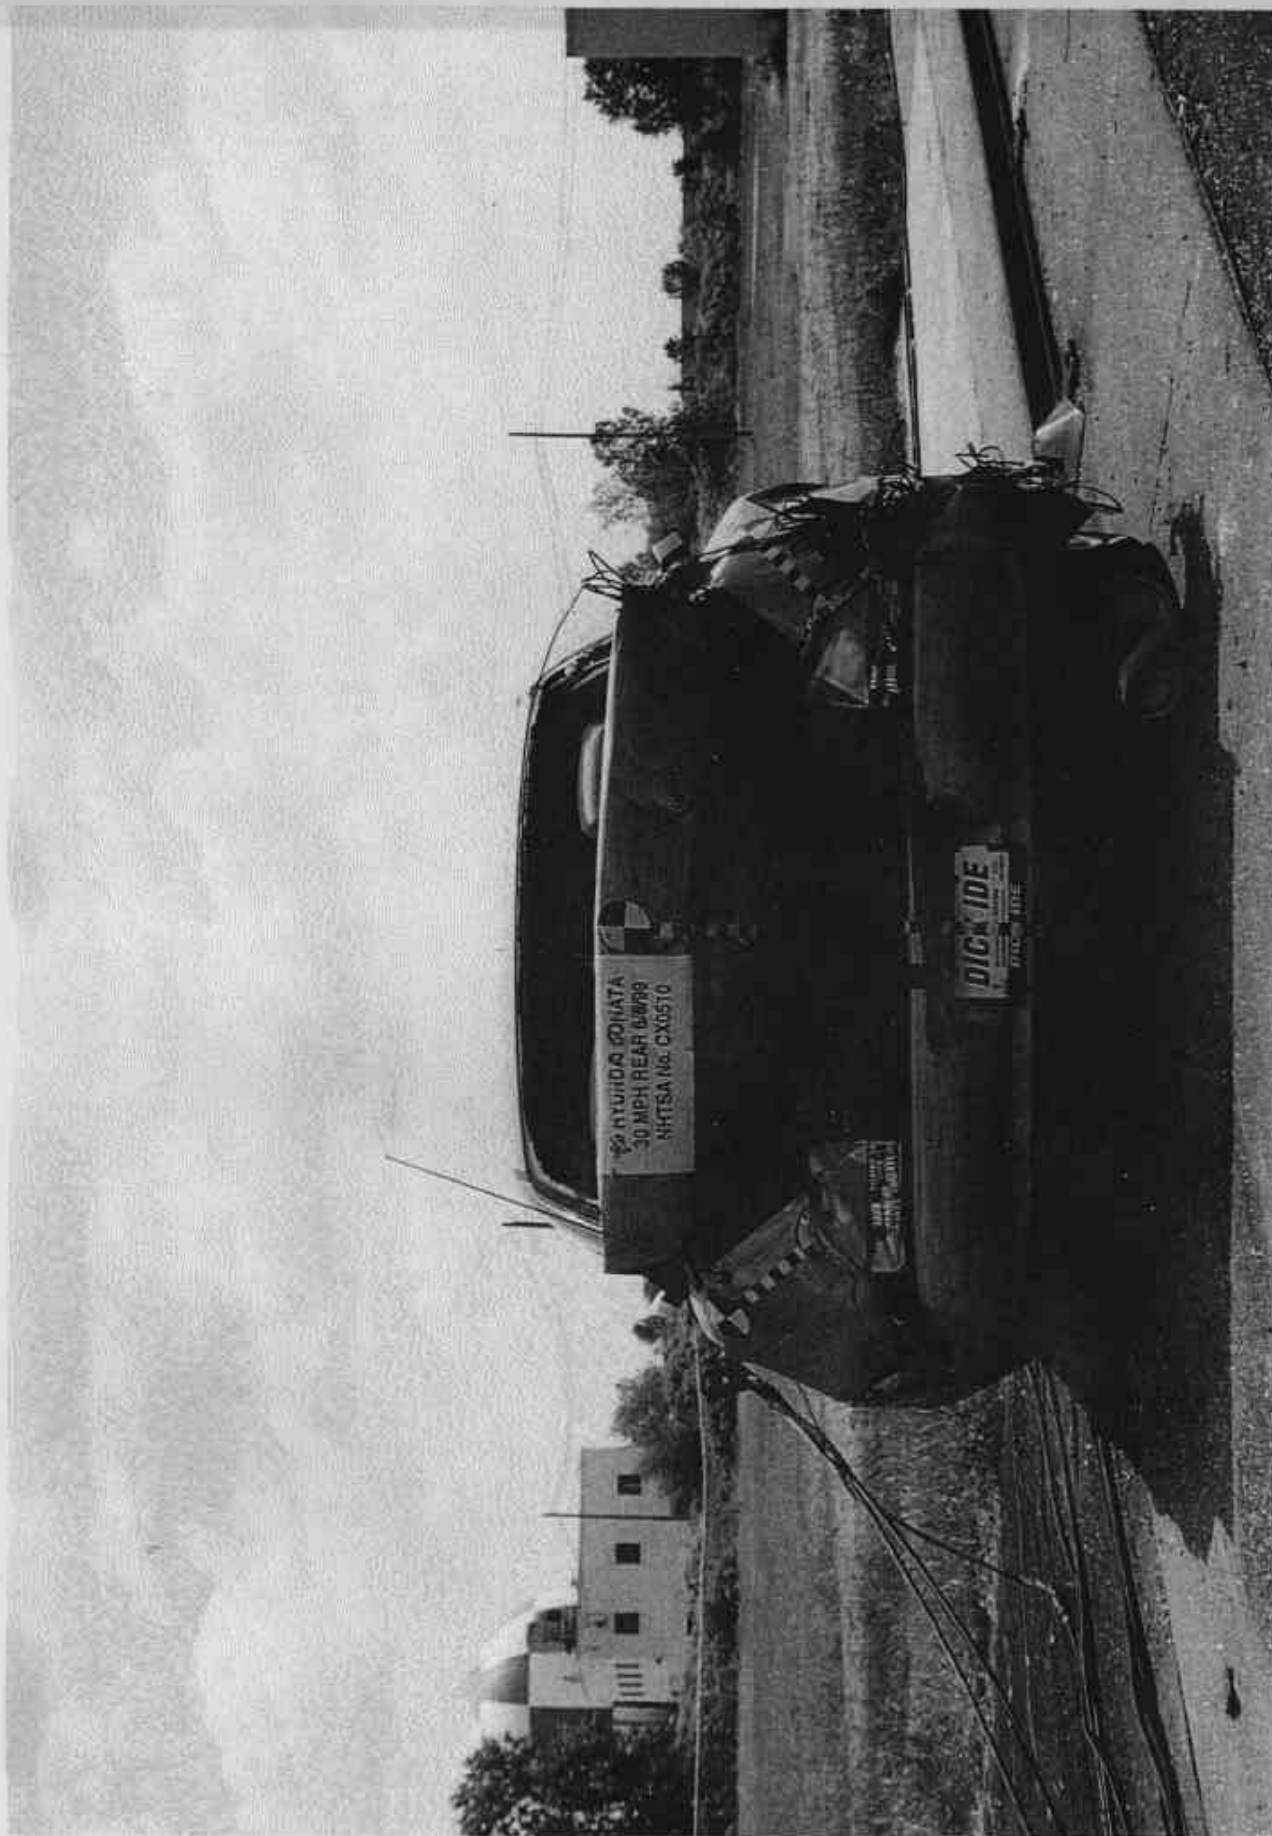
Figure A-8 POST-TEST REAR VIEW

Remarks: Driver's seat reclined (approx 43 degrees) but was operable. Passenger seat track released and was  
broken, seat back reclined (approx 17 degrees). Rear window shattered. Rear doors could not be opened  
by hand. Air bags did not deploy.
