REPORT NUMBER: SNCAP-CAL-00-6

**NEW CAR ASSESSMENT PROGRAM
SIDE IMPACT TEST**

DAIMLERCHRYSLER CORPORATION
2000 DODGE CARAVAN
MPV

NHTSA NUMBER: MY0303

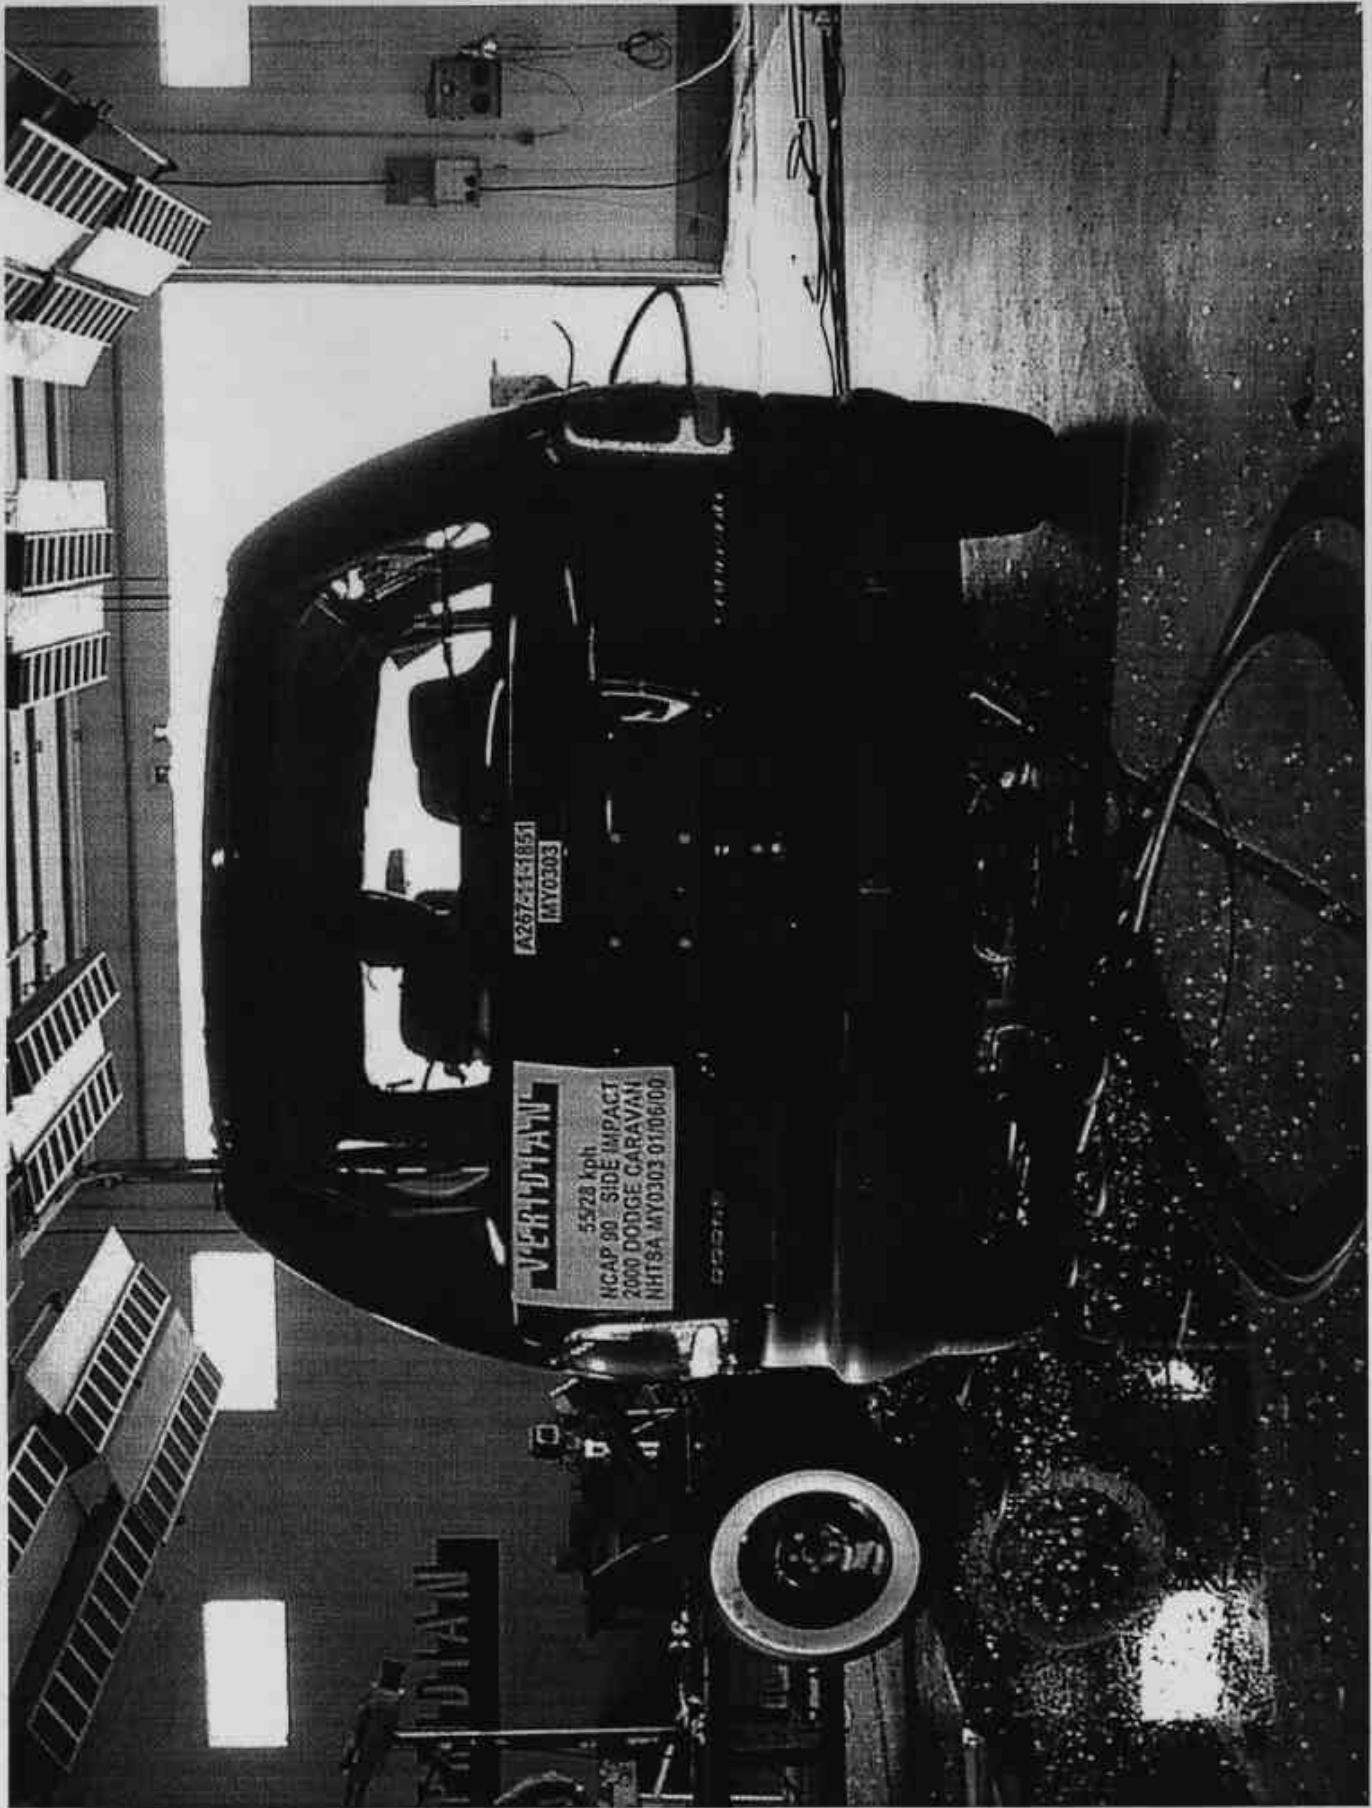
Figure A-4 POST-TEST REAR VIEW OF TEST VEHICLE

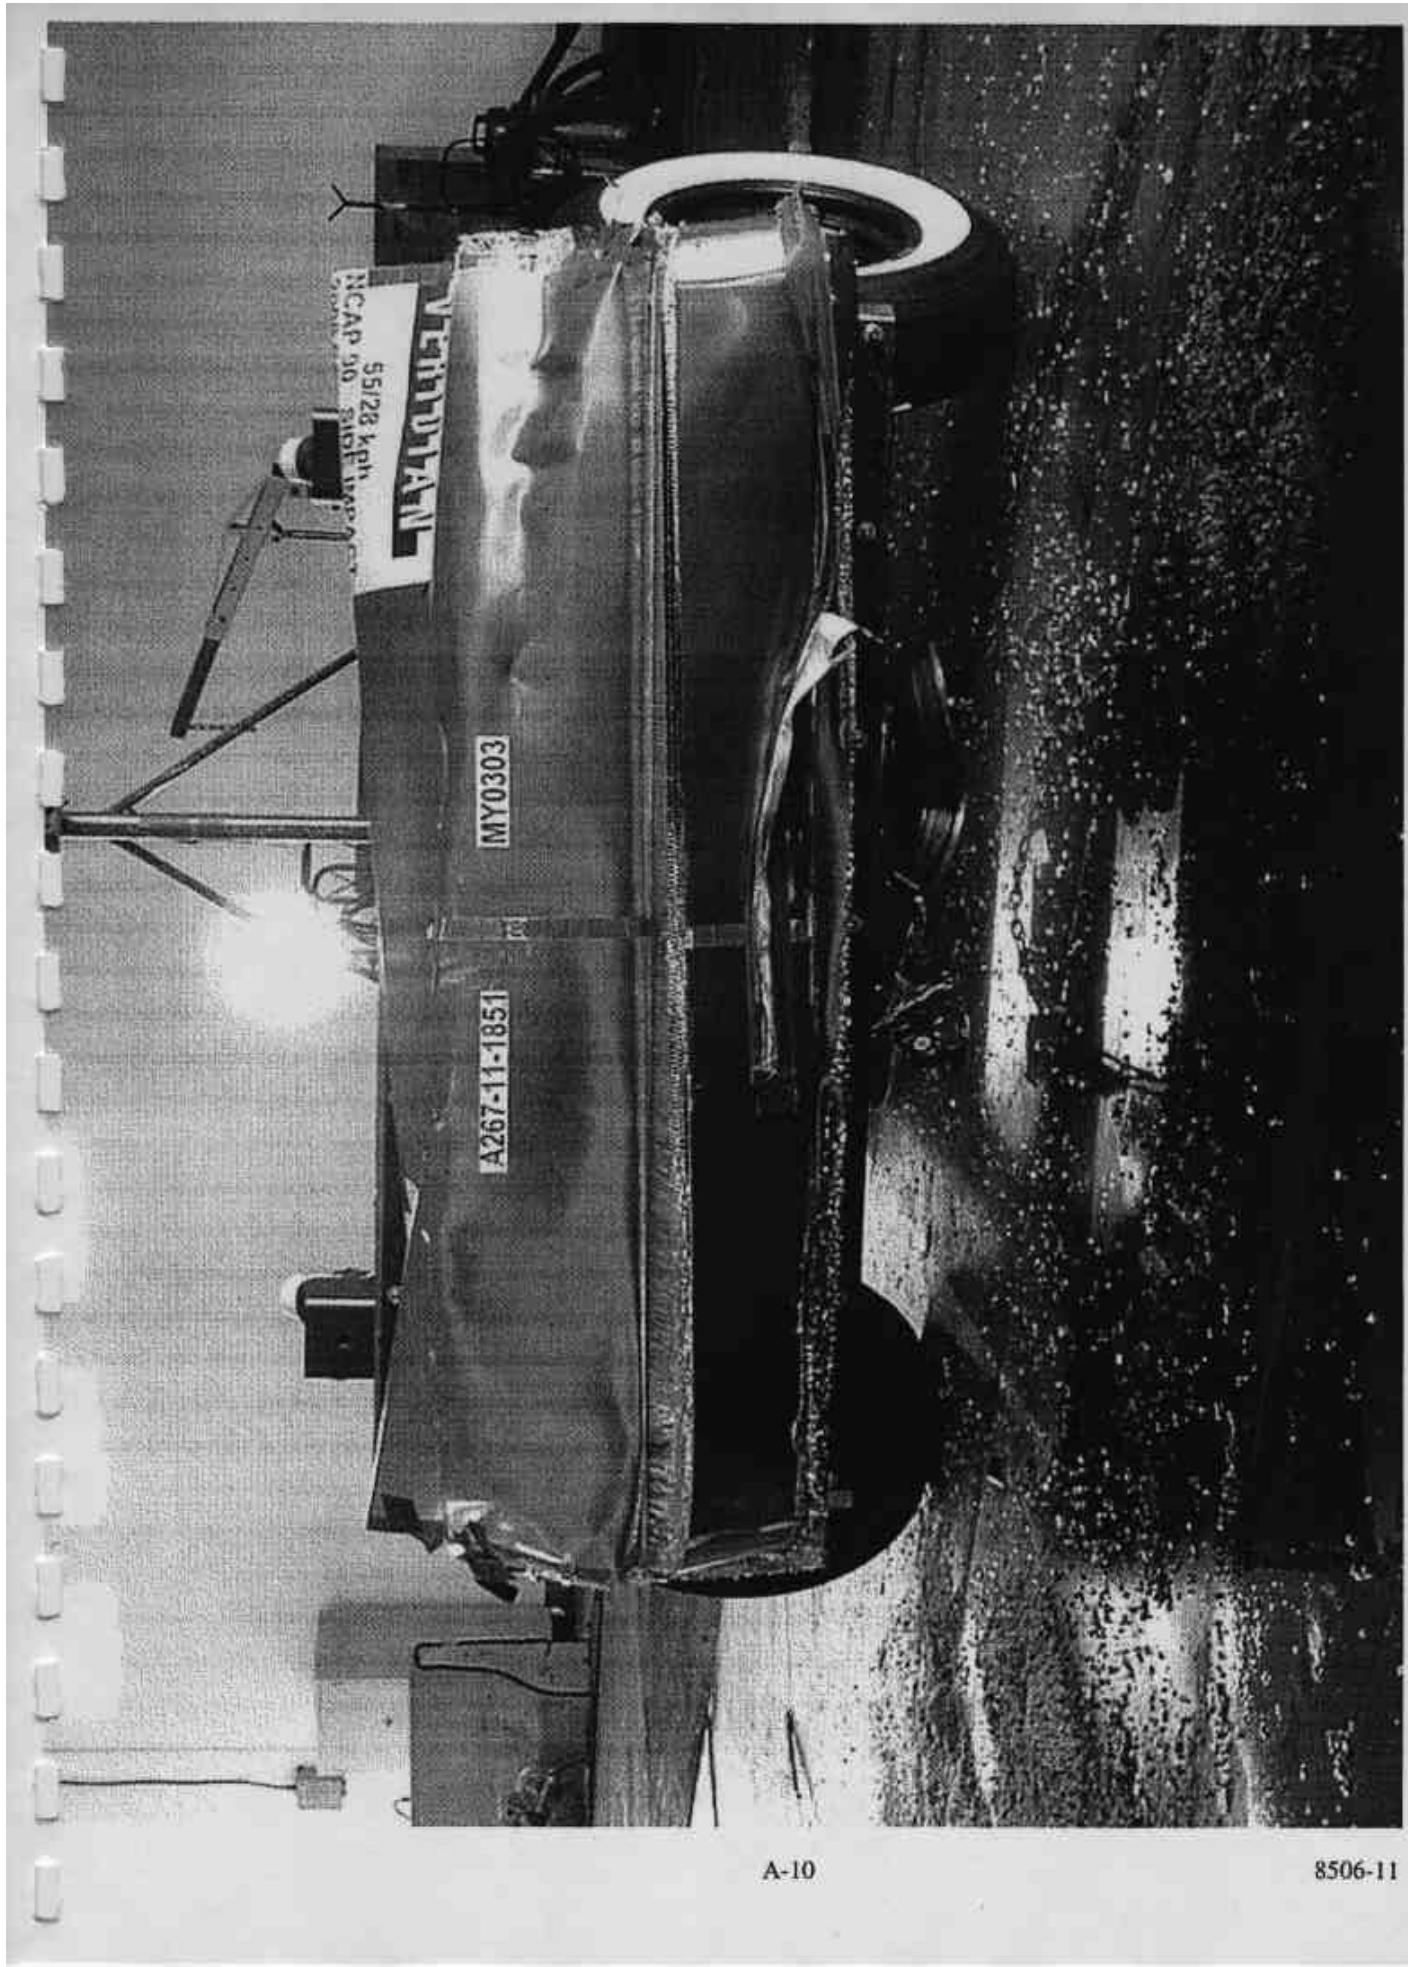
Figure A-8 POST-TEST FRONTAL VIEW OF IMPACTOR FACE

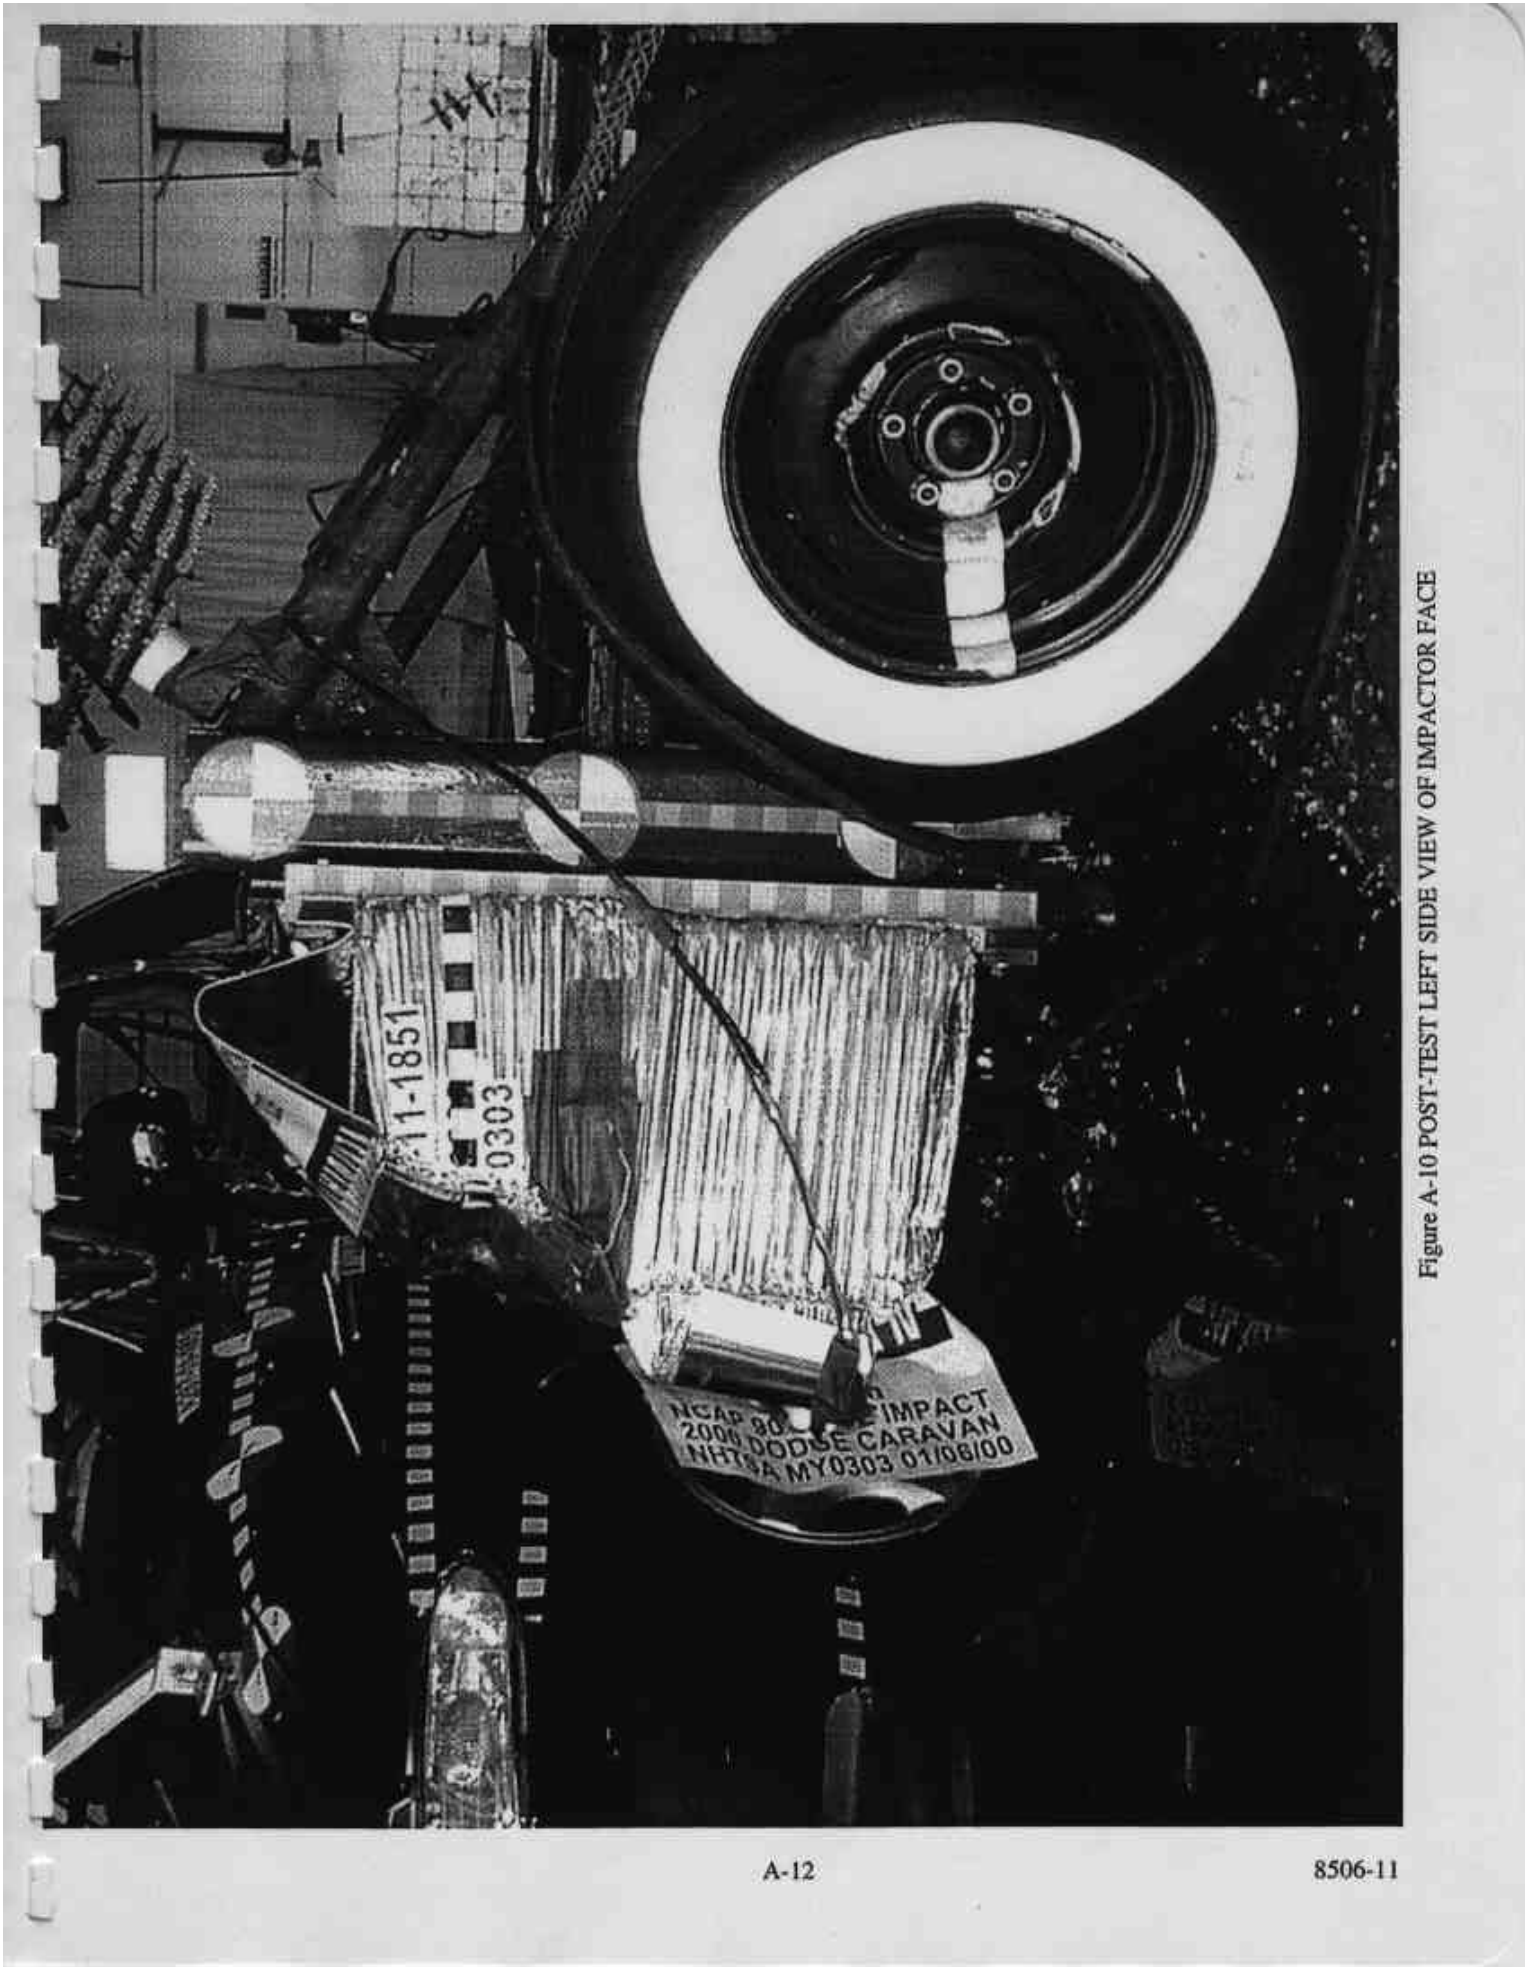
Figure A-10 POST-TEST LEFT SIDE VIEW OF IMPACTOR FACE

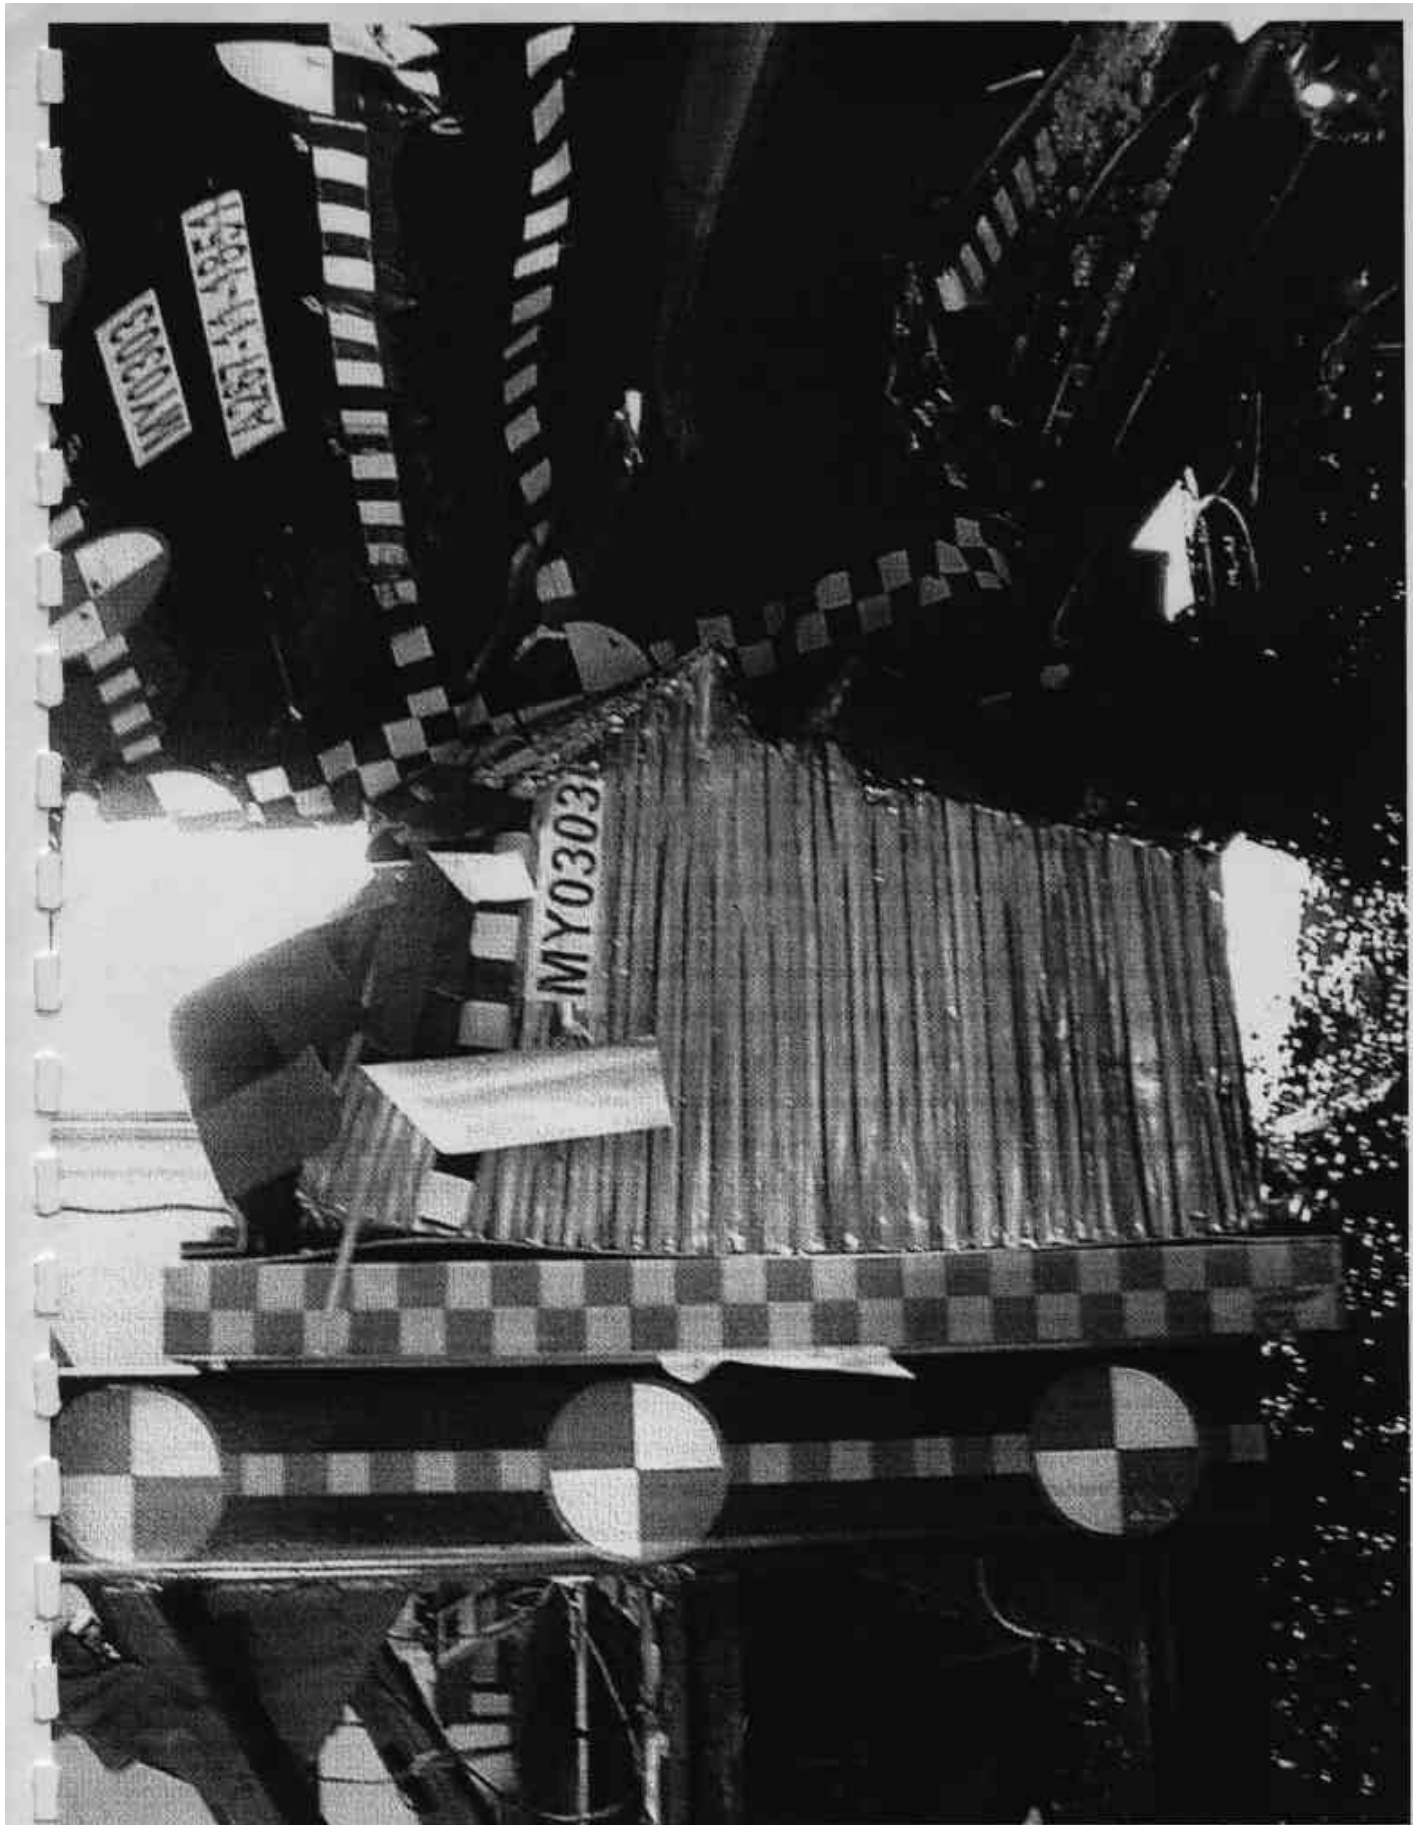
Figure A-12 POST-TEST RIGHT SIDE VIEW OF IMPACTOR FACE

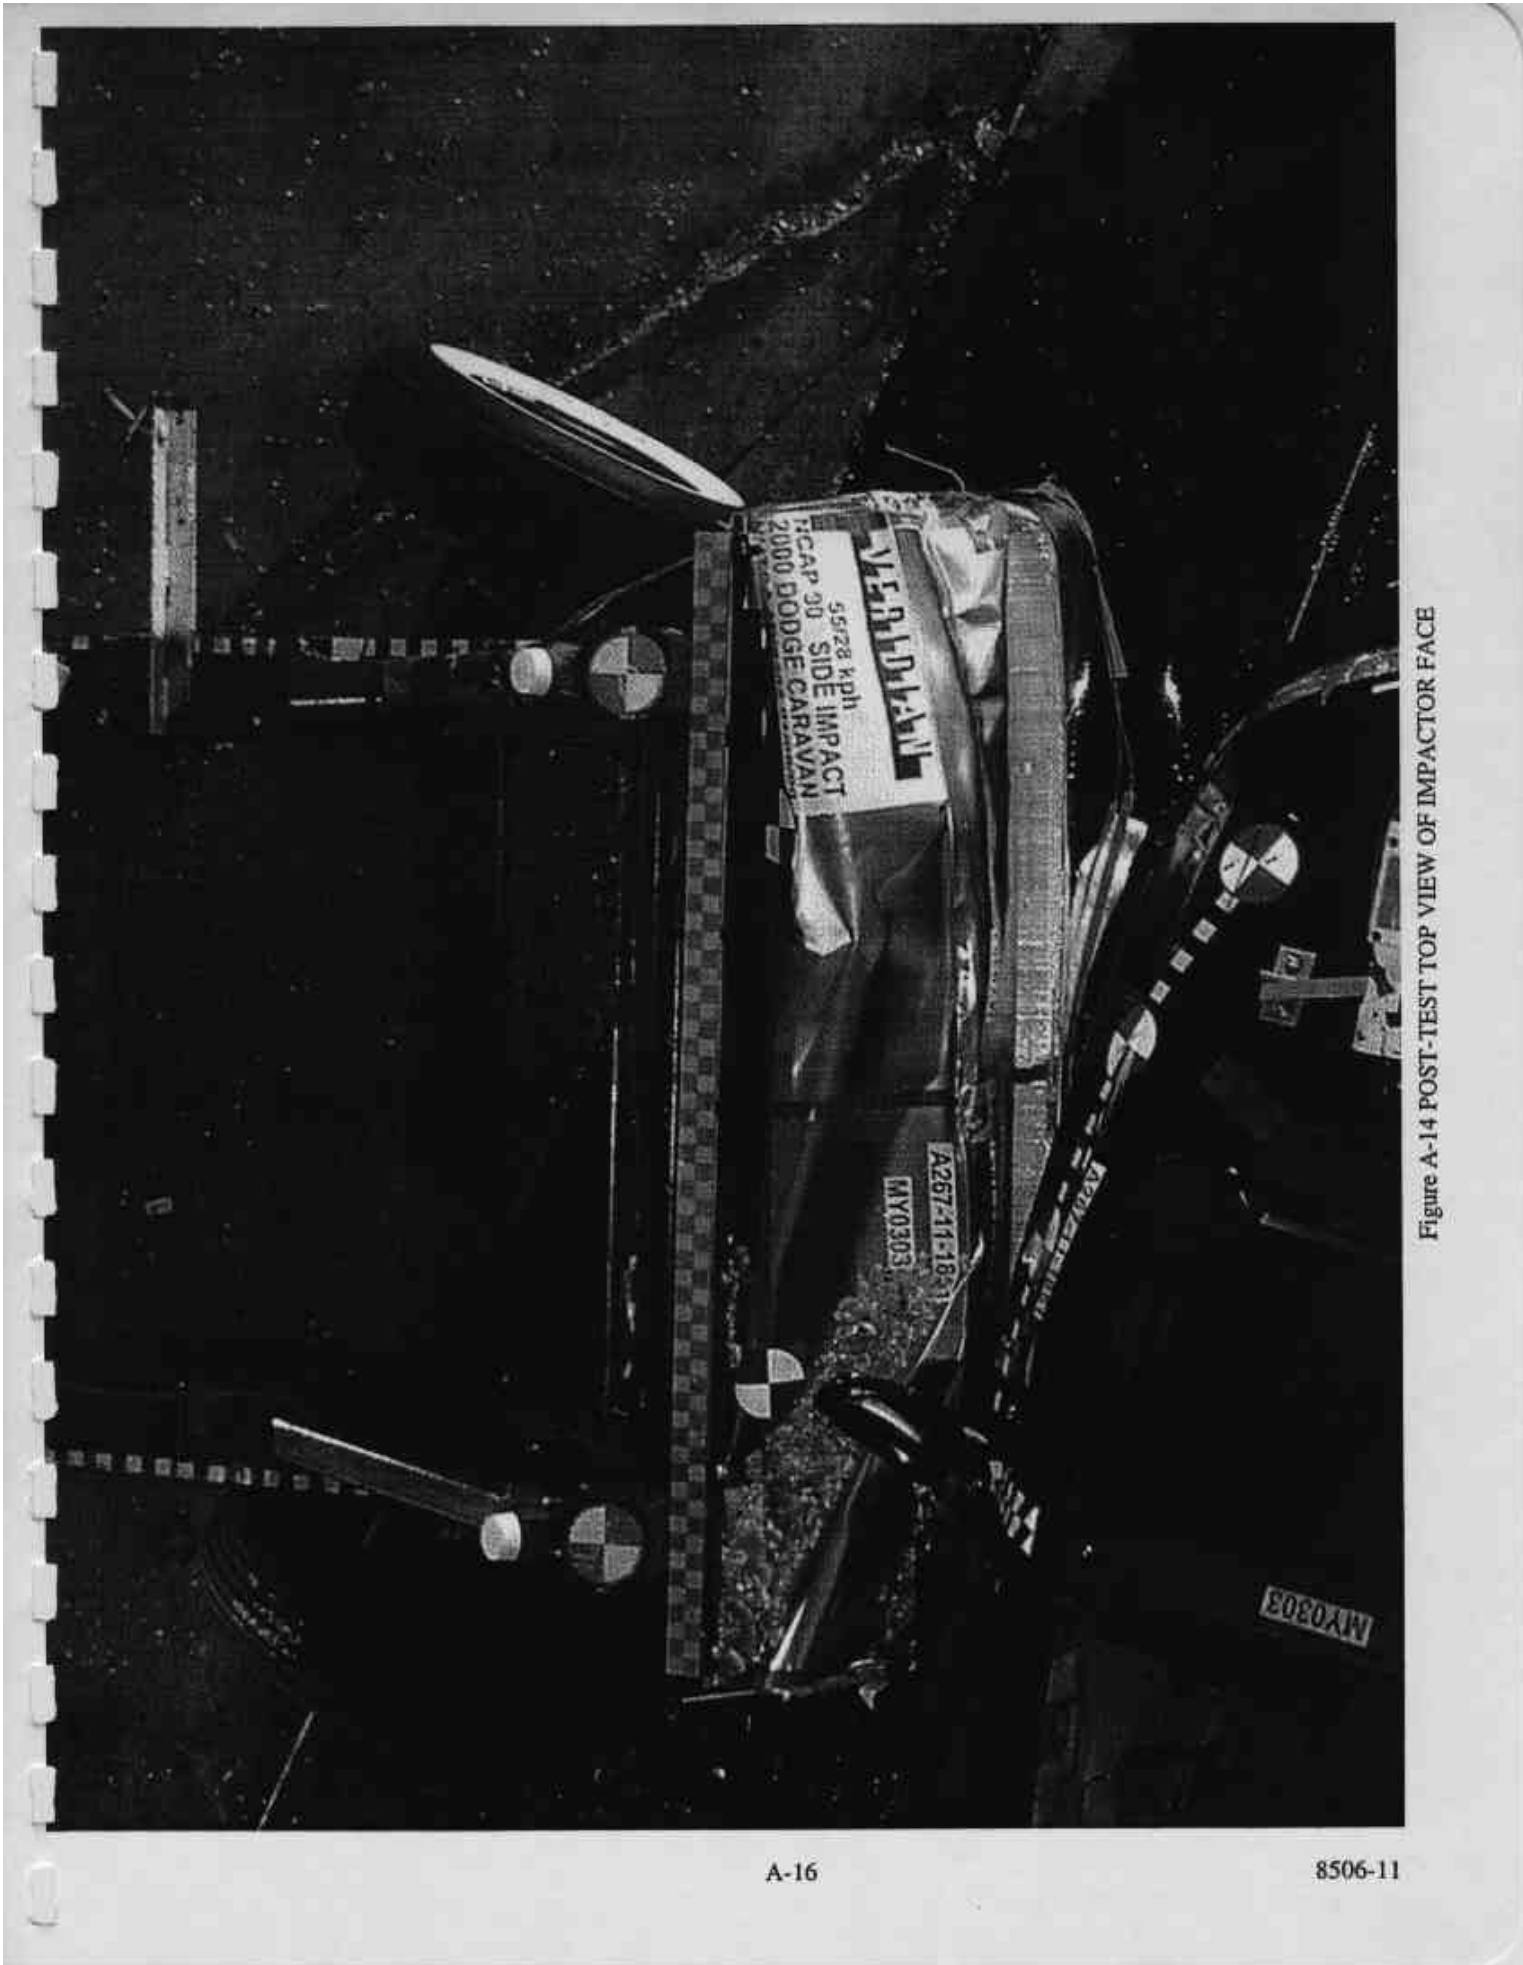
Figure A-14 POST-TEST TOP VIEW OF IMPACTOR FACE

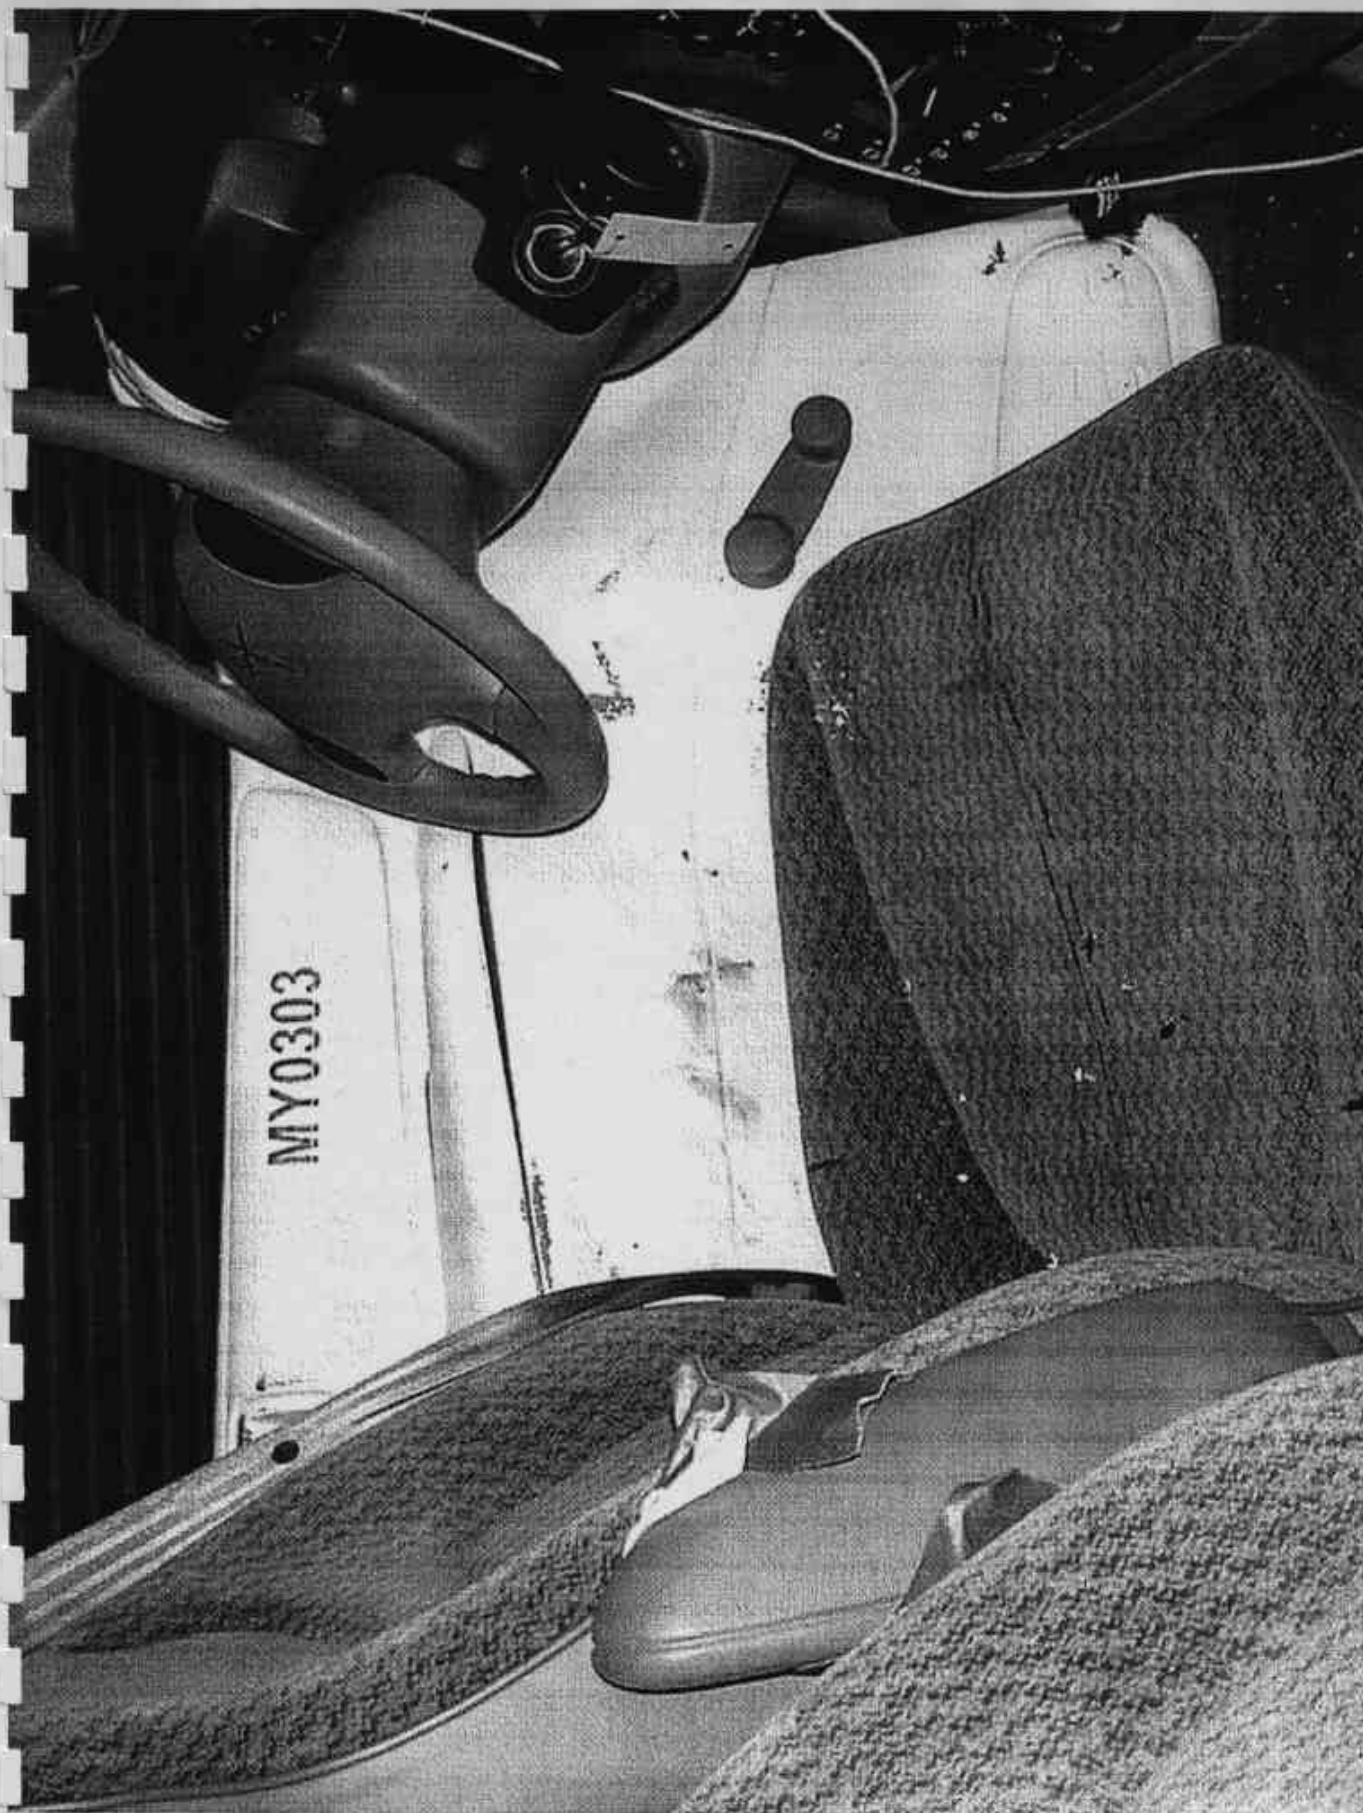
Figure A-26 POST-TEST INTERIOR OF FRONT DOOR SHOWING SID IMPACT LOCATIONS

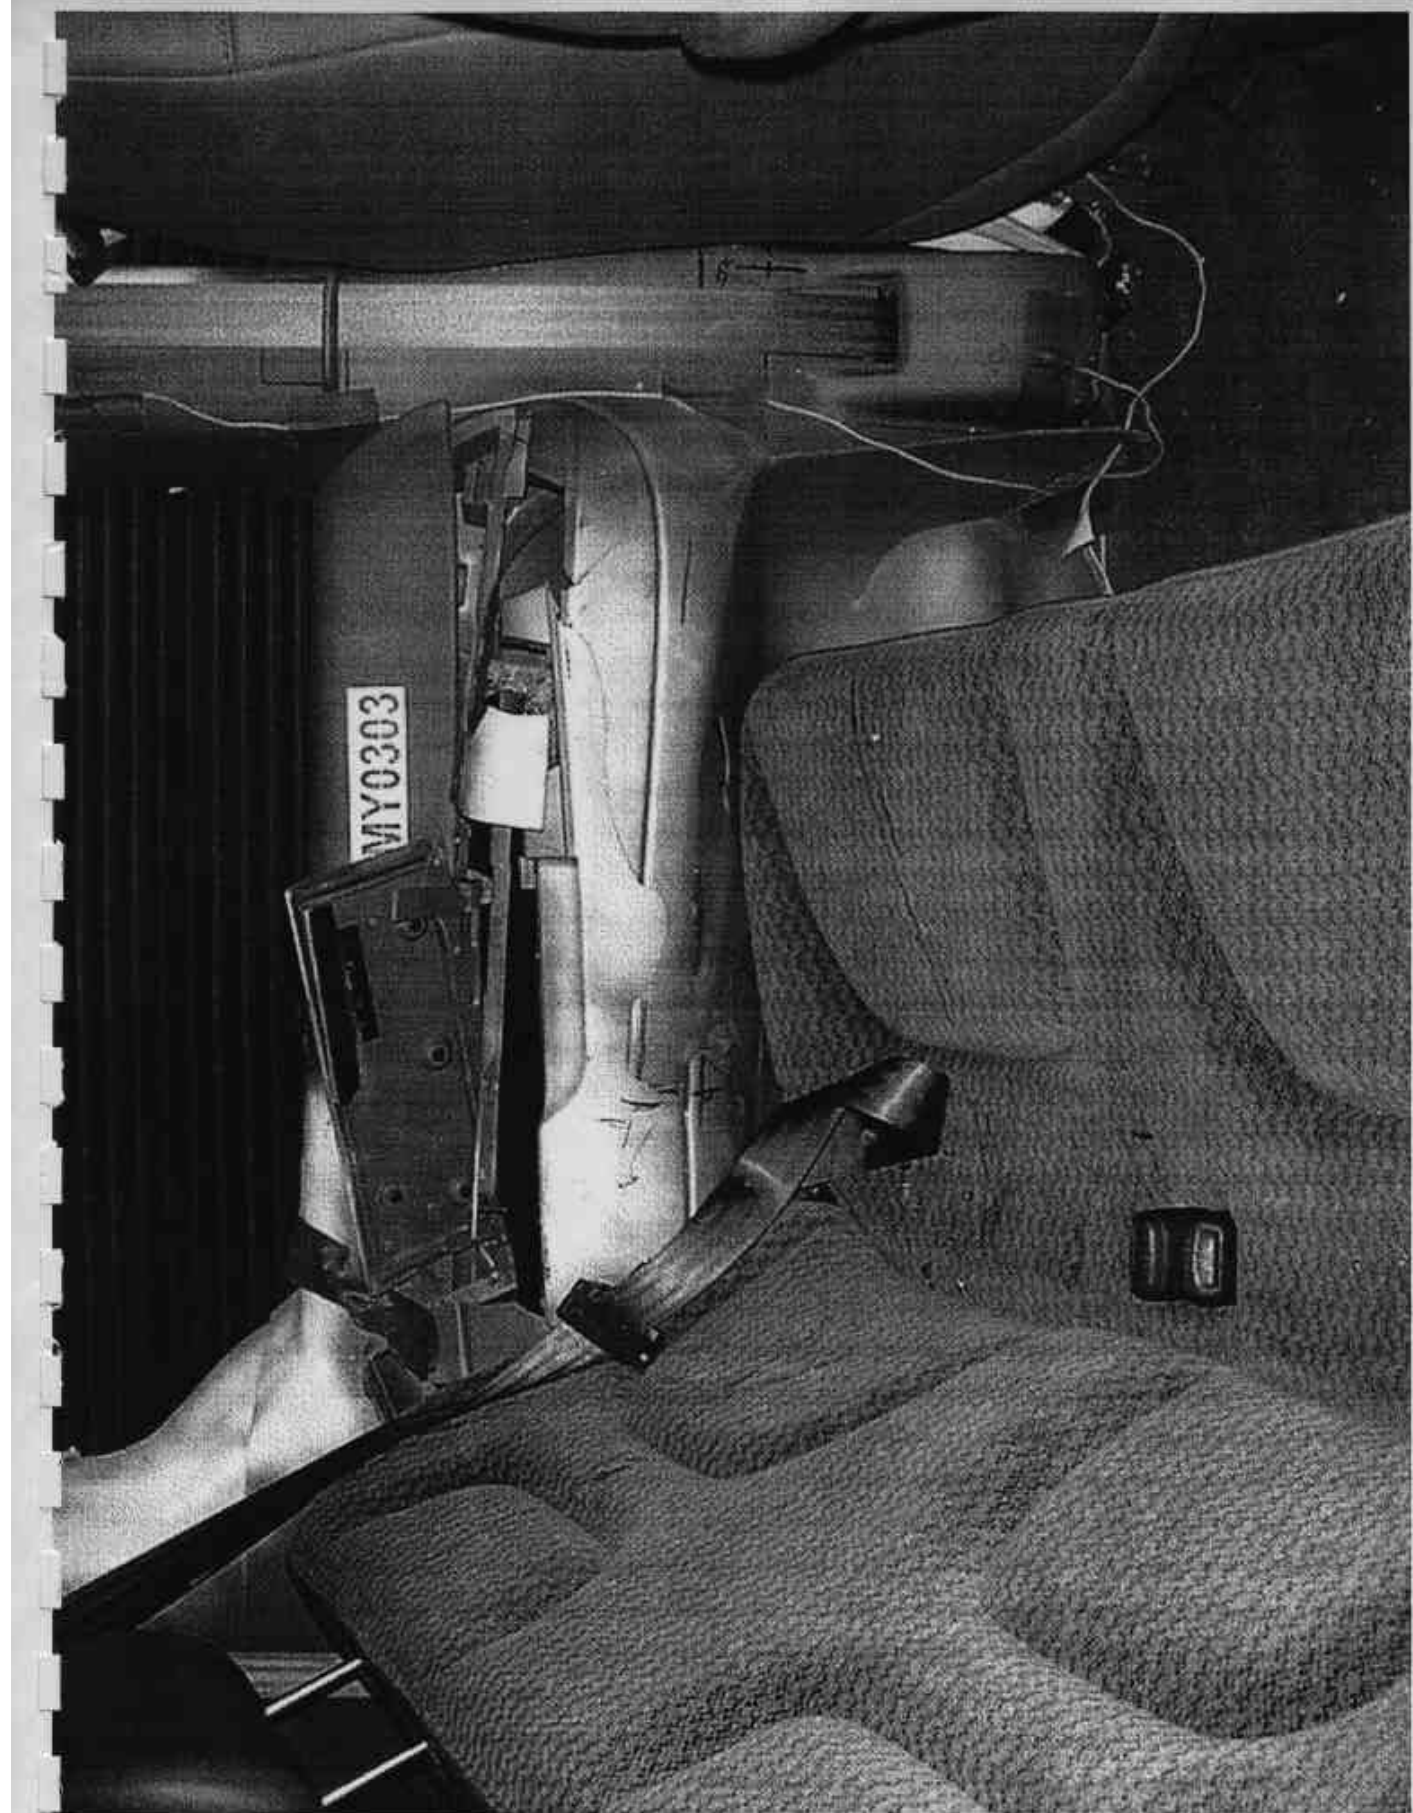
Figure A-28 POST-TEST INTERIOR OF REAR DOOR SHOWING SID IMPACT LOCATIONS

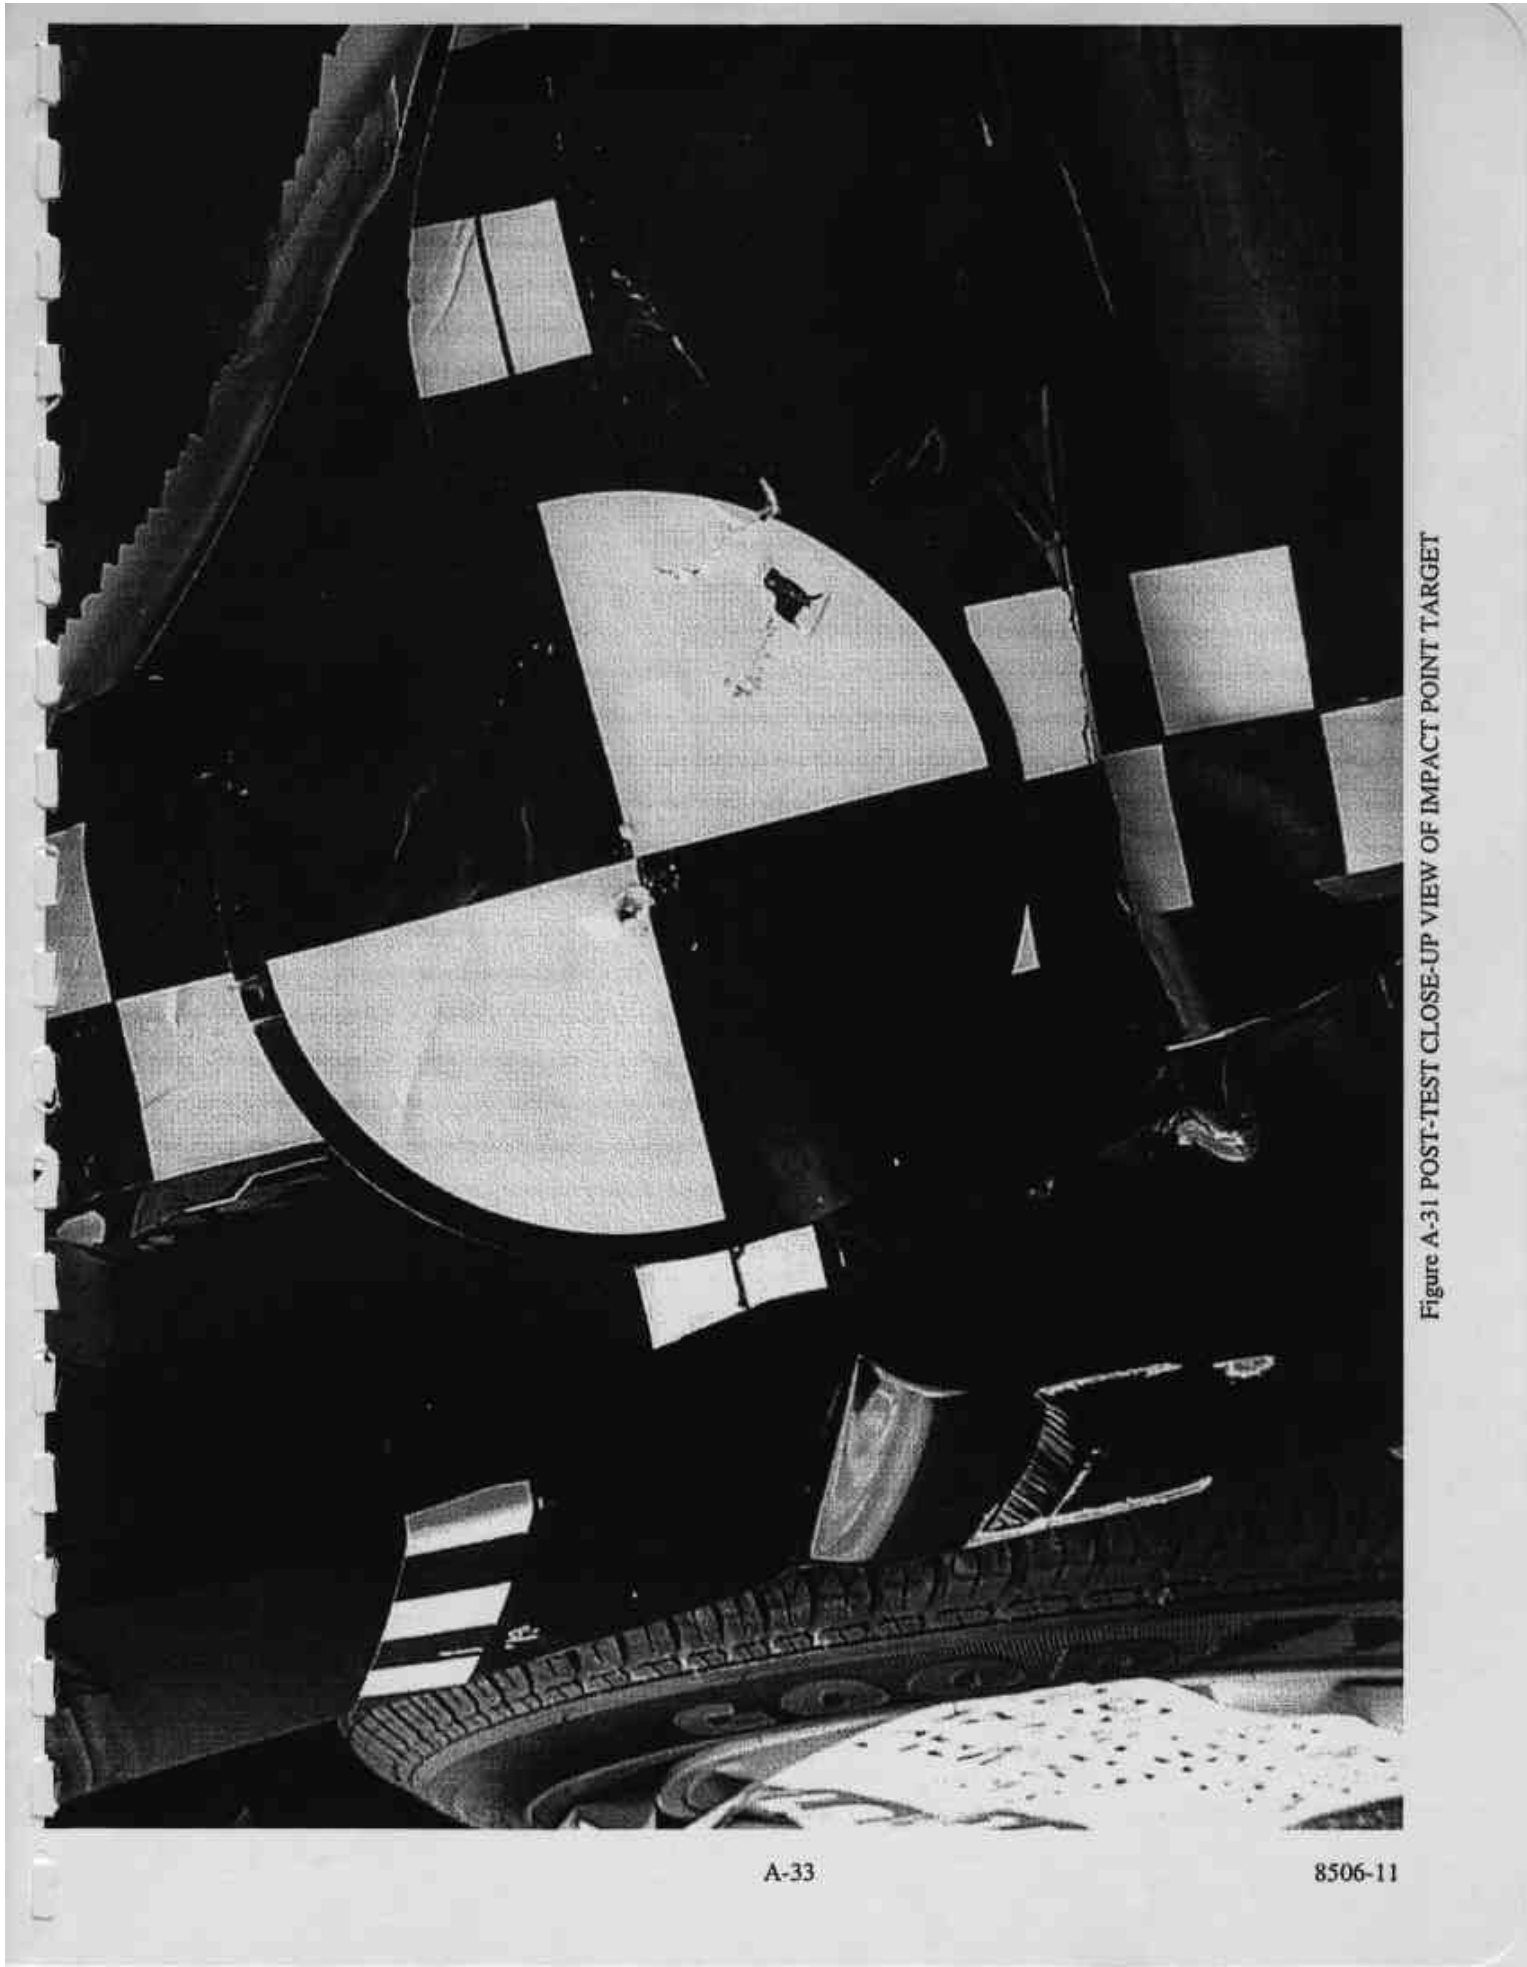
Figure A-31 POST-TEST CLOSE-UP VIEW OF IMPACT POINT TARGET

Actual Impact Point is 496 millimeters rearward of front axle centerline
