REPORT NUMBER: SNCAP-CAL-00-6

**NEW CAR ASSESSMENT PROGRAM
SIDE IMPACT TEST**

DAIMLERCHRYSLER CORPORATION
2000 DODGE CARAVAN
MPV

NHTSA NUMBER: MY0303

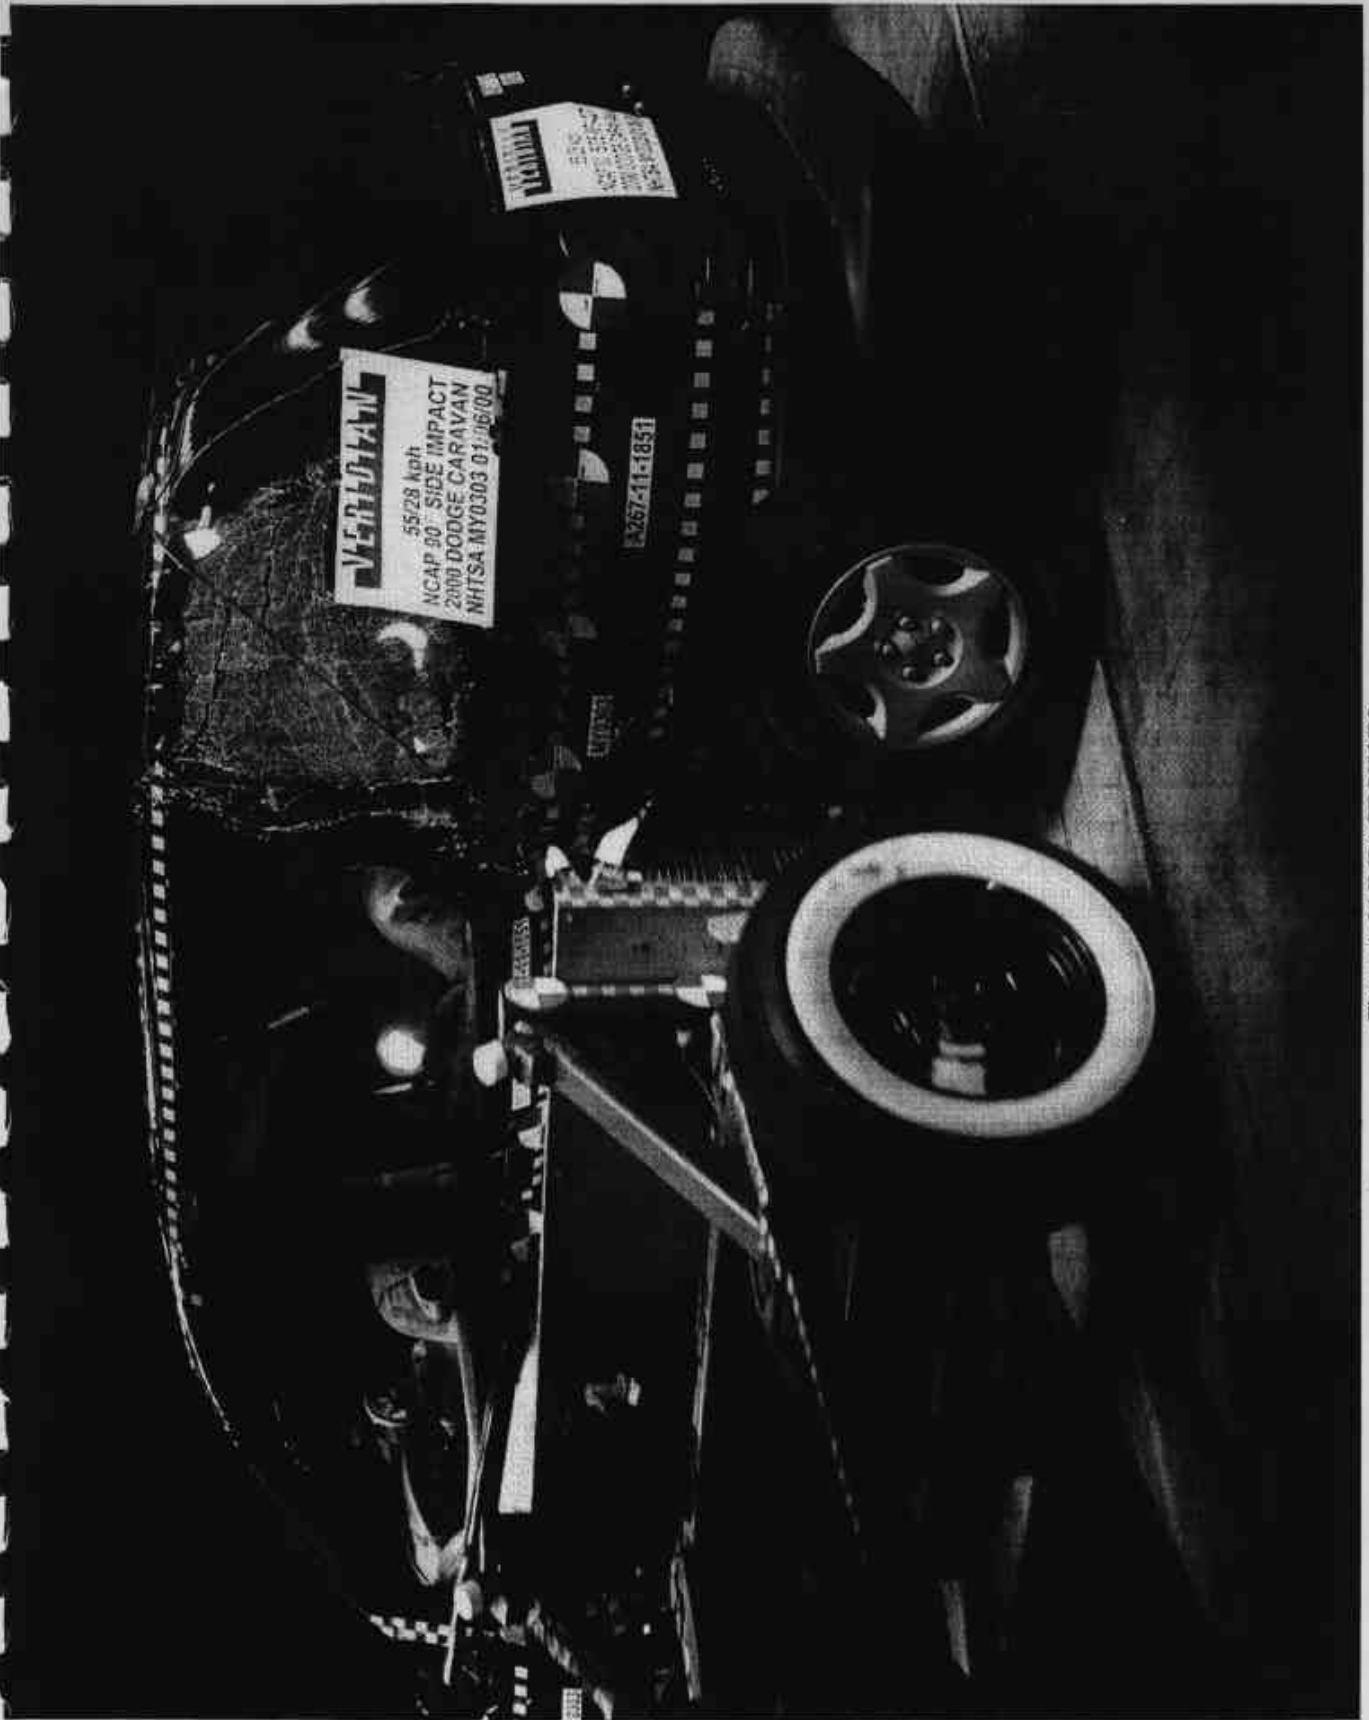
Figure A-34 IMPACT PHOTO
