**1991 Dodge Caravan
into 12-Inch Diameter Centered Pole
in Support of
Crash III Damage Algorithm Reformulation**

TRC Test Nos.: 960404-1

**Prepared by:
Transportation Research Center Inc.
10820 State Route 347
East Liberty, OH 43319**

**April - May 1996
Final Report**

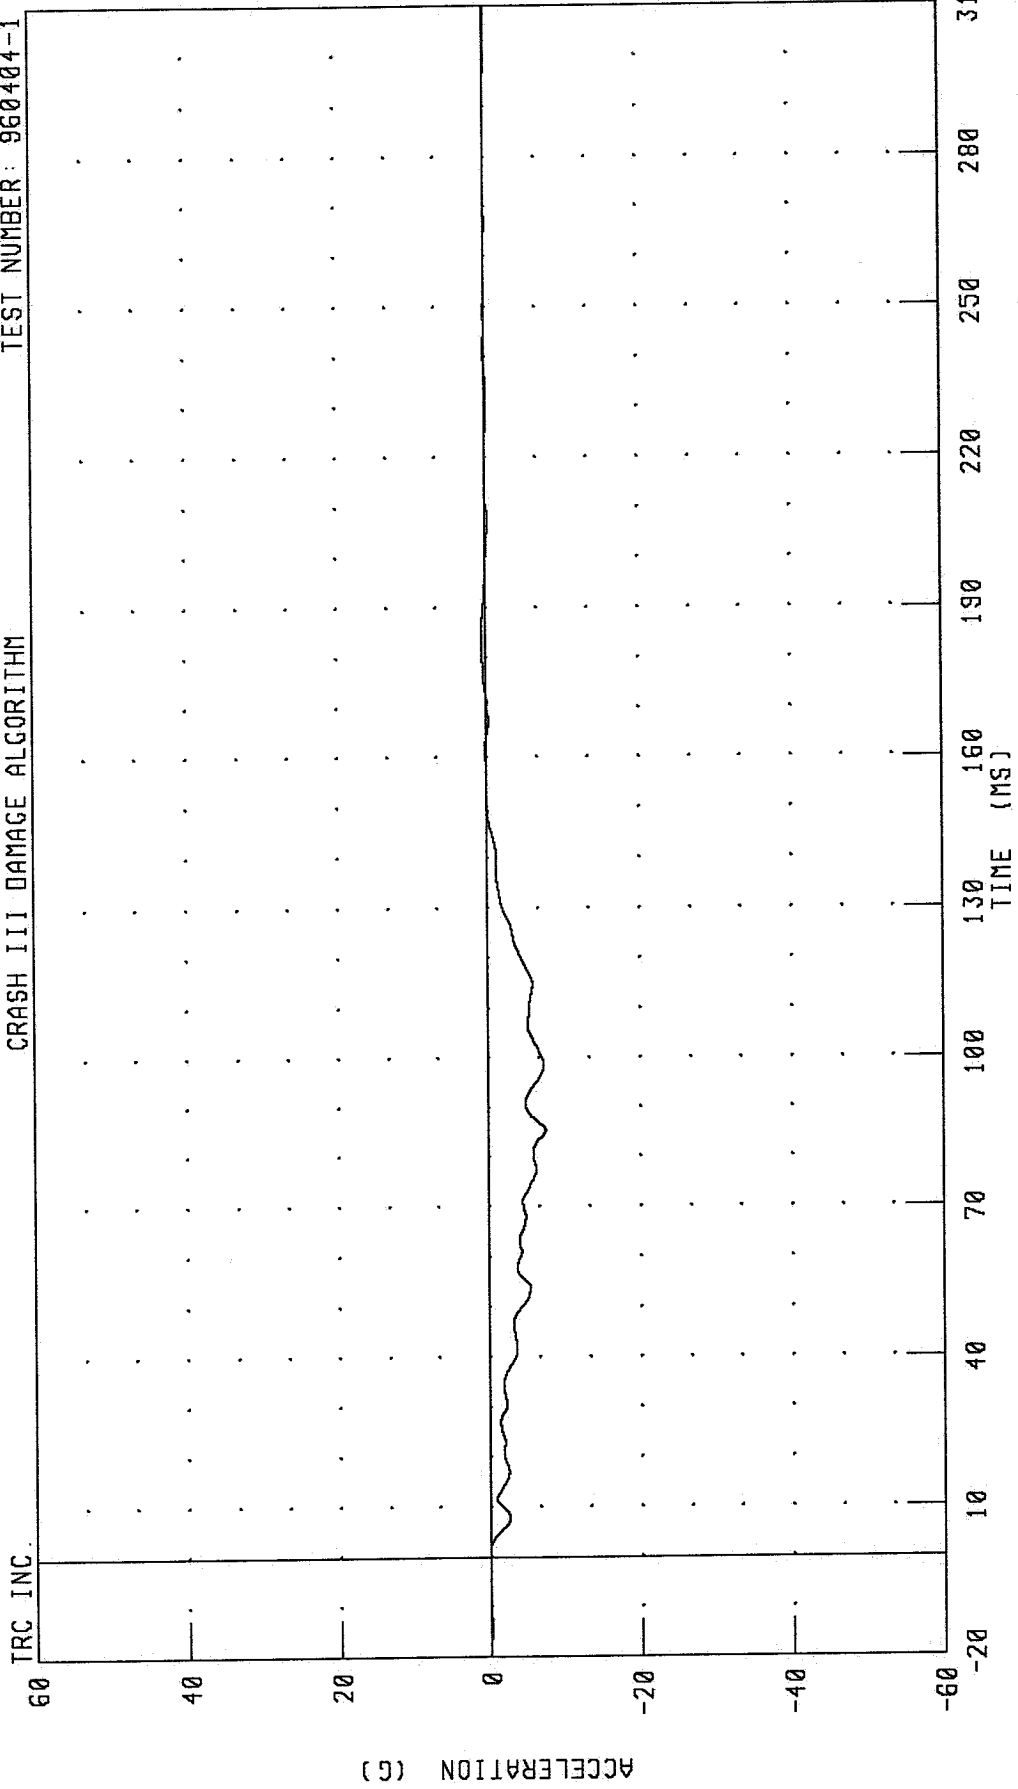
TEST NUMBER: 960404-1

1991 DODGE CARAVAN INTO POLE BARRIER AT 10 MPH TEST NO. 1
LEFT REAR SILL X-AXIS ACCELERATION
CRASH III DAMAGE ALGORITHM

CHANNEL: LRSXG1 FILTER: CH. CLASS 60

PEAK DATA: 0.52 G @ 180.56 MS; -7.53 G @ 85.36 MS

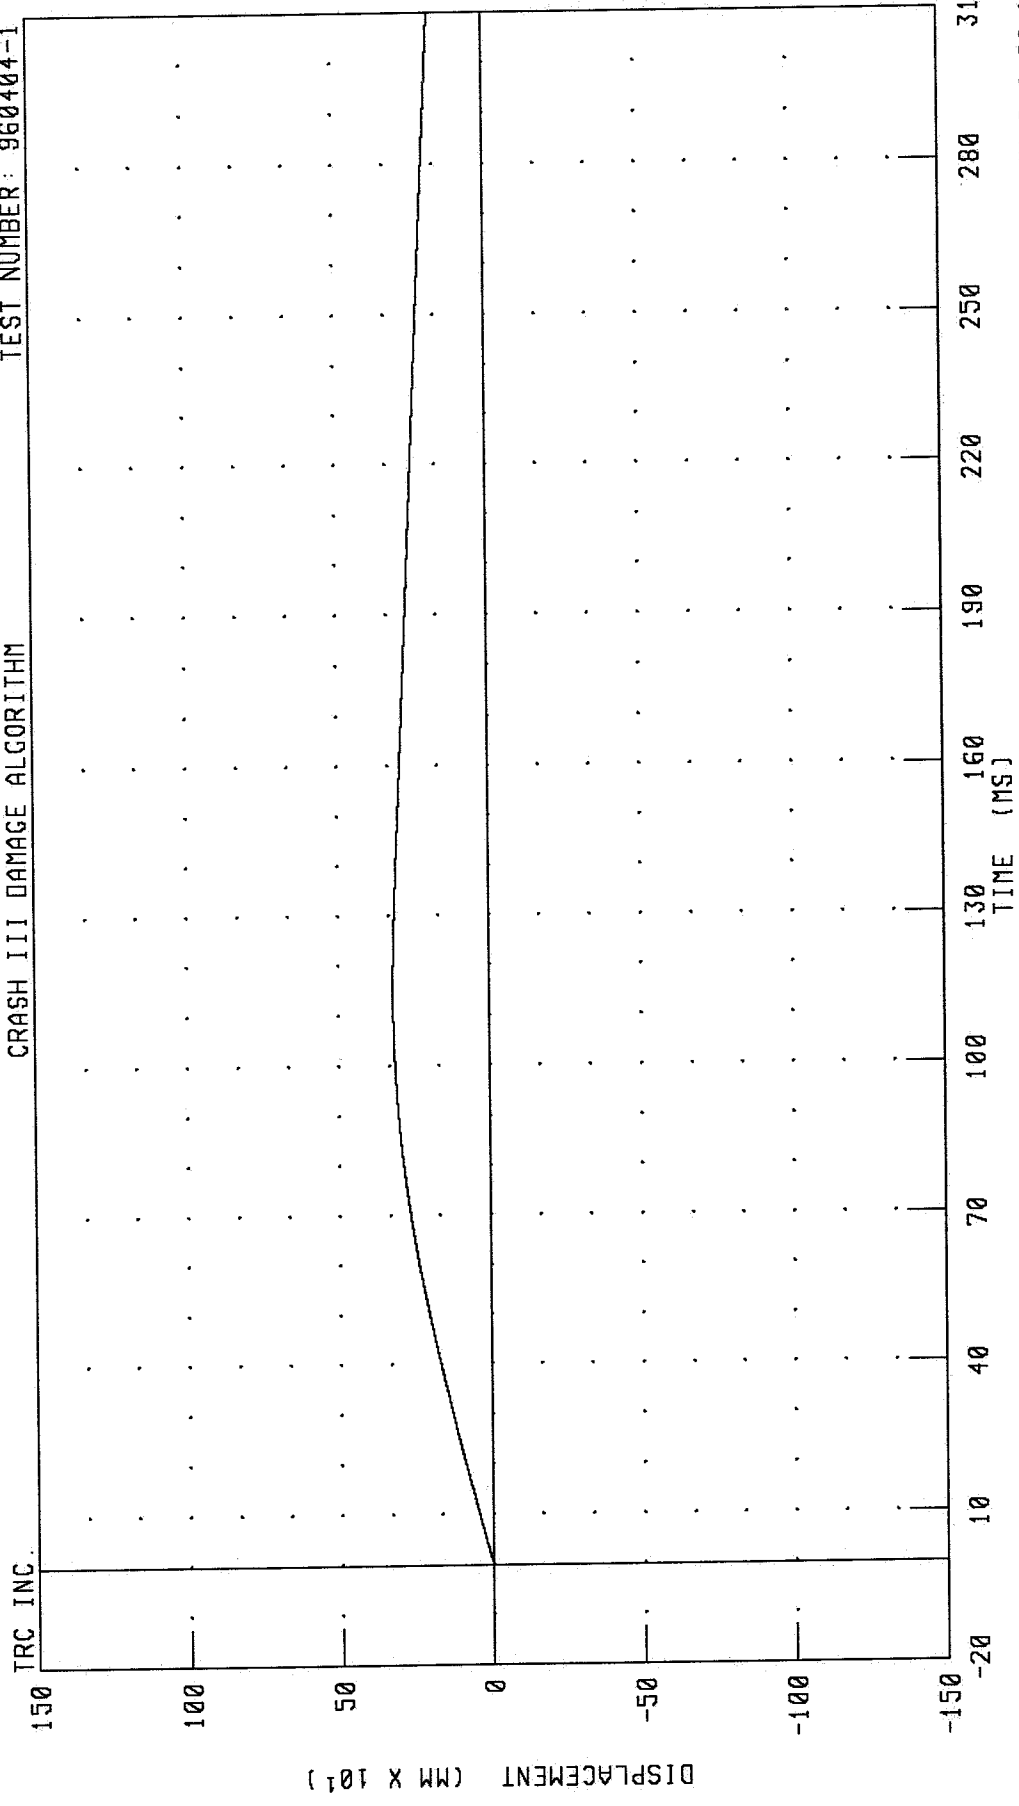
TEST NUMBER: 960404-1

1991 DODGE CARAVAN INTO POLE BARRIER AT 10 MPH TEST NO. 1
LEFT REAR SILL X-AXIS DISPLACEMENT
CRASH III DAMAGE ALGORITHM

CHANNEL: LRSXD1 FILTER: CH. CLASS 180 PEAK DATA: 320.66 MM @ 114.40 MS; 0.00 MM @ 0.00 MS

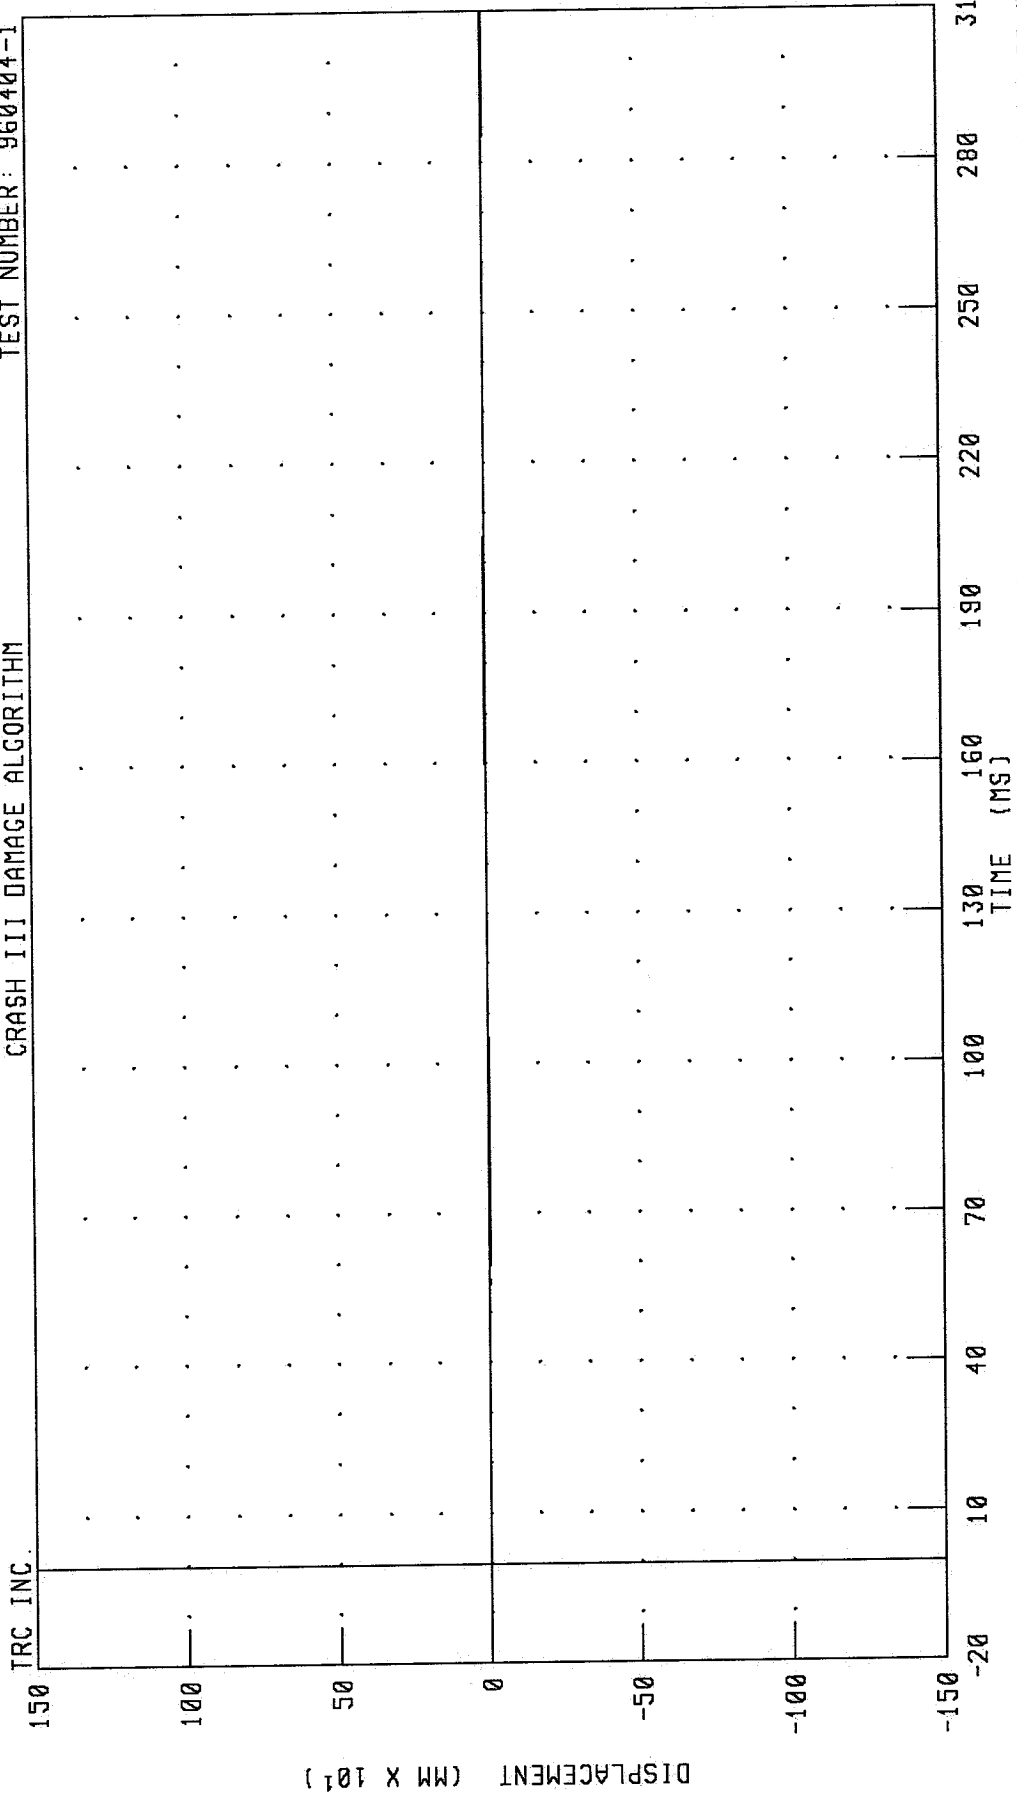
TEST NUMBER: 960404-1

1991 DODGE CARAVAN INTO POLE BARRIER AT 10 MPH TEST NO. 1
 LEFT REAR SILL Z-AXIS DISPLACEMENT
 CRASH III DAMAGE ALGORITHM

CHANNEL: LRSZD1 FILTER: CH. CLASS 180

PEAK DATA: 3.30 MM @ 184.32 MS; -3.70 MM @ 88.80 MS

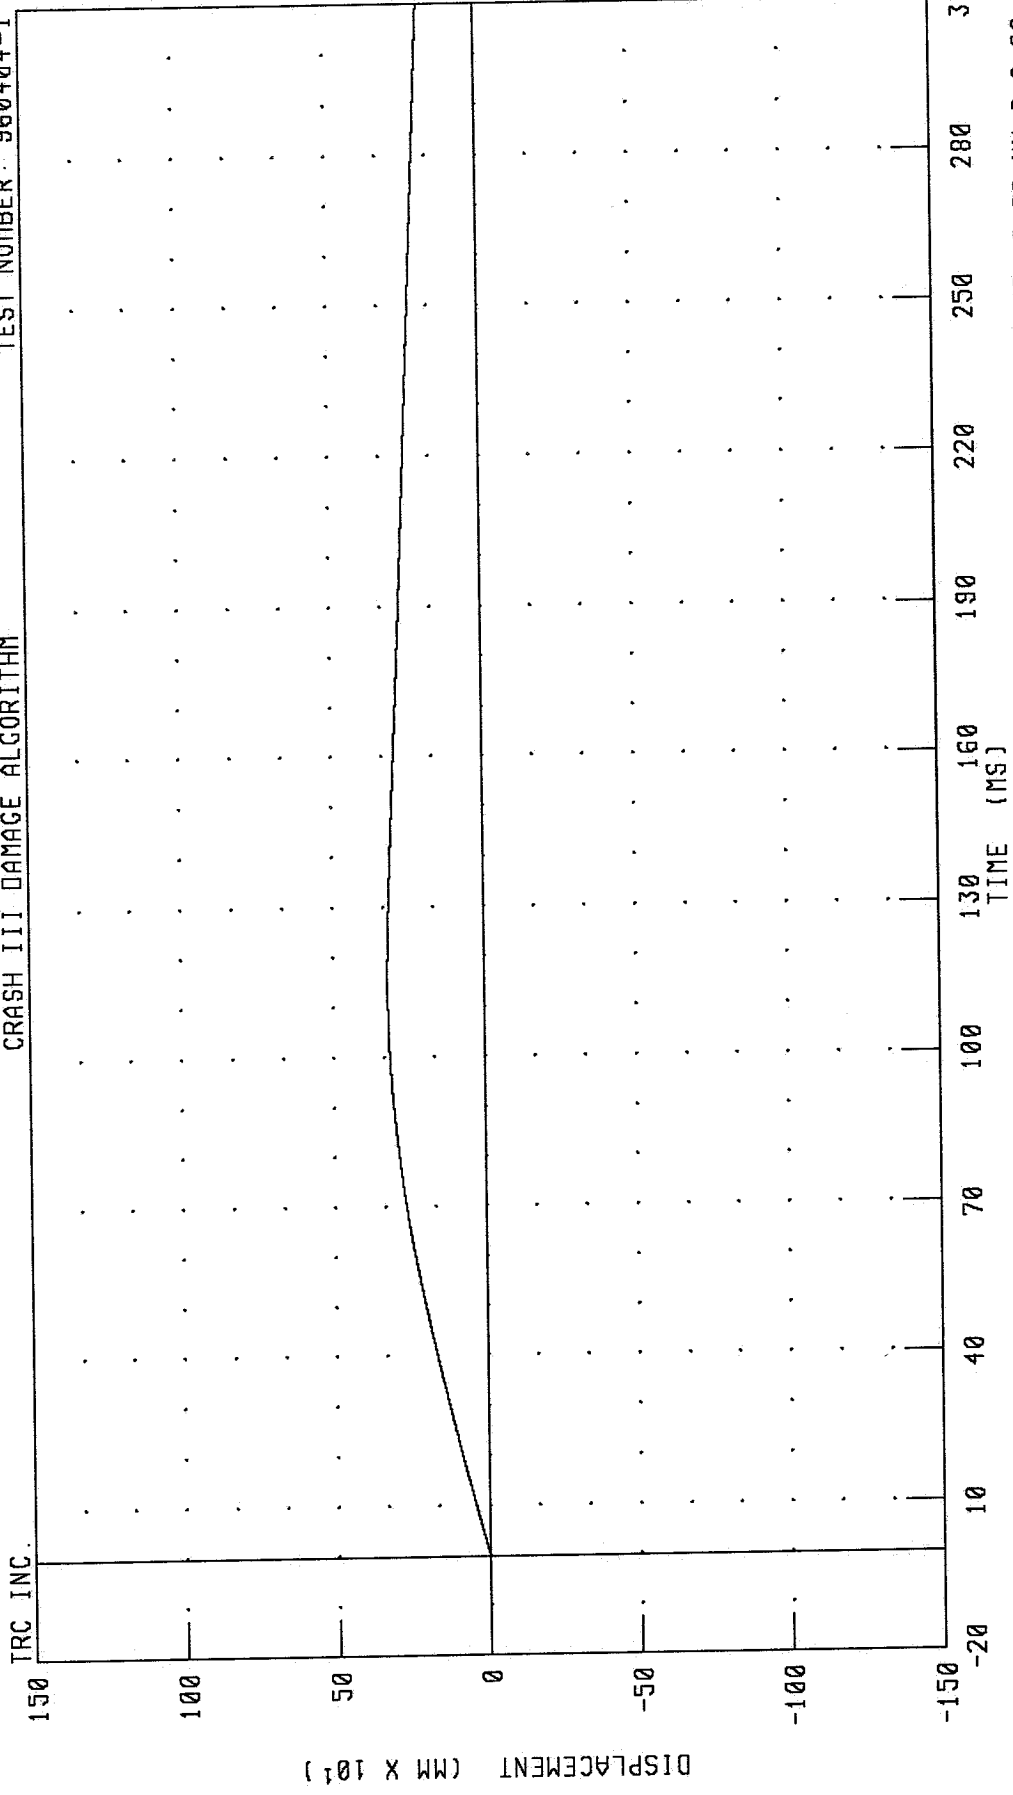
TEST NUMBER: 960404-1

1991 DODGE CARAVAN INTO POLE BARRIER AT 10 MPH TEST NO. 1
LEFT FRONT SILL X-AXIS DISPLACEMENT
CRASH III DAMAGE ALGORITHM

CHANNEL: LFSXD1 FILTER: CH. CLASS 180 PEAK DATA: 320.54 MM @ 114.56 MS; 0.00 MM @ 0.00 MS

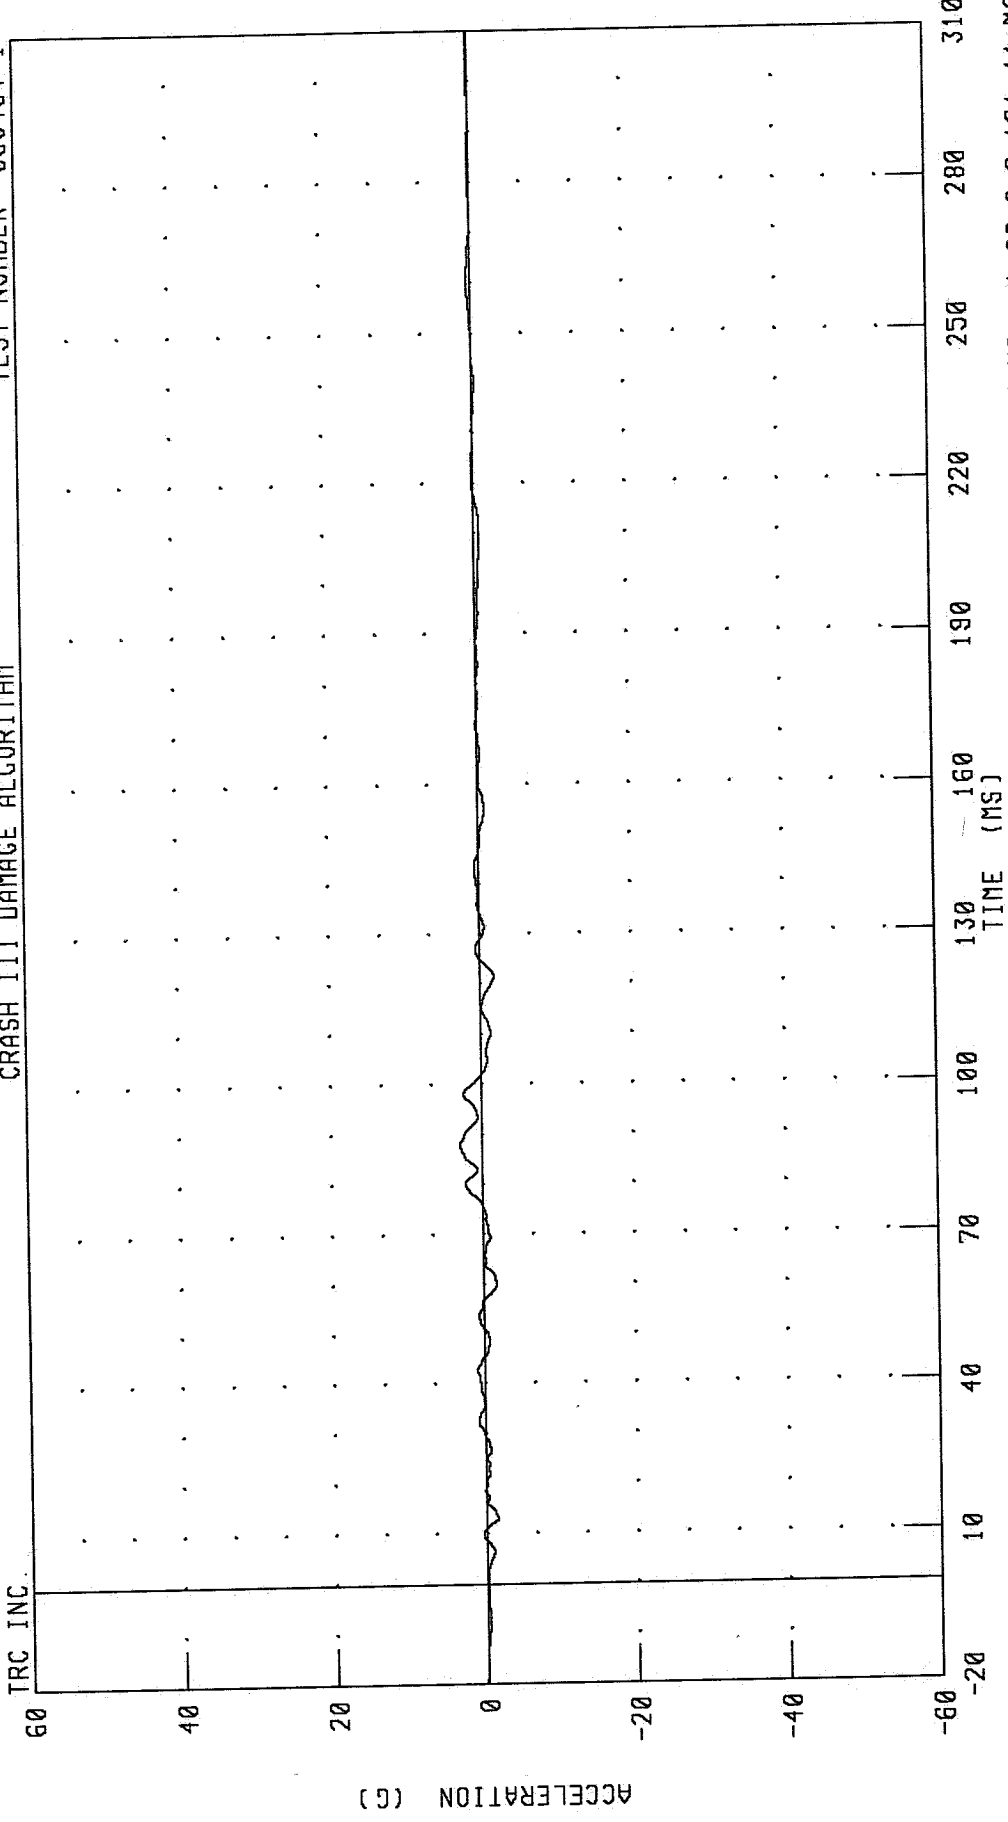
TEST NUMBER: 960404-1

1991 DODGE CARAVAN INTO POLE BARRIER AT 10 MPH TEST NO. 1
LEFT FRONT SILL Z-AXIS ACCELERATION
CRASH III DAMAGE ALGORITHM

PEAK DATA: 2.90 G @ 87.84 MS; -1.82 G @ 121.44 MS

CHANNEL: LFSZG1 FILTER: CH. CLASS 60

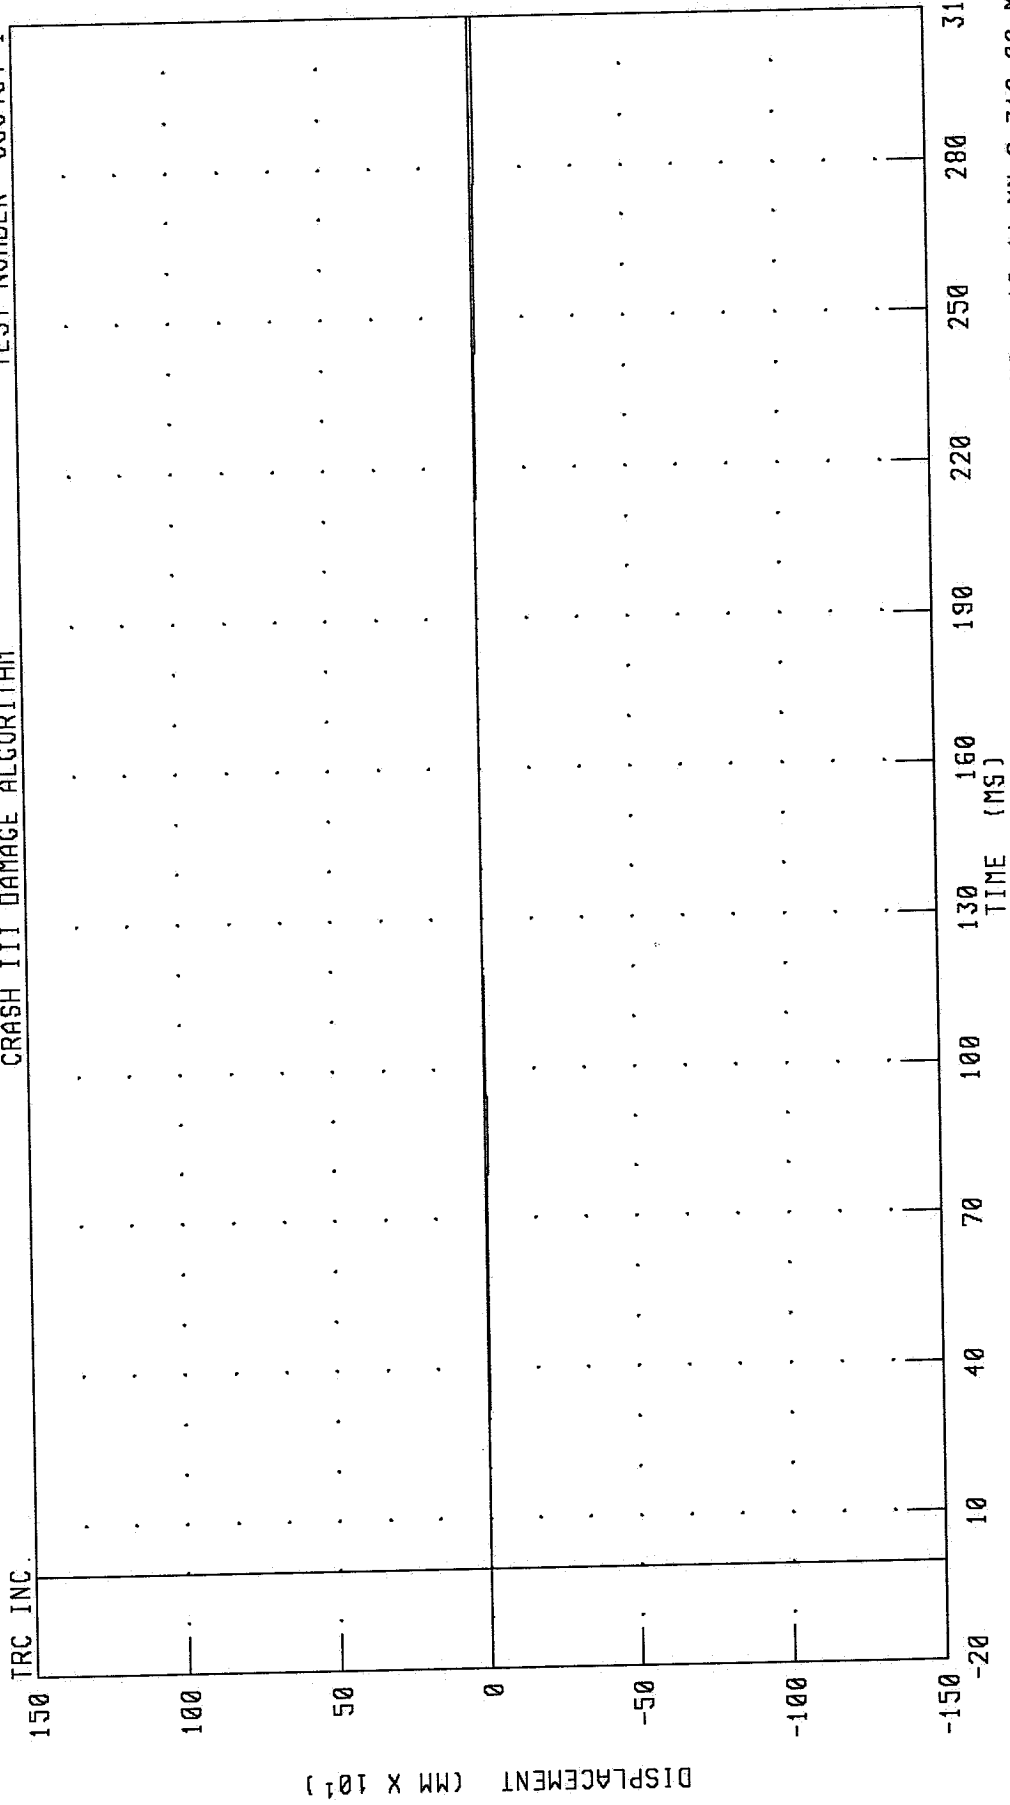
TEST NUMBER: 960404-1

1991 DODGE CARAVAN INTO POLE BARRIER AT 10 MPH TEST NO. 1
 LEFT FRONT SILL Z-AXIS DISPLACEMENT
 CRASH III DAMAGE ALGORITHM

CHANNEL: LFSZD1 FILTER: CH. CLASS 180 PEAK DATA: 0.13 MM @ 166.08 MS; -12.44 MM @ 310.00 MS

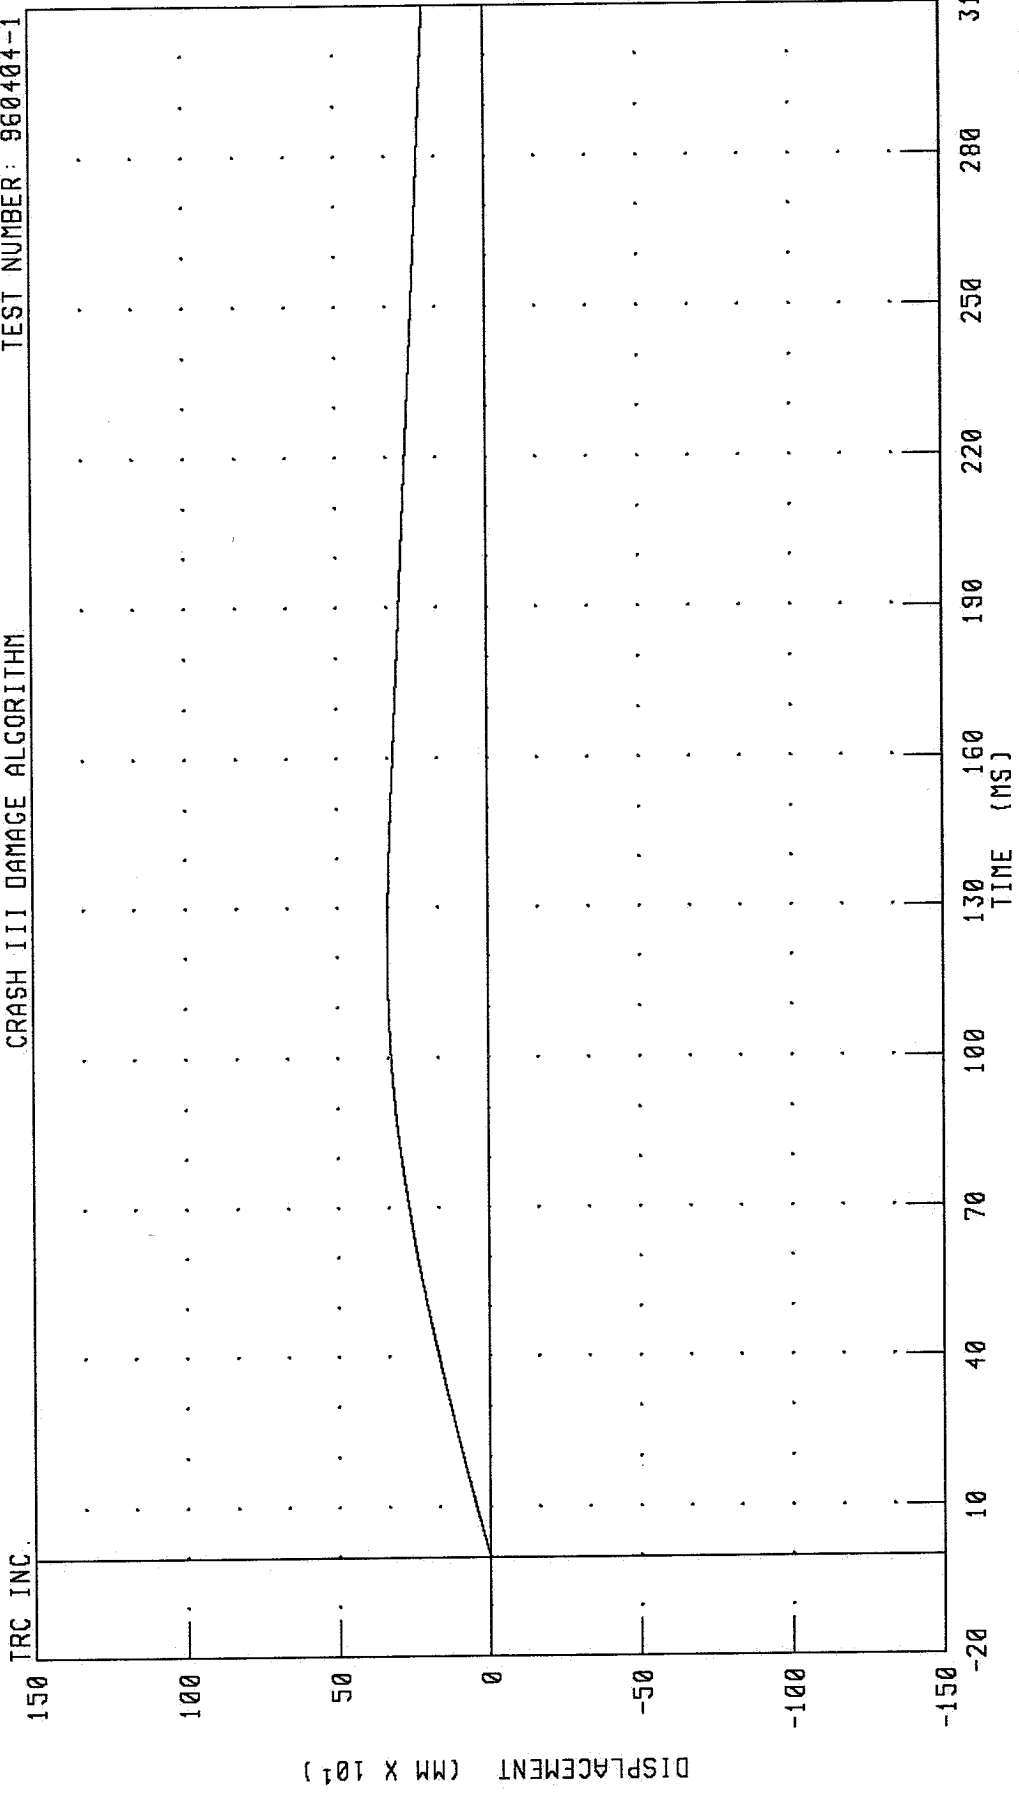
TEST NUMBER: 960404-1

1991 DODGE CARAVAN INTO POLE BARRIER AT 10 MPH TEST NO. 1
RIGHT FRONT SILL X-AXIS DISPLACEMENT
CRASH III DAMAGE ALGORITHM

CHANNEL: RFSXD1 FILTER: CH. CLASS 180

PEAK DATA: 335.00 MM @ 122.00 MS; 0.00 MM @ 0.00 MS

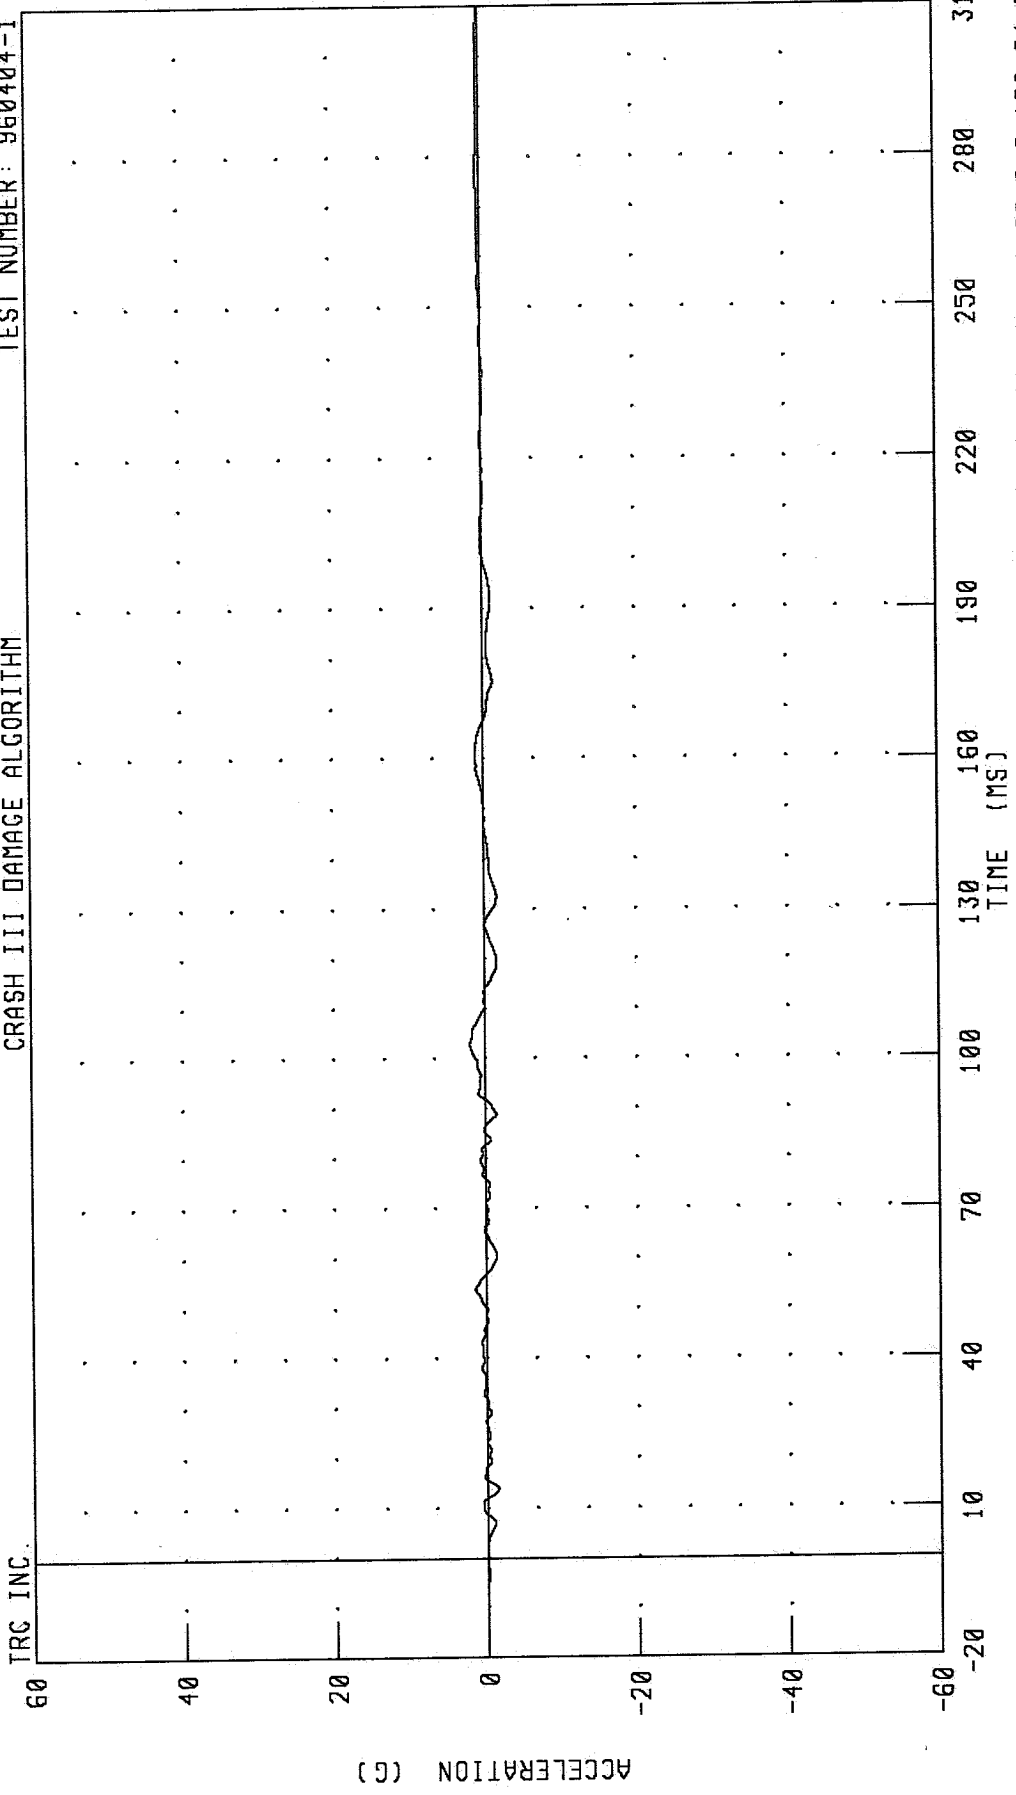
TEST NUMBER: 960404-1

1991 DODGE CARAVAN INTO POLE BARRIER AT 10 MPH TEST NO. 1
RIGHT FRONT SILL Z-AXIS ACCELERATION
CRASH III DAMAGE ALGORITHM

CHANNEL: RFSZG1 FILTER: CH. CLASS 60

PEAK DATA: 2.00 G @ 102.80 MS; -1.62 G @ 132.64 MS

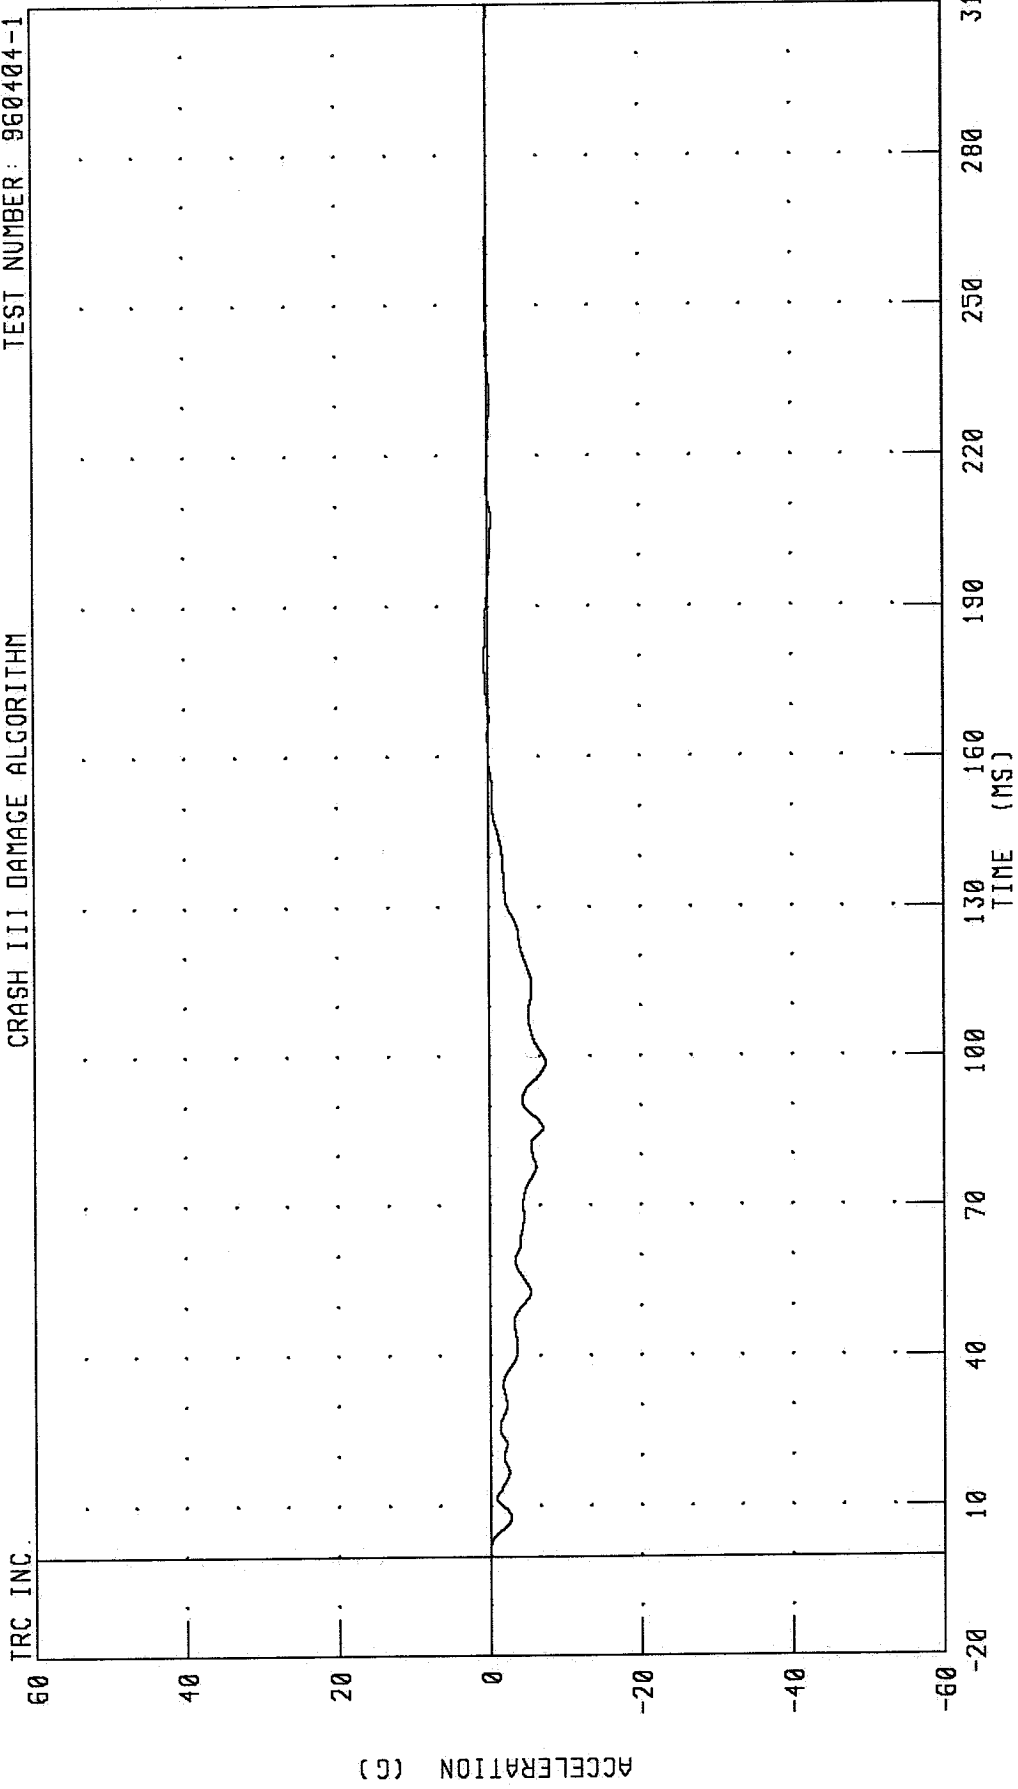
TEST NUMBER: 960404-1

1991 DODGE CARAVAN INTO POLE BARRIER AT 10 MPH TEST NO. 1
VEHICLE CG X-AXIS ACCELERATION
CRASH III DAMAGE ALGORITHM

CHANNEL: VCGXG1 FILTER: CH: CLASS 60

PEAK DATA: 0.50 G @ 179.68 MS; -7.46 G @ 98.80 MS

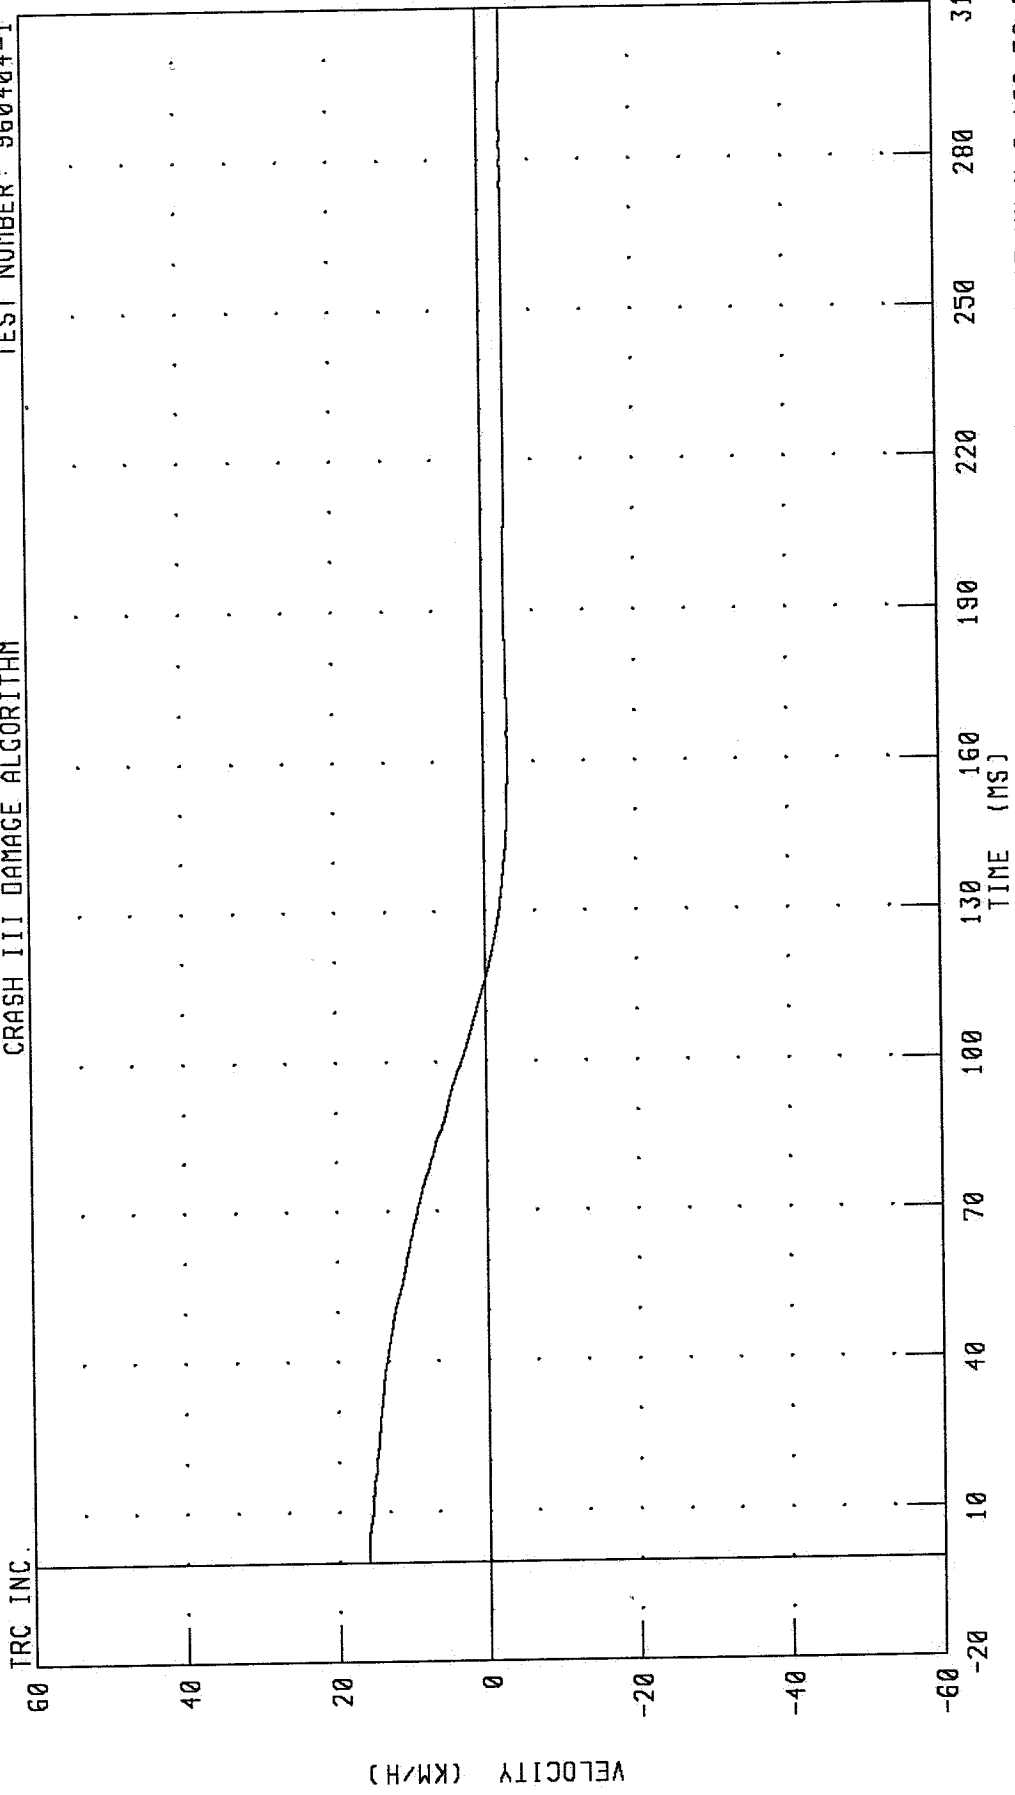
TEST NUMBER: 960404-1

1991 DODGE CARRAVAN INTO POLE BARRIER AT 10 MPH TEST NO. 1
VEHICLE CG X-AXIS VELOCITY
CRASH III DAMAGE ALGORITHM

CHANNEL: VCGXV1 FILTER: CH. CLASS 180

PEAK DATA: 16.10 KM/H @ 0.00 MS; -3.15 KM/H @ 162.56 MS

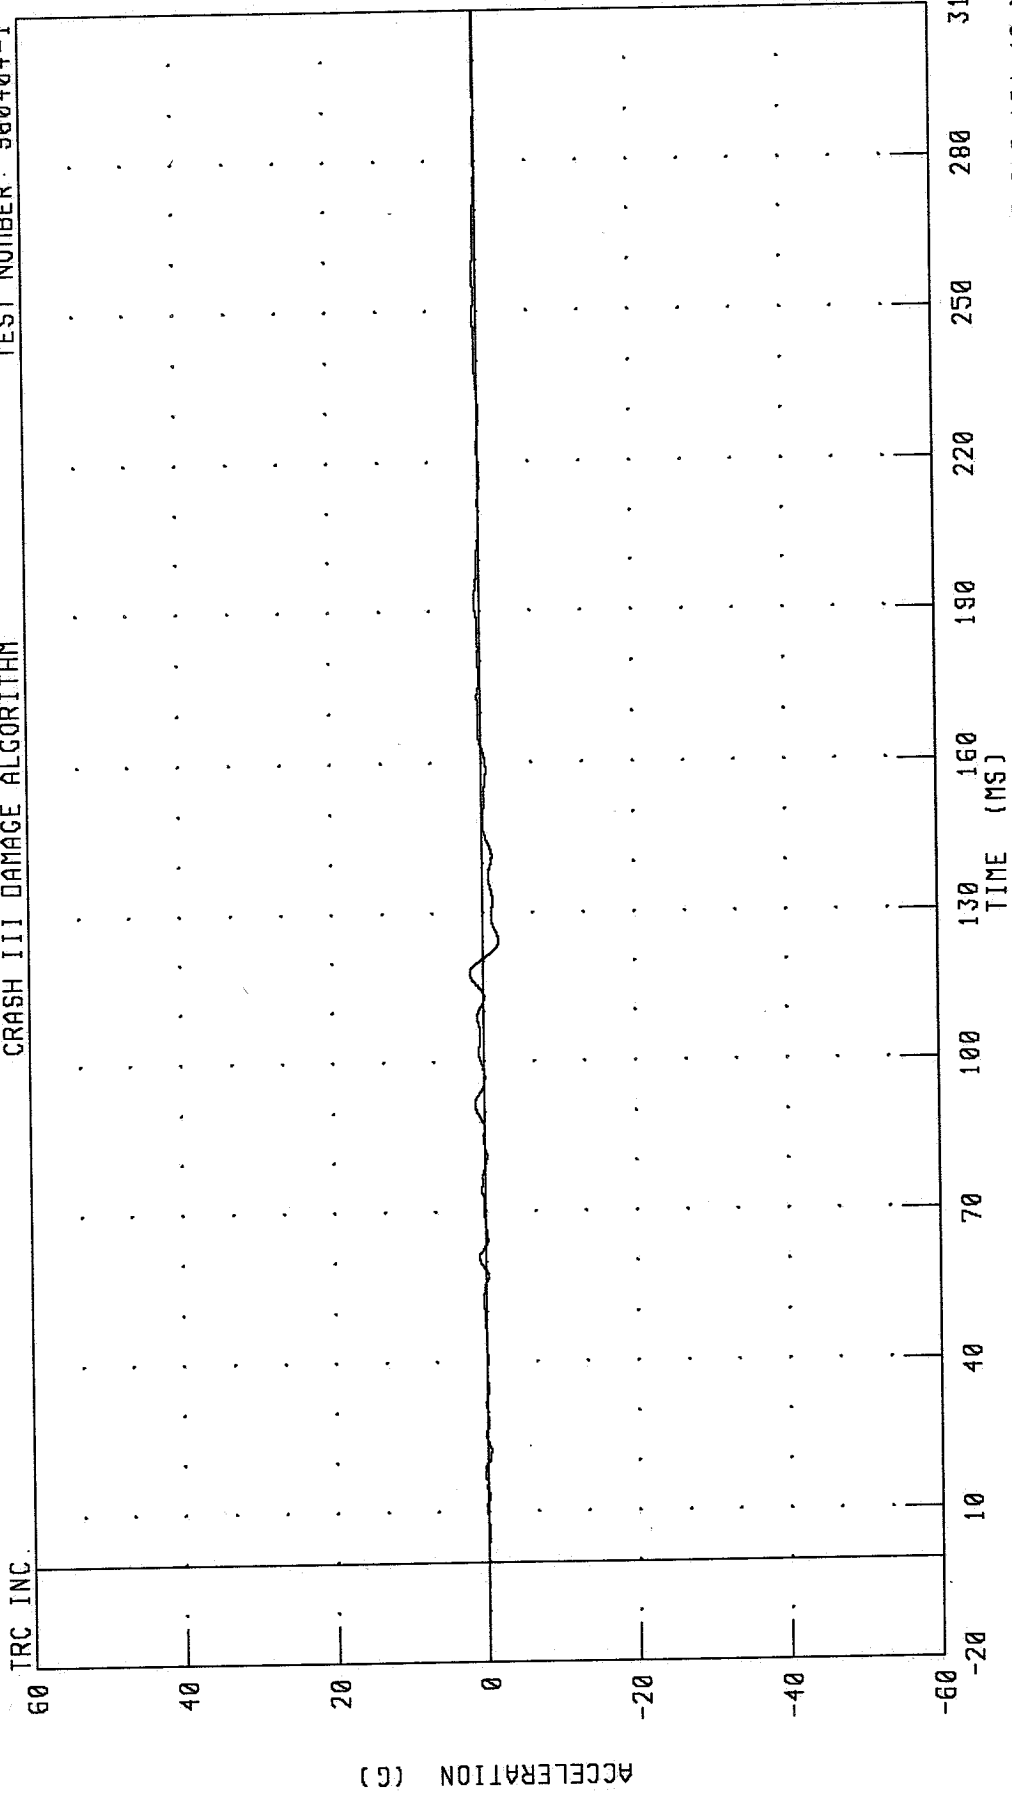
TEST NUMBER: 960404-1

1991 DODGE CARAVAN INTO POLE BARRIER AT 10 MPH TEST NO. 1
VEHICLE CC Y-AXIS ACCELERATION
CRASH III DAMAGE ALGORITHM

CHANNEL: VCGYGI FILTER: CH. CLASS 60

PEAK DATA: 1.76 G @ 117.92 MS; -2.06 G @ 124.40 MS

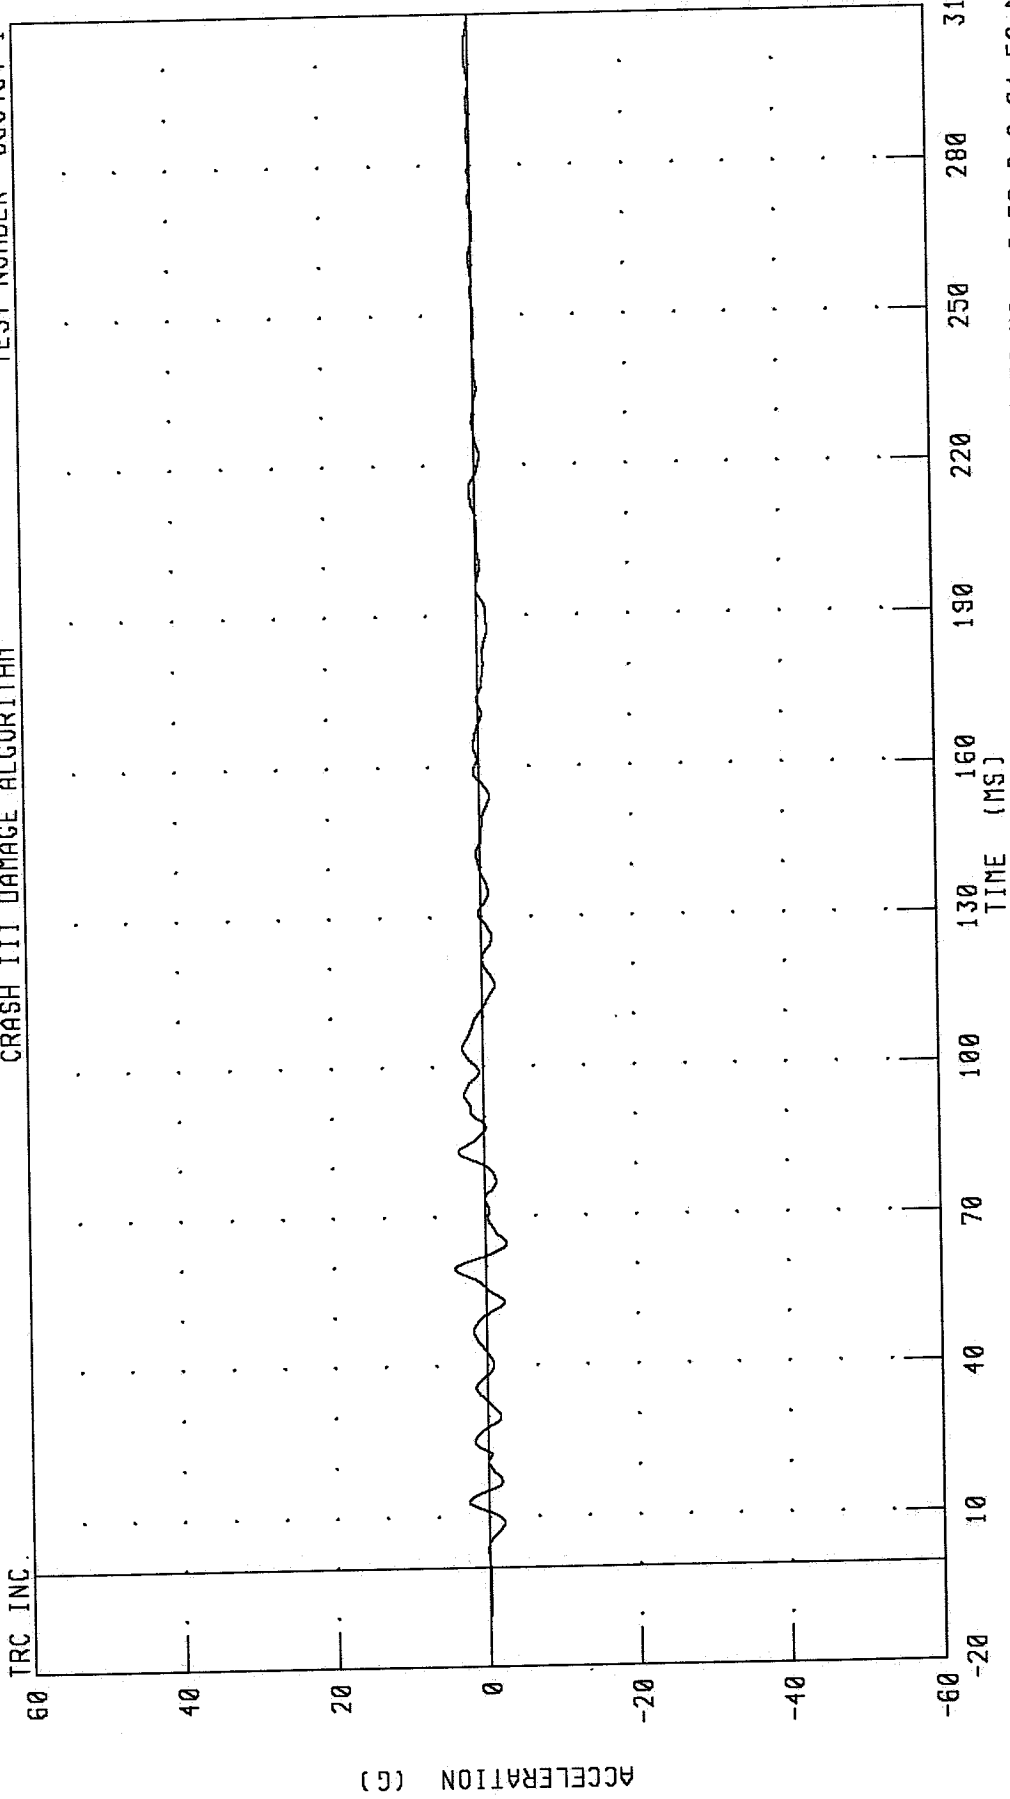
TEST NUMBER: 960404-1

1991 DODGE CARAVAN INTO POLE BARRIER AT 10 MPH TEST NO. 1
VEHICLE CG Z-AXIS ACCELERATION
CRASH III DAMAGE ALGORITHM

PEAK DATA: 4.06 G @ 59.52 MS; -2.78 G @ 64.56 MS

CHANNEL: VCGZG1 FILTER: CH. CLASS 60
