**1991 Dodge Caravan
into 12-Inch Diameter Centered Pole
in Support of
Crash III Damage Algorithm Reformulation**

TRC Test Nos.: 960404-1

**Prepared by:
Transportation Research Center Inc.
10820 State Route 347
East Liberty, OH 43319**

**April - May 1996
Final Report**

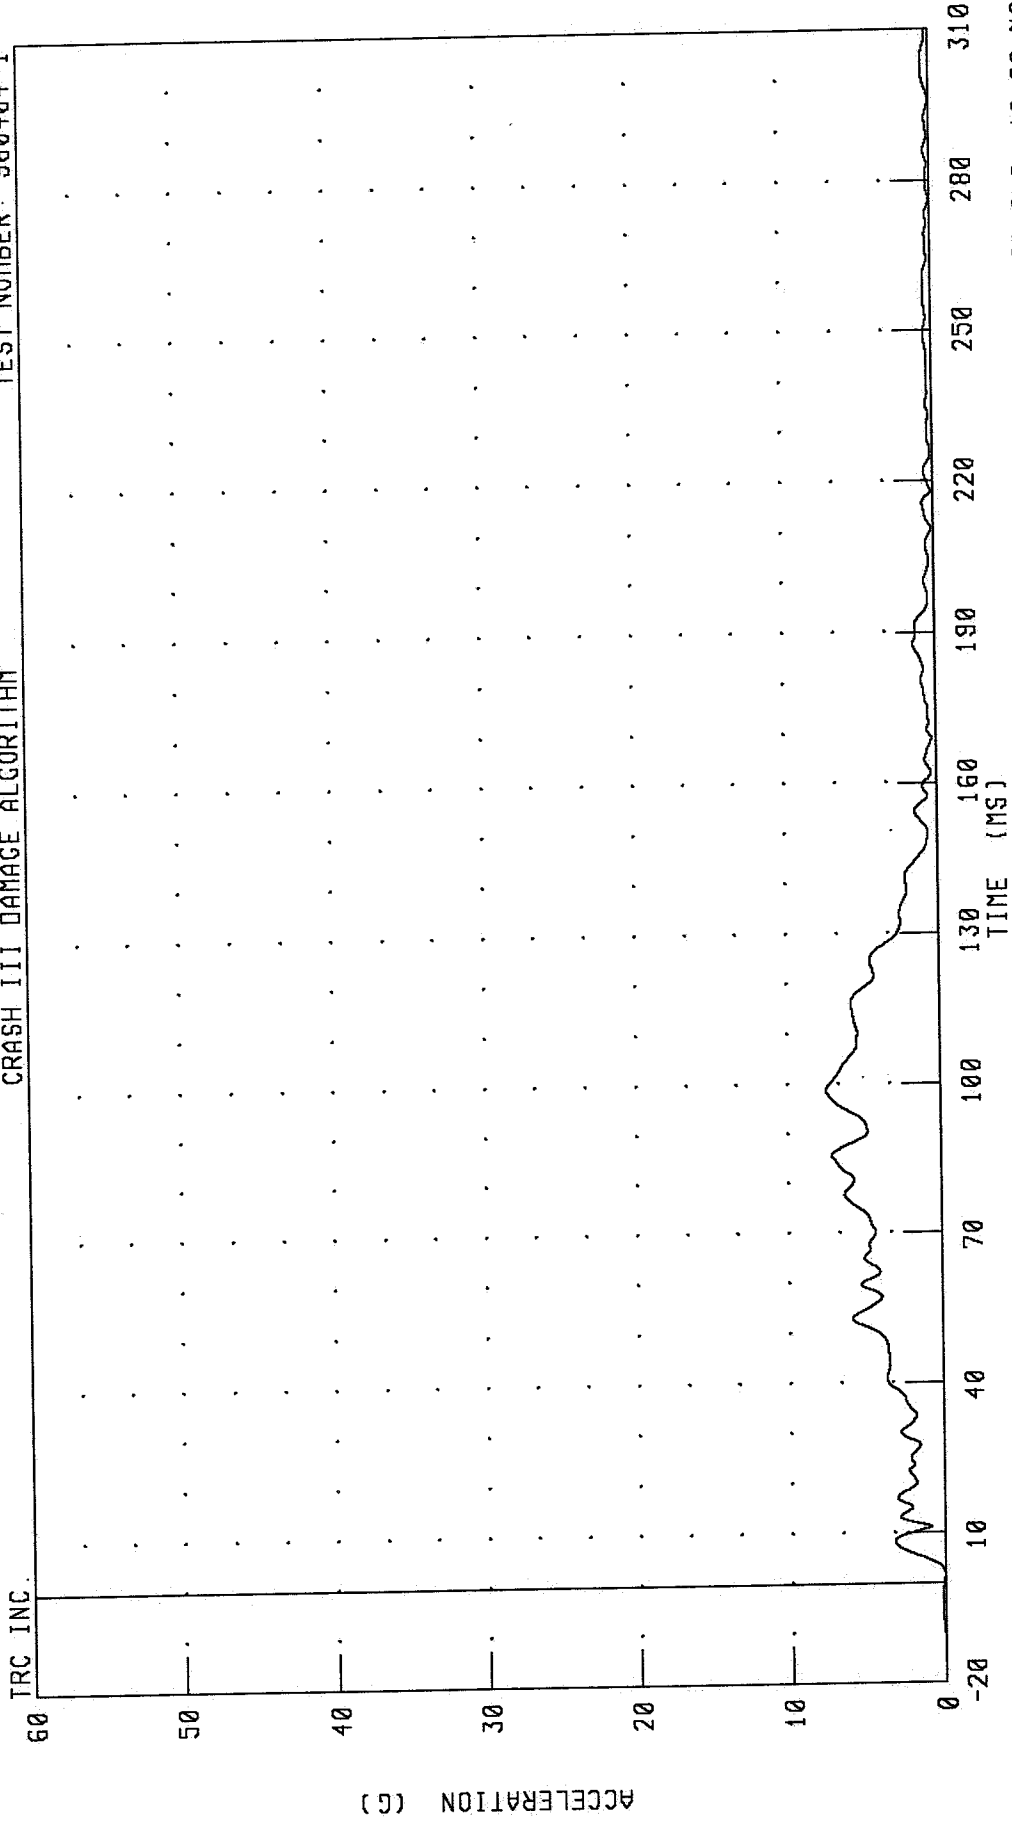
TEST NUMBER: 960404-1

1991 DODGE CARAVAN INTO POLE BARRIER AT 10 MPH TEST NO. 1
VEHICLE CG RESULTANT ACCELERATION
CRASH III DAMAGE ALGORITHM

CHANNEL: VCGRG1 FILTER: CH. CLASS 60

PEAK DATA: 7.48 G @ 98.72 MS; 0.01 G @ -19.68 MS

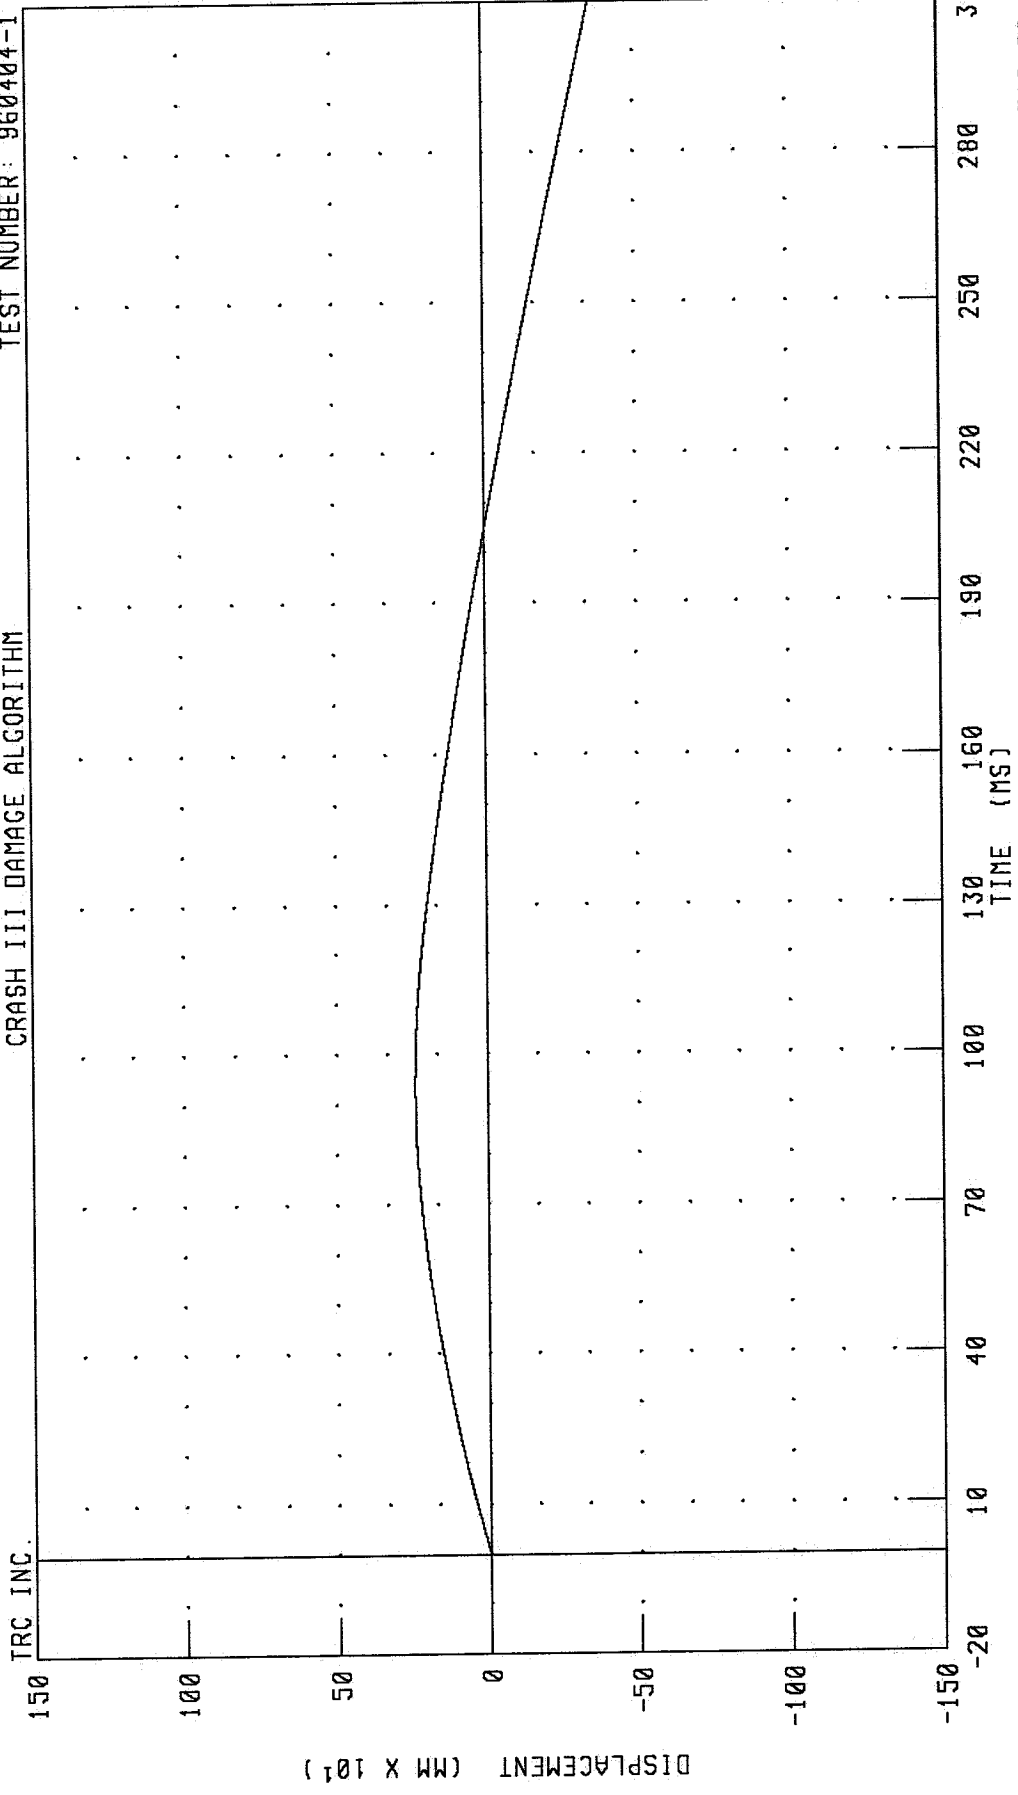
TEST NUMBER: 960404-1

1991 DODGE CARAVAN INTO POLE BARRIER AT 10 MPH TEST NO. 1
 VEHICLE CG RESULTANT DISPLACEMENT
 CRASH III DAMAGE ALGORITHM

CHANNEL: VCGRD1 FILTER: CH. CLASS 180 PEAK DATA: 239.60 MM @ 93.76 MS; -356.09 MM @ 310.00 MS

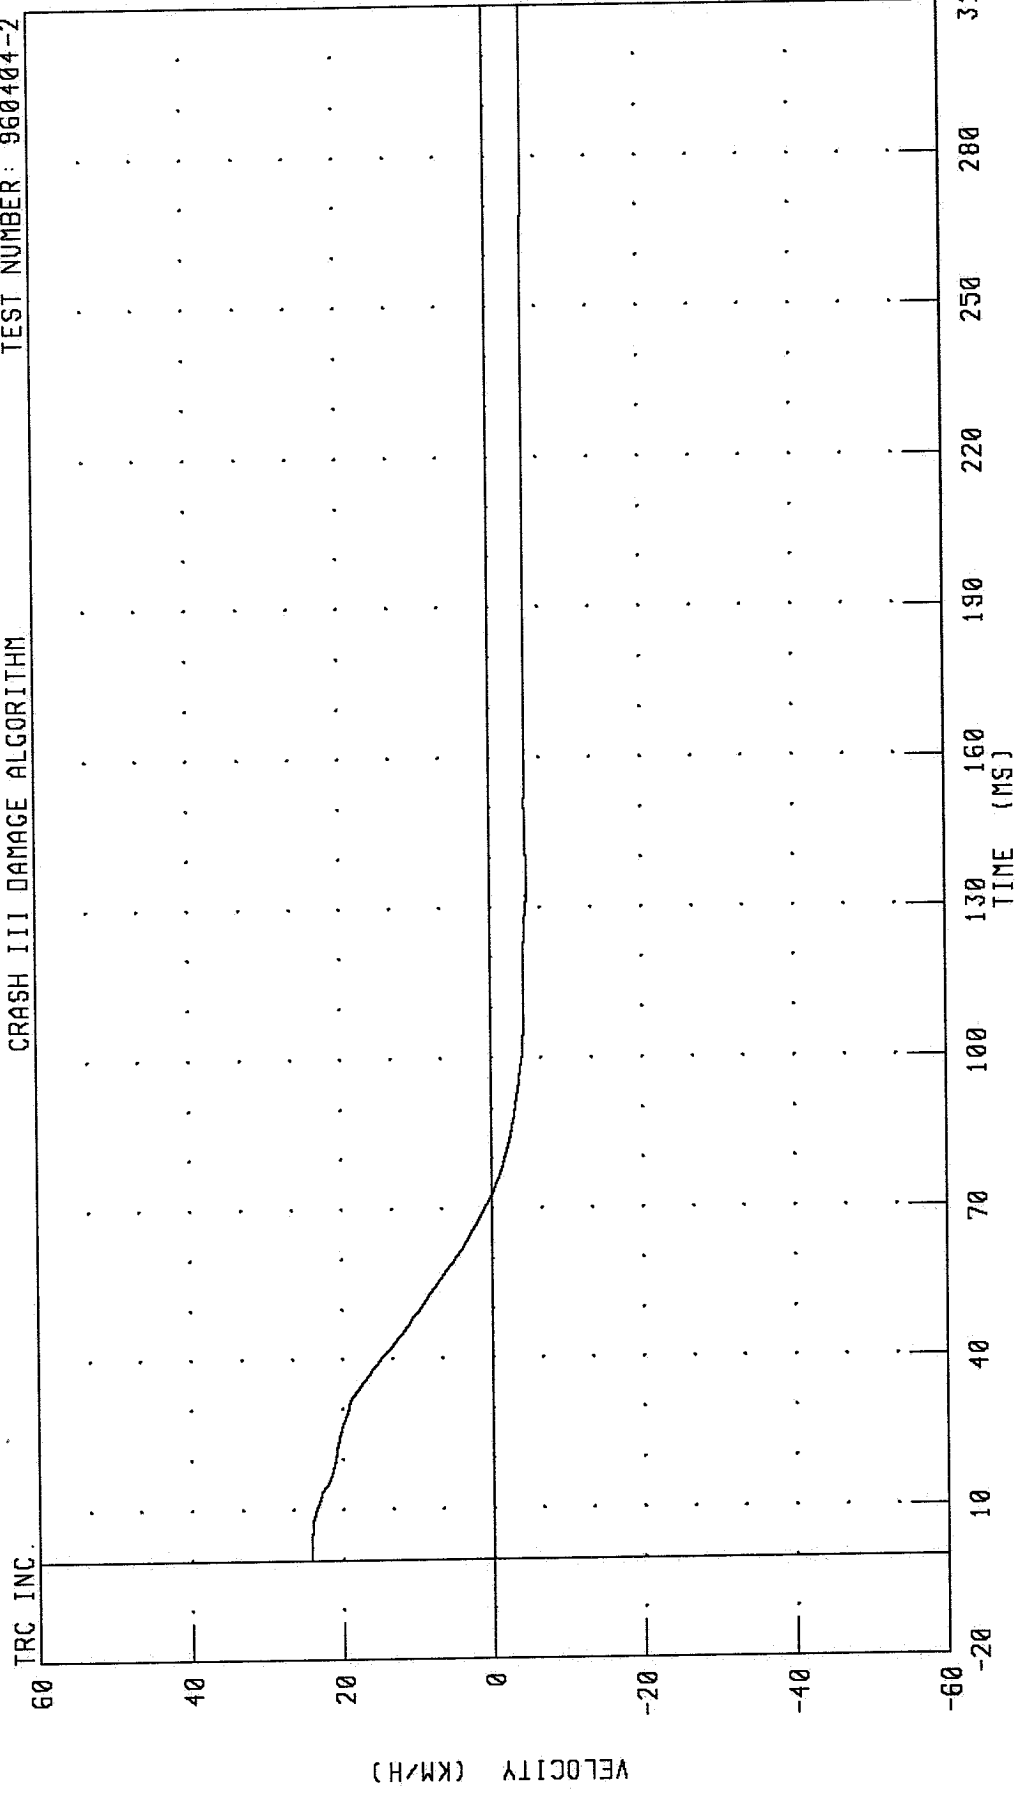
TEST NUMBER: 960404-2

1991 DODGE CARAVAN INTO POLE BARRIER AT 15 MPH TEST NO. 2
 LEFT REAR SILL X-AXIS VELOCITY
 CRASH III DAMAGE ALGORITHM

CHANNEL: LRSXV1 FILTER: CH. CLASS 180

PEAK DATA: 24.20 KM/H @ 0.00 MS; -4.95 KM/H @ 134.64 MS

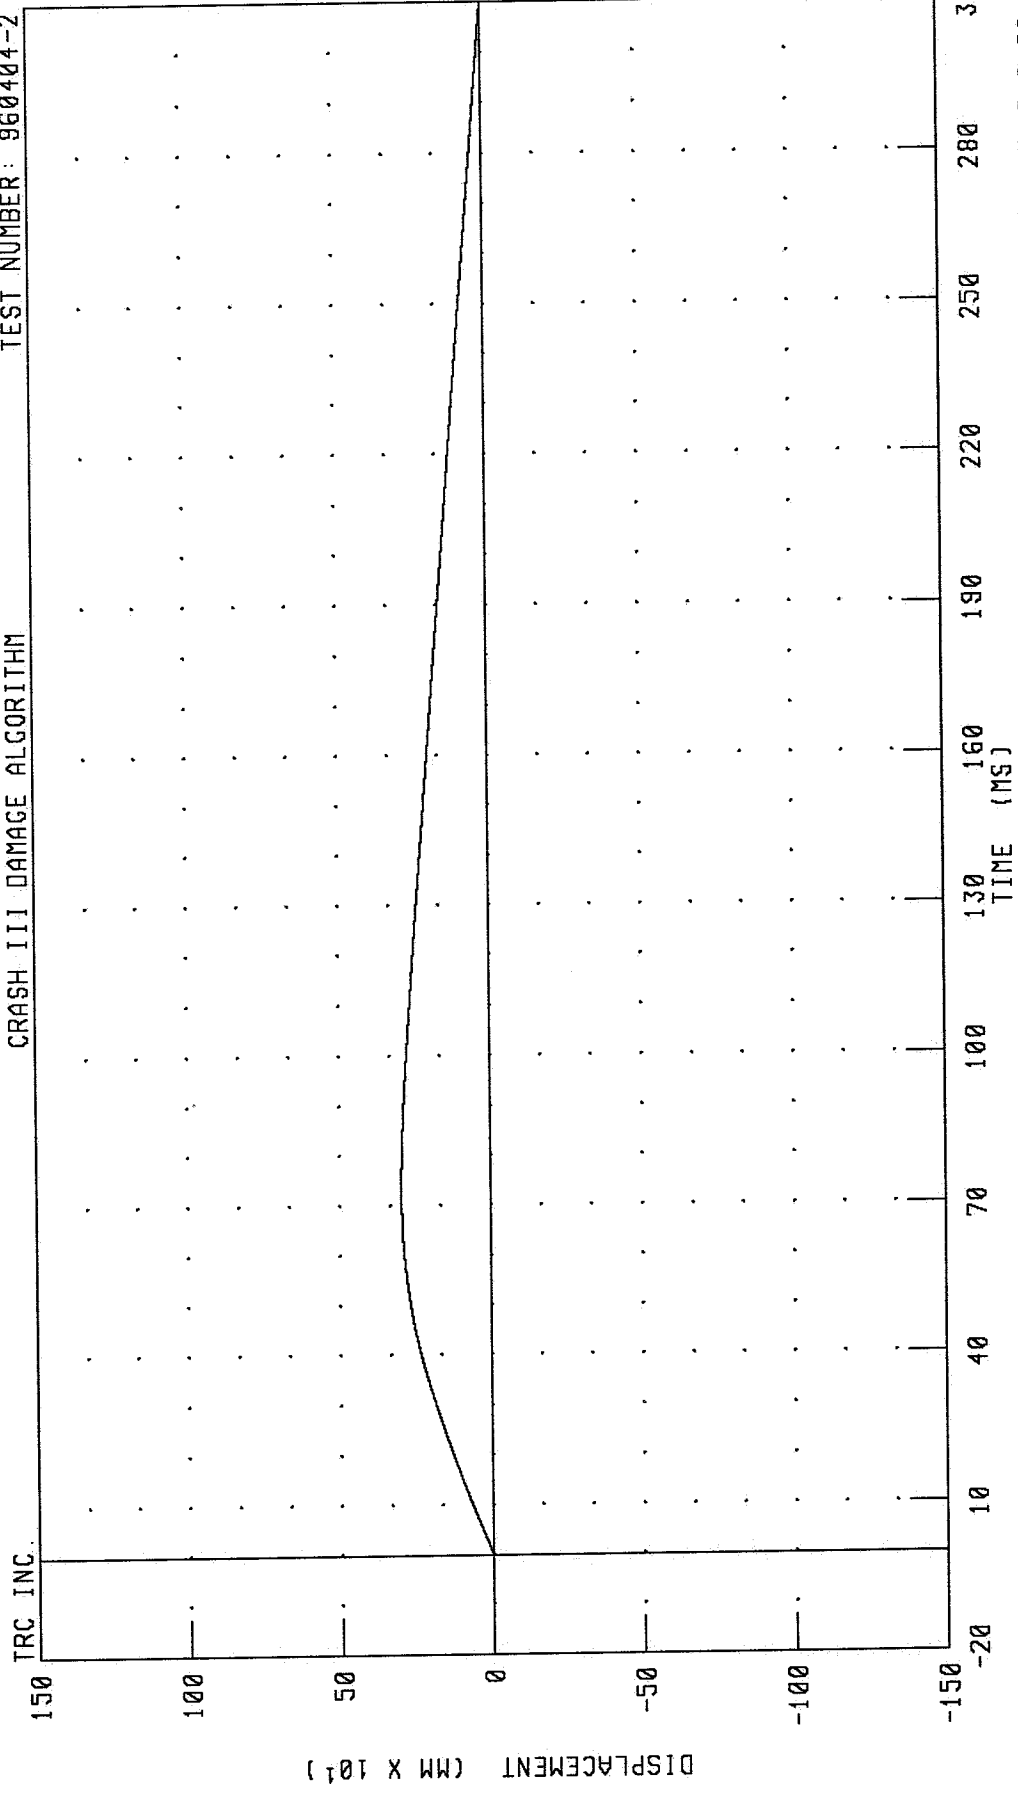
TEST NUMBER: 960404-2

1991 DODGE CARAVAN INTO POLE BARRIER AT 15 MPH TEST NO. 2
LEFT REAR SILL X-AXIS DISPLACEMENT
CRASH III DAMAGE ALGORITHM

CHANNEL: LRSXD1 FILTER: CH. CLASS 180 PEAK DATA: 295.33 MM @ 72.80 MS; 0.00 MM @ 0.00 MS

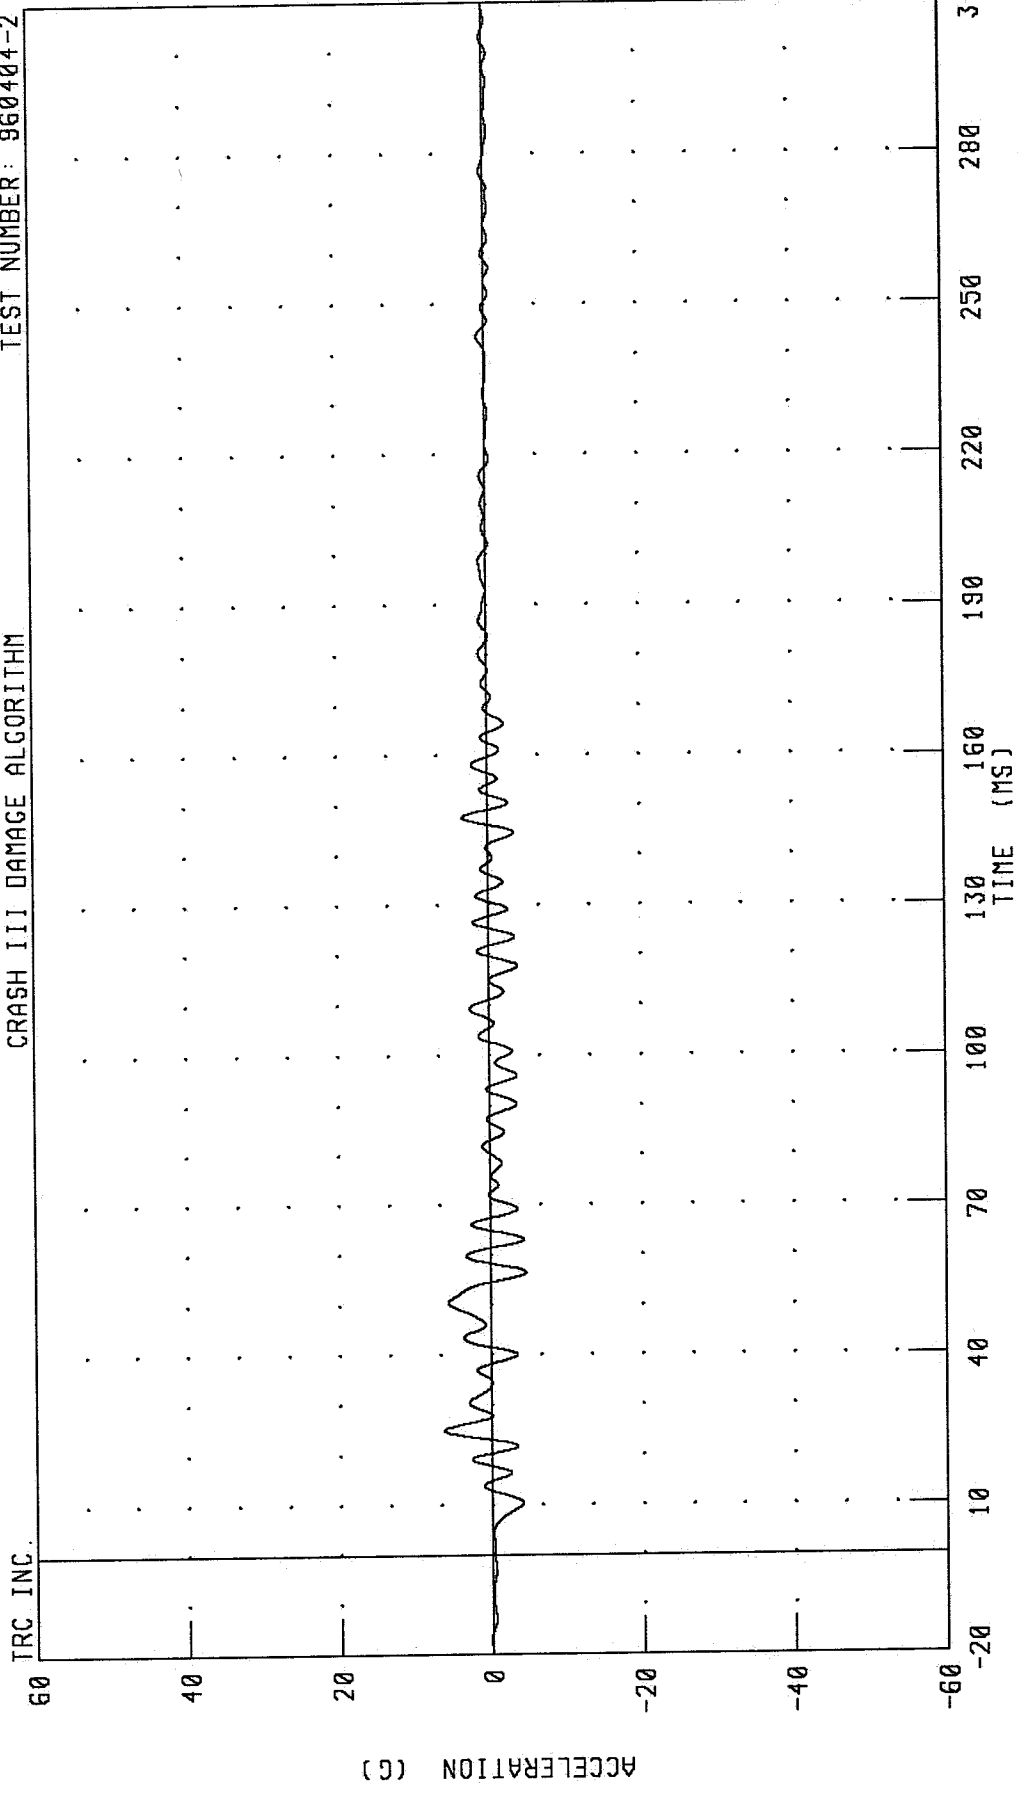
TEST NUMBER: 960404-2

1991 DODGE CARAVAN INTO POLE BARRIER AT 15 MPH TEST NO. 2
LEFT REAR SILL Z-AXIS ACCELERATION
CRASH III DAMAGE ALGORITHM

CHANNEL: LRSZG1 FILTER: CH. CLASS 60

PEAK DATA: 6.23 G @ 24.96 MS; -4.66 G @ 56.56 MS

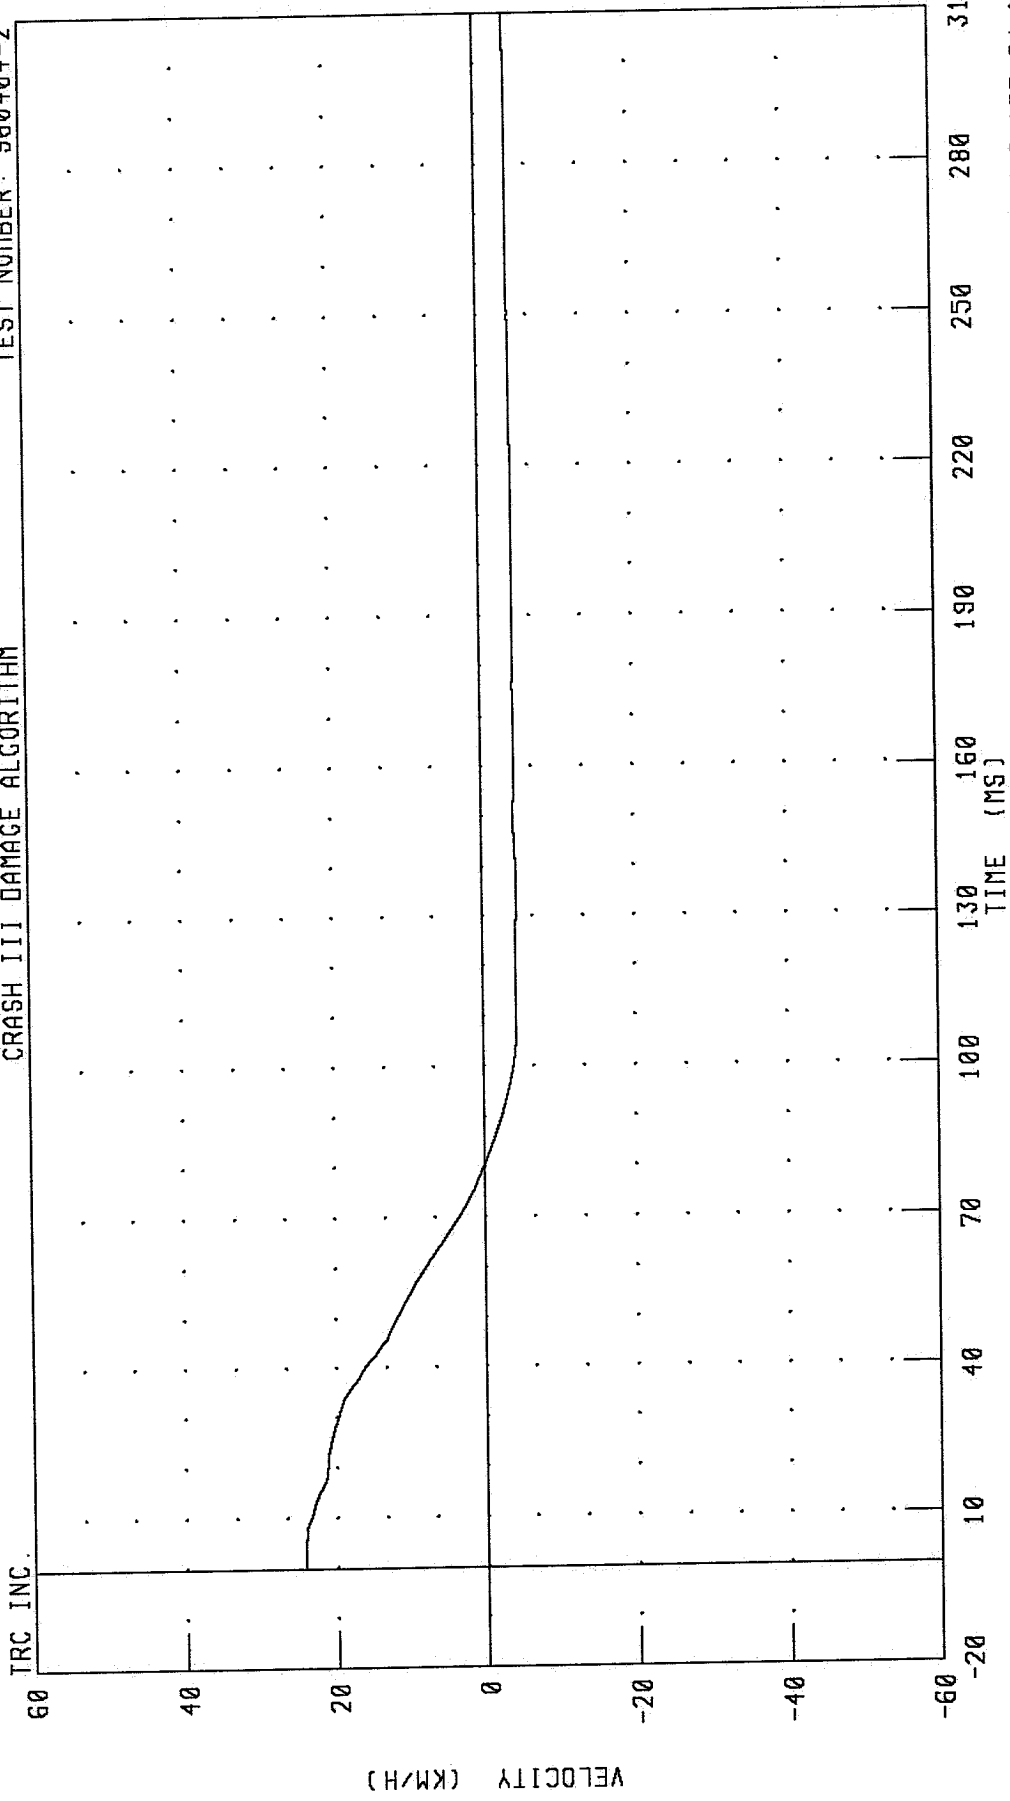
TEST NUMBER: 960404-2

1991 DODGE CARAVAN INTO POLE BARRIER AT 15 MPH TEST NO. 2
RIGHT REAR SILL X-AXIS VELOCITY
CRASH III DAMAGE ALGORITHM

CHANNEL: RRSXV1 FILTER: CH. CLASS 180

PEAK DATA: 24.20 KM/H @ 0.00 MS; -4.62 KM/H @ 135.04 MS

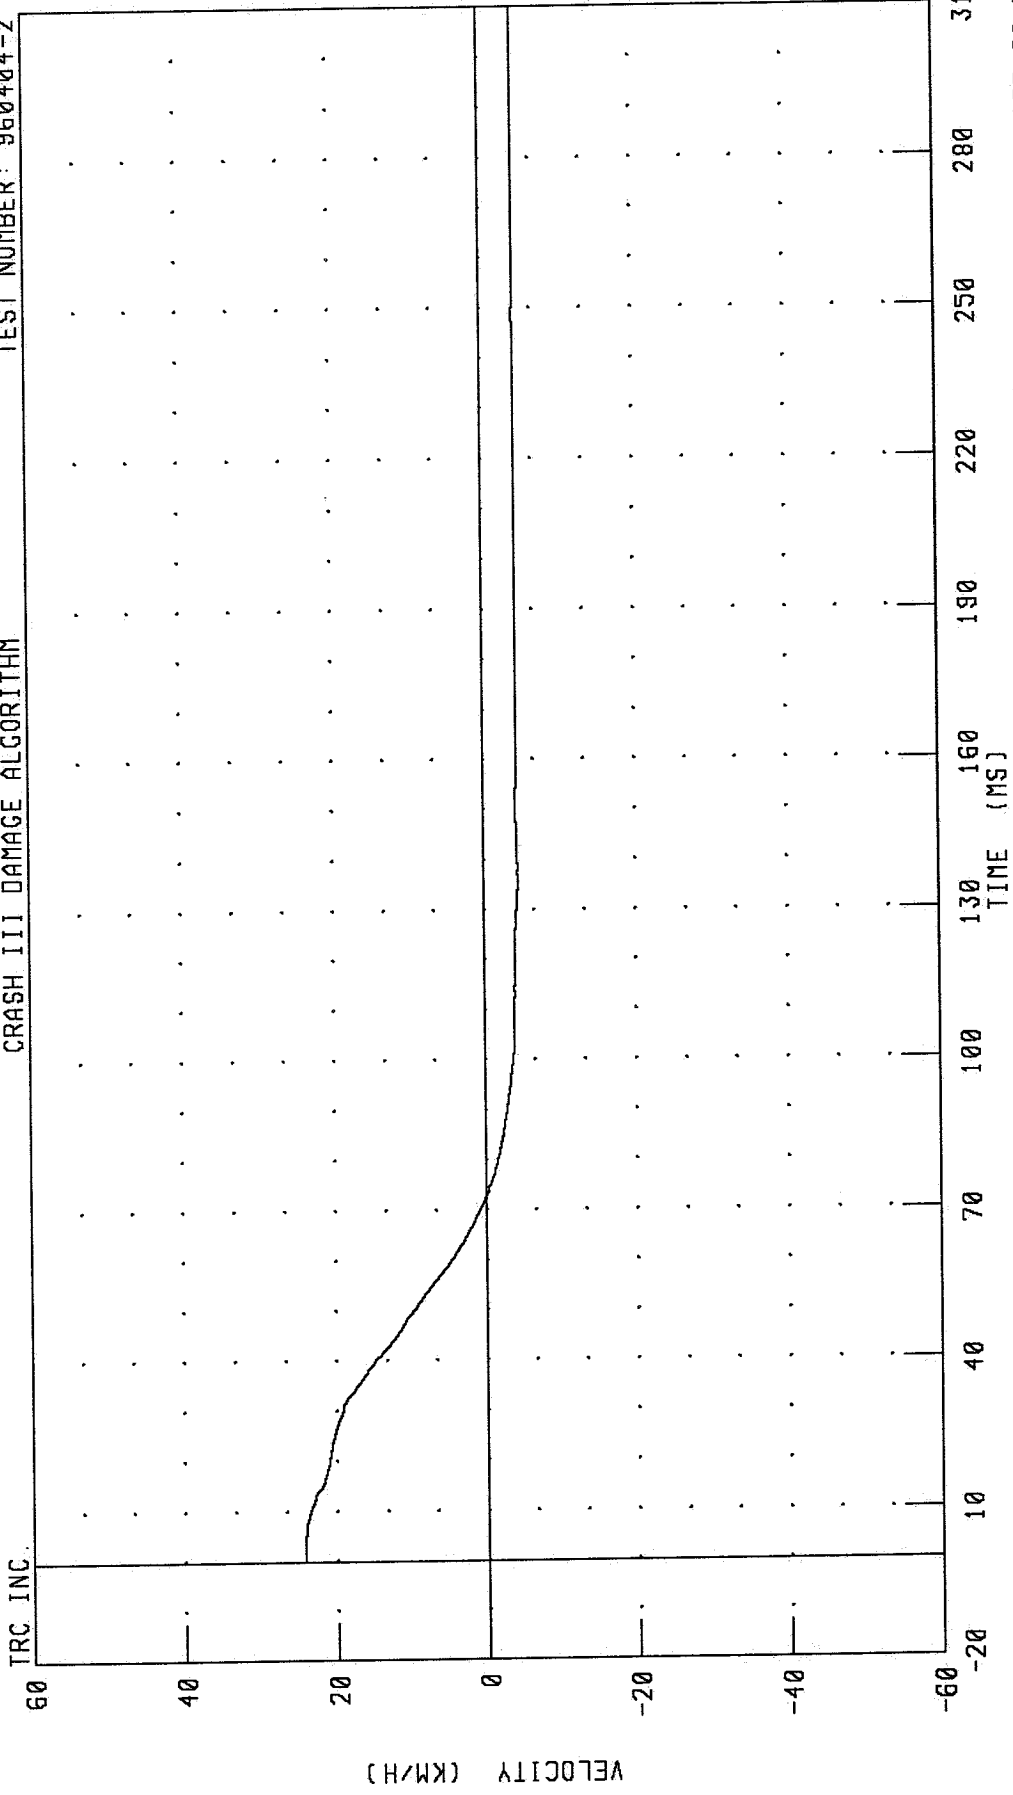
TEST NUMBER: 960404-2

1991 DODGE CARAVAN INTO POLE BARRIER AT 15 MPH TEST NO. 2
LEFT FRONT SILL X-AXIS VELOCITY
CRASH III DAMAGE ALGORITHM

CHANNEL: LFSXV1 FILTER: CH. CLASS 180

PEAK DATA: 24.20 KM/H @ 0.00 MS; -4.49 KM/H @ 135.68 MS

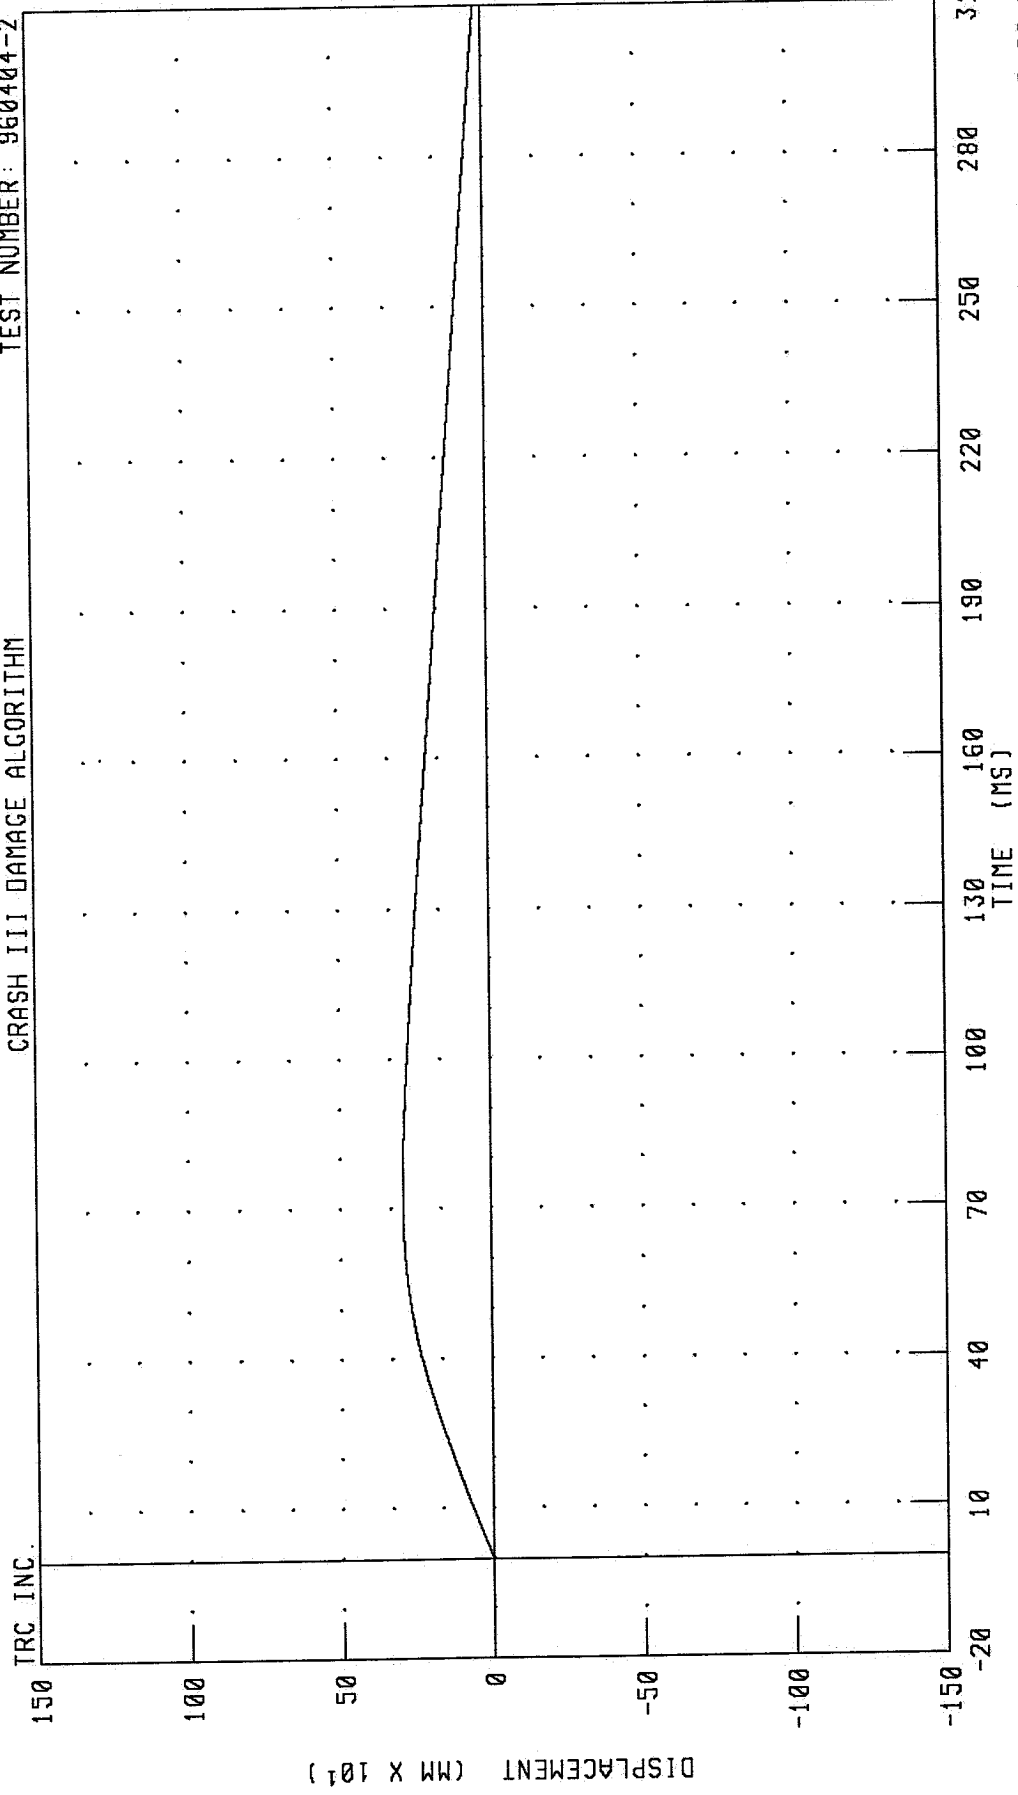
TEST NUMBER: 960404-2

1991 DODGE CARAVAN INTO POLE BARRIER AT 15 MPH TEST NO. 2
 LEFT FRONT SILL X-AXIS DISPLACEMENT
 CRASH III DAMAGE ALGORITHM

CHANNEL: LFSXD1 FILTER: CH. CLASS 180

PEAK DATA: 293.98 MM @ 72.80 MS; 0.00 MM @ 0.00 MS

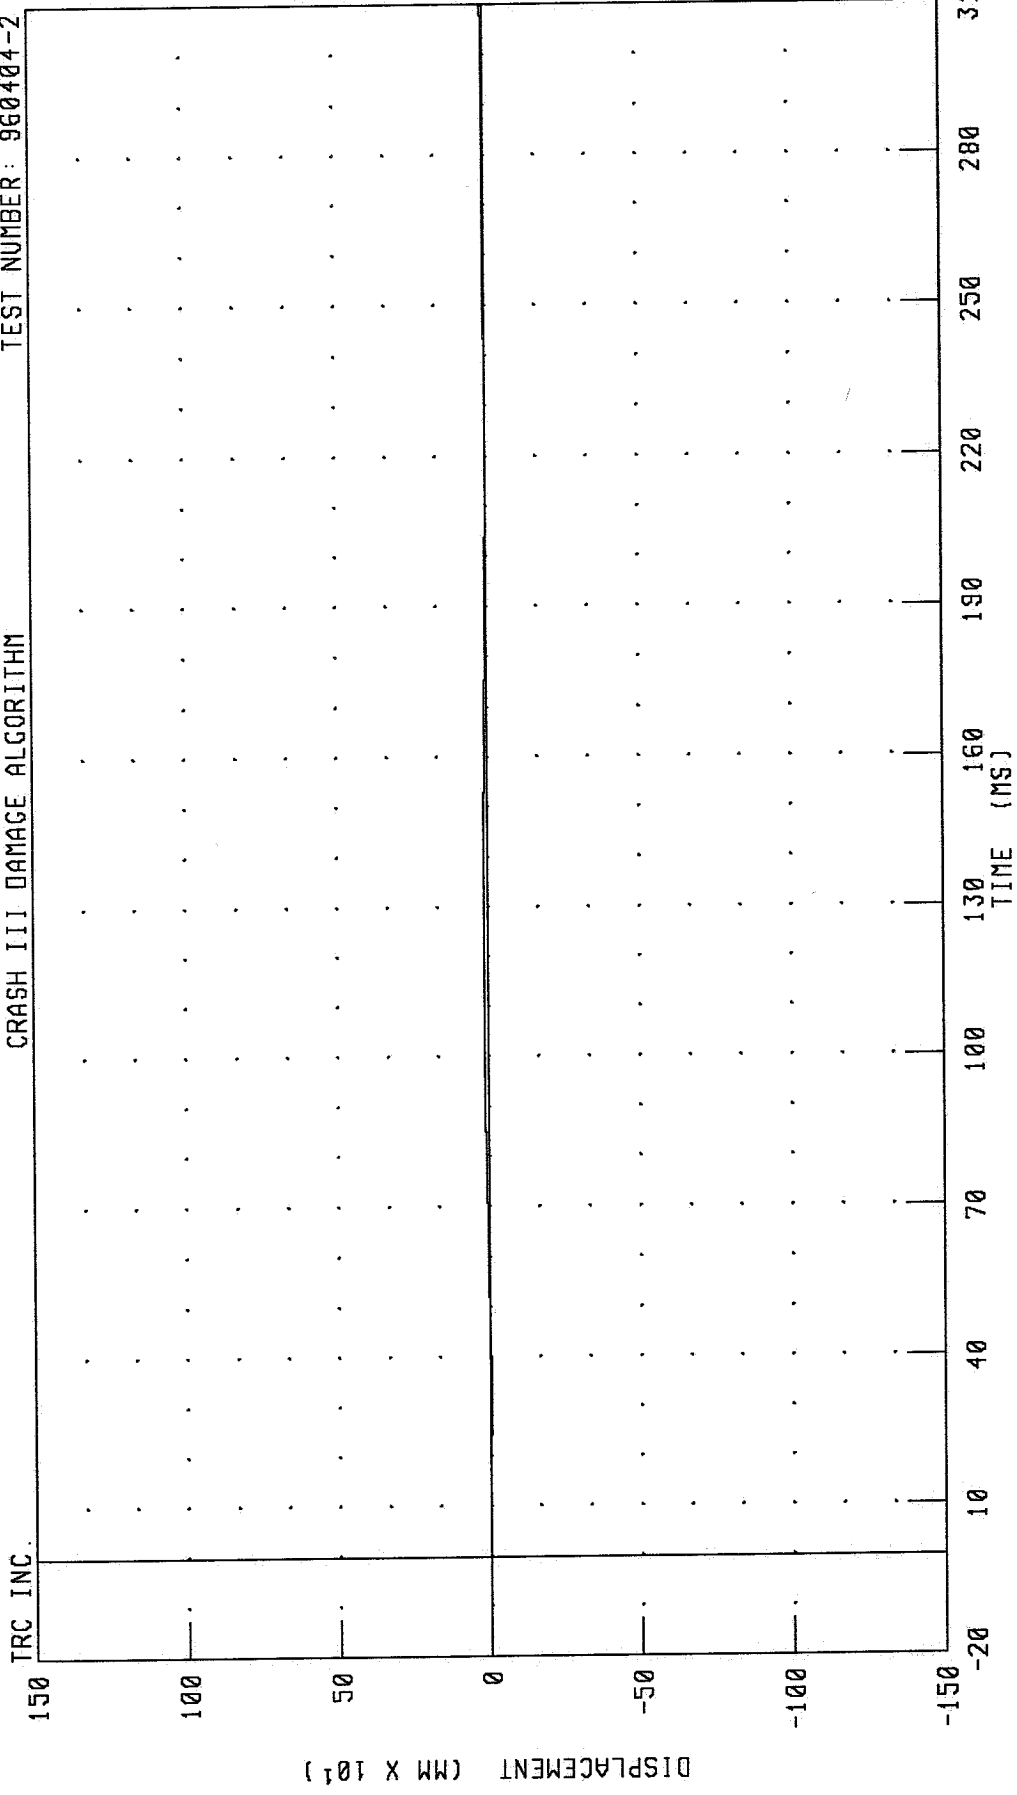
TEST NUMBER: 960404-2

CHANNEL: LFSZD1 FILTER: CH. CLASS 180 PEAK DATA: 14.89 MM @ 113.36 MS; -2.28 MM @ 35.60 MS

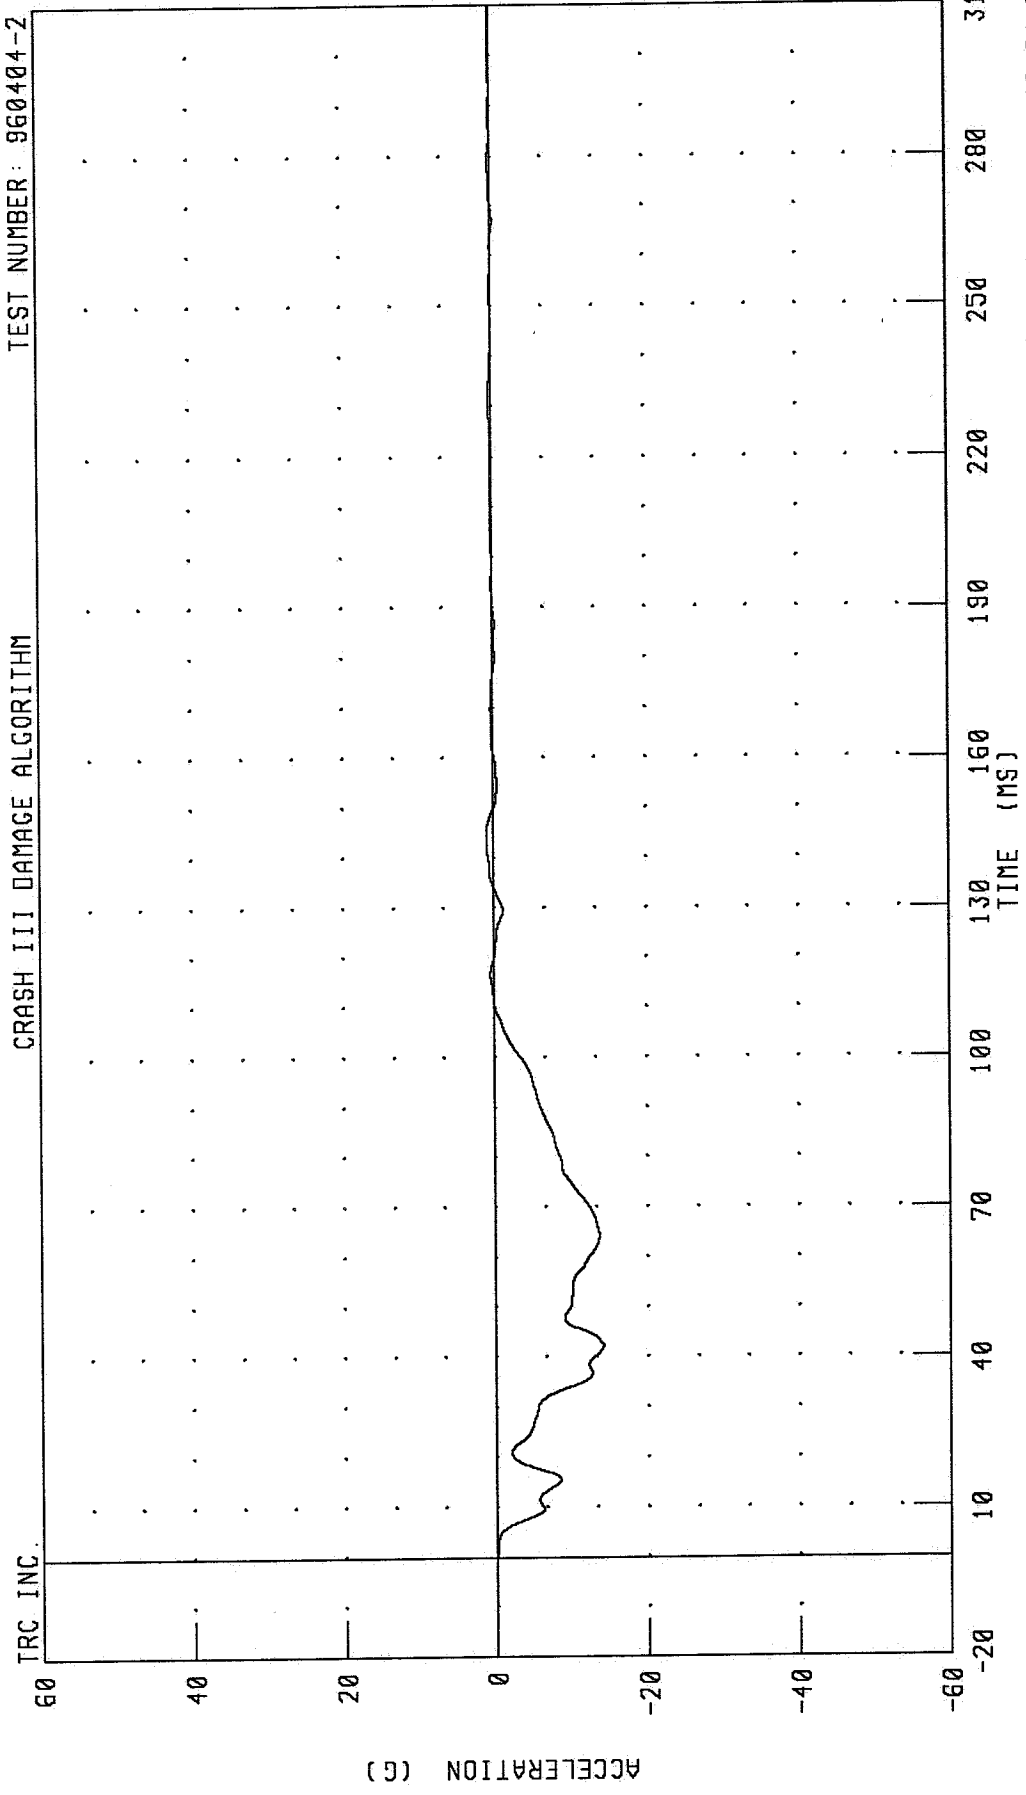
TEST NUMBER: 960404-2

1991 DODGE CARAVAN INTO POLE BARRIER AT 15 MPH TEST NO. 2
RIGHT FRONT SILL X-AXIS ACCELERATION
CRASH III DAMAGE ALGORITHM

CHANNEL: RFSXG1 FILTER: CH. CLASS 60

PEAK DATA: 0.89 G @ 141.92 MS; -14.14 G @ 42.24 MS

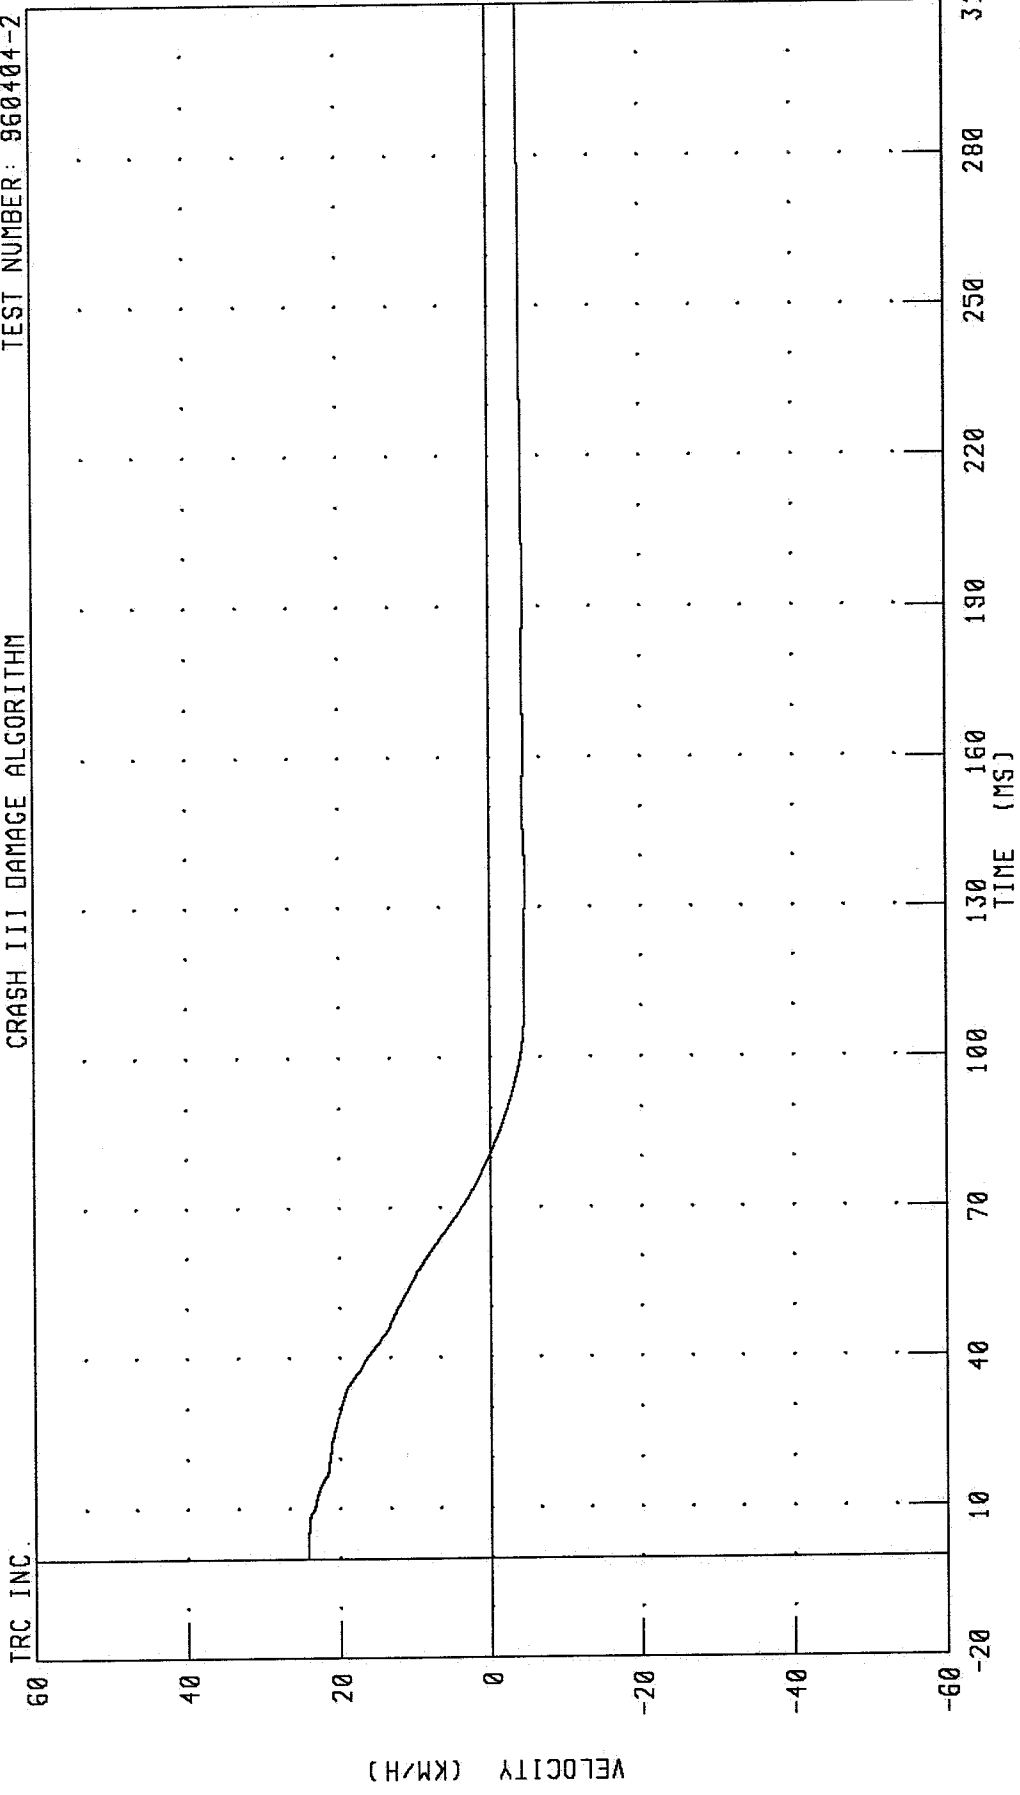
TEST NUMBER: 960404-2

1991 DODGE CARAVAN INTO POLE BARRIER AT 15 MPH TEST NO. 2
RIGHT FRONT SILL X-AXIS VELOCITY
CRASH III DAMAGE ALGORITHM

CHANNEL: RFSXV1 FILTER: CH. CLASS 180

PEAK DATA: 24.20 KM/H @ 0.96 MS; -4.74 KM/H @ 134.88 MS

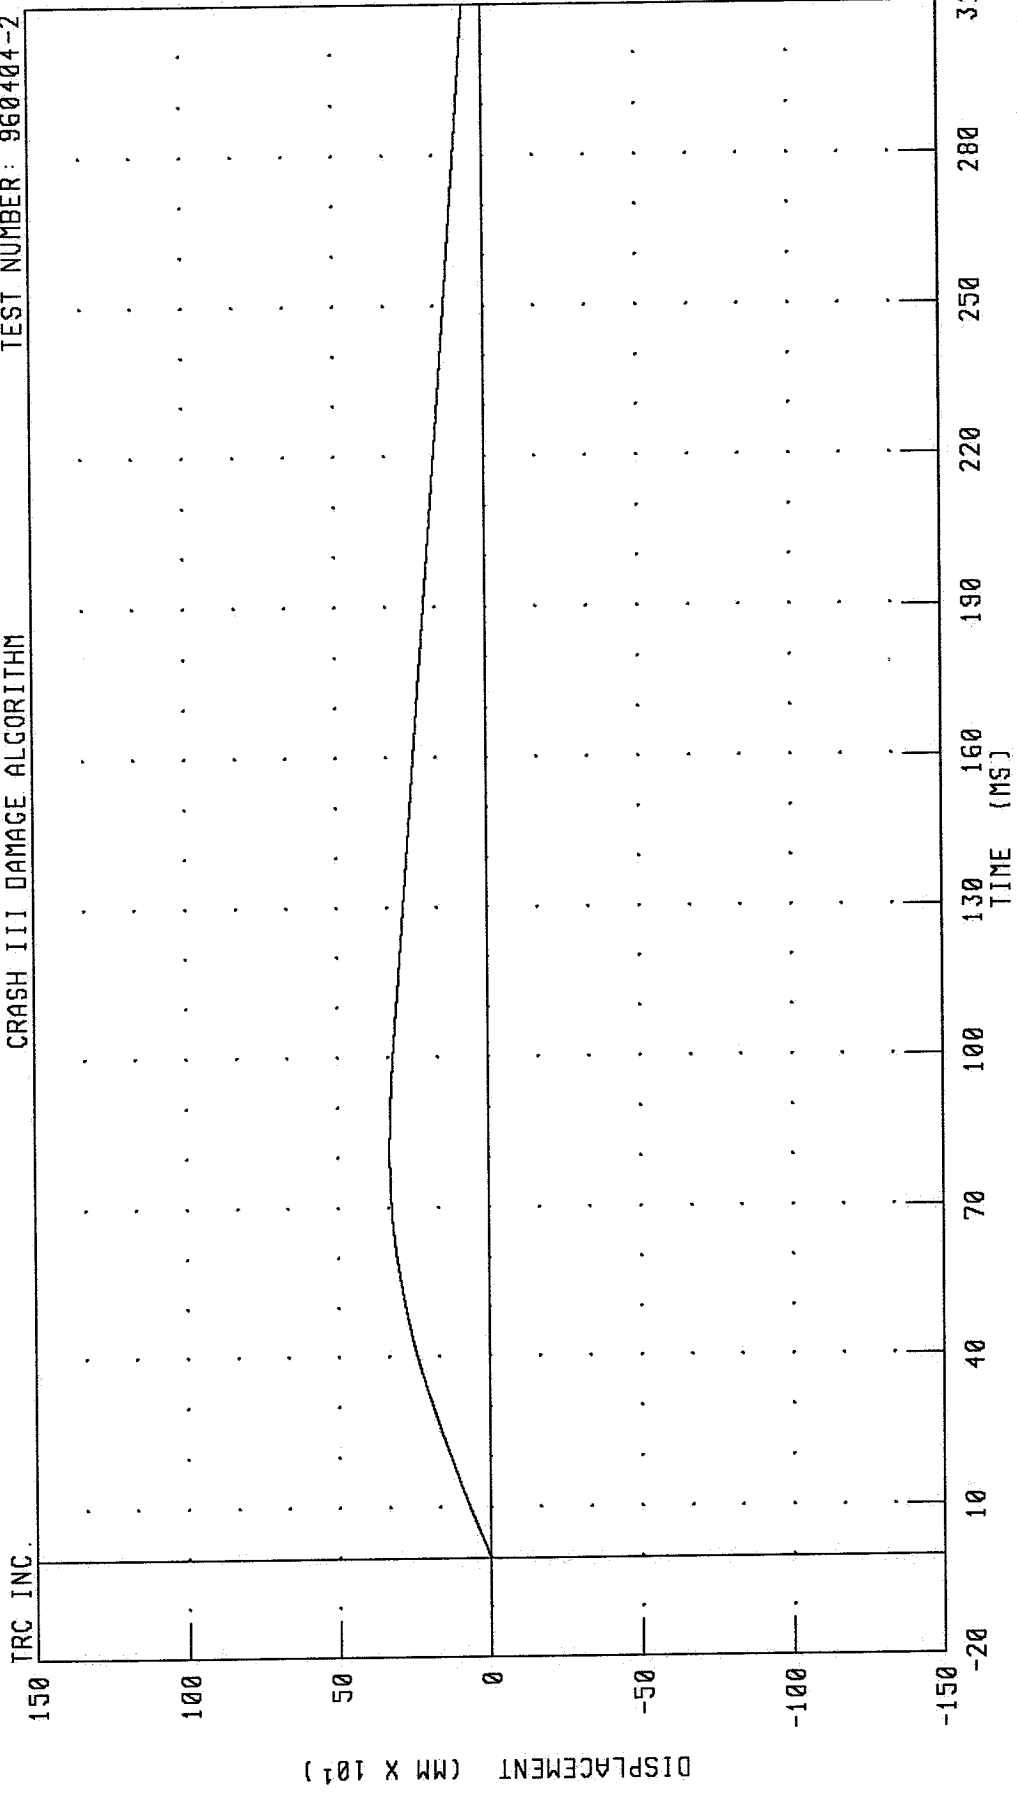
TEST NUMBER: 960404-2

1991 DODGE CARAVAN INTO POLE BARRIER AT 15 MPH TEST NO. 2
RIGHT FRONT SILL X-AXIS DISPLACEMENT
CRASH III DAMAGE ALGORITHM

CHANNEL: RFSXD1 FILTER: CH. CLASS 180
