**1991 Dodge Caravan
into 12-Inch Diameter Centered Pole
in Support of
Crash III Damage Algorithm Reformulation**

TRC Test Nos.: 960404-1

**Prepared by:
Transportation Research Center Inc.
10820 State Route 347
East Liberty, OH 43319**

**April - May 1996
Final Report**

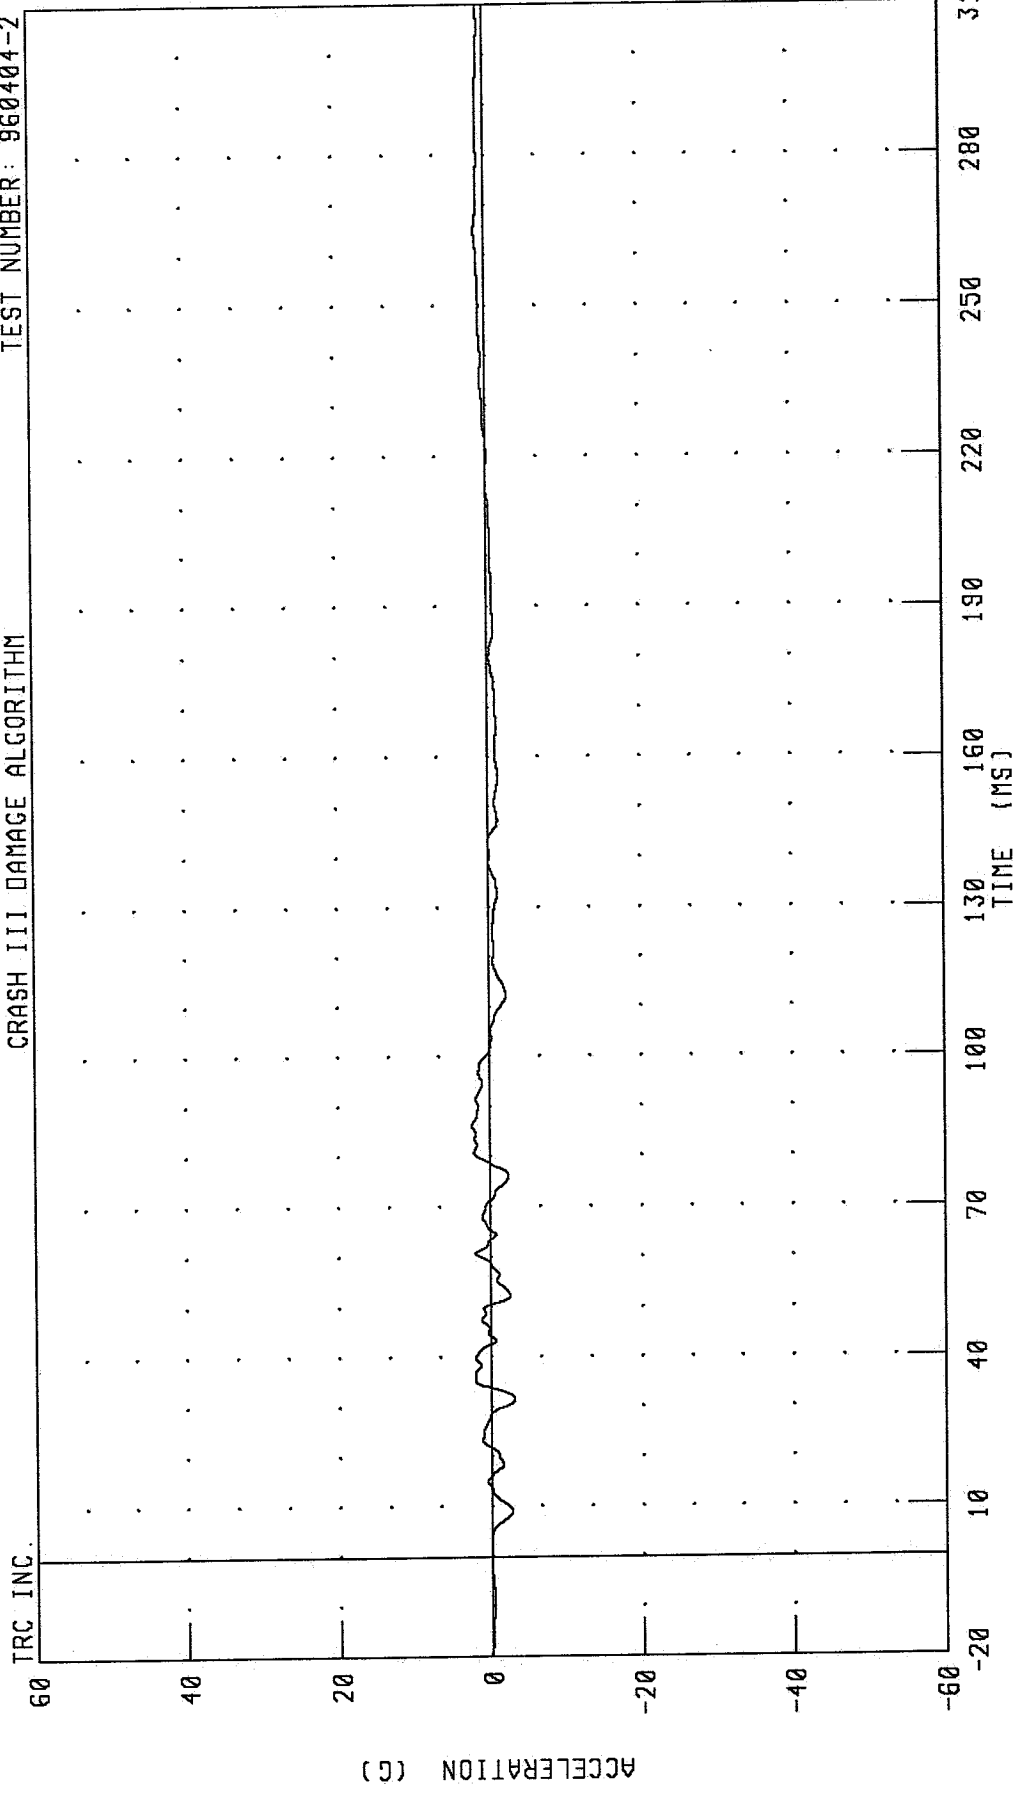
TEST NUMBER: 960404-2

1991 DODGE CARAVAN INTO POLE BARRIER AT 15 MPH TEST NO. 2
RIGHT FRONT SILL Z-AXIS ACCELERATION
CRASH III DAMAGE ALGORITHM

CHANNEL: RFSZG1 FILTER: CH. CLASS 60

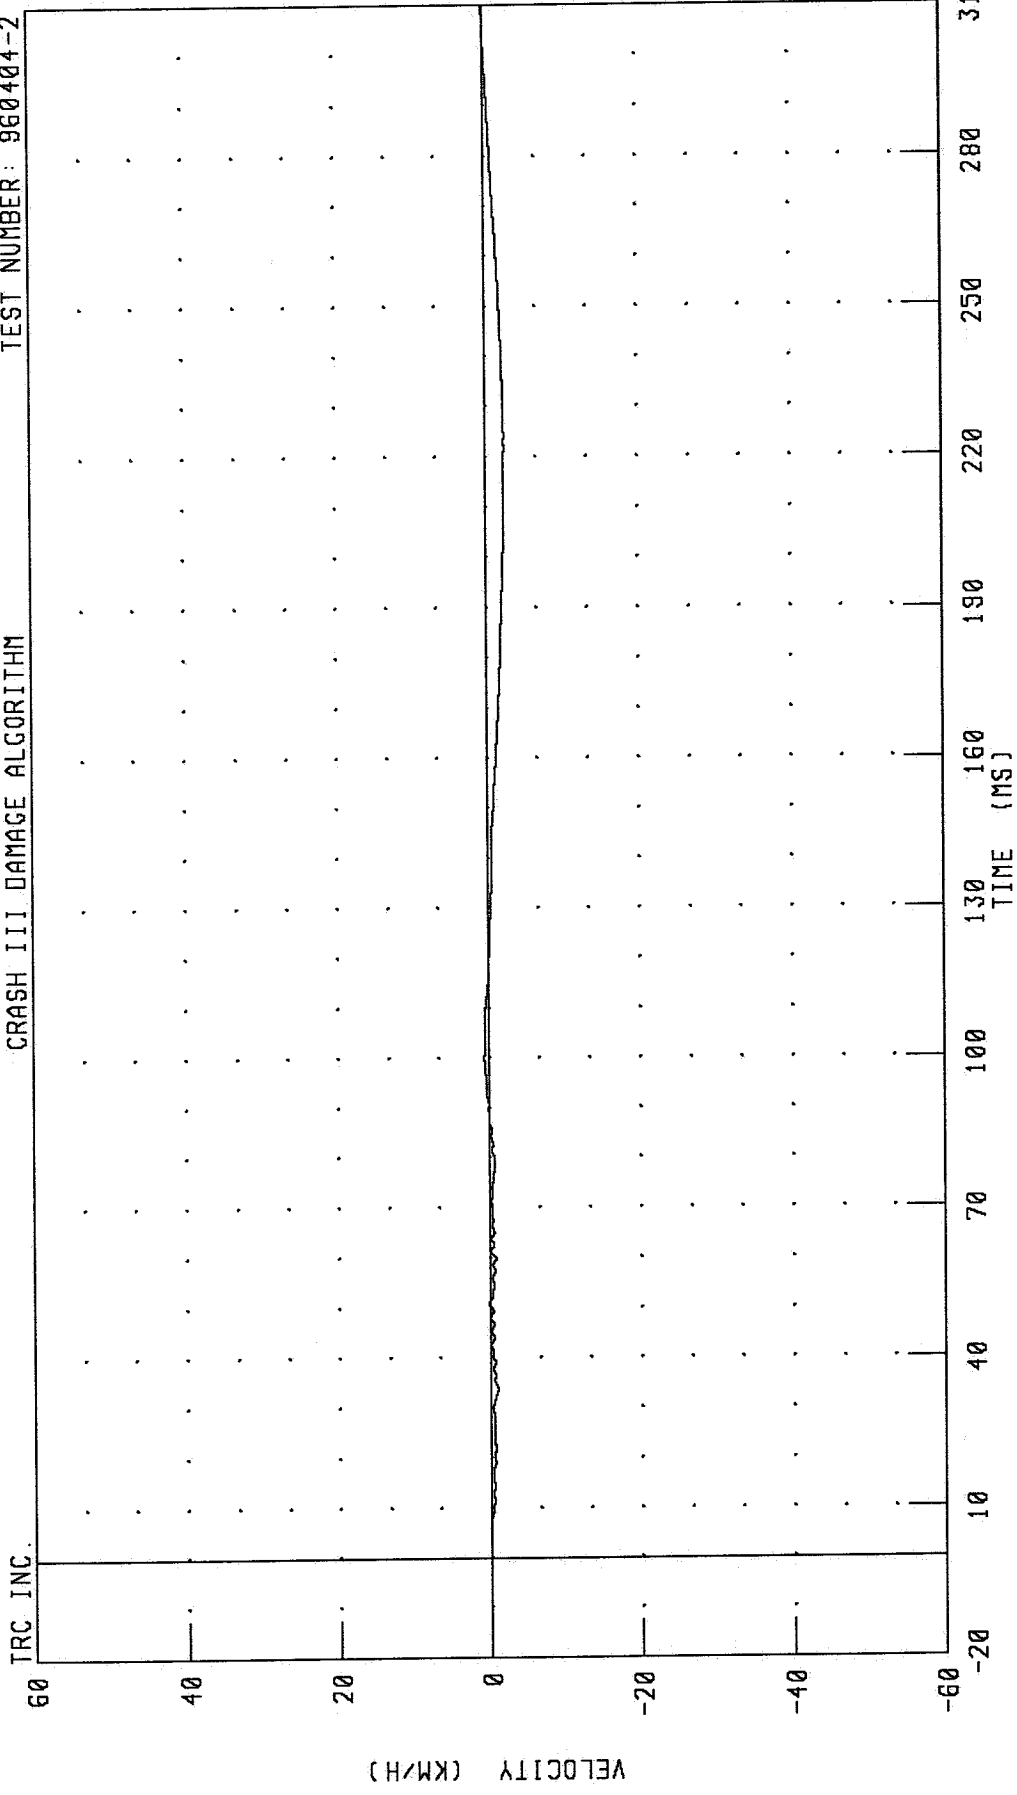
CRASH III DAMAGE ALGORITHM TEST NUMBER: 960404-2

CHANNEL: RFSZV1 FILTER: CH. CLASS 180

PEAK DATA: 0.64 KM/H @ 99.84 MS; -2.45 KM/H @ 221.68 MS

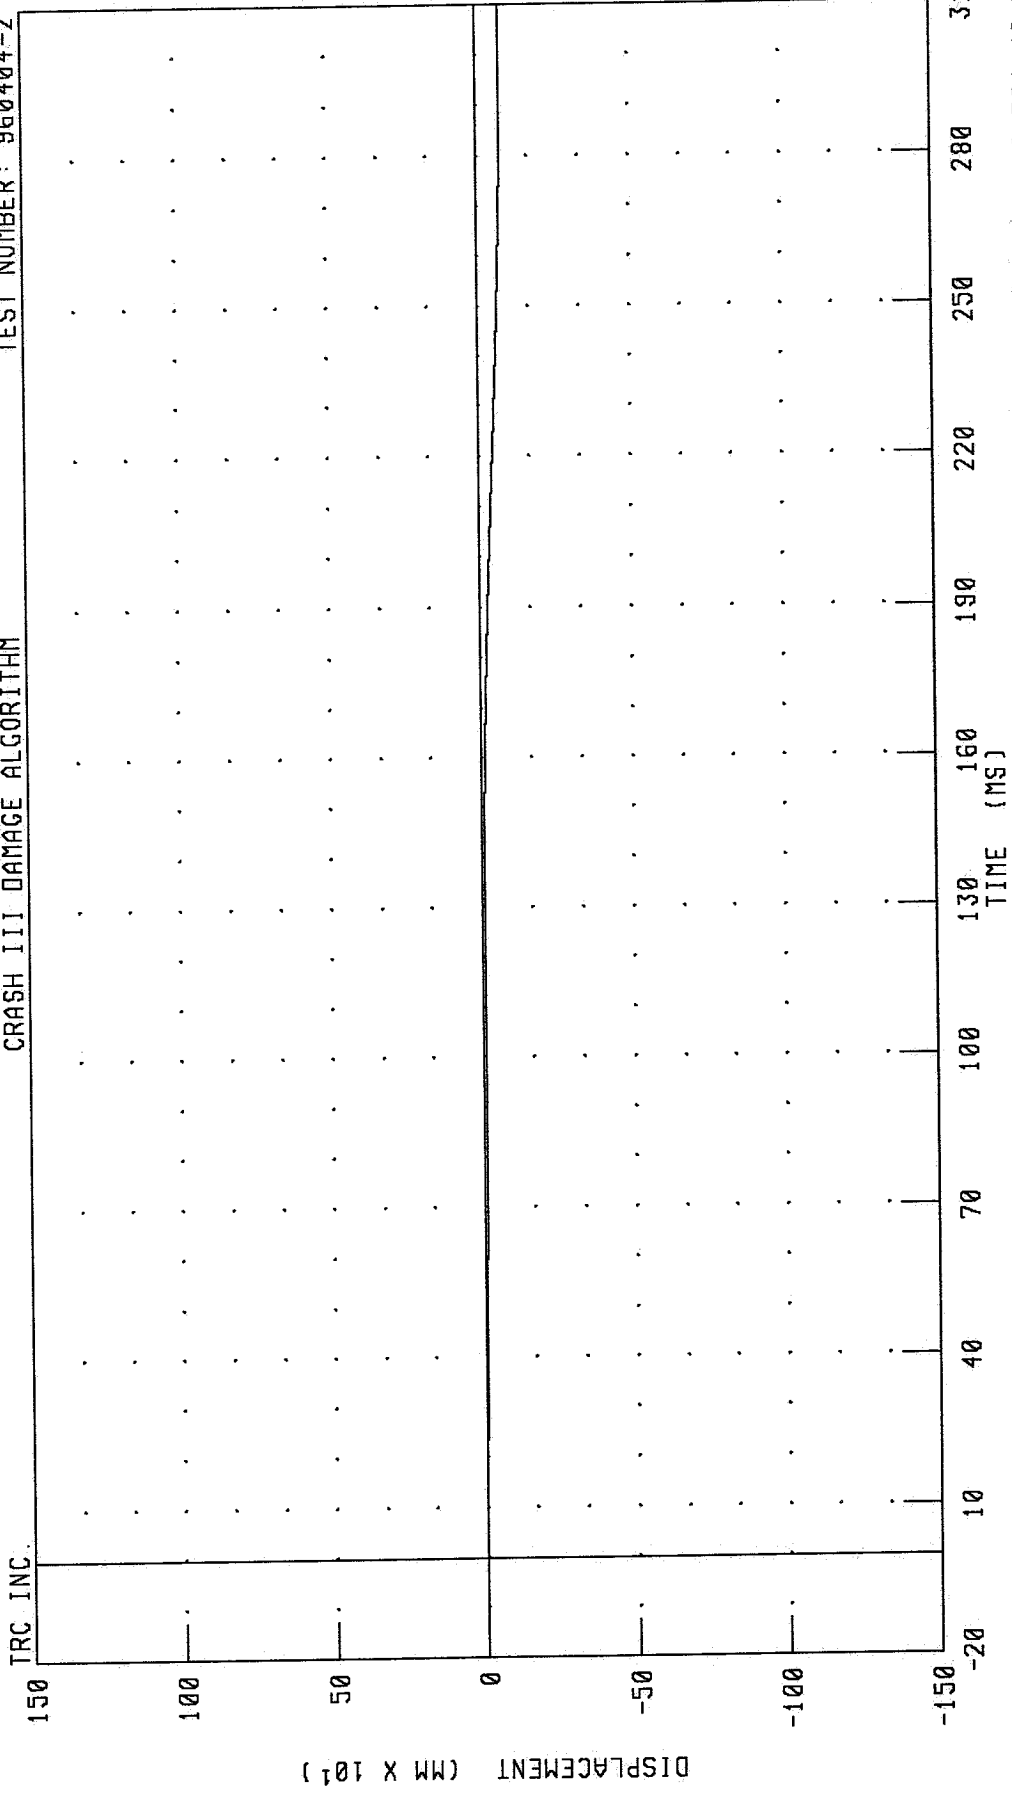
TEST NUMBER: 960404-2

1991 DODGE CARAVAN INTO POLE BARRIER AT 15 MPH TEST NO. 2
 RIGHT FRONT SILL Z-AXIS DISPLACEMENT
 CRASH III DAMAGE ALGORITHM

CHANNEL: RFSZ01 FILTER: CH. CLASS 180

PEAK DATA: 0.00 MM @ 0.00 MS; -78.00 MM @ 304.40 MS

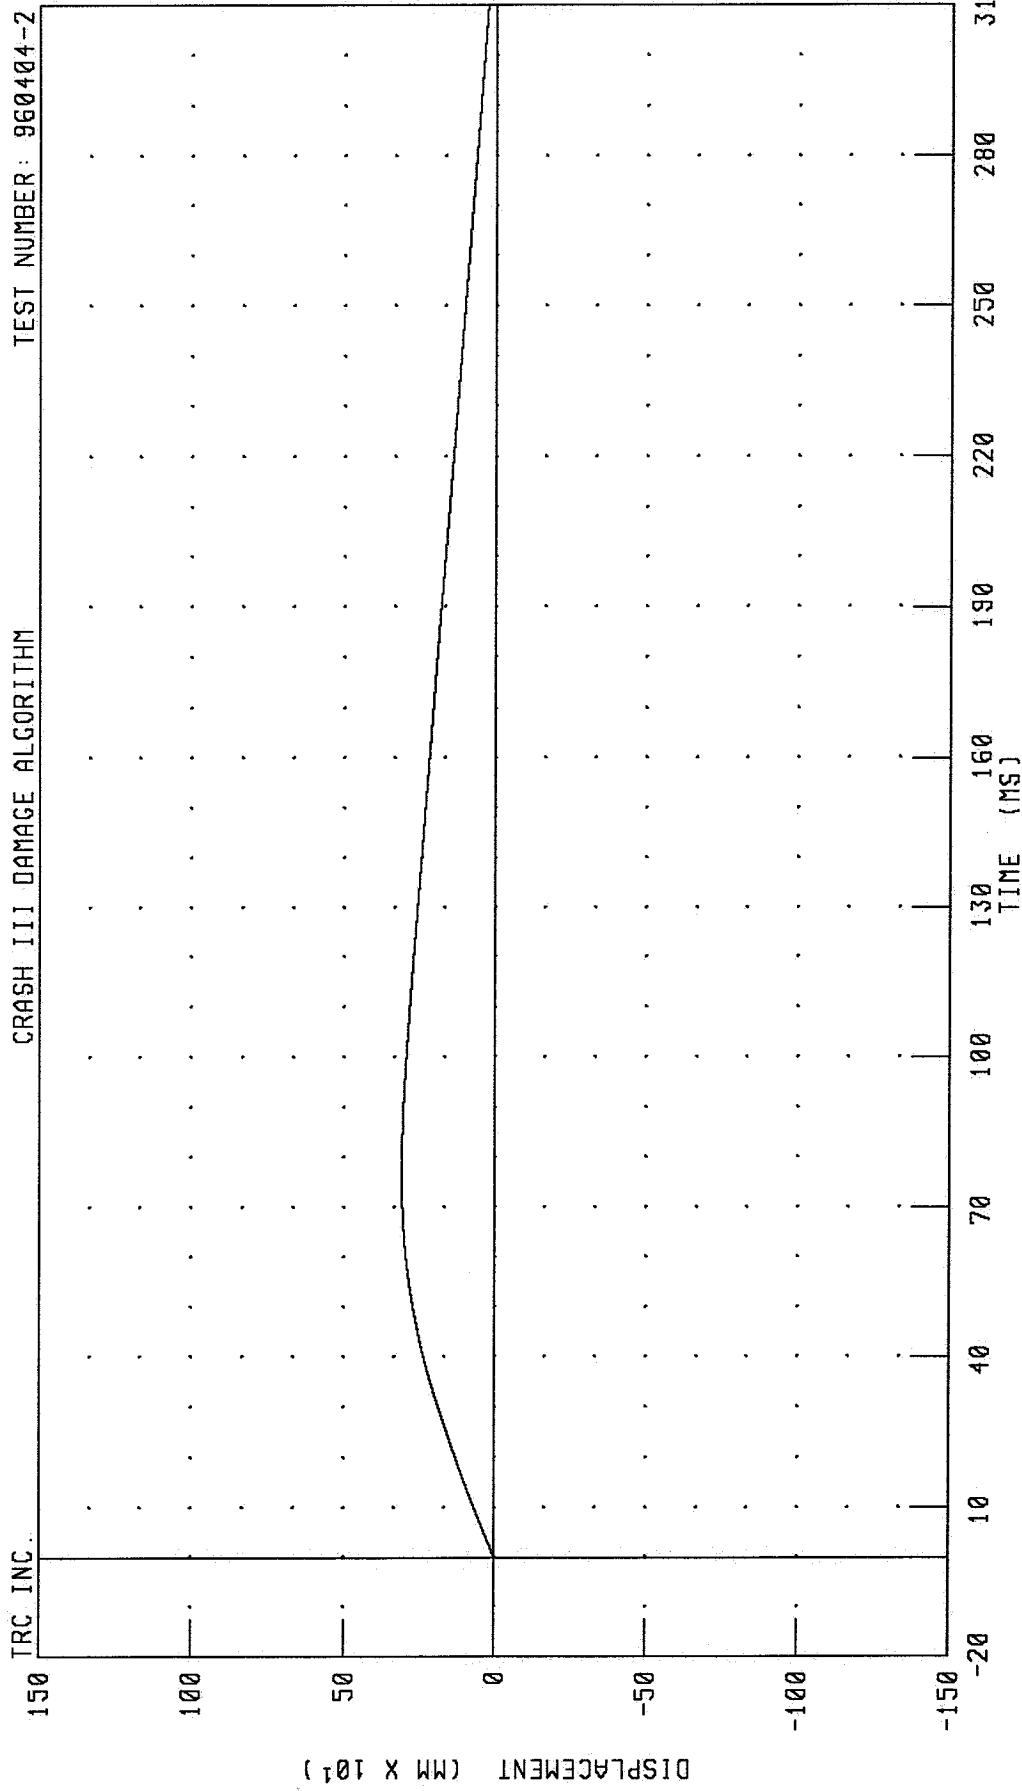
TEST NUMBER: 960404-2

1991 DODGE CARAVAN INTO POLE BARRIER AT 15 MPH TEST NO. 2
VEHICLE CG X-AXIS DISPLACEMENT
CRASH III DAMAGE ALGORITHM

CHANNEL: YCGXD1 FILTER: CH. CLASS 180

PEAK DATA: 309.23 MM @ 76.88 MS; 0.00 MM @ 0.00 MS

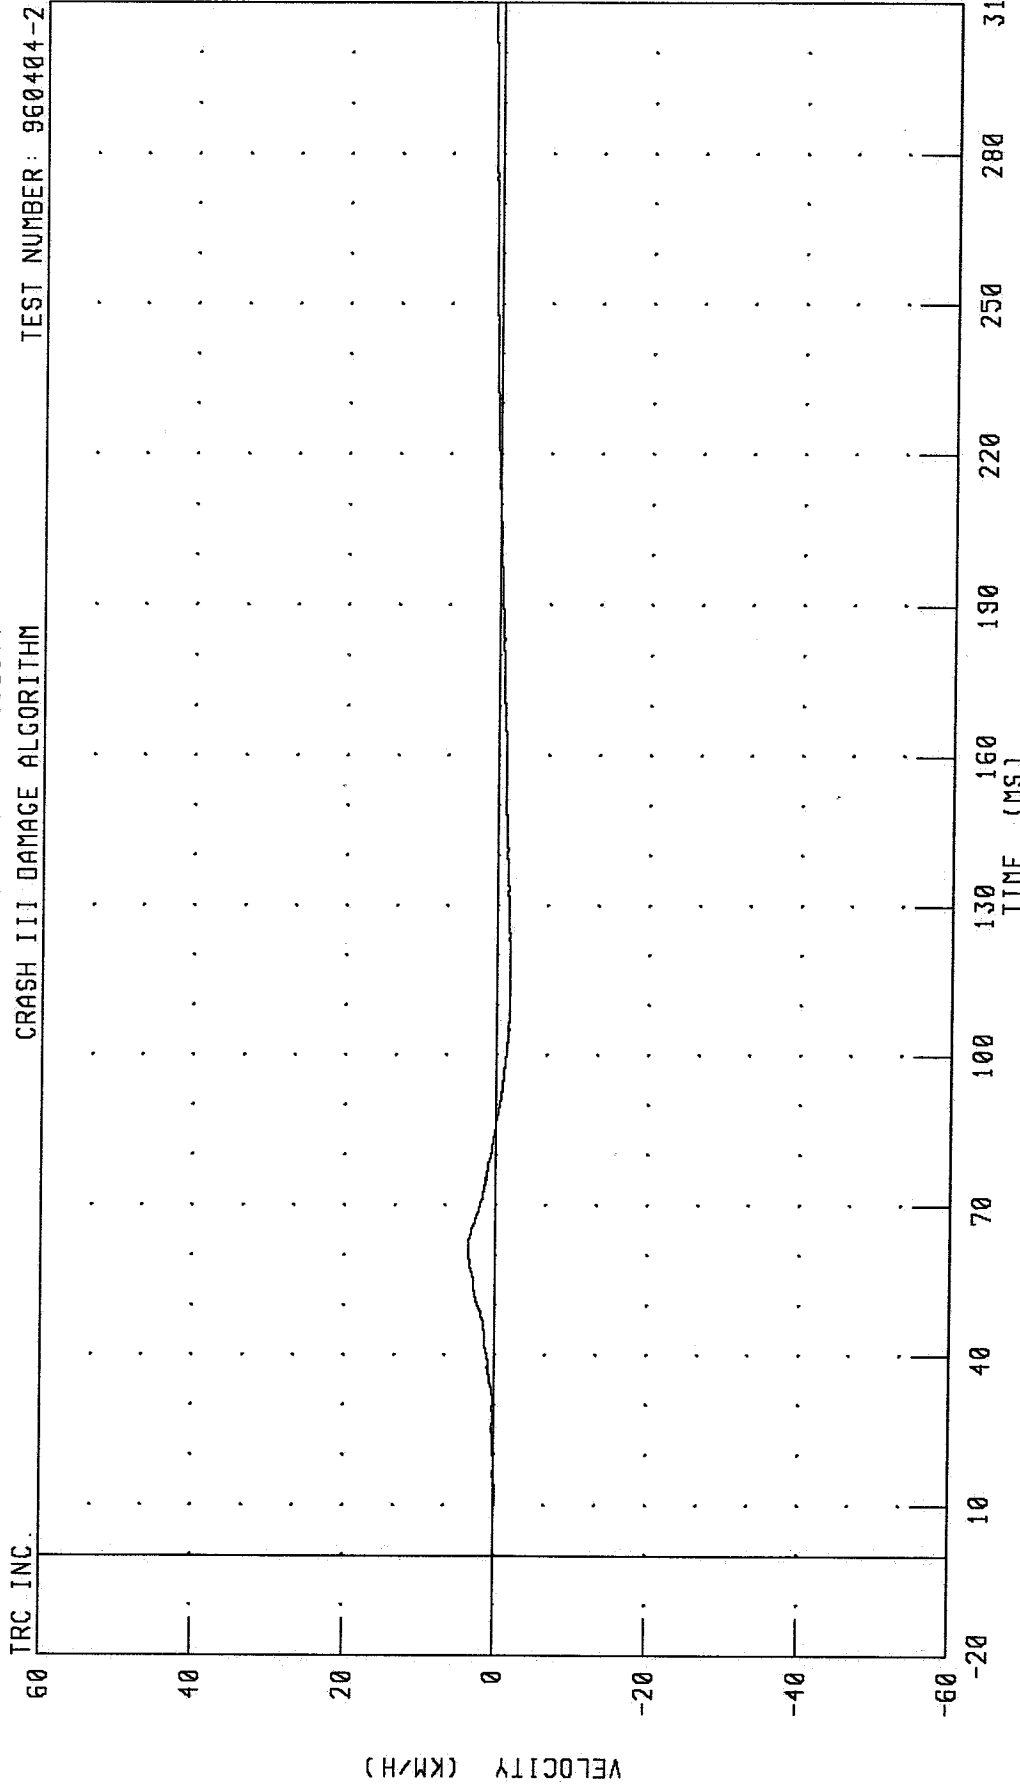
1991 DODGE CARAVAN INTO POLE BARRIER AT 15 MPH TEST NO. 2
VEHICLE CG Y-AXIS VELOCITY
CRASH III DAMAGE ALGORITHM

CHANNEL: VCGYV1 FILTER: CH: CLASS 180

PEAK DATA: 3.61 KM/H @ 60.64 MS; -1.75 KM/H @ 114.16 MS

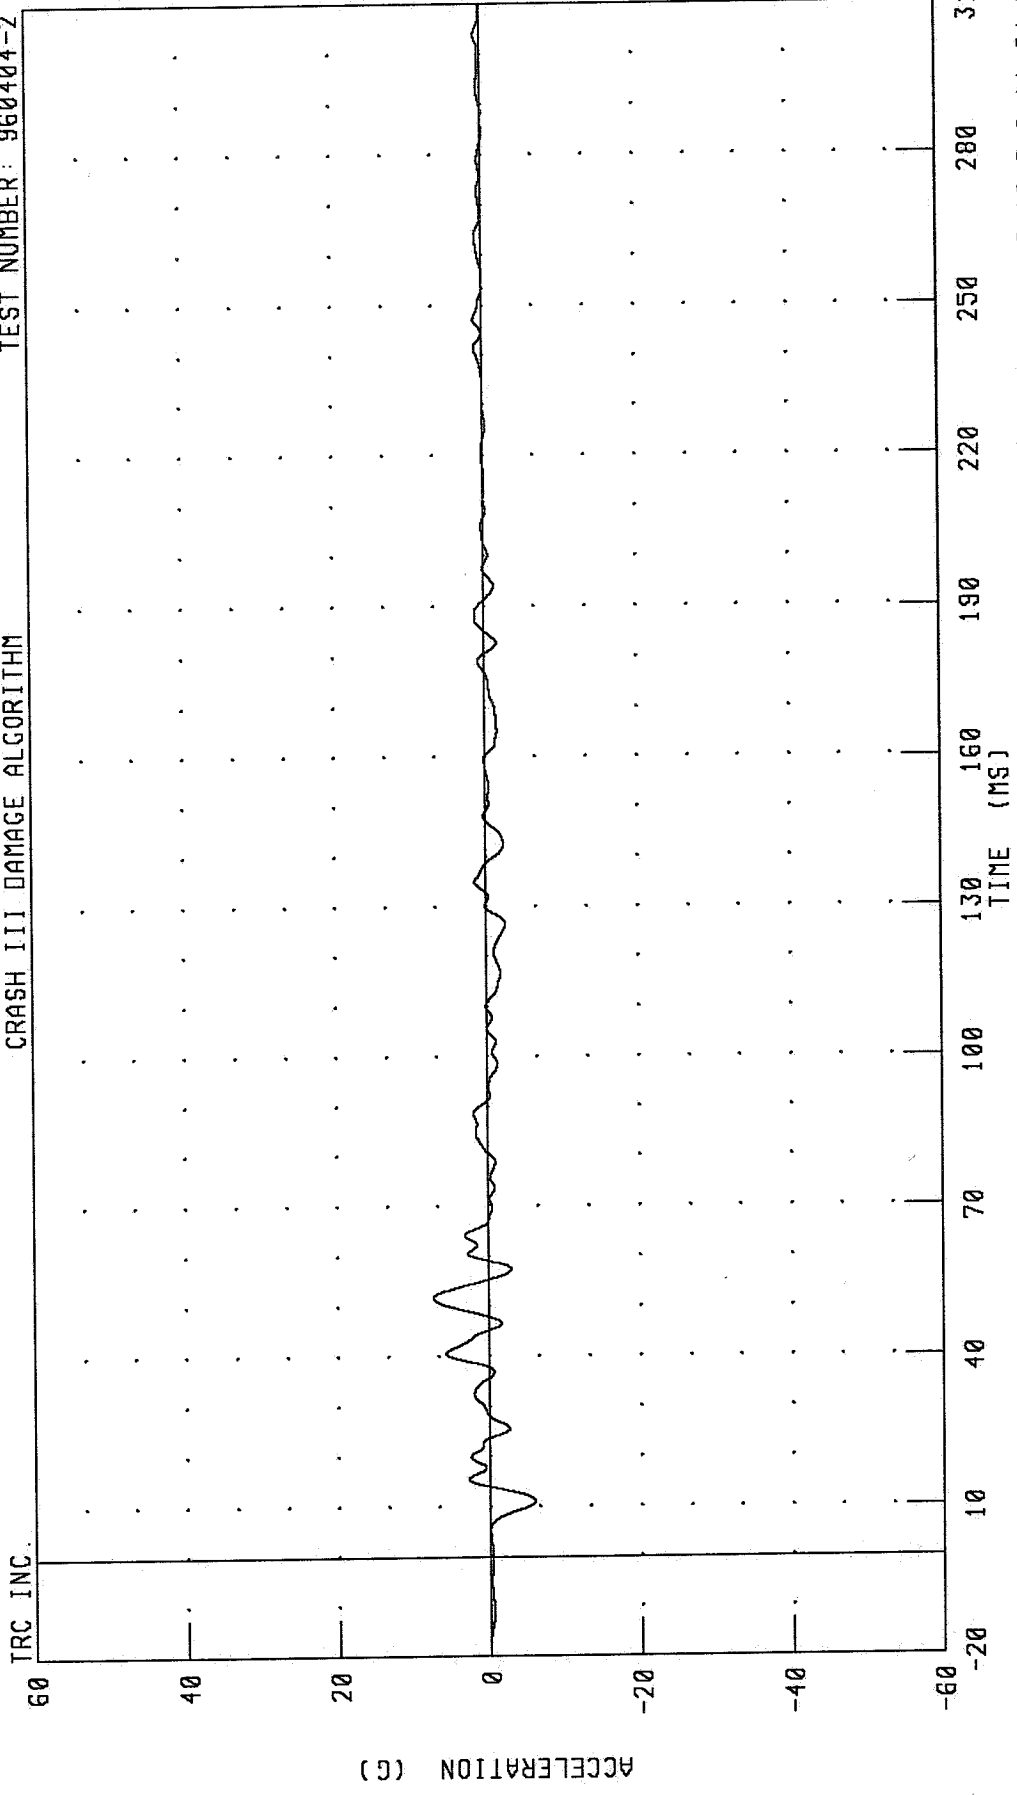
TEST NUMBER: 960404-2

1991 DODGE CARAVAN INTO POLE BARRIER AT 15 MPH TEST NO. 2
VEHICLE CG Z-AXIS ACCELERATION
CRASH III DAMAGE ALGORITHM

CHANNEL: VCGZG1 FILTER: CH. CLASS 60

PEAK DATA: 7.35 G @ 51.76 MS; -6.10 G @ 11.04 MS

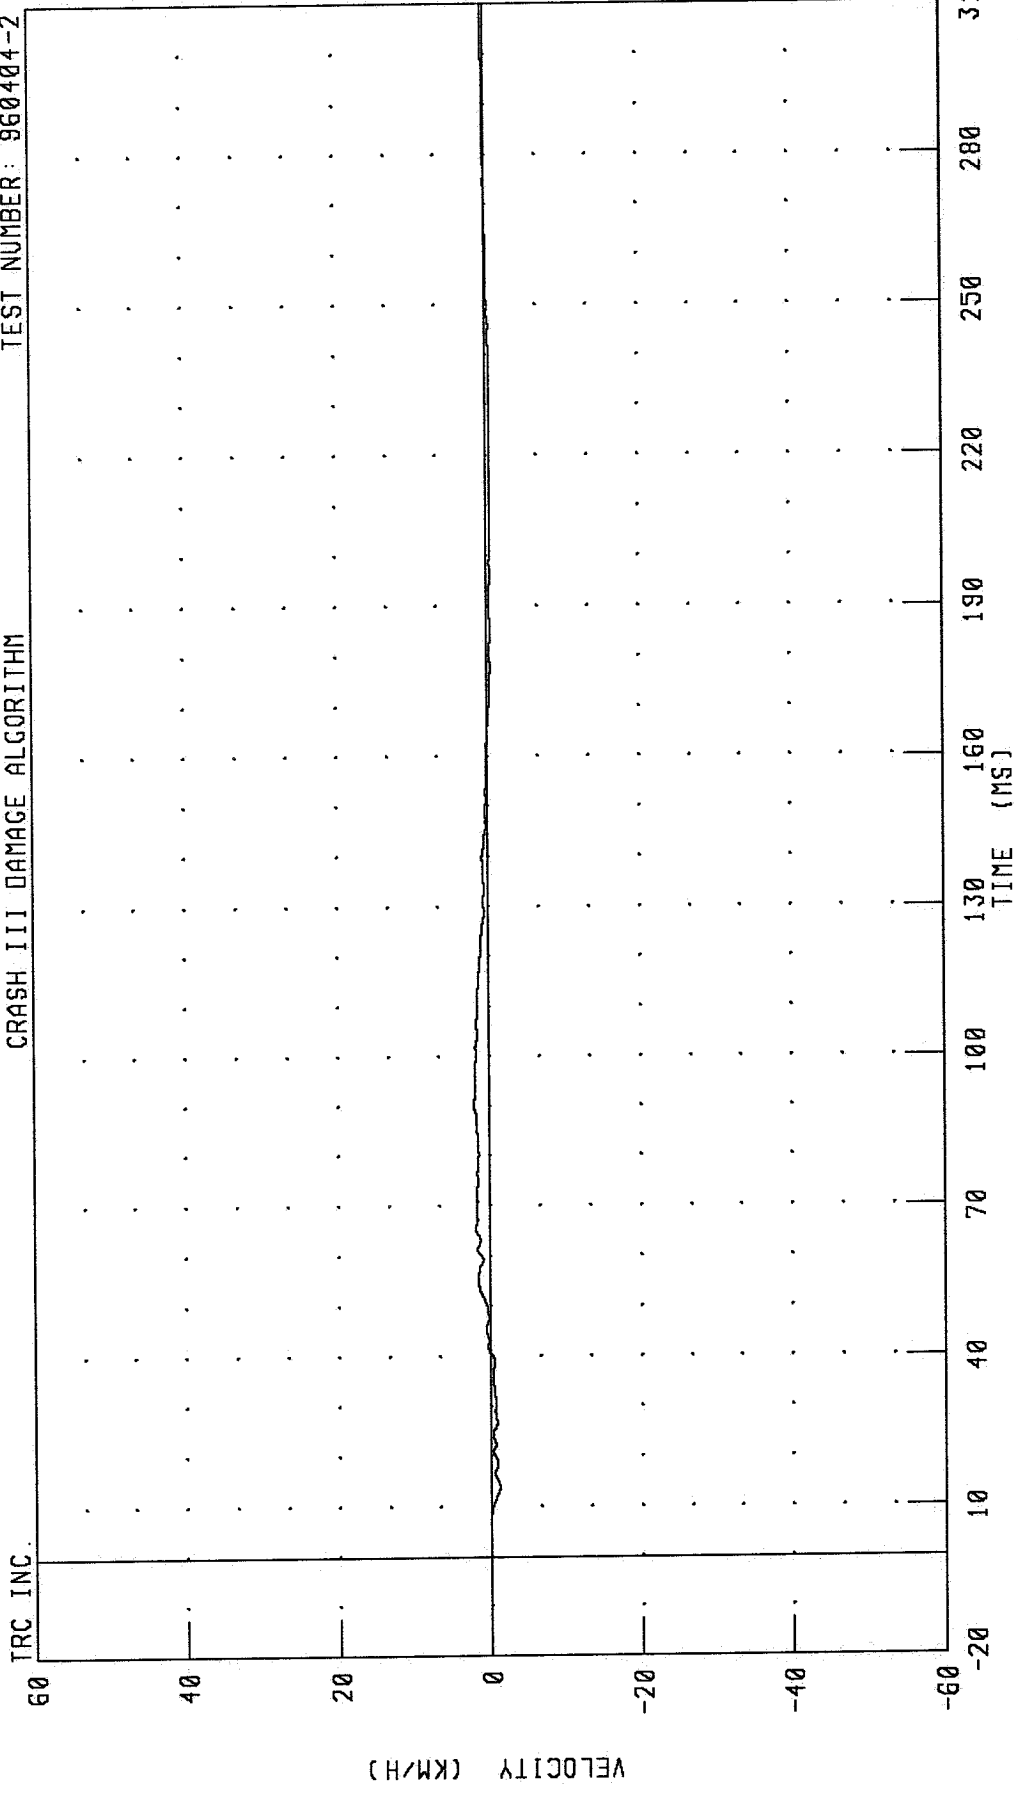
TEST NUMBER: 960404-2

CHANNEL: VCGZV1 FILTER: CH. CLASS 180

PEAK DATA: 2.01 KM/H @ 90.16 MS; -1.14 KM/H @ 13.84 MS

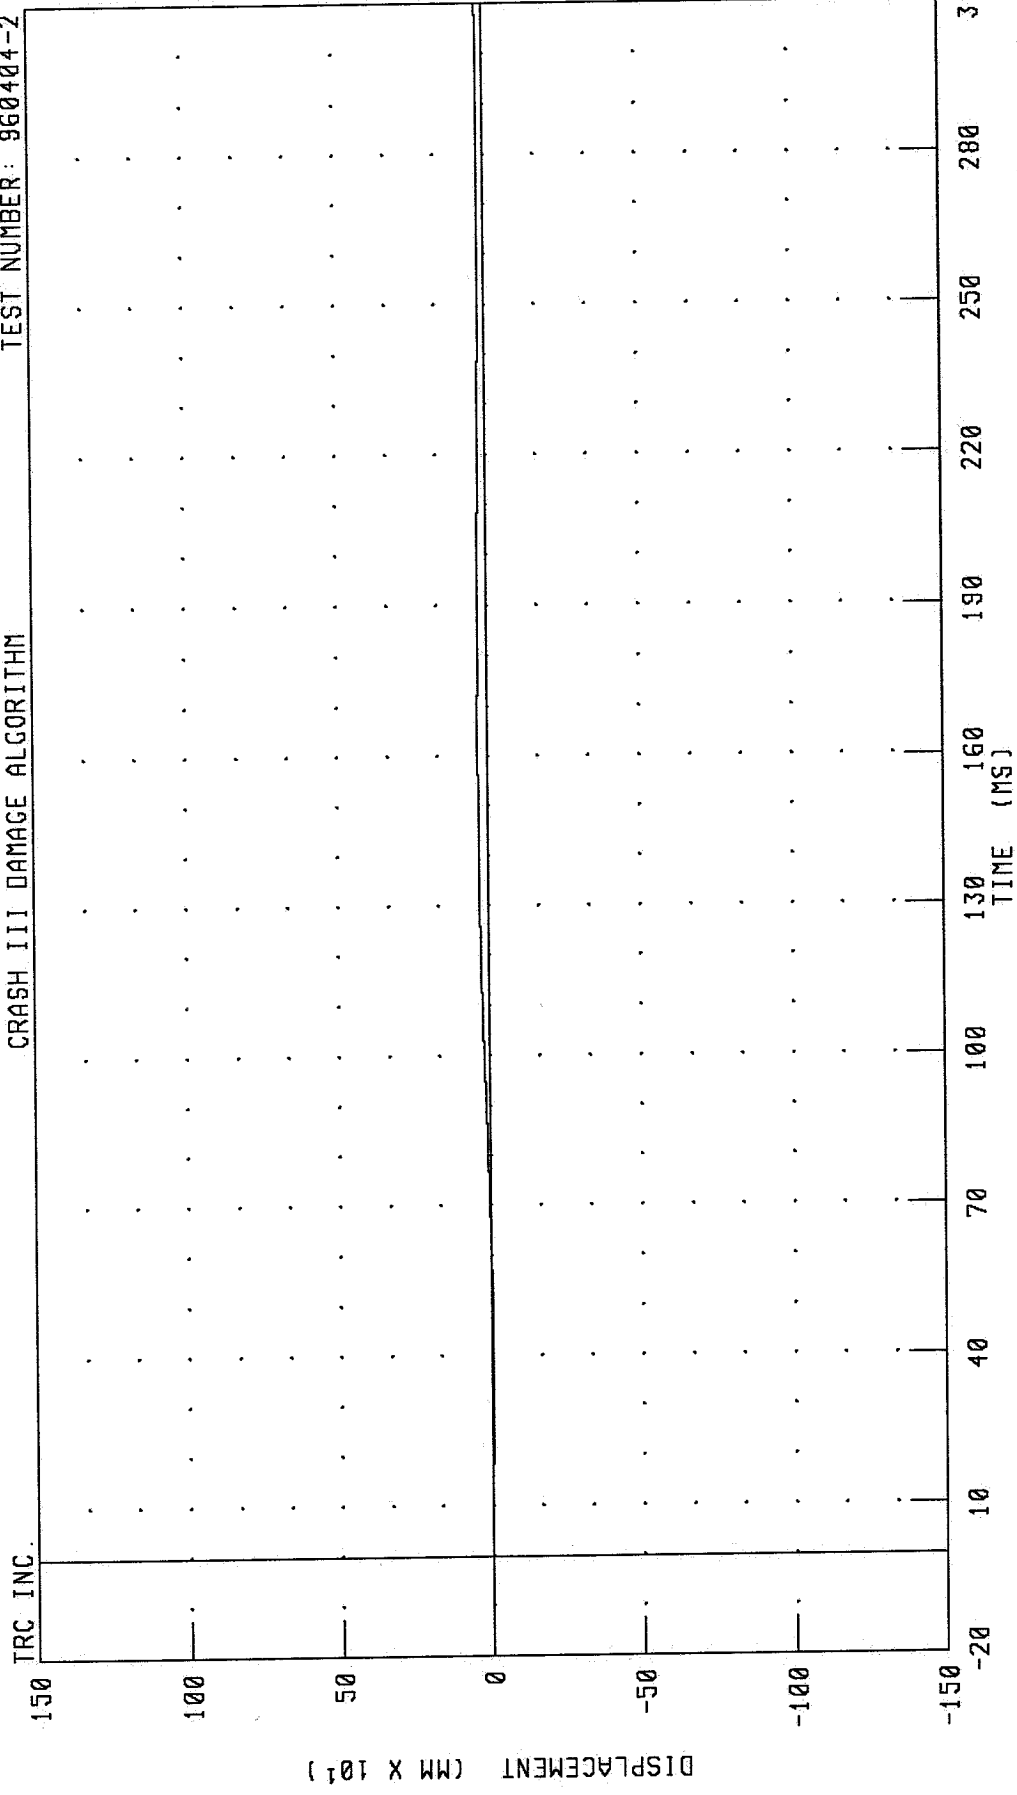
TEST NUMBER: 960404-2

1991 DODGE CARAVAN INTO POLE BARRIER AT 15 MPH TEST NO. 2
 VEHICLE CG Z-AXIS DISPLACEMENT
 CRASH III DAMAGE ALGORITHM

CHANNEL: VCGZD1 FILTER: CH: CLASS 180

PEAK DATA: 32.37 MM @ 165.28 MS; -5.10 MM @ 40.64 MS

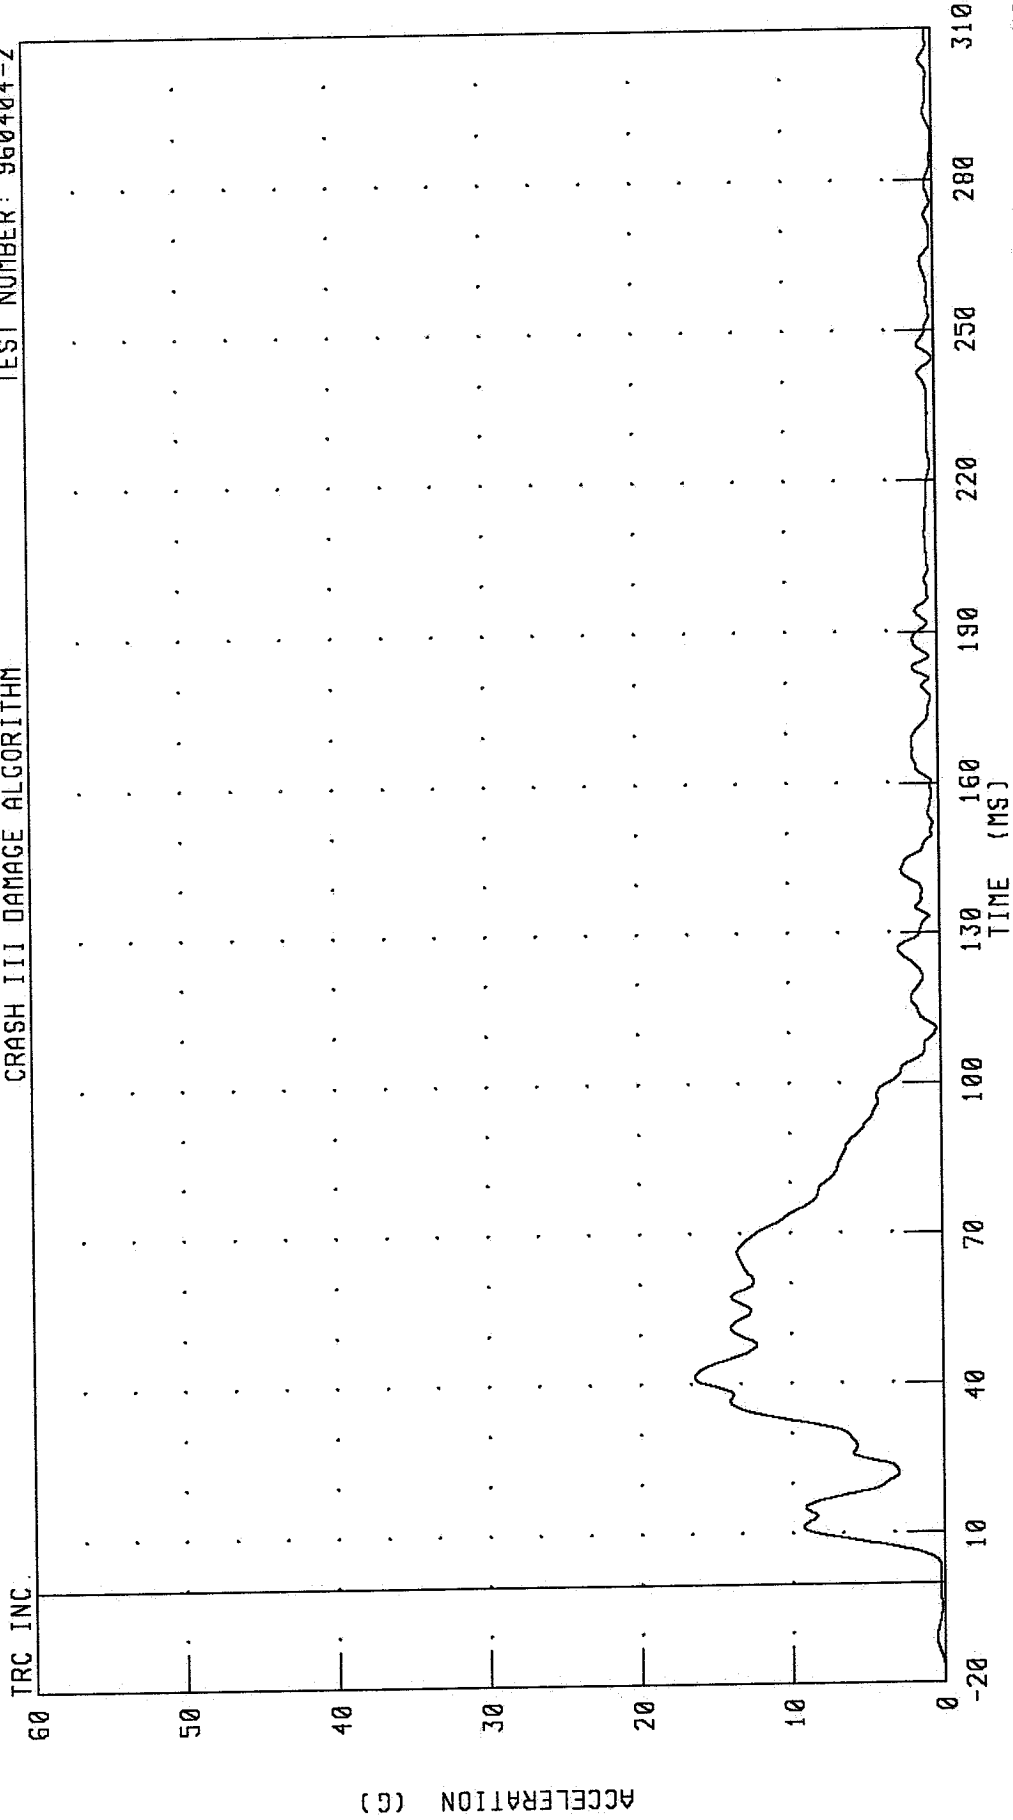
TEST NUMBER: 960404-2

1991 DODGE CARAVAN INTO POLE BARRIER AT 15 MPH TEST NO. 2
VEHICLE CG RESULTANT ACCELERATION
CRASH III DAMAGE ALGORITHM

CHANNEL: VCGRG1 FILTER: CH. CLASS 60

PEAK DATA: 16.41 G @ 41.52 MS; 0.05 G @ -19.28 MS

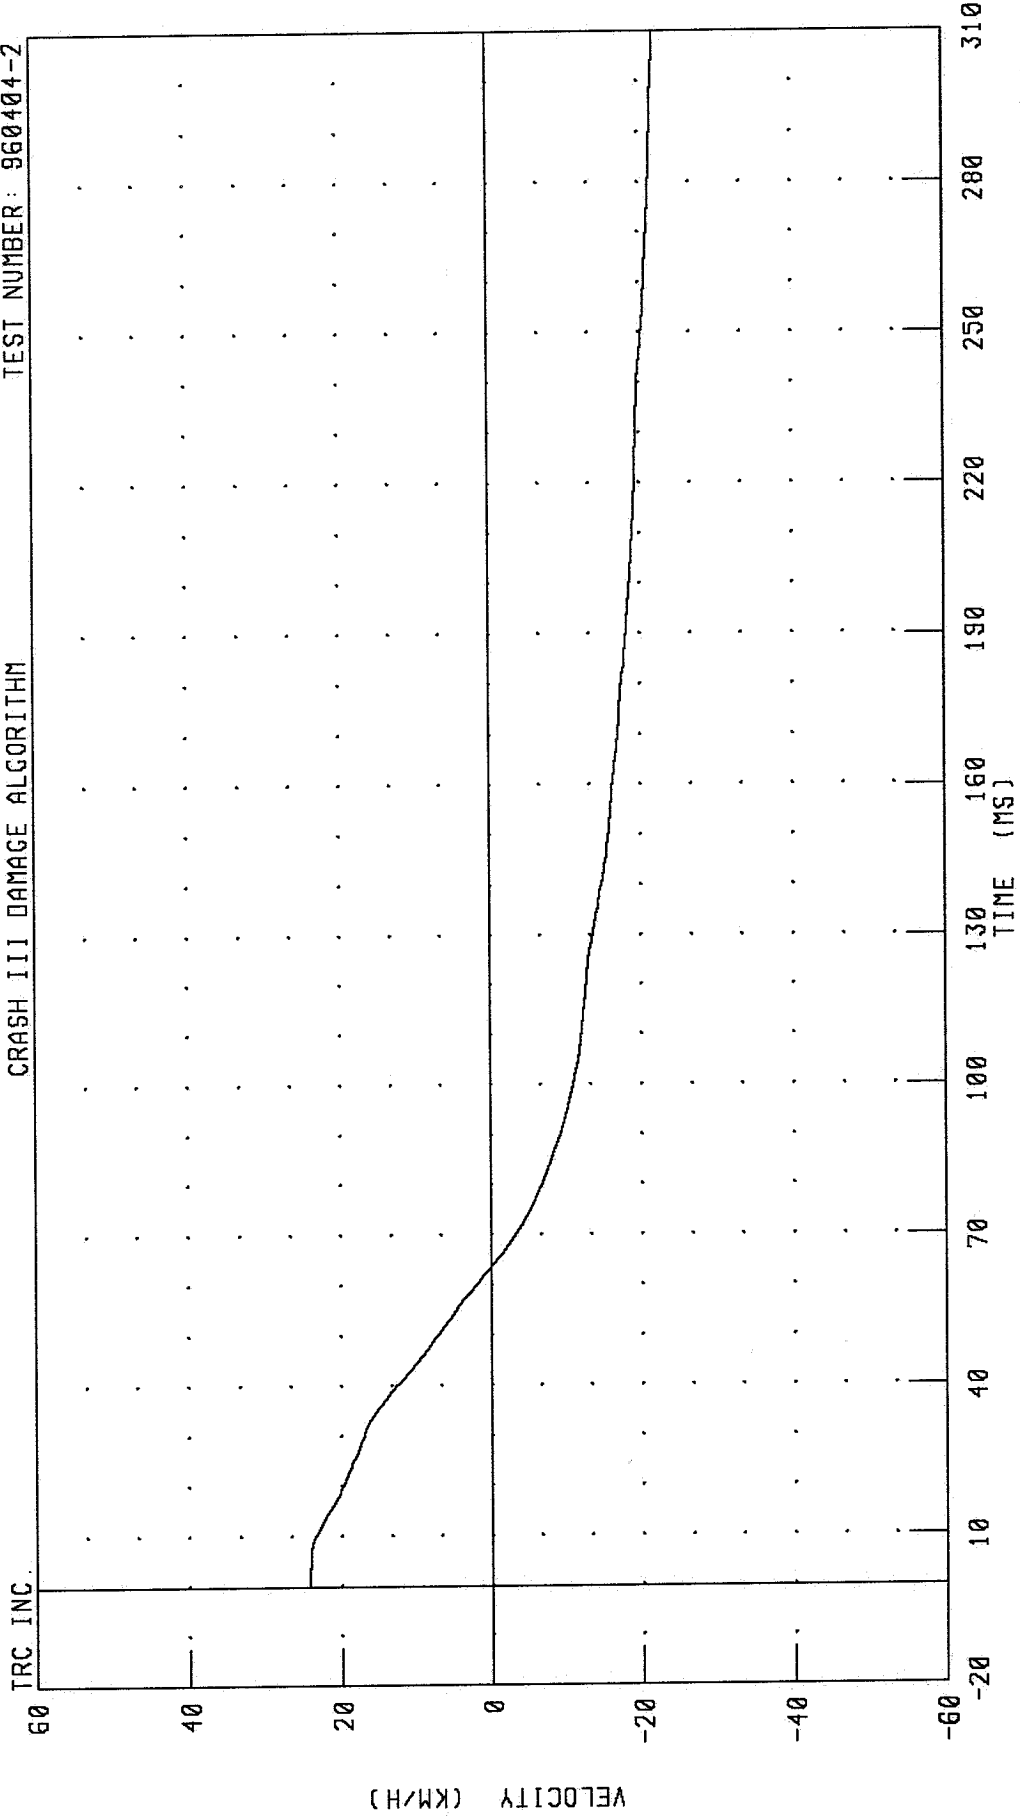
CRASH III DAMAGE ALGORITHM TEST NUMBER: 960404-2

CHANNEL: VCGRV1 FILTER: CH. CLASS 180 PEAK DATA: 24.20 KM/H @ 0.00 MS; -22.07 KM/H @ 310.00 MS

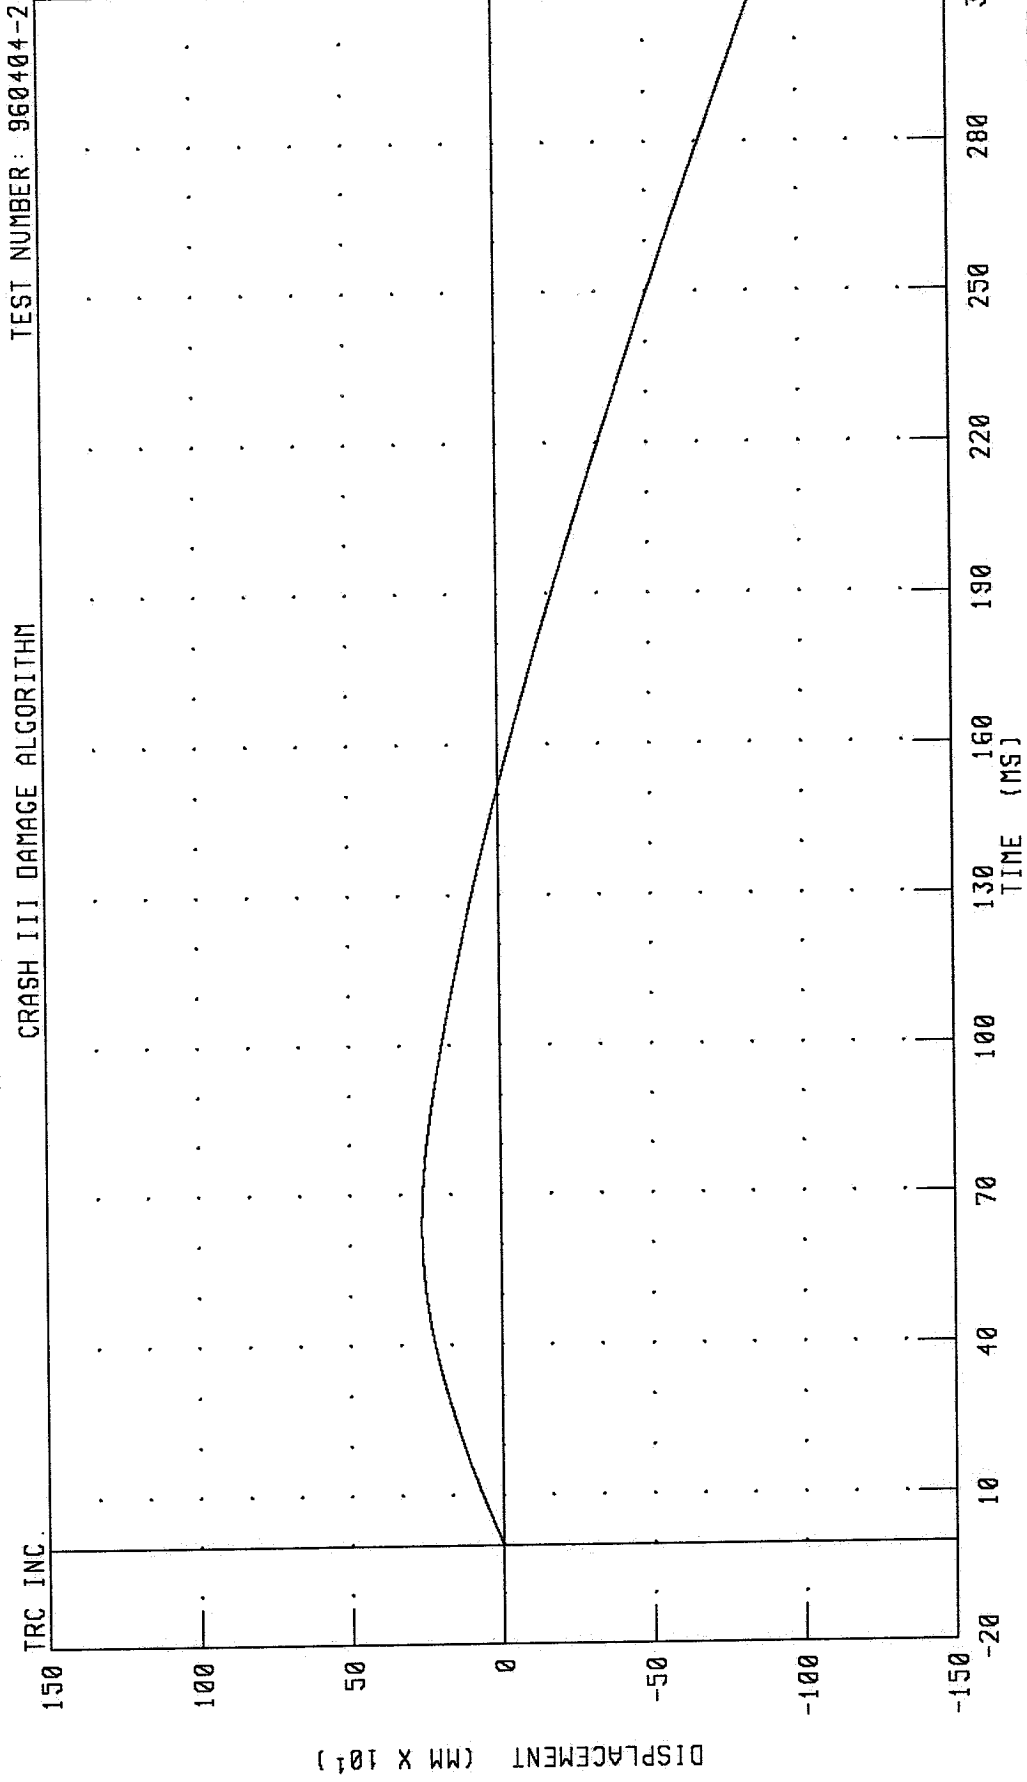
1991 DODGE CARAVAN INTO POLE BARRIER AT 15 MPH TEST NO. 2
VEHICLE CG RESULTANT DISPLACEMENT
CRASH III DAMAGE ALGORITHM

CHANNEL: VCGRD1 FILTER: CH. CLASS 180

PEAK DATA: 261.02 MM @ 63.68 MS; -858.01 MM @ 310.00 MS

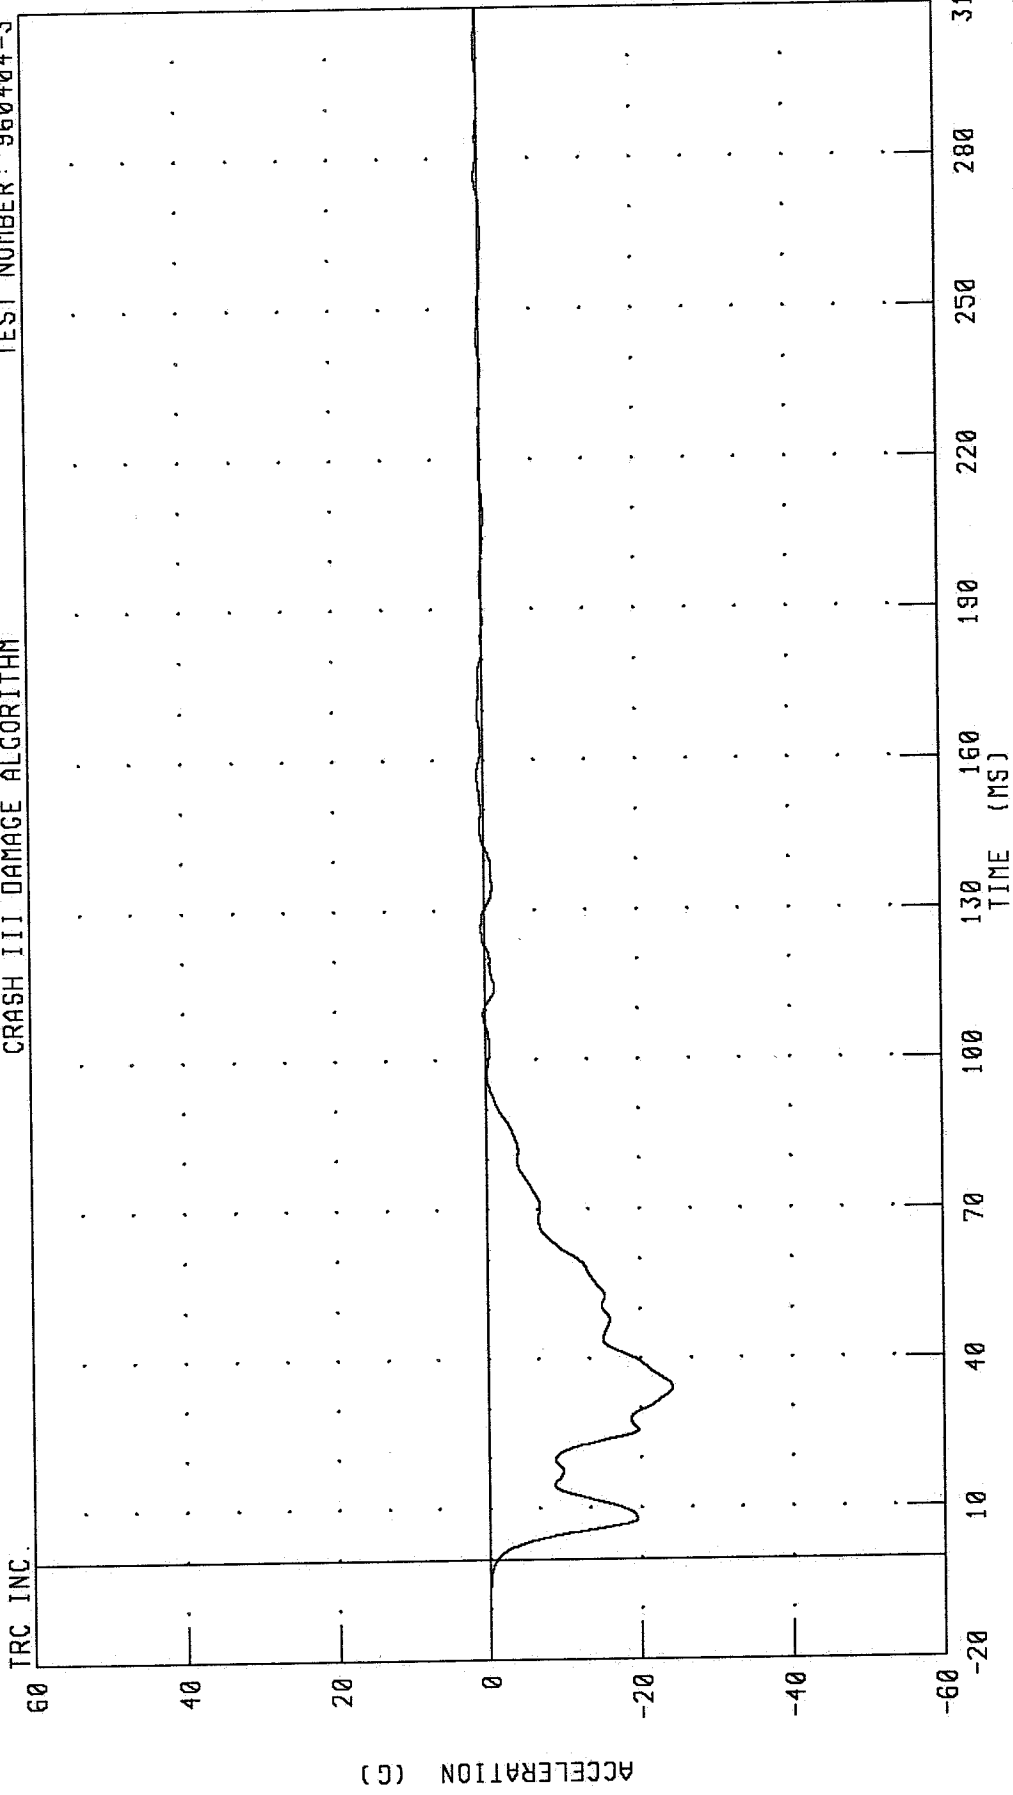
TEST NUMBER: 960404-3

1991 DODGE CARAVAN INTO POLE BARRIER AT 20 MPH TEST NO. 3
LEFT REAR SILL X-AXIS ACCELERATION
CRASH III DAMAGE ALGORITHM

CHANNEL: LRSXG1 FILTER: CH. CLASS 60

PEAK DATA: 0.88 G @ 157.04 MS; -24.19 G @ 34.24 MS
