**1991 Dodge Caravan
into 12-Inch Diameter Centered Pole
in Support of
Crash III Damage Algorithm Reformulation**

TRC Test Nos.: 960404-1

**Prepared by:
Transportation Research Center Inc.
10820 State Route 347
East Liberty, OH 43319**

**April - May 1996
Final Report**

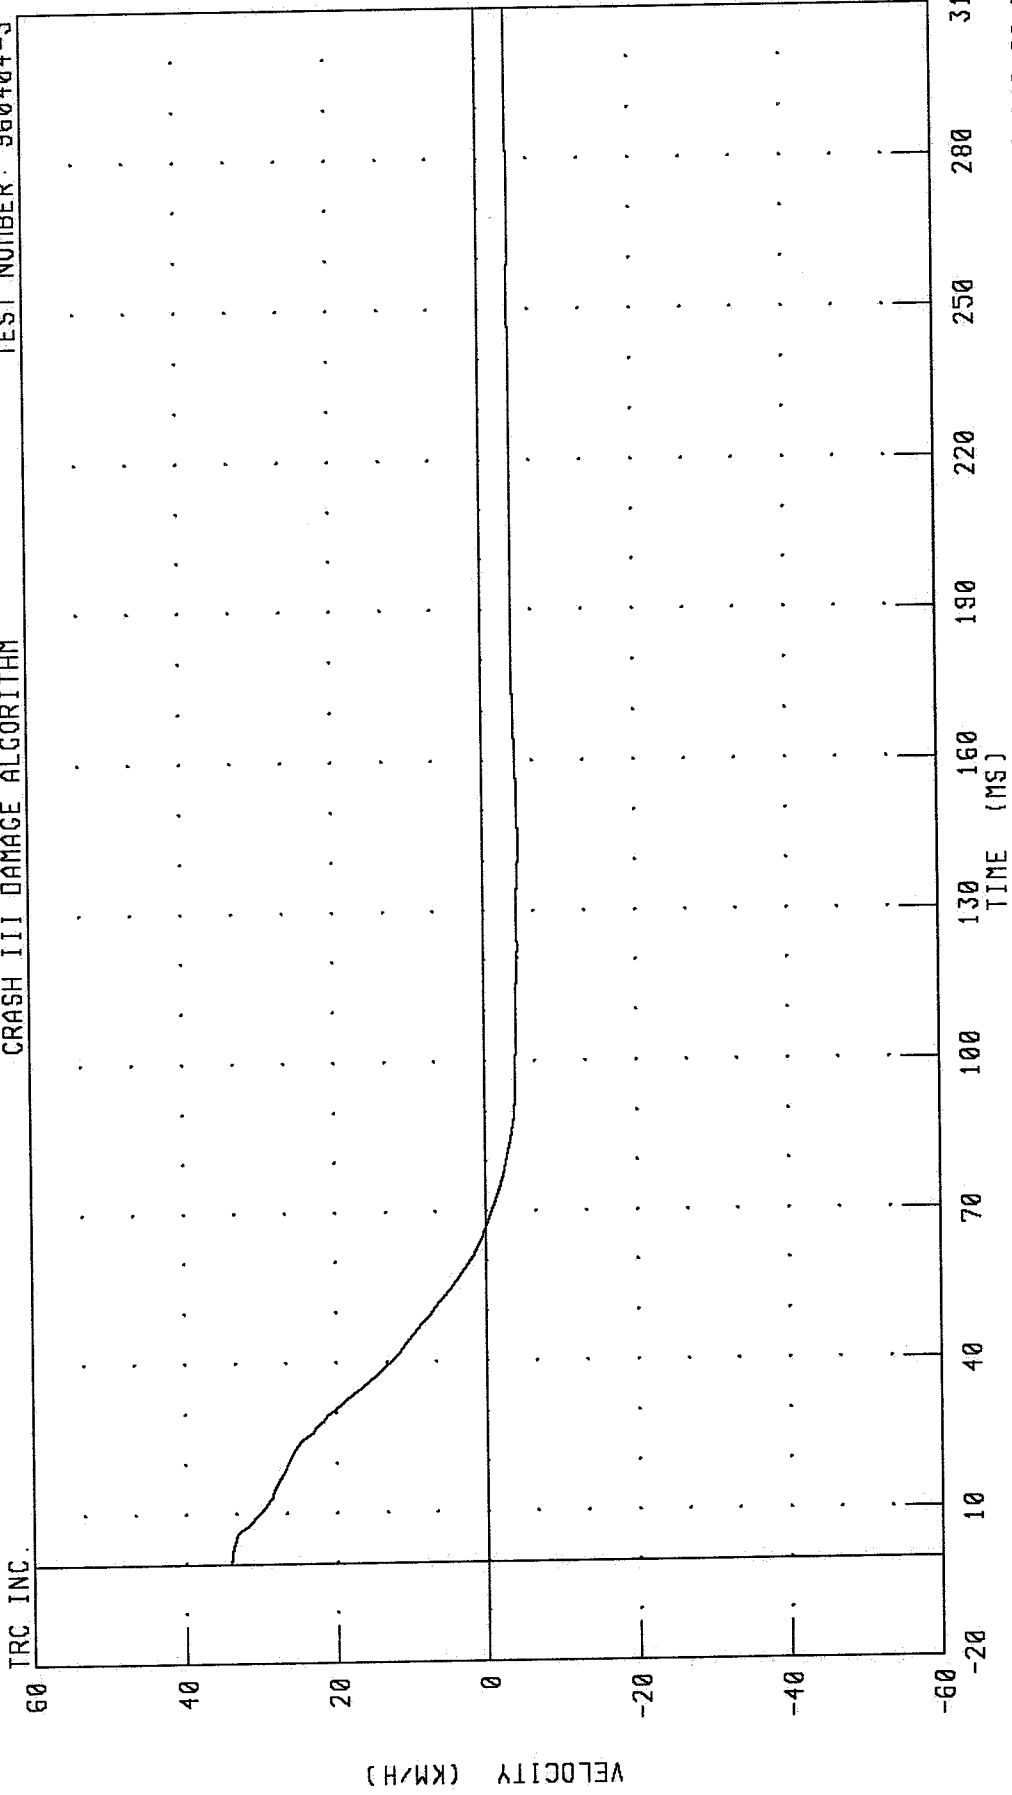
TEST NUMBER: 960404-3

CHANNEL: LRSXV1 FILTER: CH. CLASS 180

PEAK DATA: 34.00 KM/H @ 0.00 MS; -4.71 KM/H @ 142.08 MS

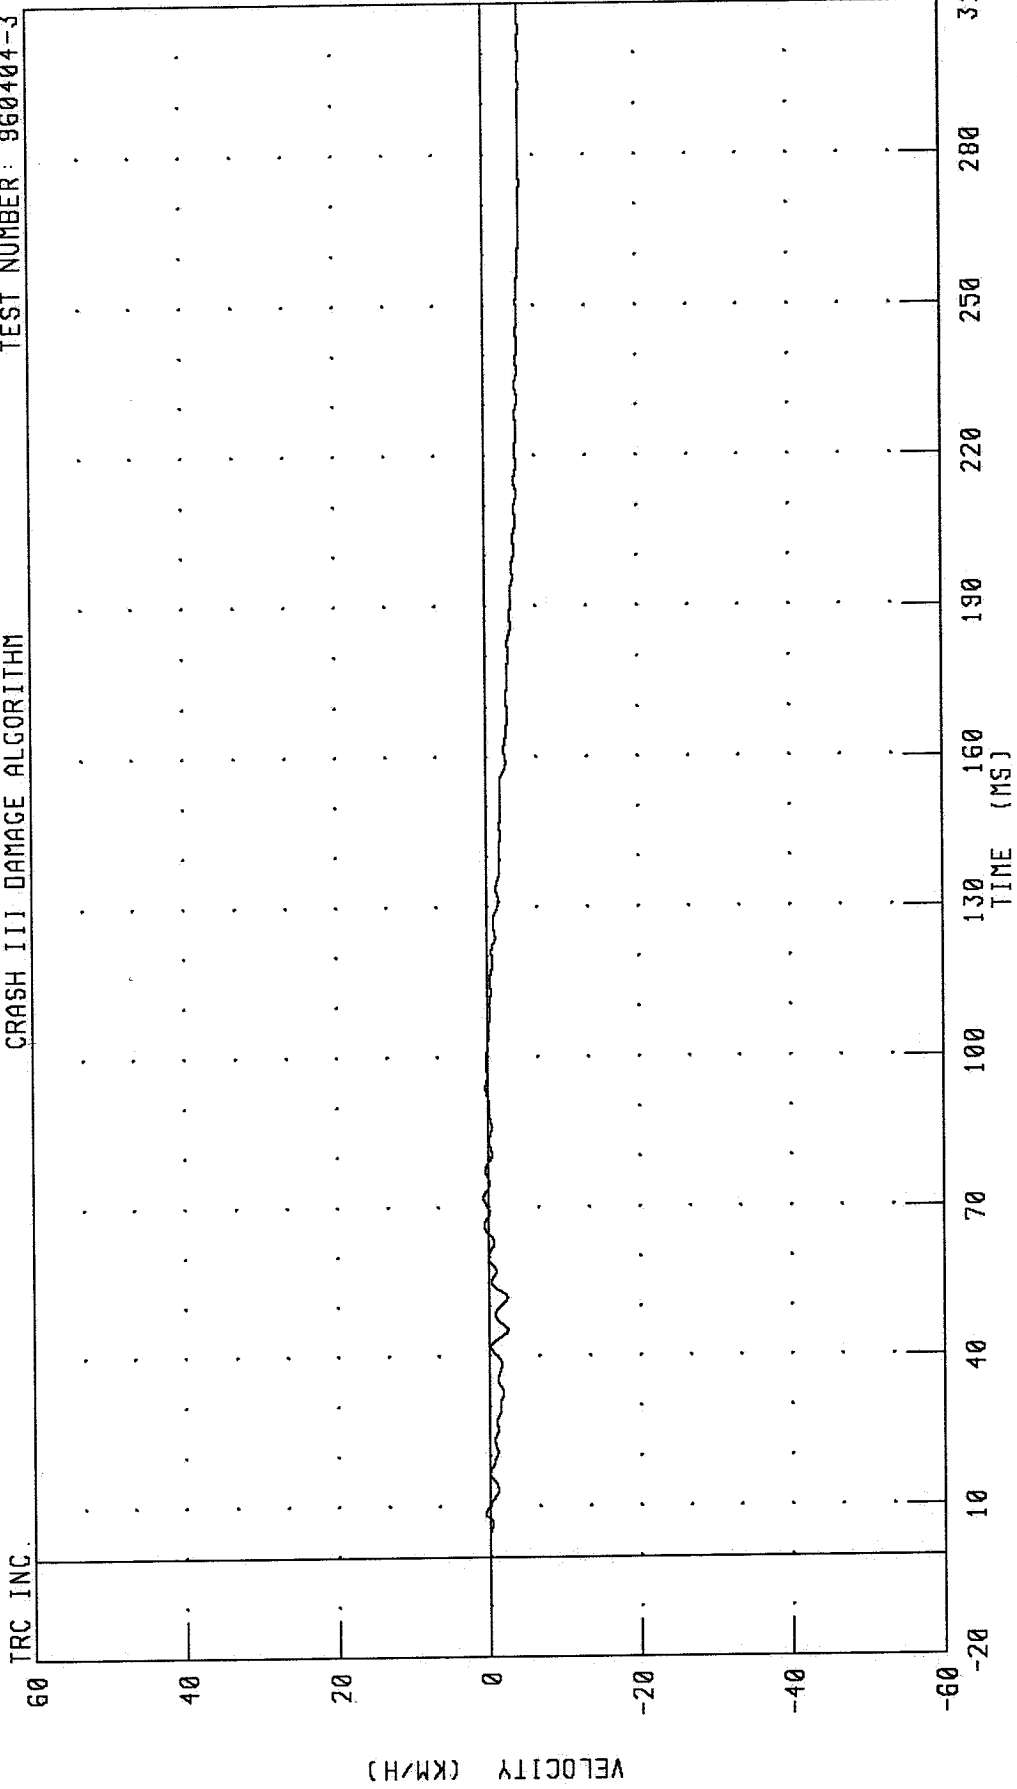
TEST NUMBER: 960404-3

CHANNEL: LRSZY1 FILTER: CH. CLASS 180

PEAK DATA: 0.64 KM/H @ 71.92 MS; -4.85 KM/H @ 304.96 MS

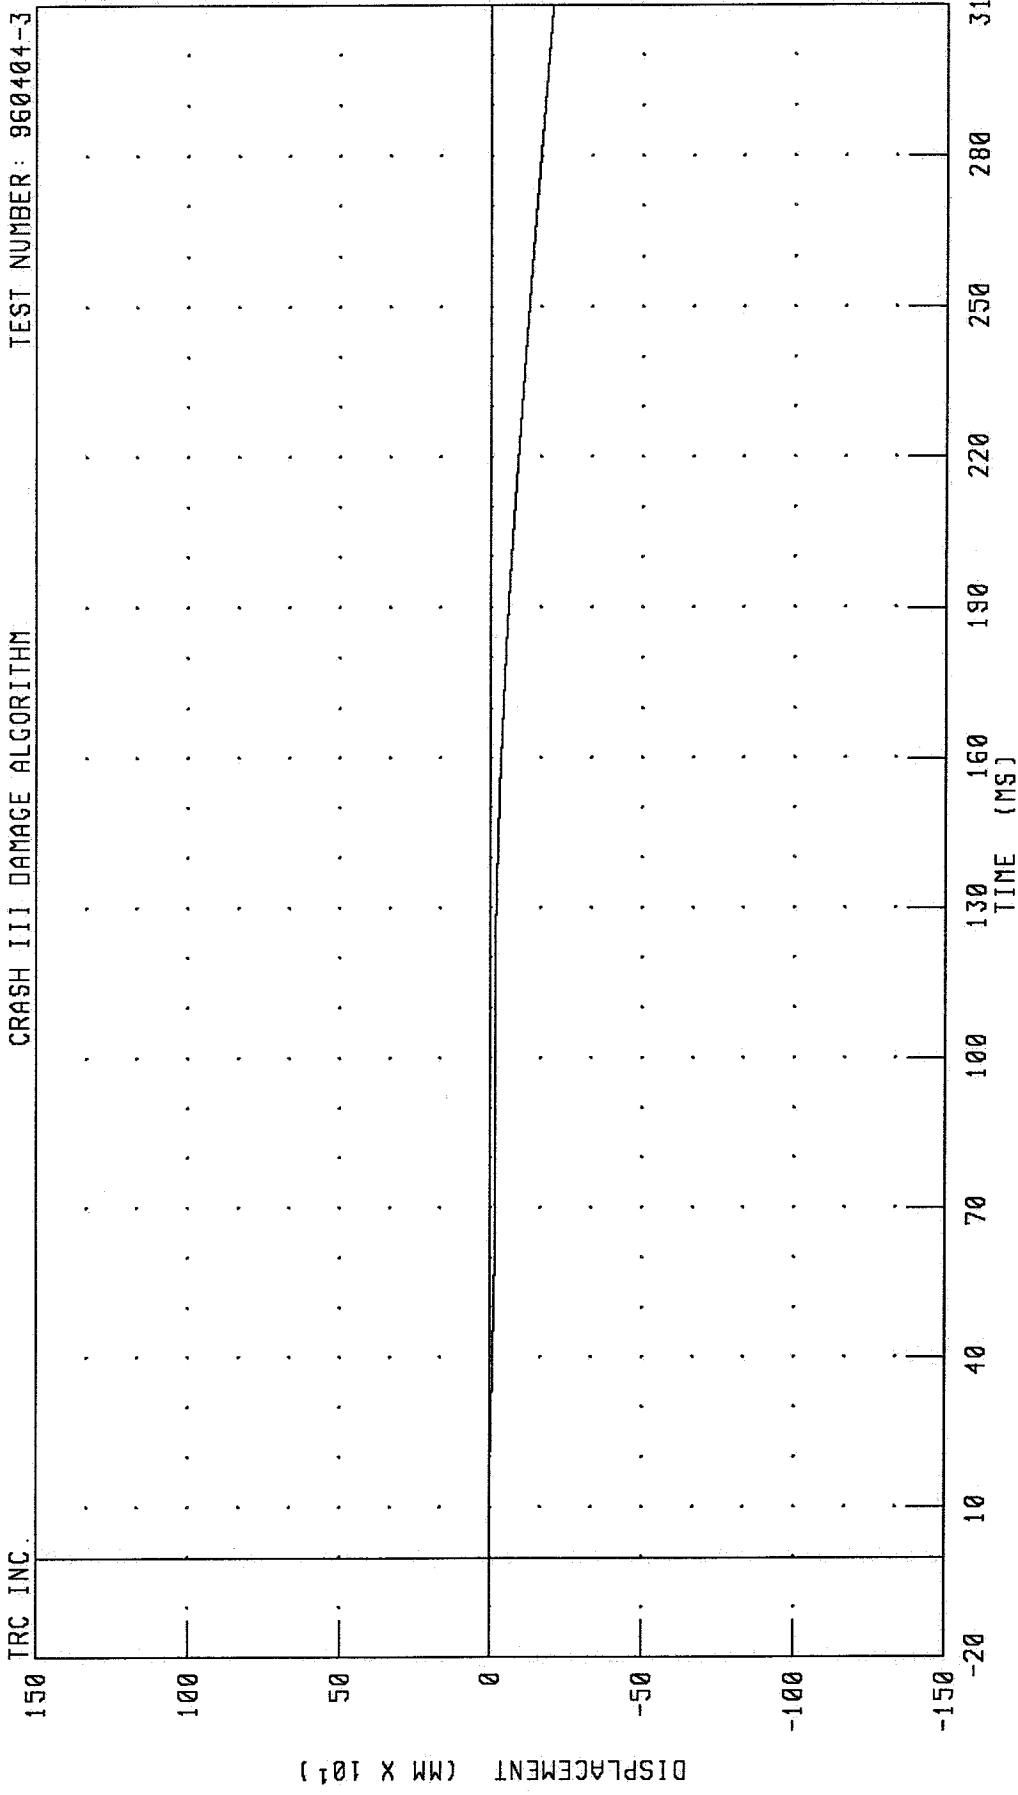
TRC INC. CRASH III DAMAGE ALGORITHM TEST NUMBER: 960404-3

CHANNEL: LRSZD1 FILTER: CH. CLASS 180

PEAK DATA: 0.01 MM @ 10.00 MS; -203.92 MM @ 310.00 MS

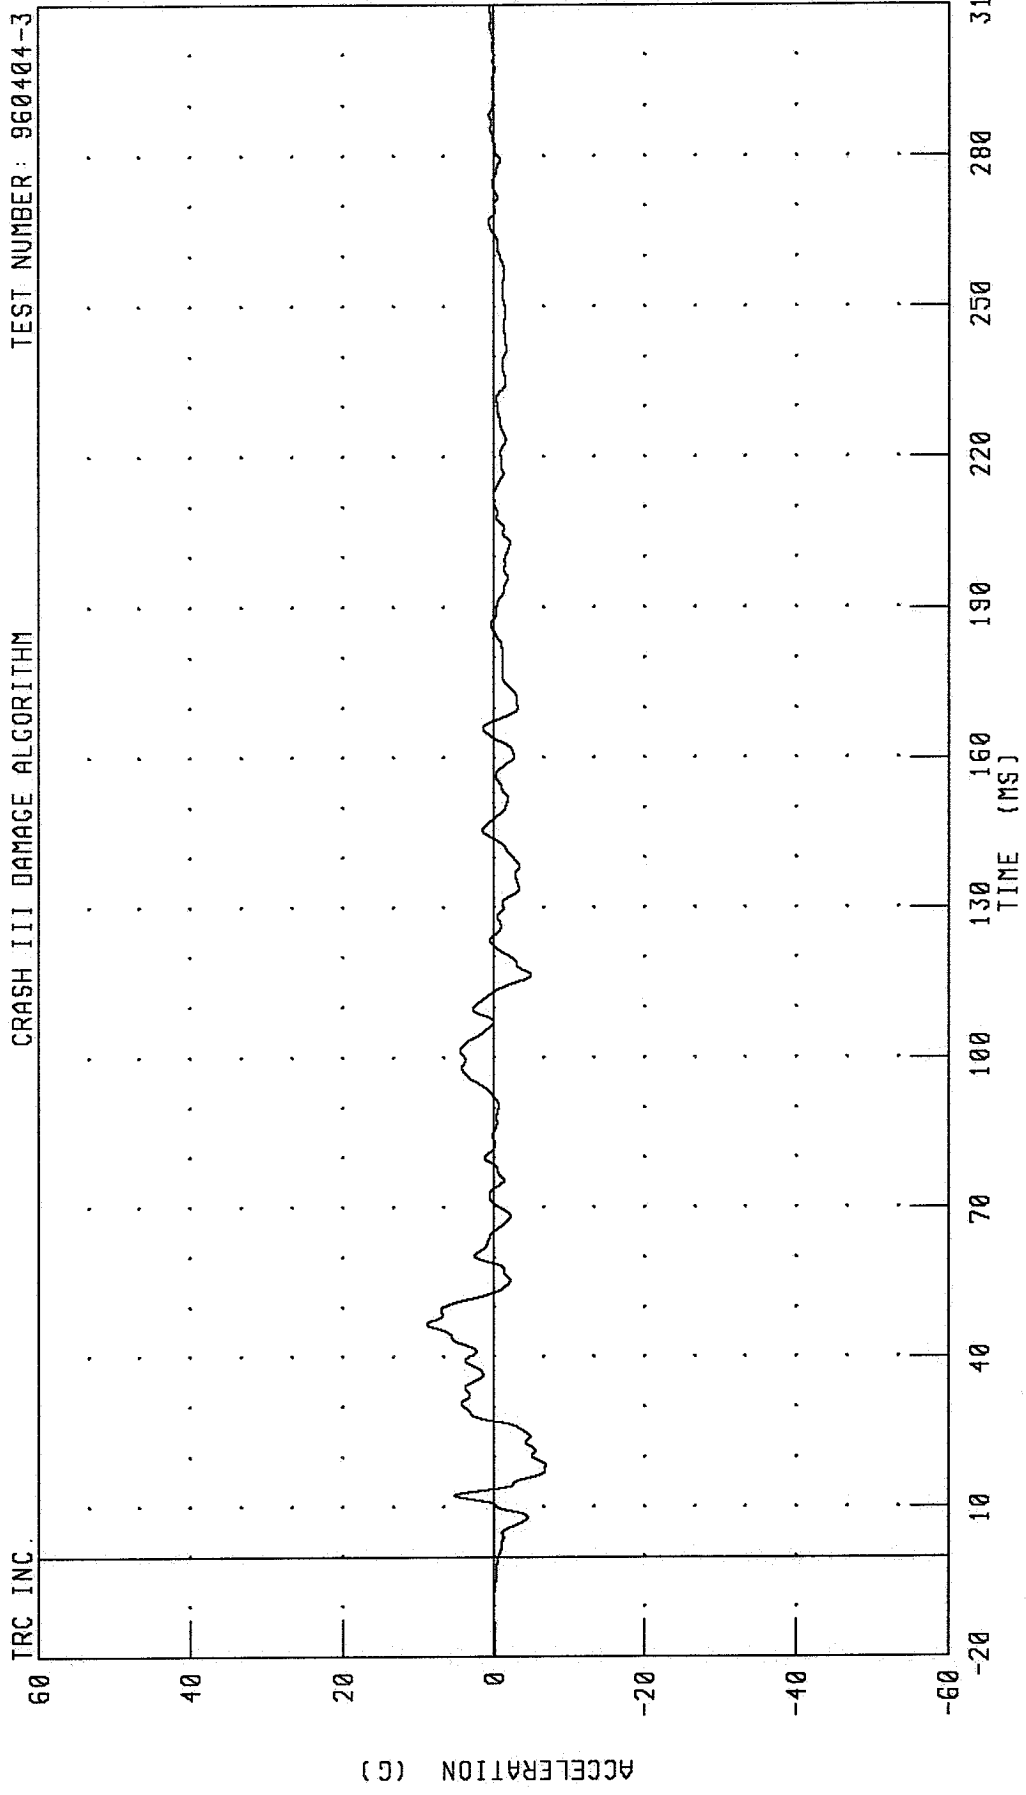
TEST NUMBER: 960404-3

CHANNEL: RRSZG1 FILTER: CH. CLASS 60

PEAK DATA: 8.85 G @ 46.64 MS; -6.92 G @ 18.40 MS

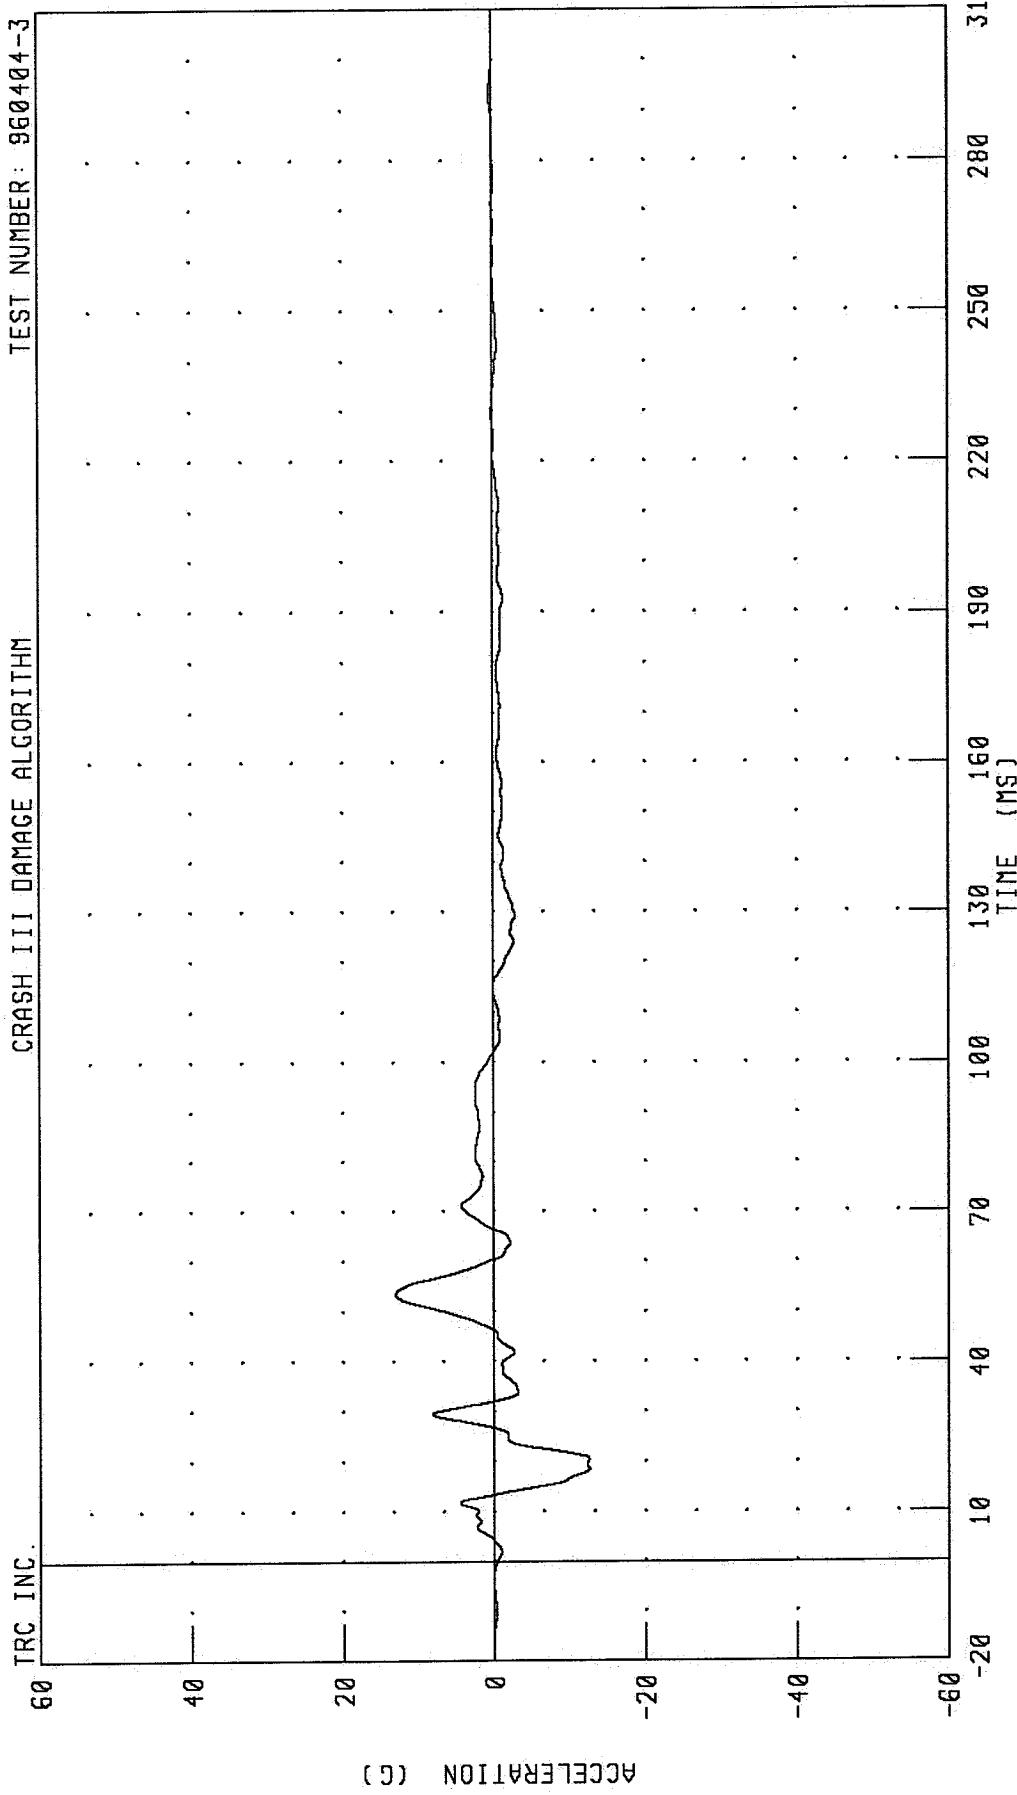
TRC INC. CRASH III DAMAGE ALGORITHM TEST NUMBER: 960404-3

CHANNEL: LFSZG1 FILTER: CH. CLASS 60 PEAK DATA: 13.04 G @ 53.44 MS; -12.62 G @ 18.48 MS

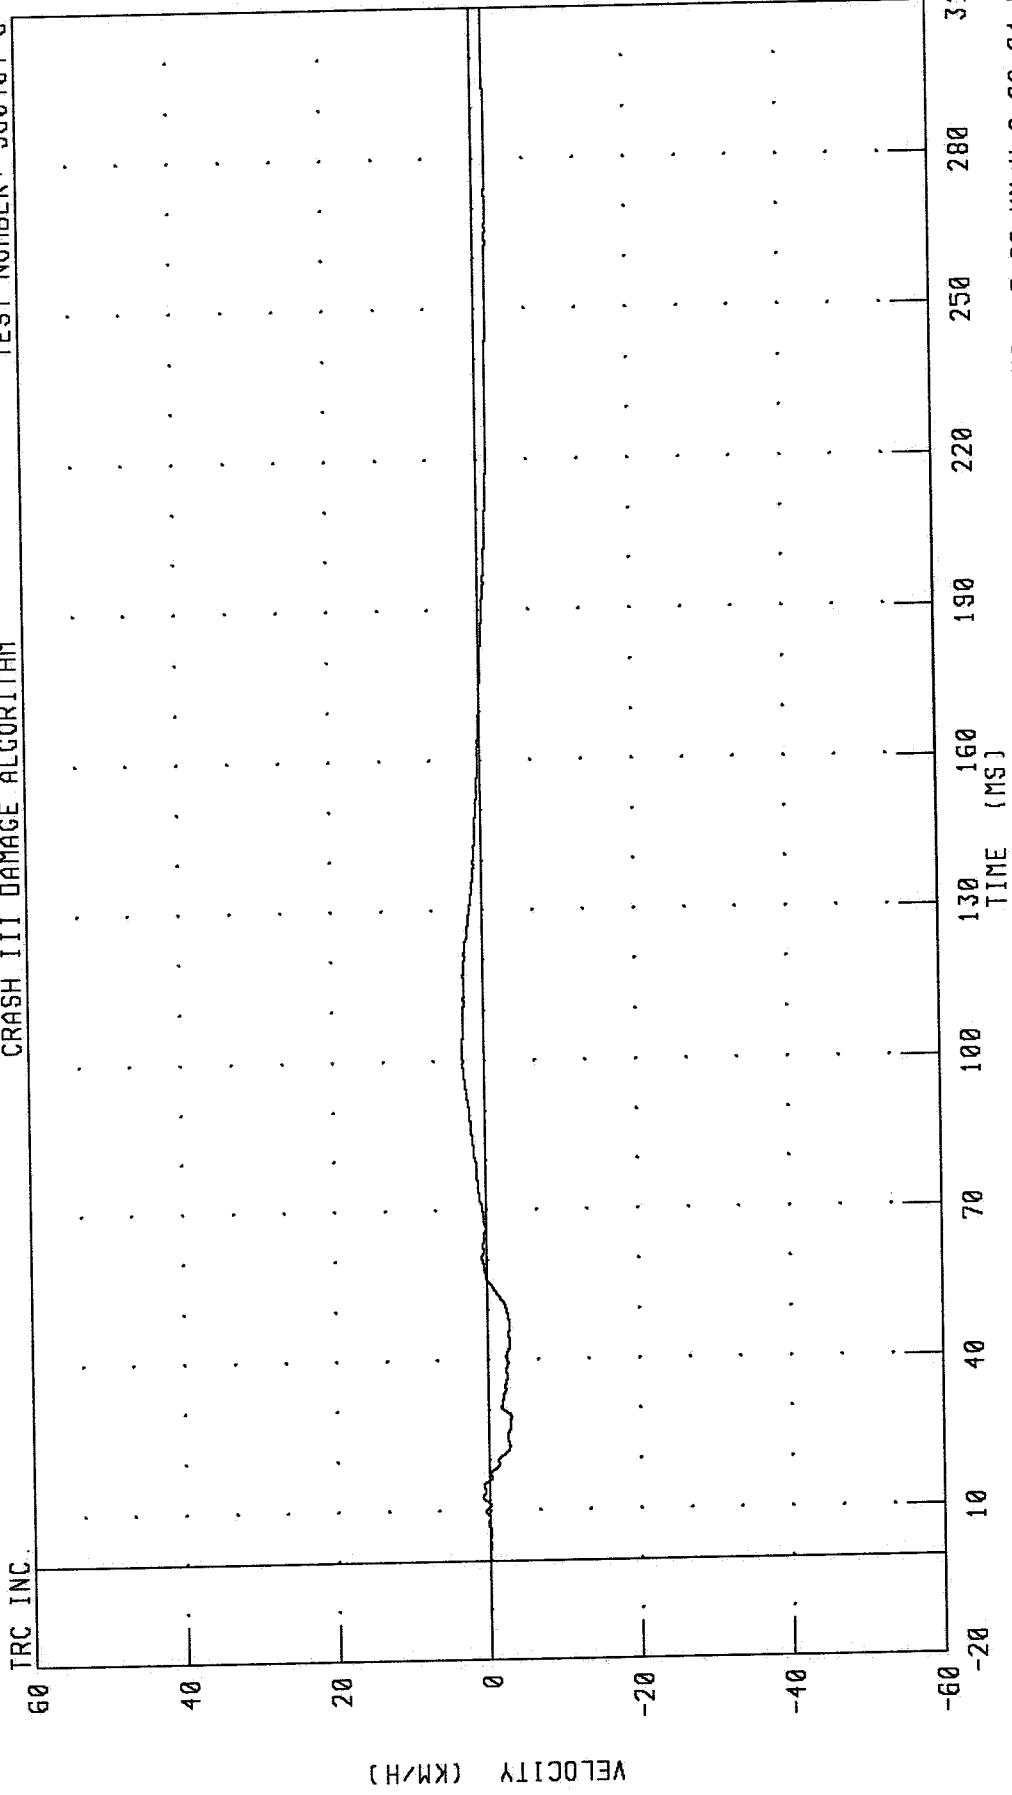
1991 DODGE CARAVAN INTO POLE BARRIER AT 20 MPH TEST NO. 3
LEFT FRONT SILL Z-AXIS VELOCITY

CHANNEL: LFSZV1 FILTER: CH: CLASS 180

PEAK DATA: 2.89 KM/H @ 101.28 MS; -3.00 KM/H @ 28.64 MS

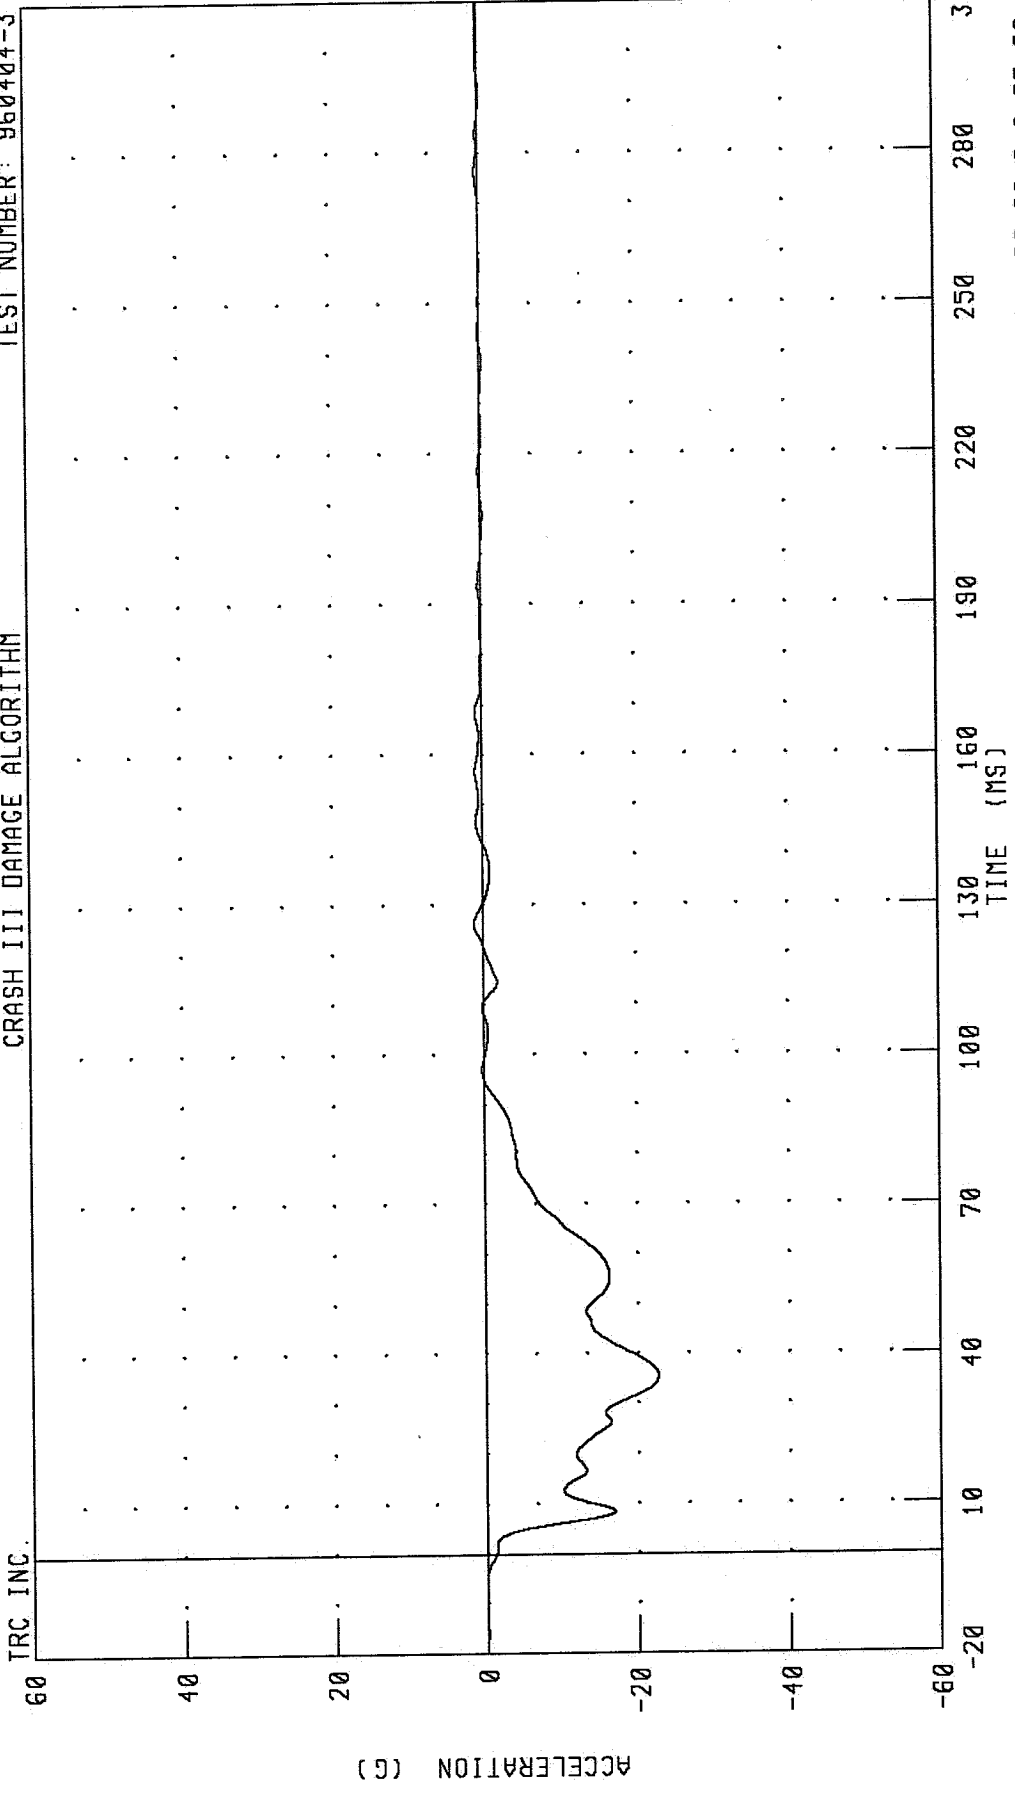
TEST NUMBER: 960404-3

CHANNEL: RFSXG1 FILTER: CH. CLASS 60

PEAK DATA: 1.25 G @ 126.08 MS; -22.69 G @ 35.68 MS

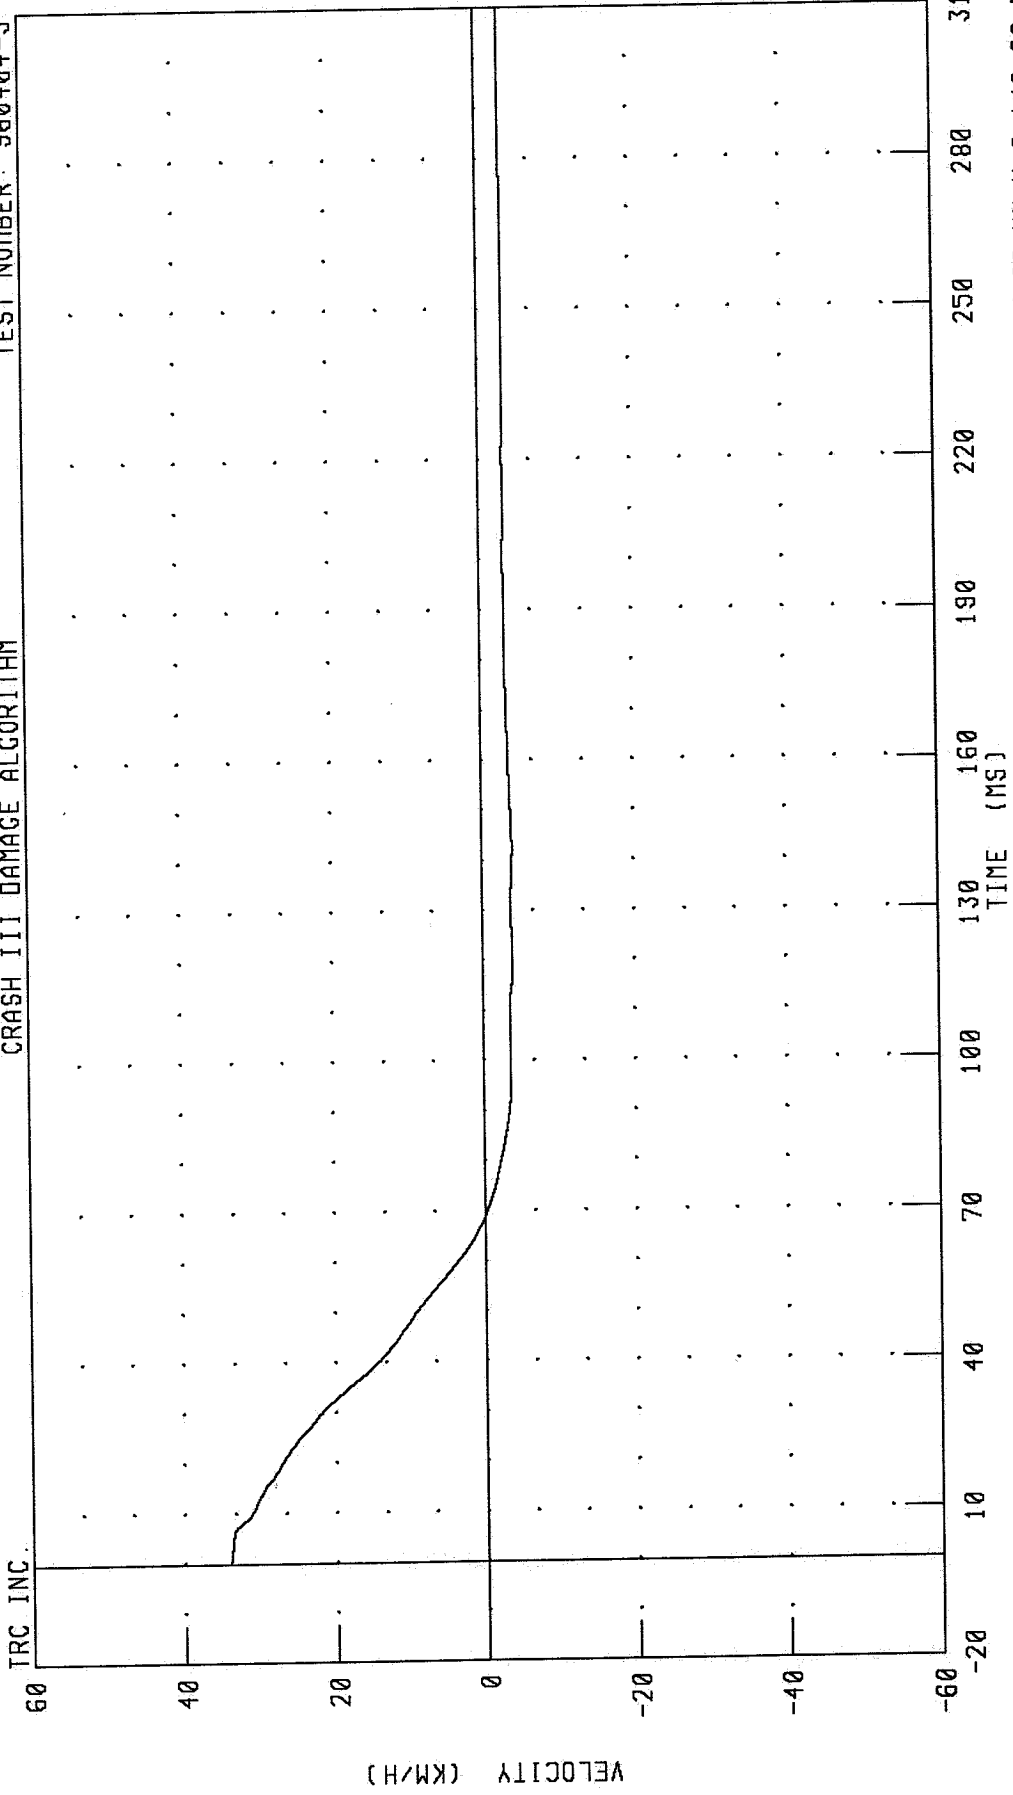
TEST NUMBER: 960404-3

CHANNEL: RFSXV1 FILTER: CH. CLASS 180

PEAK DATA: 34.00 KM/H @ 0.00 MS; -3.98 KM/H @ 142.08 MS

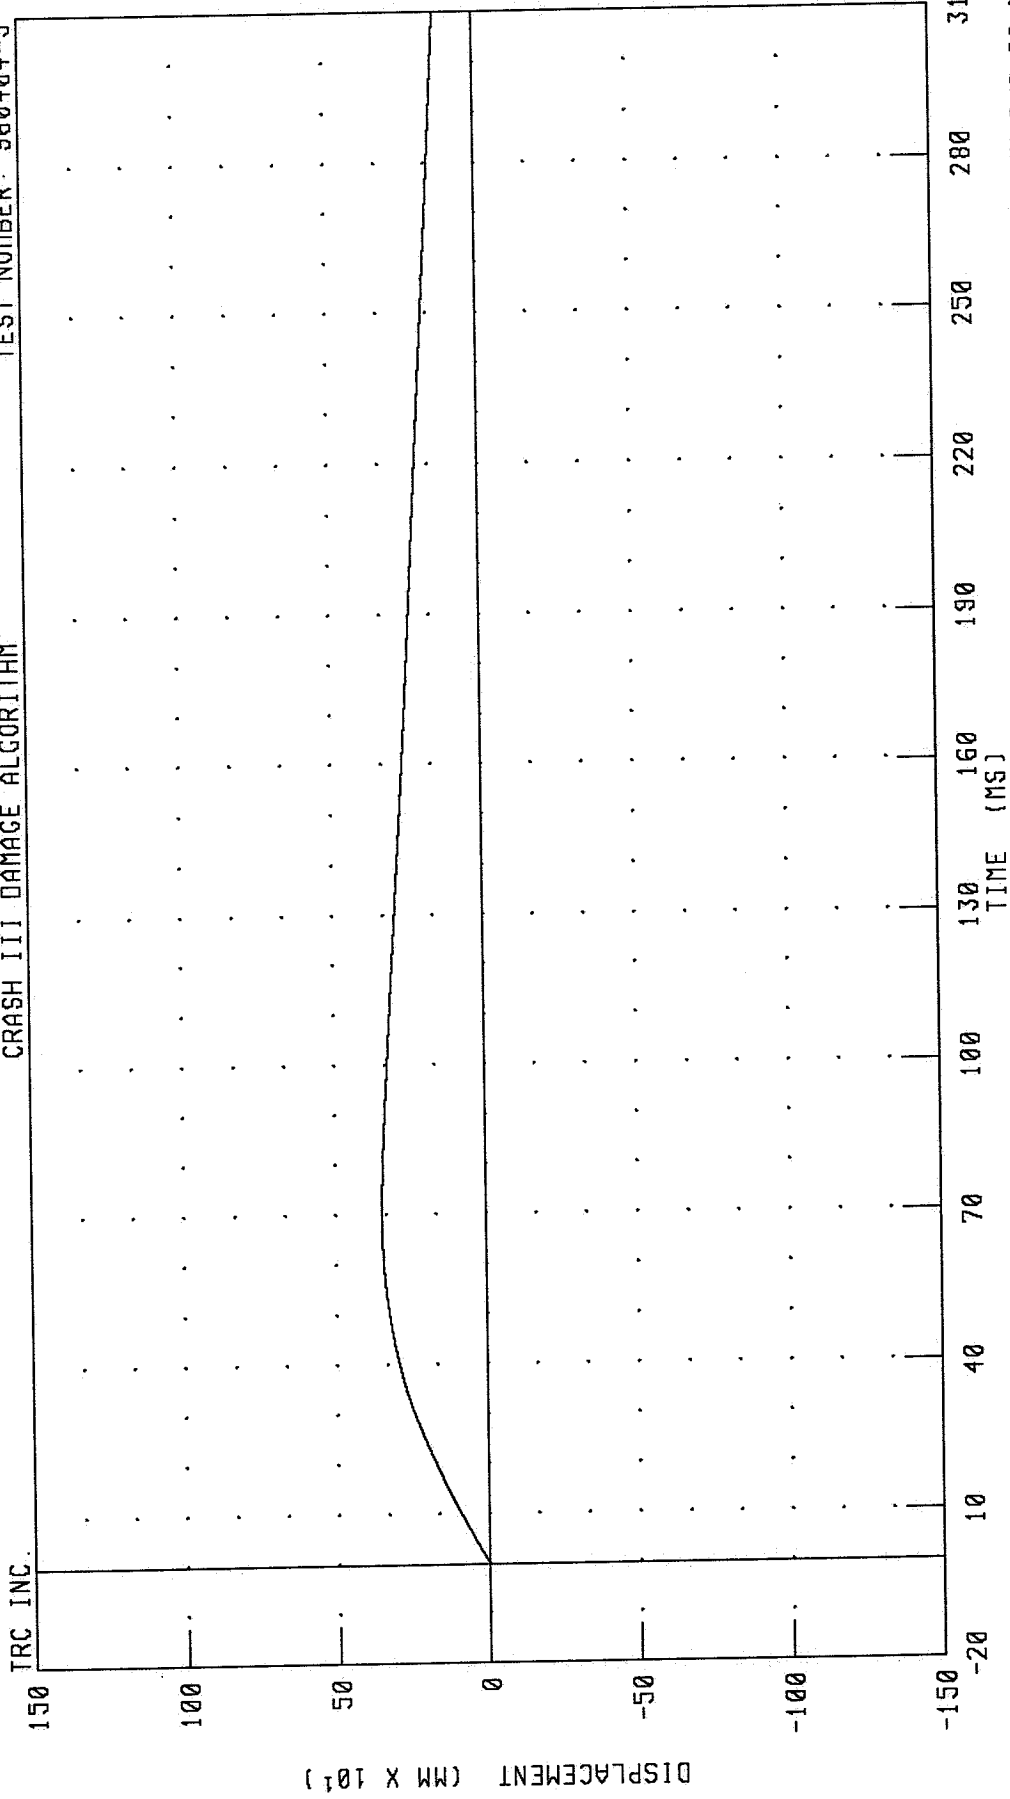
TEST NUMBER: 960404-3

CHANNEL: RFSX01 FILTER: CH. CLASS 180

PEAK DATA: 346.87 MM @ 68.88 MS; 0.00 MM @ 0.00 MS

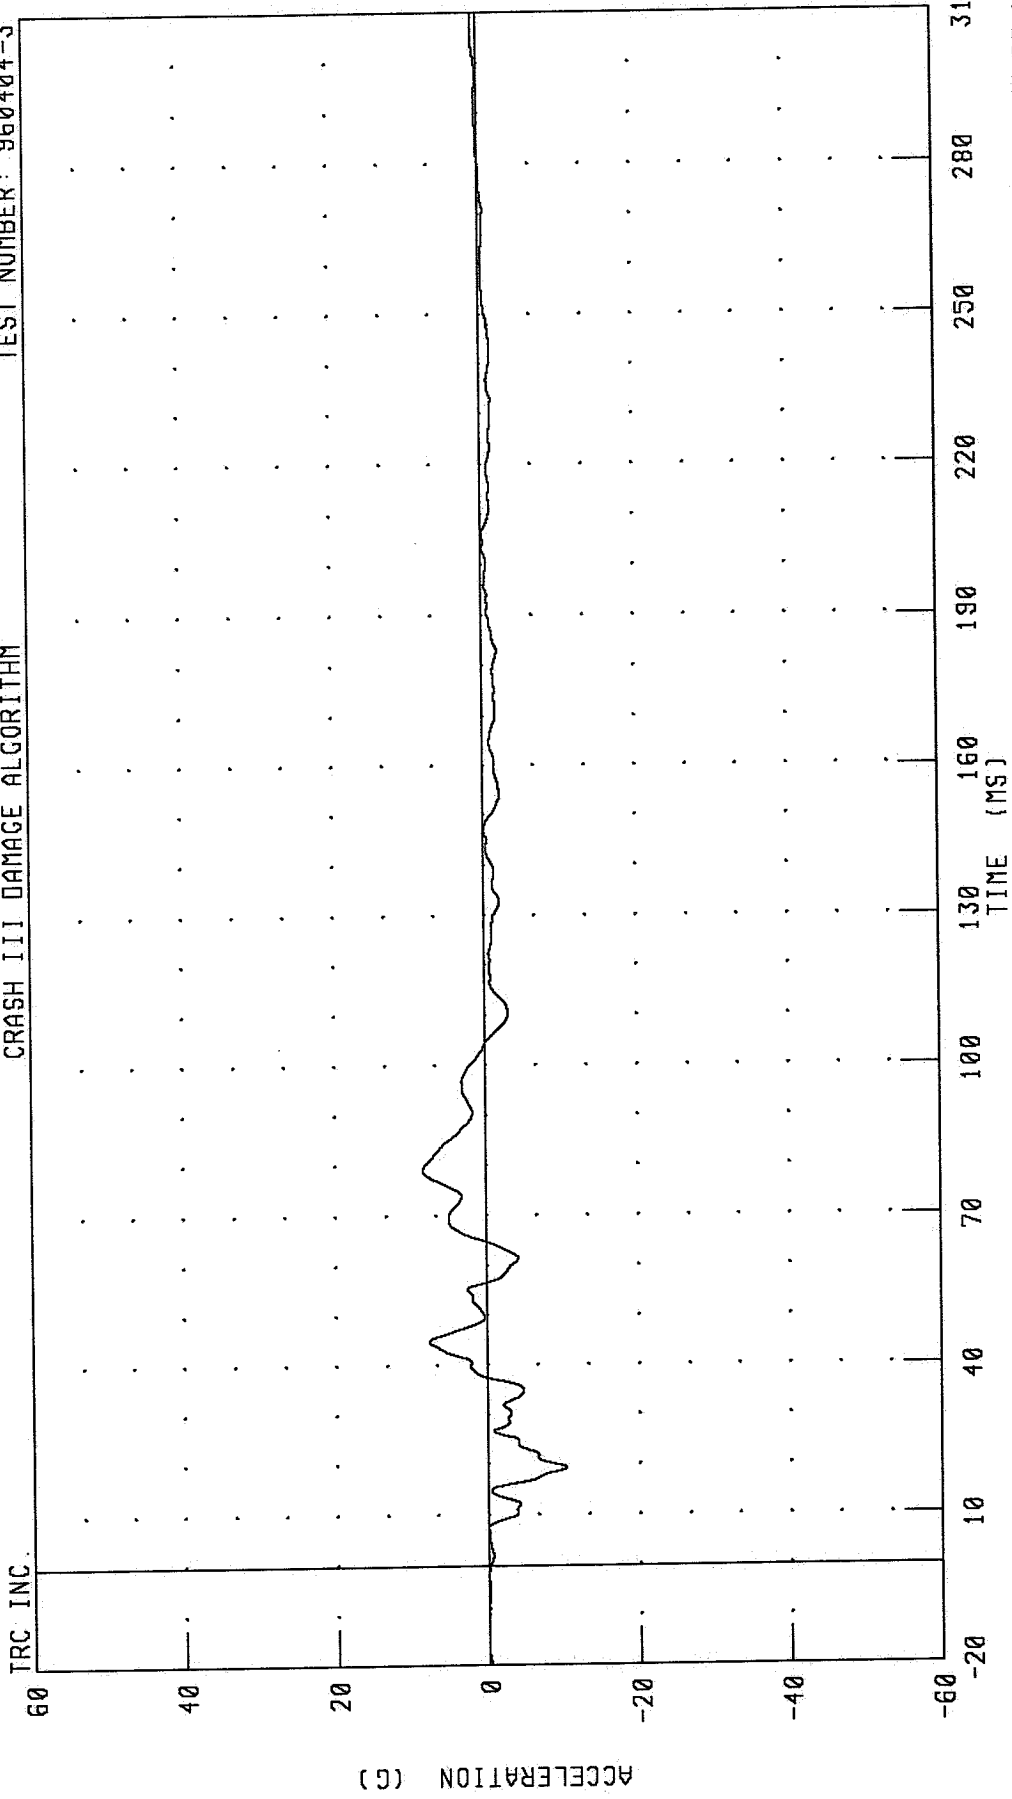
TEST NUMBER: 960404-3

TRC INC. CHANNEL: RFSZG1 FILTER: CH. CLASS 60 PEAK DATA: 8.28 G @ 79.04 MS; -10.28 G @ 19.28 MS

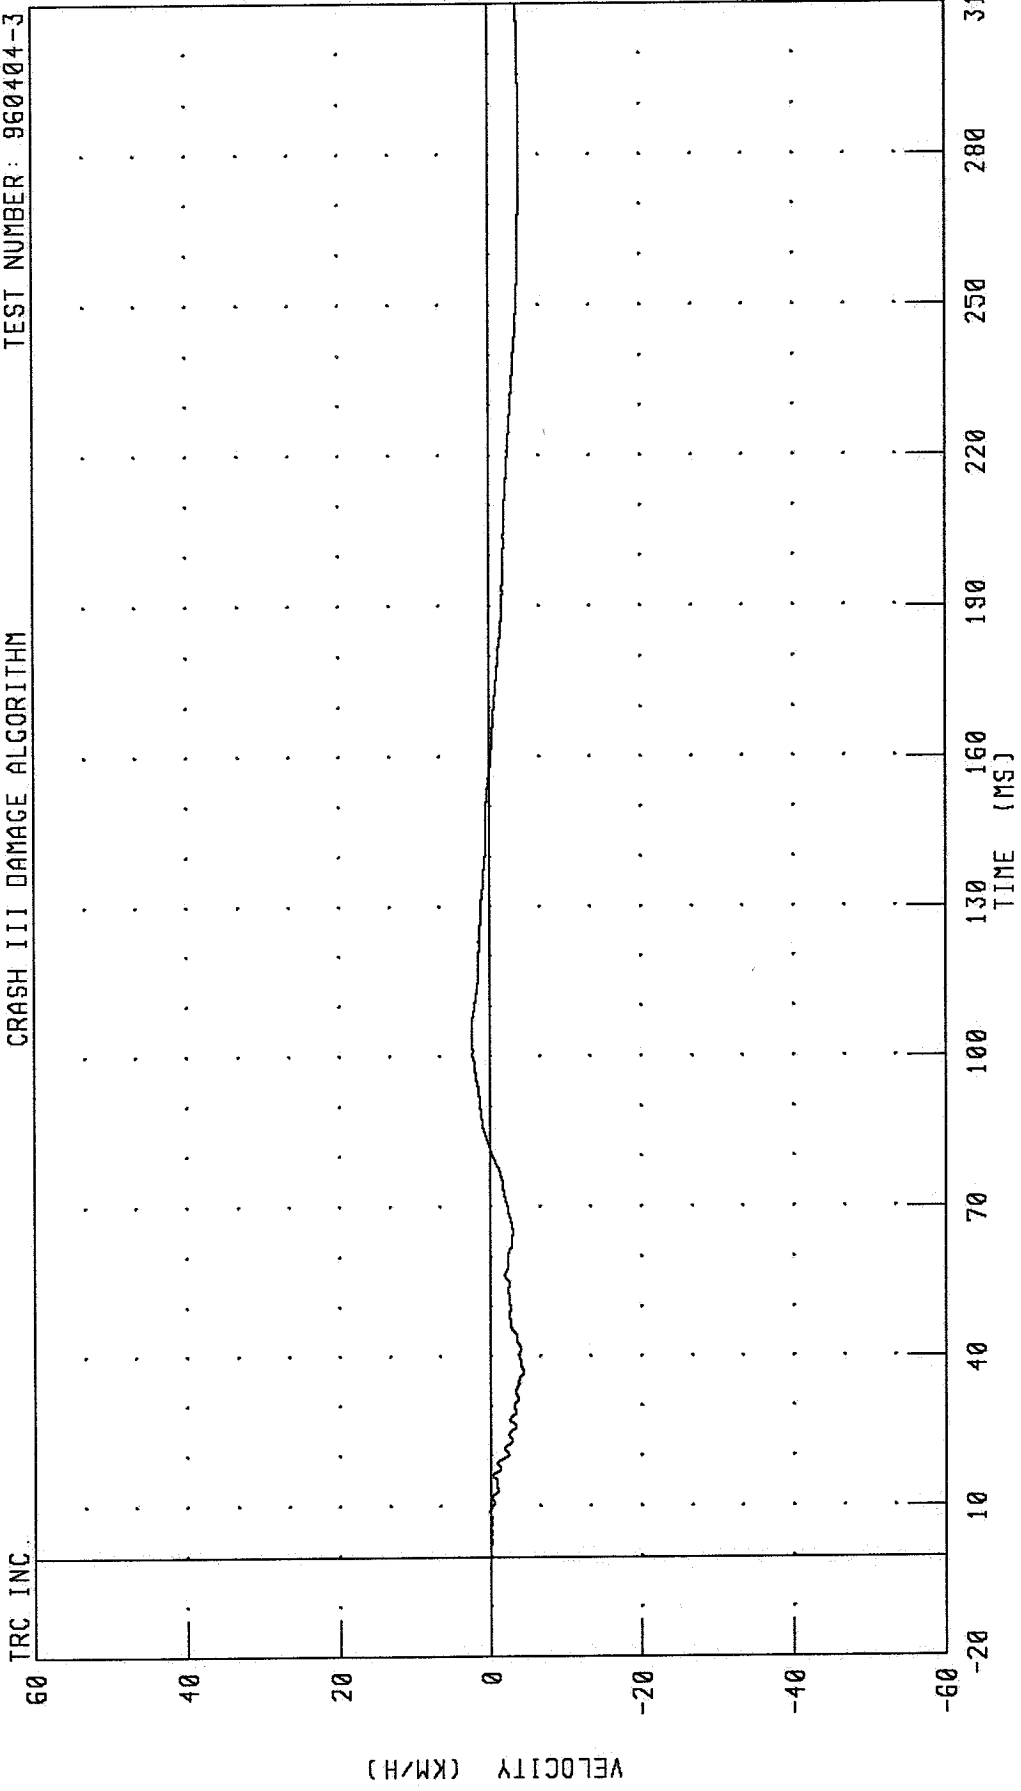
TEST NUMBER: 960404-3

CHANNEL: RFSZV1 FILTER: CH. CLASS 180

PEAK DATA: 2.41 KM/H @ 104.96 MS; -4.40 KM/H @ 36.96 MS

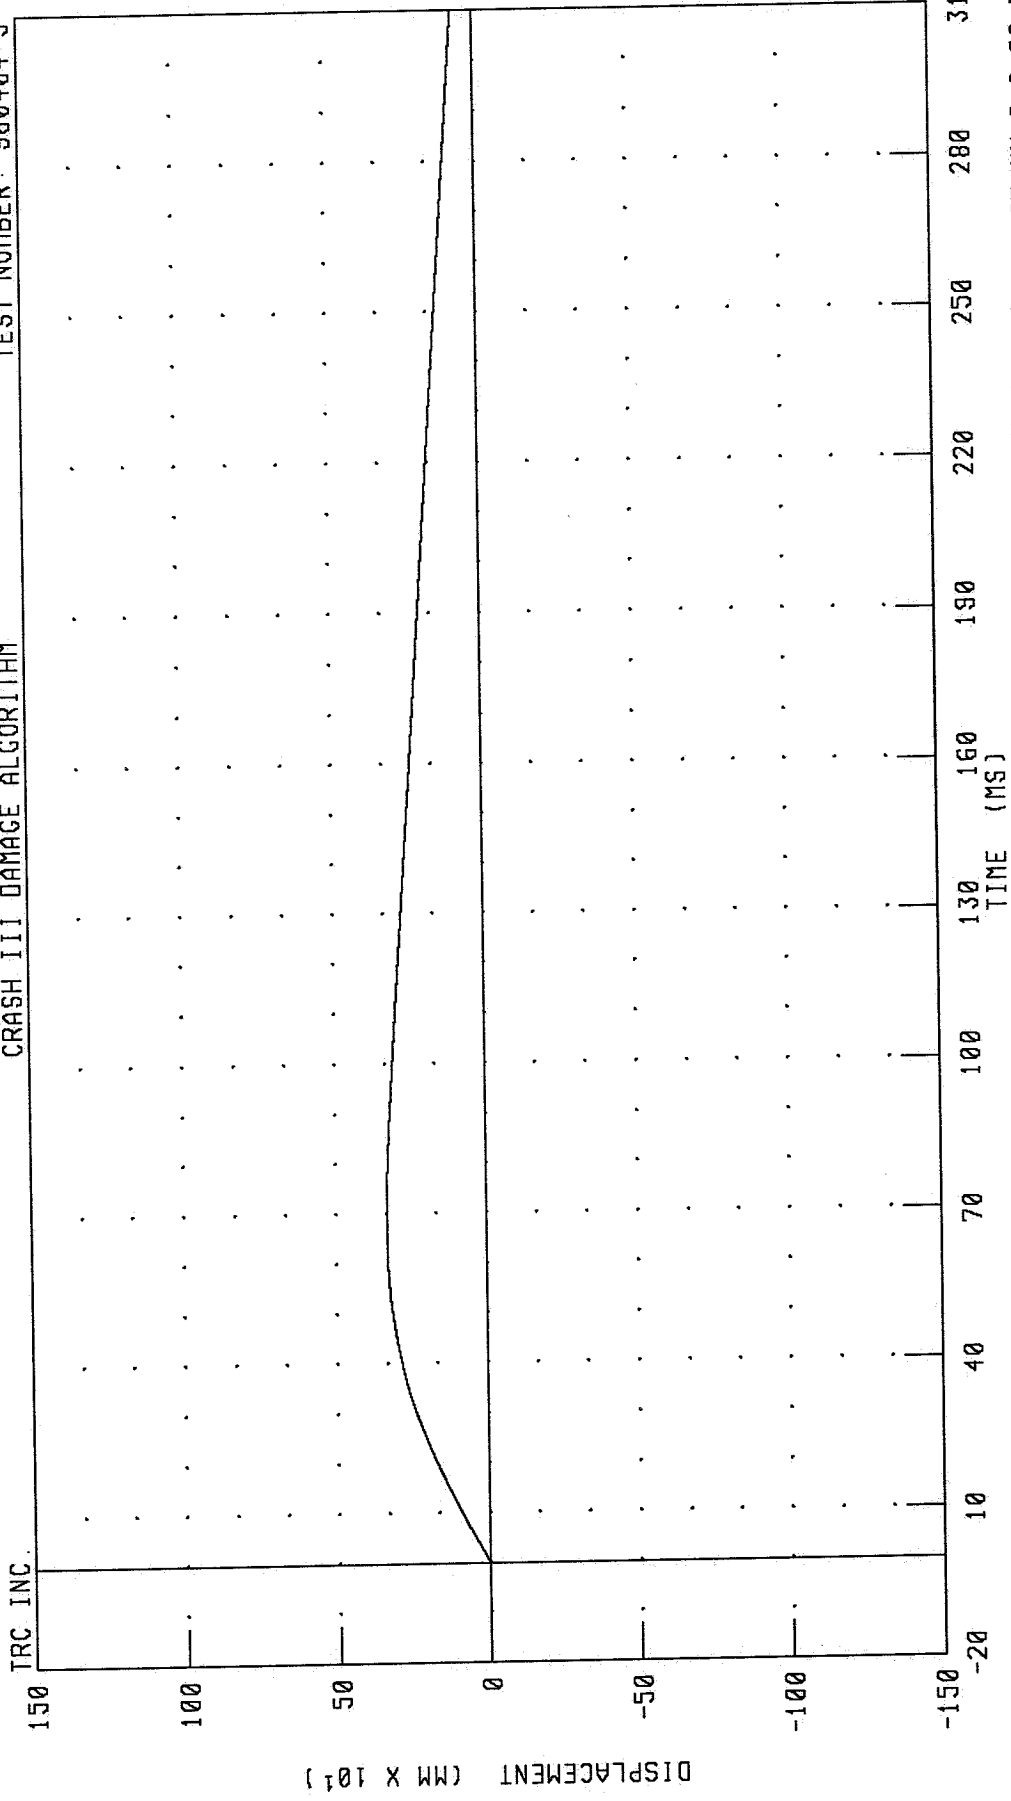
TEST NUMBER: 960404-3

CHANNEL: VCGXD1 FILTER: CH. CLASS 180 PEAK DATA: 332.06 MM @ 67.76 MS; 0.00 MM @ 0.00 MS
