**1991 Dodge Caravan
into 12-Inch Diameter Centered Pole
in Support of
Crash III Damage Algorithm Reformulation**

TRC Test Nos.: 960404-1

**Prepared by:
Transportation Research Center Inc.
10820 State Route 347
East Liberty, OH 43319**

**April - May 1996
Final Report**

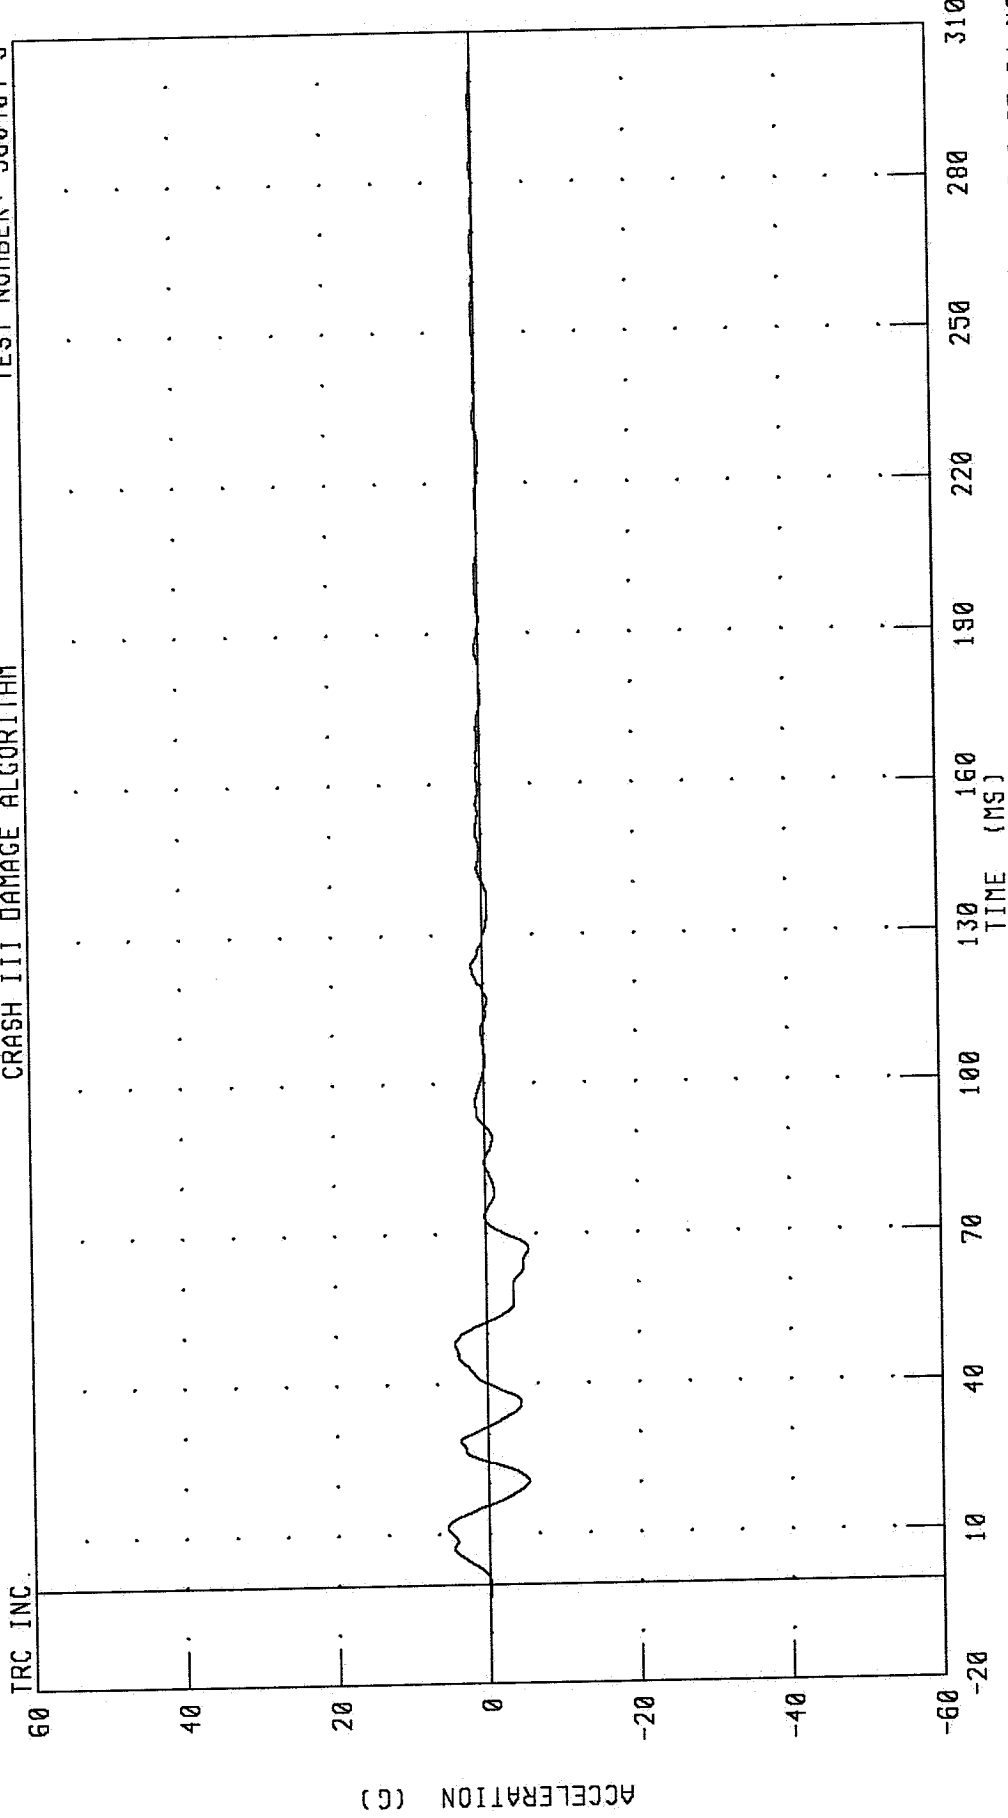
TEST NUMBER: 960404-3

1991 DODGE CARAVAN INTO POLE BARRIER AT 20 MPH TEST NO. 3
VEHICLE CG Y-AXIS ACCELERATION
CRASH III DAMAGE ALGORITHM

PEAK DATA: 5.44 G @ 11.28 MS; -5.63 G @ 67.04 MS

CHANNEL: VCGY01 FILTER: CH. CLASS 60

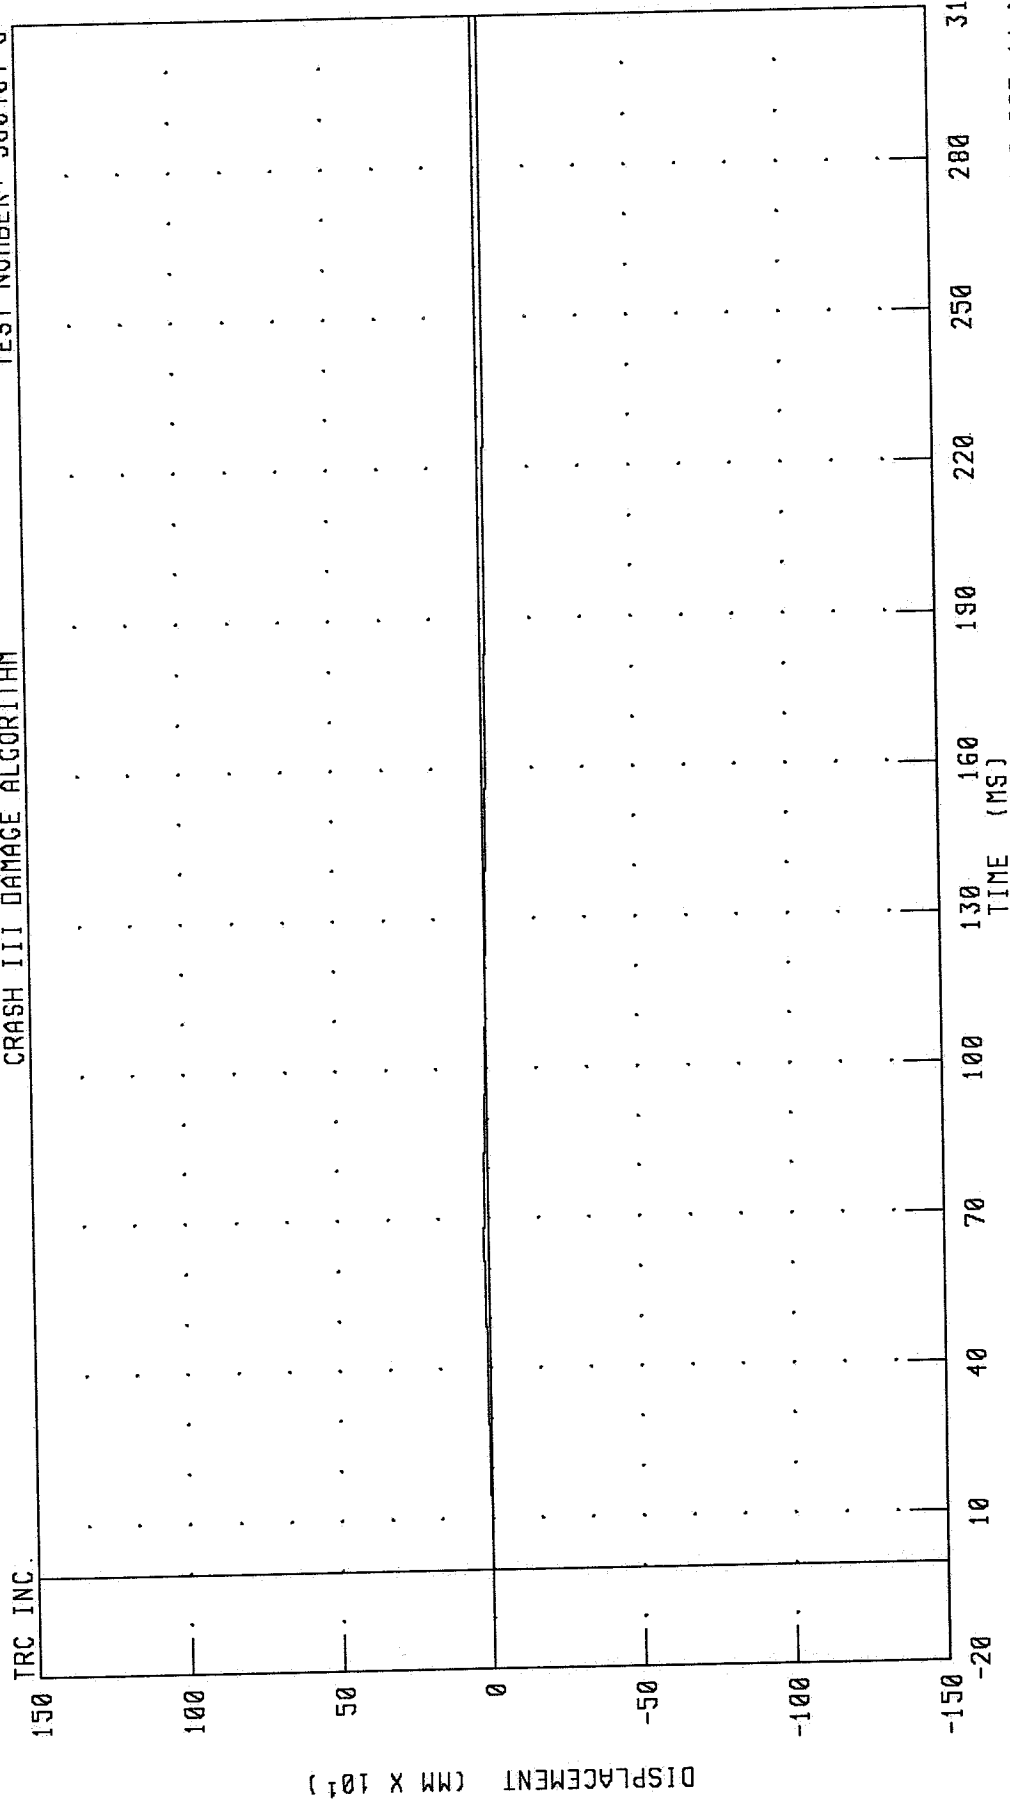
TEST NUMBER: 960404-3

CHANNEL: VCGYD1 FILTER: CH. CLASS 180 PEAK DATA: 15.39 MM @ 64.56 MS; -22.16 MM @ 285.44 MS

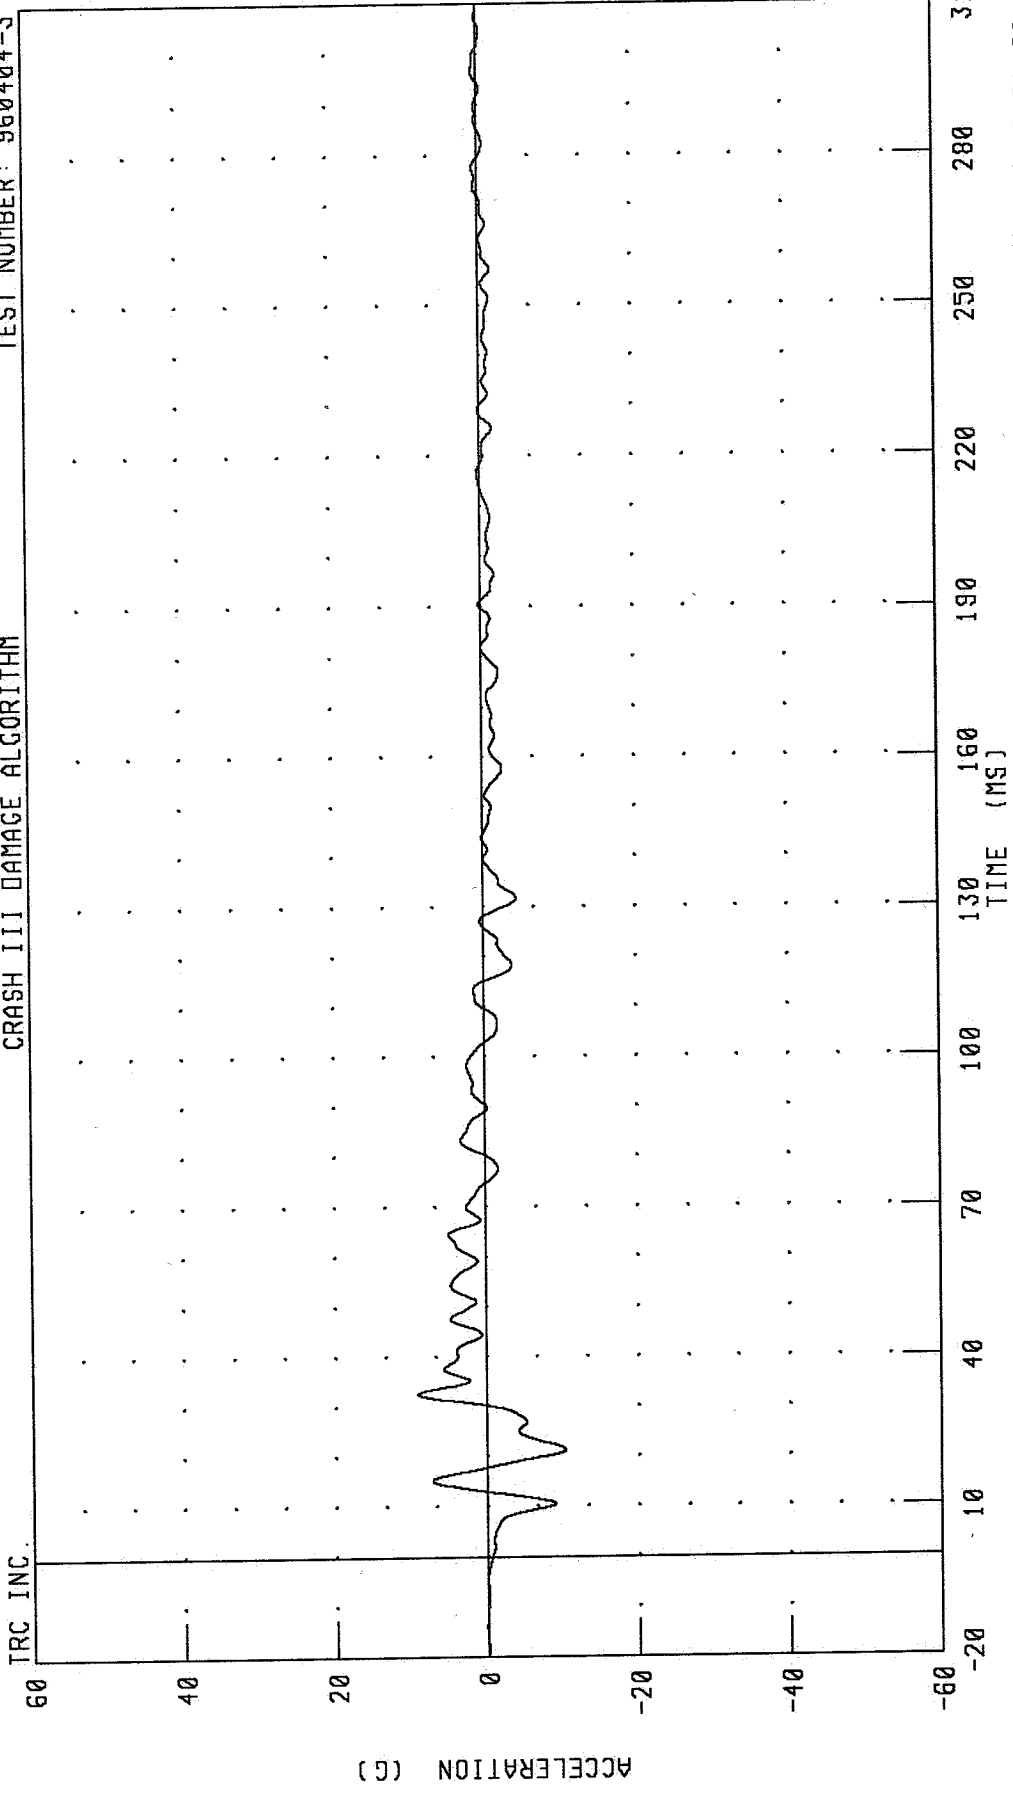
TEST NUMBER: 960404-3

1991 DODGE CARAVAN INTO POLE BARRIER AT 20 MPH TEST NO. 3
VEHICLE CG Z-AXIS ACCELERATION
CRASH III DAMAGE ALGORITHM

CHANNEL: VCGZG1 FILTER: CH. CLASS 60

PEAK DATA: 9.10 G @ 32.64 MS; -10.39 G @ 21.28 MS

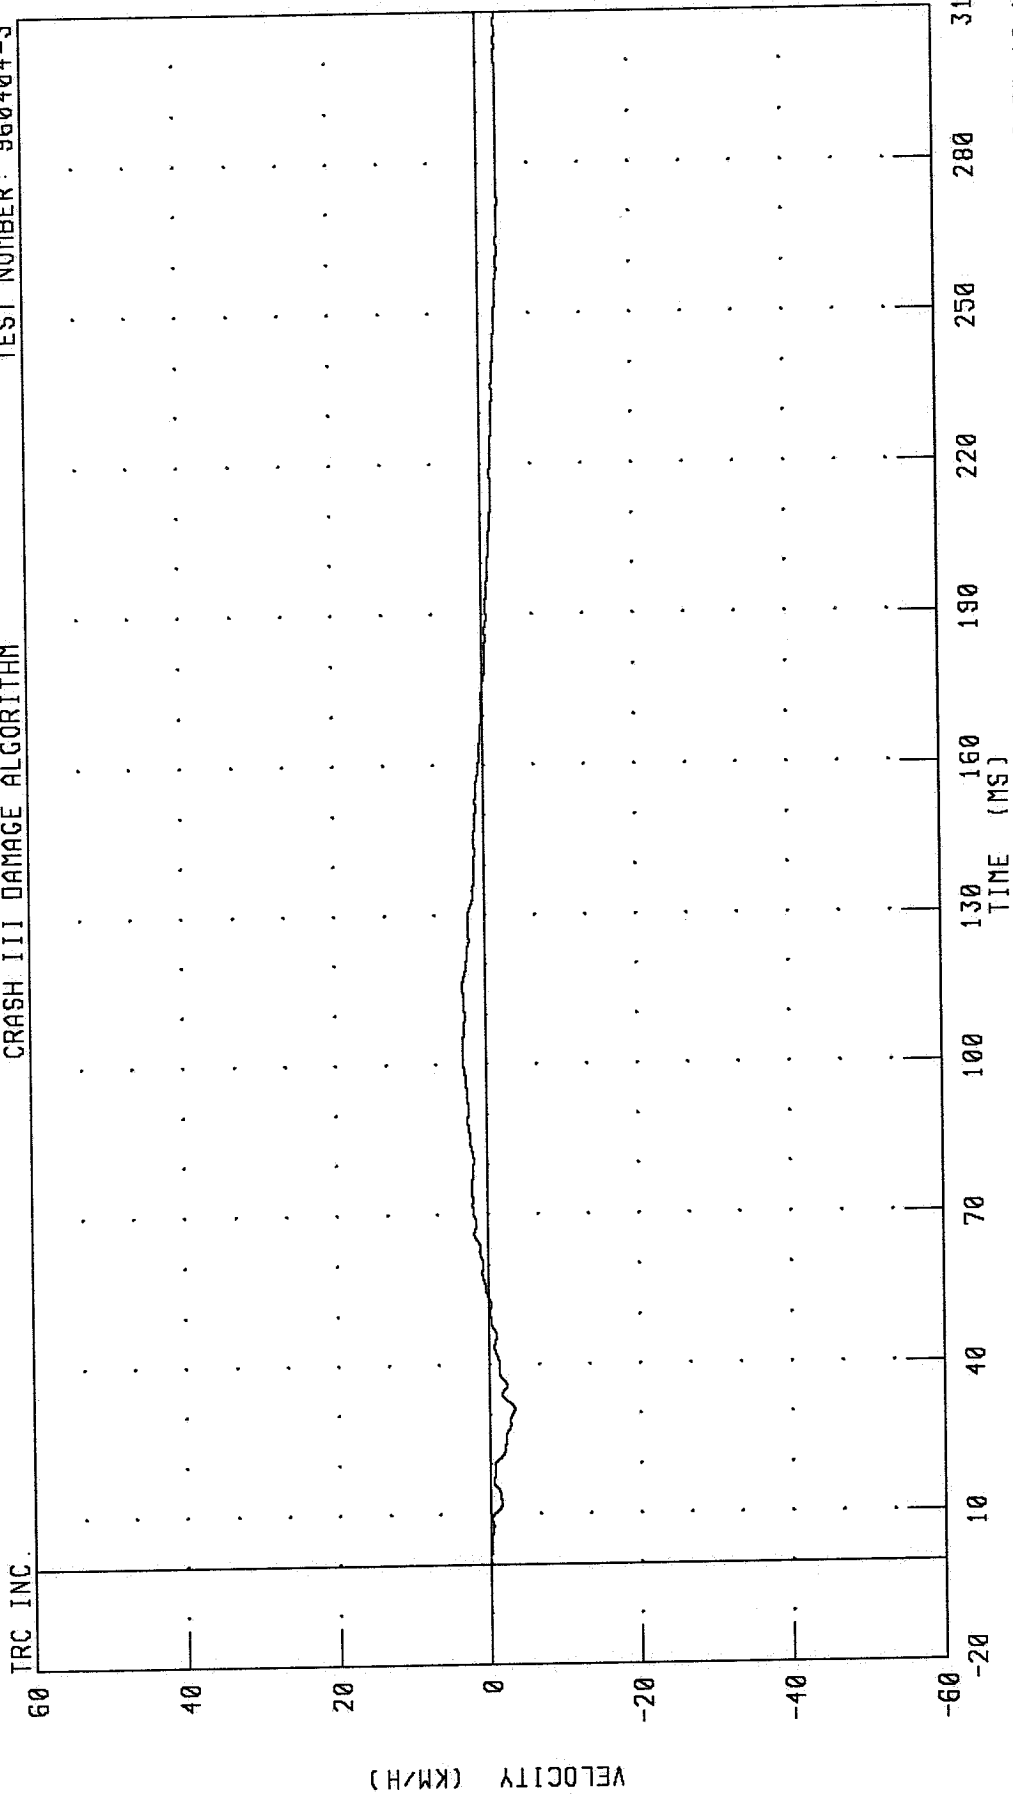
TEST NUMBER: 960404-3

CHANNEL: VCGZV1 FILTER: CH. CLASS 180 PEAK DATA: 3.13 KM/H @ 103.44 MS; -3.36 KM/H @ 31.12 MS

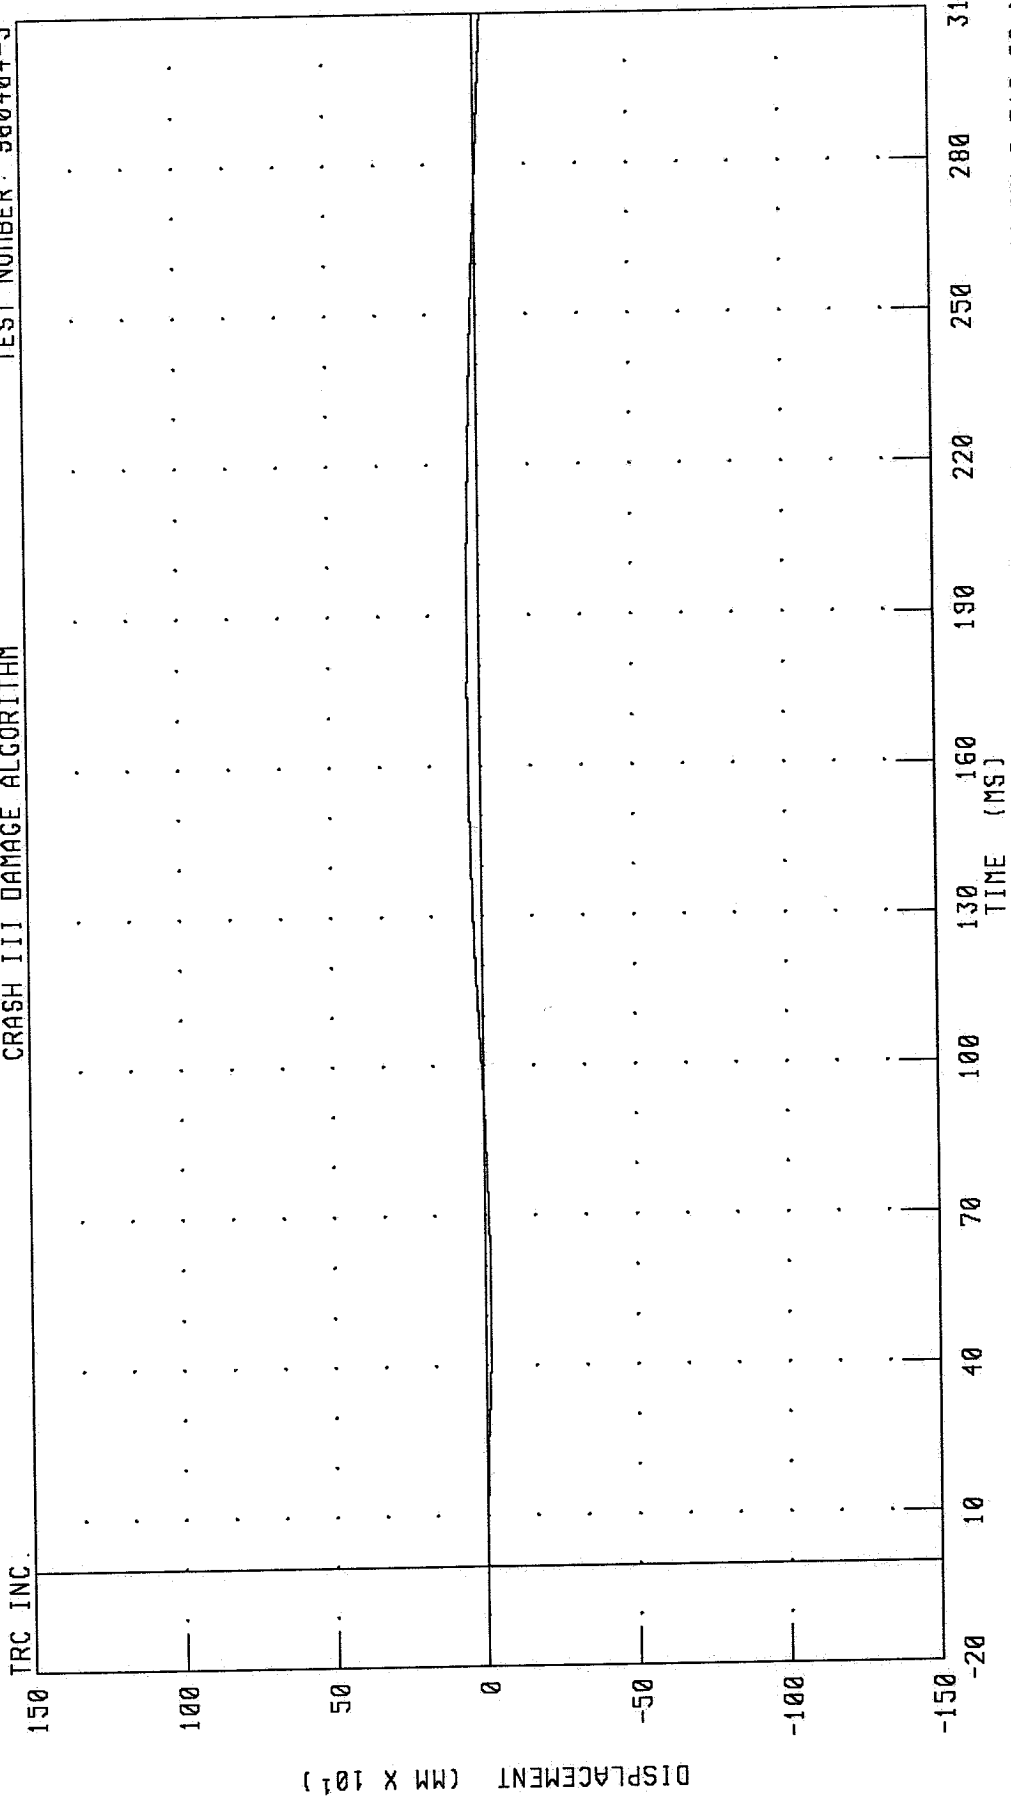
TEST NUMBER: 960404-3

1991 DODGE CARAVAN INTO POLE BARRIER AT 20 MPH TEST NO. 3
 VEHICLE CG Z-AXIS DISPLACEMENT
 CRASH III DAMAGE ALGORITHM

CHANNEL: YCGZ01 FILTER: CH. CLASS 180 PEAK DATA: 40.55 MM @ 175.12 MS; -23.91 MM @ 310.00 MS

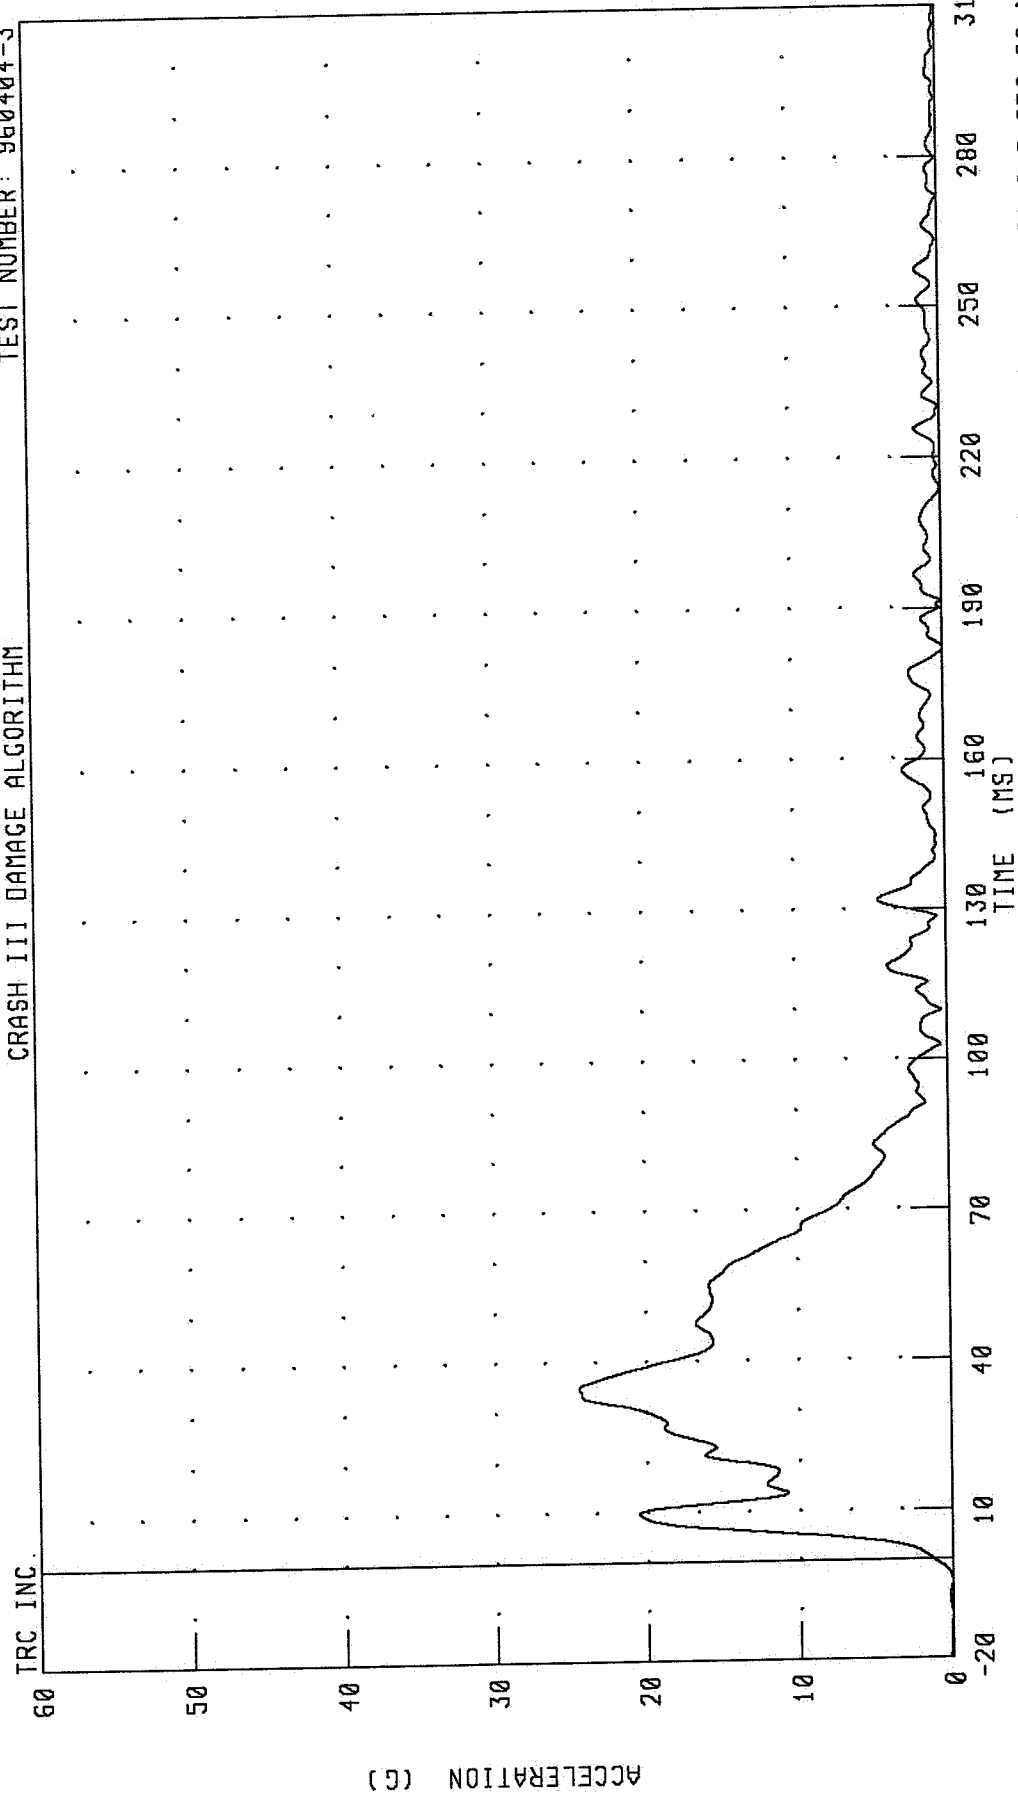
TEST NUMBER: 960404-3

1991 DODGE CARAVAN INTO POLE BARRIER AT 20 MPH TEST NO. 3
VEHICLE CG RESULTANT ACCELERATION
CRASH III DAMAGE ALGORITHM

TRC INC. CHANNEL: VCGRG1 FILTER: CH. CLASS 60
PEAK DATA: 24.42 G @ 34.80 MS; 0.01 G @ 272.00 MS

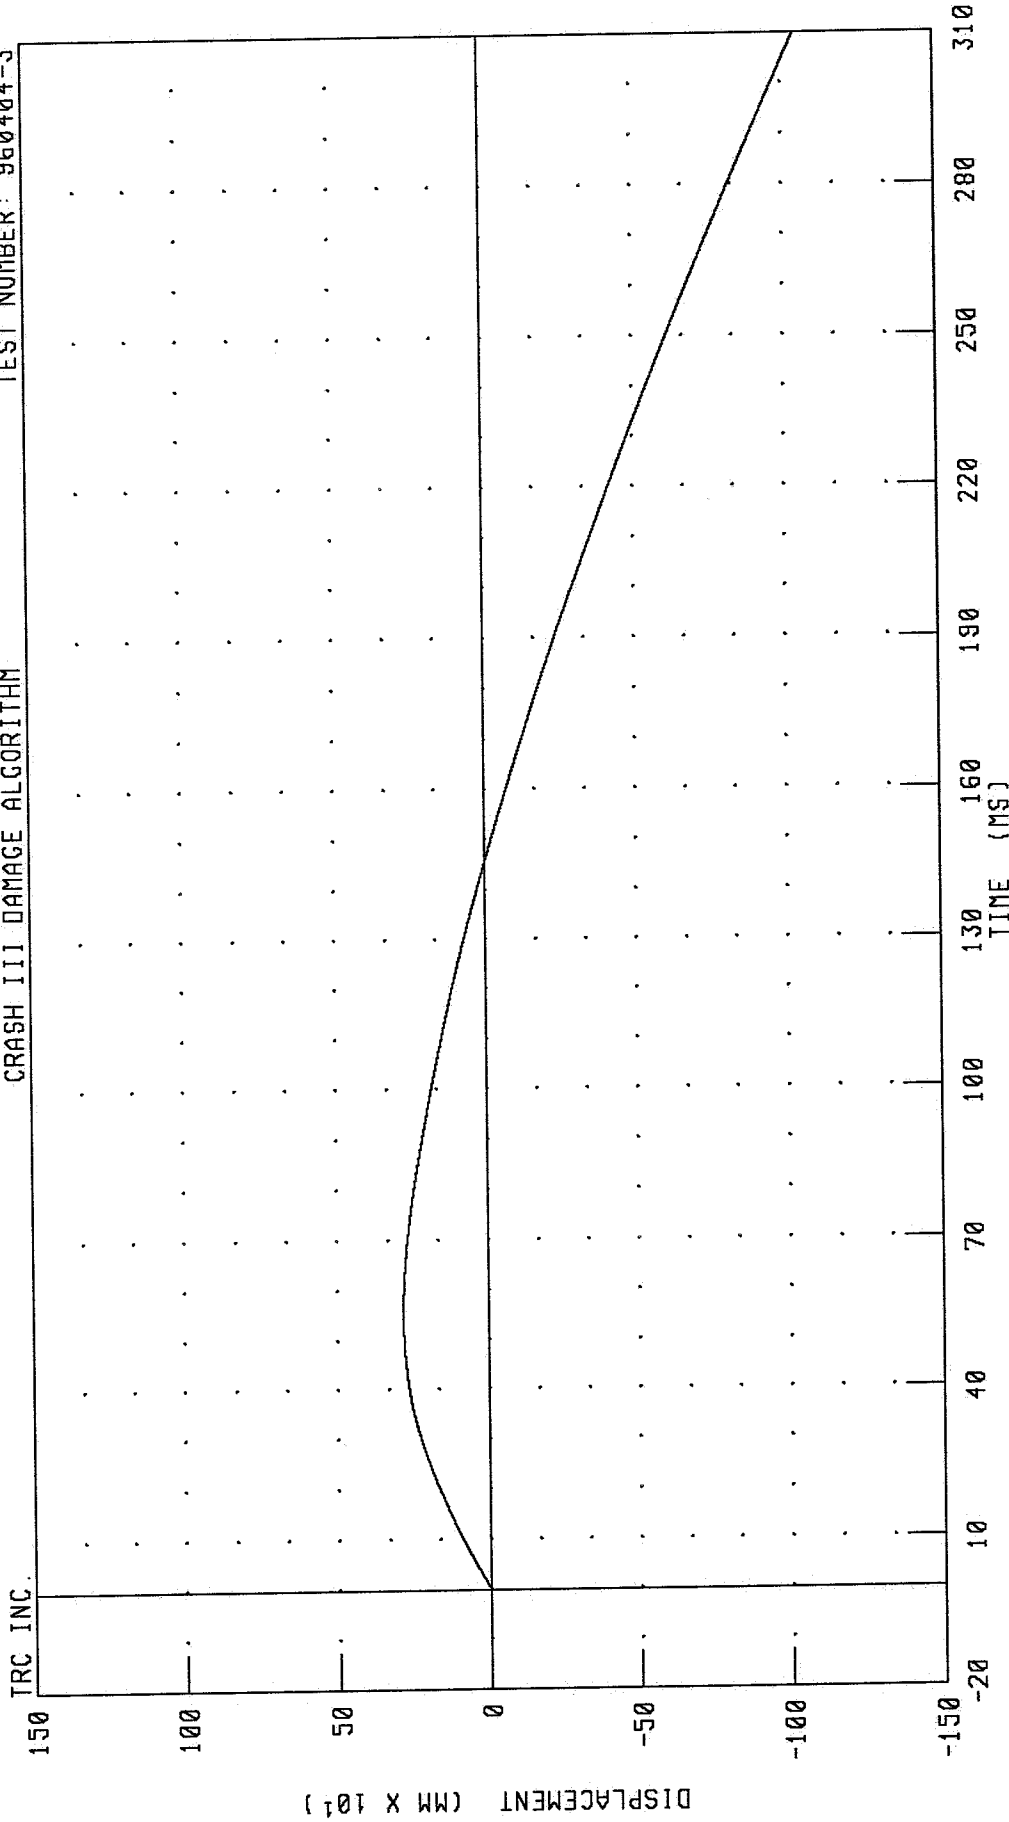
TEST NUMBER: 960404-3

CHANNEL: VCGRD1 FILTER: CH. CLASS 180 PEAK DATA: 283.13 MM @ 55.20 MS; -1042.83 MM @ 310.00 MS

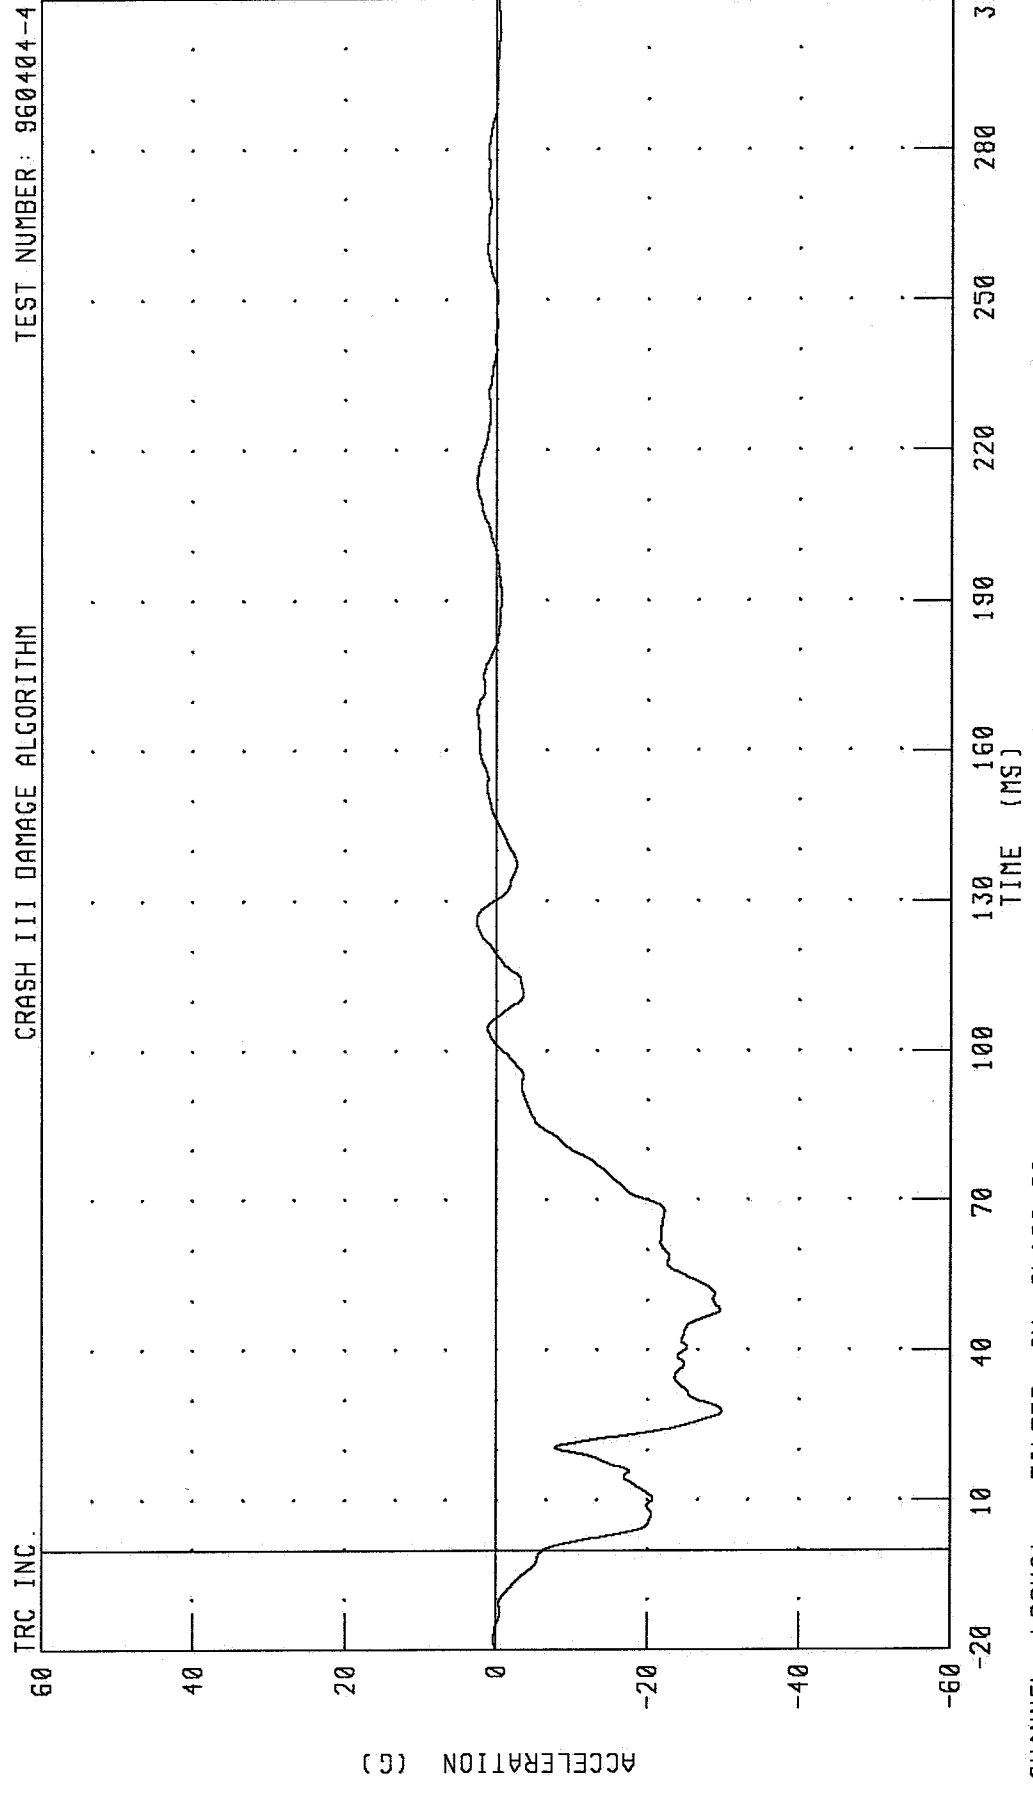
1991 DODGE CARAVAN INTO POLE BARRIER AT 35 MPH TEST NO. 4
LEFT REAR SILL X-AXIS ACCELERATION
CRASH III DAMAGE ALGORITHM

CHANNEL: LRSXG1 FILTER: CH. CLASS 60

PEAK DATA: 2.62 G @ 126.48 MS; -29.80 G @ 27.92 MS

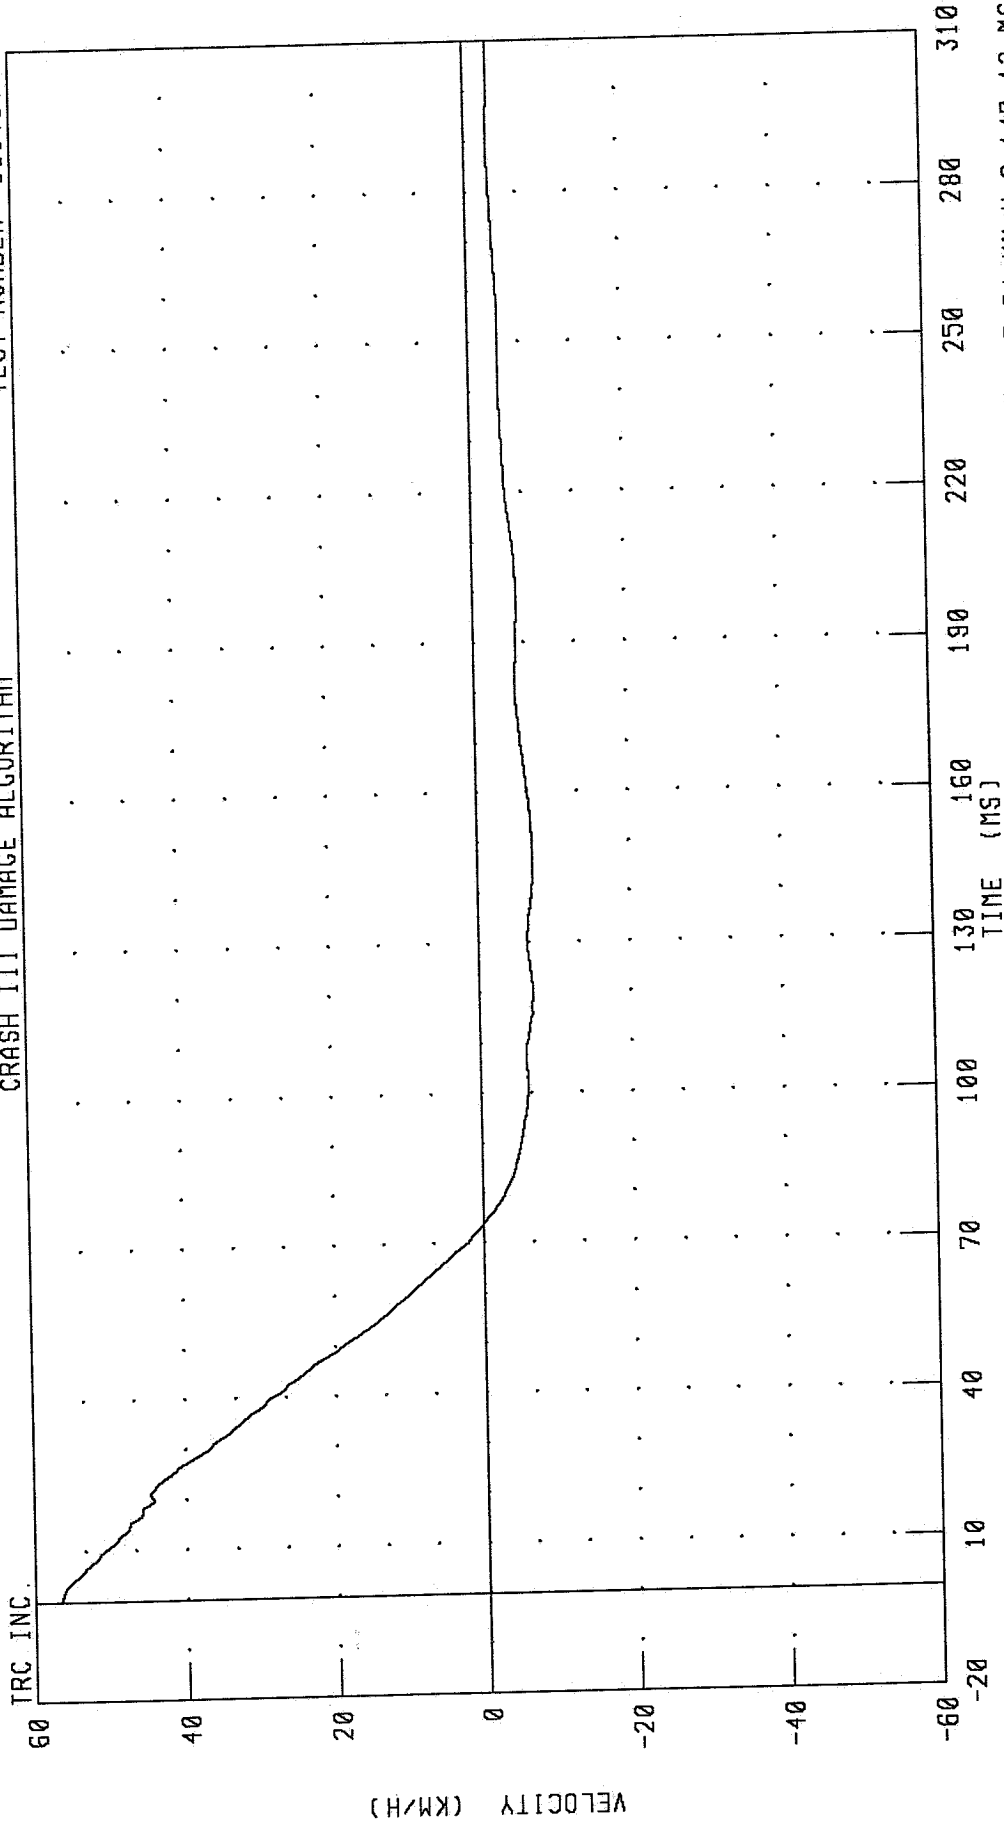
TEST NUMBER: 960404-4

CHANNEL: LRSXV1 FILTER: CH. CLASS 180

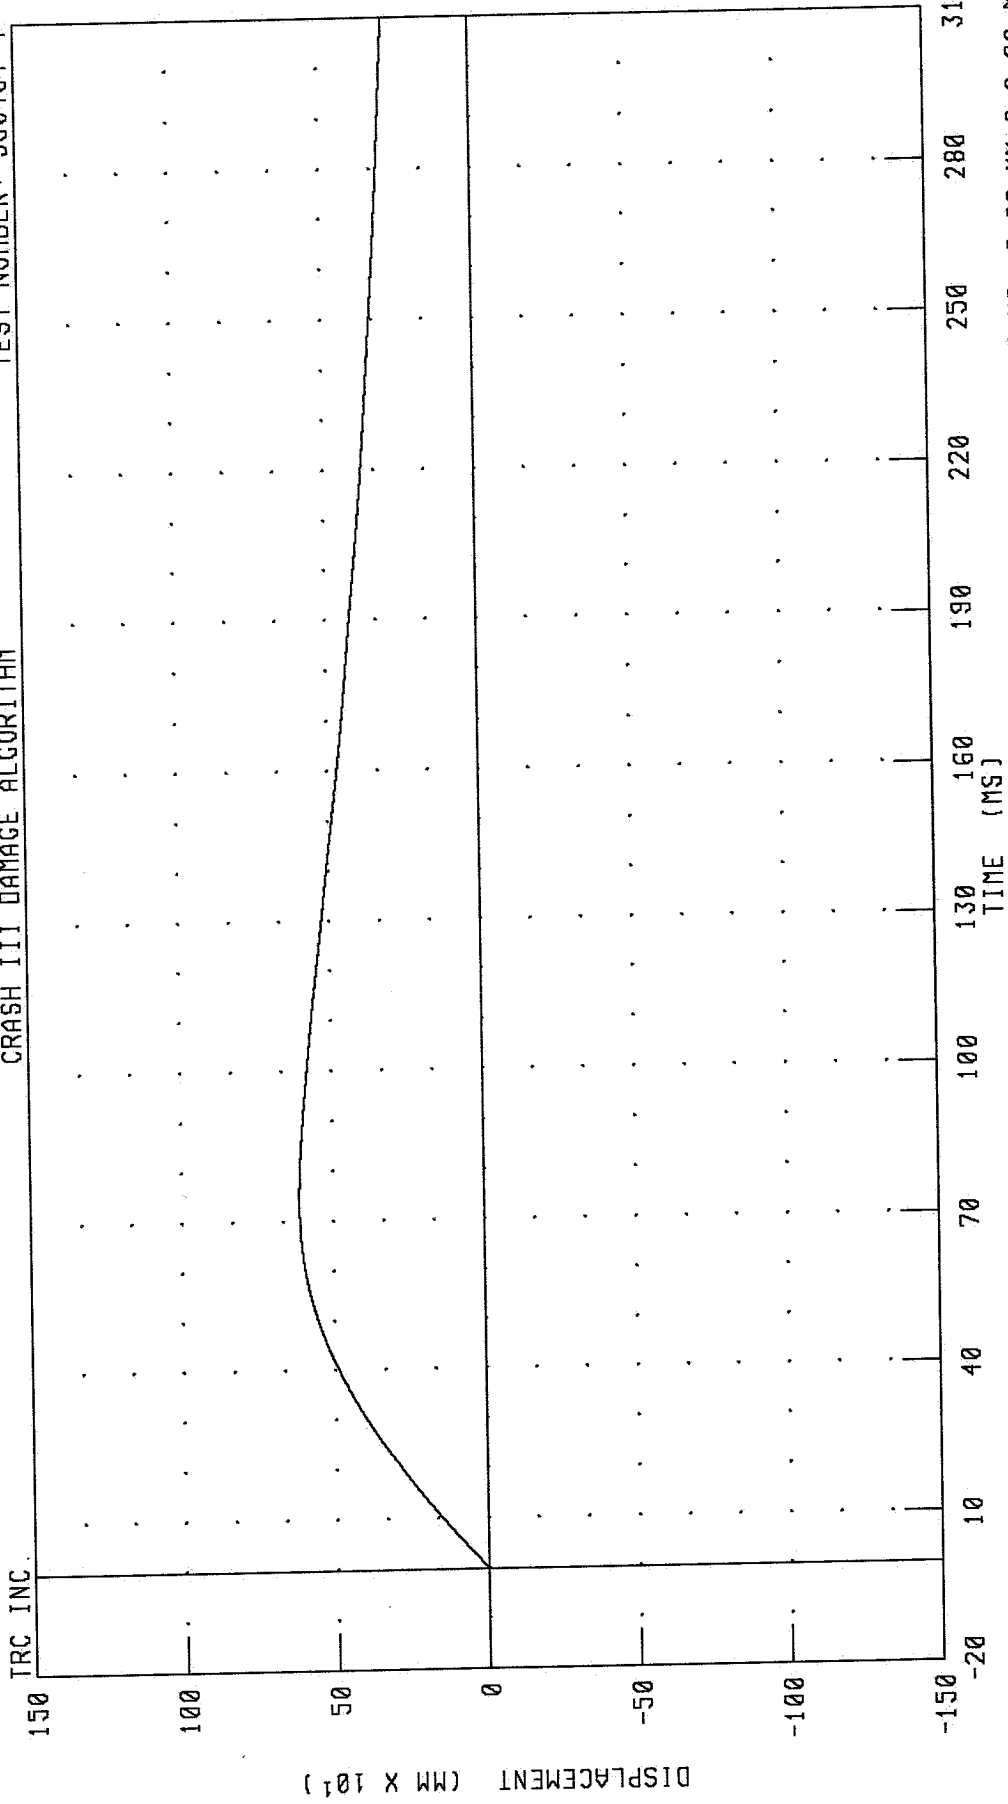
TEST NUMBER: 960404-4

1991 DODGE CARAVAN INTO POLE BARRIER AT 35 MPH TEST NO. 4
LEFT REAR SILL X-AXIS DISPLACEMENT
CRASH III DAMAGE ALGORITHM

CHANNEL: LRSXD1 FILTER: CH. CLASS 180 PEAK DATA: 612.74 MM @ 73.76 MS; 0.00 MM @ 0.00 MS

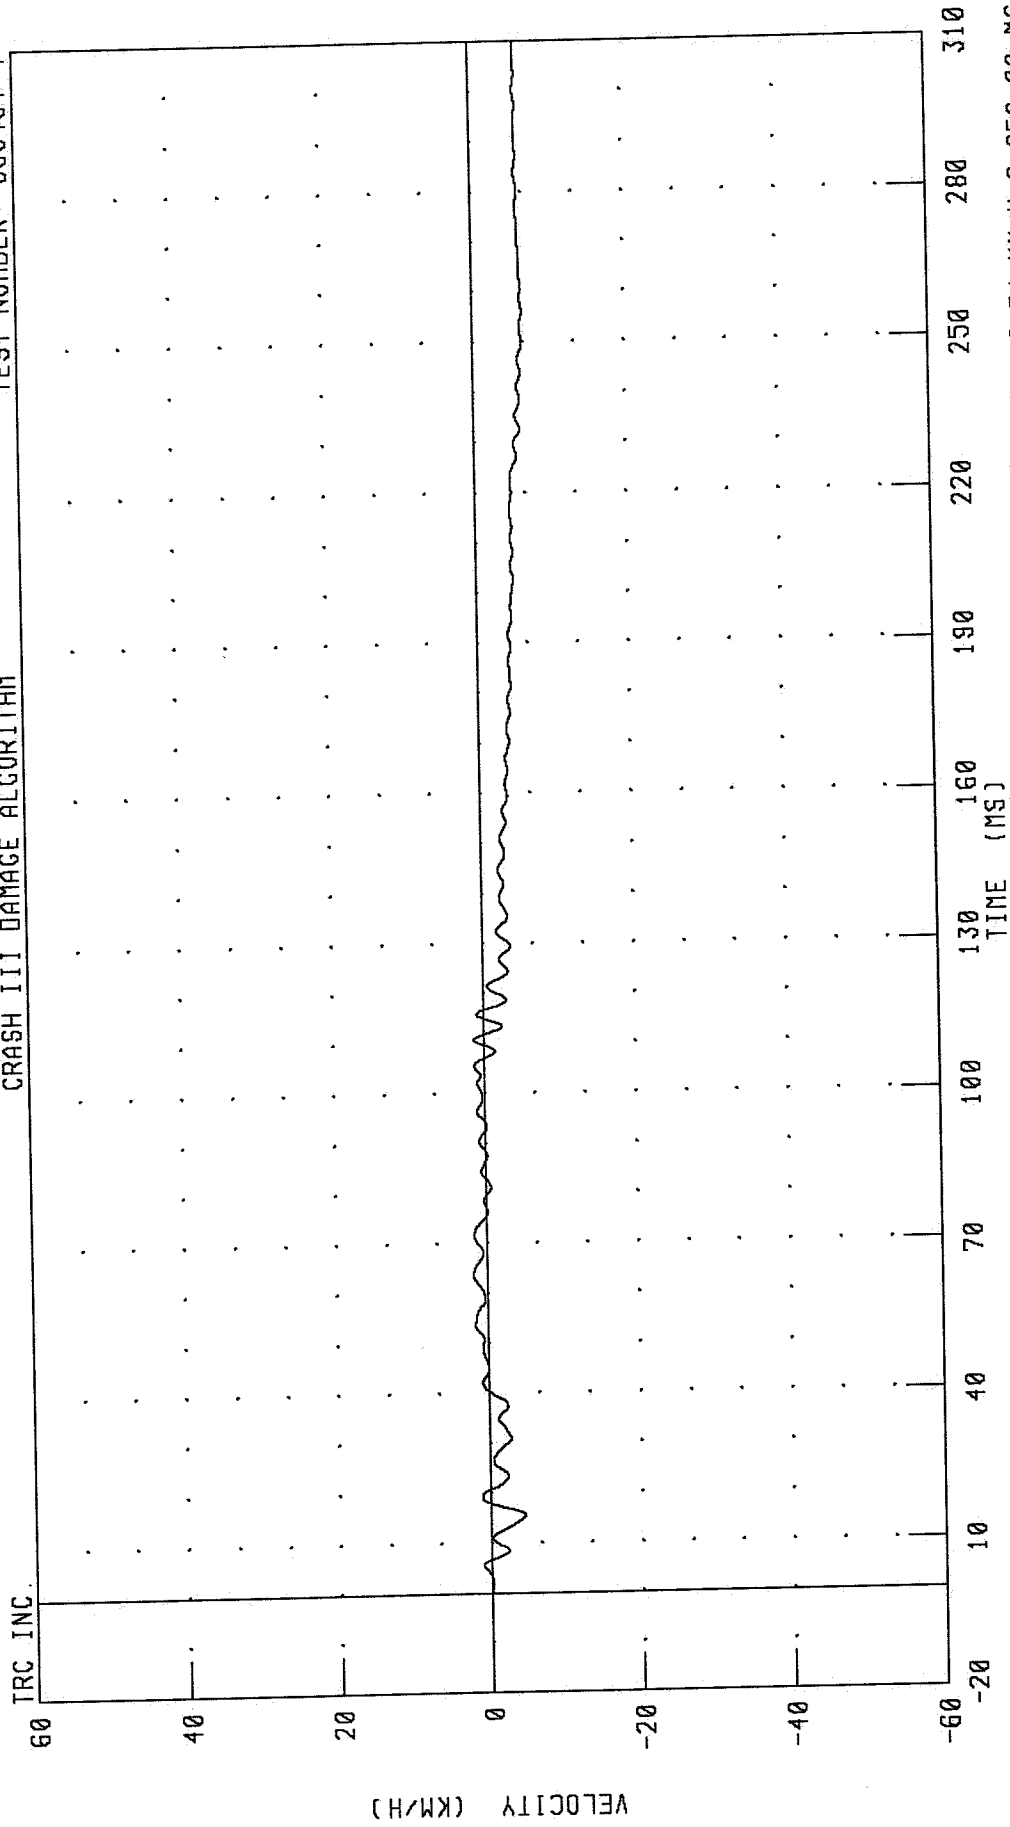
TEST NUMBER: 960404-4

CHANNEL: LRSZY1 FILTER: CH. CLASS 180 PEAK DATA: 1.88 KM/H @ 63.60 MS; -6.54 KM/H @ 256.00 MS

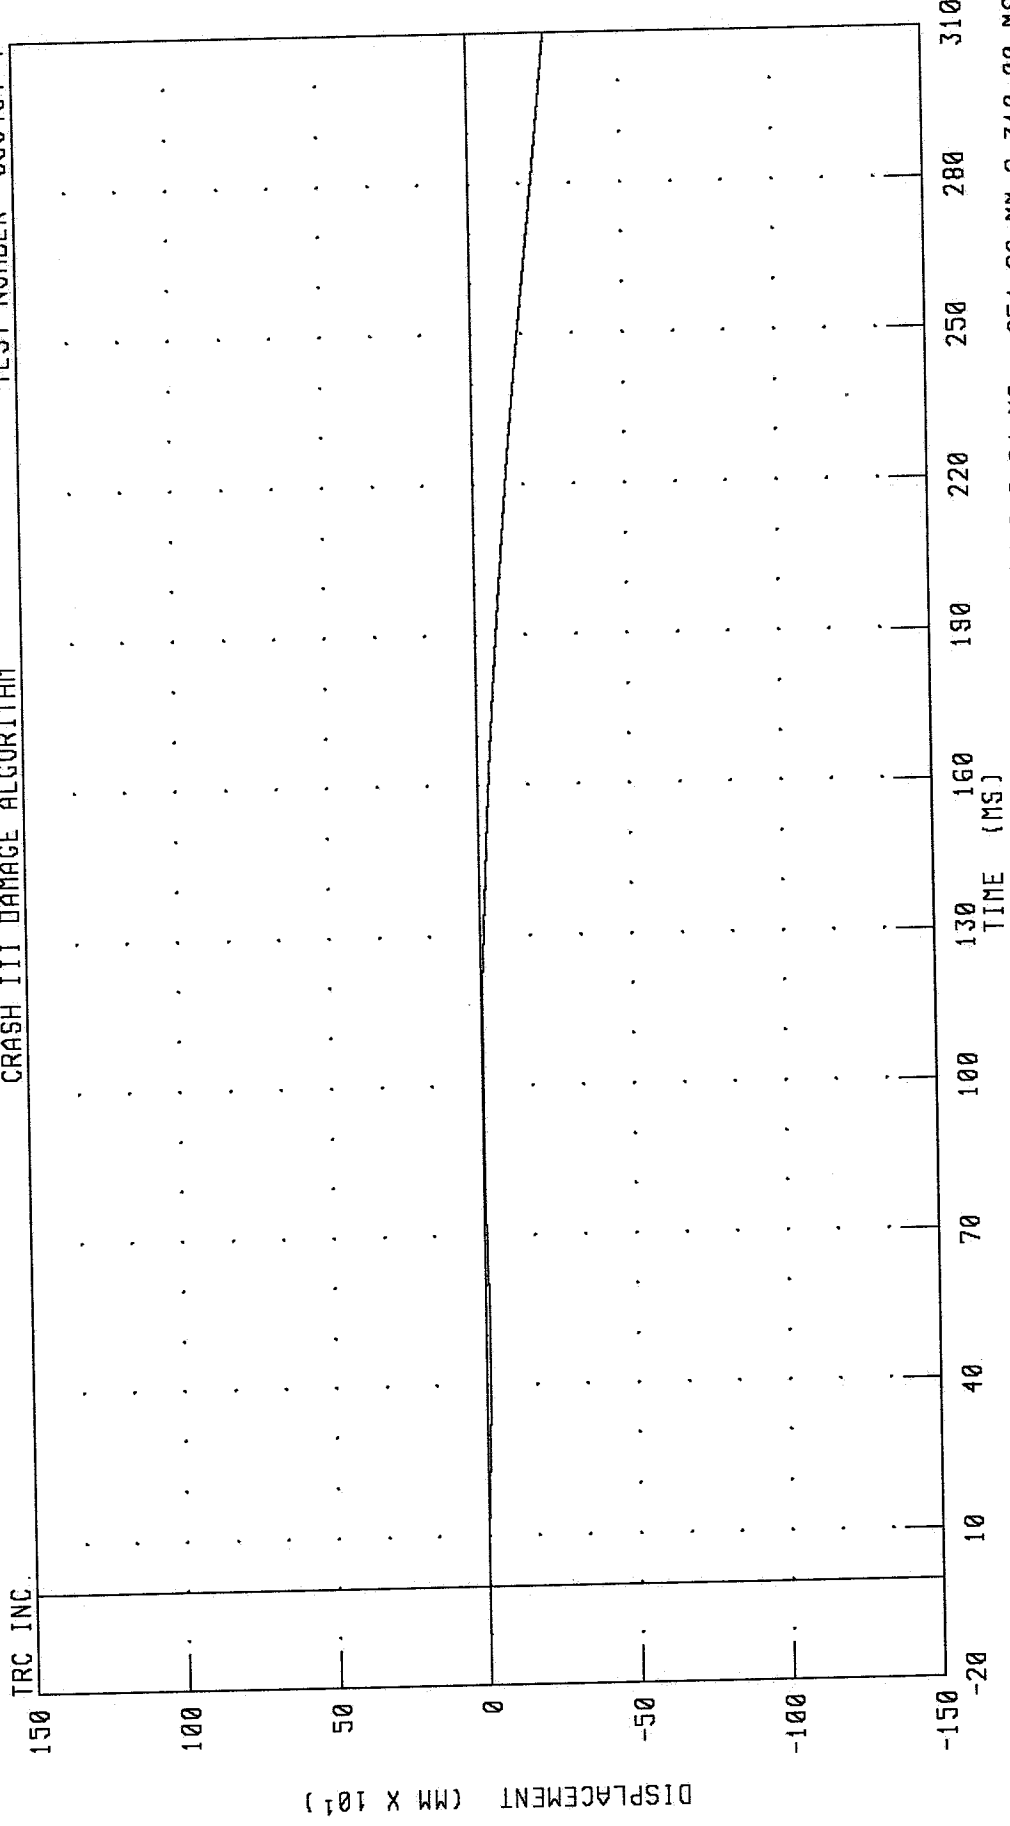
TEST NUMBER: 960404-4

1991 DODGE CARAVAN INTO POLE BARRIER AT 35 MPH TEST NO. 4
LEFT REAR SILL Z-AXIS DISPLACEMENT
CRASH III DAMAGE ALGORITHM

CHANNEL: LRSZ01 FILTER: CH. CLASS 180 PEAK DATA: 0.47 MM @ 6.64 MS, -254.68 MM @ 310.00 MS
