**1991 Dodge Caravan
into 12-Inch Diameter Centered Pole
in Support of
Crash III Damage Algorithm Reformulation**

TRC Test Nos.: 960404-1

**Prepared by:
Transportation Research Center Inc.
10820 State Route 347
East Liberty, OH 43319**

**April - May 1996
Final Report**

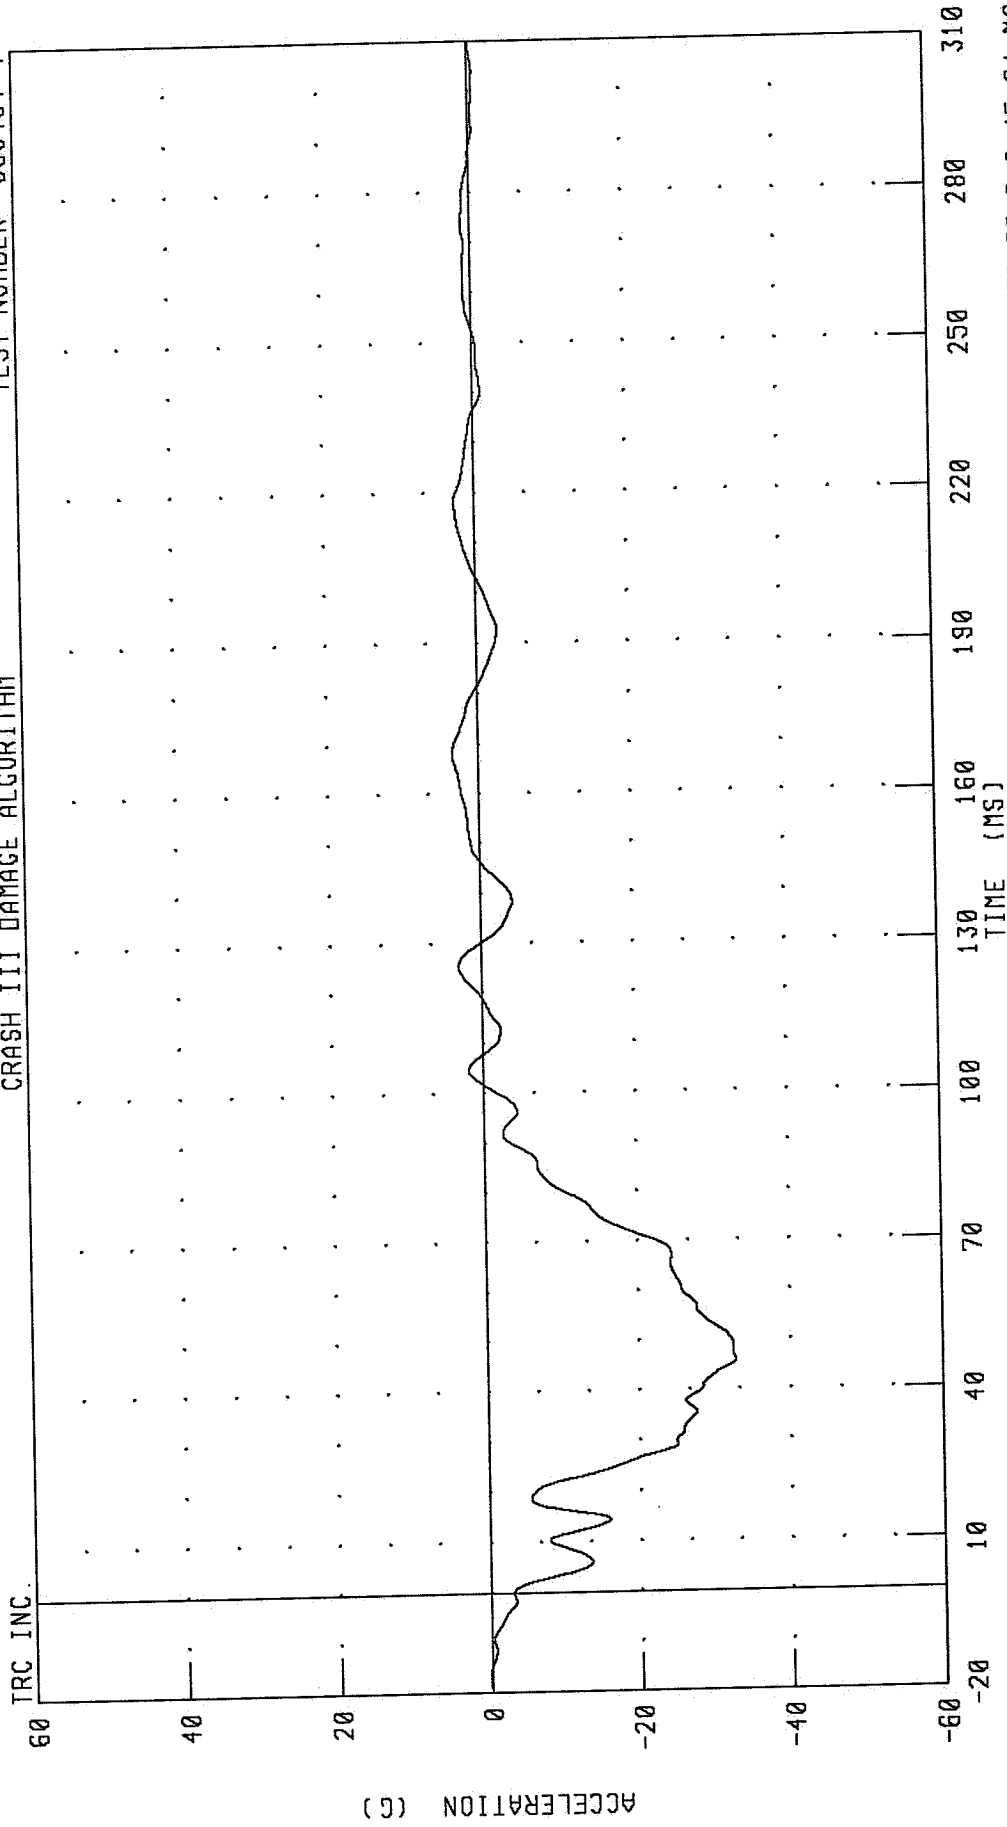
TEST NUMBER: 960404-4

1991 DODGE CARAVAN INTO POLE BARRIER AT 35 MPH TEST NO. 4
RIGHT REAR SILL X-AXIS ACCELERATION
CRASH III DAMAGE ALGORITHM

CHANNEL: RRSXG1 FILTER: CH. CLASS 60 PEAK DATA: 3.40 G @ 168.08 MS; -32.89 G @ 45.84 MS

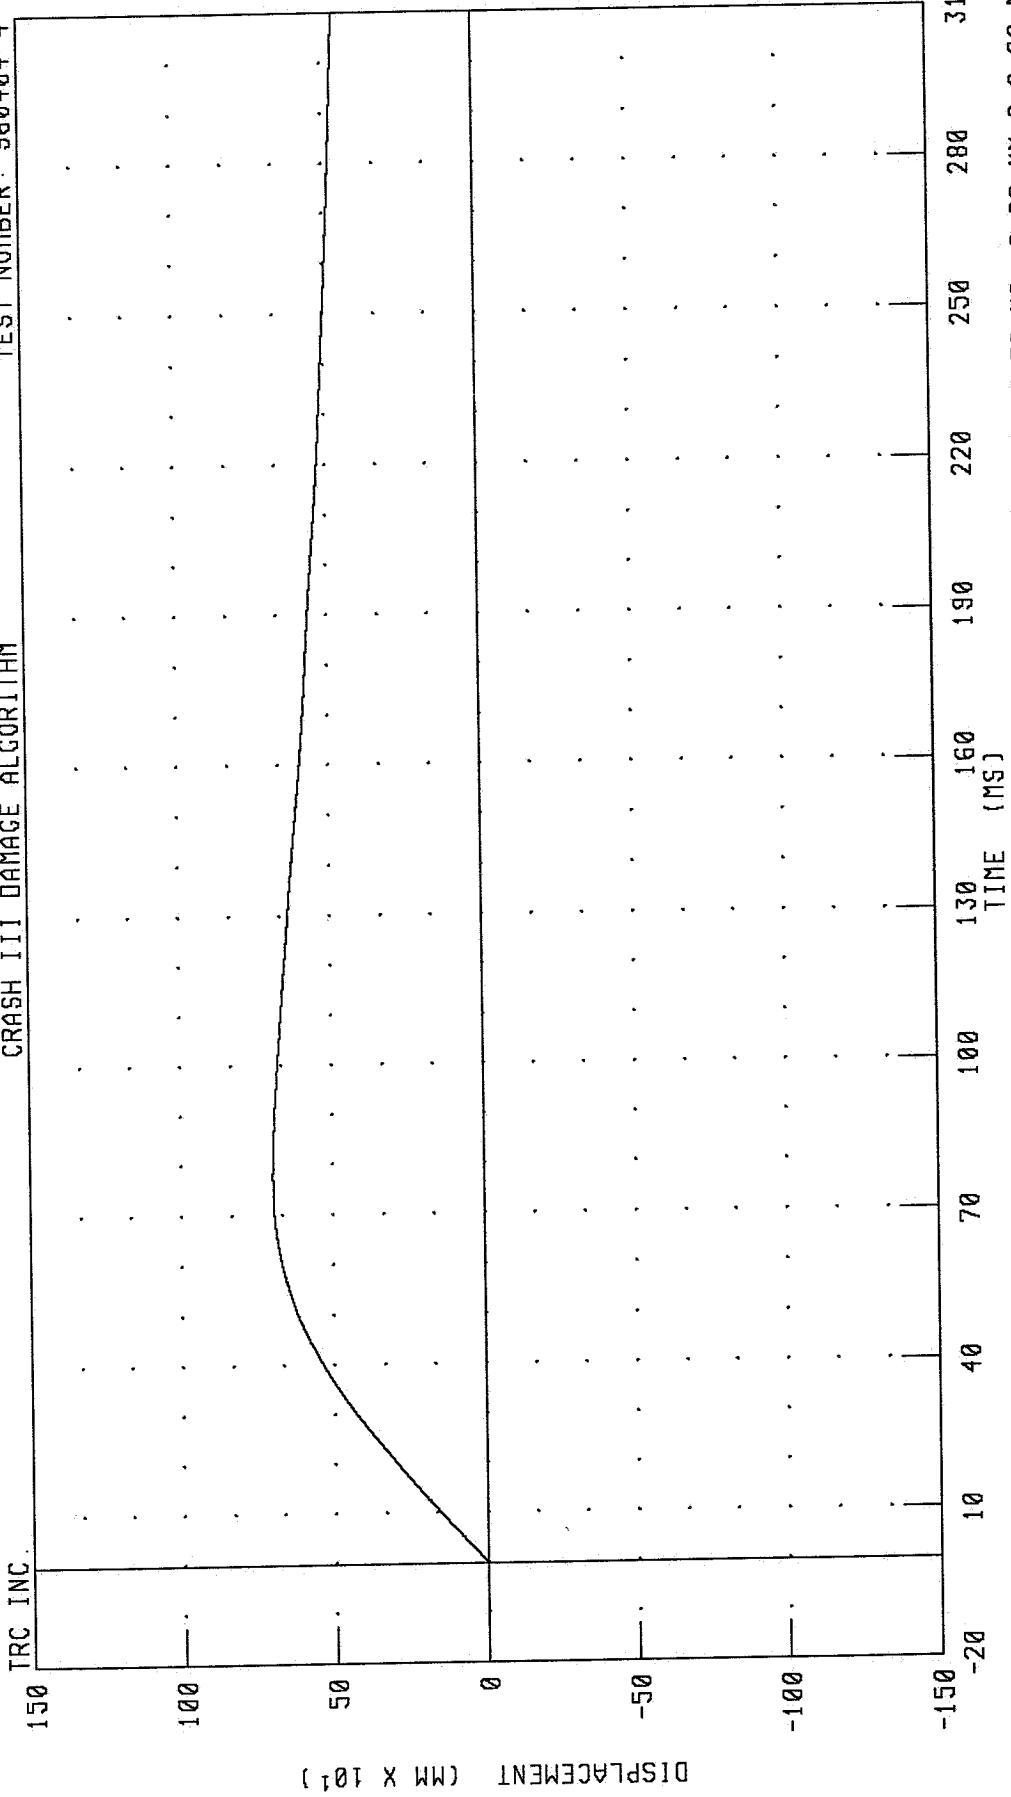
TEST NUMBER: 960404-4

CHANNEL: RRSXD1 FILTER: CH. CLASS 180 PEAK DATA: 696.77 MM @ 77.76 MS; 0.00 MM @ 0.00 MS

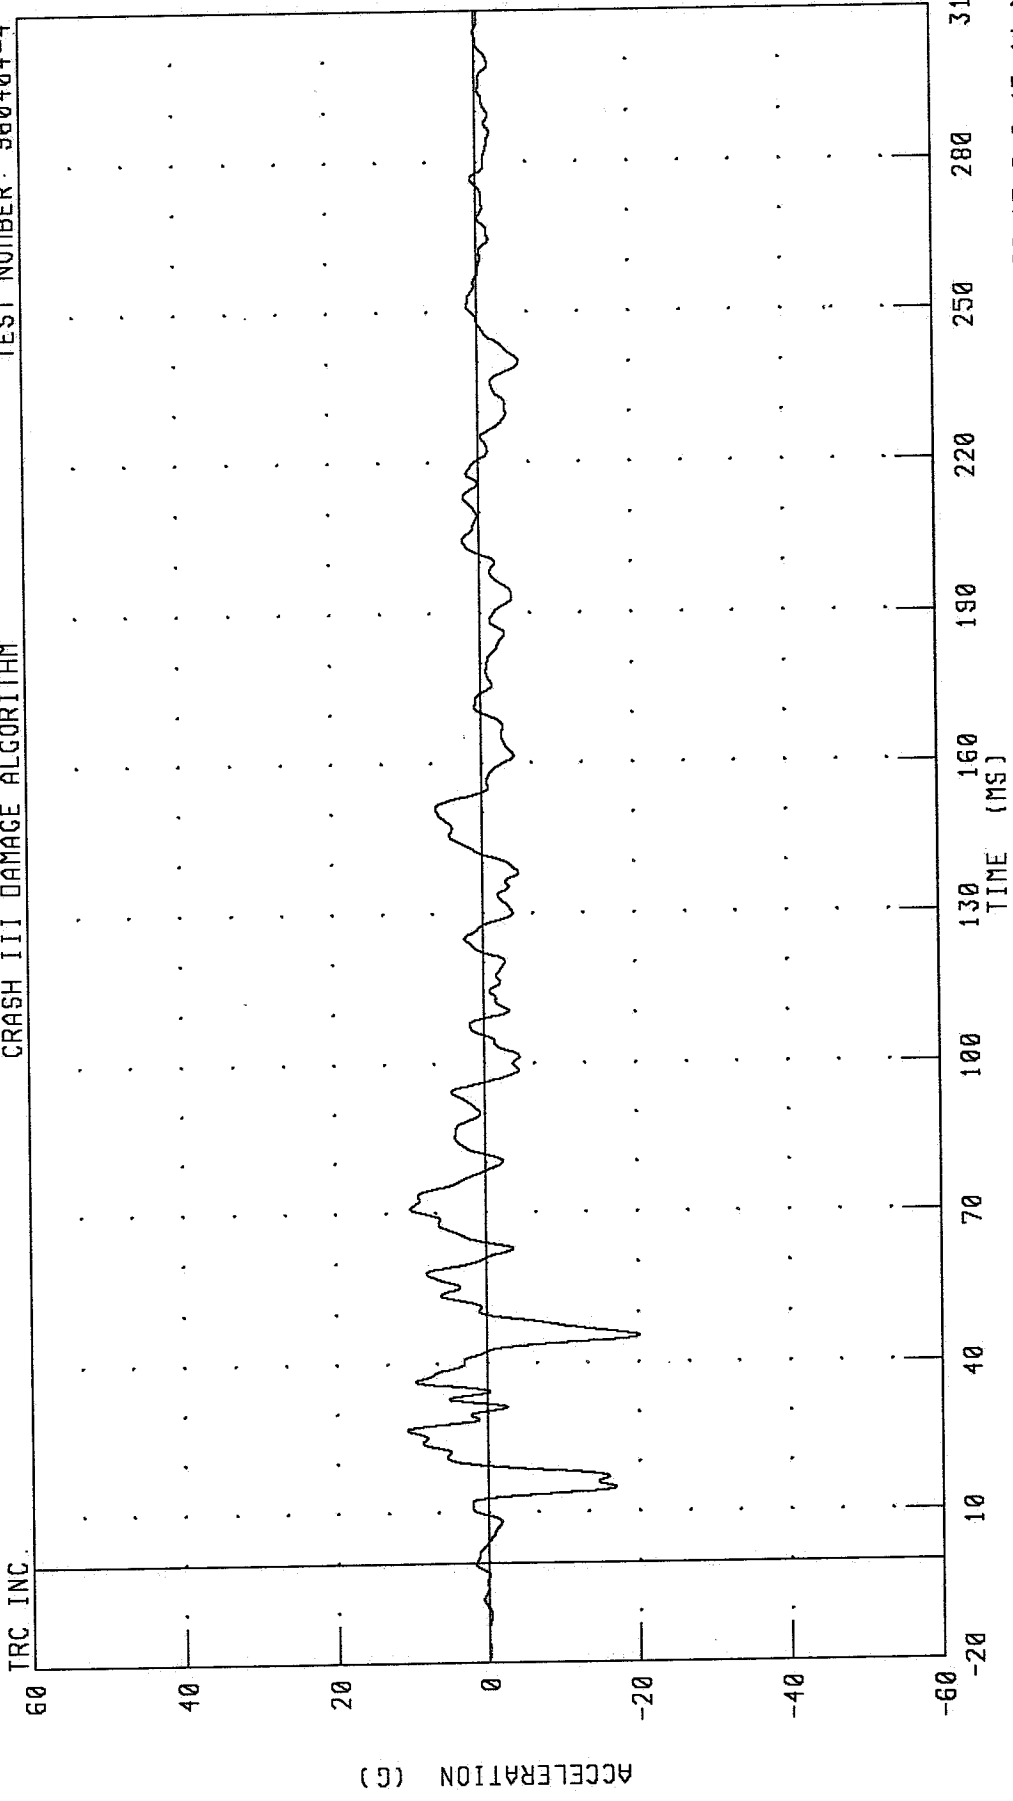
TEST NUMBER: 960404-4

CHANNEL: RRSZG1 FILTER: CH. CLASS 60

PEAK DATA: 10.75 G @ 26.80 MS; -20.17 G @ 45.44 MS

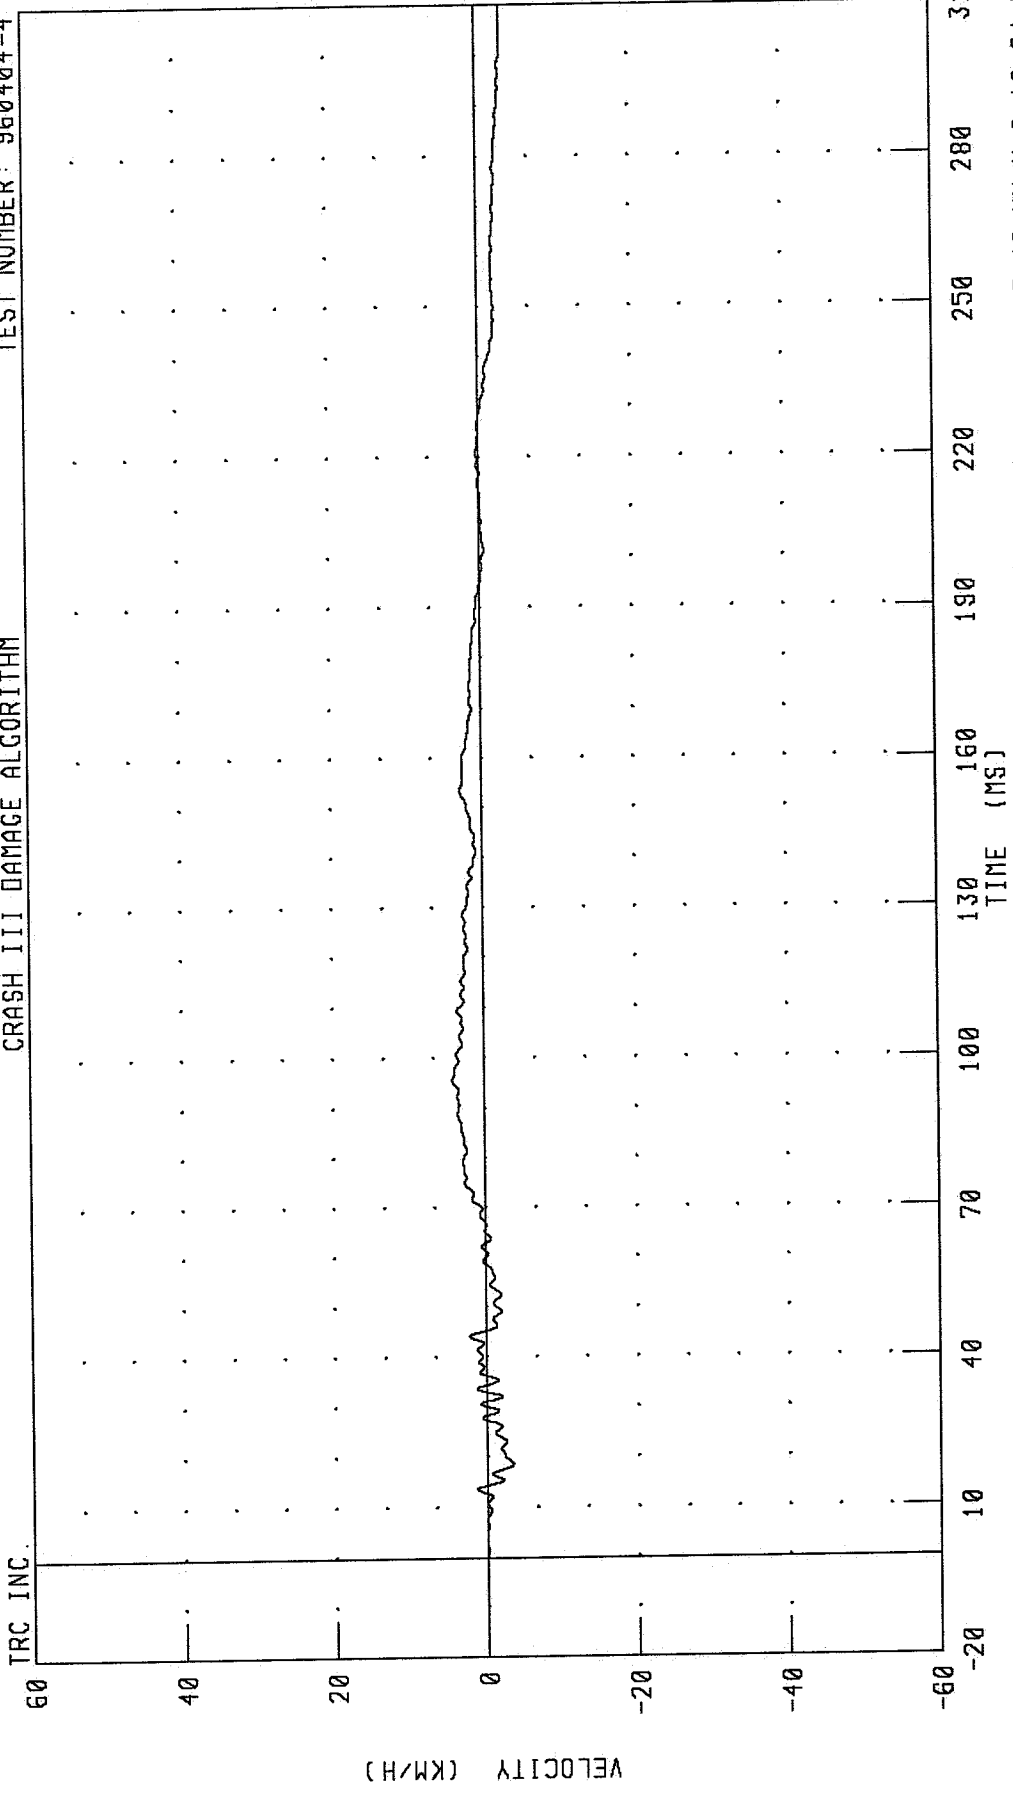
TEST NUMBER: 960404-4

CHANNEL: RRSZV1 FILTER: CH. CLASS 180

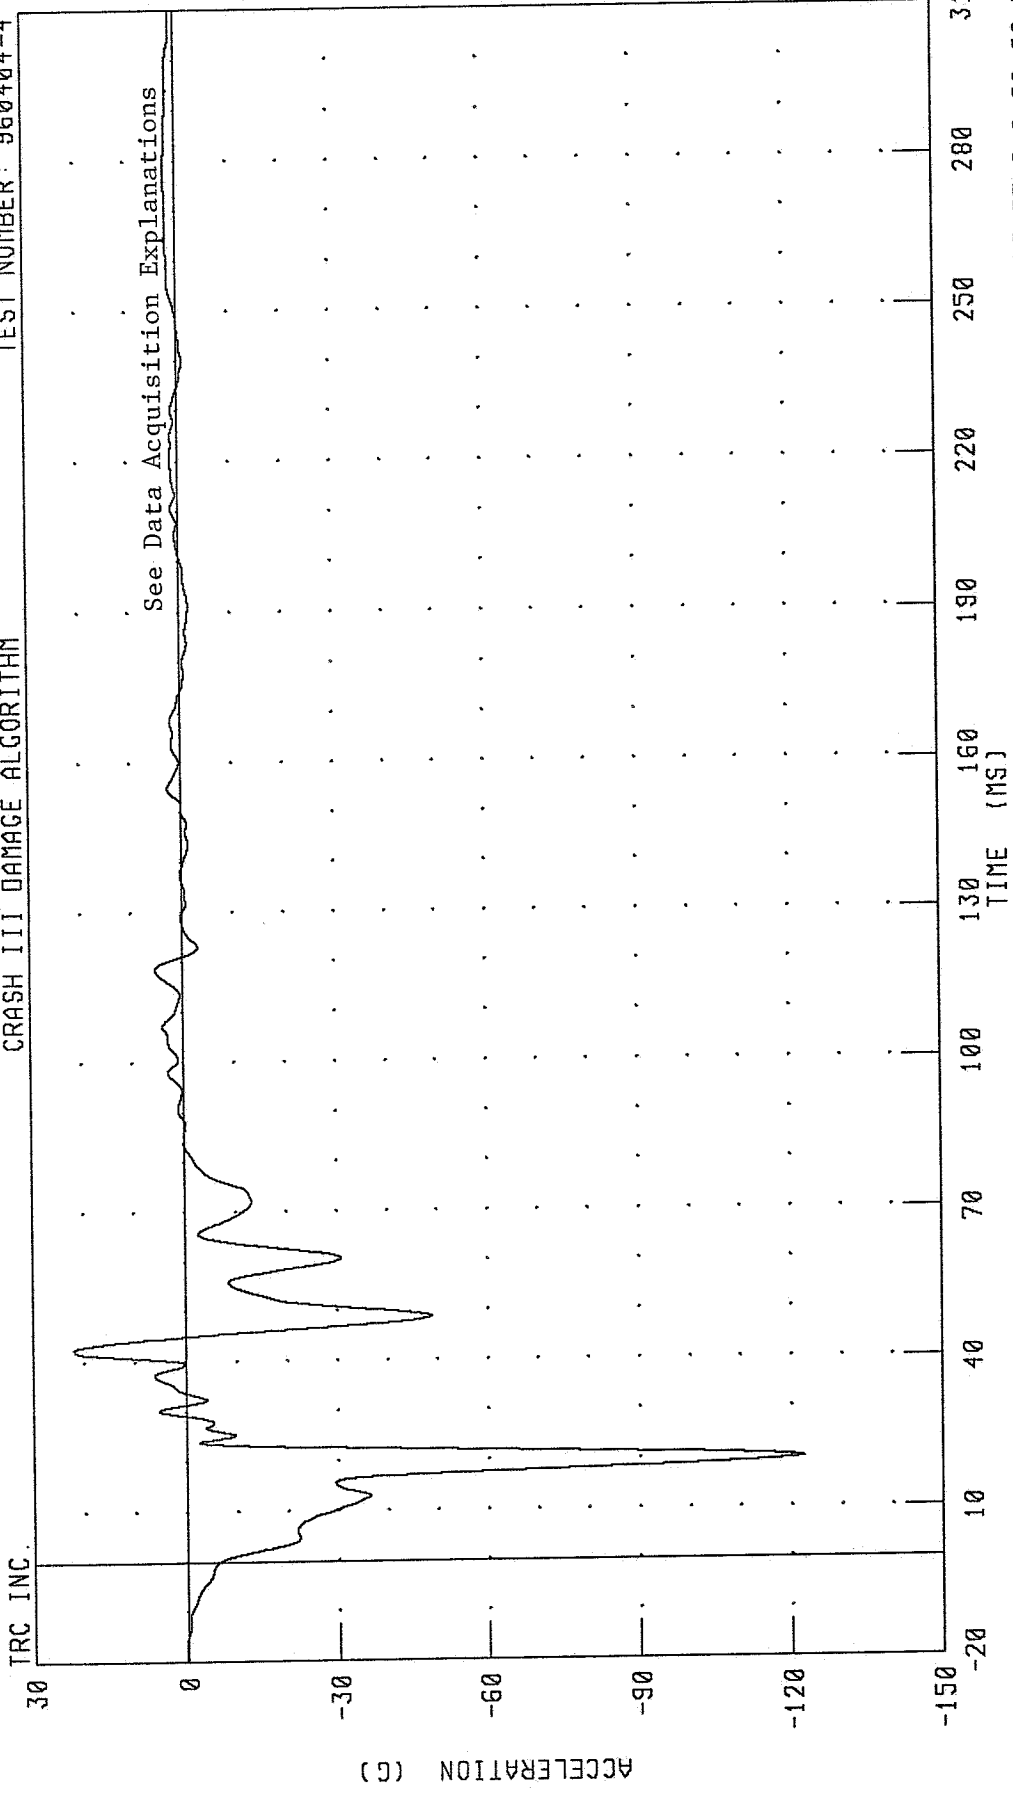
TEST NUMBER: 960404-4

CHANNEL: LFSXG1 FILTER: CH. CLASS 60

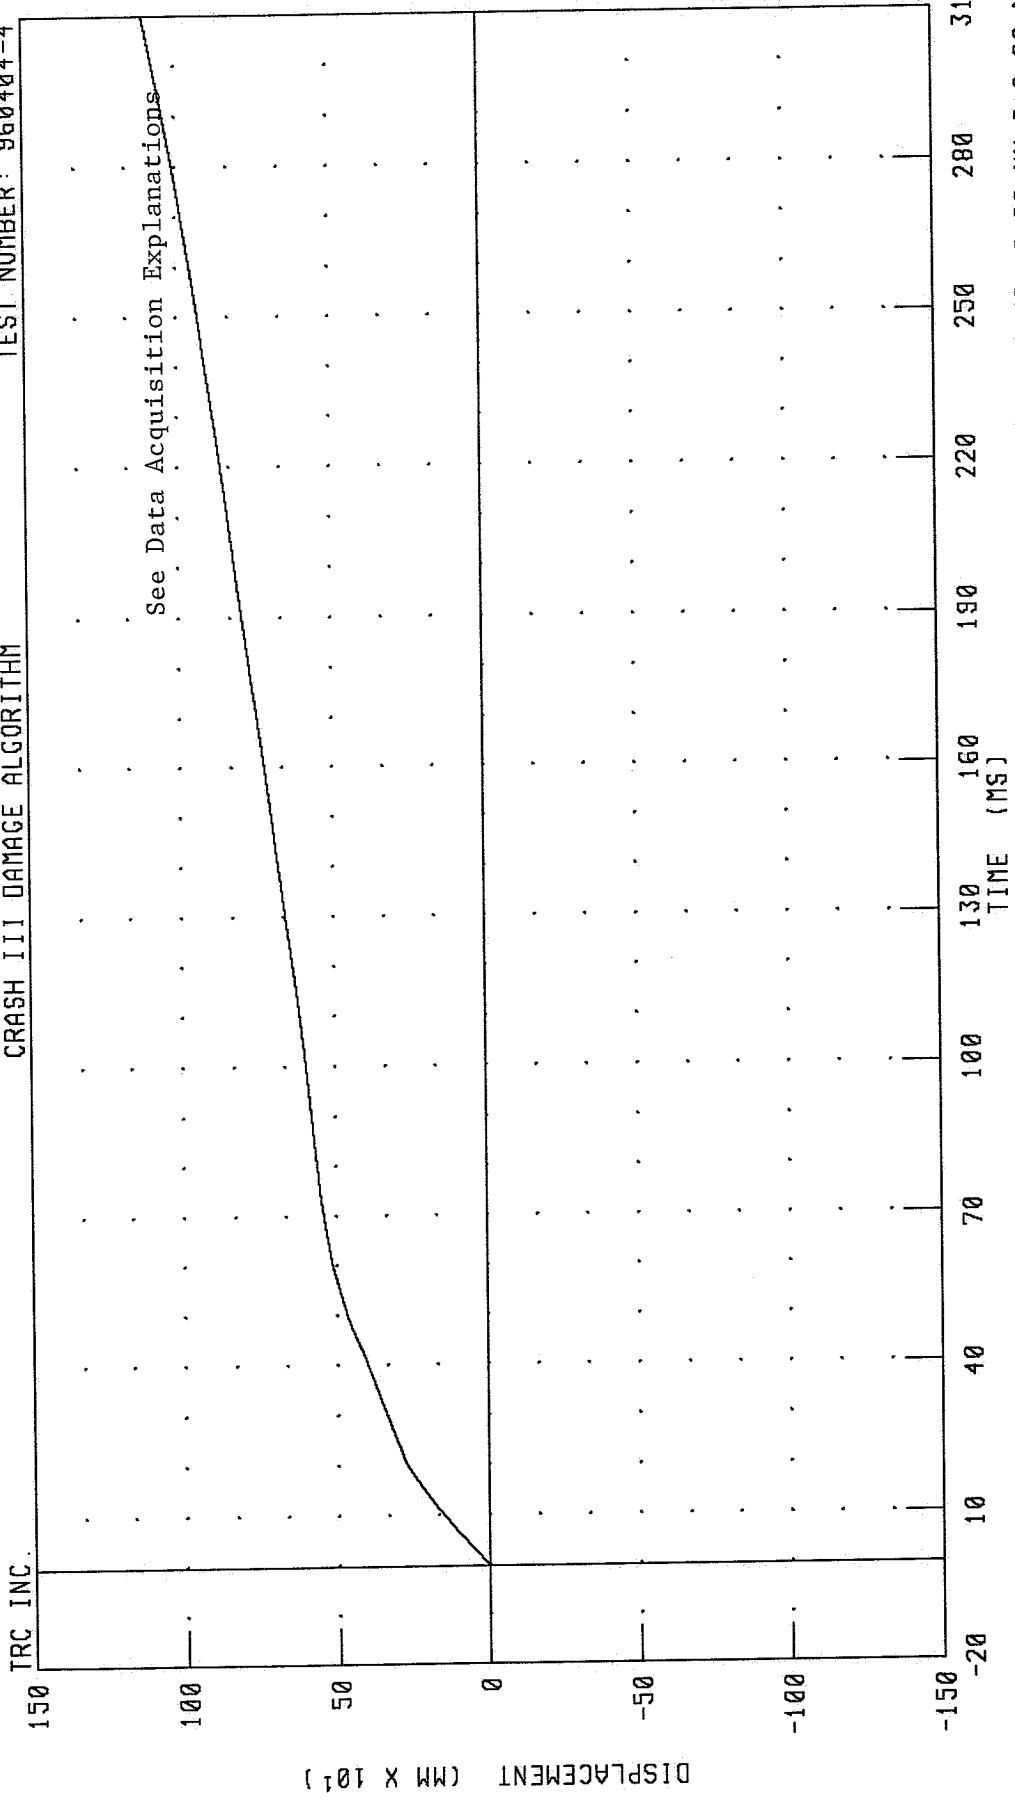
TEST NUMBER: 960404-4

CHANNEL: LFSXD1 FILTER: CH. CLASS 180 PEAK DATA: 1104.49 MM @ 310.00 MS; 0.00 MM @ 0.00 MS

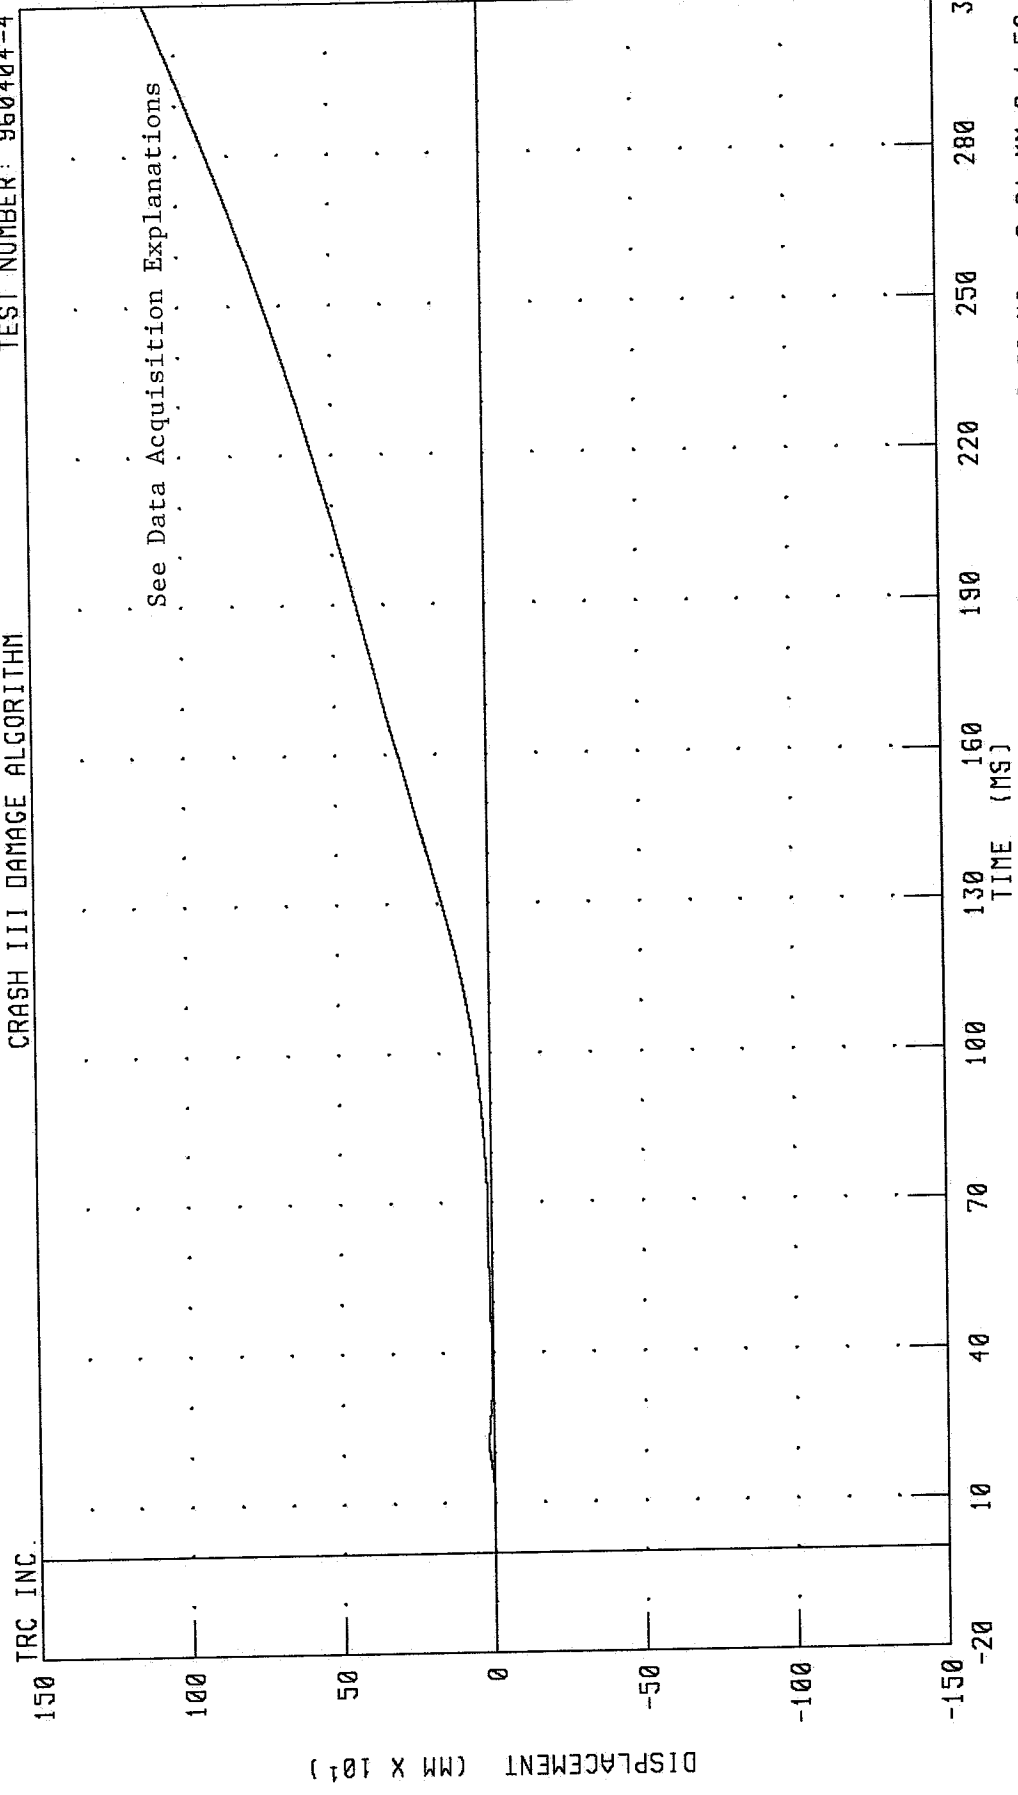
TEST NUMBER: 960404-4

CHANNEL: LFSZD1 FILTER: CH. CLASS 180 PEAK DATA: 1103.59 MM @ 310.00 MS; -0.01 MM @ 1.52 MS

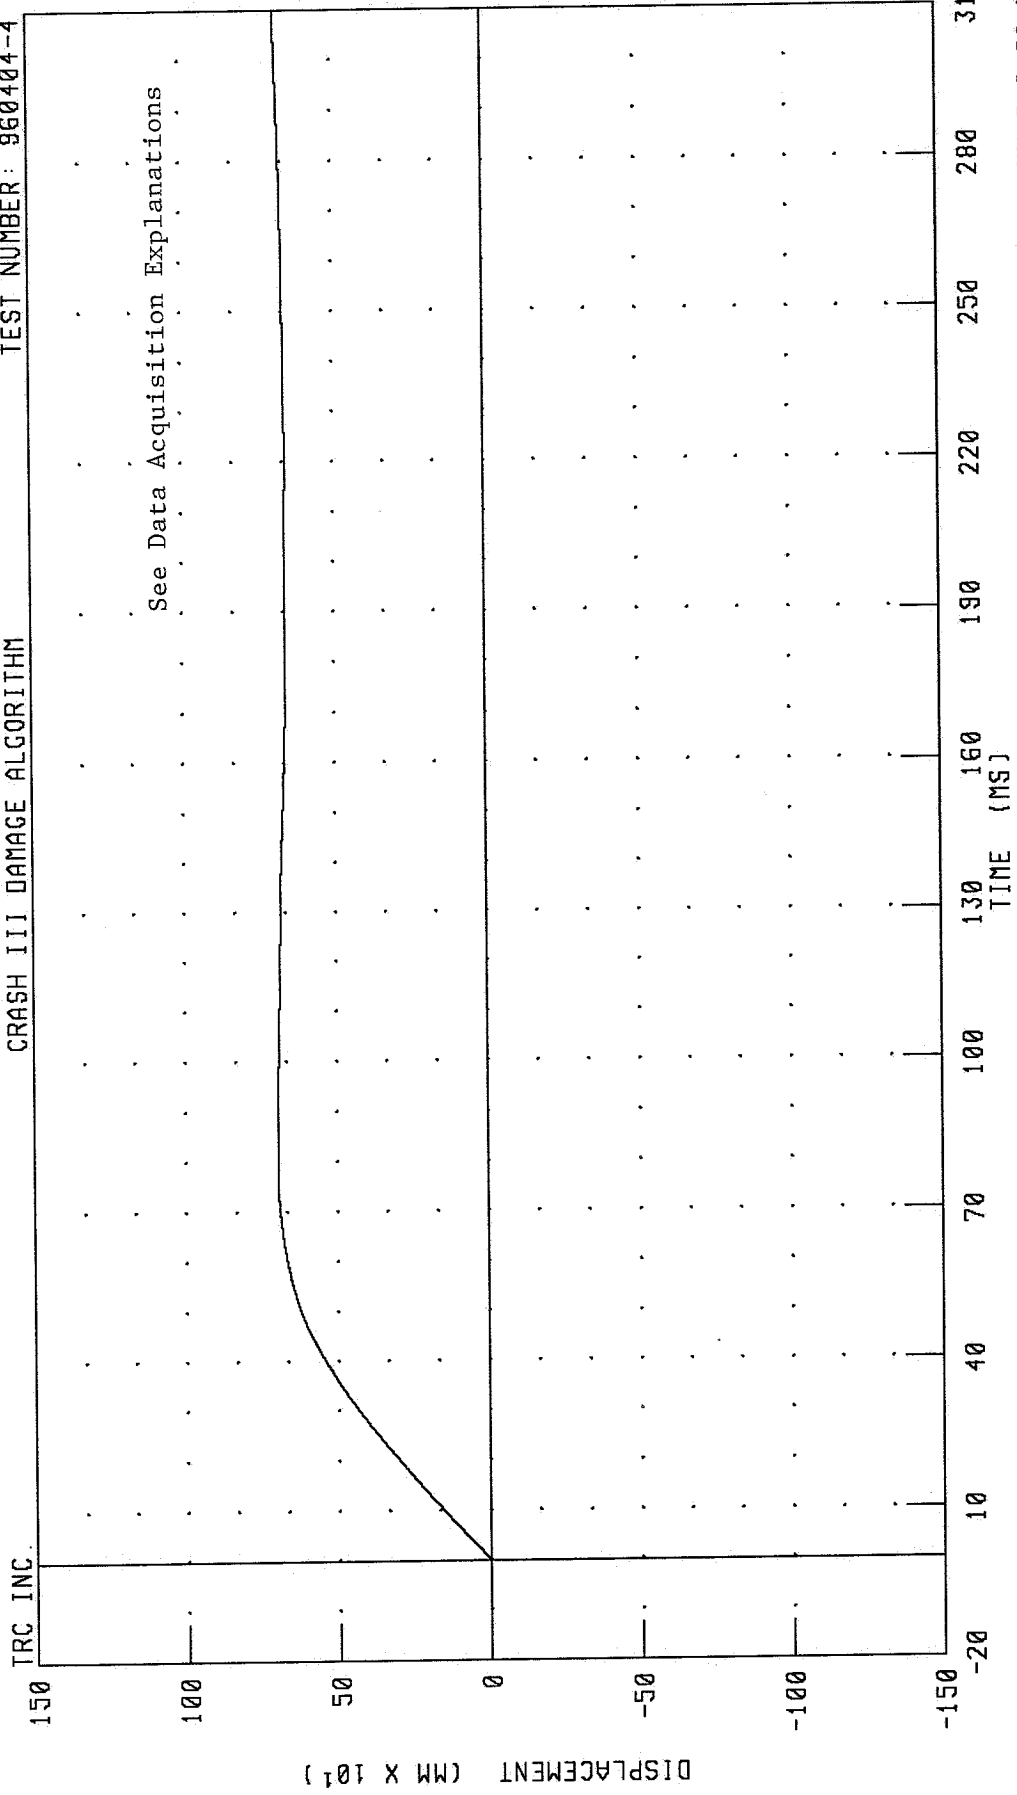
TEST NUMBER: 960404-4

CHANNEL: RFSXD1 FILTER: CH. CLASS 180 PEAK DATA: 696.45 MM @ 81.60 MS; 0.00 MM @ 0.00 MS

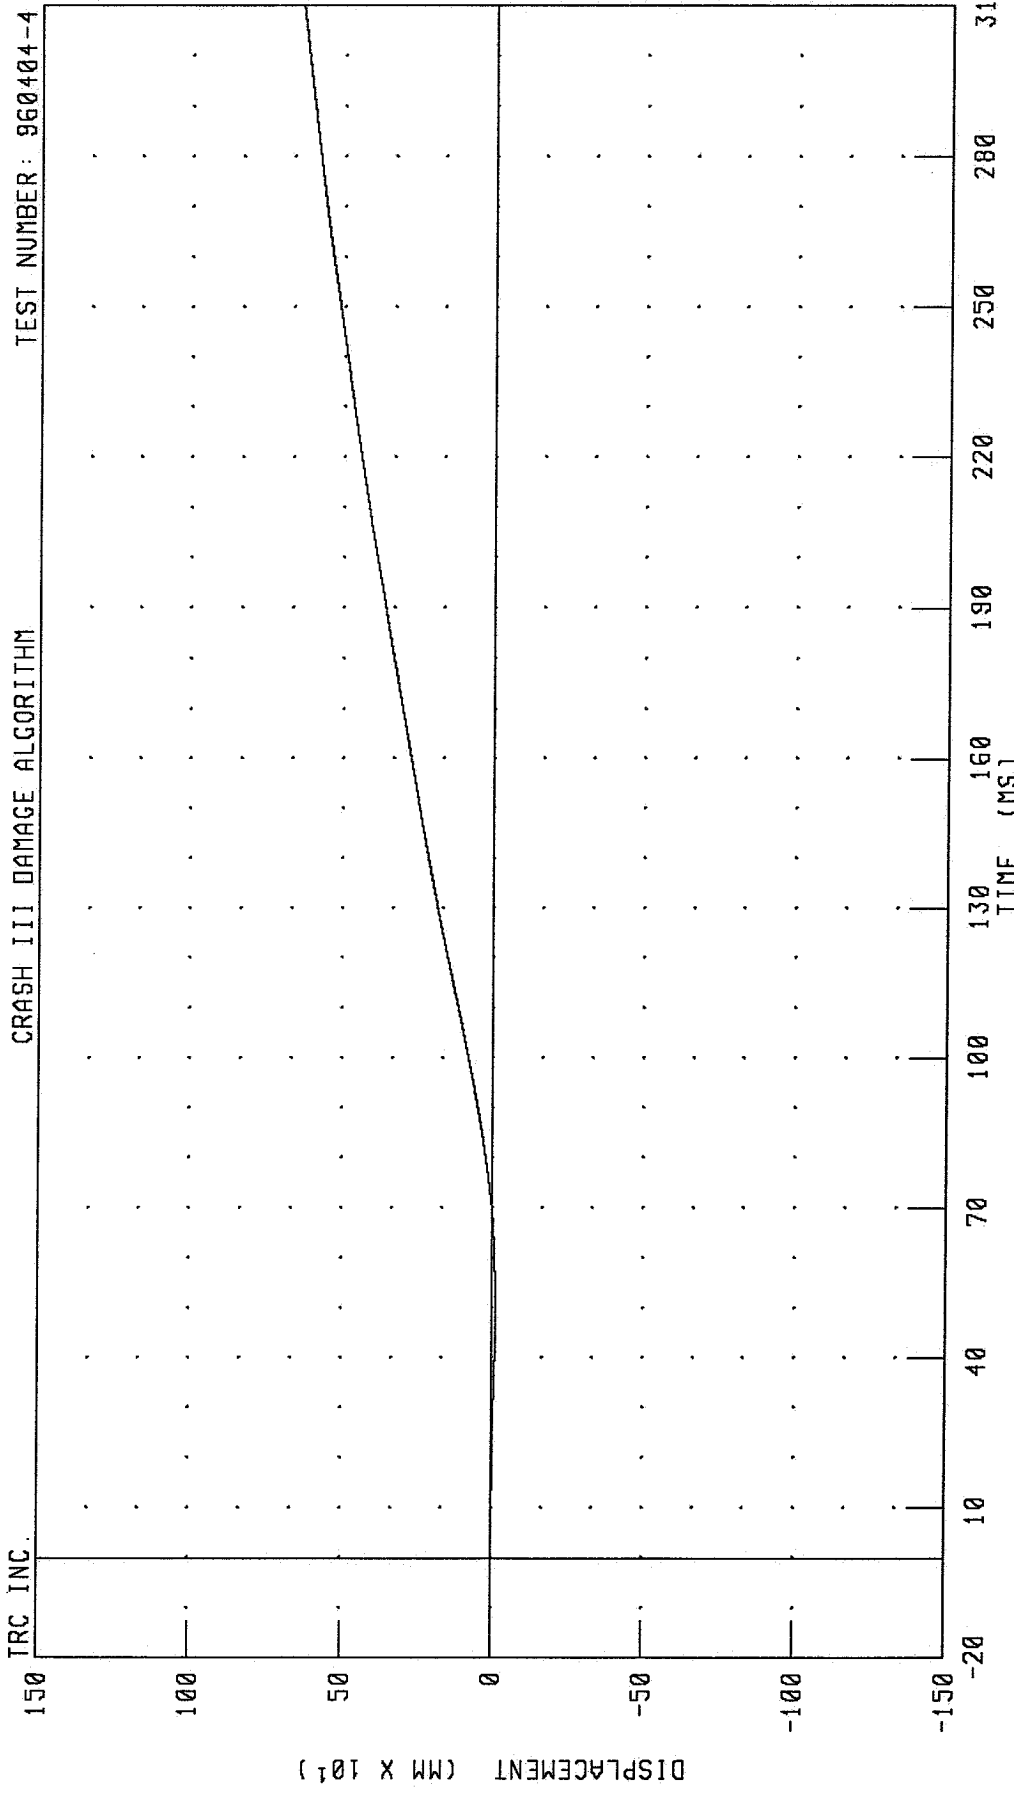
1991 DODGE CARAVAN INTO POLE BARRIER AT 35 MPH TEST NO. 4
RIGHT FRONT SILL Z-AXIS DISPLACEMENT
CRASH III DAMAGE ALGORITHM

CHANNEL: RFSZD1 FILTER: CH. CLASS 180

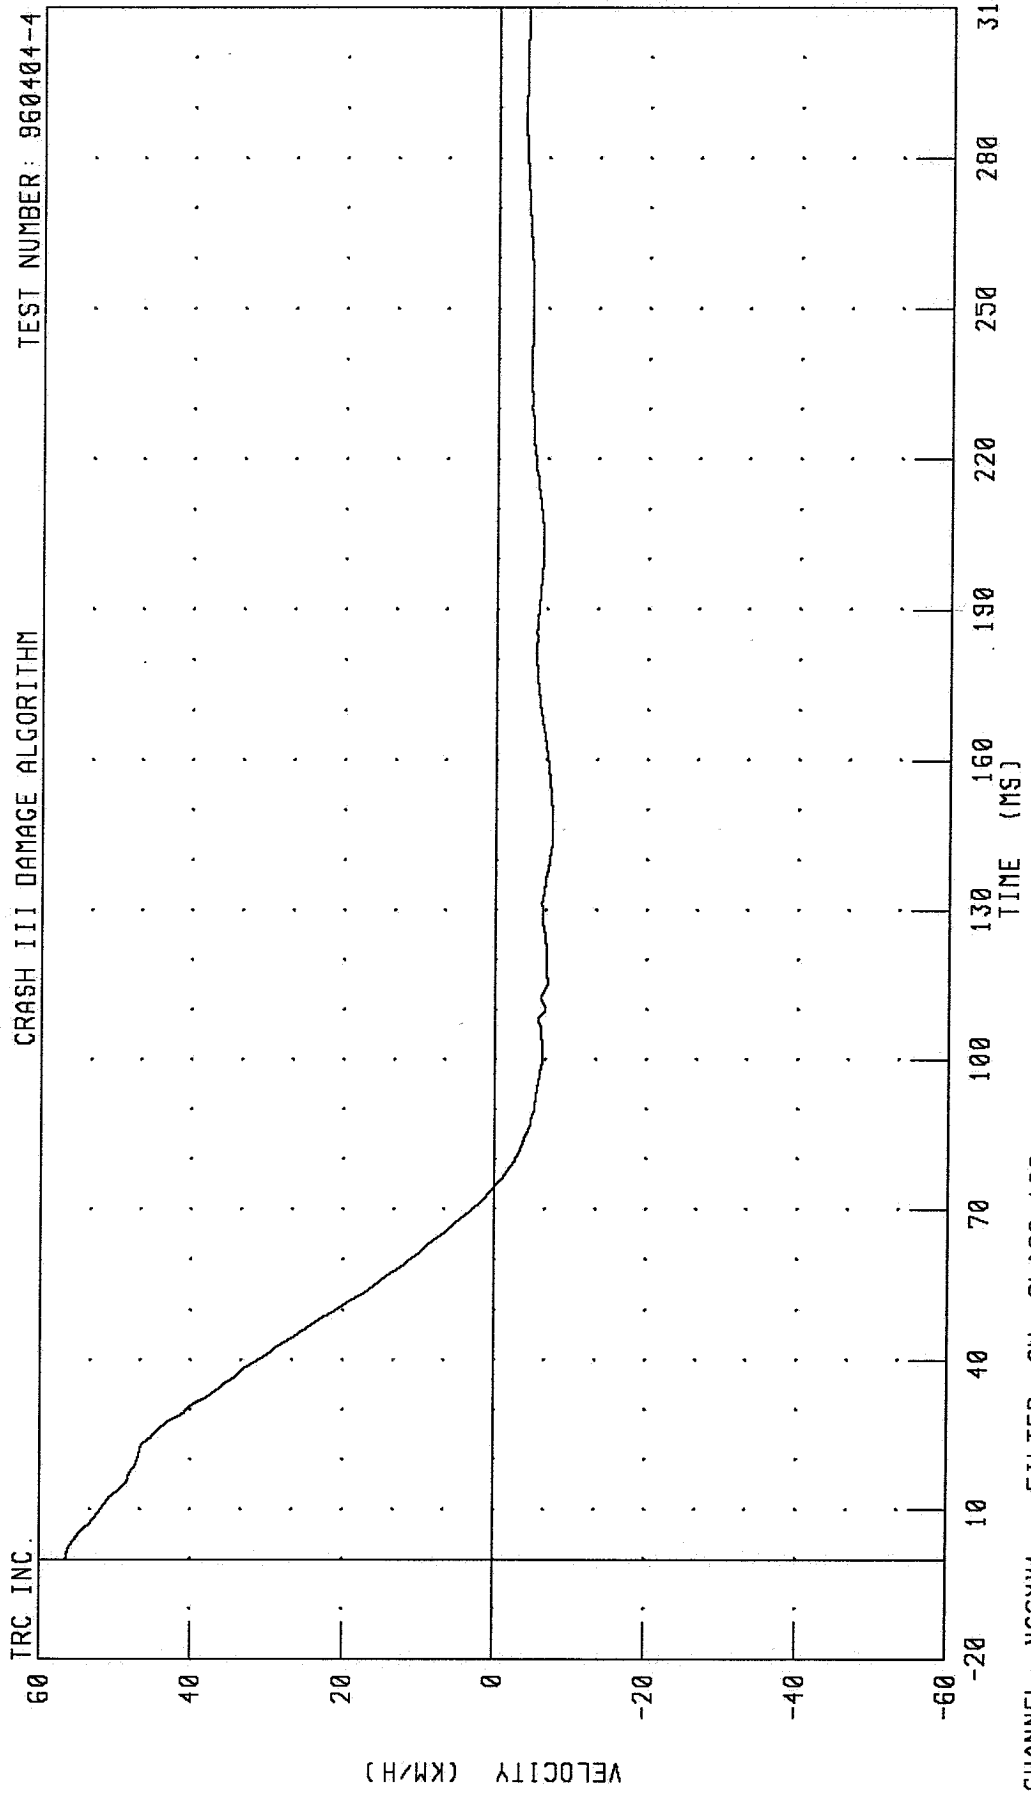
1991 DODGE CARAVAN INTO POLE BARRIER AT 35 MPH TEST NO. 4
VEHICLE CG X-AXIS VELOCITY
CRASH III DAMAGE ALGORITHM

CHANNEL: VCGXV1 FILTER: CH. CLASS 180 PEAK DATA: 56.50 KM/H @ 0.00 MS; -7.51 KM/H @ 147.36 MS
