**REPORT NUMBER KAR99060-01**

**NEW CAR ASSESSMENT PROGRAM  
SIDE IMPACT TEST**

**GENERAL MOTORS CORPORATION  
2000 CHEVROLET MALIBU  
4 DOOR SEDAN  
NHTSA NUMBER: GM0002**

**FINAL REPORT**

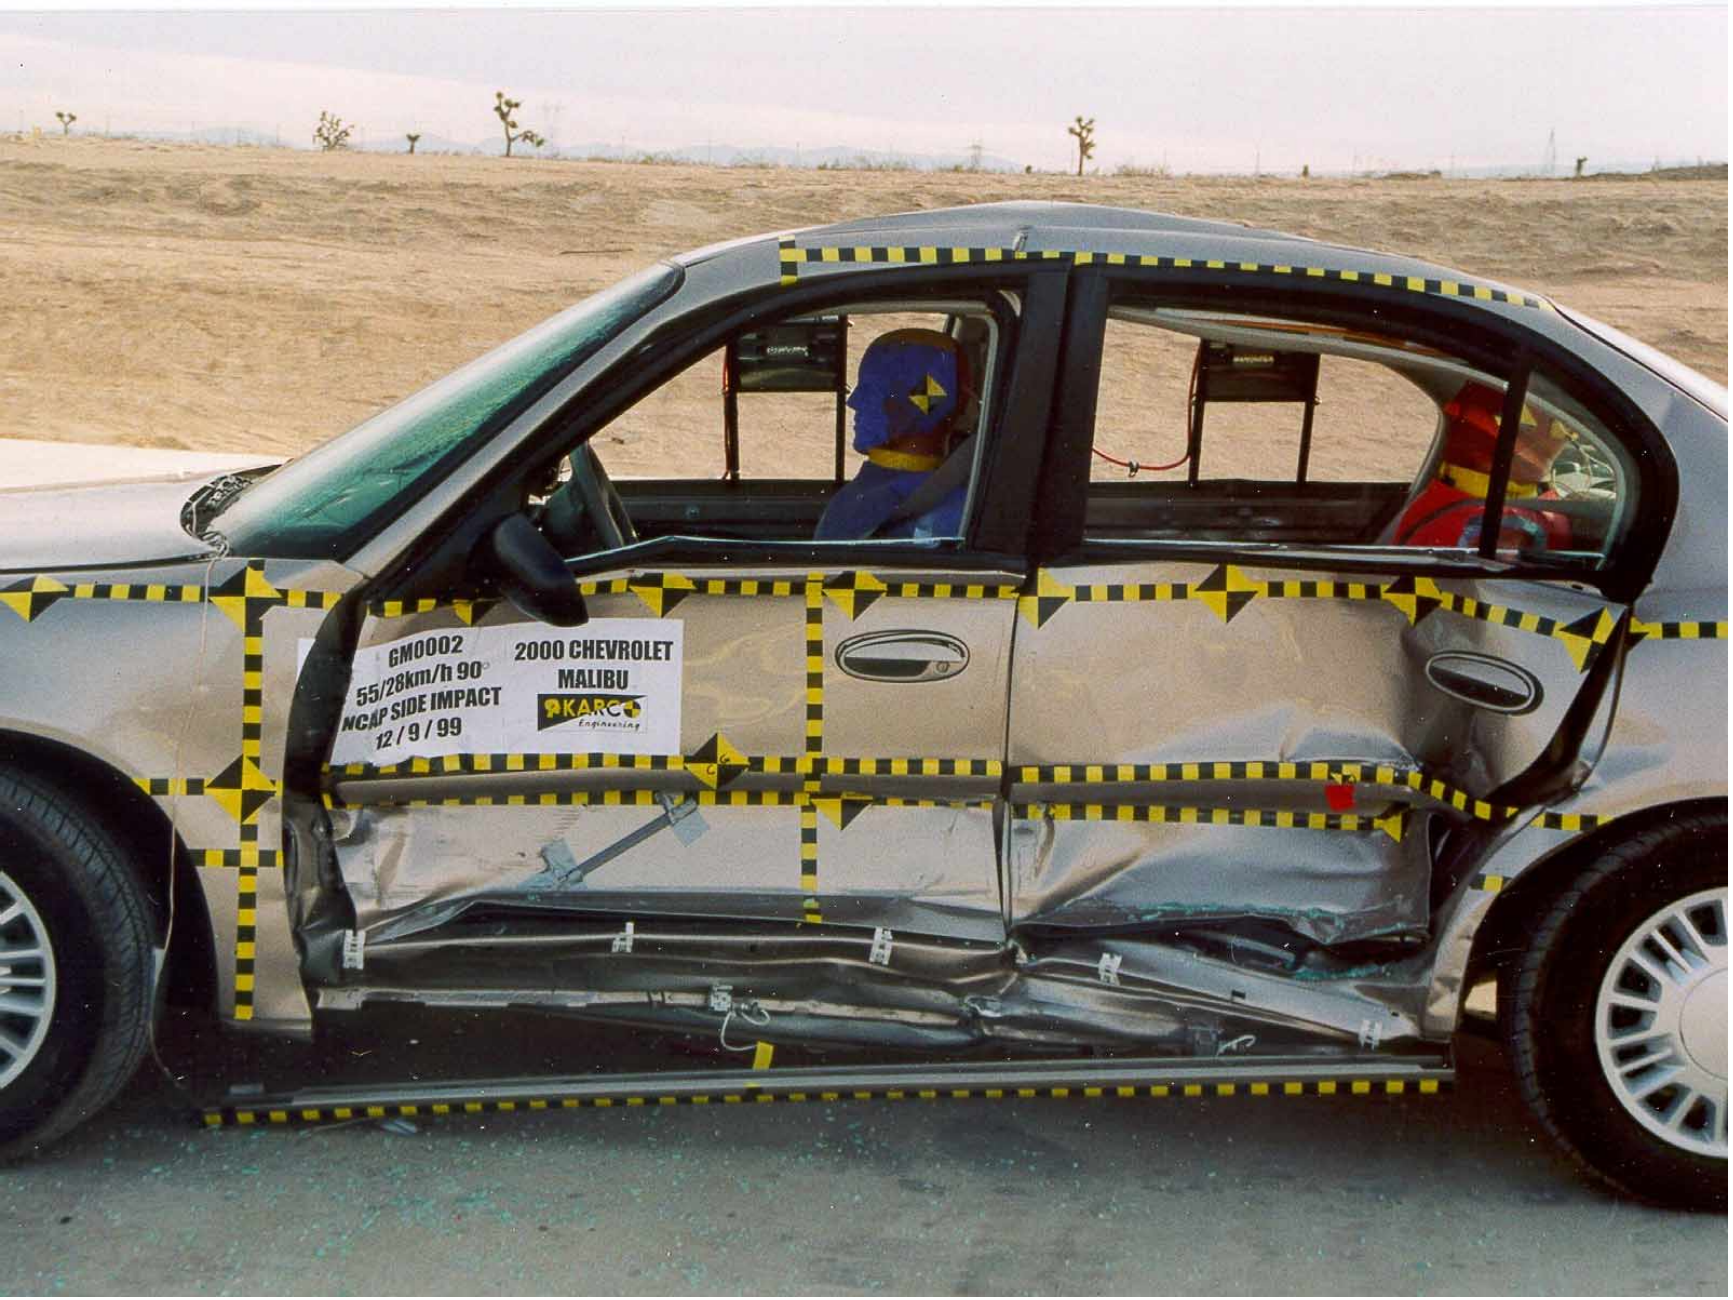
FIGURE A-10: POST-TEST LEFT SIDE (STRUCK SIDE) VIEW

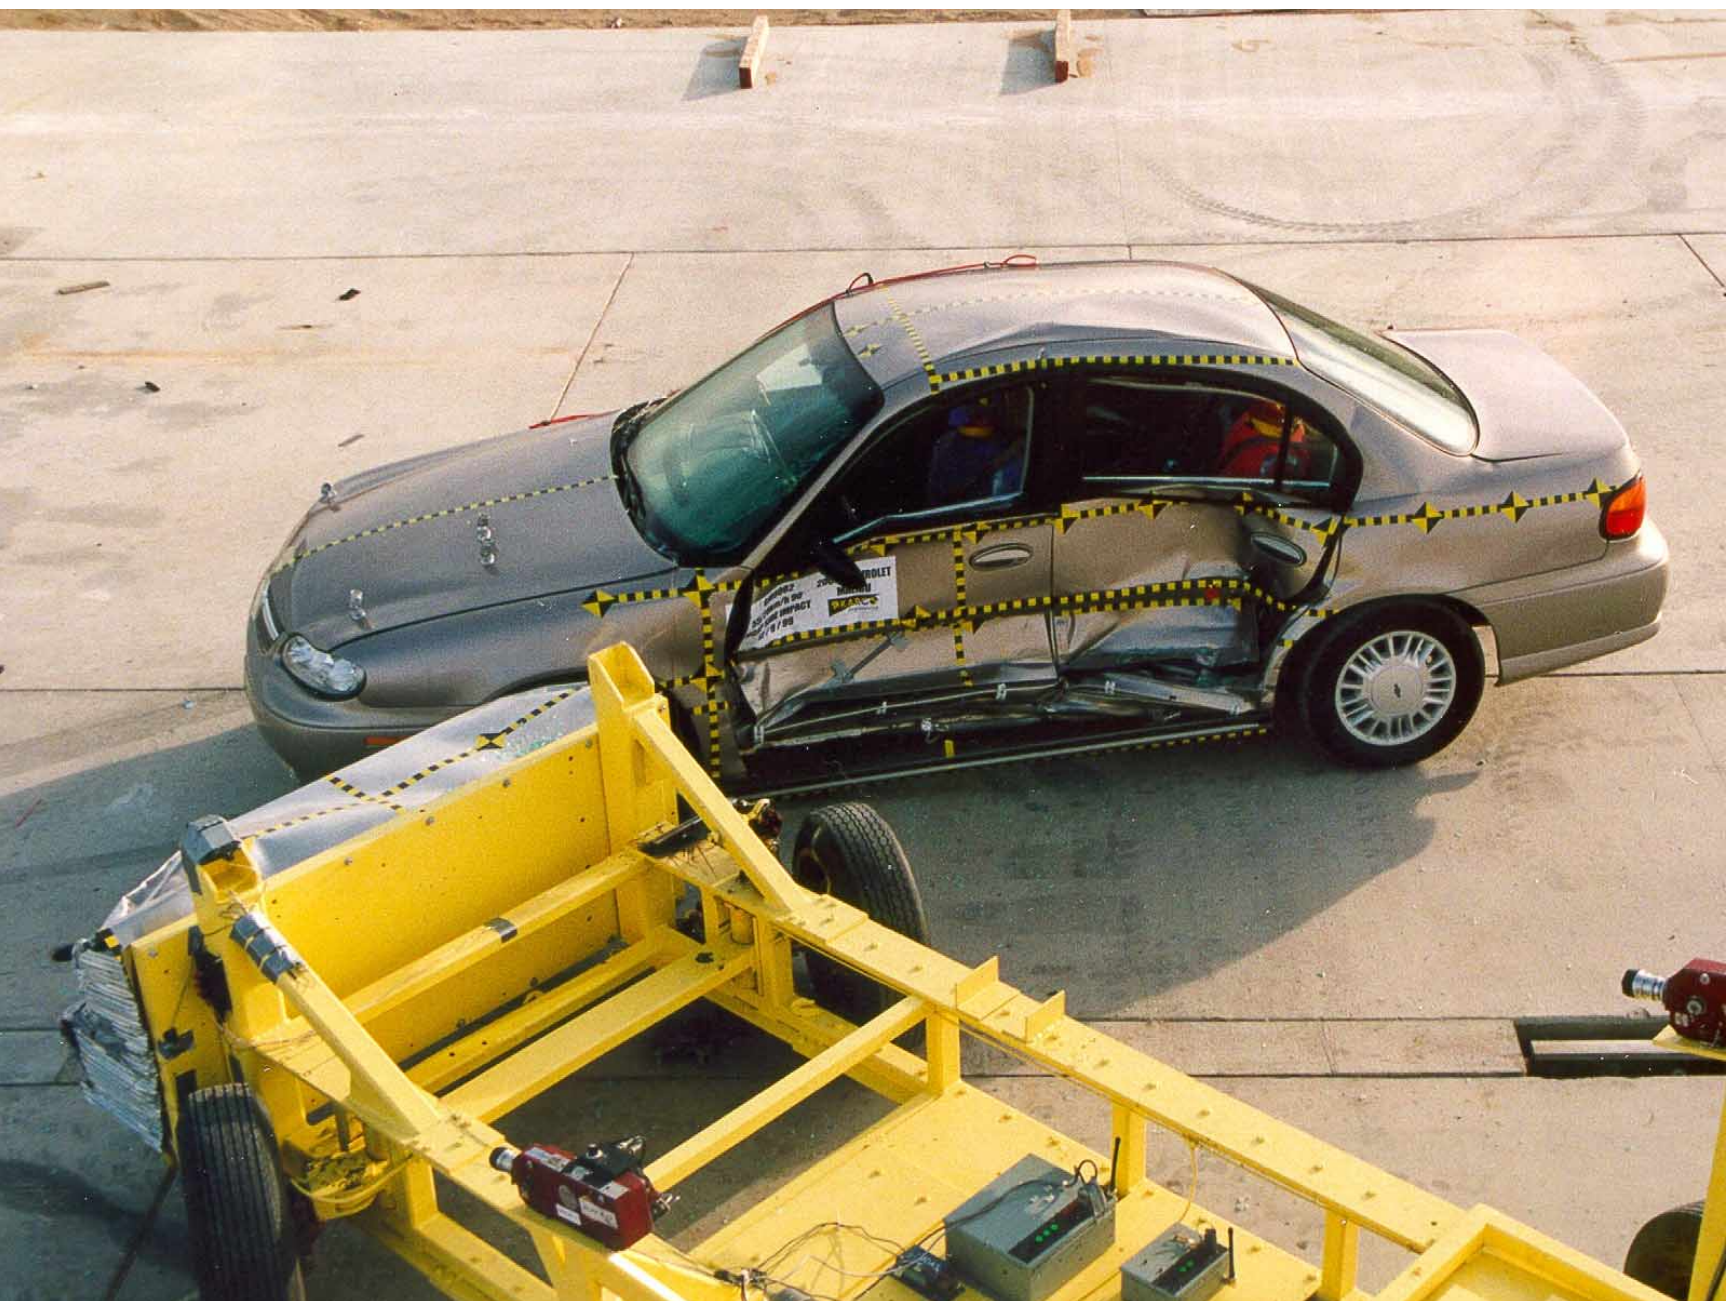
FIGURE A-12: POST-TEST OVERHEAD OVERALL

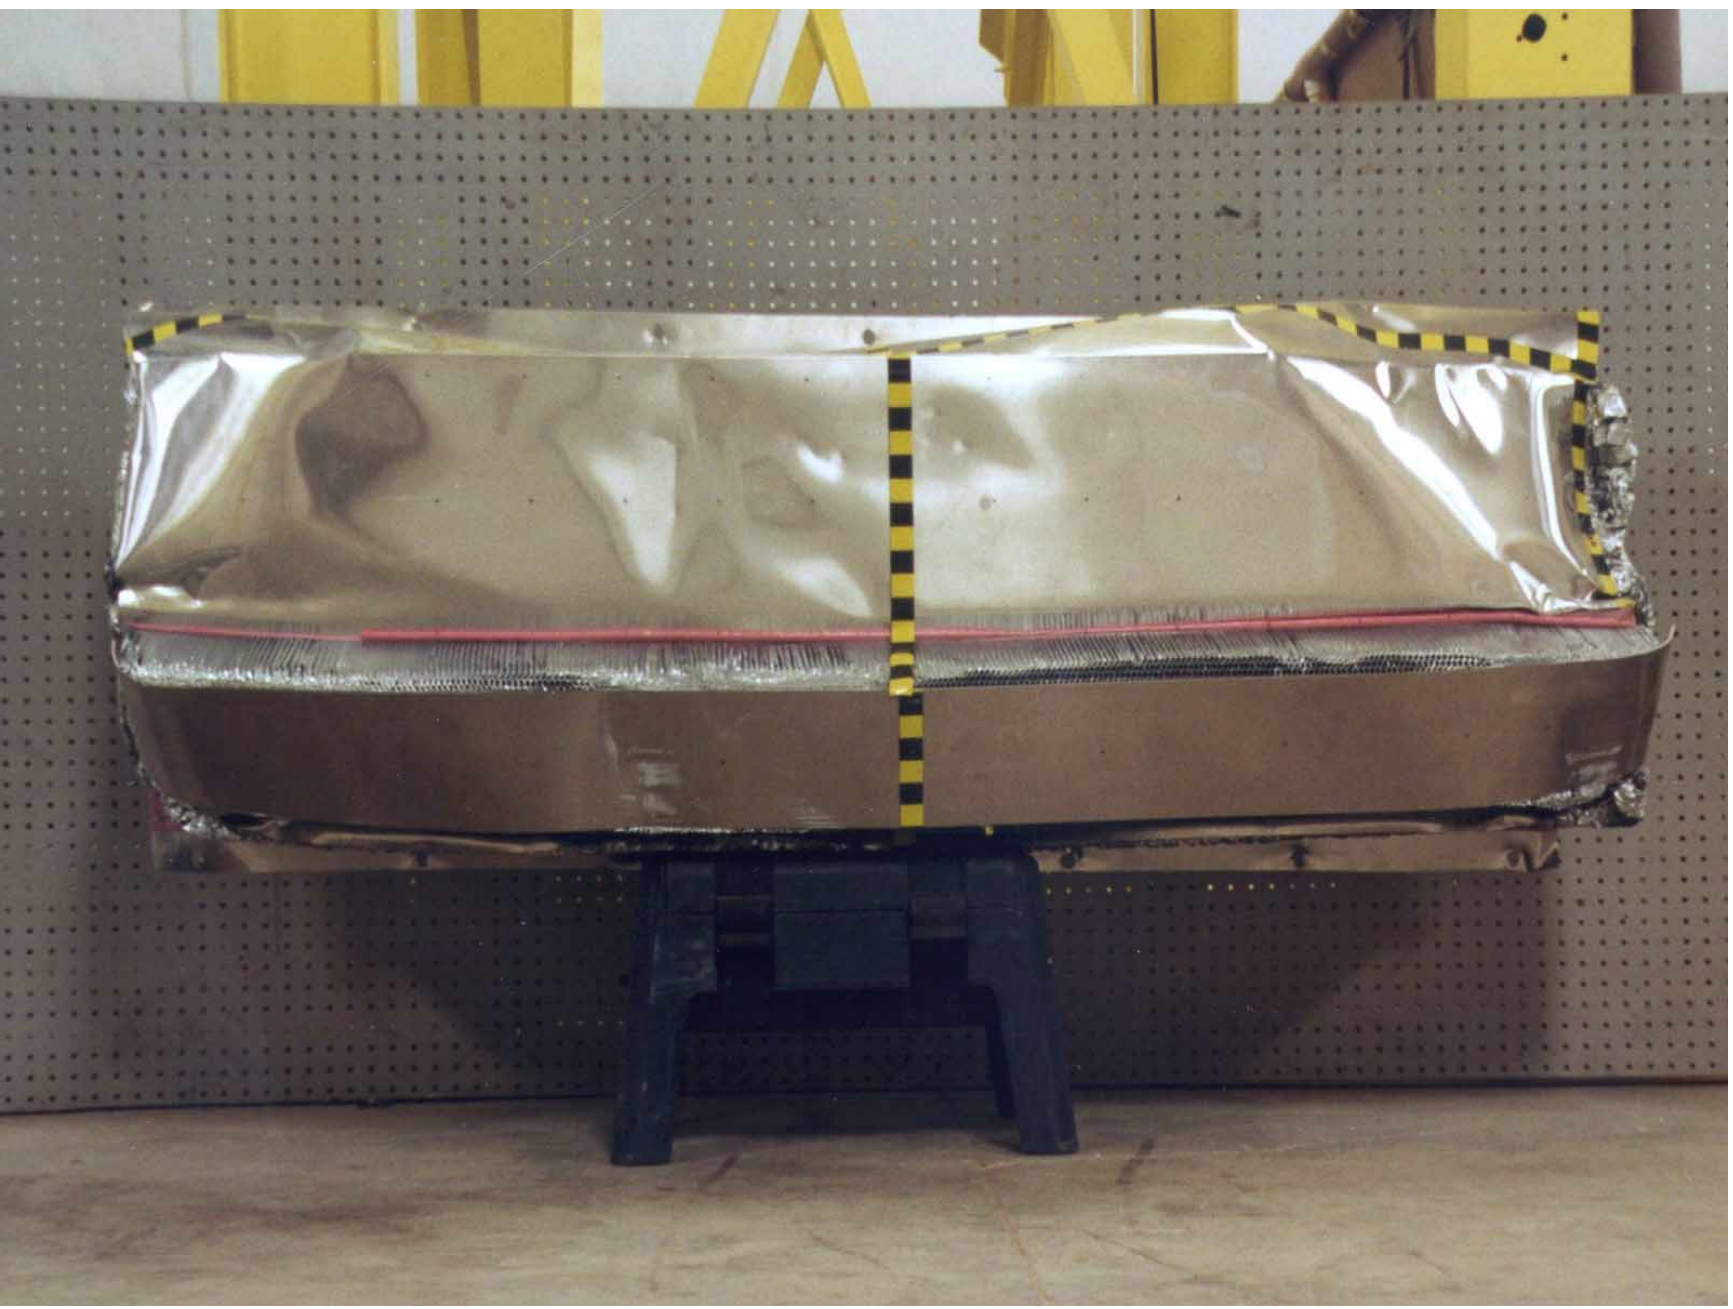
FIGURE A-34: POST-TEST FRONT VIEW OF DEFORMABLE BARRIER

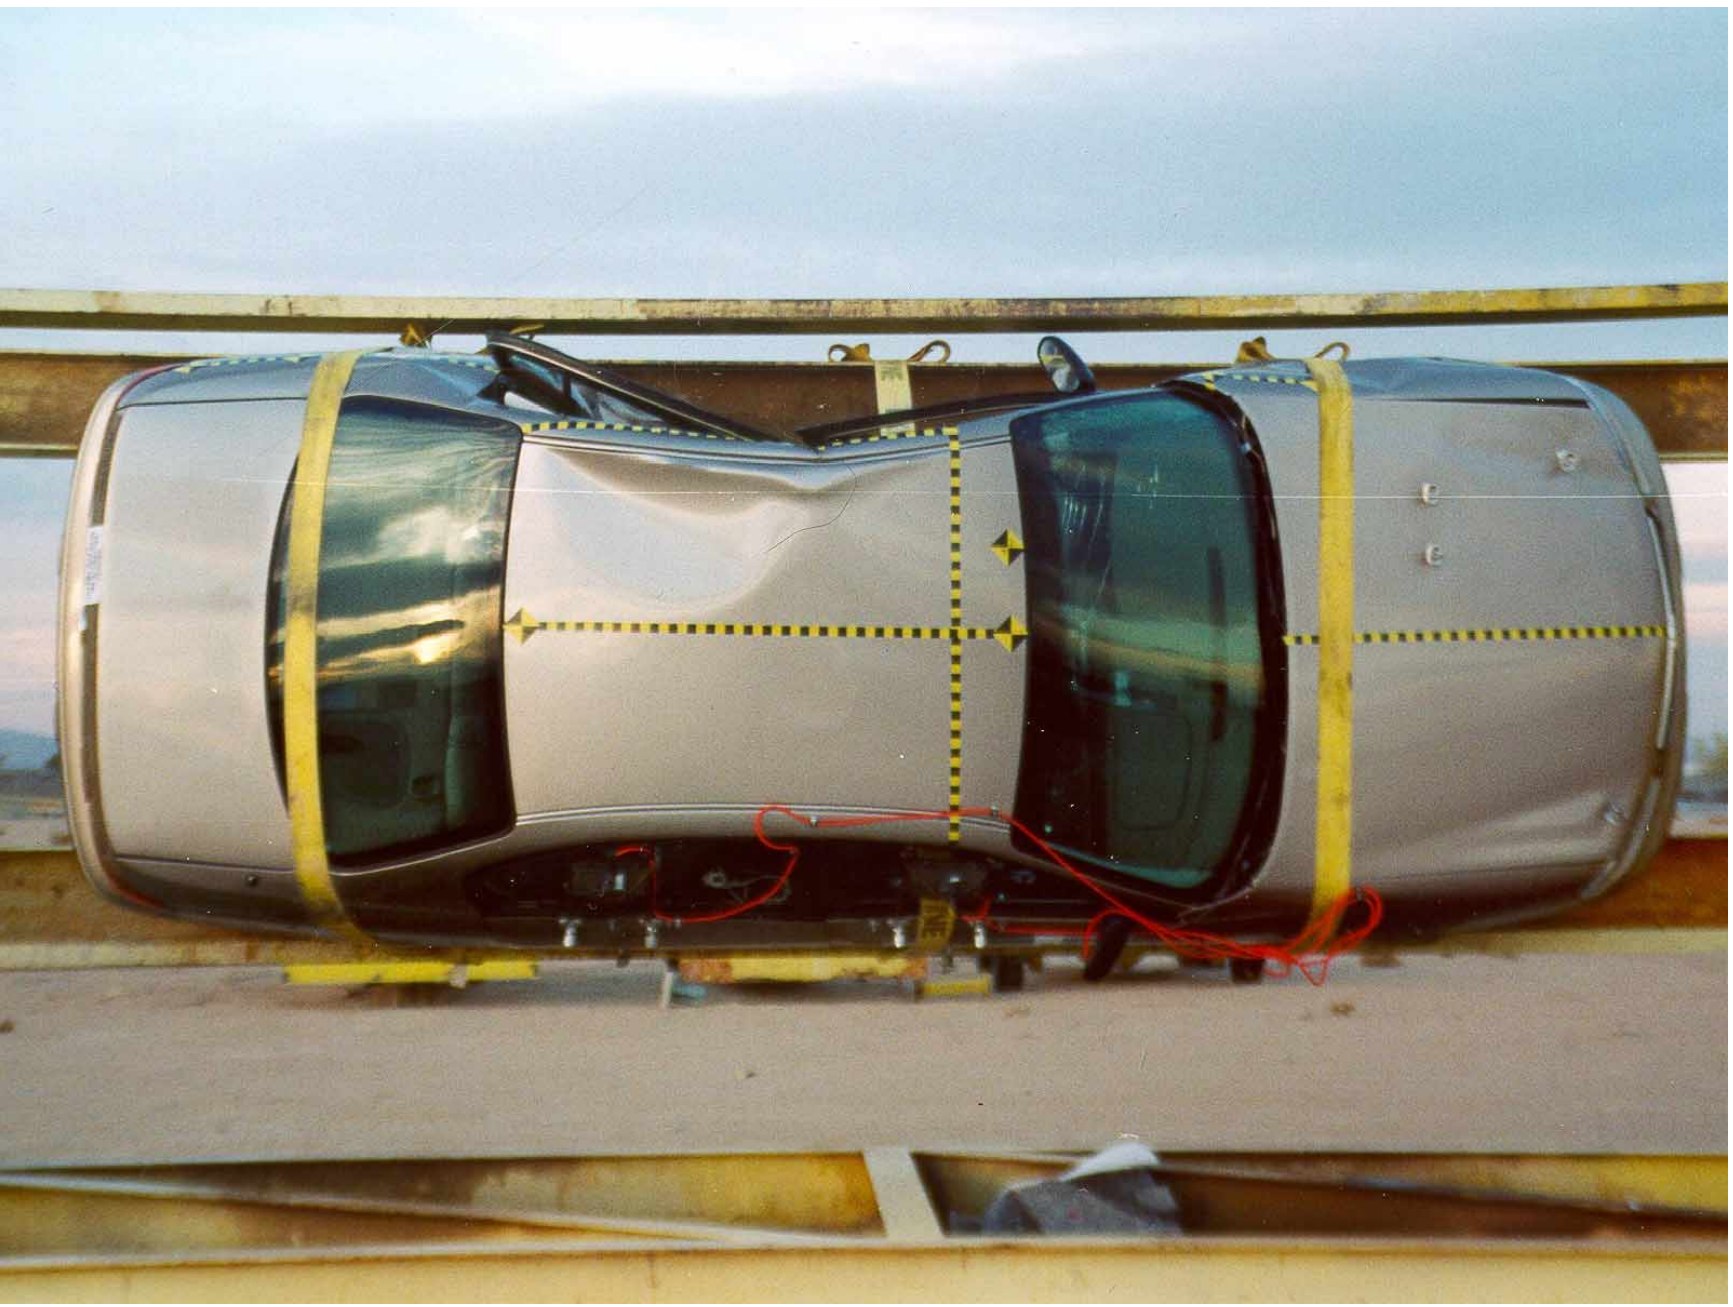
FIGURE A-41: VEHICLE ON ROLLOVER, TOP VIEW

No solvent leakage occurred during static rollover testing.
