**NEW CAR ASSESSMENT PROGRAM  
SIDE IMPACT TEST**

**GENERAL MOTORS CORPORATION  
2000 CHEVROLET  
S-10 PICKUP  
NHTSA NUMBER: MY0107**

**PREPARED BY:  
KARCO ENGINEERING  
9270 HOLLY ROAD  
ADELANTO, CALIFORNIA 92301**

FINAL REPORT

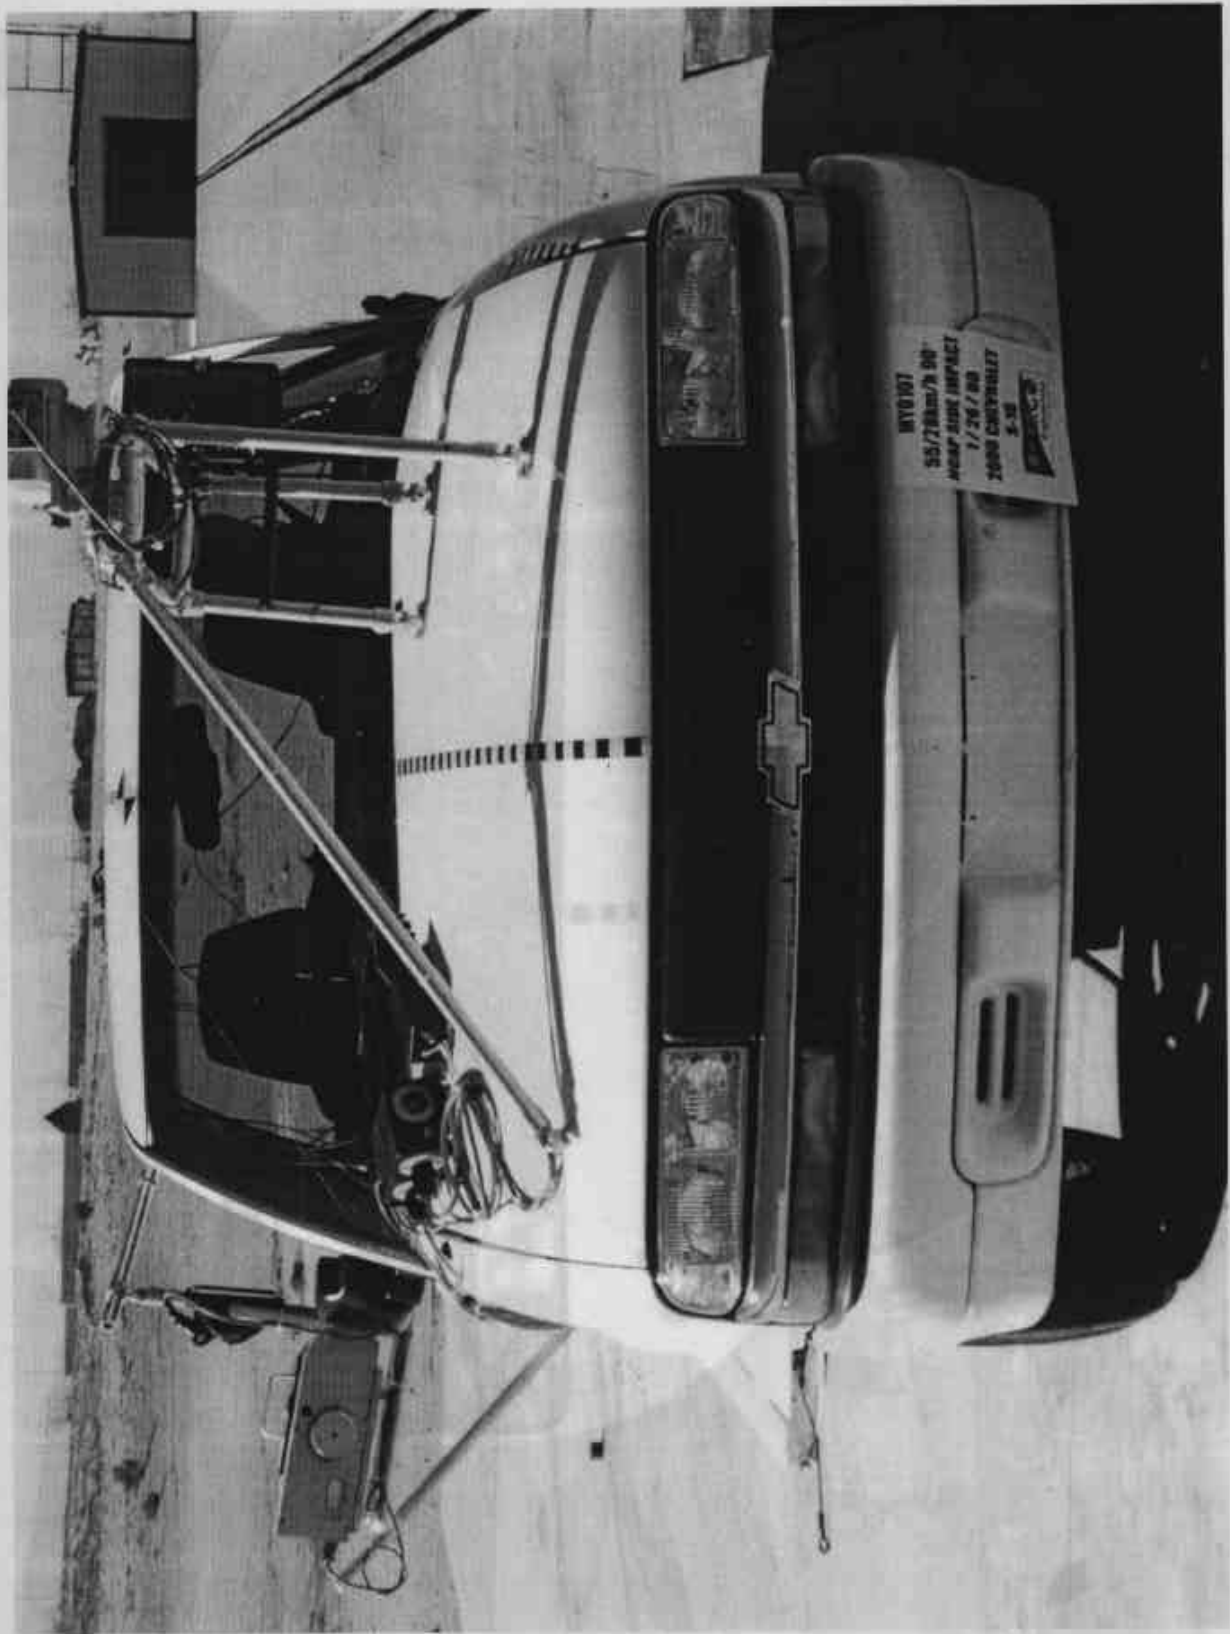
FIGURE A-6: POST-TEST FRONT VIEW

| Critical Areas of Performance | Observations and Conclusions |
|---|---|
| Windshield Damage | Glazing Cracks on Struck Side Only |

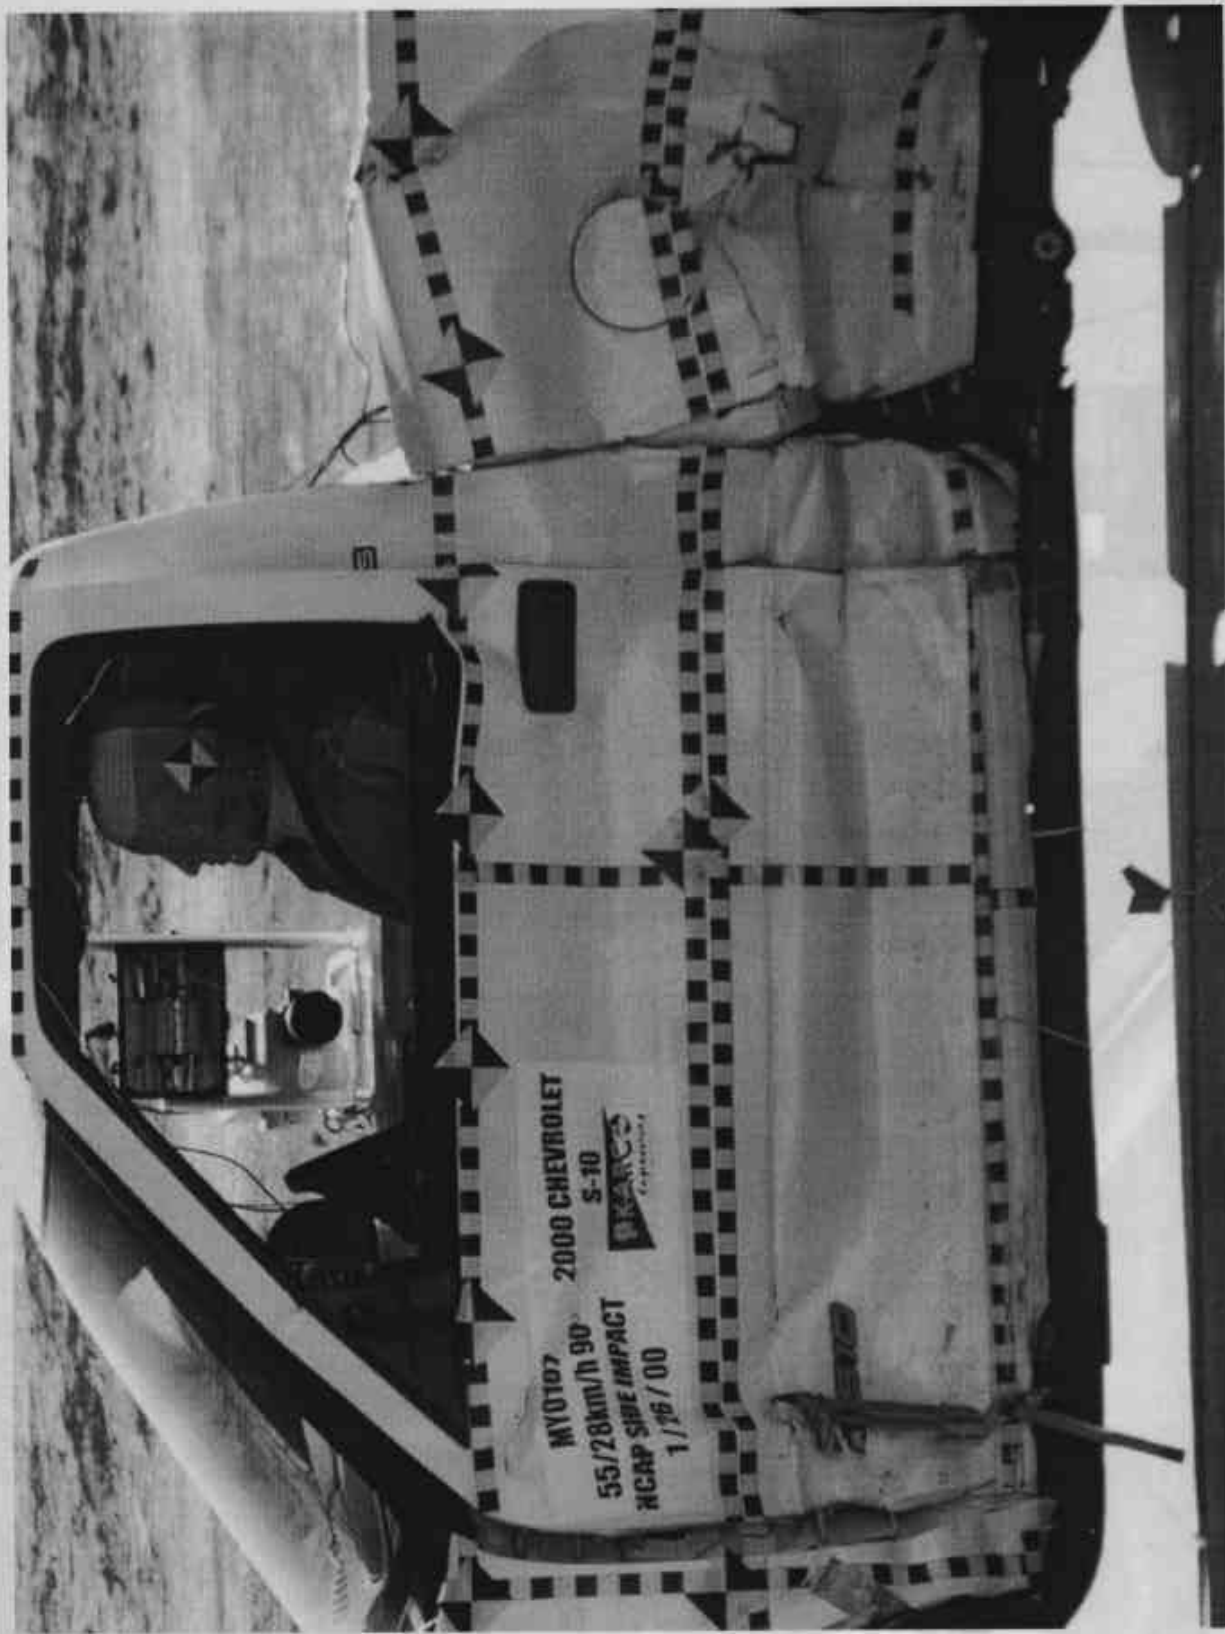
FIGURE A-10: POST-TEST LEFT SIDE (STRUCK SIDE) VIEW

The test vehicle sustained a maximum static crush of 410 mm at level 1, 1650 mm rearward of the left vertical impact point. The driver SID, Serial No. 056, was calibrated just prior to this test. The SID injury criteria is summarized as follows:

| Critical Areas of Performance | Observations and Conclusions |
|---|---|
| Pillar Performance | Pillars pushed inward with no apparent failure |
| Window Damage | Left Front Windows Shattered During Impact |

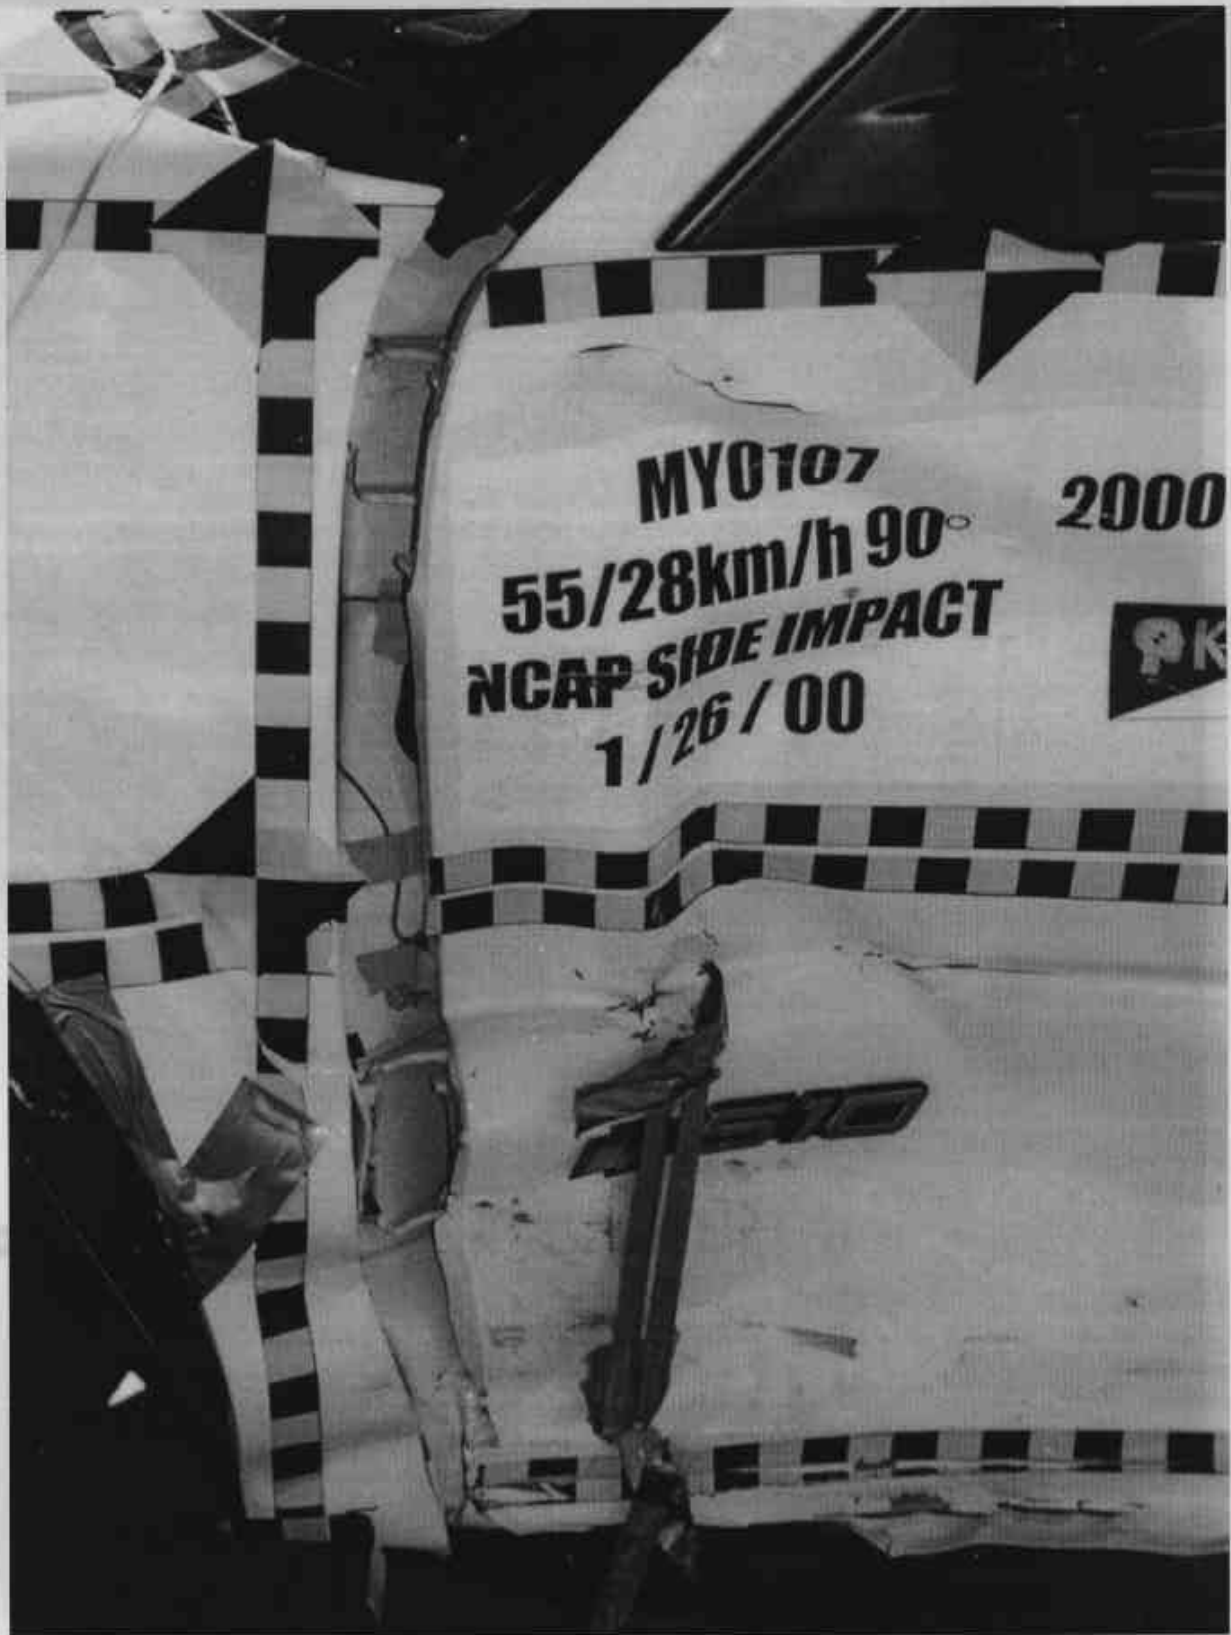
FIGURE A-17: POST-TEST IMPACT POINT TARGET CLOSE-UP

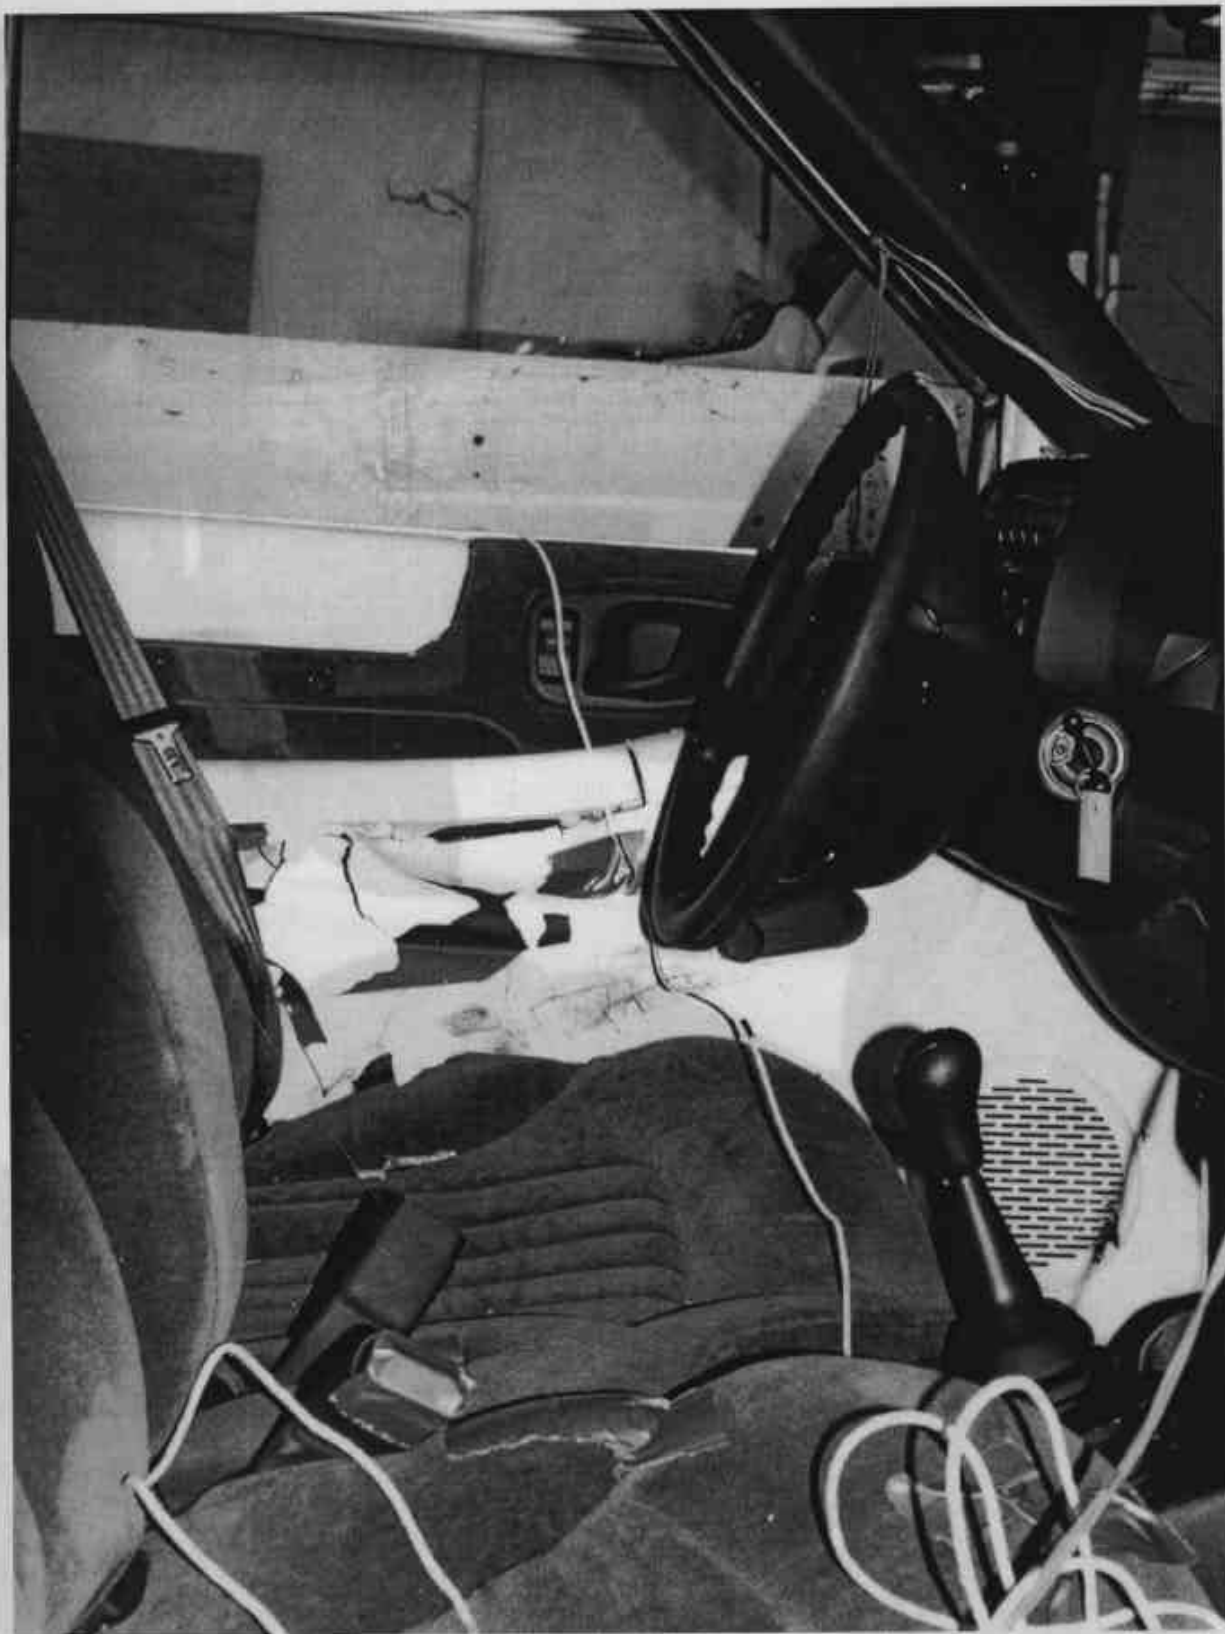
FIGURE A-26: POST-TEST DRIVER DUMMY CONTACT POINTS (INSIDE VIEW)

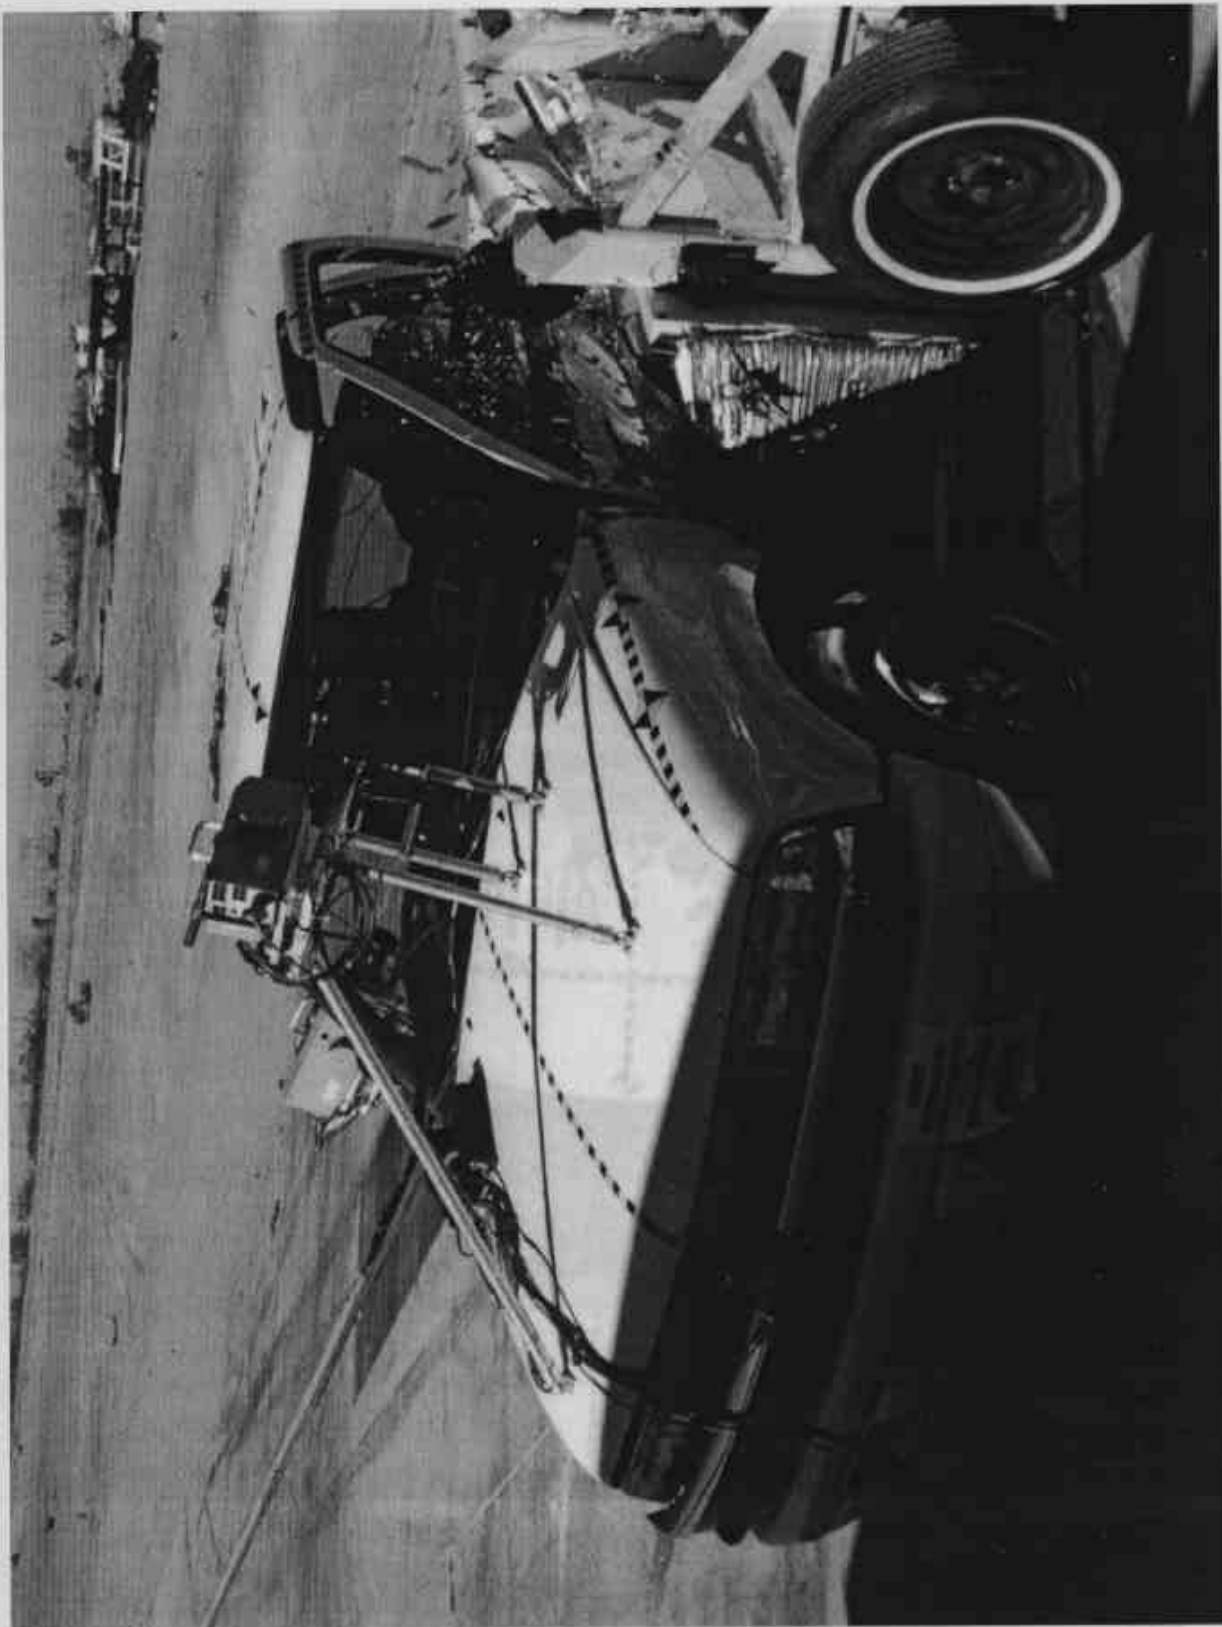
FIGURE A-36: VEHICLE DURING IMPACT
