# Insurance Institute for Highway Safety Crashworthiness Evaluation

## Crash Test Report 2000 Subaru Legacy (CF00005)

**Vehicle identification number:** 4S3BE6357Y7205144  
**Body style:** Midsize four-door sedan  
**Engine/transmission:** Longitudinal 2.5-liter 4-cylinder, 4-speed automatic, 4-wheel drive

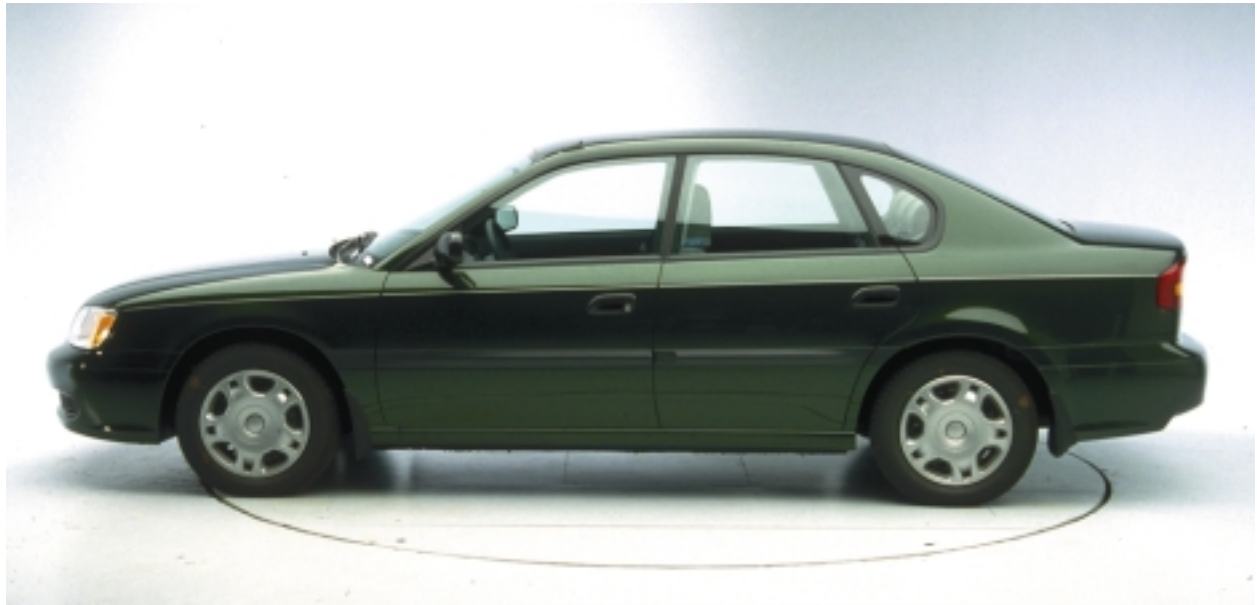
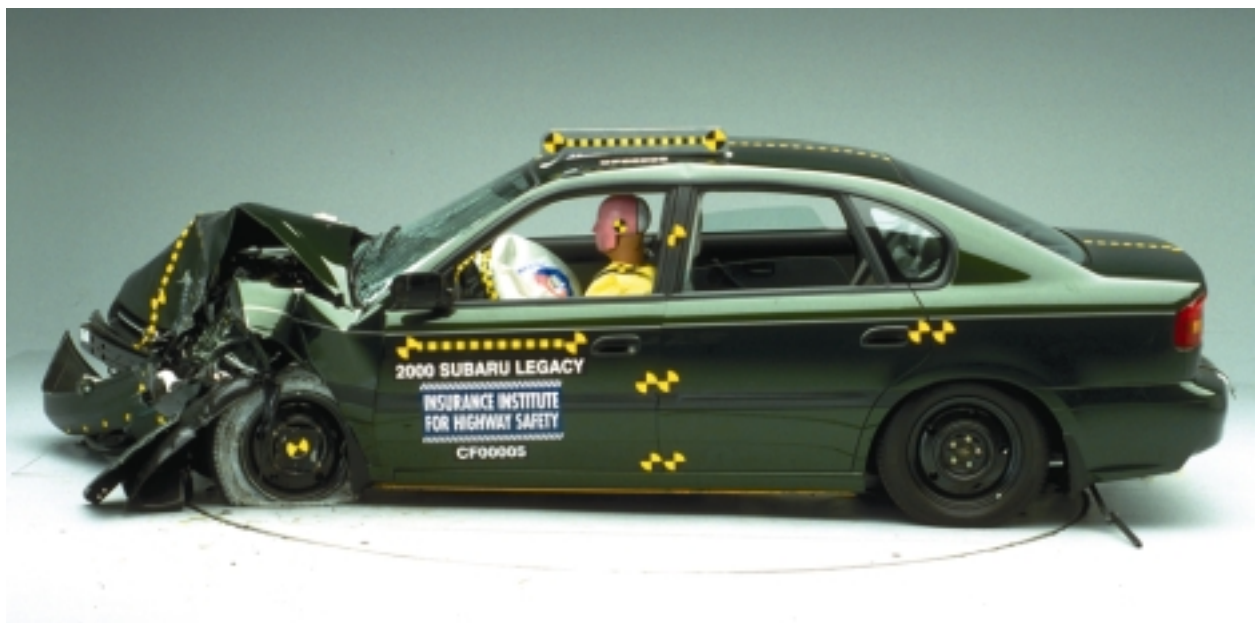
**Figure 1**  
**Precrash and Postcrash Side Views — 2000 Subaru Legacy**

A 2000 Subaru Legacy was crash tested on February 15, 2000 into a fixed deformable barrier at 39.8 mi/h (64.0 km/h) and a 40 percent overlap on the driver side. A Hybrid III 50th percentile male dummy was positioned in the driver seat with the lap/shoulder belt fastened.

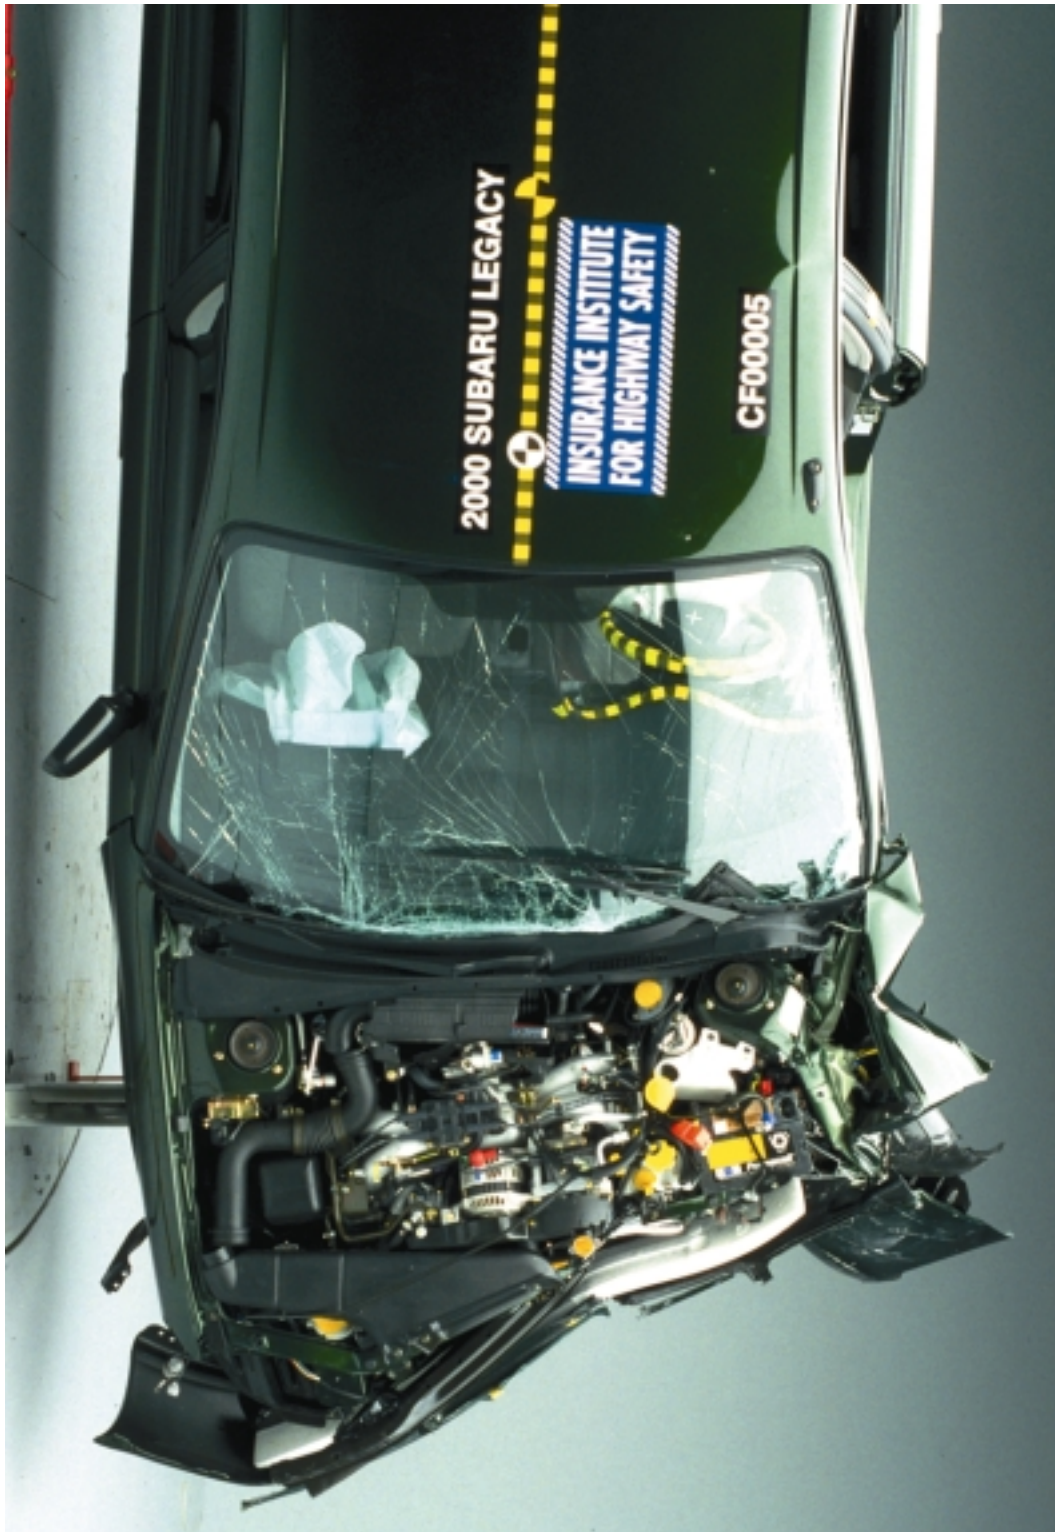
Figure 2  
Overhead View of Crash Deformation — 2000 Subaru Legacy

Figure 2 shows the overhead view of the crash deformation. Figure 3 illustrates the precrash and postcrash contour measures of the front bumper cover profile and the resulting permanent crush. Figure 4 shows the precrash and postcrash views from below. Figure 5 illustrates the deformation of the side rails, floor stiffeners, and radiator and engine supports, which are visible in Figure 4.

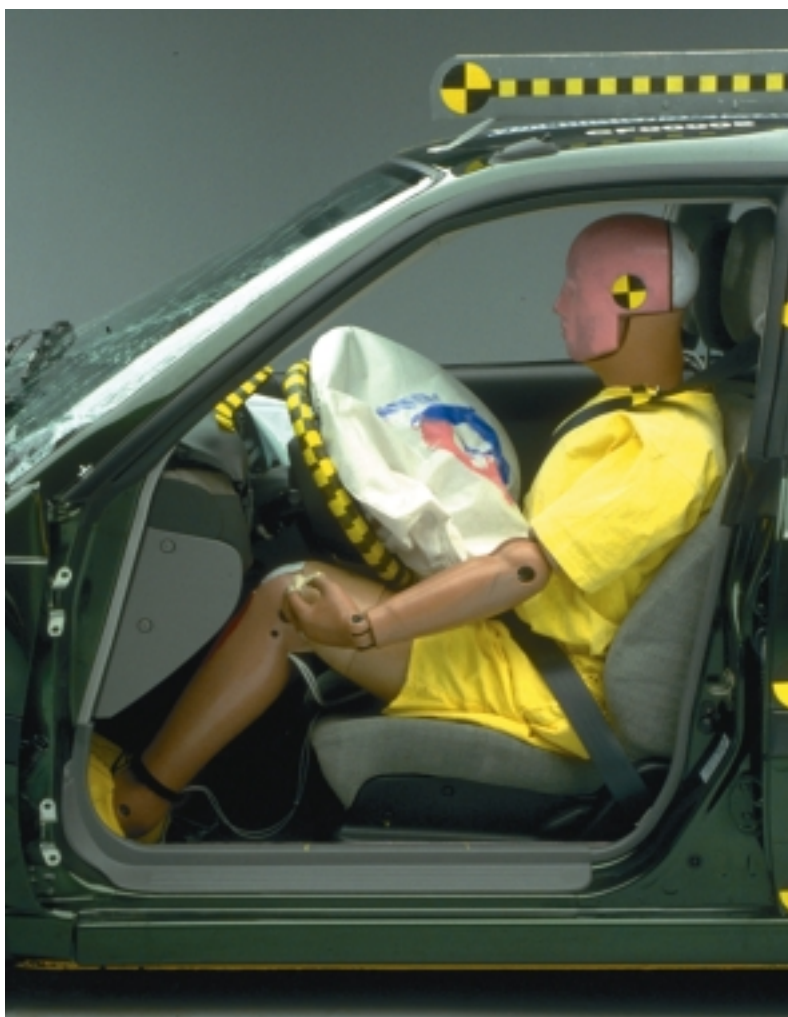
**Figure 6**  
**Dummy and Vehicle Interior, Postcrash — 2000 Subaru Legacy**

**Left leg and foot:** Paint transferred from the dummy's left knee indicated the knee contacted the instrument panel just above the knee bolster and near the left side of the steering column. Paint transferred from the dummy's left shin indicated the shin contacted the undamaged bolster directly below the knee impact location. The left foot was found slightly dorsiflexed and considerably everted, with the sole of the forefoot resting on the toepan just inboard of the footrest and the back of the heel on the floormat/carpeting.

**Right leg and foot:** Paint transferred from the dummy's right knee indicated the knee contacted the column-mounted ignition switch and the adjacent hard plastic portion of the lower edge of the instrument panel. Paint transferred from the dummy's right shin indicated the shin contacted the undamaged knee bolster directly below the knee impact location on the instrument panel. The right foot was found considerably inverted but in neutral dorsiflexion, with the heel resting on the floor and the lateral edge of the forefoot against the accelerator pedal, which in turn was not fully depressed against the toepan.
