Insurance Institute for Highway Safety Crashworthiness Evaluation

Crash Test Report 2000 Nissan Altima (CF00004)

Vehicle identification number: 1N4DL01D7YC113115
Body style: Midsize four-door sedan
Engine/transmission: Transverse 2.4-liter 4-cylinder, 4-speed automatic, front-wheel drive

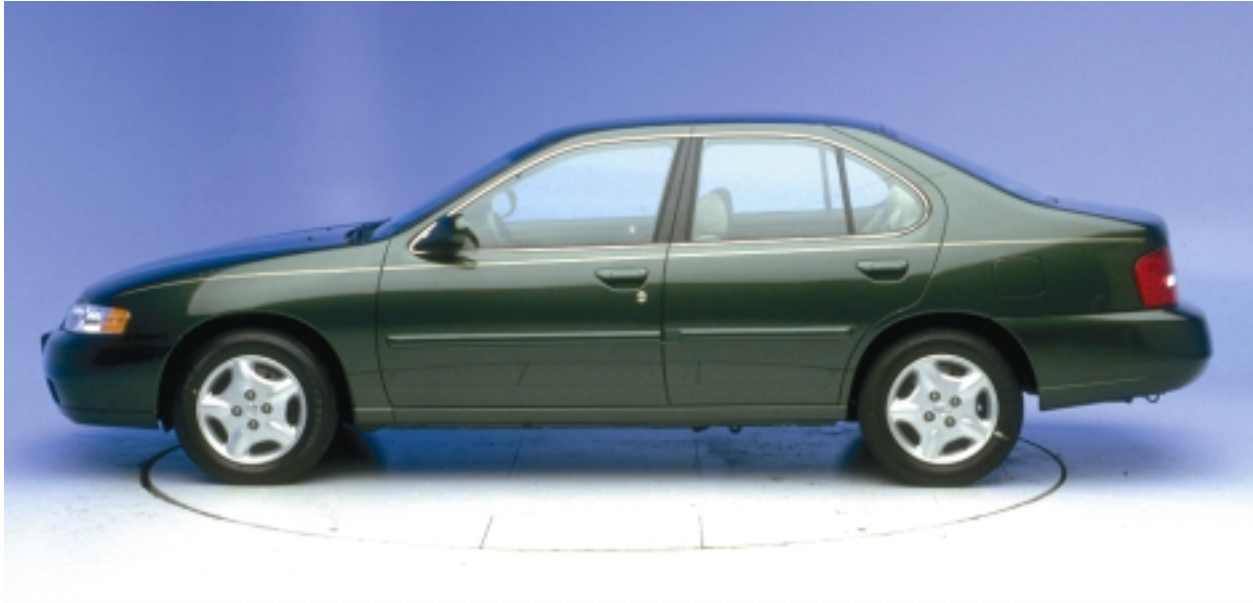
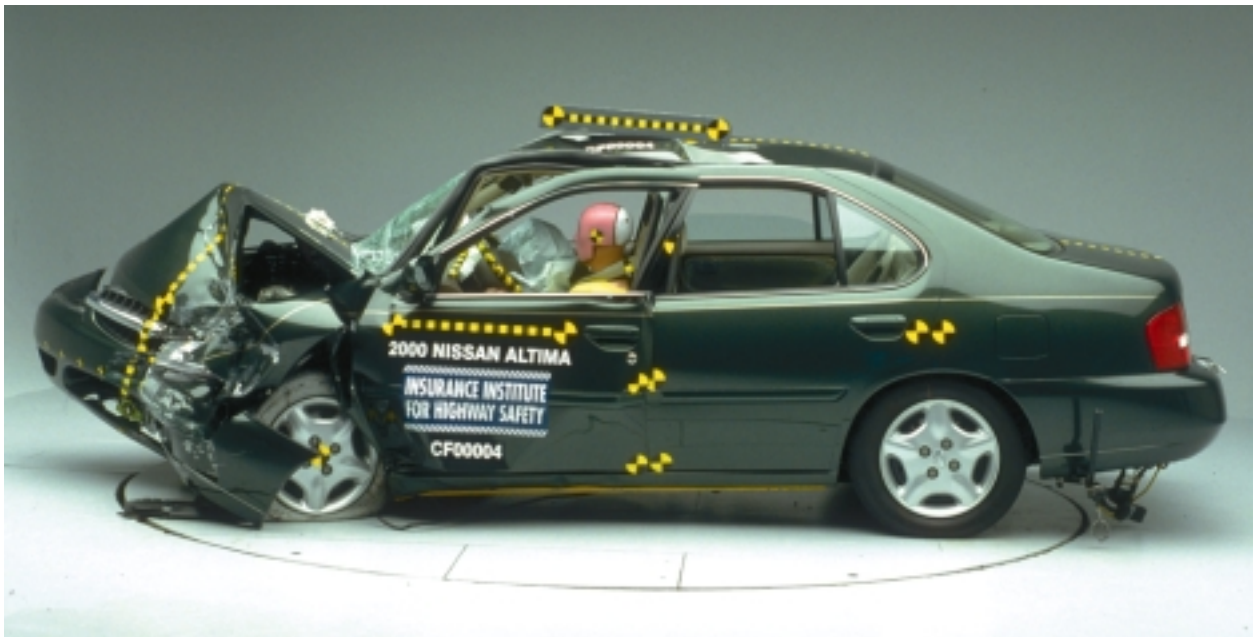
Figure 1
Pre-crash and Post-crash Side Views — 2000 Nissan Altima

A 2000 Nissan Altima was crash tested on February 9, 2000 into a fixed deformable barrier at 39.7 mi/h (63.9 km/h) and a 41 percent overlap on the driver side. A Hybrid III 50th percentile male dummy was positioned in the driver seat with the lap/shoulder belt fastened.

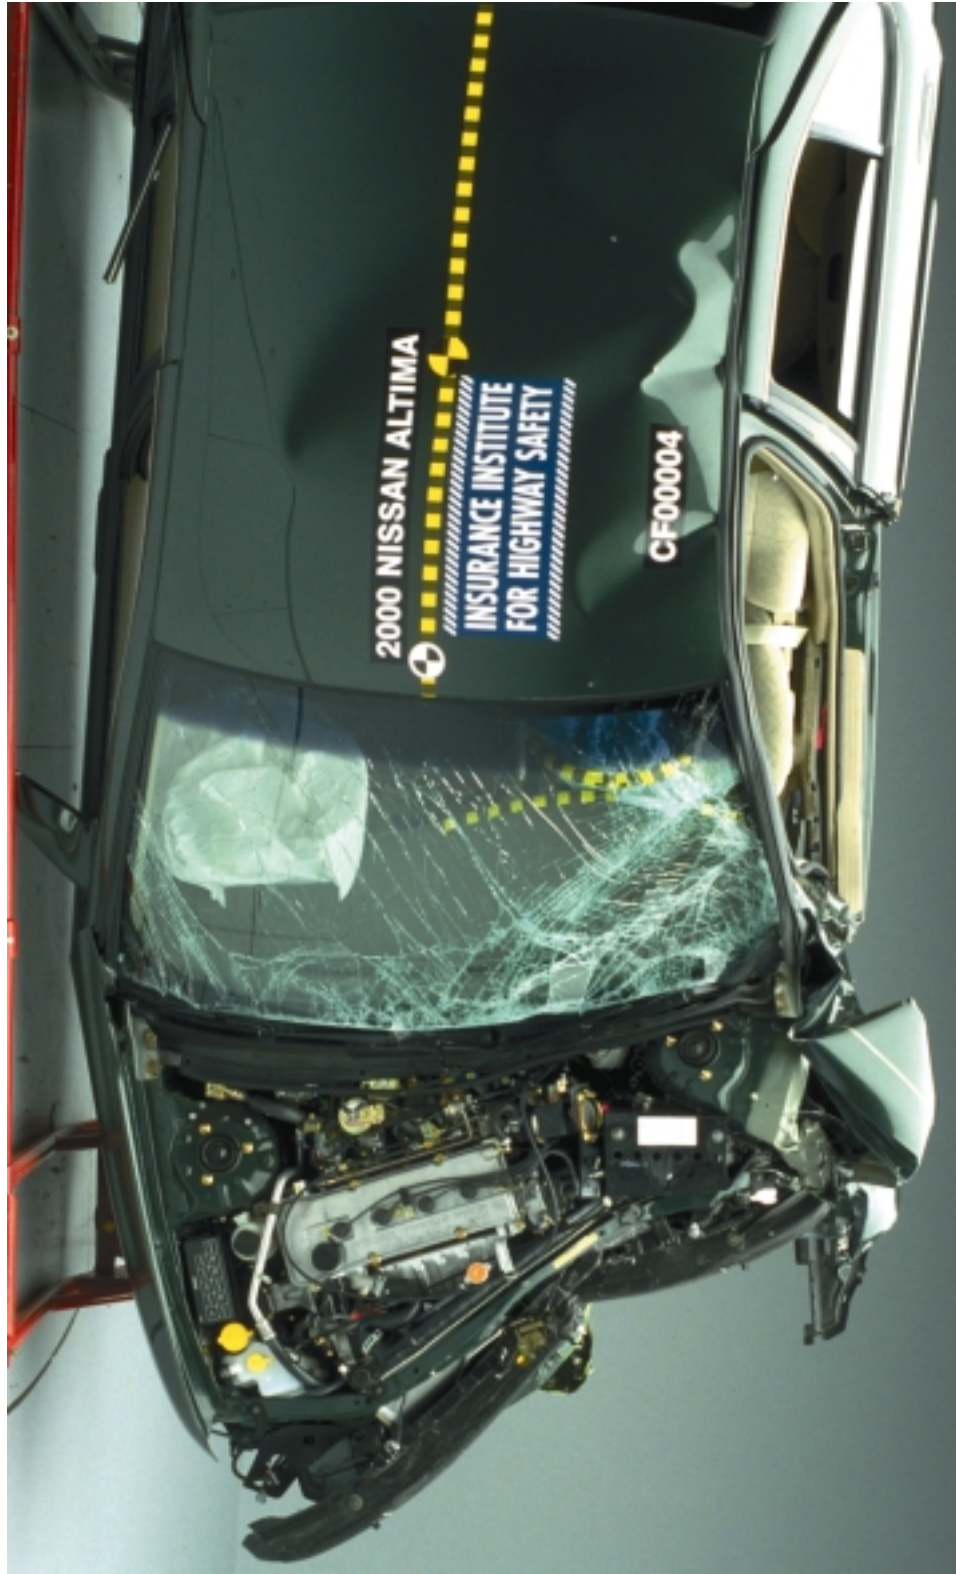
Figure 2
Overhead View of Crash Deformation — 2000 Nissan Altima

Figure 2 shows the overhead view of the crash deformation. Figure 3 illustrates the precrash and postcrash contour measures of the front bumper cover profile and the resulting permanent crush. Figure 4 shows the precrash and postcrash views from below. Figure 5 illustrates the deformation of the side rails, floor stiffeners, and radiator and engine supports, which are visible in Figure 4.

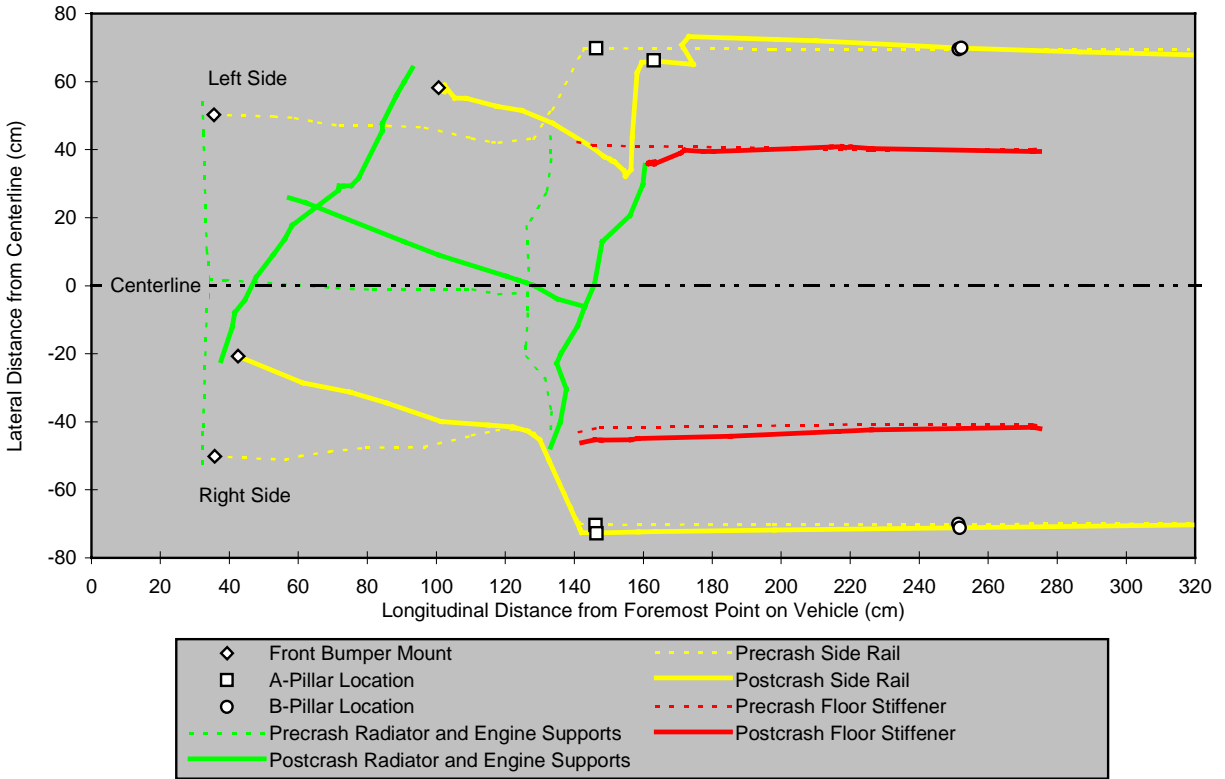
Figure 5
Structural Deformation, Views from Below and Side — 2000 Nissan Altima

The floor in front of the driver's seat was severely buckled at the intersection of the floorpan and toe-pan. A 50-cm length of the spot-welded seam between the left side of the driver floorpan and driver door sill was split apart.

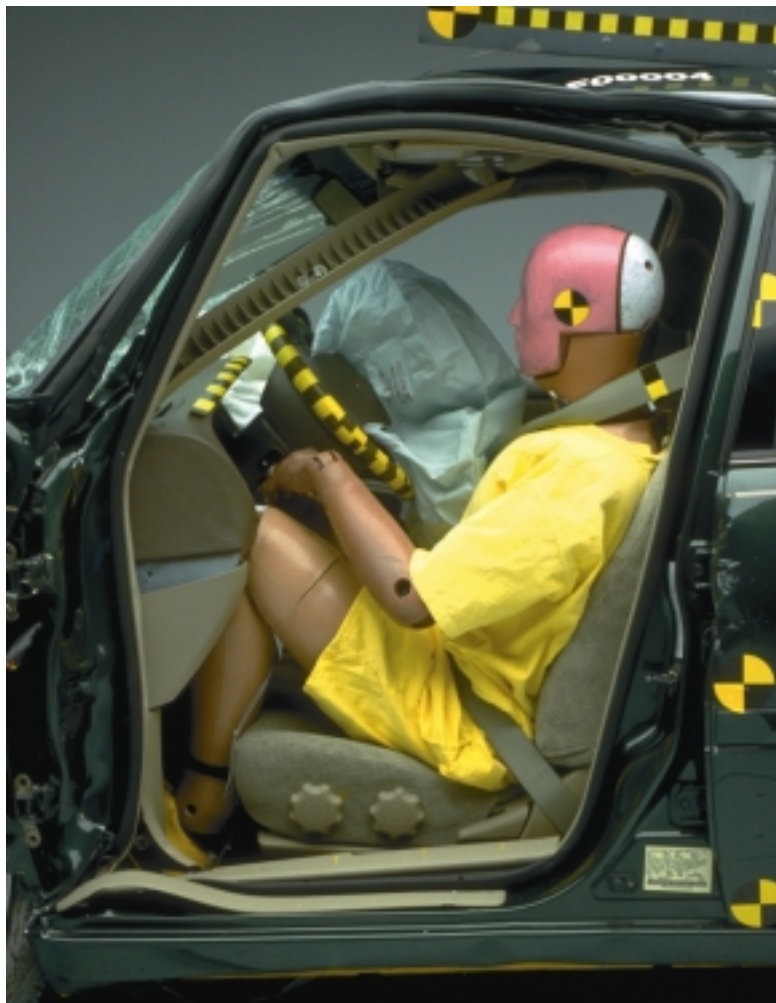
Figure 6
Dummy and Vehicle Interior, Postcrash — 2000 Nissan Altima

Postcrash examination of the driver seat rails indicated no discernible movement of the seat in its tracks during the crash. Deformation of the floor under the driver seat caused the seat to tip outboard slightly, with the left edge of the seat back almost touching the B-pillar.

The upper end of the steering column moved upward 11 cm and rearward 9 cm relative to the driver seat.
