Insurance Institute for Highway Safety Crashworthiness Evaluation

Crash Test Report 1999 Pontiac Grand Am (CF99026)

Vehicle identification number: 1G2NE52T7XC579674
Body style: Midsize four-door sedan
Engine/transmission: Transverse 2.4-liter 4-cylinder, 4-speed automatic, front-wheel drive

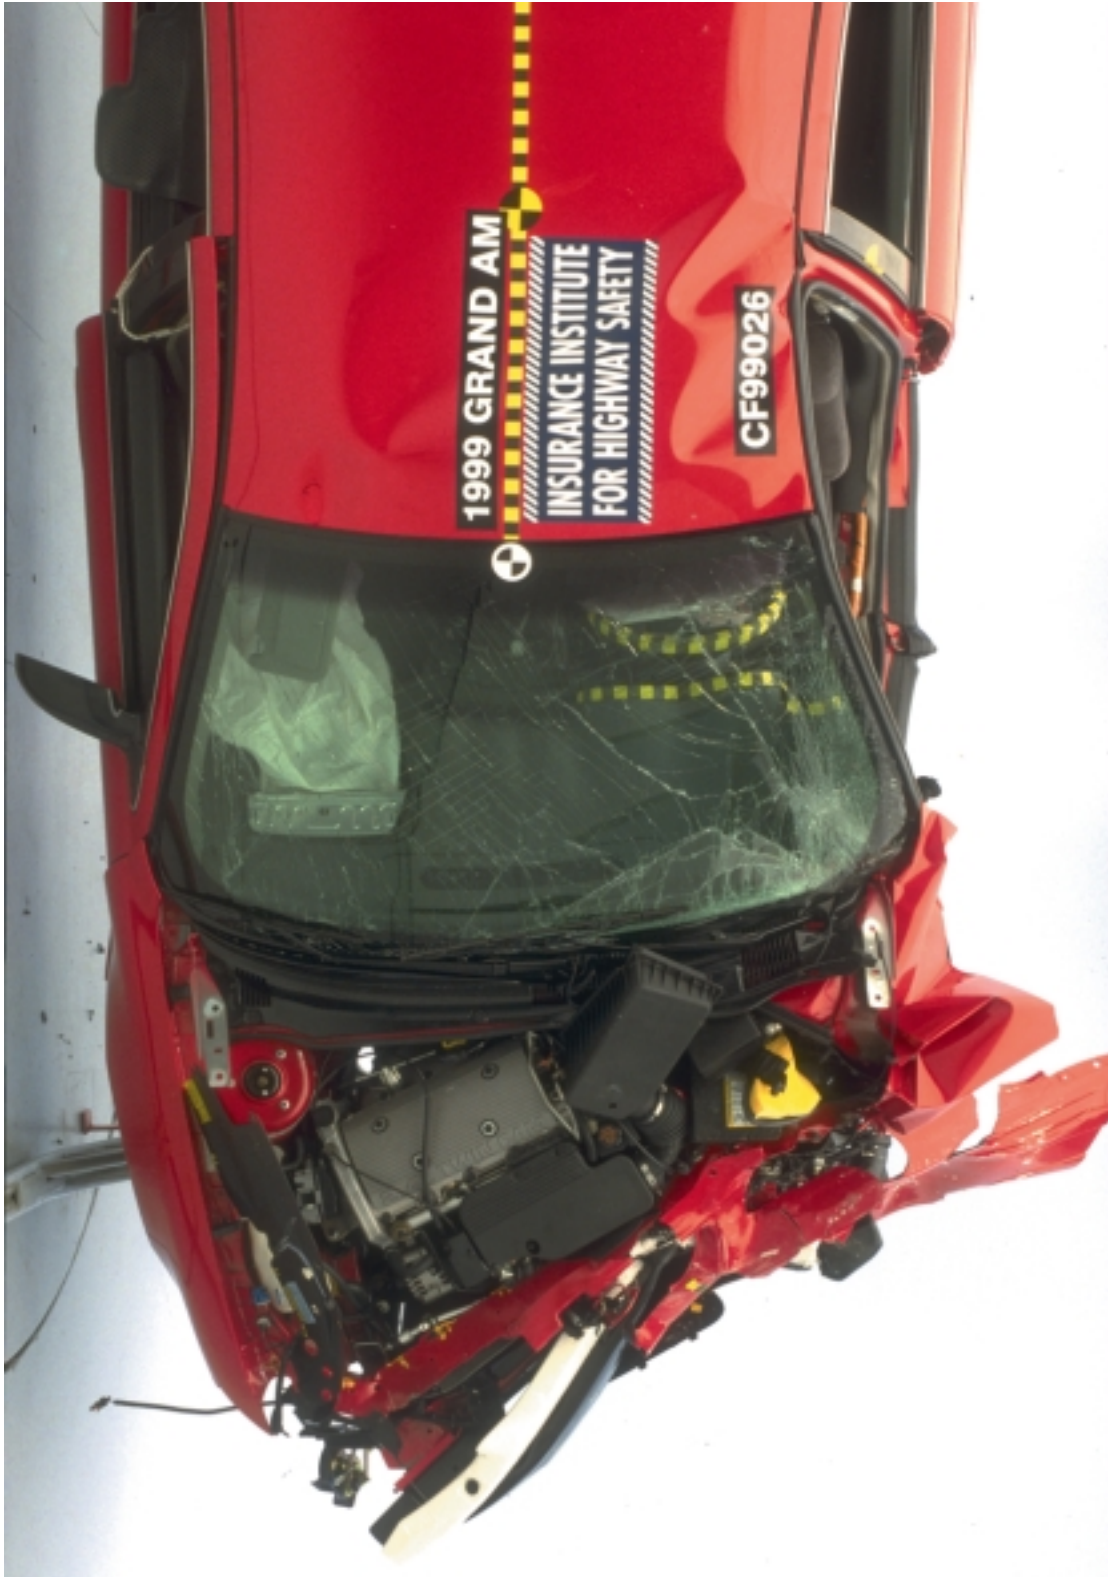
Figure 2
Overhead View of Crash Deformation — 1999 Pontiac Grand Am

Figure 2 shows the overhead view of the crash deformation. Figure 3 illustrates the precrash and postcrash contour measures of the front bumper cover profile and the resulting permanent crush. Figure 4 shows the precrash and postcrash views from below. Figure 5 illustrates the deformation of the side rails, door sills, and engine cradle, which are visible in Figure 4.

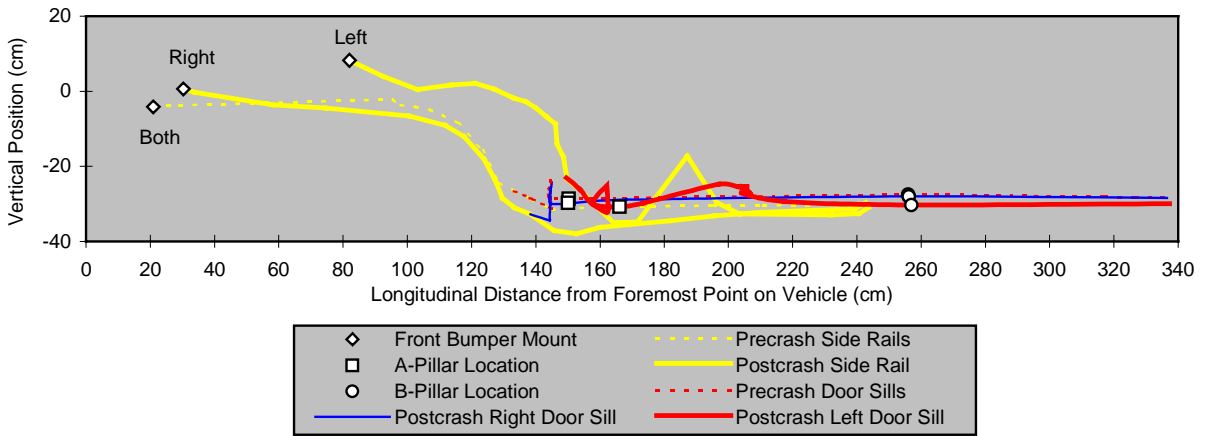
Figure 5
Structural Deformation, Views from Below and Side — 1999 Pontiac Grand Am

The floorpan was buckled sharply upward just in front of the driver seat, and the welded seam joining the floorpan to the door sill was torn open. The tear was about 32 cm long and had a maximum gap width of 4 cm.
