Insurance Institute for Highway Safety Crashworthiness Evaluation

Crash Test Report 2000 Saturn LS (CF99022)

Vehicle identification number: 1G8JW52R5YY600967
Body style: Midsize four-door sedan
Engine/transmission: Transverse 3.0-liter V6, 4-speed automatic,
front-wheel drive

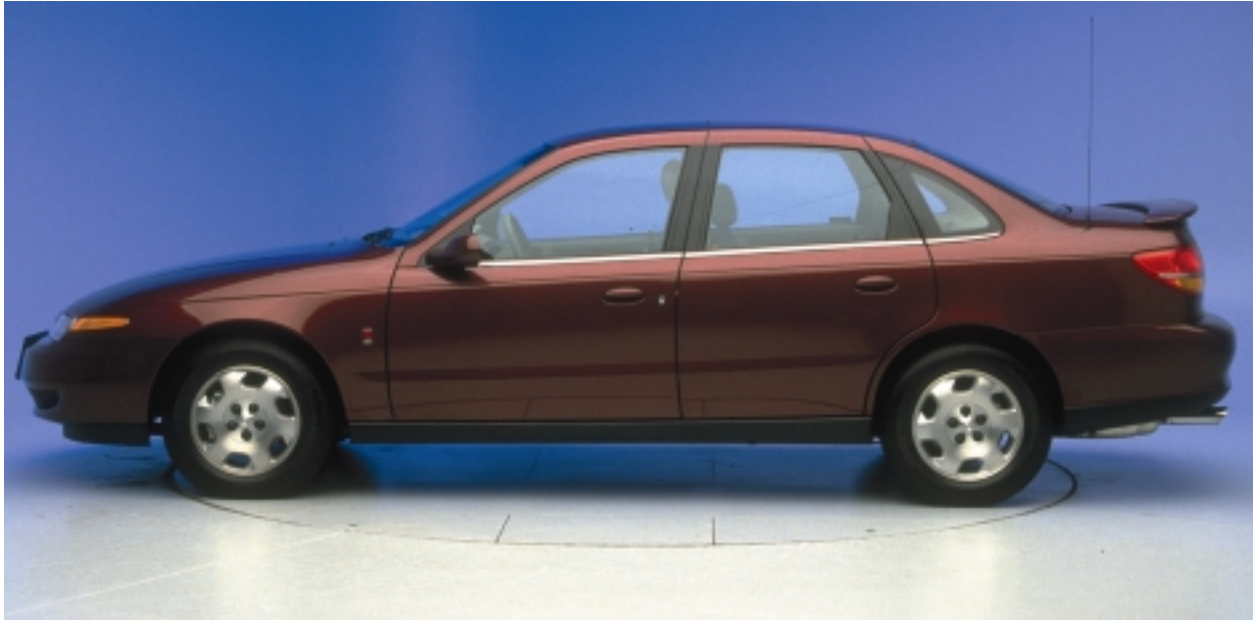
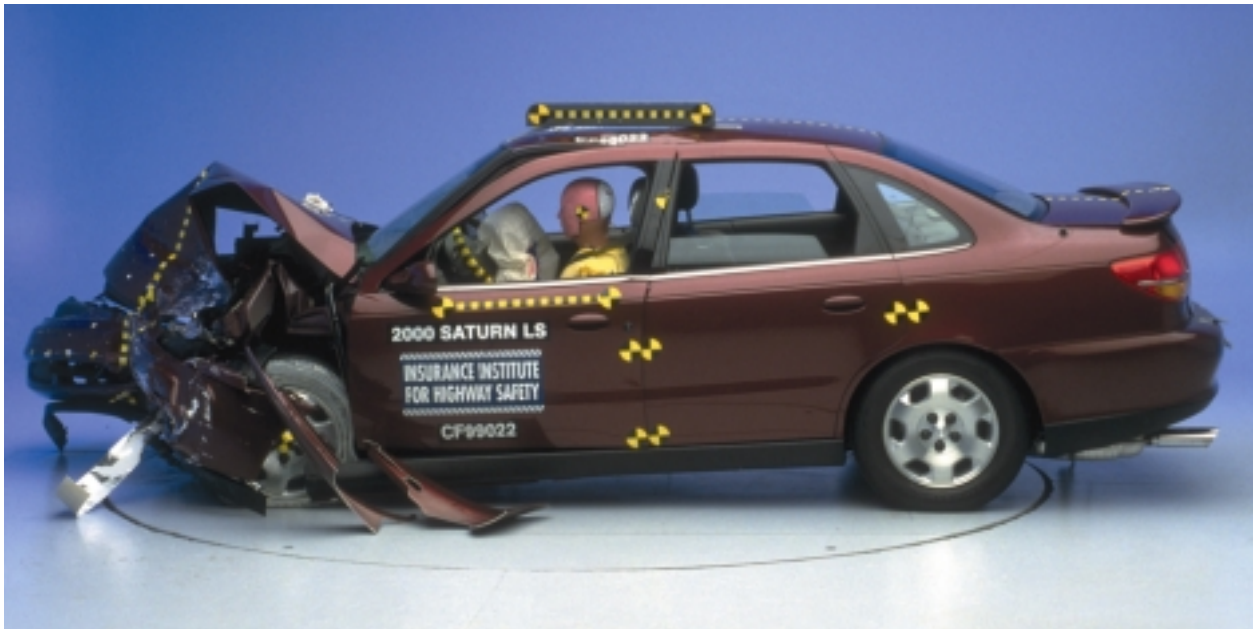
Figure 1
Pre-crash and Post-crash Side Views — 2000 Saturn LS

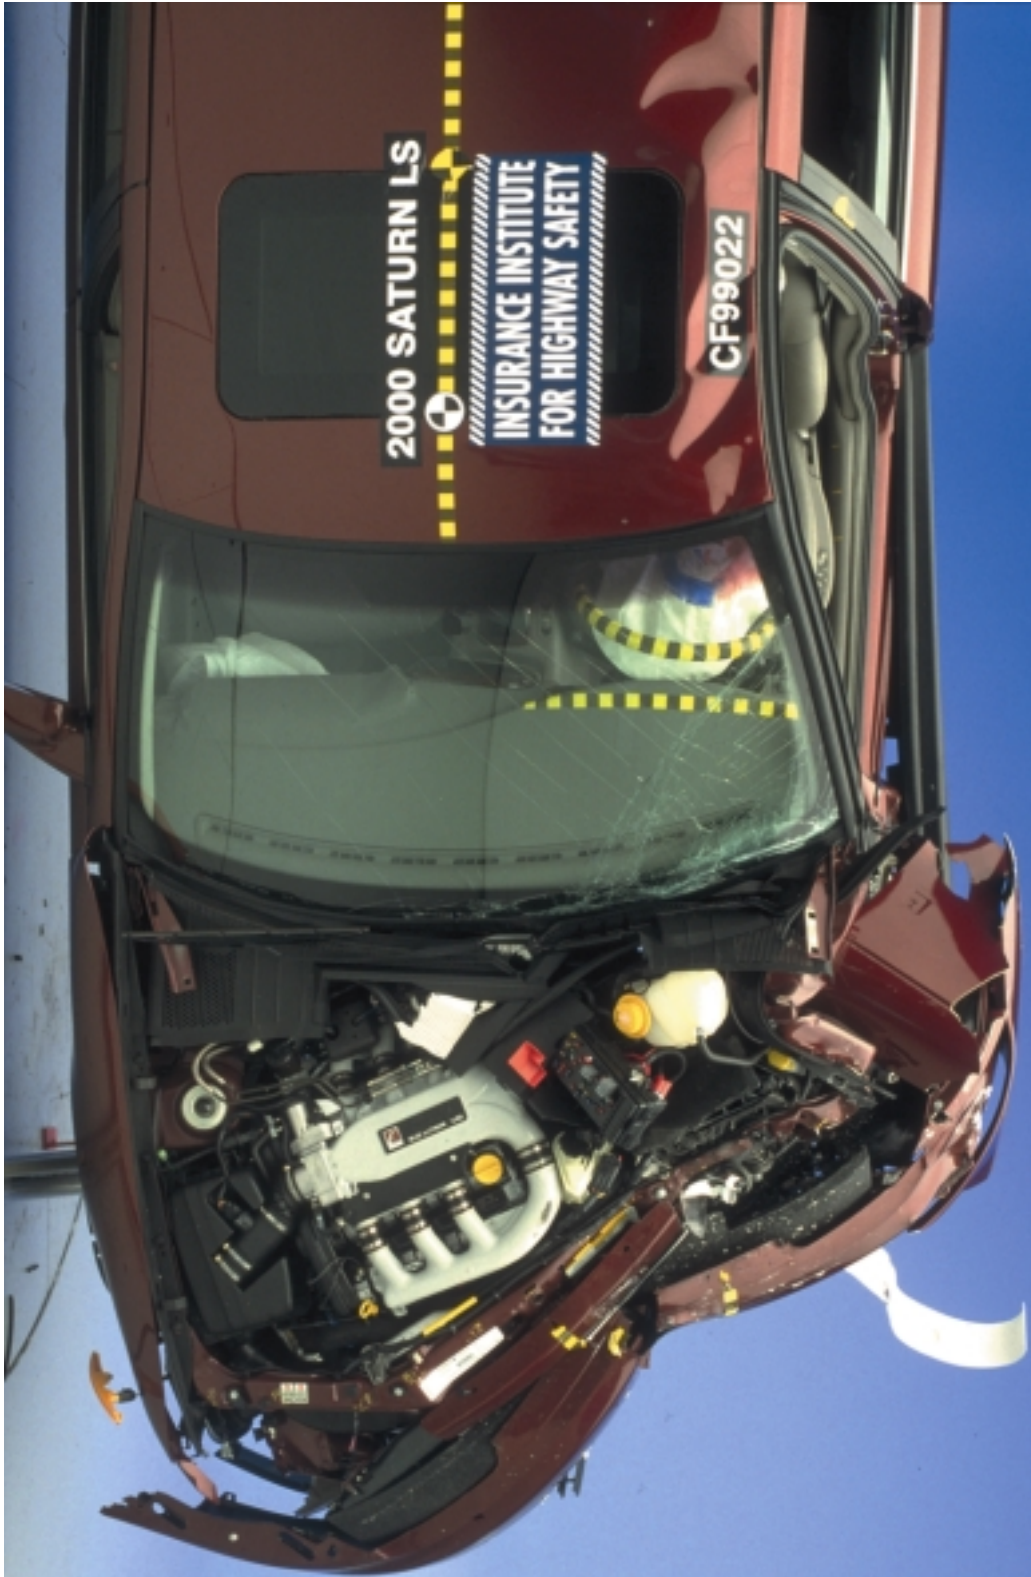
Figure 2
Overhead View of Crash Deformation — 2000 Saturn LS

Figure 2 shows the overhead view of the crash deformation. Figure 3 illustrates the precrash and postcrash contour measures of the front bumper cover profile and the resulting permanent crush. Figure 4 shows the precrash and postcrash views from below. Figure 5 illustrates the deformation of the side rails, door sills, and engine cradle, which are visible in Figure 4.

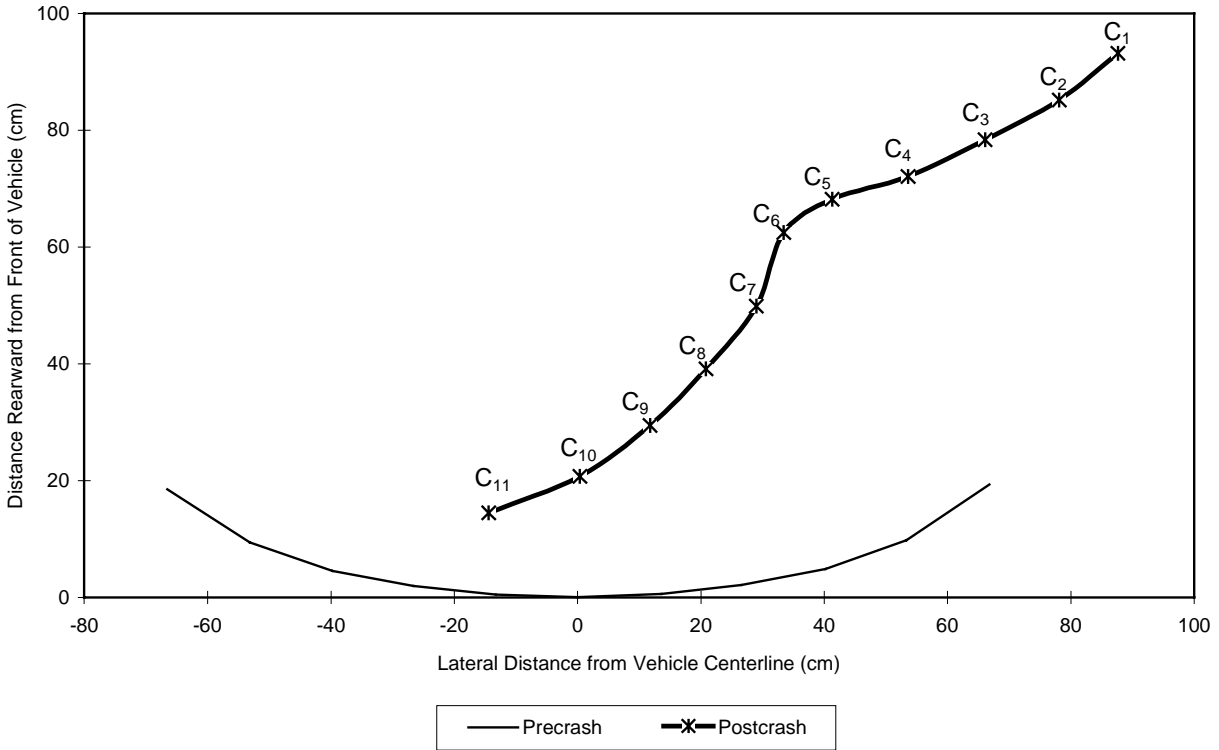
Figure 3
Front Bumper Cover Crush Contour — 2000 Saturn LS

C₁	C₂	C₃	C₄	C₅	C₆	C₇	C₈	C₉	C₁₀	C₁₁
Postcrash Contour (cm)	93	85	78	72	68	63	50	39	29	21	14
Precrash Contour (cm)	19	10	5	2	1	0	1	2	5	9	19
Resulting Crush (cm)	74	75	73	70	67	63	49	37	24	12	-5

The length of the reference line was 133 cm precrash and 102 cm postcrash.

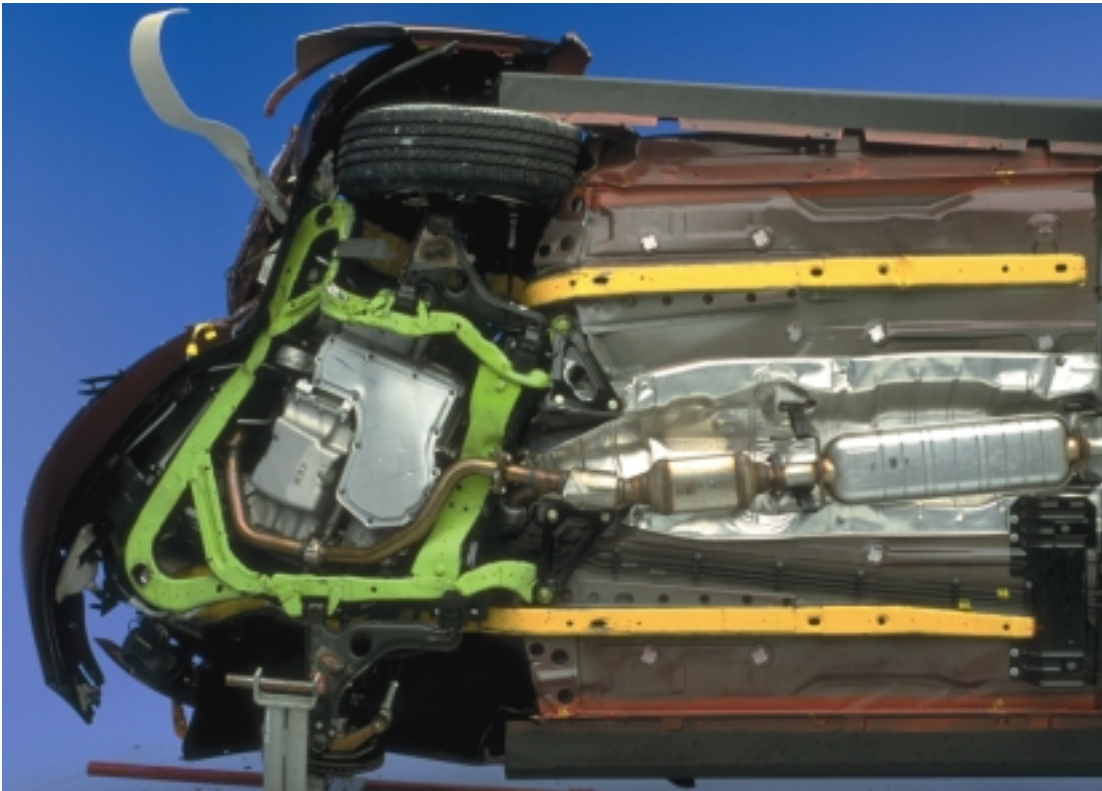
Figure 4
Precrash and Postcrash Views from Below — 2000 Saturn LS

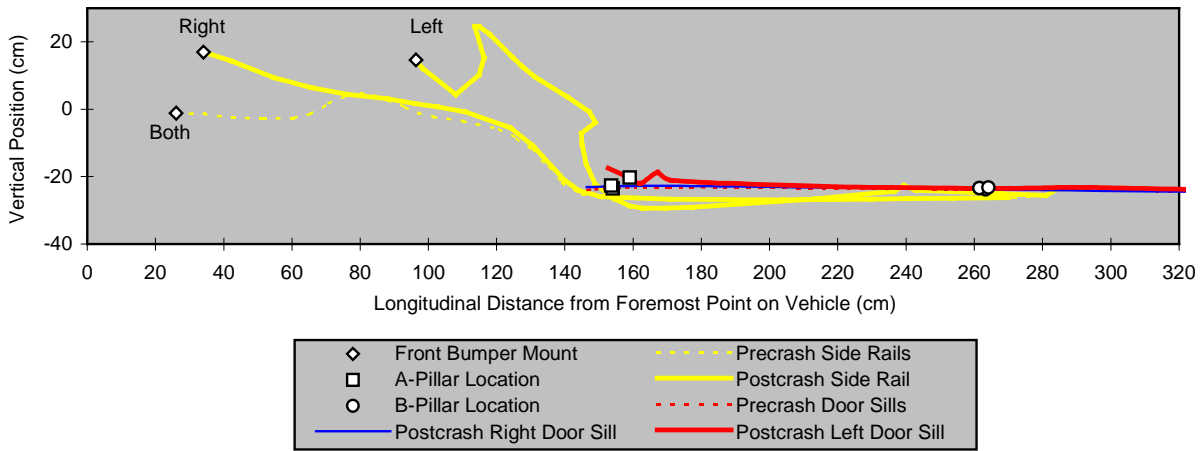
Figure 5
Structural Deformation, Views from Below and Side — 2000 Saturn LS

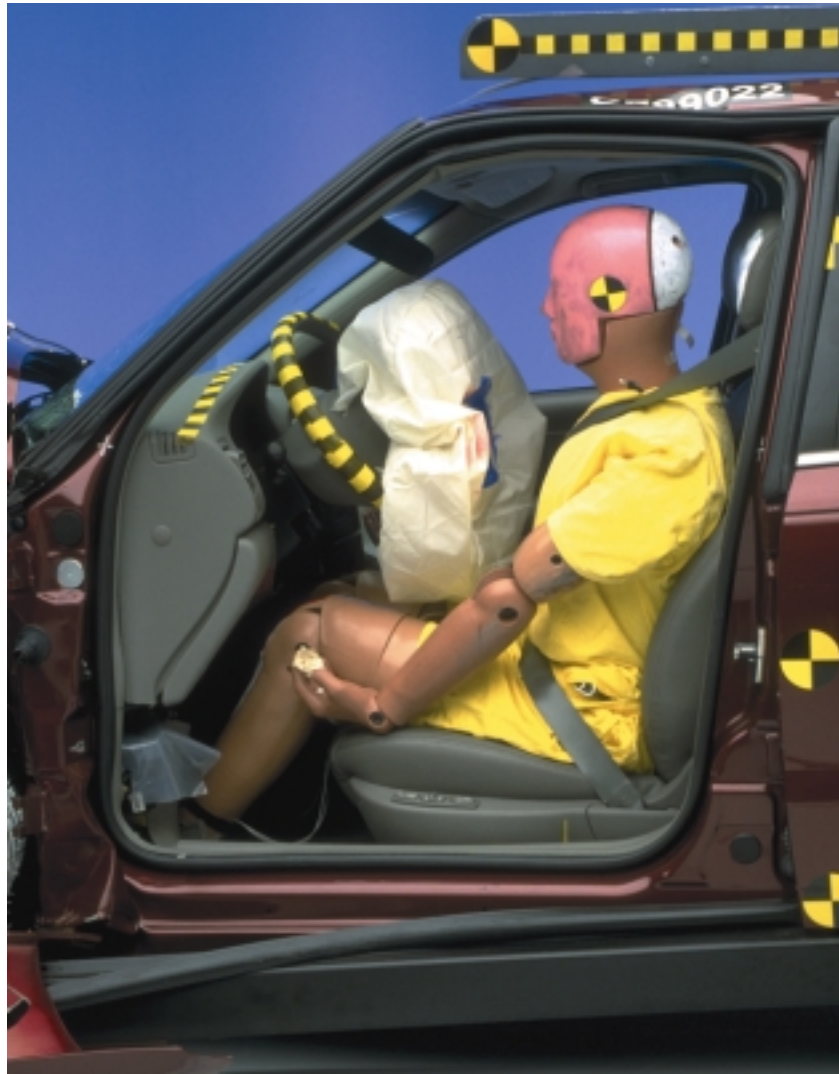
Figure 6
Dummy and Vehicle Interior, Postcrash — 2000 Saturn LS
