# Insurance Institute for Highway Safety Crashworthiness Evaluation

## Crash Test Report 1999 Saab 9-5 (CF98021)

**Vehicle identification number:** YS3EF48E9X3006053  
**Body style:** Midsize four-door sedan  
**Engine/transmission:** Transverse 2.3-liter turbocharged 4-cylinder,  
4-speed automatic, front-wheel drive

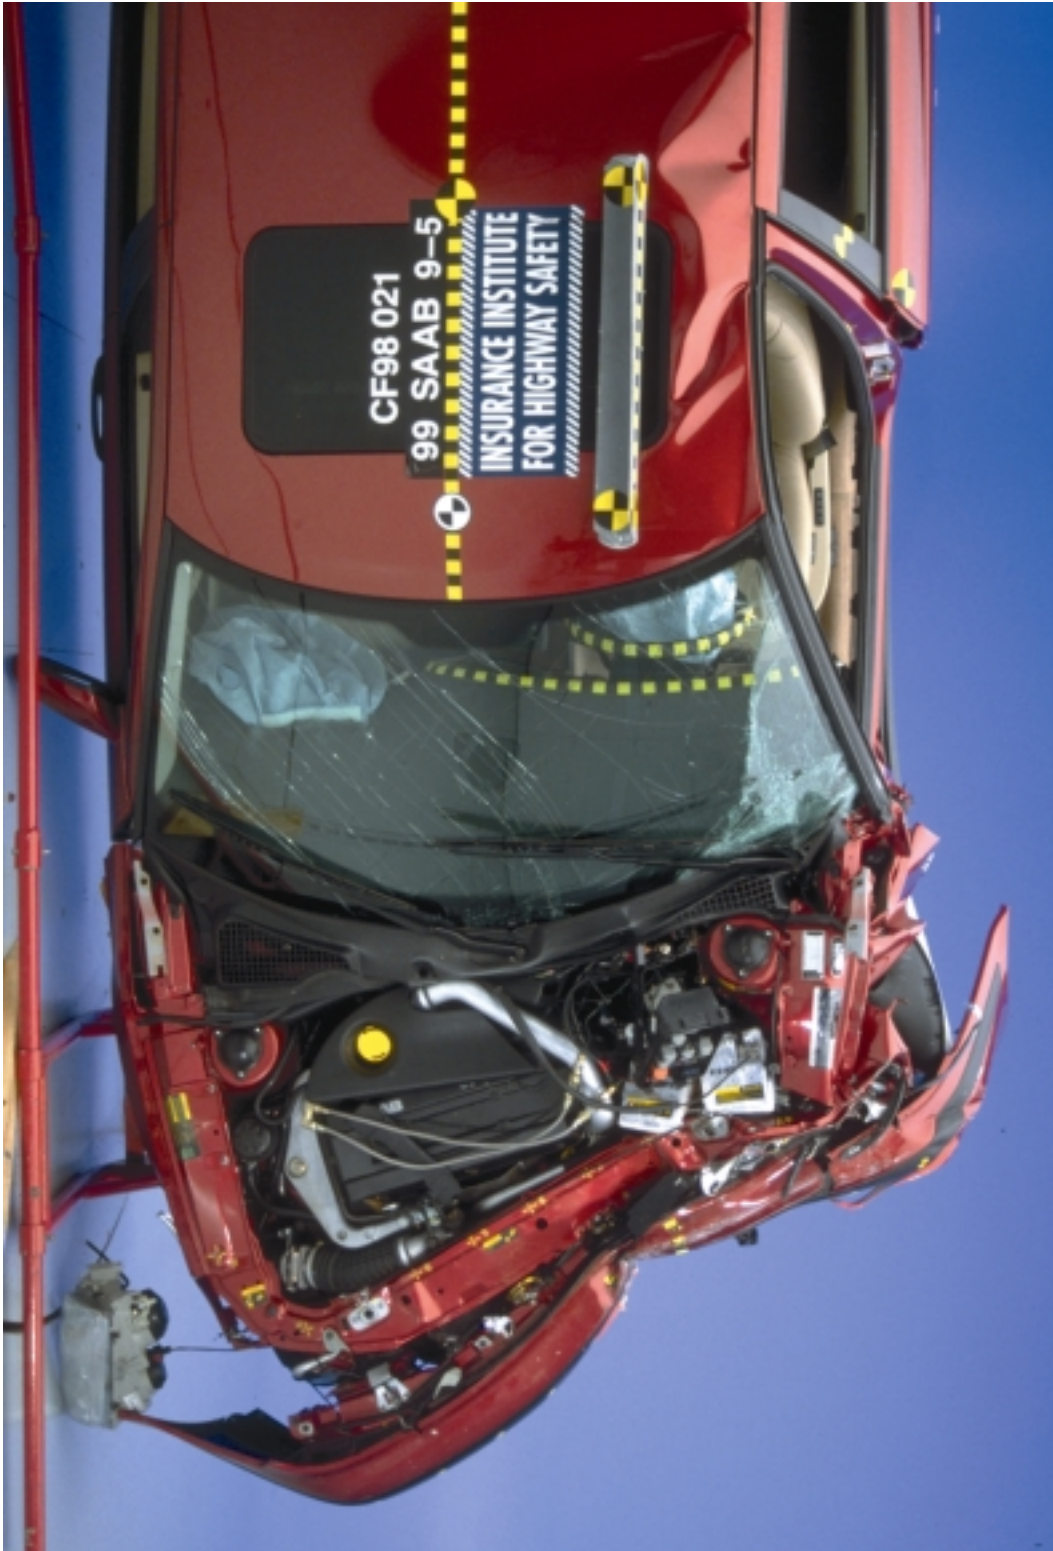
**Figure 2**  
**Overhead View of Crash Deformation — 1999 Saab 9-5**

Figure 2 shows the overhead view of the crash deformation. Figure 3 illustrates the precrash and postcrash contour measures of the front bumper cover profile and the resulting permanent crush. Figure 4 illustrates the corresponding measures of both the front bumper reinforcement bar and upper crossmember of the radiator support. Figure 5 shows the precrash and postcrash views from below. Figure 6 illustrates the deformation of the side rails, floor rails, and engine cradle, which are visible in Figure 5.

All doors remained closed during the crash. The driver door aperture shortened 7 cm, as measured at the lower edge of the window. After the crash, the driver door and left rear door required additional effort but no tools to open, and the right front and right rear doors opened with ease.

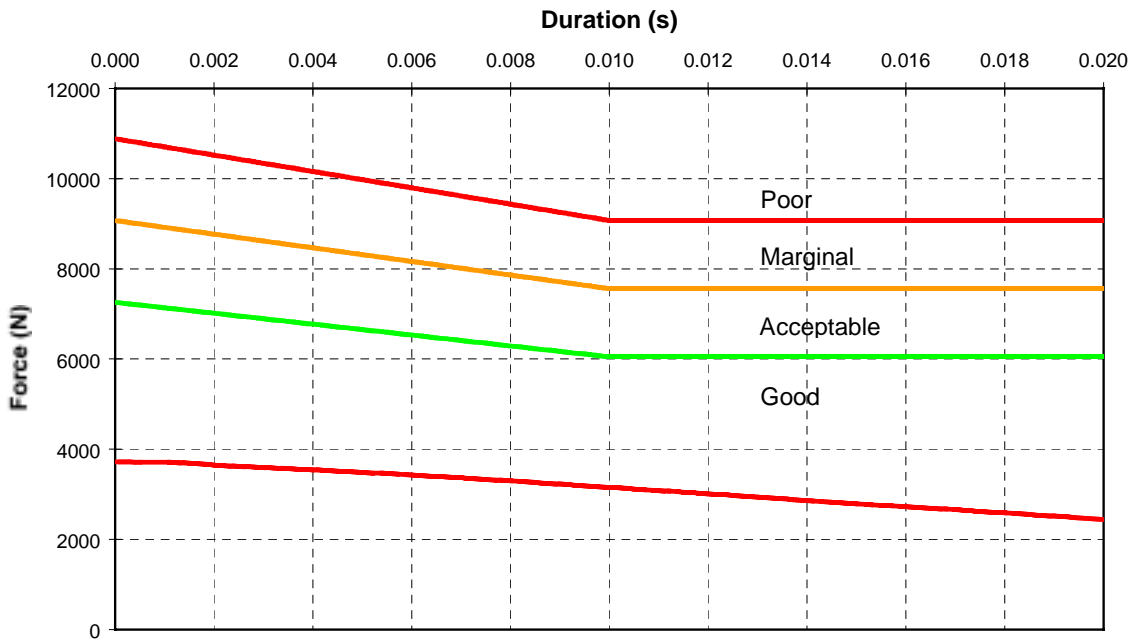
A- 24 CF98021 1999 Saab 9-5 Left Femur Axial Force Analysis

\* This critical value is for instantaneous loading. Femur loads are compared with magnitude-duration injury criteria in Figures A-24 and A-37.
