# Insurance Institute for Highway Safety Crashworthiness Evaluation

## Crash Test Report 2000 Mazda MPV (CF00011)

**Vehicle identification number:** JM3LW28G9Y0102571  
**Body style:** Passenger van with sliding doors on both sides  
**Engine/transmission:** Transverse 2.5-liter V6, 4-speed automatic front-wheel drive

March 22, 2000

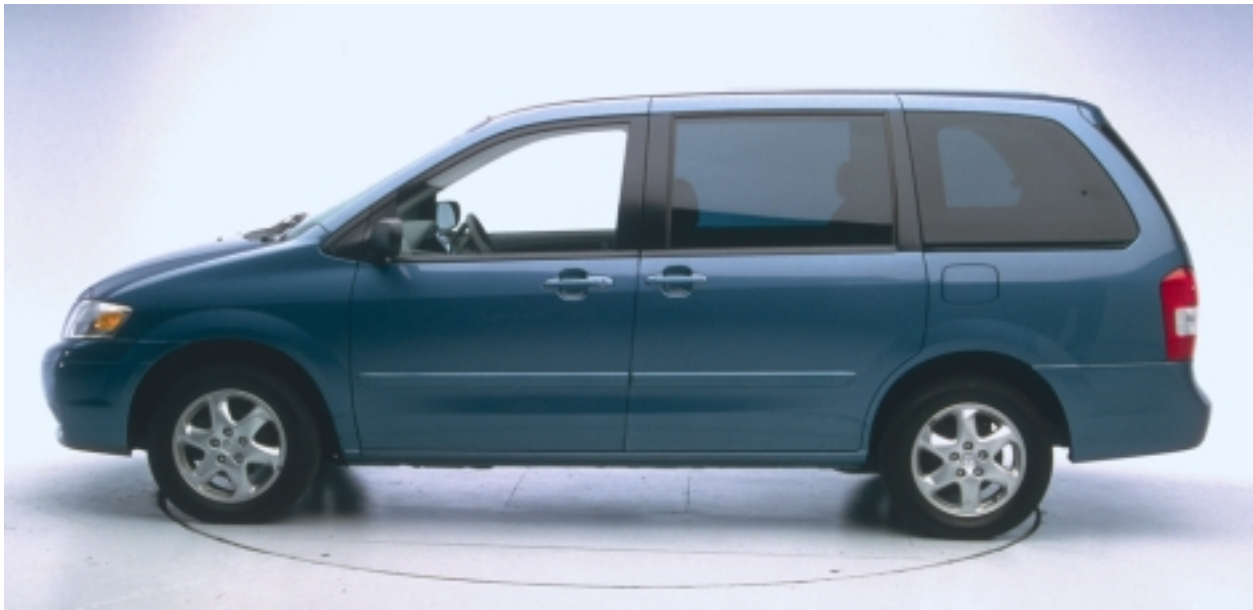
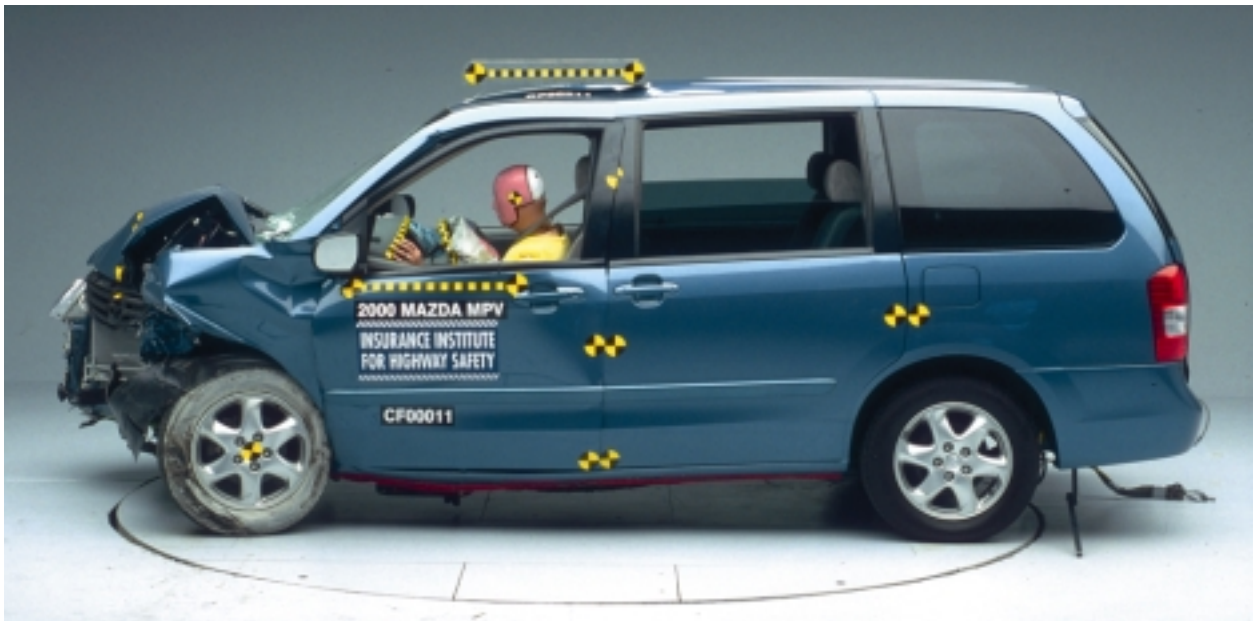
Figure 1  
Precrash and Postcrash Side Views – 2000 Mazda MPV

All doors remained closed during the crash. After the crash, the driver door required tools (minor manipulation of the latch) to open, and the left rear sliding door required slight additional effort but no tools to open. The right front door and right rear sliding door opened with ease. The driver door aperture shortened 7 cm, as measured at the lower edge of the window.

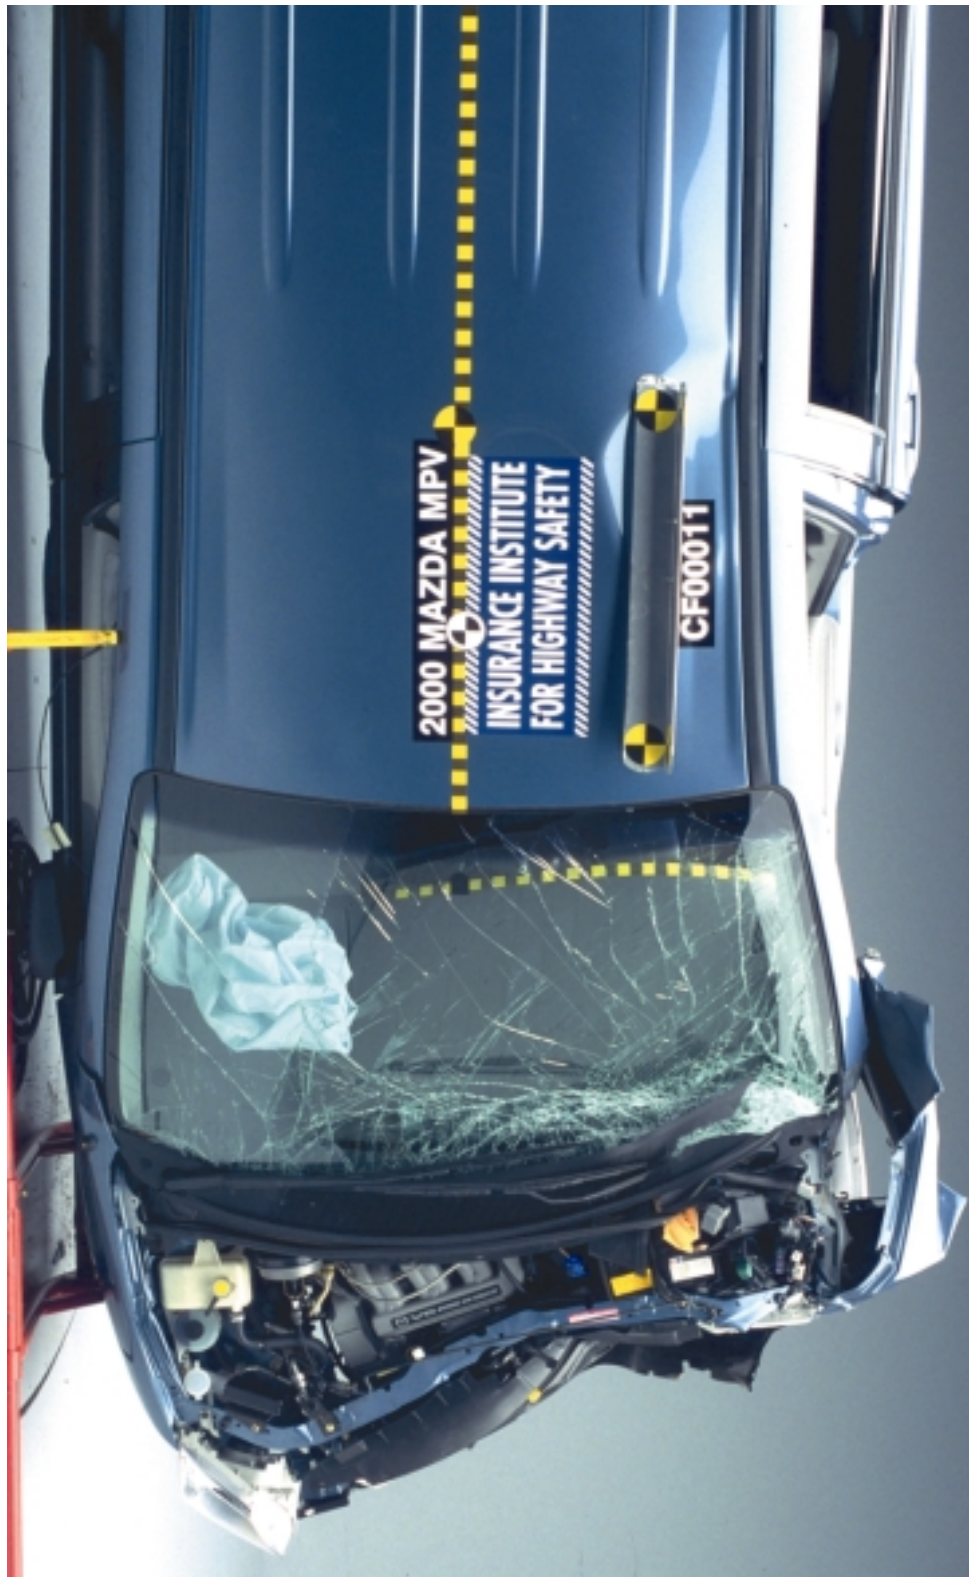
Figure 2  
Overhead View of Crash Deformation – 2000 Mazda MPV

Figure 2 shows the overhead view of the crash deformation. Figure 3 illustrates the precrash and postcrash contour measures of the front bumper cover profile and the resulting permanent crush. Figure 4 shows the precrash and postcrash views from below. Figure 5 illustrates the deformation of the side rails, door sills, and radiator and engine supports, which are visible in Figure 4.

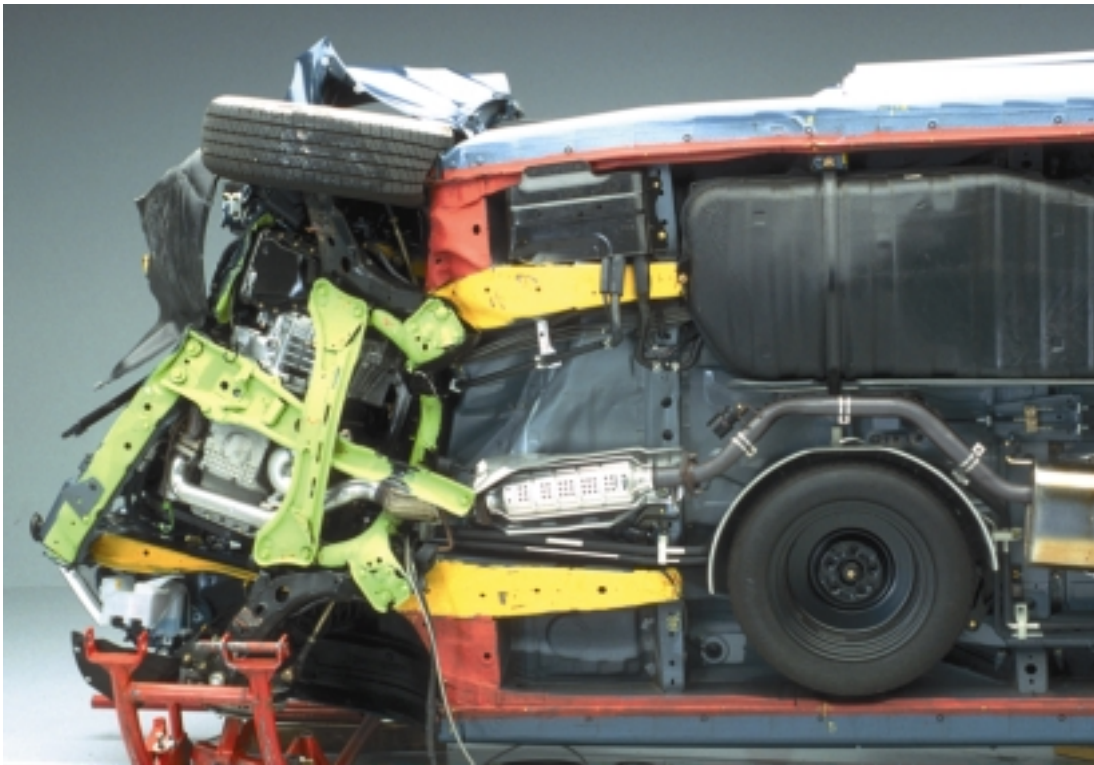
Figure 4  
Precrash and Postcrash Views from Below – 2000 Mazda MPV

After the crash, the spot-welded seam between the driver floorpan and driver toepan was torn across the full width of the driver footwell. The left side rail that intruded into the footwell was visible through the tear.

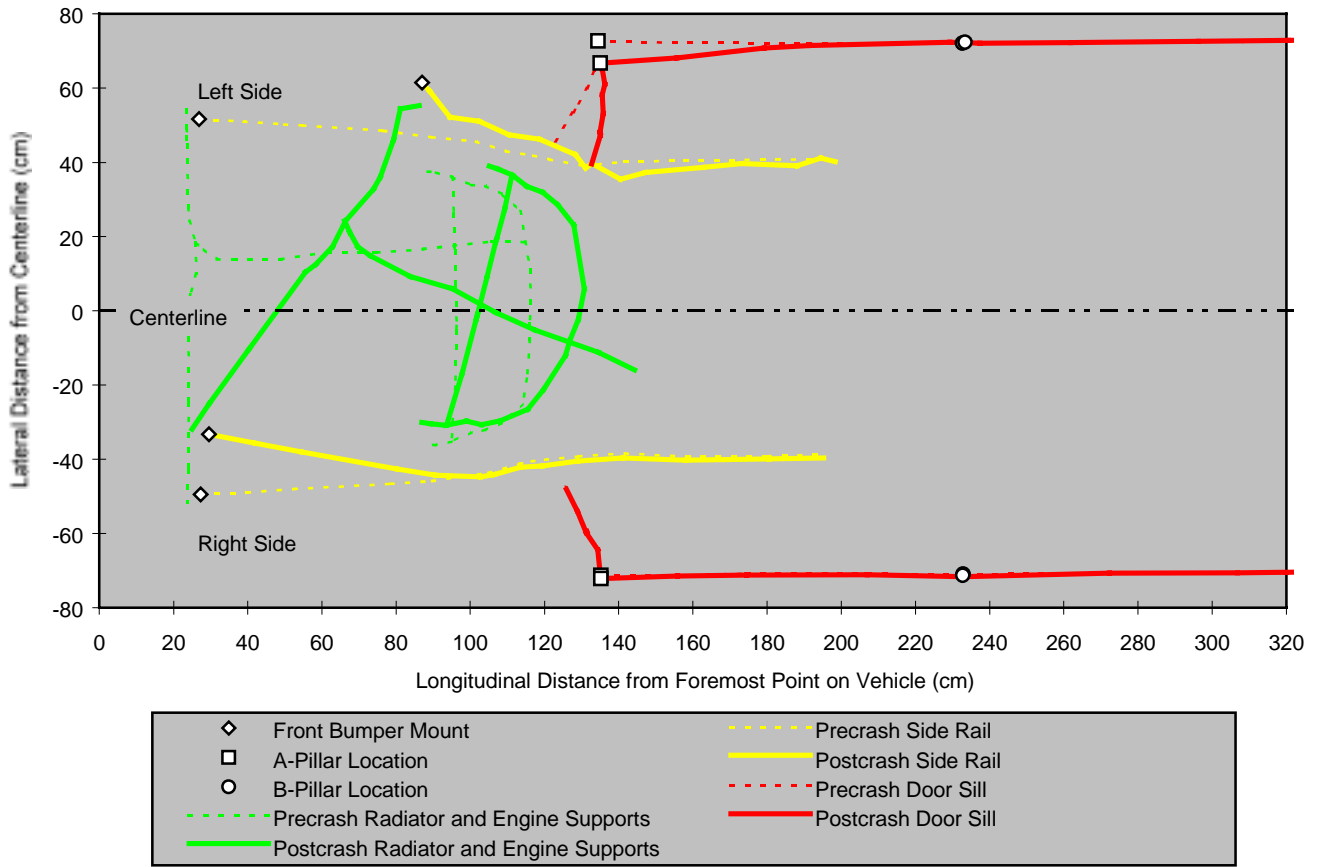
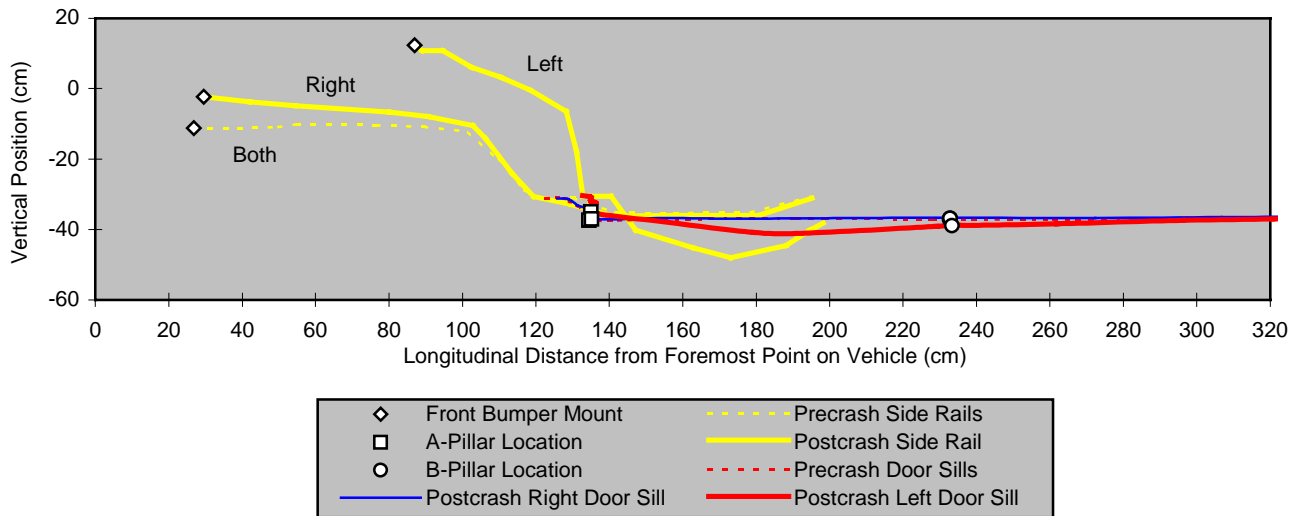
**Figure 5**  
**Structural Deformation, Views from Below and Side – 2000 Mazda MPV**

Various measures of intrusion were made after the crash. These residual measures of intrusion typically are less than the maximum deformation that occurs during the crash. The coordinate reference system for these measures is described in the IIHS Offset Barrier Crash Test Protocol (Version VII). The measures of deformation shown in Table 1 have been adjusted to better reflect the displacement of the various target locations relative to the driver, based on the locations of the four driver seat-attachment bolts. The average displacement of the seat-attachment bolts relative to the reference system also is shown in Table 1.

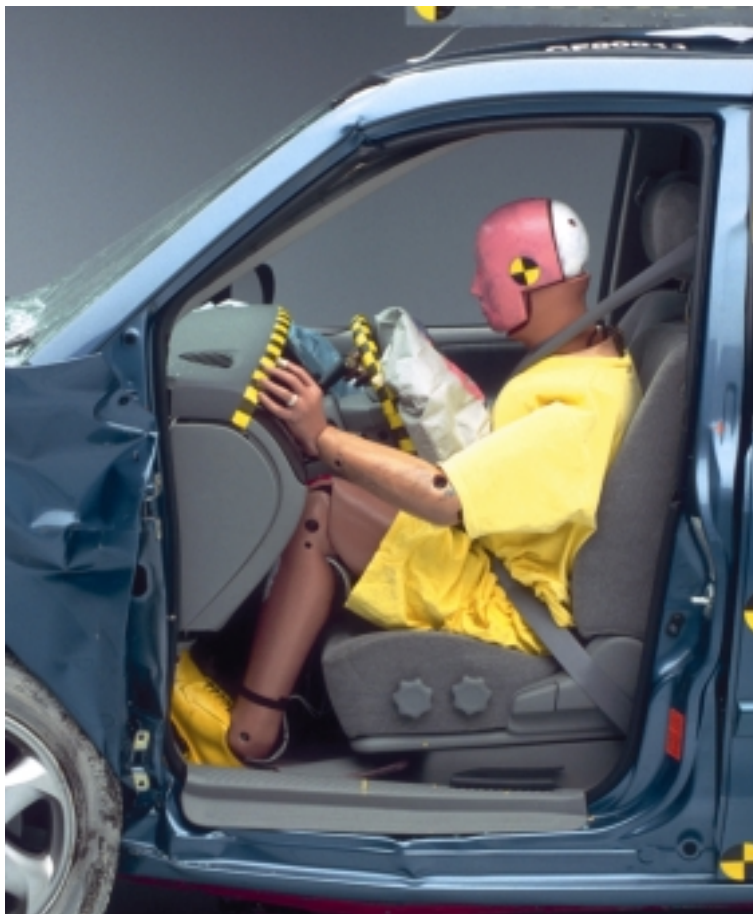
**Figure 6**  
**Dummy and Vehicle Interior, Postcrash – 2000 Mazda MPV**

**Left leg and foot:** After the crash, the left knee and shin were found pressed against the knee bolster. Paint transferred from the dummy's left knee indicated the knee contacted the bolster to the left of the steering column at the left instrument panel intrusion reference point. Paint transferred from the dummy's left shin indicated the shin contacted the bolster directly below the knee impact location and then slid upward into the initial knee contact location. The left foot was found fully dorsiflexed and slightly inverted, with the sole at the heel and medial forefoot pressed against the intruded toepan and the back of the heel resting on the floorpan.

**Right leg and foot:** After the crash, the right knee and shin were found pressed against the knee bolster. Paint transferred from the dummy's right knee indicated the knee primarily contacted the bolster to the right of steering column. The knee also contacted the lower edge of the column-mounted ignition key and the switch housing. Paint transferred from the dummy's right shin indicated the shin contacted the bolster below the knee impact location on the bolster. The right foot was found fully dorsiflexed and slightly everted, with the medial sole of the forefoot pressed against the fully depressed accelerator pedal and the back of the heel against a downward buckle in the floorpan.
