Insurance Institute for Highway Safety Crashworthiness Evaluation

Crash Test Report 2000 Ford Taurus (CF00010)

Vehicle identification number: 1FAFP55U1YG148178
Body style: Large 4-door sedan
Engine/transmission: Transverse 3.0-liter V6, 4-speed automatic,
front-wheel drive

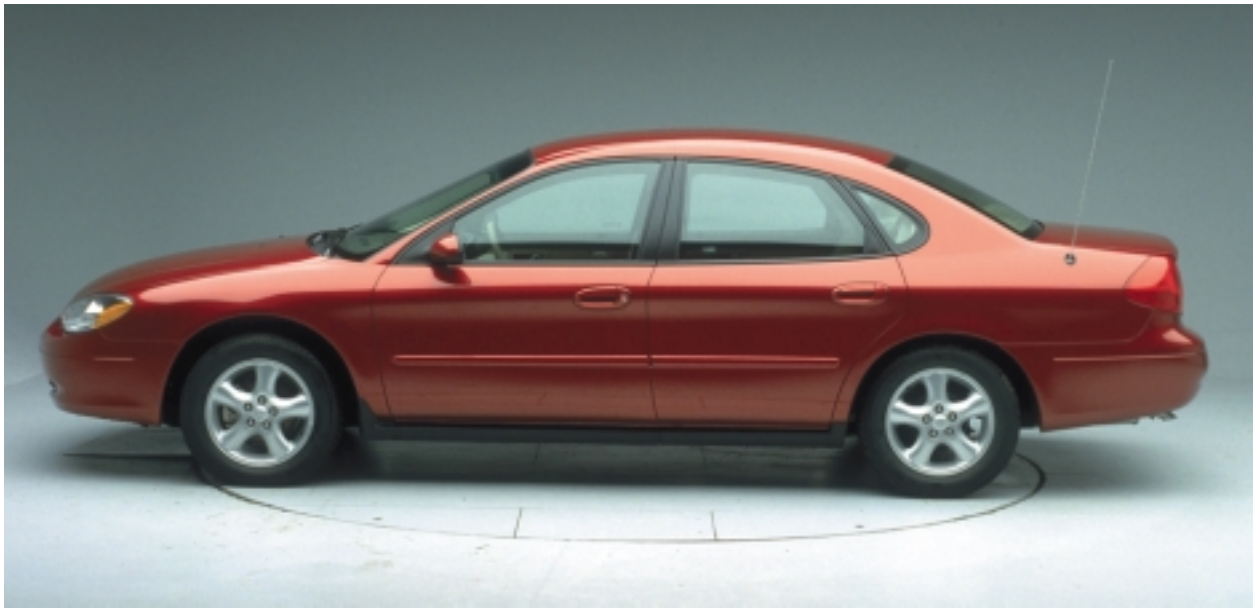
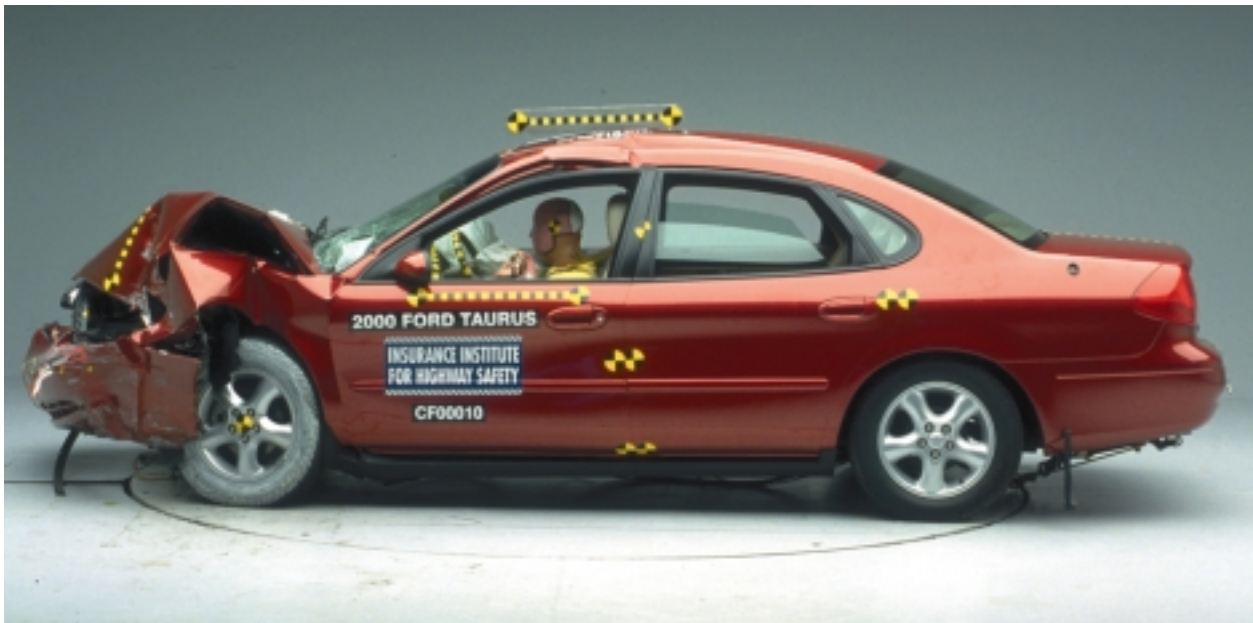
Figure 1
Precrash and Postcrash Side Views – 2000 Ford Taurus

A 2000 Ford Taurus was crash tested on March 14, 2000 into a fixed deformable barrier at 39.9 mi/h (64.3 km/h) and a 41 percent overlap on the driver side. A Hybrid III 50th percentile male dummy was positioned in the driver seat with the lap/shoulder belt fastened.

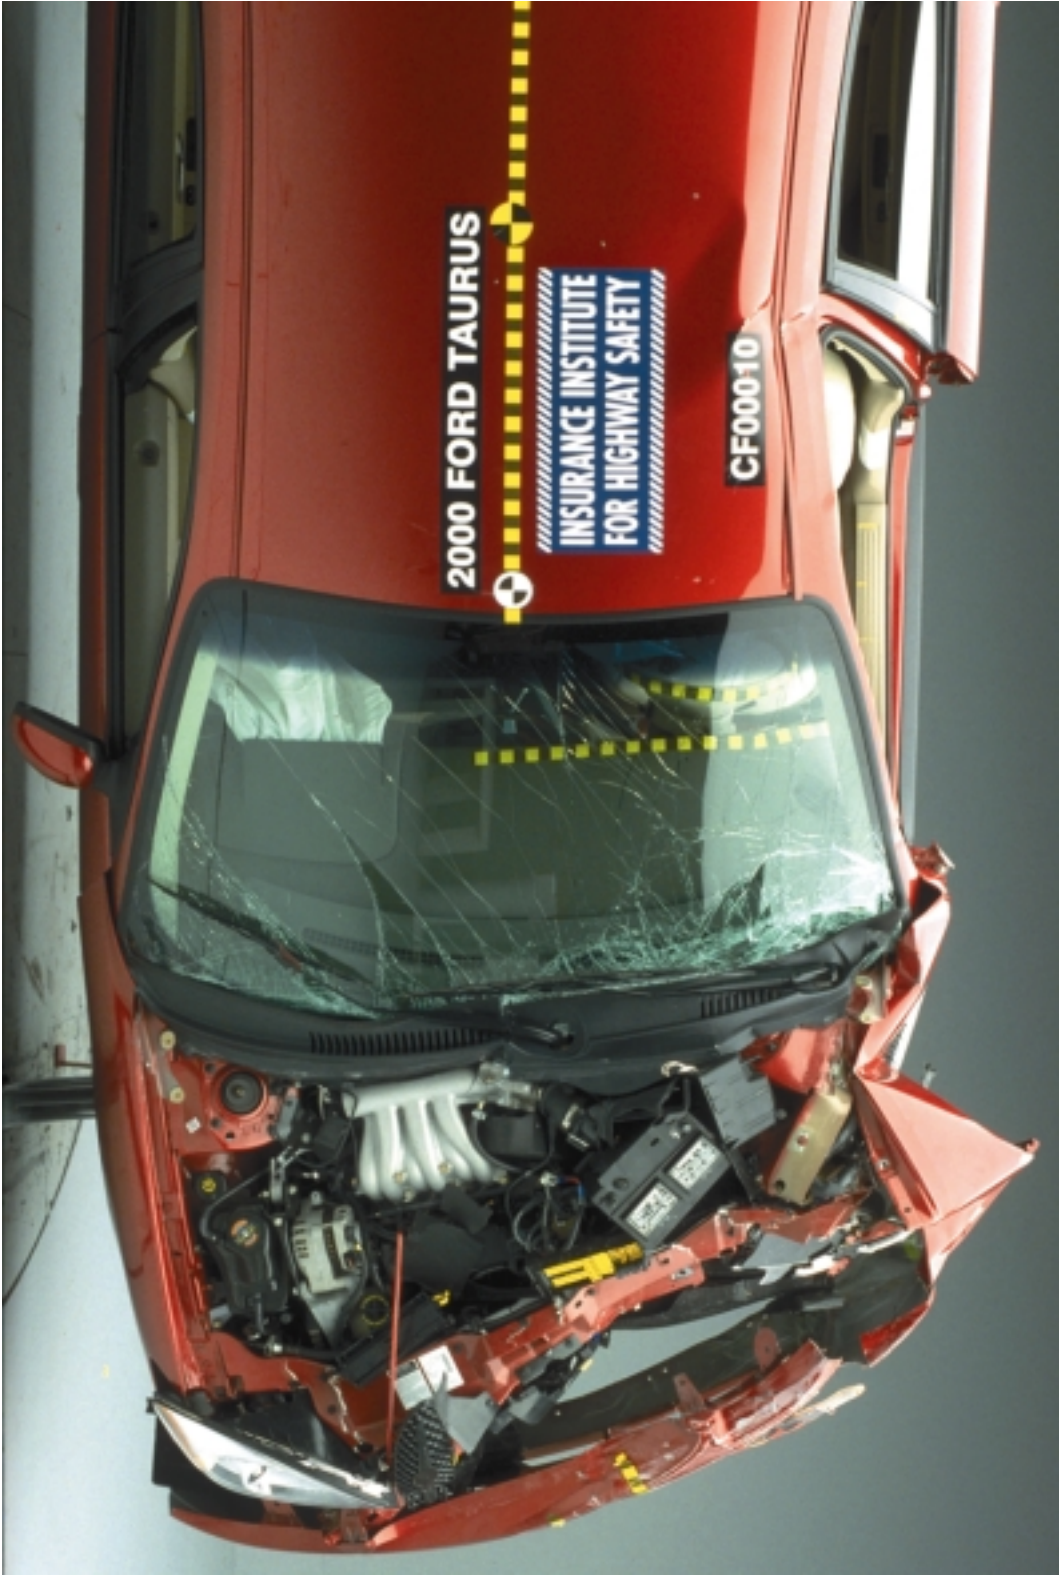
Figure 2
Overhead View of Crash Deformation – 2000 Ford Taurus

Figure 2 shows the overhead view of the crash deformation. Figure 3 illustrates the precrash and postcrash contour measures of the front bumper cover profile and the resulting permanent crush. Figure 4 shows the precrash and postcrash views from below. Figure 5 illustrates the deformation of the side rails, floor rails, and engine cradle, which are visible in Figure 4.

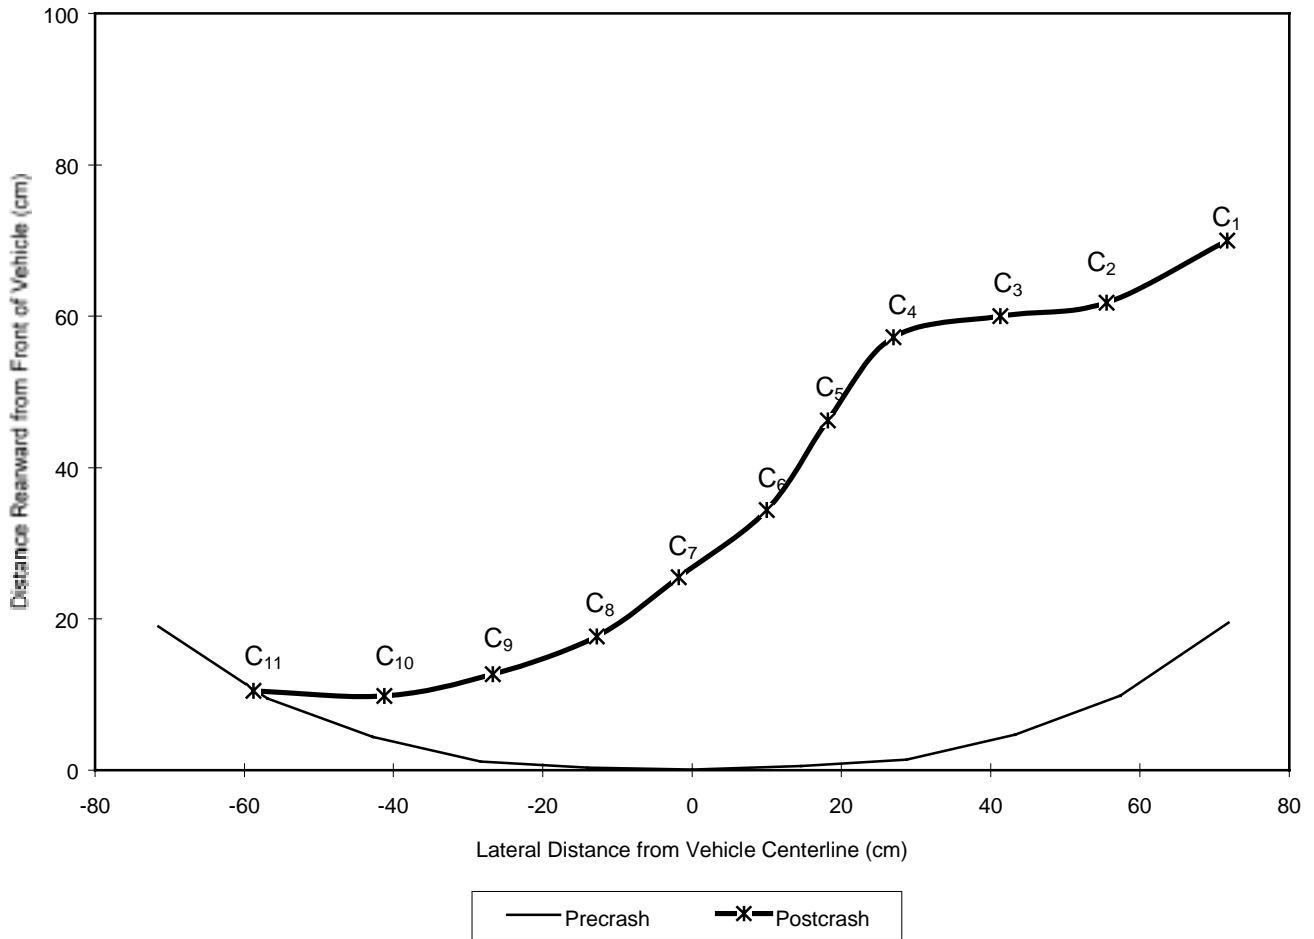
Figure 3
Front Bumper Cover Crush Contour – 2000 Ford Taurus

C ₁	C ₂	C ₃	C ₄	C ₅	C ₆	C ₇	C ₈	C ₉	C ₁₀	C ₁₁
Postcrash Contour (cm)	70	62	60	57	46	34	26	18	13	10	10
Precrash Contour (cm)	20	10	5	1	1	0	0	1	4	9	19
Resulting Crush (cm)	50	52	55	56	45	34	26	17	9	1	-9

The bumper cover was torn almost completely off the vehicle during the crash. The postcrash contour represents the best attempt to fit the cover back onto the vehicle. The length of the reference line was 143 cm precrash and 130 cm postcrash.

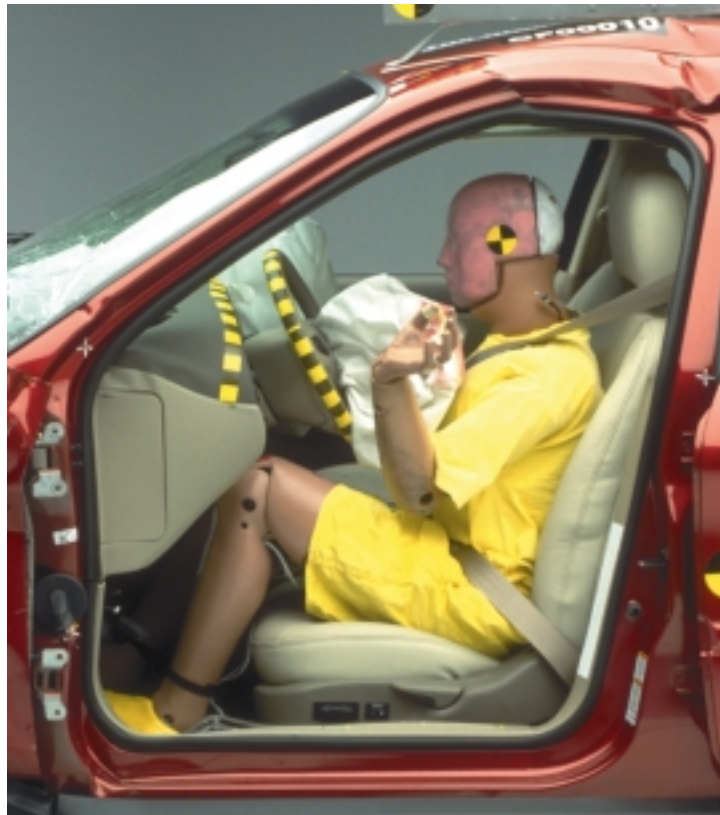
Figure 6
Dummy and Vehicle Interior, Postcrash – 2000 Ford Taurus

Analysis of the high-speed film taken from camera position E indicated the driver seat belt crash tensioner fired at 28 ms into the crash, but the driver airbag did not deploy until 60 ms. The deploying airbag contacted the dummy's face at 66 ms into the crash. The face remained in contact with the airbag as it inflated; full inflation occurred by 84 ms. Paint transferred from the dummy's face indicated the nose loaded the airbag 9 cm above and 8 cm to the left of its center. Although the airbag fabric obscured the dummy's face and then the steering wheel, the dummy's face appeared to approach the steering wheel through the deflating airbag at about 120 ms. Sudden increases in the rearward, lateral, and vertical accelerations of the dummy's head, as well as the neck shear force occurring at the same time and later (118 ms and 132 ms), were consistent with two contacts between the dummy's head and steering wheel. As the head moved into the airbag and began to rebound, it moved slightly outward and downward. The head then moved back upward, and the center rear of the head contacted the upper center of the head restraint twice, at 232 ms and 288 ms, as determined from the head acceleration data. After the crash, a small

paint transfer mark from the left side of the dummy' head was found on the top front corner of the B-pillar plastic trim, which had pulled away from the B-pillar at the top. However, the high-speed film did not reveal any obvious contact with the trim. Table 2 provides the timing of these events.
