# Insurance Institute for Highway Safety Crashworthiness Evaluation

## Crash Test Report 2000 Toyota Avalon (CF00012)

**Vehicle identification number:** 4T1BF28B7YU042528  
**Body style:** Midsize 4-door sedan  
**Engine/transmission:** Transverse 3.0-liter V6, 4-speed automatic,  
front-wheel drive

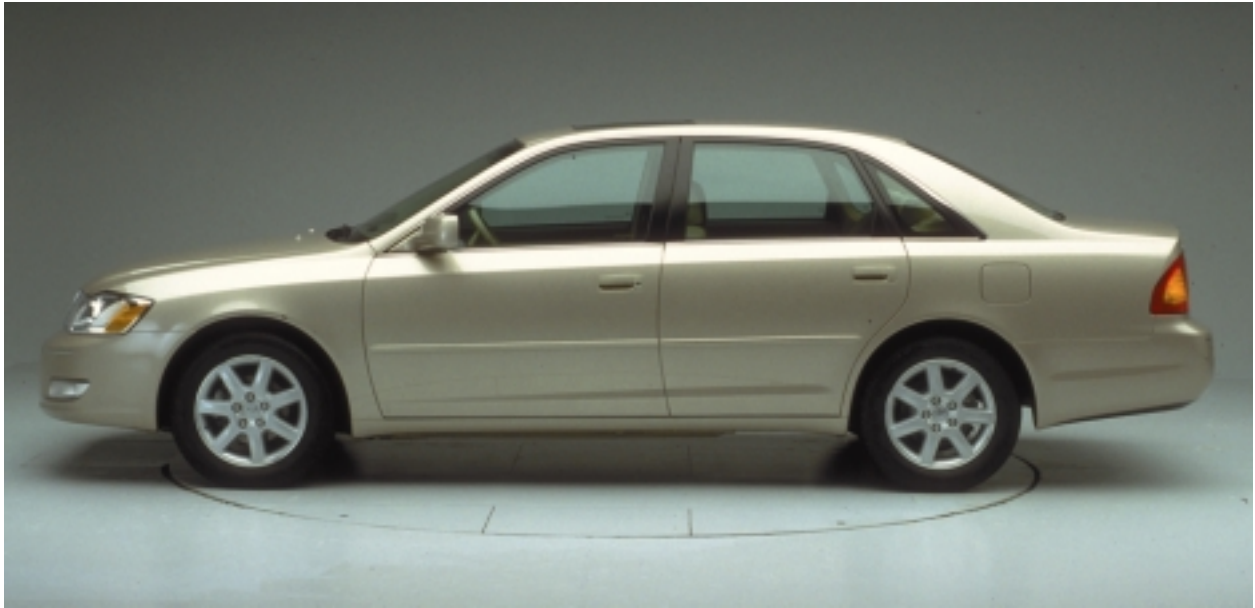
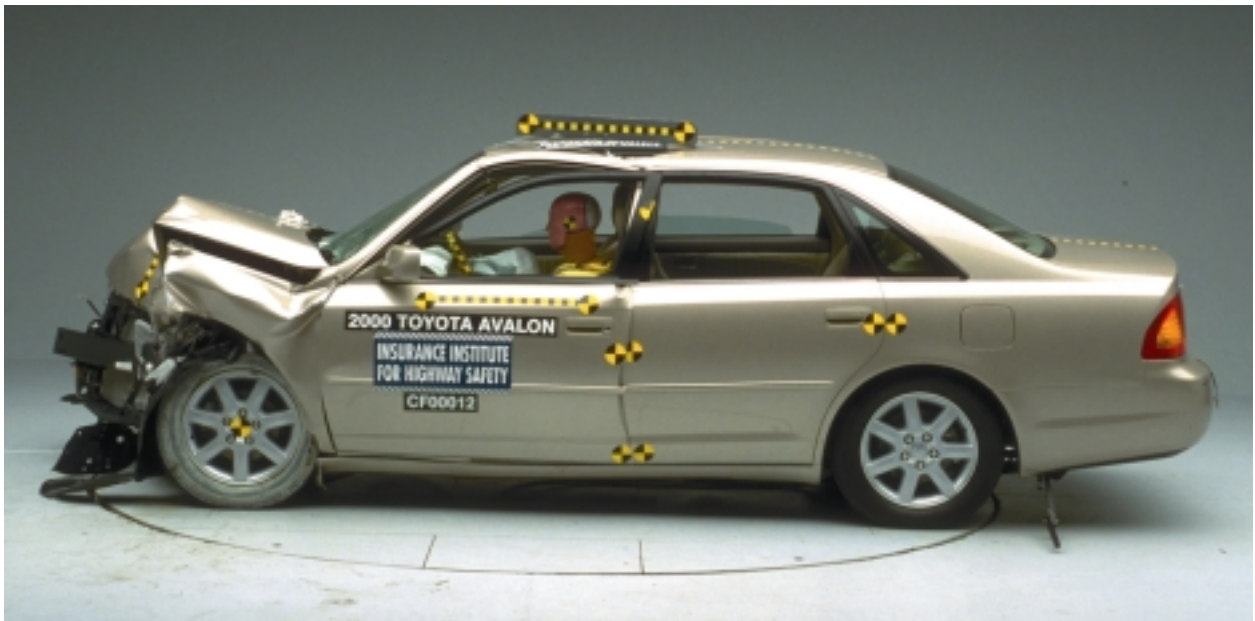
**Figure 1**  
**Preocrash and Postcrash Side Views — 2000 Toyota Avalon**

A 2000 Toyota Avalon was crash tested on March 23, 2000 into a fixed deformable barrier at 40.0 mi/h (64.3 km/h) and a 41 percent overlap on the driver side. A Hybrid III 50th percentile male dummy was positioned in the driver seat with the lap/shoulder belt fastened.

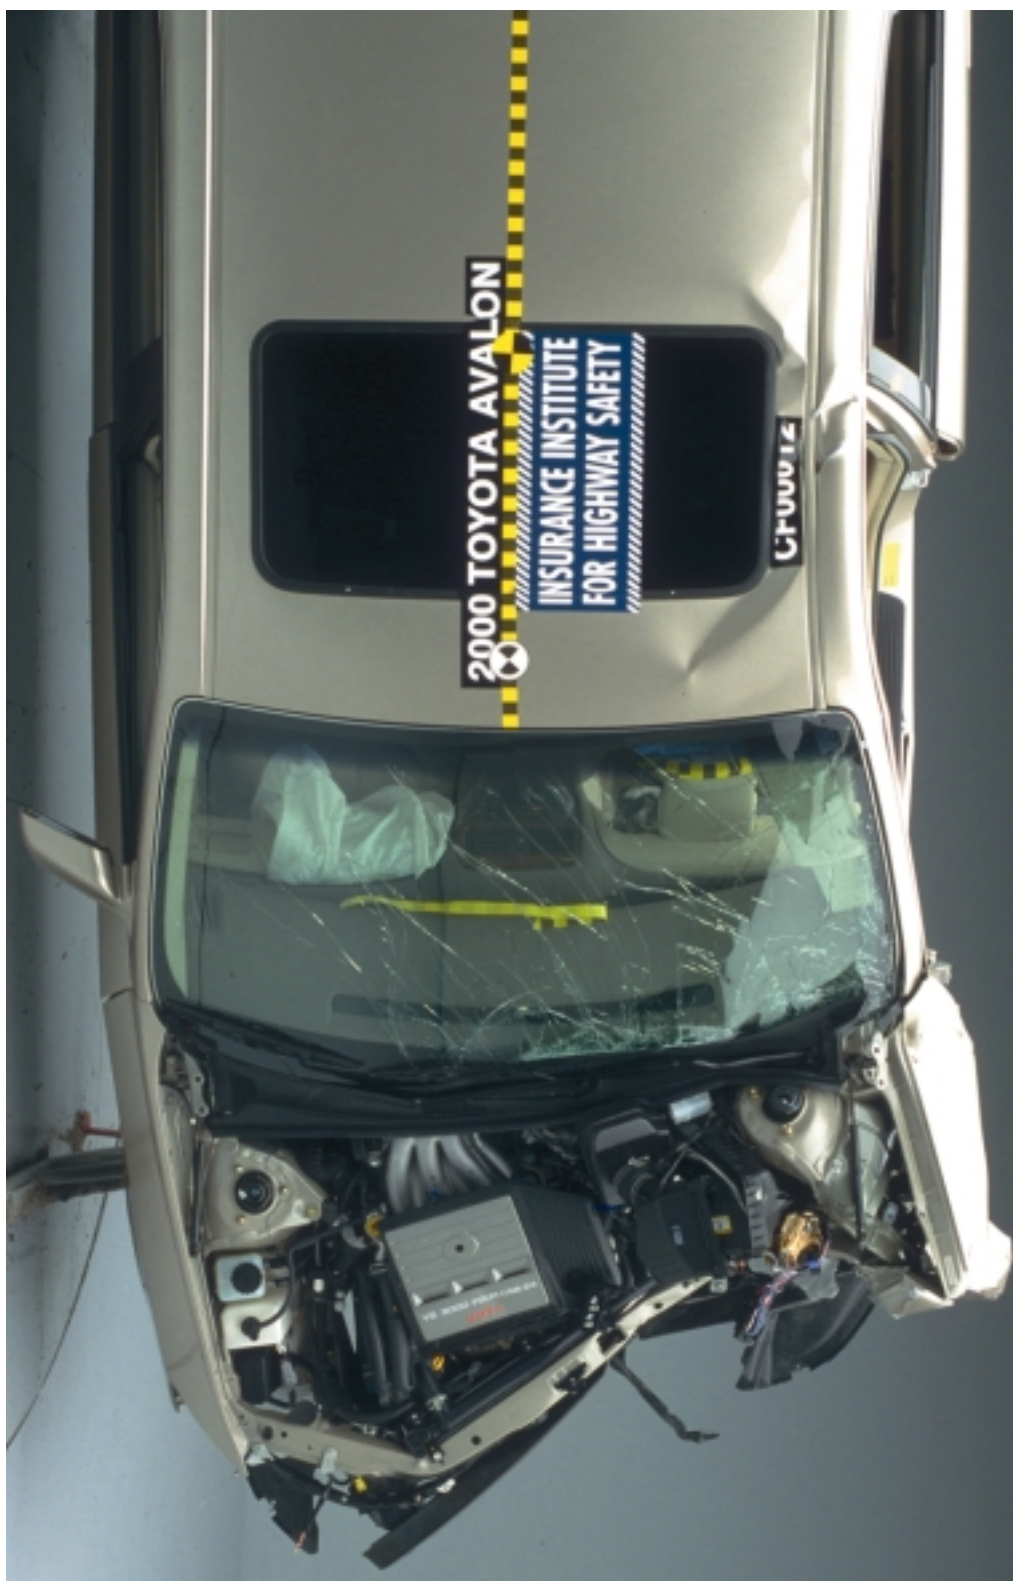
**Figure 2**  
**Overhead View of Crash Deformation — 2000 Toyota Avalon**

Figure 2 shows the overhead view of the crash deformation. Figure 3 illustrates the precrash and postcrash contour measures of the front bumper cover profile and the resulting permanent crush. Figure 4 shows the precrash and postcrash views from below. Figure 5 illustrates the deformation of the side rails, door sills, and engine cradle, which are visible in Figure 4.

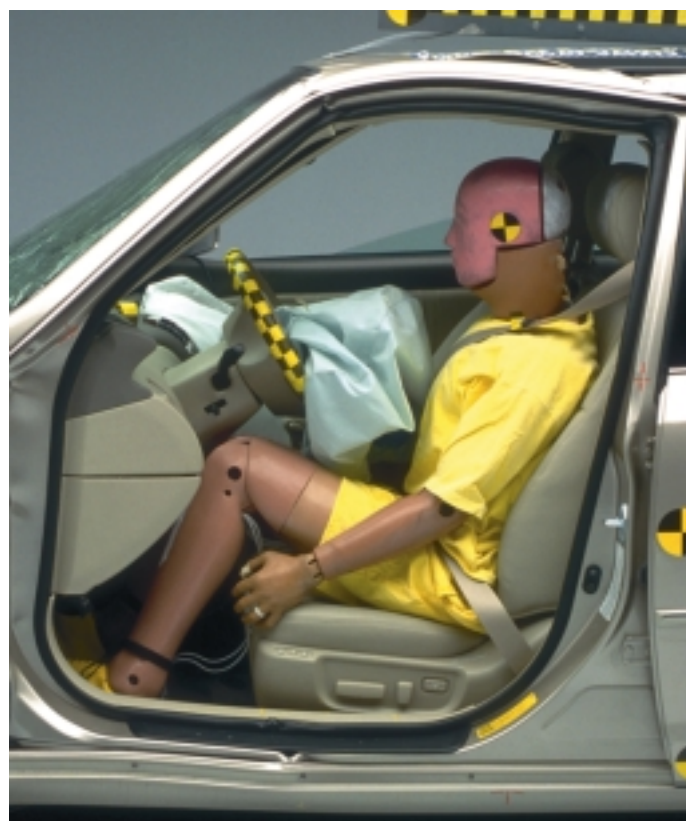
**Figure 6**  
**Dummy and Vehicle Interior, Postcrash — 2000 Toyota Avalon**

Analysis of the high-speed film taken from camera position E indicated the deploying airbag contacted the dummy's face at 54 ms into the crash and then receded by 58 ms. The dummy's face began to load the airbag at 72 ms (4 ms after the airbag became fully inflated). Paint transferred from the dummy's face indicated the nose contacted the airbag 1 cm directly to the right of its center. As the head moved into the airbag, it moved downward and tilted to the left. On rebound from the airbag, the head moved upward, and the left upper rear part of the head contacted the upper B-pillar trim (which had come loose earlier in the crash) at 217 ms. The head continued upward and rearward, pushing the B-pillar trim rearward as the neck began to

extend rearward. The center rear of the head contacted the head restraint upper outboard quadrant at 248 ms; as the neck continued to extend, the left upper front and top right parts of the head contacted the grab handle and roof rail, respectively, just ahead of the B-pillar at 270 ms. Table 2 provides the timing of these events.
