# Insurance Institute for Highway Safety Crashworthiness Evaluation

## Crash Test Report 2000 Lincoln LS (CF00017)

**Vehicle identification number:** 1LNHM87AXYY878774  
**Body style:** Large 4-door sedan  
**Engine/transmission:** Longitudinal 3.9-liter V-8, 5-speed automatic,  
rear-wheel drive

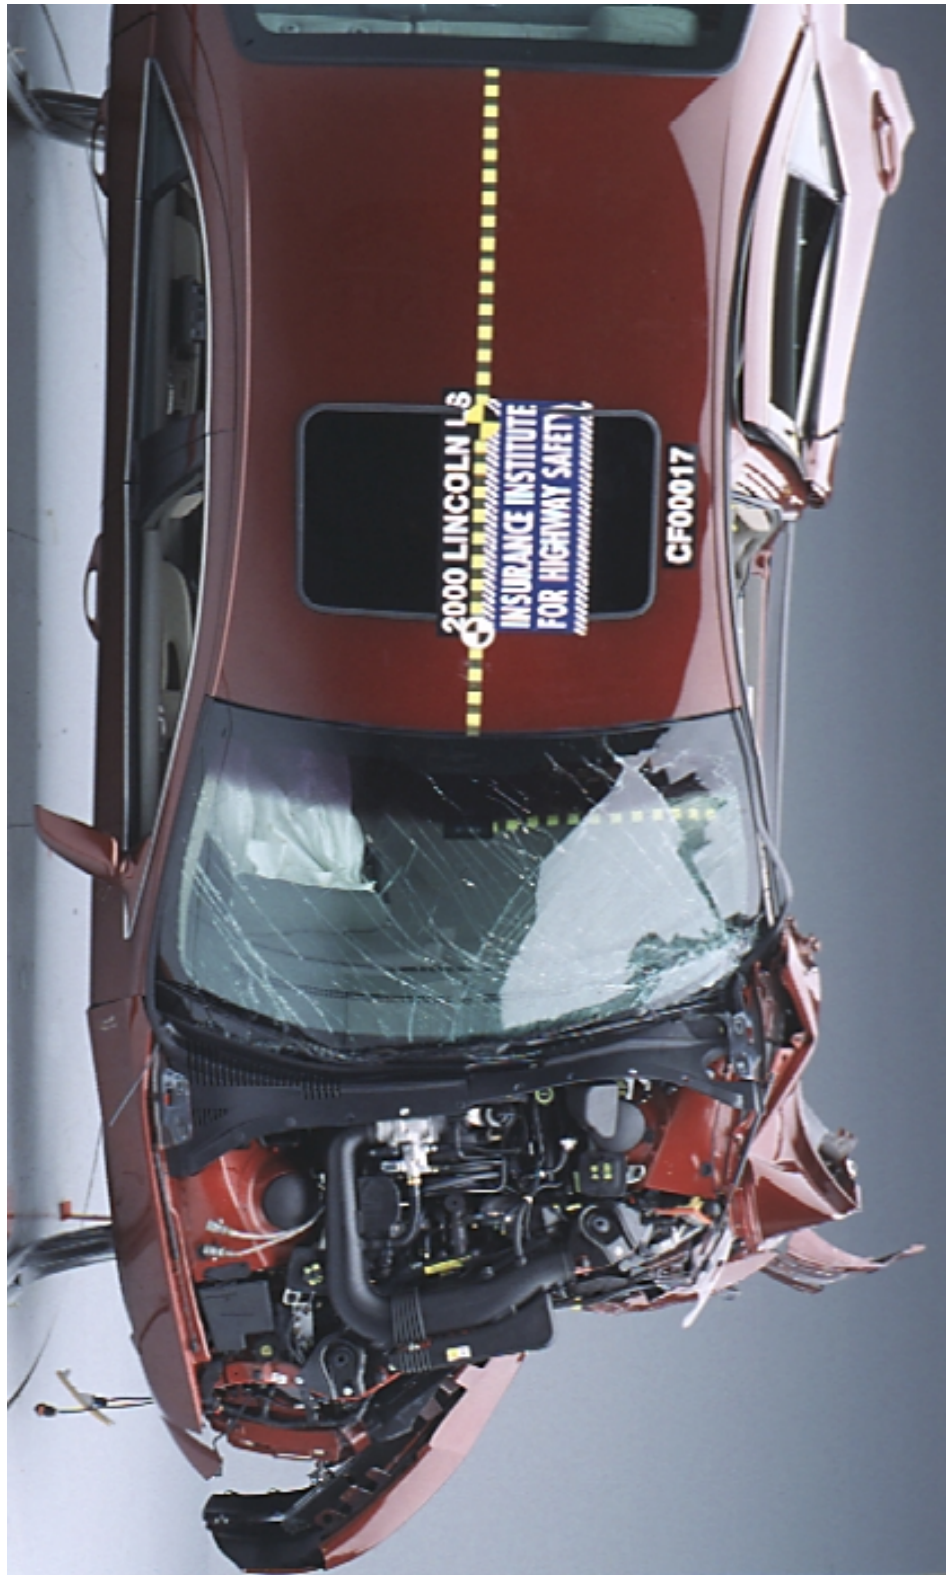
**Figure 2**  
**Overhead View of Crash Deformation — 2000 Lincoln LS**

Figure 2 shows the overhead view of the crash deformation. Figure 3 illustrates the precrash and postcrash contour measures of the front bumper cover profile and the resulting permanent crush. Figure 4 shows the precrash and postcrash views from below. Figure 5 illustrates the deformation of the side rails, doorsills, and engine cradle, which are visible in Figure 4.

The floor underneath and behind the driver's seat was severely buckled. A 51-cm length of the spot-welded seam between the left side of the floorpan and rocker panel, under the B-pillar, was split apart.
