Insurance Institute for Highway Safety Crashworthiness Evaluation

Crash Test Report 2000 Nissan Sentra (CF00016)

Vehicle identification number: 3N1CB51D8YL304992
Body style: Small 4-door sedan
Engine/transmission: Transverse 1.8-liter 4-cylinder, 4-speed automatic,
front-wheel drive

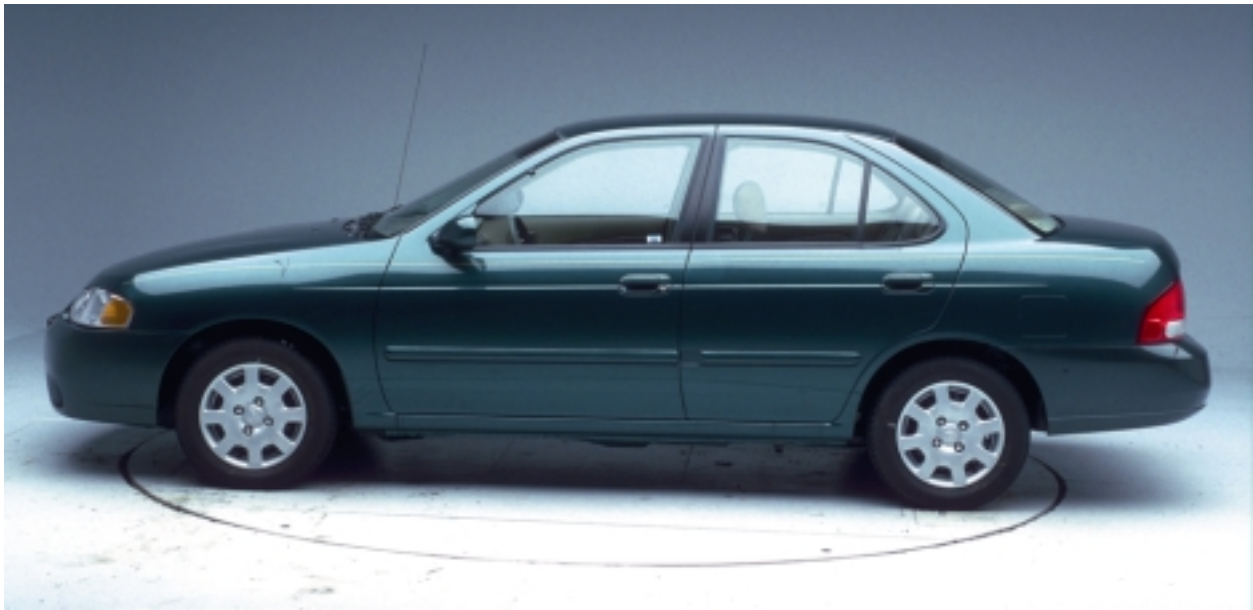
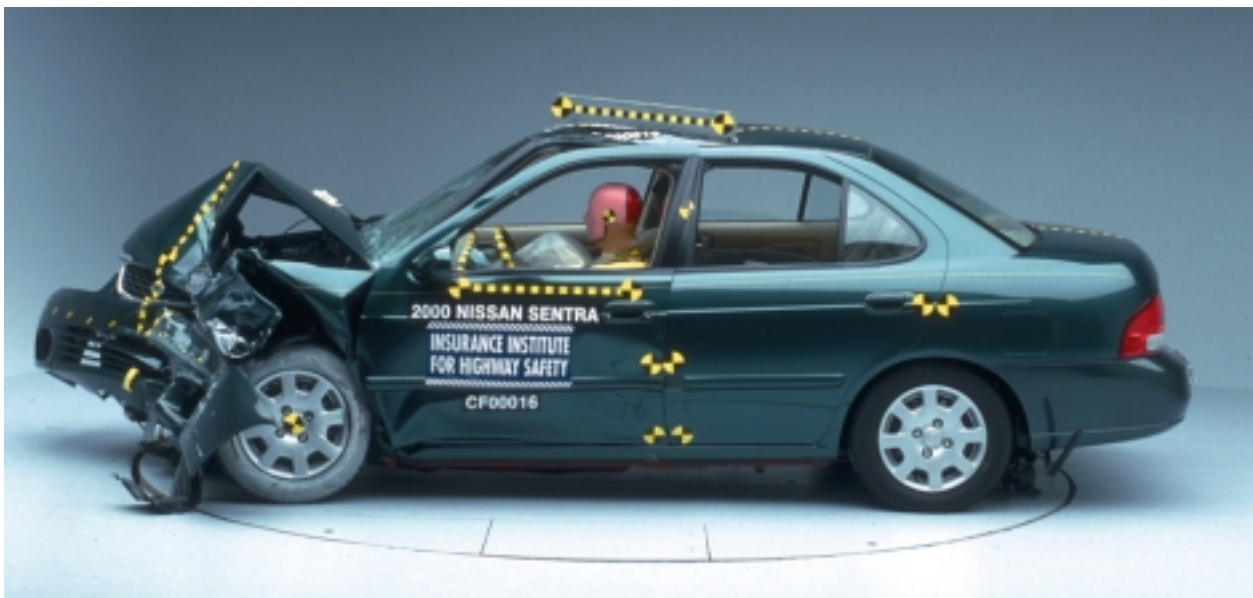
Figure 1
Precrash and Postcrash Side Views – 2000 Nissan Sentra

A 2000 Nissan Sentra was crash tested on May 2, 2000 into a fixed deformable barrier at 39.8 mi/h (64.0 km/h) and a 41 percent overlap on the driver side. A Hybrid III 50th percentile male dummy was positioned in the driver seat with the lap/shoulder belt fastened.

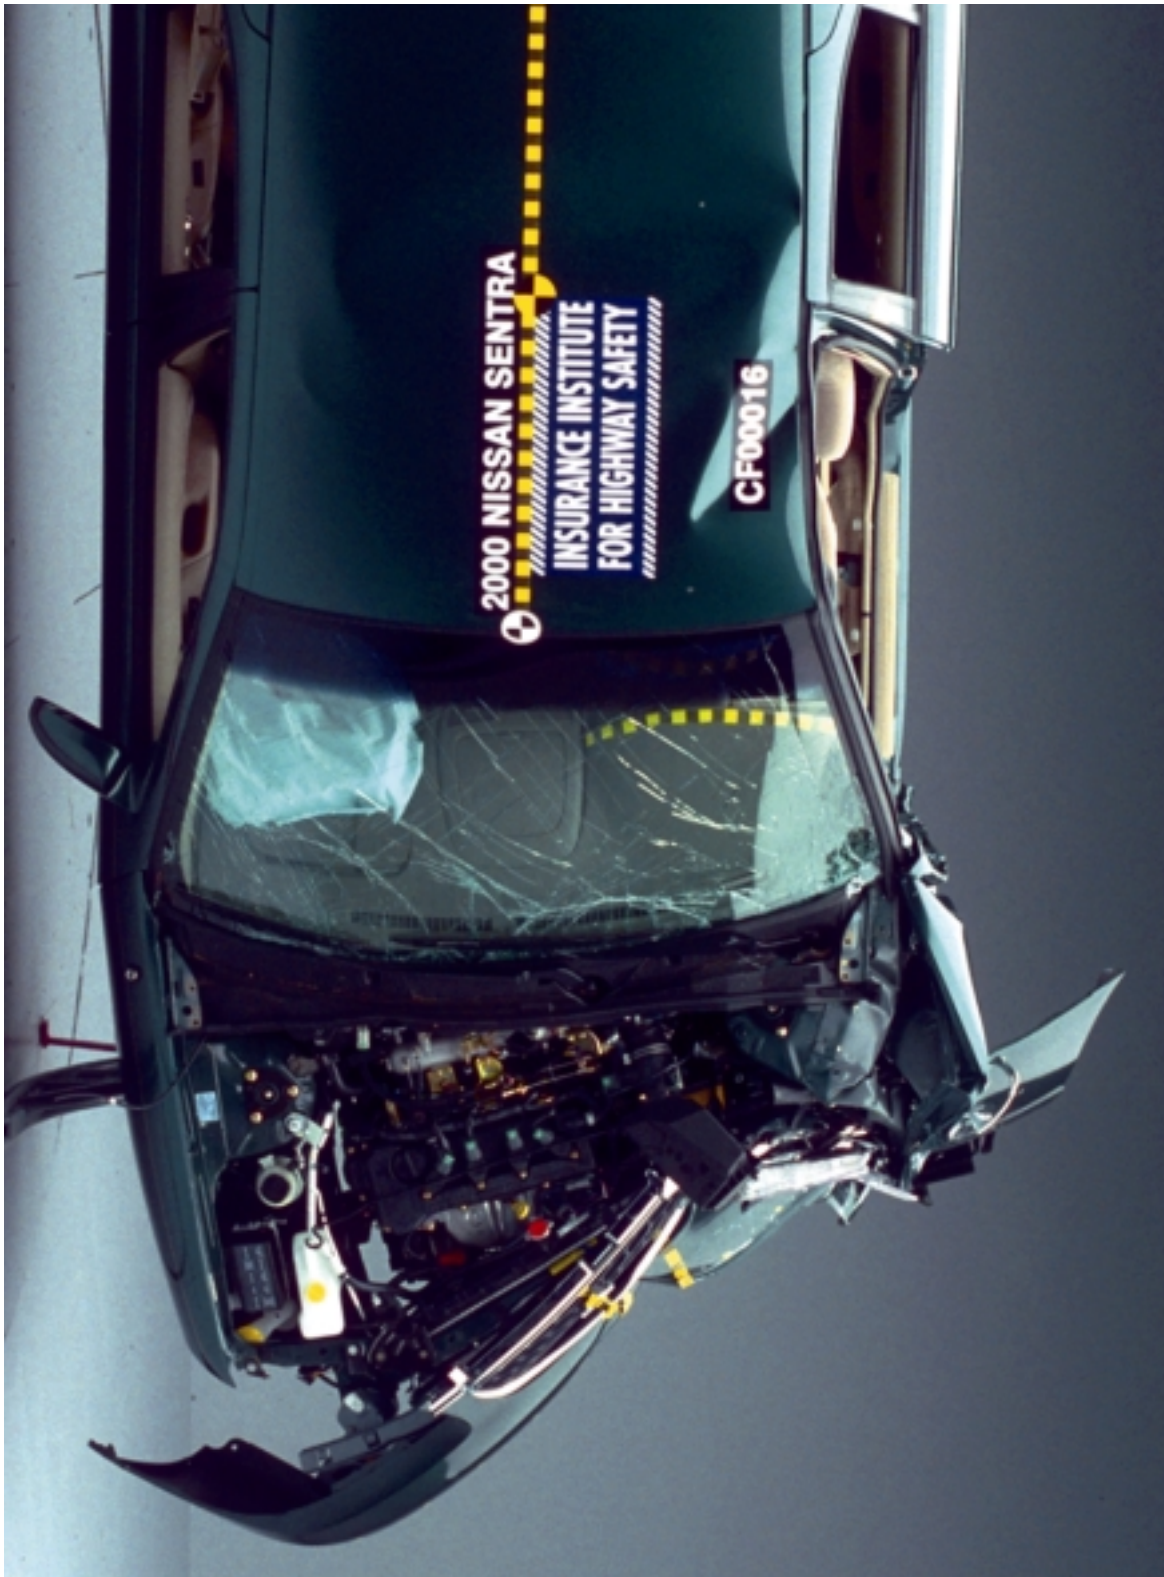
Figure 2
Overhead View of Crash Deformation – 2000 Nissan Sentra

Figure 2 shows the overhead view of the crash deformation. Figure 3 illustrates the precrash and postcrash contour measures of the front bumper cover profile and the resulting permanent crush. Figure 4 shows the precrash and postcrash views from below. Figure 5 illustrates the deformation of the side rails, door sills, and radiator and engine supports, which are visible in Figure 4.

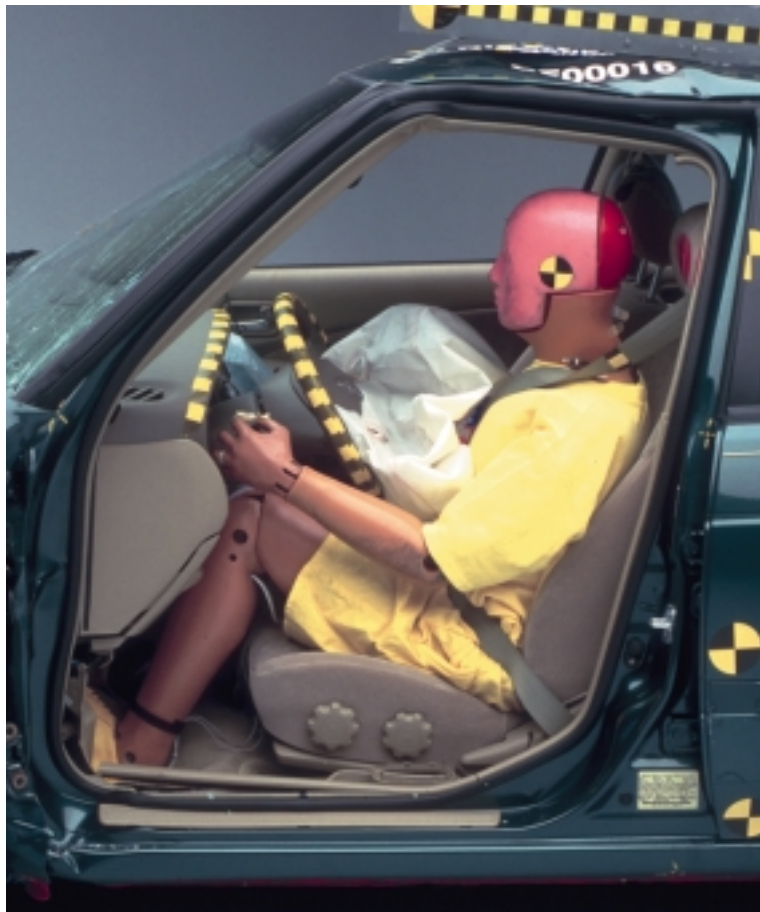
Figure 6
Dummy and Vehicle Interior, Postcrash – 2000 Nissan Sentra

Analysis of the high-speed film taken from camera position E indicated the deploying airbag contacted the dummy's face at 34 ms into the crash. The dummy's face began to load the airbag at 54 ms, about when the airbag became fully inflated. Paint transferred from the dummy's face indicated the nose contacted the center of the airbag. On rebound from the airbag, the head moved outboard, and the center rear part of the head contacted the upper B-pillar at 235 ms (time determined from head acceleration data). The head then moved inboard as the dummy settled back into the seat. Table 2 provides the timing of these events.

Left leg and foot: Paint transferred from the dummy's left knee indicated the knee contacted the instrument panel 2 cm directly above the left instrument panel intrusion reference point. The knee also contacted the lower left corner of the steering column trim. Paint transferred from the dummy's left shin indicated the shin contacted the bolster below the knee impact location on the instrument panel. The shin also contacted the edge of the coin storage compartment door. The left foot was found fully dorsiflexed and considerably everted, with the sole of the forefoot suspended over the footrest and the back of the heel resting in a downward buckle in the floormat/carpeting on the floorpan.

Right leg and foot: Paint transferred from the dummy's right knee indicated the knee contacted the steering column and ignition switch. The ignition key was bent, and the small plastic trim panel around the ignition switch was found dislodged and caught between the knee and shin skin. Paint transferred from the dummy's right shin indicated the shin contacted the knee bolster below and to the left of the right instrument panel intrusion reference point. The right foot was found slightly dorsiflexed and somewhat everted. The sole at the heel was pressed against the intruded toepan, and the lateral edge of the forefoot was touching the accelerator pedal, which had been bent to the right.
