# Insurance Institute for Highway Safety Crashworthiness Evaluation

## Crash Test Report 2000 Nissan Maxima (CF00015)

**Vehicle identification number:** JN1CA31A0YT214504  
**Body style:** Midsize 4-door sedan  
**Engine/transmission:** Transverse 3.0-liter, 4-speed automatic,  
front-wheel drive

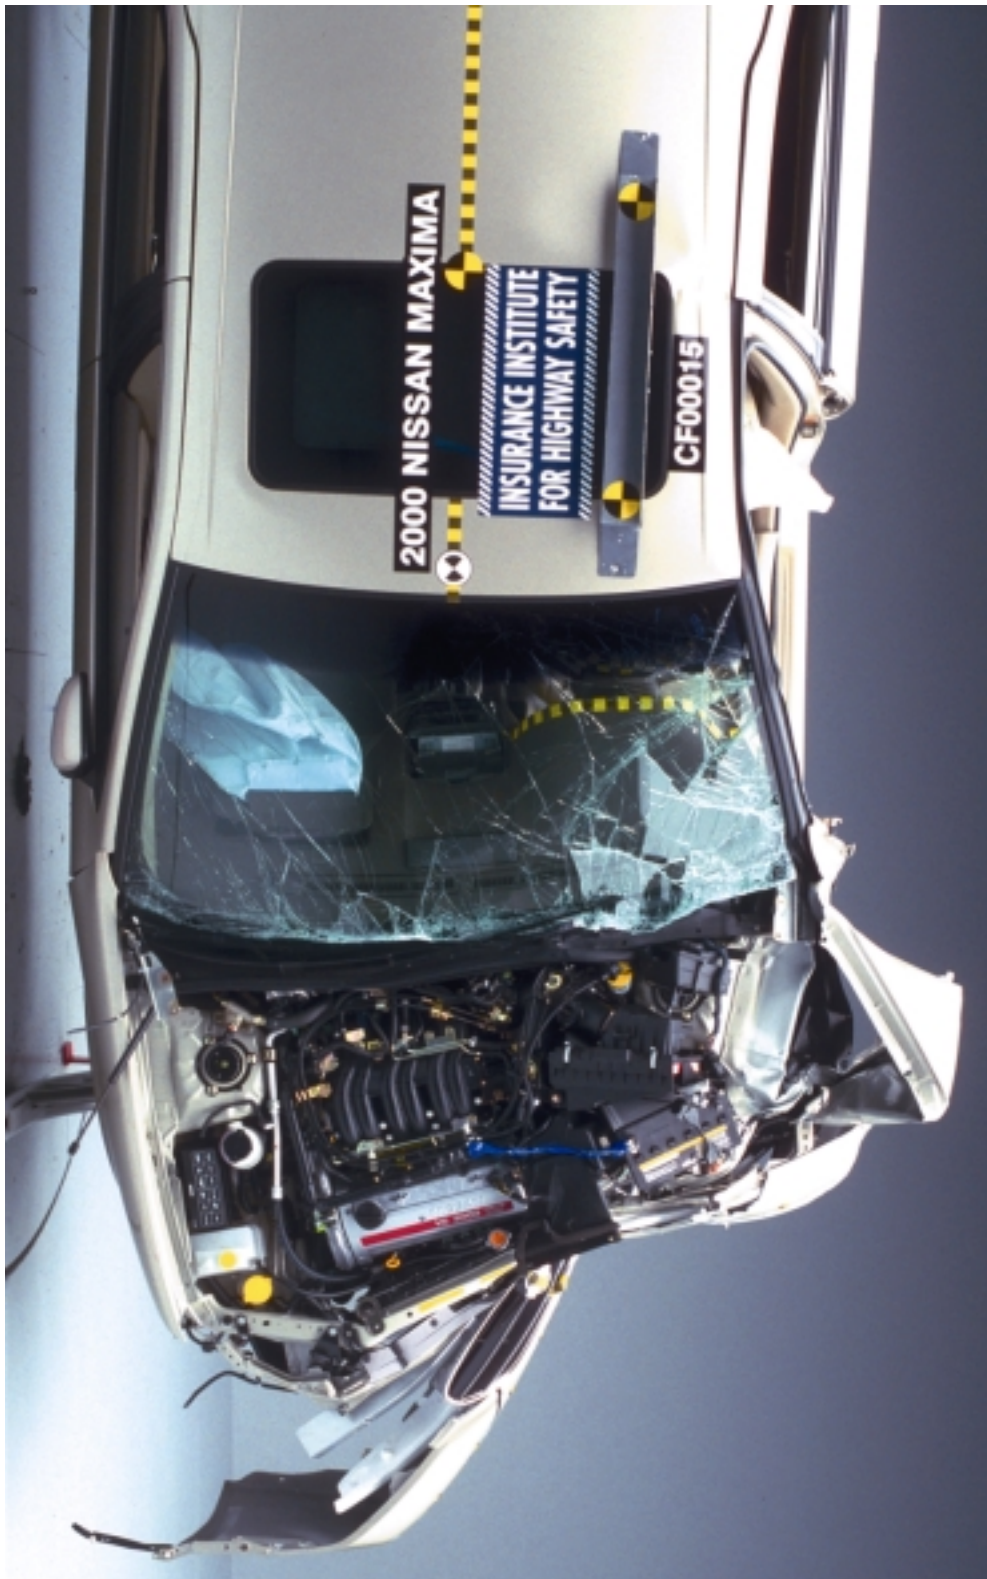
Figure 2  
Overhead View of Crash Deformation – 2000 Nissan Maxima

Figure 2 shows the overhead view of the crash deformation. Figure 3 illustrates the precrash and postcrash contour measures of the front bumper cover profile and the resulting permanent crush. Figure 4 shows the precrash and postcrash views from below. Figure 5 illustrates the deformation of the side rails, door sills, and radiator and engine supports, which are visible in Figure 4.

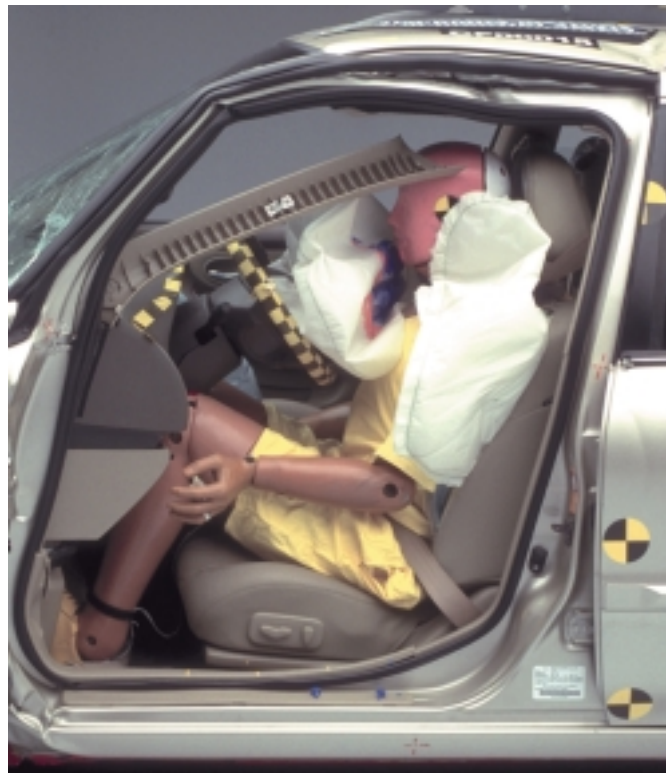
**Figure 6**  
**Dummy and Vehicle Interior, Postcrash – 2000 Nissan Maxima**

Postcrash examination of the driver seat rails indicated no discernible movement of the seat in its tracks during the crash. Deformation of the floor under the driver seat caused the seat to pitch forward somewhat and to tip outboard into contact with the B-pillar.

upper outboard part of the head restraint, but the deployed side airbag obscured the view of this contact. There was no contact between the dummy and the side airbag. Table 2 provides the timing of these events.
