# Insurance Institute for Highway Safety Crashworthiness Evaluation

## Crash Test Report 1998 Nissan Frontier (CF98005)

**Vehicle identification number:** 1N6DD21S6WC314905  
**Body style:** Small pickup with short bed and regular cab  
**Engine/transmission:** Longitudinal 2.4-liter 4-cylinder, 5-speed manual, rear-wheel drive

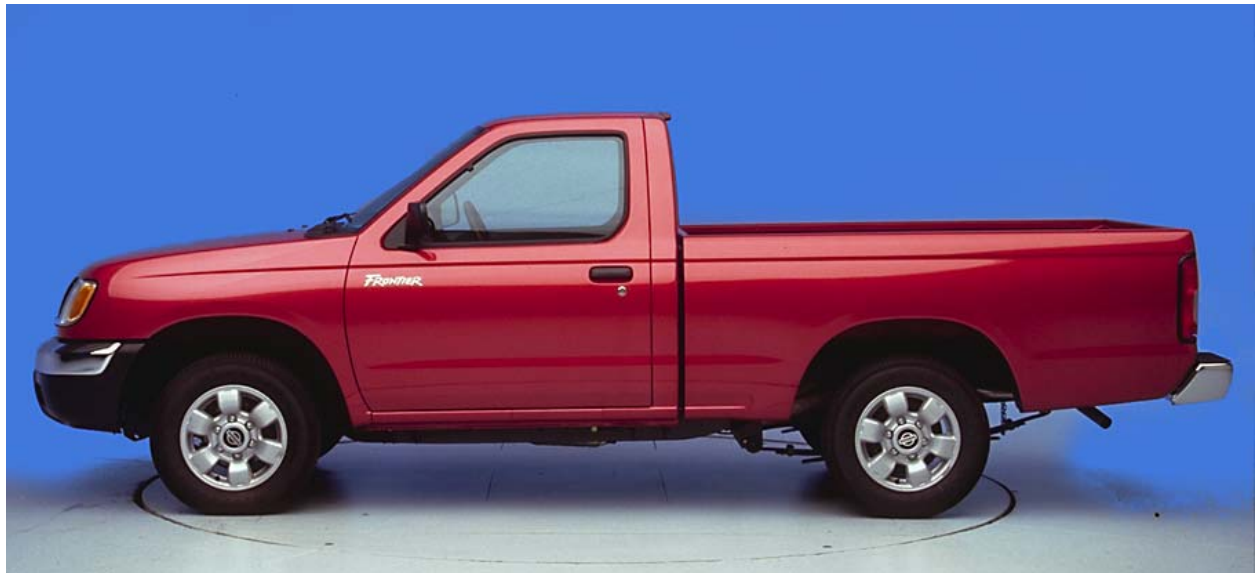
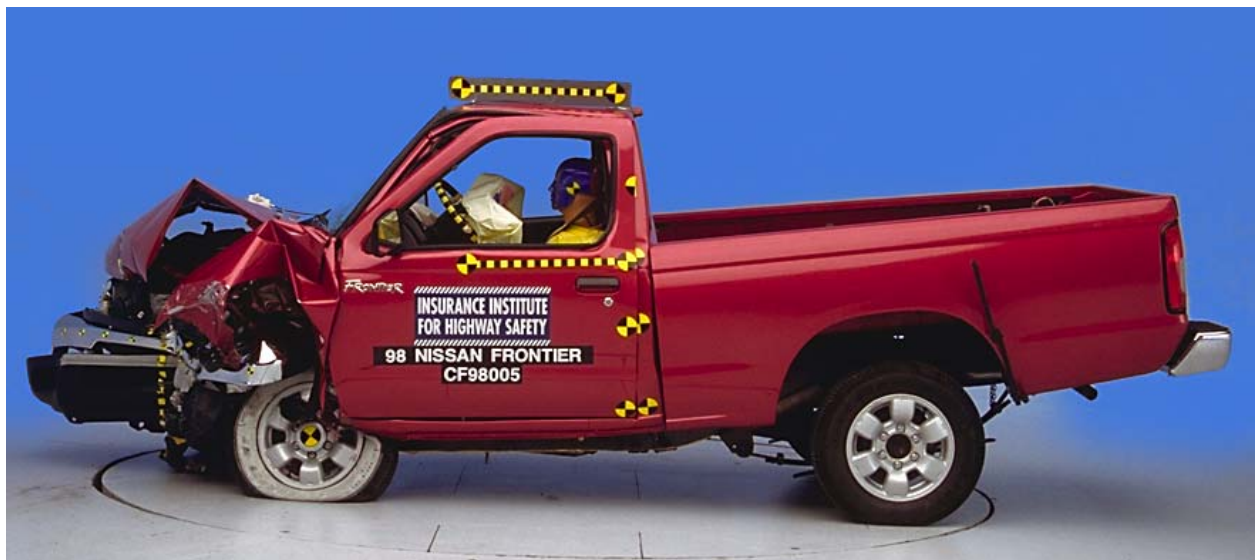
**Figure 1**  
**Precrash and Postcrash Side Views — 1998 Nissan Frontier**

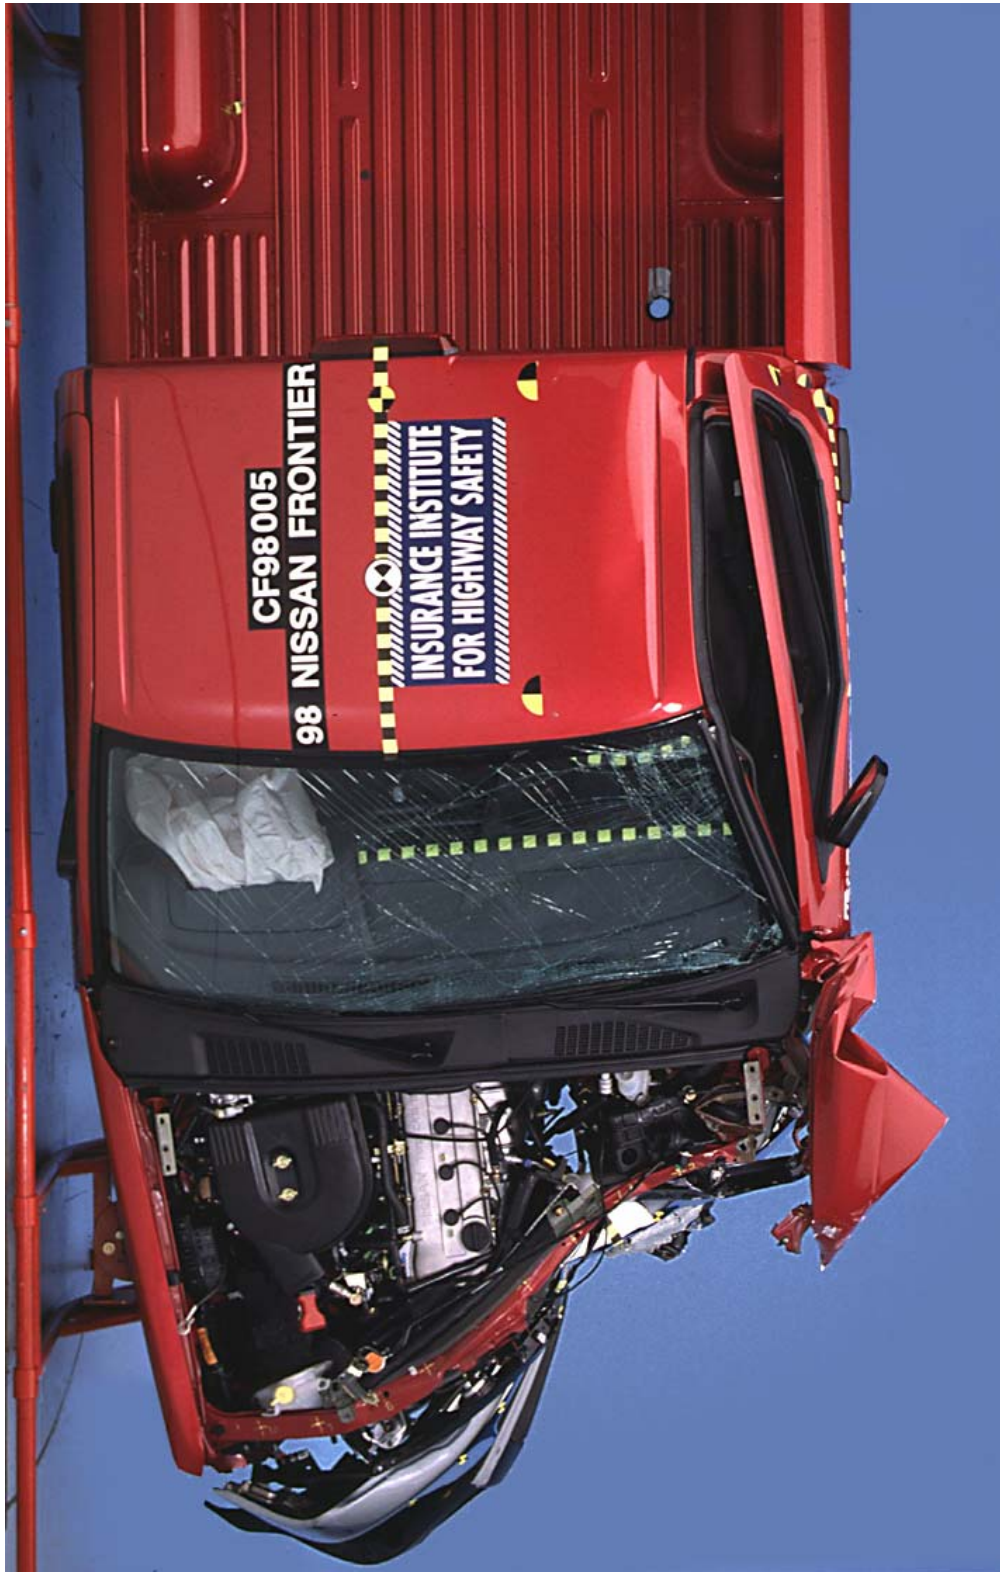
**Figure 2**  
**Overhead View of Crash Deformation — 1998 Nissan Frontier**

Figure 2 shows the overhead view of the crash deformation. Figures 3 and 4 illustrate the precrash and postcrash contour measures of the front bumper face bar and the upper crossmember of the radiator support. Figure 5 shows the precrash and postcrash views from below. Figure 6 illustrates the deformation of the frame rails, crossmembers, and door sills, which are visible in Figure 5.

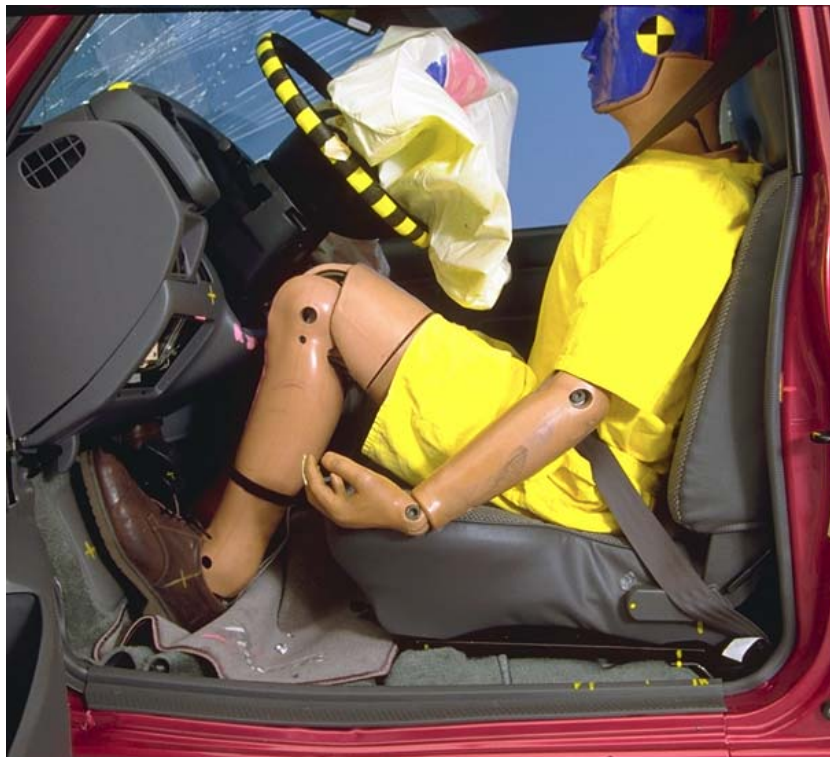
**Figure 7**  
**Dummy and Vehicle Interior, Postcrash — 1998 Nissan Frontier**

**Left leg and foot:** Paint transferred from the dummy's left knee indicates the knee primarily contacted the left side and bottom of the steering column plastic trim. A small amount of paint was transferred to the left underside of the airbag module near the column. Paint transferred from the dummy's left shin indicates the shin contacted both the flat area of the knee bolster, including the fuse box cover, to the left of the steering column and the bolster's protrusion around the column. The left foot was found fully dorsiflexed and slightly everted, with the back of the heel on the floormat/carpeting and the sole away from the intruded toepan.

**Right leg and foot:** Paint transferred from the dummy's right knee indicates the knee contacted the lower right corner of the steering column trim and the right edge of the knee bolster's protrusion around the steering column. Paint transferred from the dummy's right shin indicates the shin contacted the bolster below the right knee impact location. The outside edge of the shin contacted the hand-operated parking brake lever recessed in the bolster to the right of the column. The right foot was found fully dorsiflexed and slightly everted, with the sole from the heel through the arch pressed against the intruded toepan. The lateral edge of the heel was against the transmission tunnel, and the lateral edge of the foot near the toes was underneath the center console side trim.
