Insurance Institute for Highway Safety Crashworthiness Evaluation

Crash Test Report 1998 Jeep Wrangler (CF98008)

Vehicle identification number: 1J4FY29P7WP760709
Body style: Small two-door utility vehicle
Engine/transmission: Longitudinal, 2.5-liter 4-cylinder, 5-speed manual, 4-wheel drive

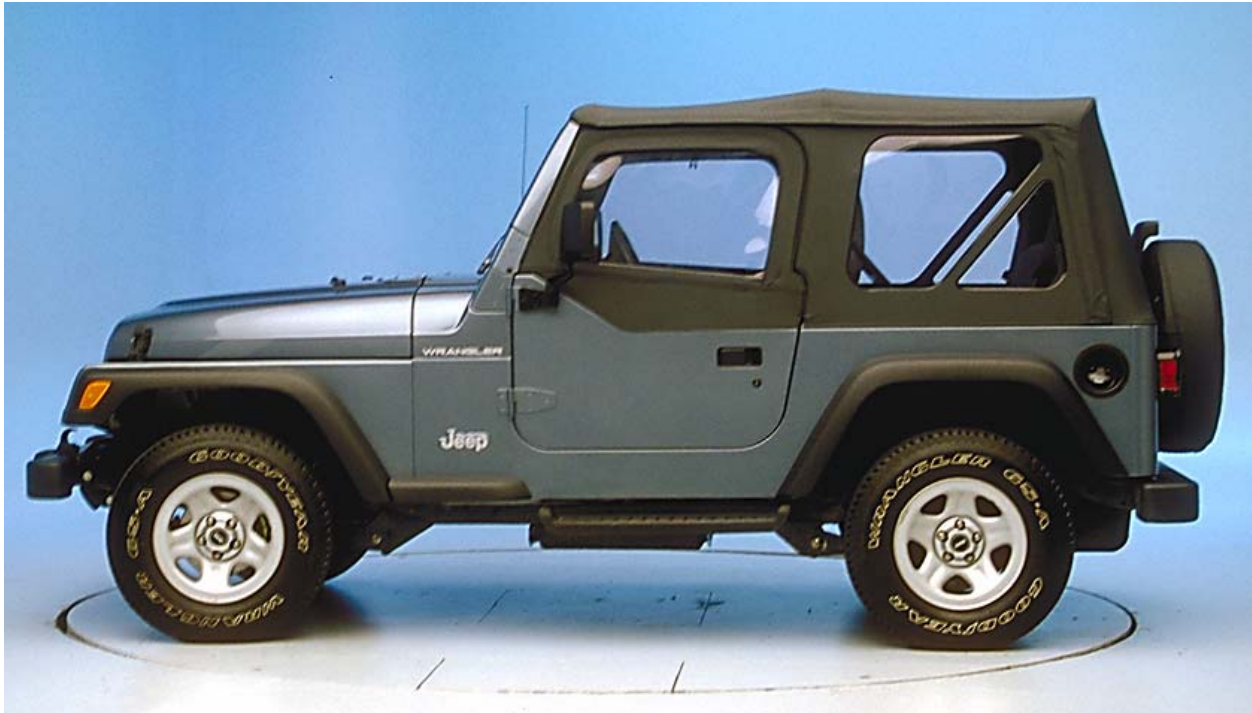
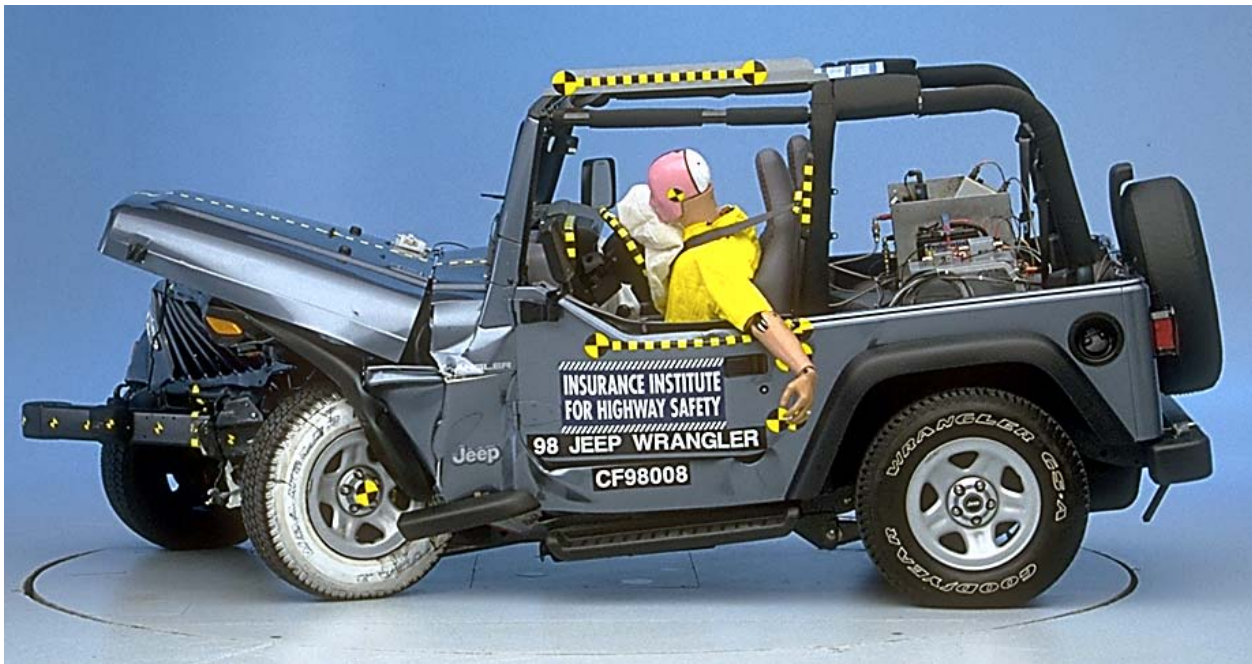
Figure 1
Pre-crash and Post-crash Side Views — 1998 Jeep Wrangler

A 1998 Jeep Wrangler was crash tested on April 14, 1998 into a fixed deformable barrier at 39.8 mi/h (64.1 km/h) and a 40 percent overlap on the driver side. A Hybrid III 50th percentile male dummy was positioned in the driver seat with the lap/shoulder belt fastened.

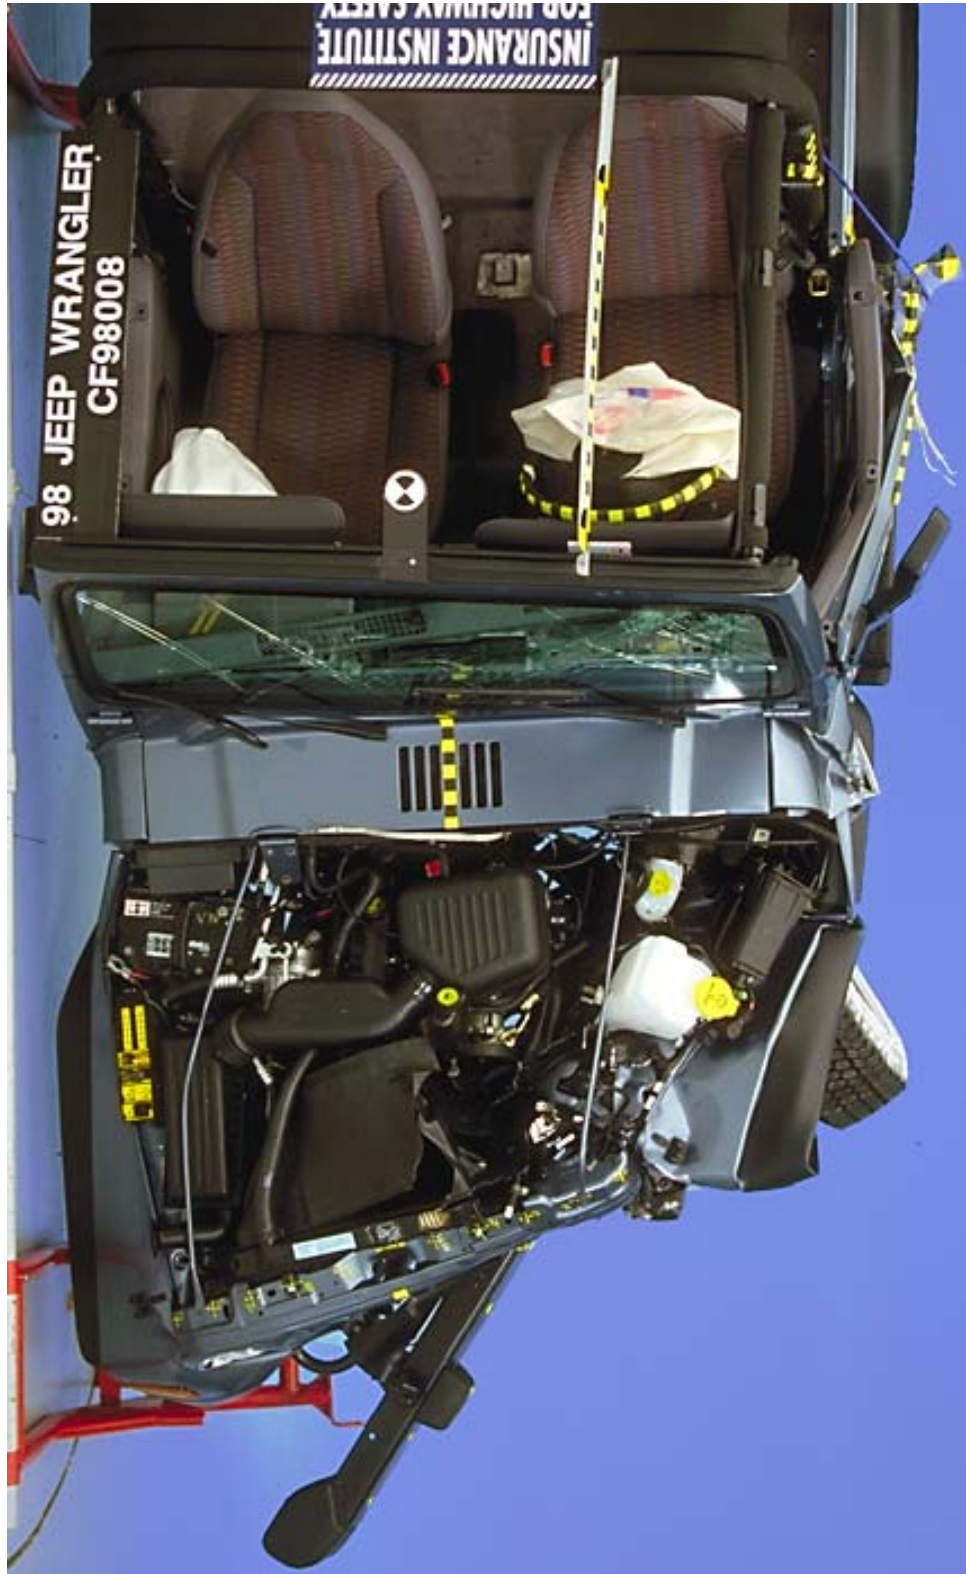
Figure 2
Overhead View of Crash Deformation — 1998 Jeep Wrangler

Figure 2 shows the overhead view of the crash deformation. Figures 3 and 4 illustrate the precrash and postcrash contour measures of the front bumper face bar and upper crossmember of the radiator support. Figure 5 shows the precrash and postcrash views from below. Figure 6 illustrates the deformation of the frame rails, door sills, and front crossmember, which are visible in Figure 5.

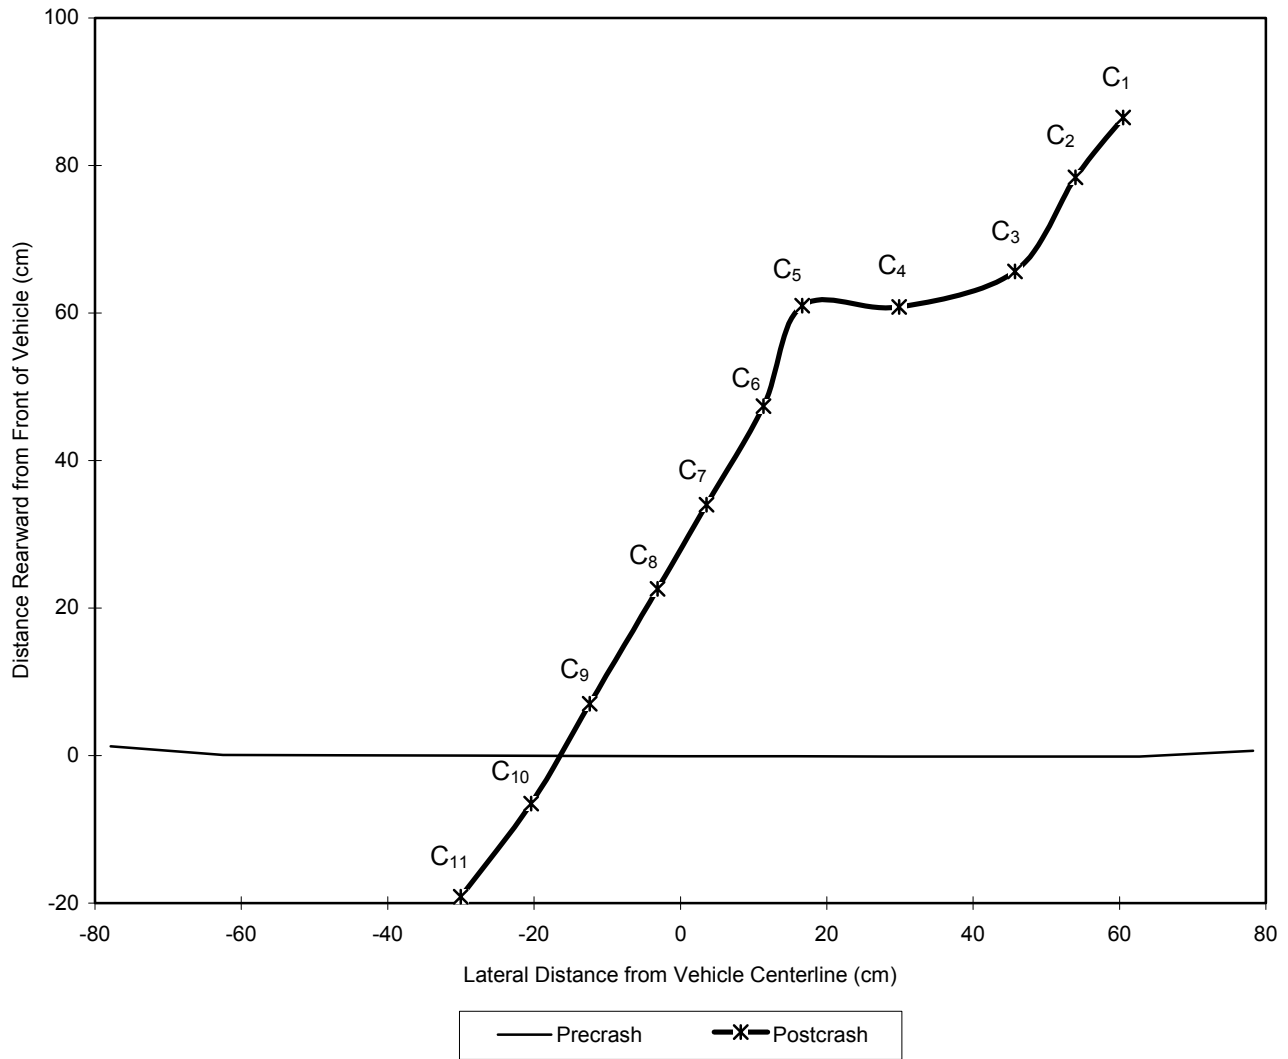
Figure 3
Front Bumper Bar Crush Contour — 1998 Jeep Wrangler

C₁	C₂	C₃	C₄	C₅	C₆	C₇	C₈	C₉	C₁₀	C₁₁
Postcrash Contour (cm)	87	78	66	61	61	47	34	23	7	-7	-19
Precrash Contour (cm)	1	0	0	0	0	0	0	0	0	0	1
Resulting Crush (cm)	86	78	66	61	61	47	34	23	7	-7	-20

The length of the reference line was 156 cm precrash and 91 cm postcrash.

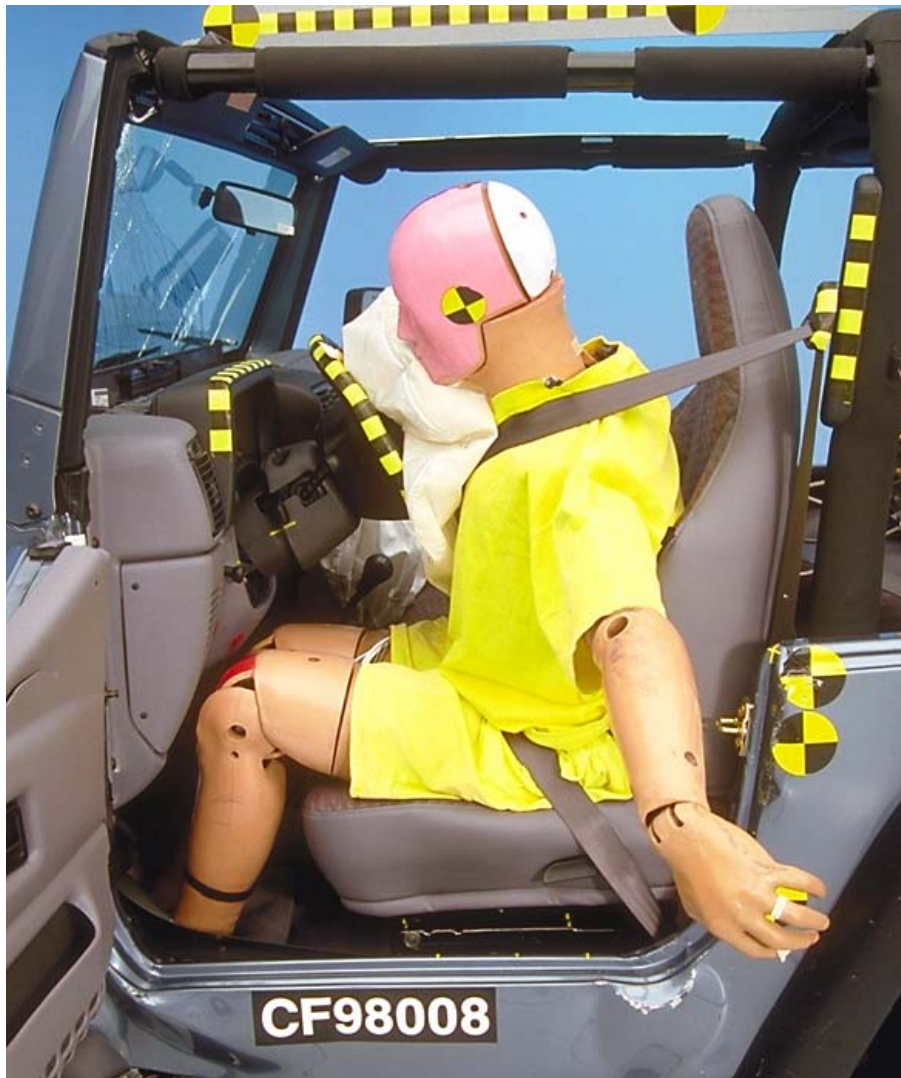
Figure 7
Dummy and Vehicle Interior, Postcrash — 1998 Jeep Wrangler

Left leg and foot: Paint transferred from the dummy's left knee indicated the knee primarily contacted the flat portion of the knee bolster to the left of the steering column, 4 cm above and 2 cm to the left of the left instrument panel intrusion reference point. A small amount of paint was transferred to the left edge of the bolster's protrusion around the steering column. The plastic bolster trim was undeformed, but the steel plate underlying the bolster was dented inward about 2 cm at the primary left knee impact location. Paint transferred from the dummy's left shin indicated the shin contacted the bolster on the flat area below the primary left knee impact location, extending downward to a separate lower section of the bolster. The plastic trim of this lower section was found cracked. The left foot was found fully dorsiflexed, slightly inverted, and externally rotated about 40 degrees. The left rear of the heel was pressed into a downward buckle of the floormat/carpeting, and the entire lateral edge of the sole was resting against the kick panel and buckled floormat/carpeting.

Right leg and foot: Paint transferred from the dummy's right knee indicated the knee contacted the knee bolster at and to the right of the bolster's protrusion around the steering column, 3 cm above and 3 cm to the left of the right instrument panel intrusion reference point. A much smaller amount of paint was transferred to the bolster's protrusion above and to the left of the primary right knee impact location. The underlying steel plate was not dented on its right side. Paint transferred from the dummy's right shin indicated the shin contacted the bolster directly below the primary right knee impact location; the shin also contacted the lowermost section of the bolster. The right foot was found fully dorsiflexed, slightly inverted, and externally rotated about 15 degrees. The back of the heel was pressed into a downward buckle in the floormat/carpeting, and the medial sole at the ball of the foot and the heel was touching the floormat on the intruded toepan.

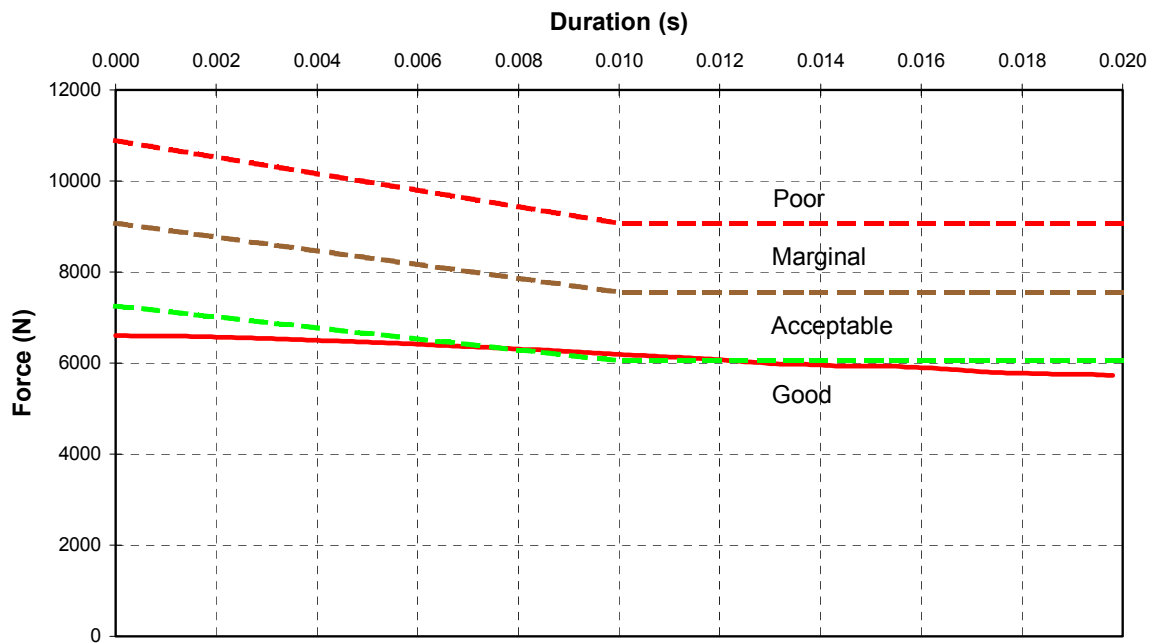
A-24 CF98008 1998 Jeep Wrangler Left Femur Axial Force Analysis

The left femur axial force reached a maximum of 6.6 kN and remained above 6.1 kN for 5 ms.
