# Insurance Institute for Highway Safety Crashworthiness Evaluation

## Crash Test Report 1998 Volkswagen New Beetle (CF98009)

**Vehicle identification number:** 3VWBB61C3WM005467  
**Body style:** Small two-door hatchback  
**Engine/transmission:** Transverse 2.0-liter 4-cylinder, 5-speed manual, front-wheel drive

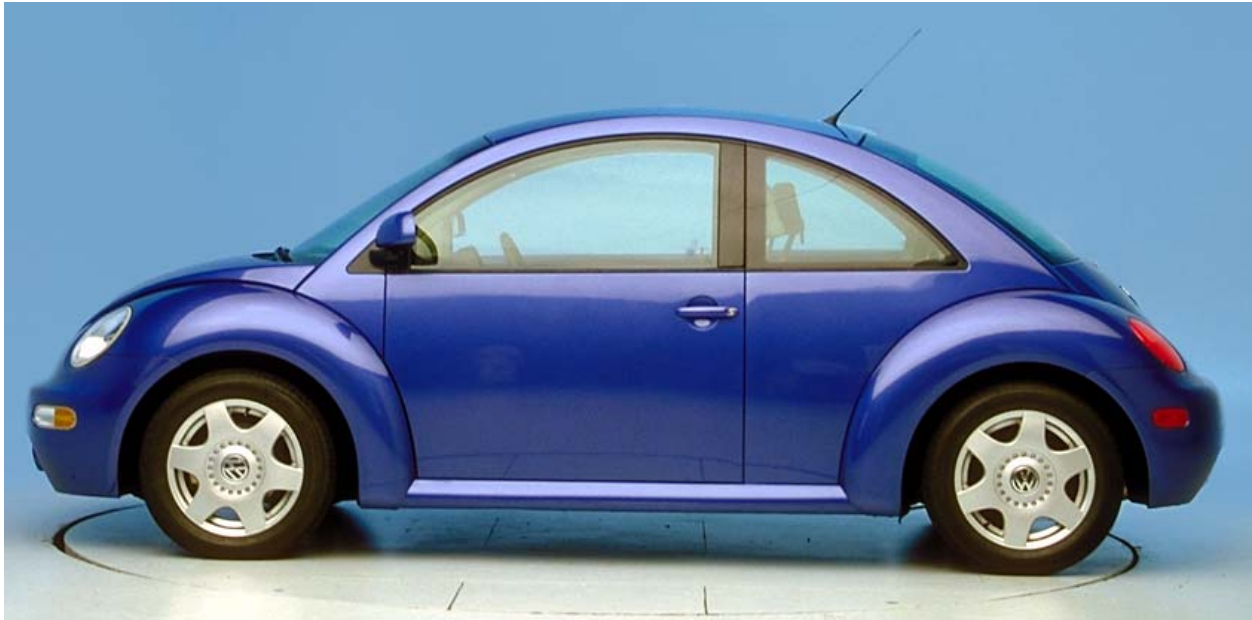
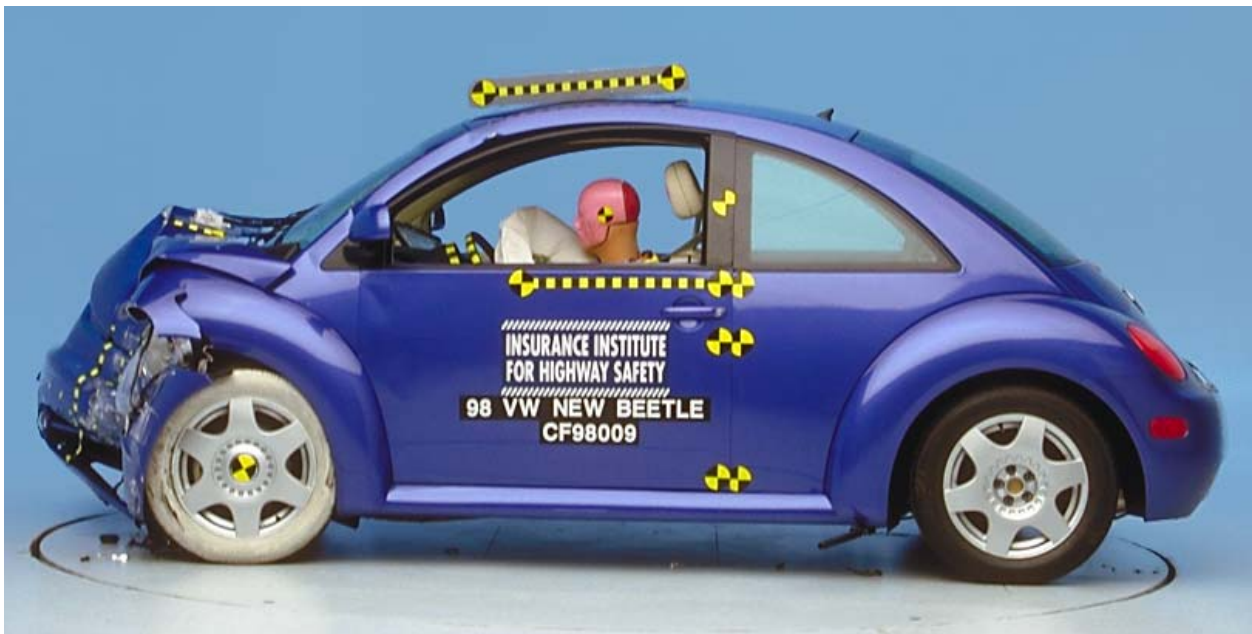
**Figure 1**  
**Precrash and Postcrash Side Views — 1998 Volkswagen New Beetle**

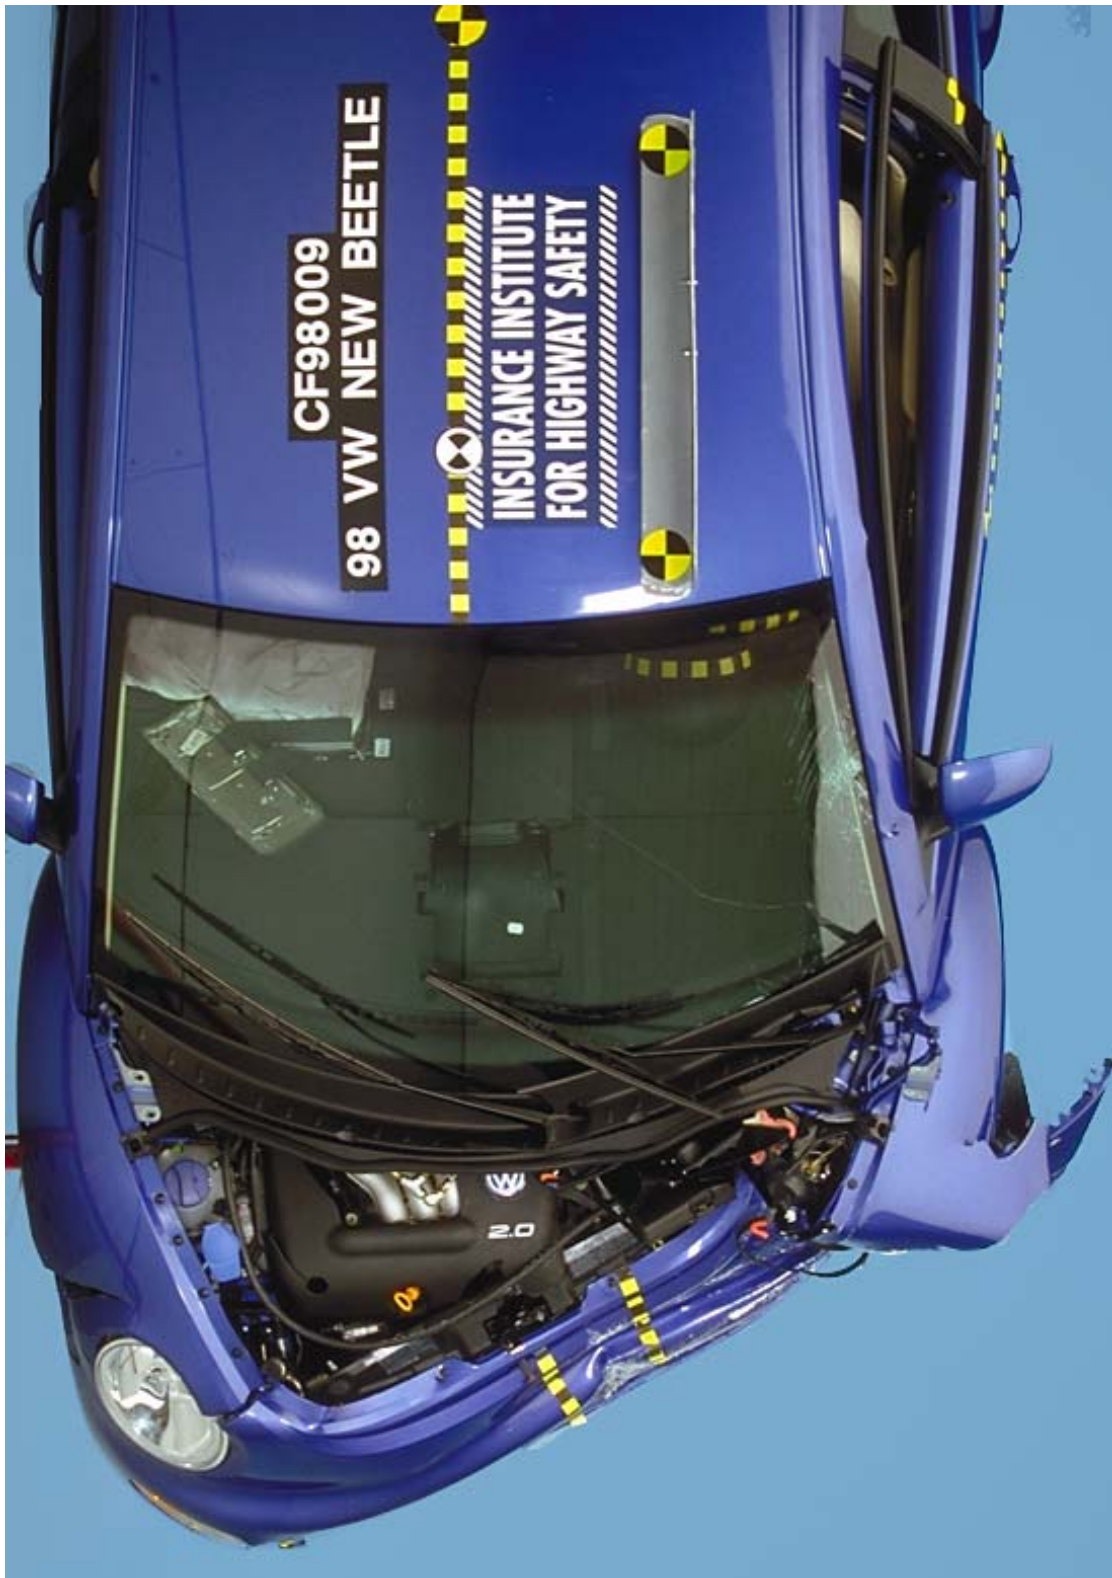
**Figure 2**  
**Overhead View of Crash Deformation — 1998 Volkswagen New Beetle**

Figure 2 shows the overhead view of the crash deformation. Figure 3 illustrates the precrash and postcrash contour measures of the front bumper cover and the resulting permanent crush. Figure 4 illustrates the corresponding measures of both the front bumper reinforcement bar and the upper crossmember of the radiator support. Figure 5 shows the precrash and postcrash views from below. Figure 6 illustrates the deformation of the side rails, door sills, and engine support, which are visible in Figure 5.

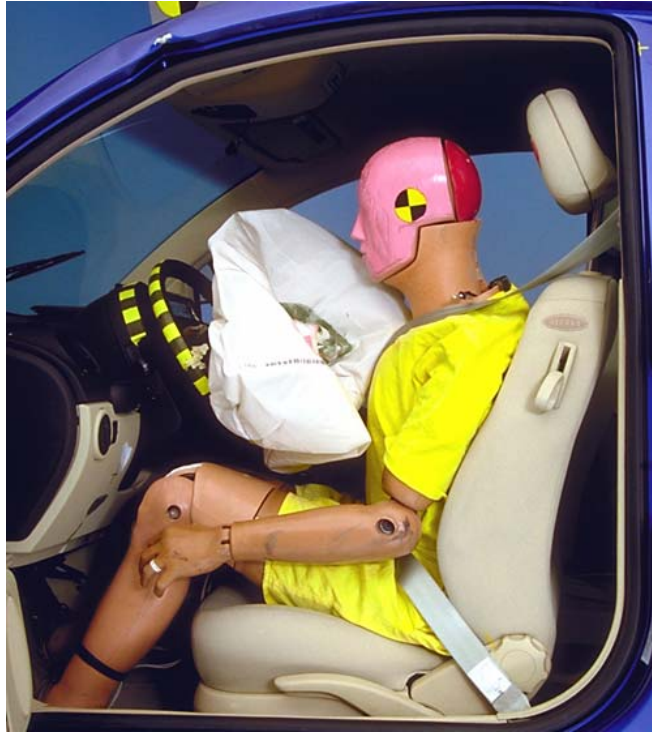
**Figure 7**  
**Dummy and Vehicle Interior, Postcrash — 1998 Volkswagen New Beetle**
