# Insurance Institute for Highway Safety Crashworthiness Evaluation

## Crash Test Report 1998 Jeep Cherokee (CF98012)

**Vehicle identification number:** 1J4FJ68S3WL223246  
**Body style:** Small four-door utility vehicle  
**Engine/transmission:** Longitudinal, 4.0-liter 6-cylinder, 4-speed automatic, 4-wheel drive

**Crash test date:**  
May 7, 1998

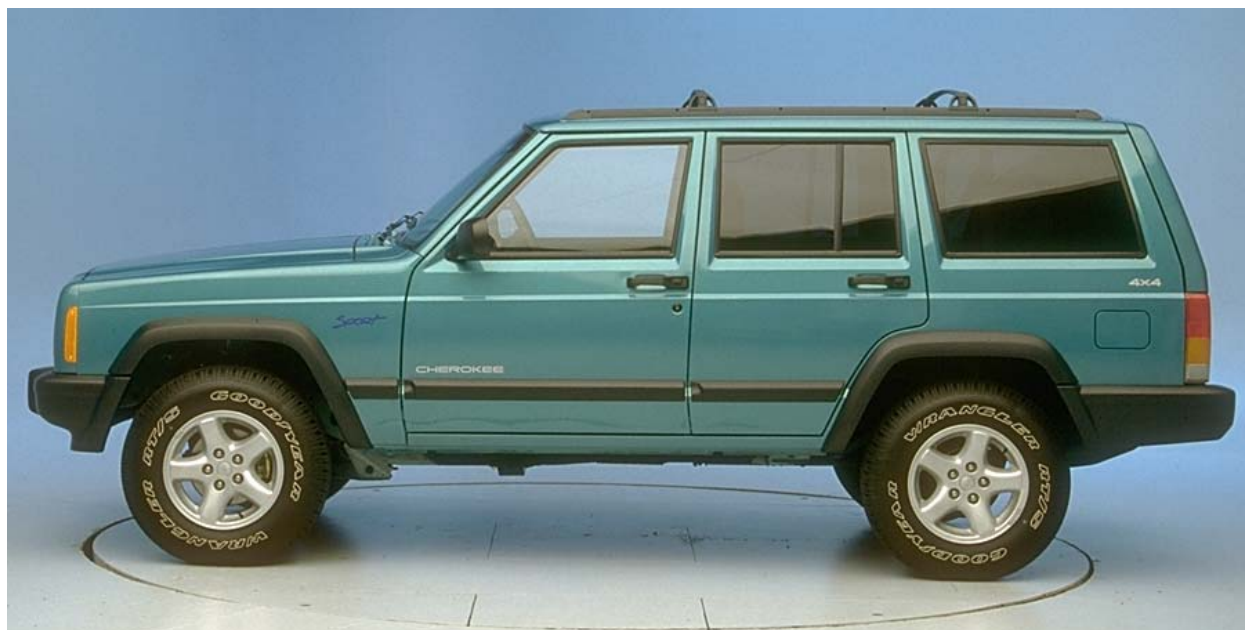
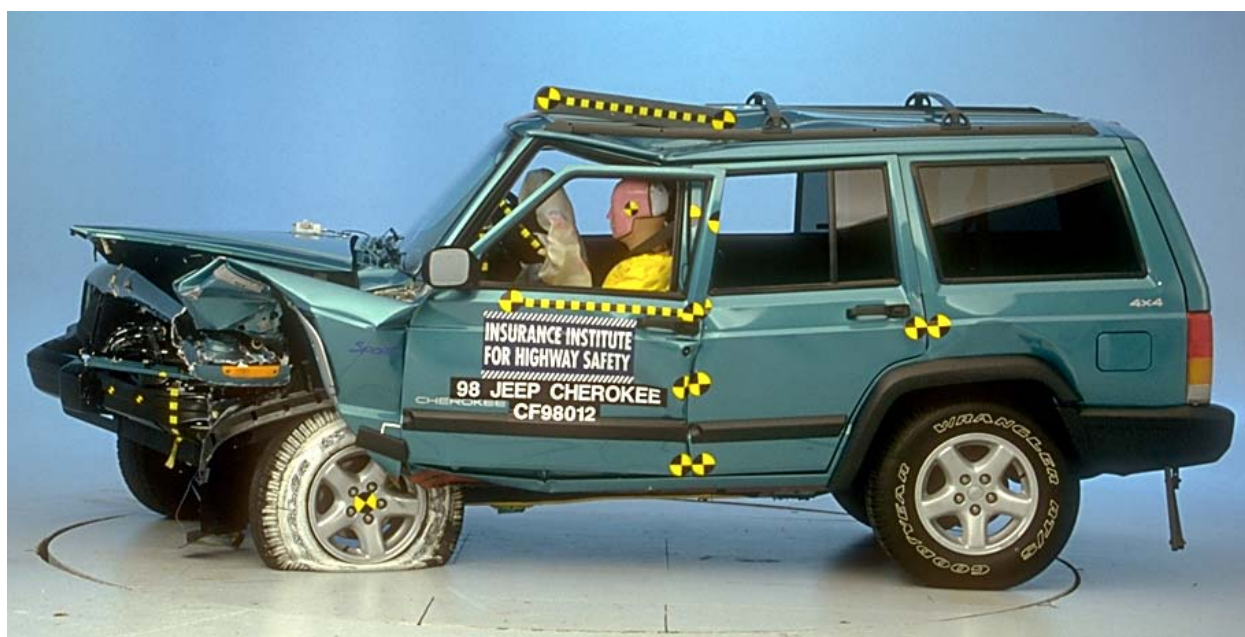
**Figure 1**  
**Precrash and Postcrash Side Views — 1998 Jeep Cherokee**

A 1998 Jeep Cherokee was crash tested on May 7, 1998 into a fixed deformable barrier at 39.9 mi/h (64.2 km/h) and a 39 percent overlap on the driver side. A Hybrid III 50th percentile male dummy was positioned in the driver seat with the lap/shoulder belt fastened.

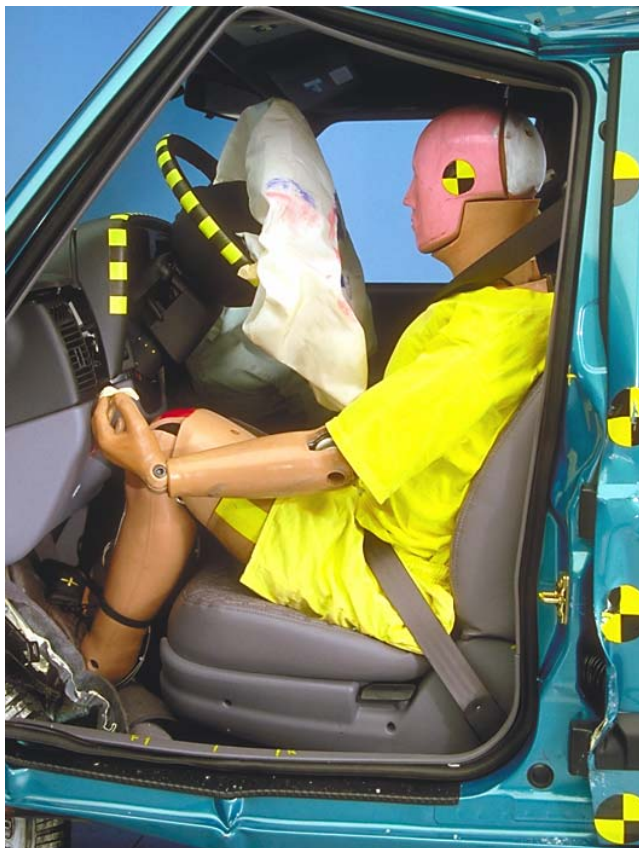
**Figure 7**  
**Dummy and Vehicle Interior, Postcrash — 1998 Jeep Cherokee**

Analysis of the high-speed film taken from camera positions D and E indicated the deploying airbag contacted the dummy's chest at 50 ms into the crash and the dummy's face at 56 ms. The chest remained in contact with the airbag as it inflated; full inflation occurred by 68 ms. Paint transferred from the dummy's face onto the airbag indicated the nose loaded the fully inflated airbag 5 cm above and 1 cm to the left of its center. Film analysis of the dummy's head and steering wheel movements showed their close proximity at the time head acceleration rapidly increased (95 ms), indicating the dummy's head bottomed out the airbag and contacted the steering wheel underneath. Nearly simultaneous rapid increases in the magnitudes of the recorded neck A-P shear forces, neck axial tension forces, and neck extension bending moments were observed as well. During rebound from the airbag, the dummy's head moved downward and outward, approaching but not contacting the window sill. The head then moved upward and

rearward, and the upper left side of the head contacted the plastic trim on the left roof rail from about 400 to 480 ms. Late in the crash (about 1,152 ms), the head moved outward and contacted the B-pillar and shoulder belt upper anchorage. Table 2 provides the timing of these events.
