REPORT NUMBER: 301-CAL-00-7

**SAFETY COMPLIANCE TESTING FOR FMVSS 301  
FUEL SYSTEM INTEGRITY**

MAZDA MOTOR CORPORATION  
2000 MAZDA PROTEGE  
4-DOOR SEDAN

NHTSA NUMBER: CY5402

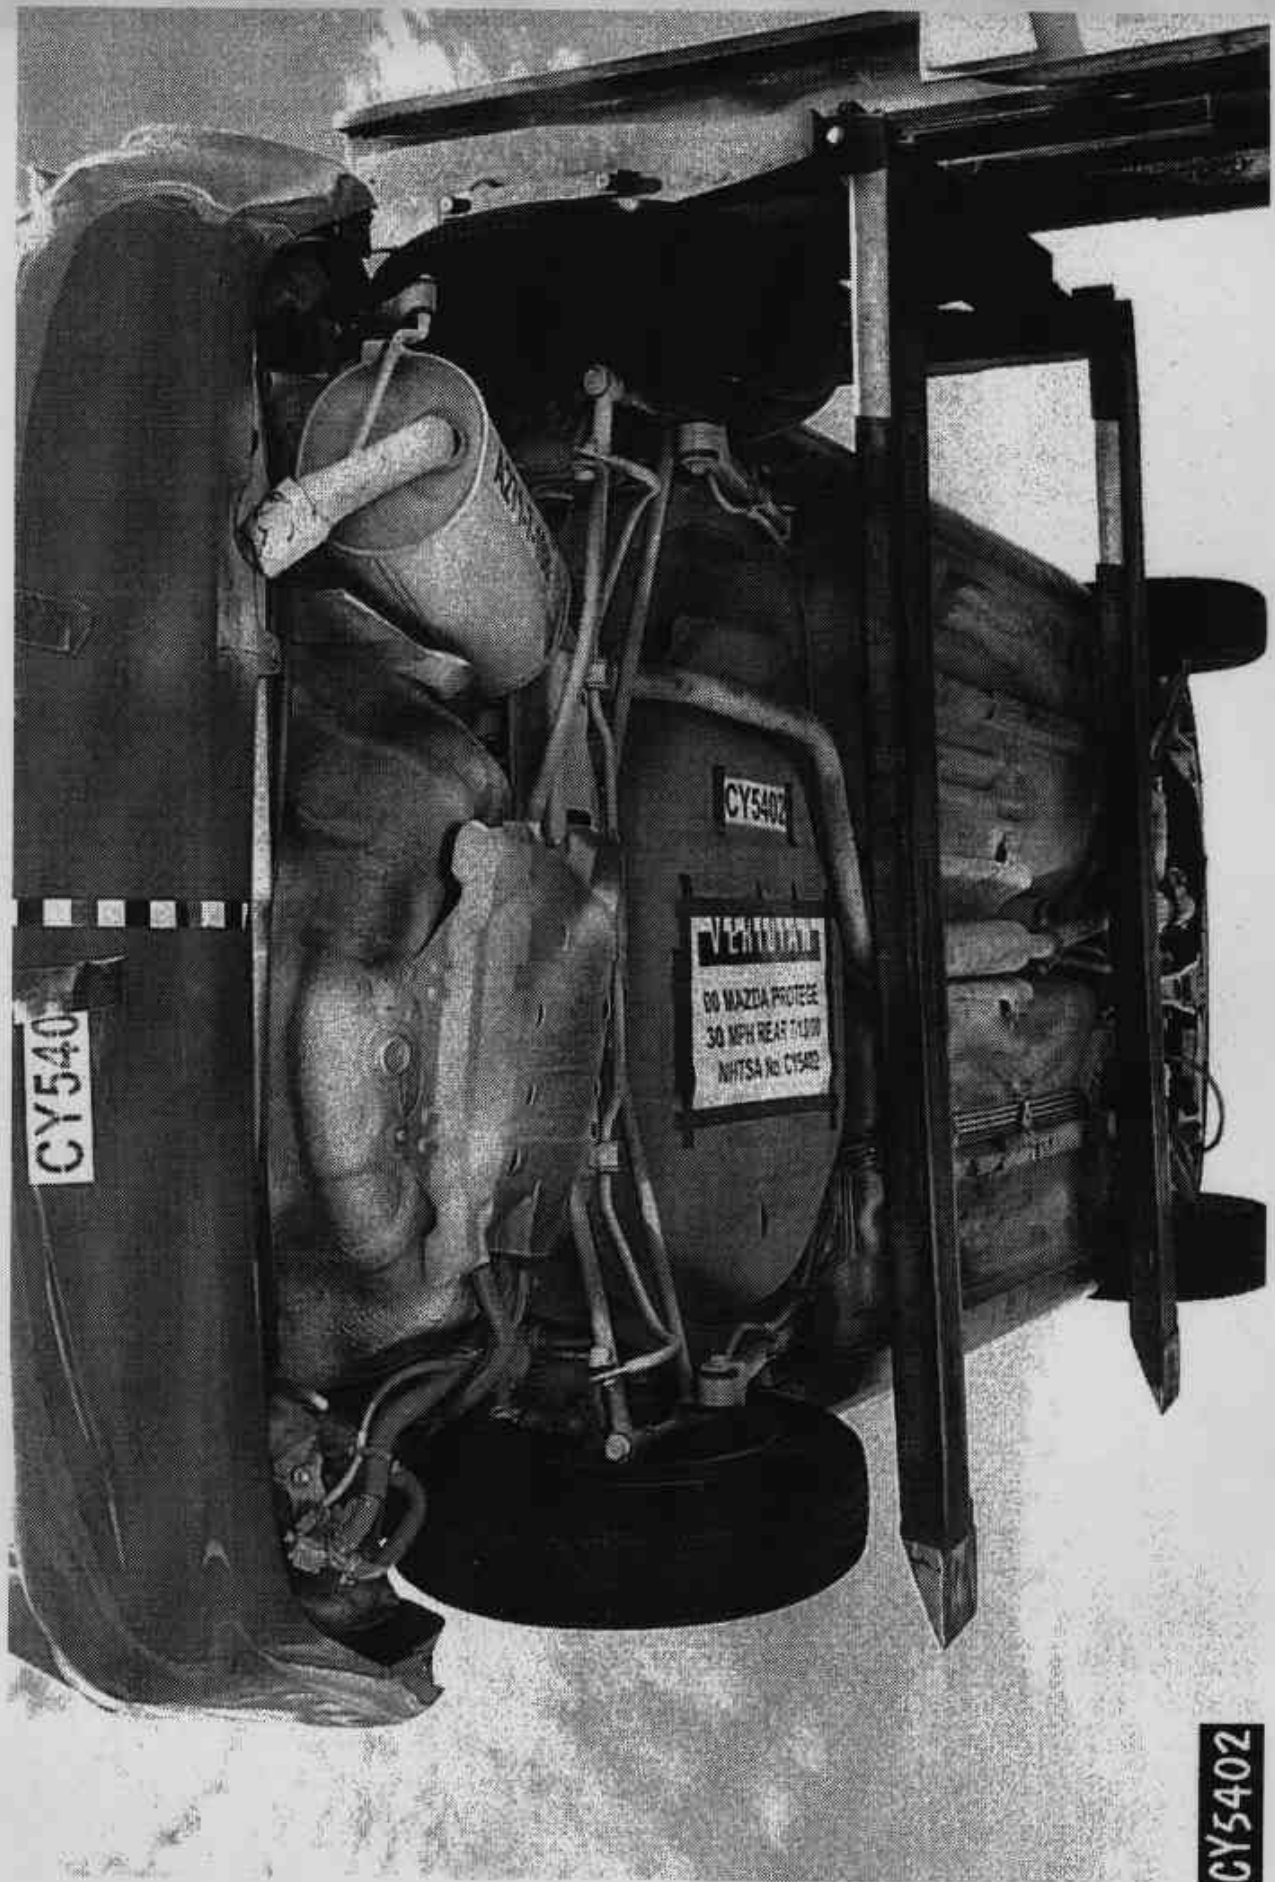
Figure A-16: POST-TEST REAR UNDERBODY VIEW

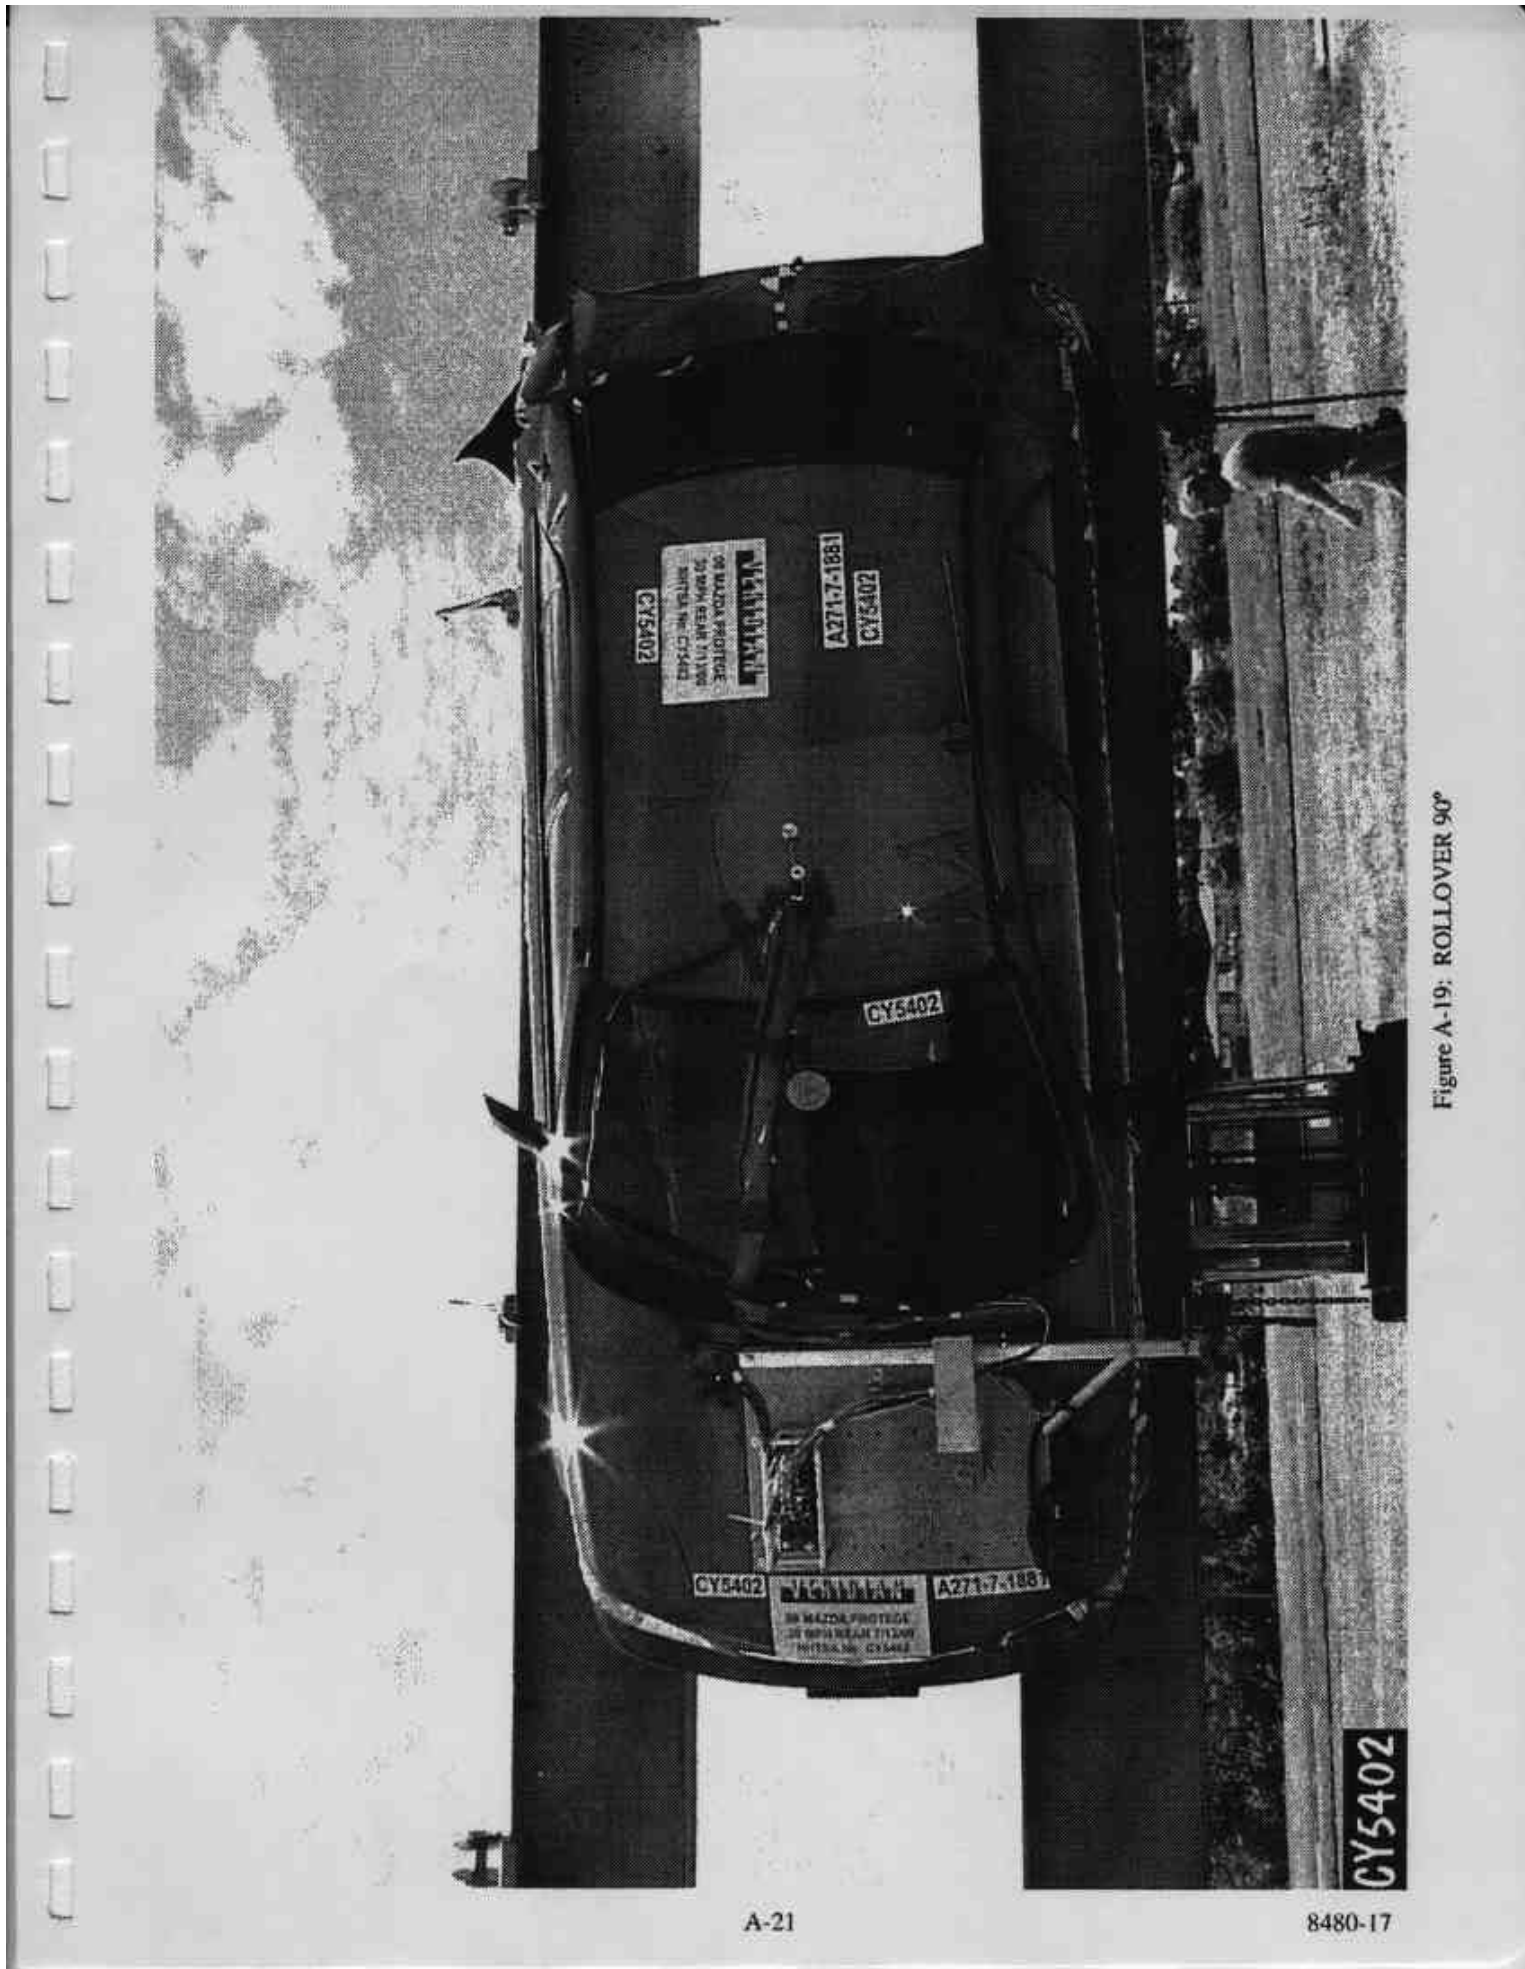
Figure A-19: ROLLOVER 90°
