**Evaluation of Motor Vehicle Fire Initiation and Propagation**  
**Part 5: Crash Tests on a Rear Wheel Drive Passenger Car**

Jack L. Jensen, Jeffrey Santrock

General Motors Corporation

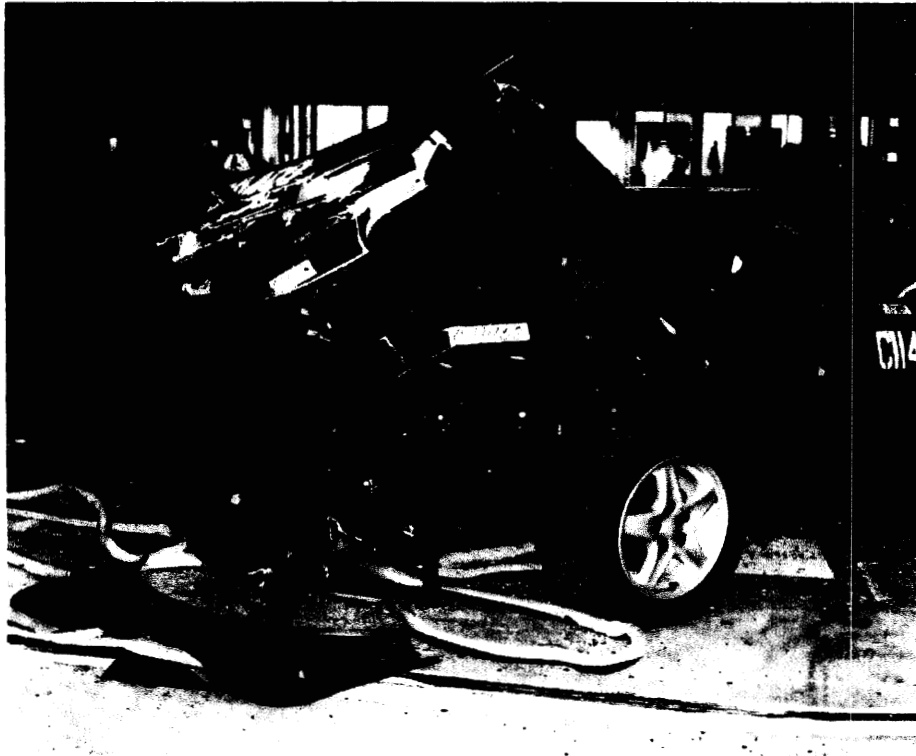
**Figure 5**

Post-Test Photograph of Test C11408, Right -Rear View

Post-test photographs of the vehicle are shown in Figures 4 and 5.

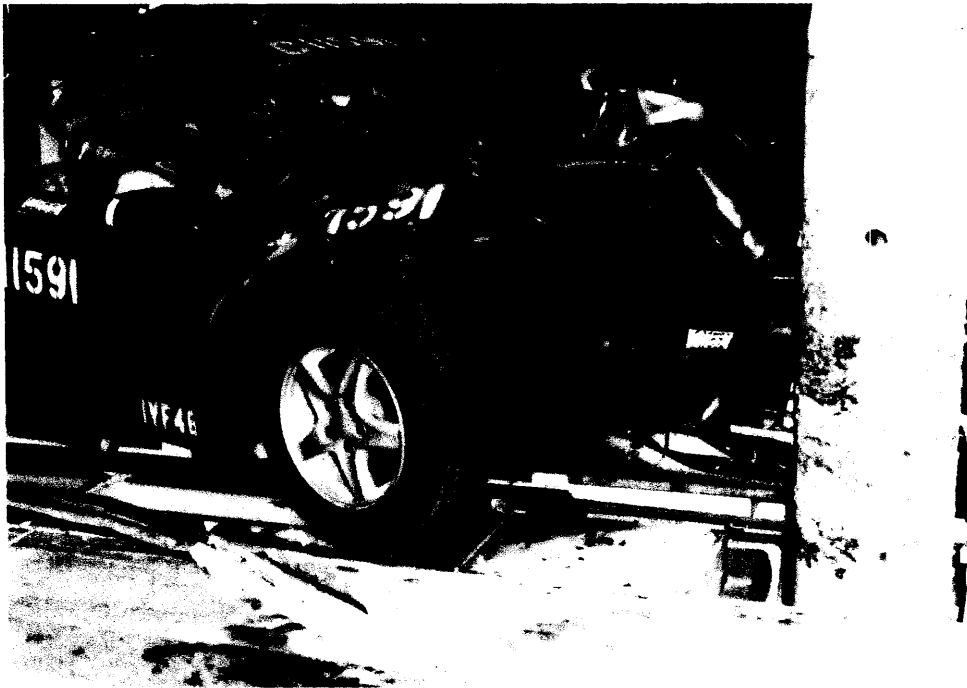
**Figure 15**

Post-Test Photograph of Test C11591, Front-Right View

Post-test photographs of the vehicle are shown in Figure 15 and Figure 16.

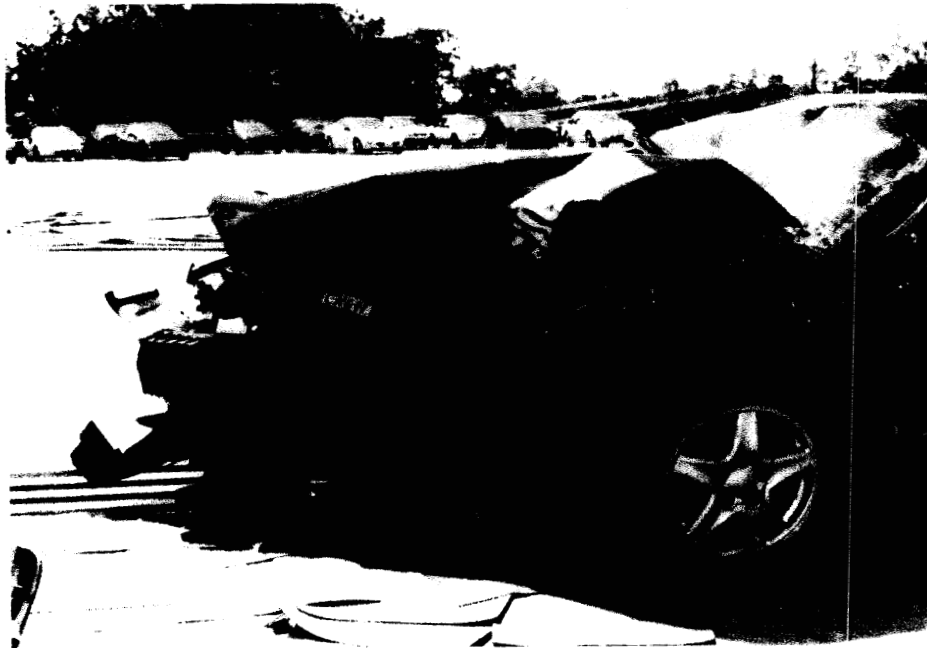
**Figure 29**

Post-Test Photograph of Test C11647, Front Left View

Post-test photographs of the vehicle are shown in Figure 29 and Figure 30.

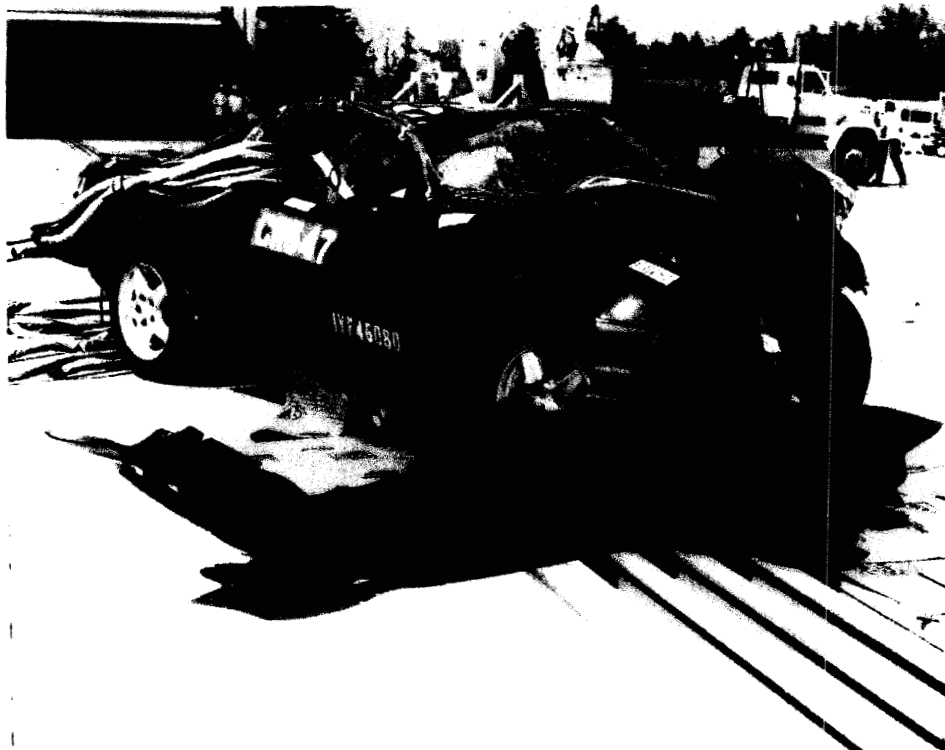
**Figure 30**

Post-Test Photograph of Test C11647, Front Right View
