REPORT NUMBER: 214-CAL-01-2

**SAFETY COMPLIANCE TESTING FOR FMVSS 214
SIDE IMPACT PROTECTION
INDICANT**

GENERAL MOTORS CORPORATION
2001 OLDSMOBILE AURORA
4-DOOR SEDAN

NHTSA NUMBER: C10102

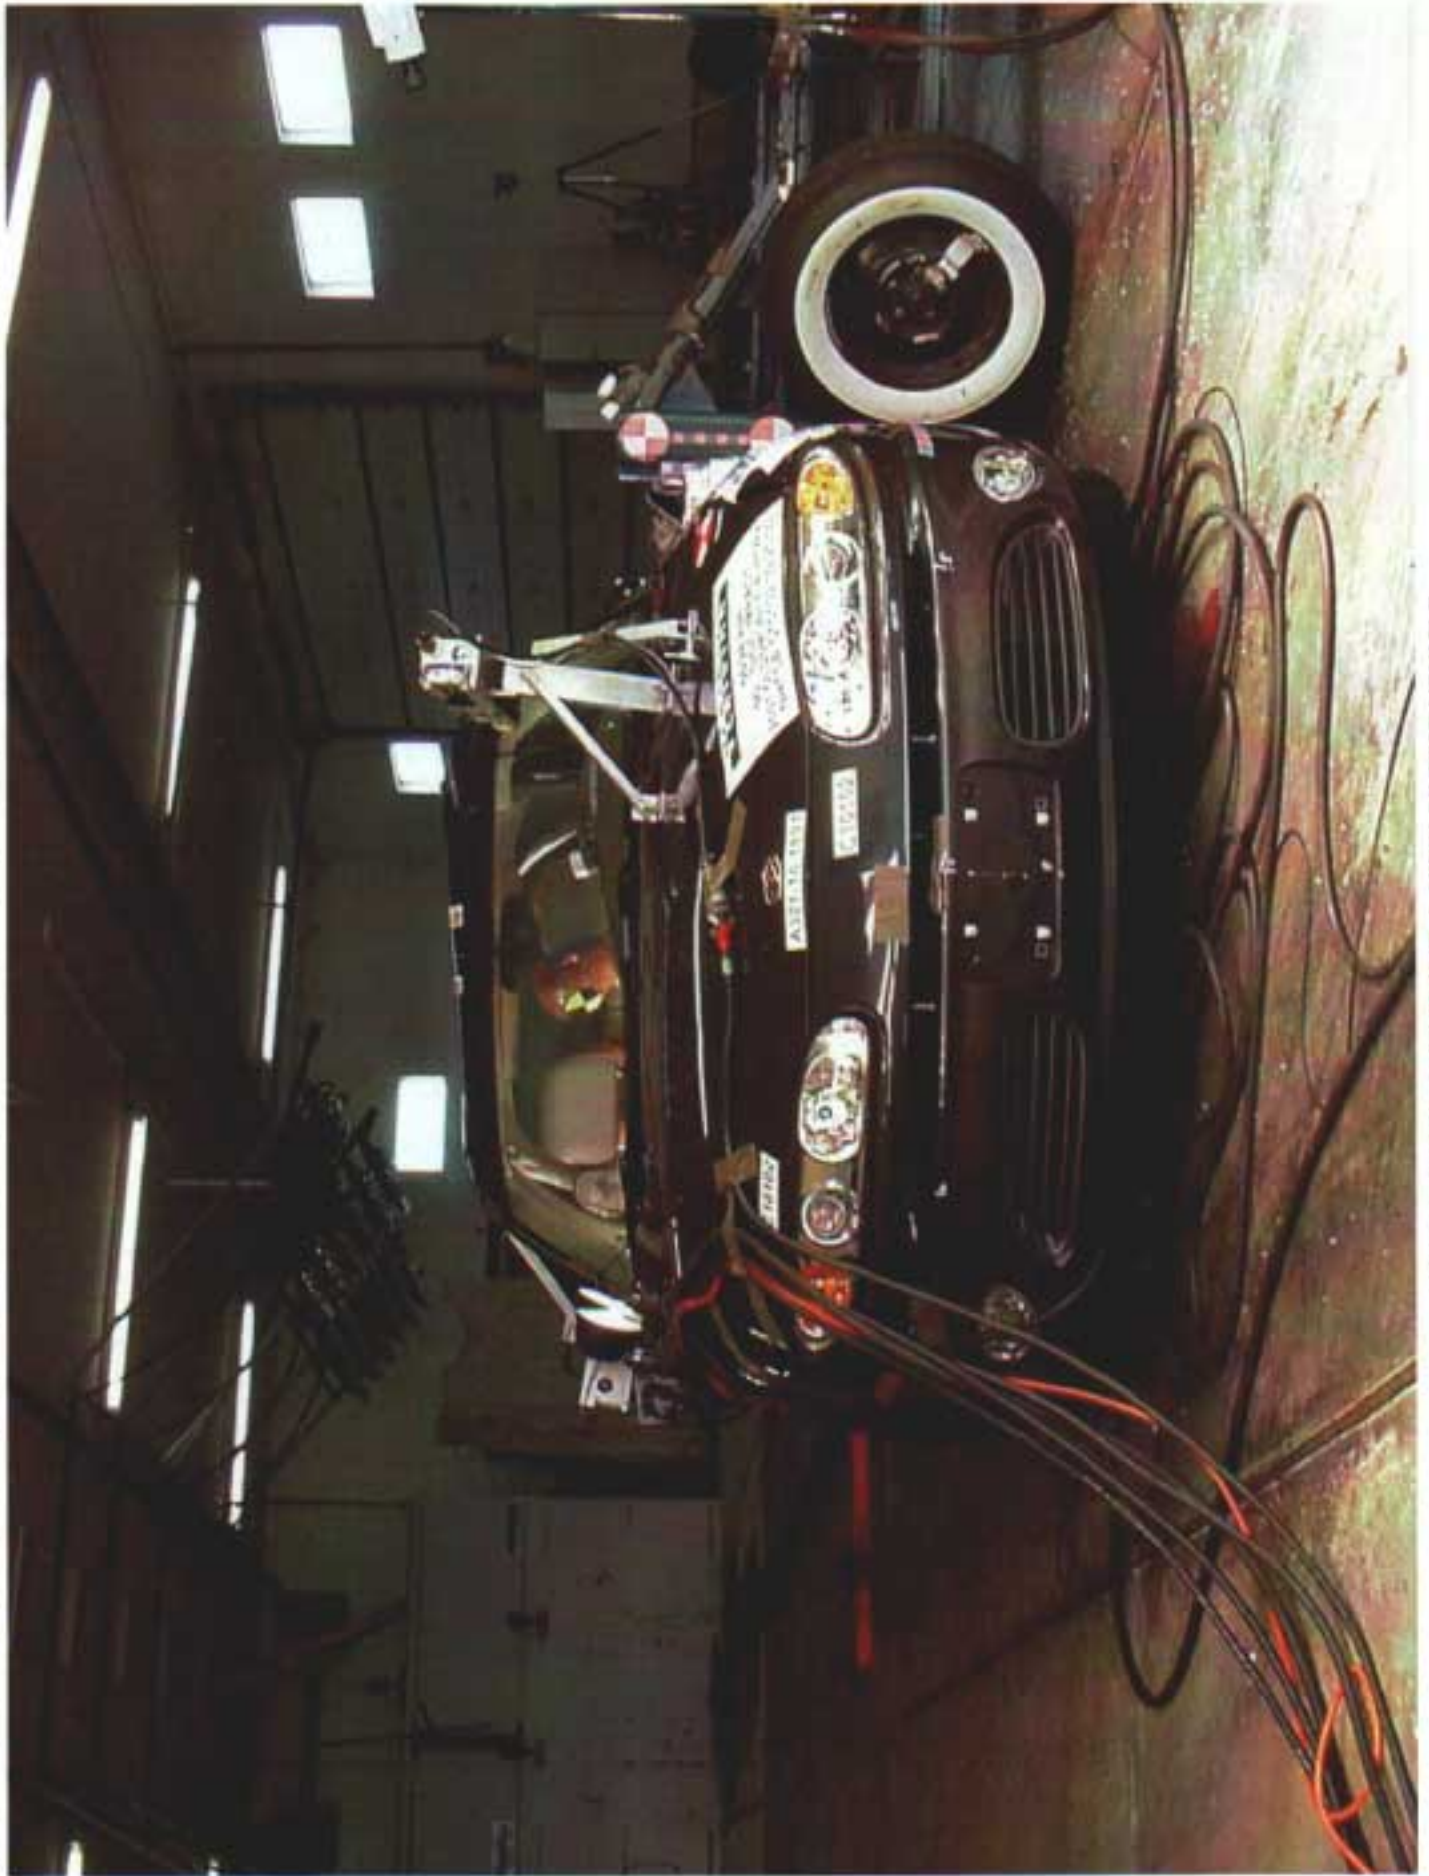
Figure A-2 POST-TEST FRONTAL VIEW OF TEST VEHICLE

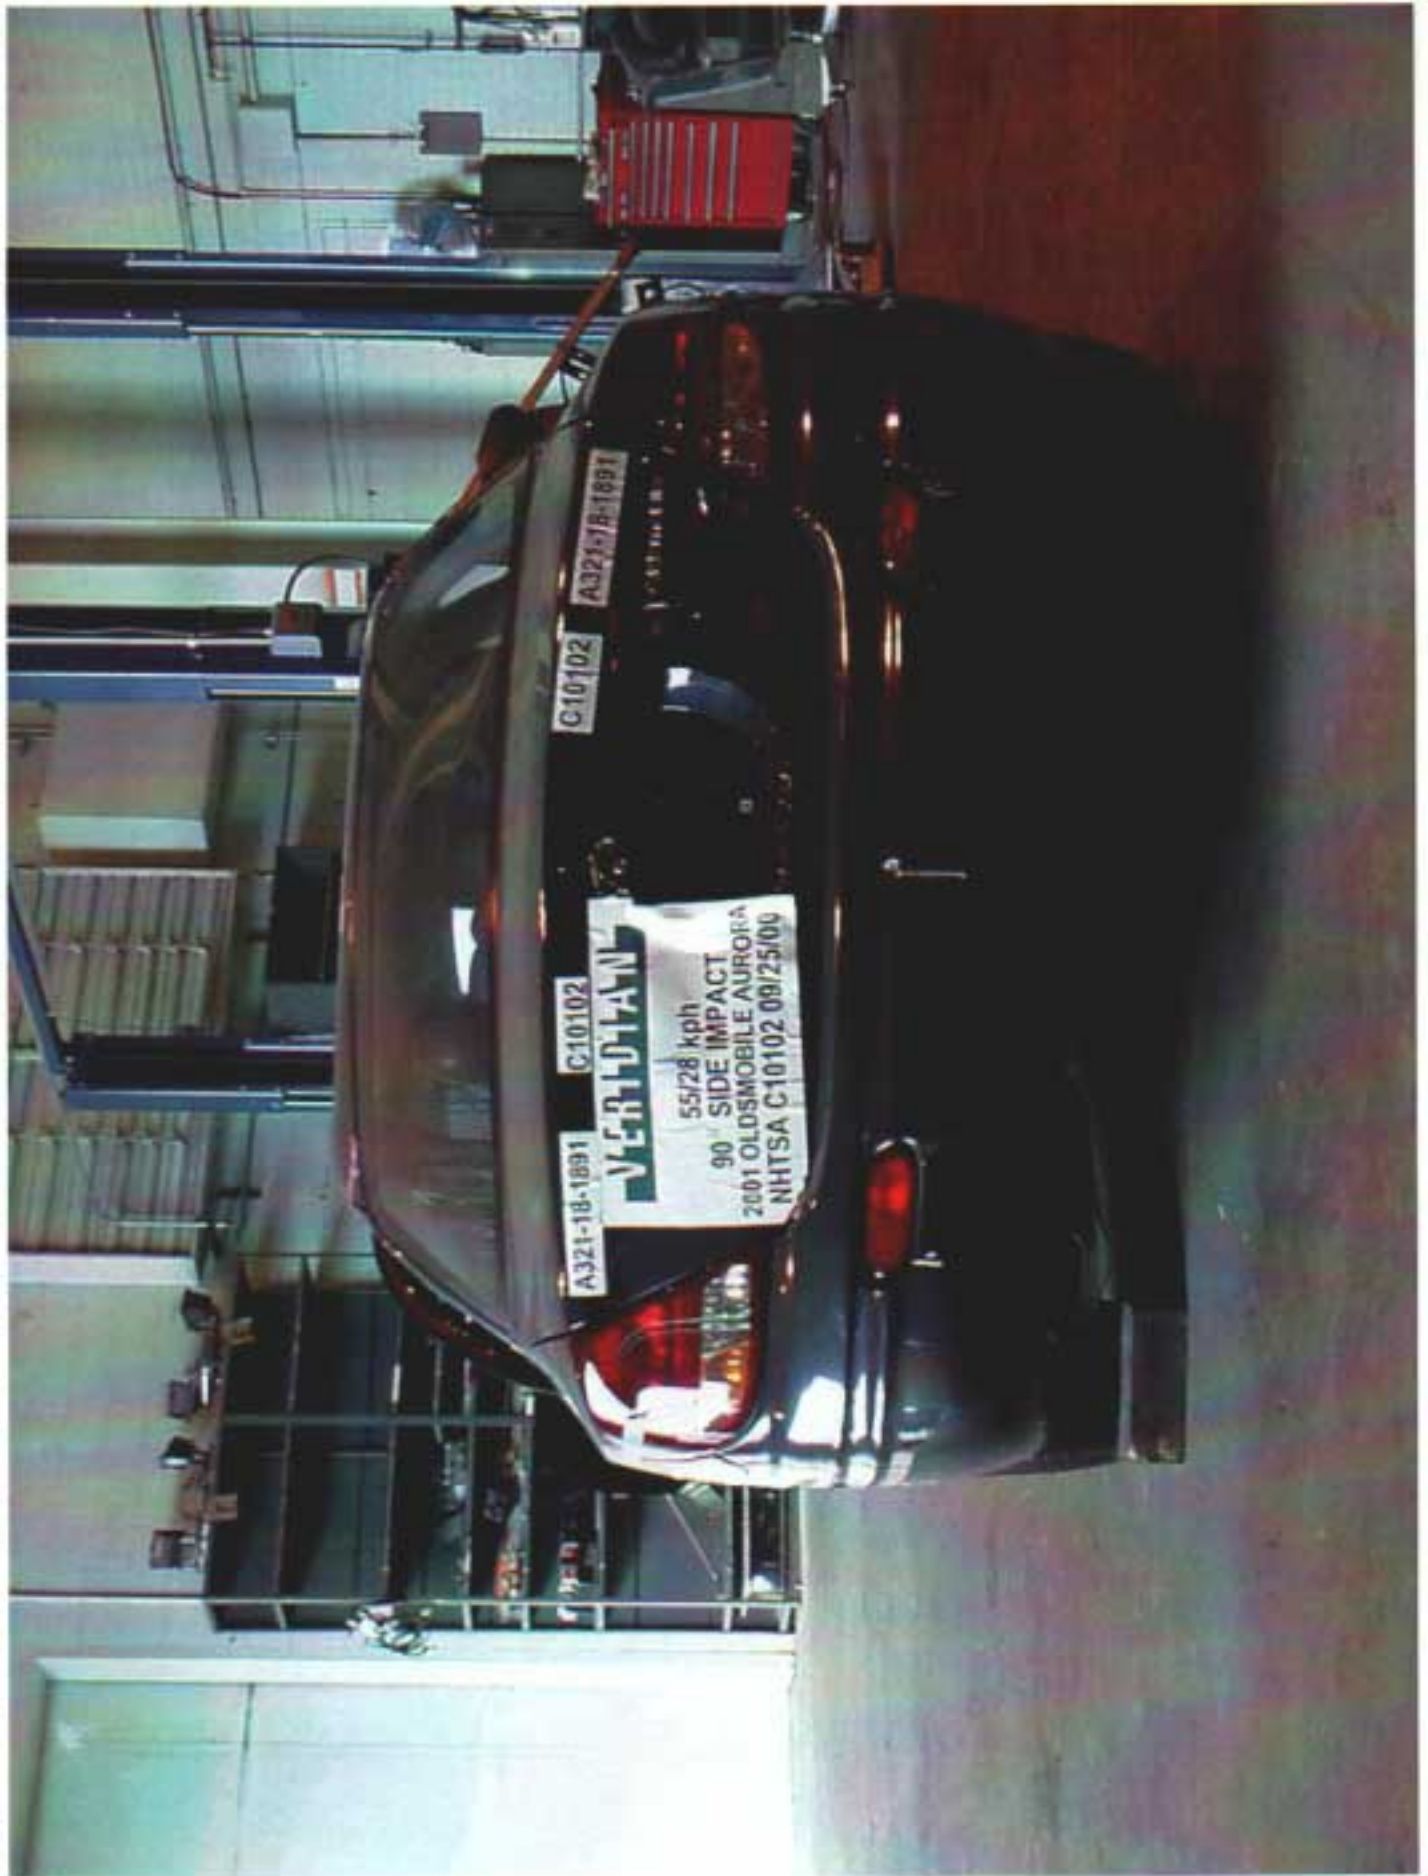
Figure A-4 POST-TEST REAR VIEW OF TEST VEHICLE

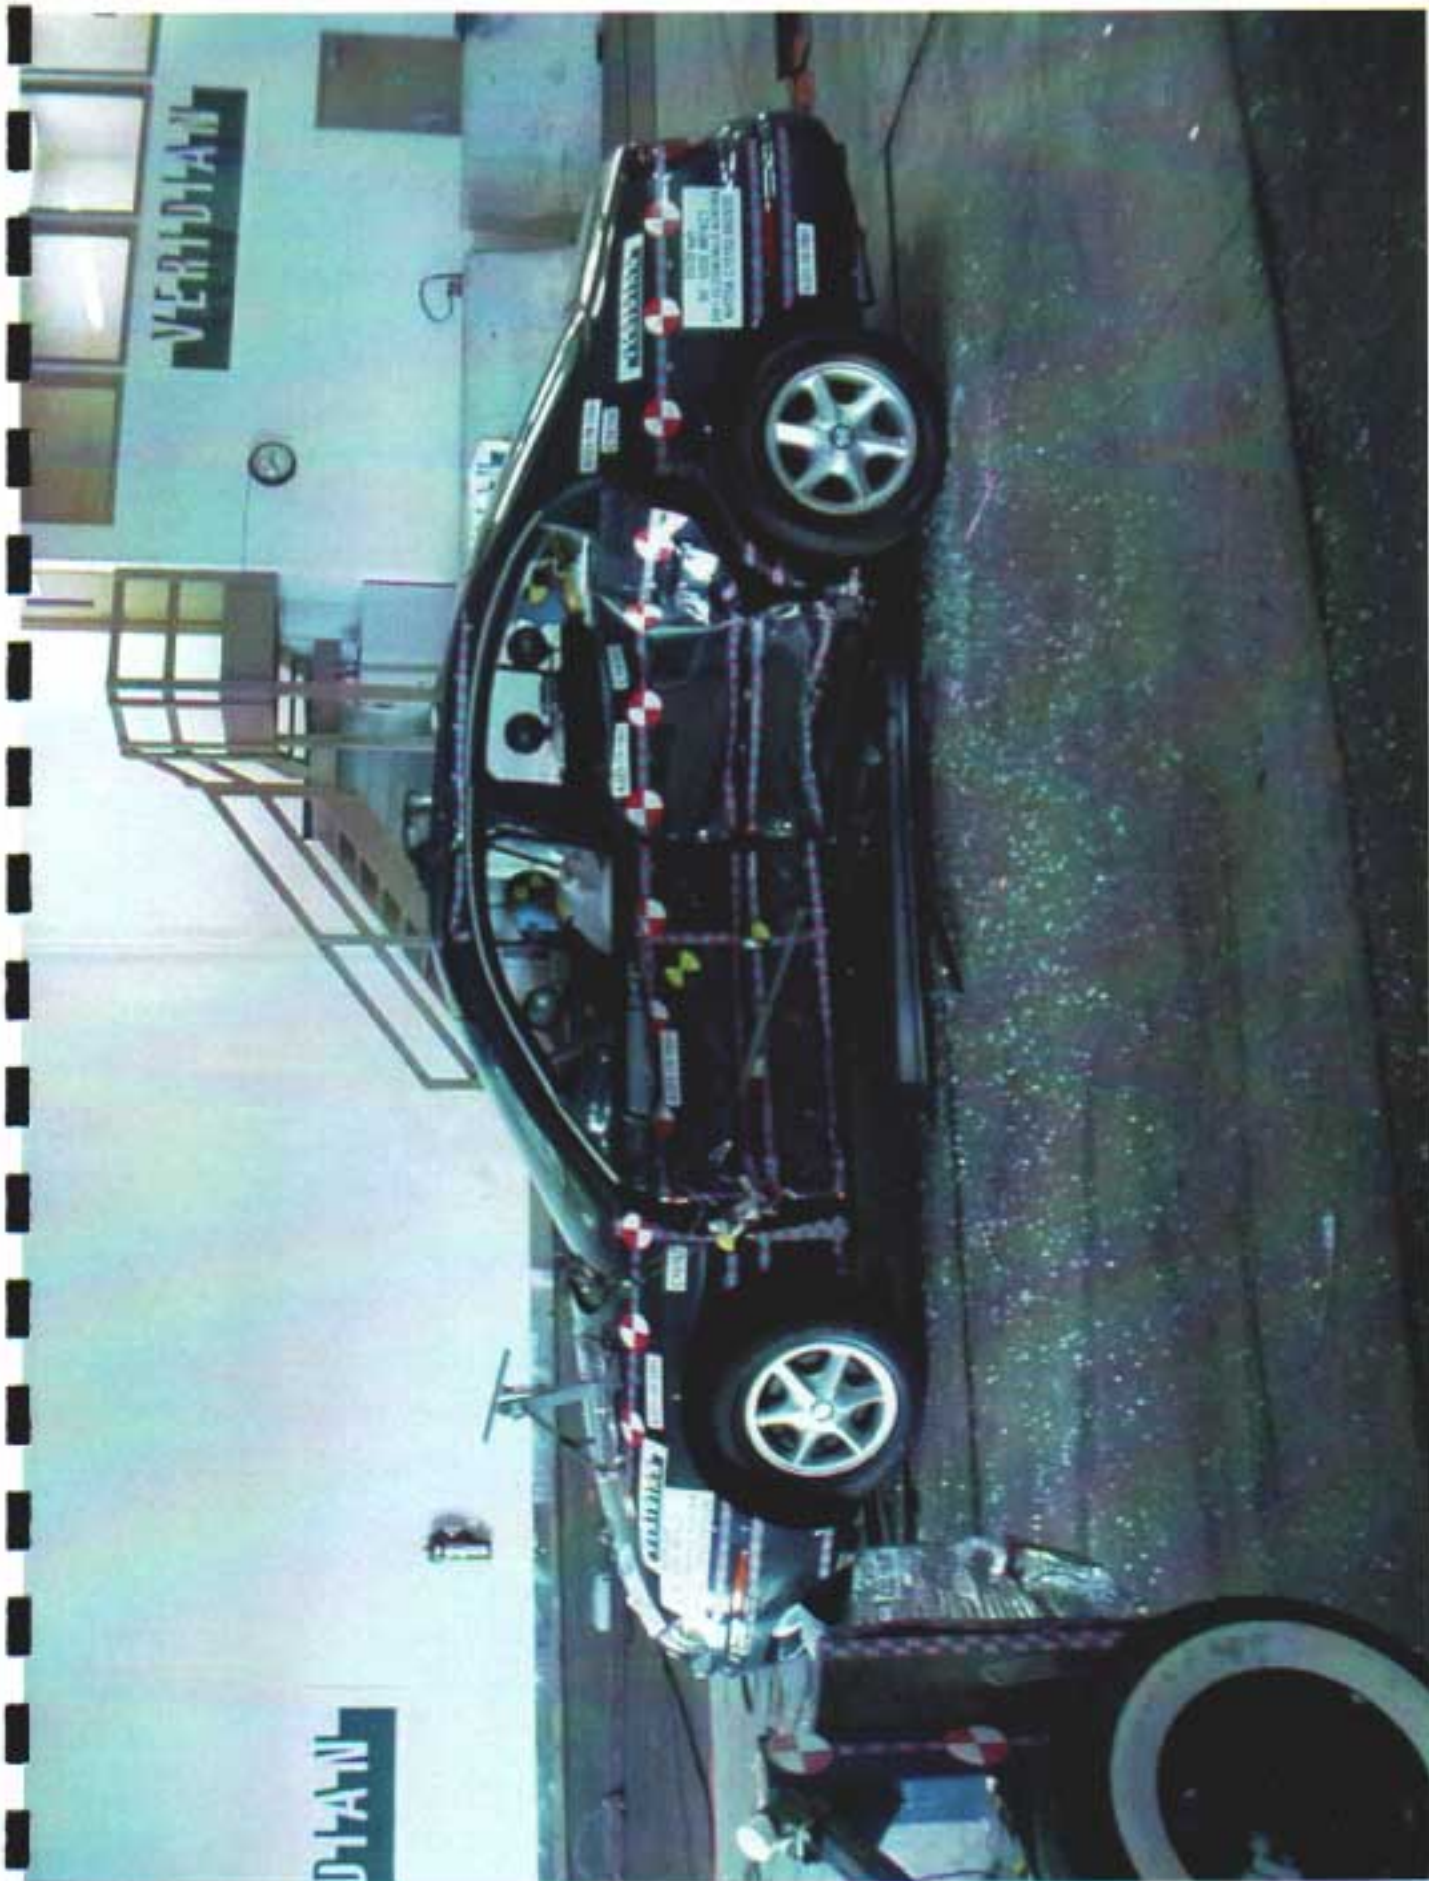
Figure A-6 POST-TEST IMPACTED SIDE VIEW OF TEST VEHICLE

MAXIMUM EXTERIOR STATIC CRUSH:

1. LEVEL 1 (262 mm above ground) = 161 millimeters

2. LEVEL 2 (484 mm above ground) = 327 millimeters

3. LEVEL 3 (574 mm above ground) = 318 millimeters

4. LEVEL 4 (848 mm above ground) = 300 millimeters

5. LEVEL 5 (1349 mm above ground) = 109 millimeters

Maximum Post-Test Intrusion = 327 millimeters

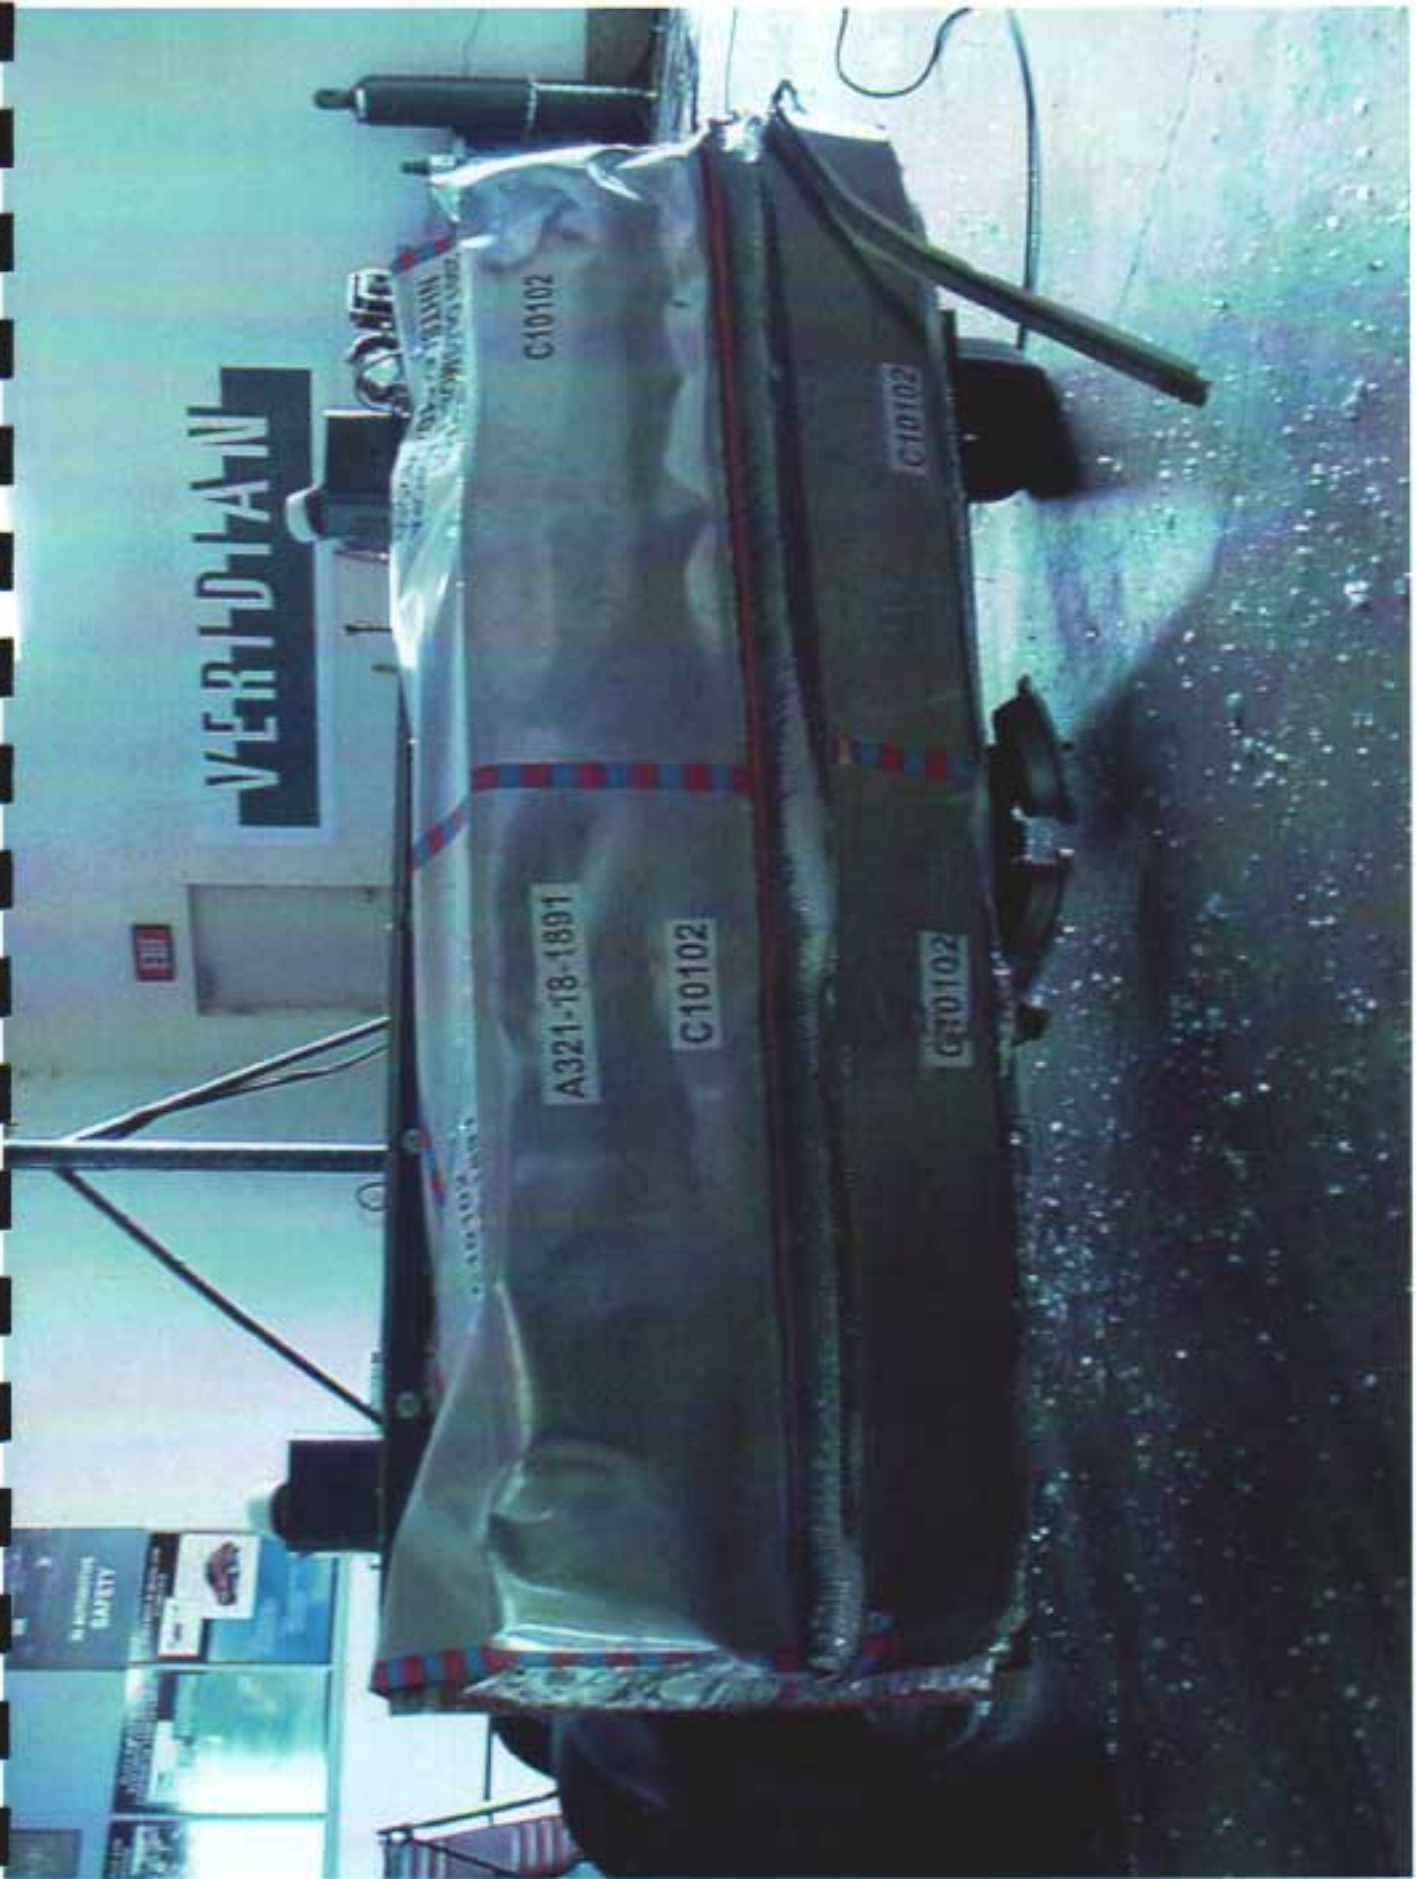
Figure A-8 POST-TEST FRONTAL VIEW OF IMPACTOR FACE

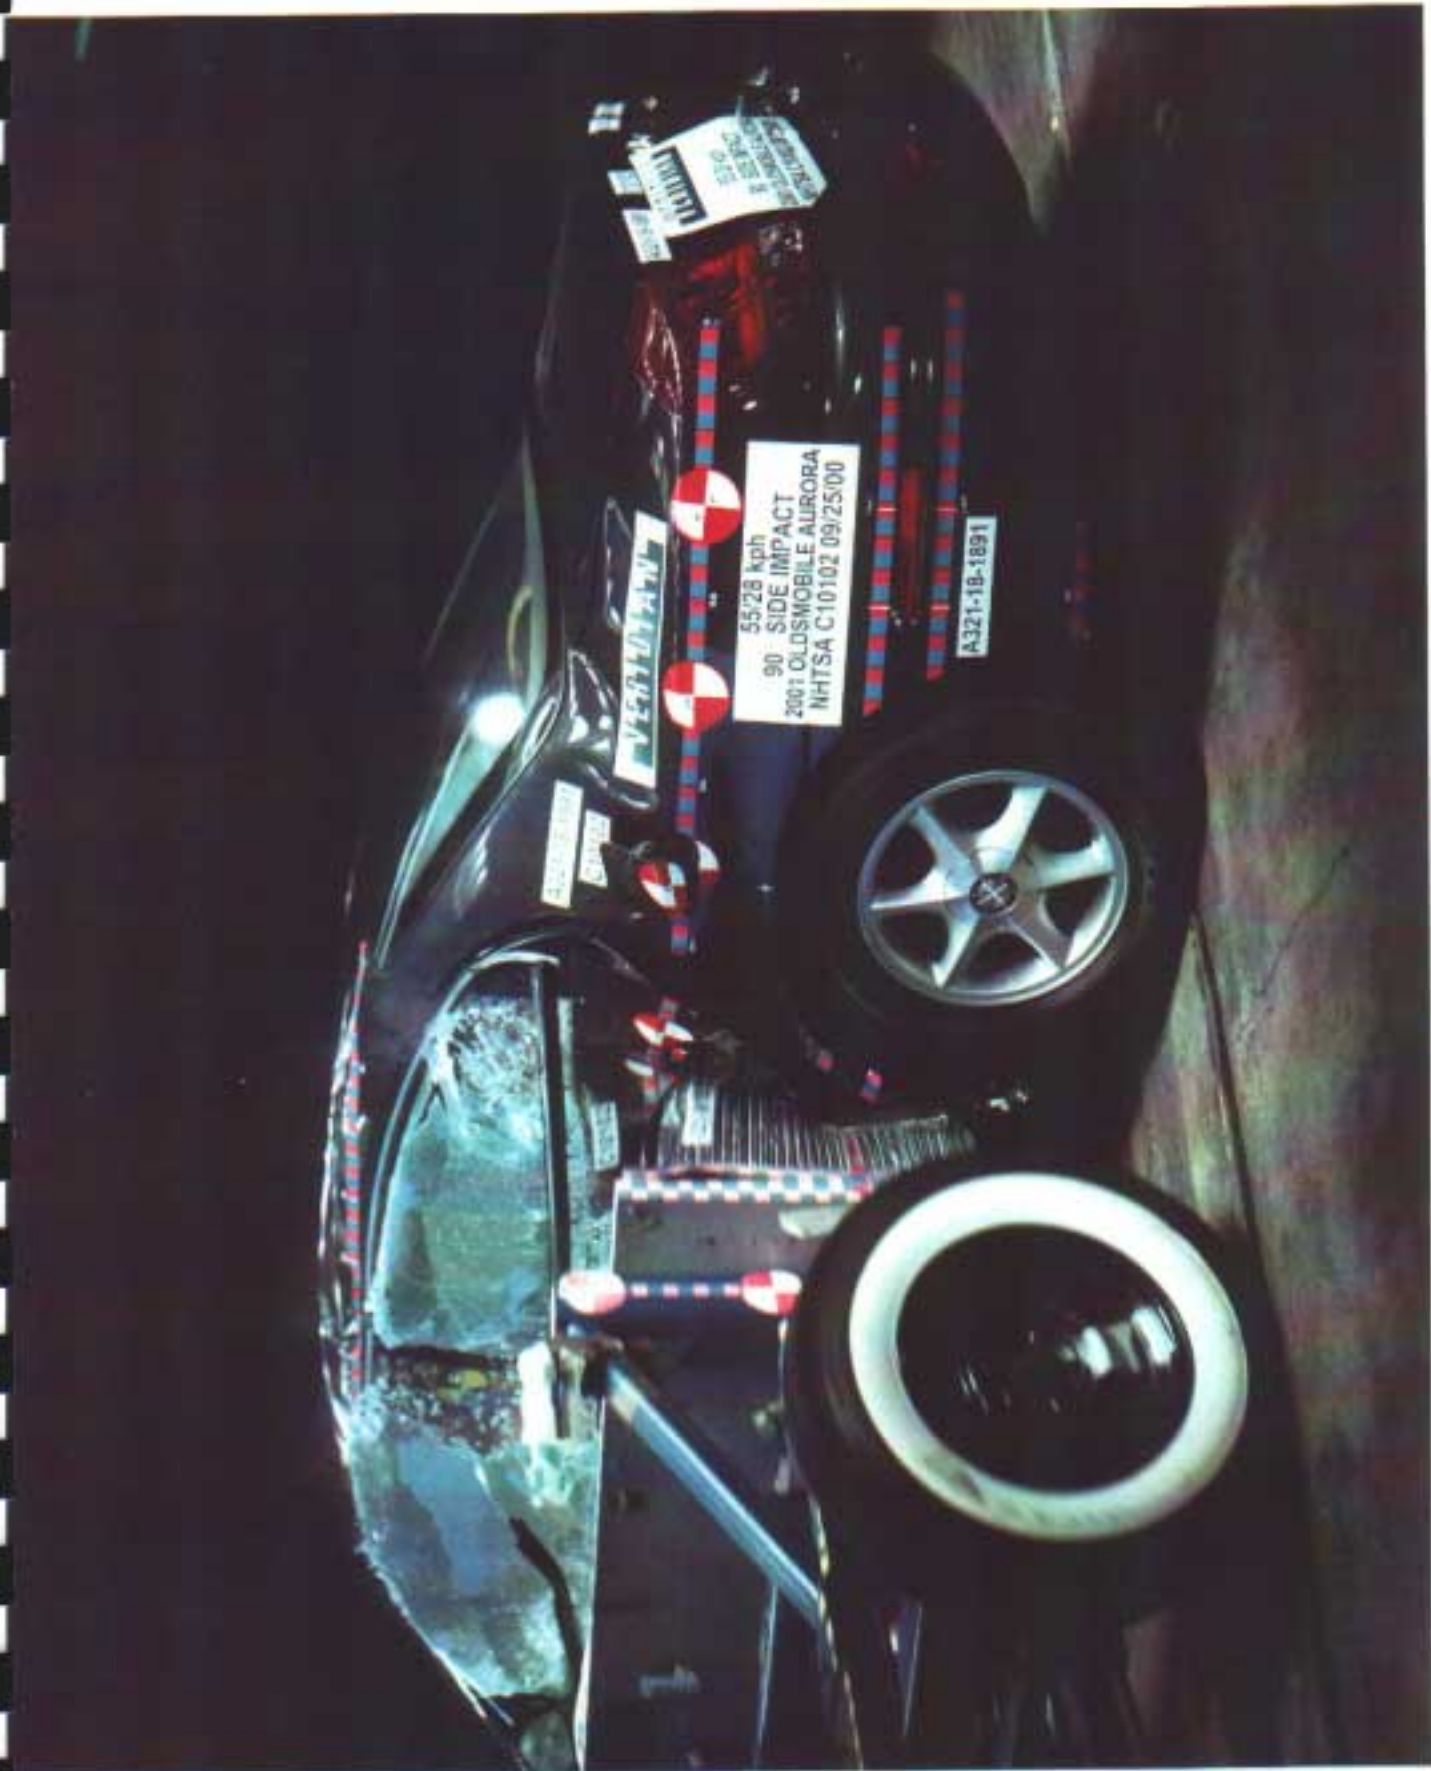
Figure A-34 IMPACT PHOTO
