Report Number NCAP-TRC-01-002

New Car Assessment Program (NCAP)

Frontal Barrier Impact Test

2001 Volvo S80

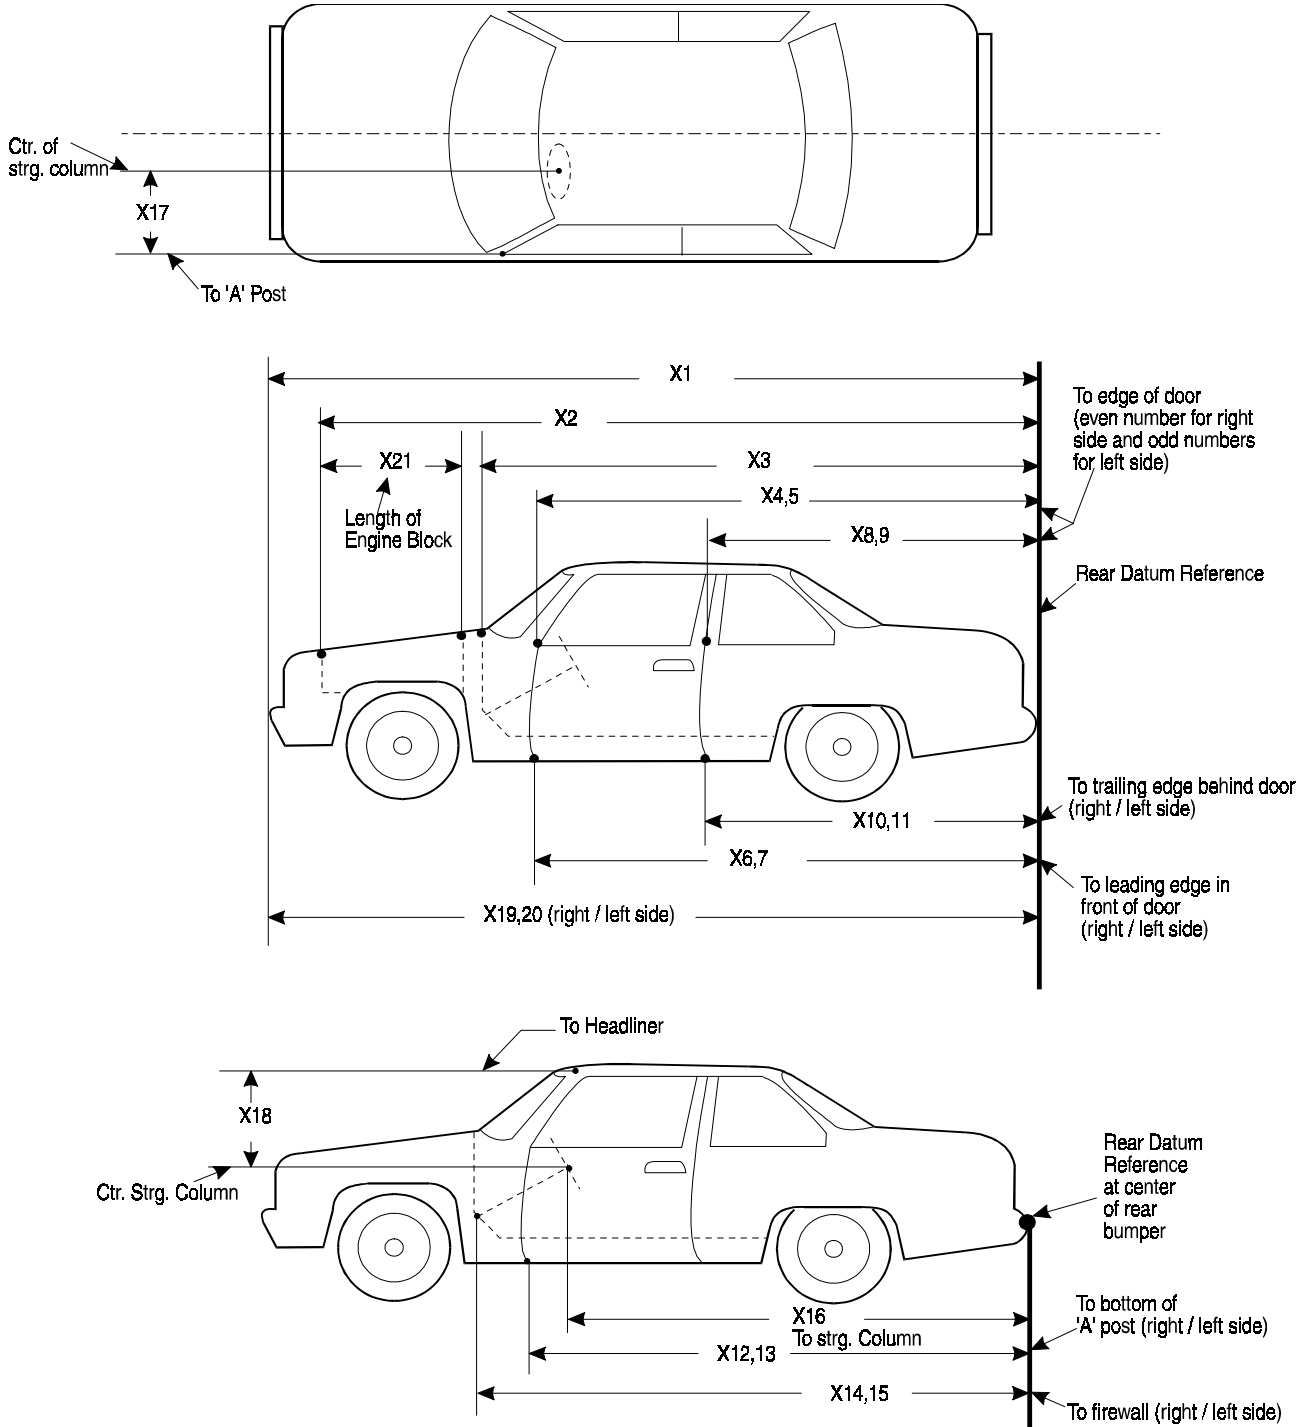
Figure 12 Pre-Test And Post-Test Measurement Points

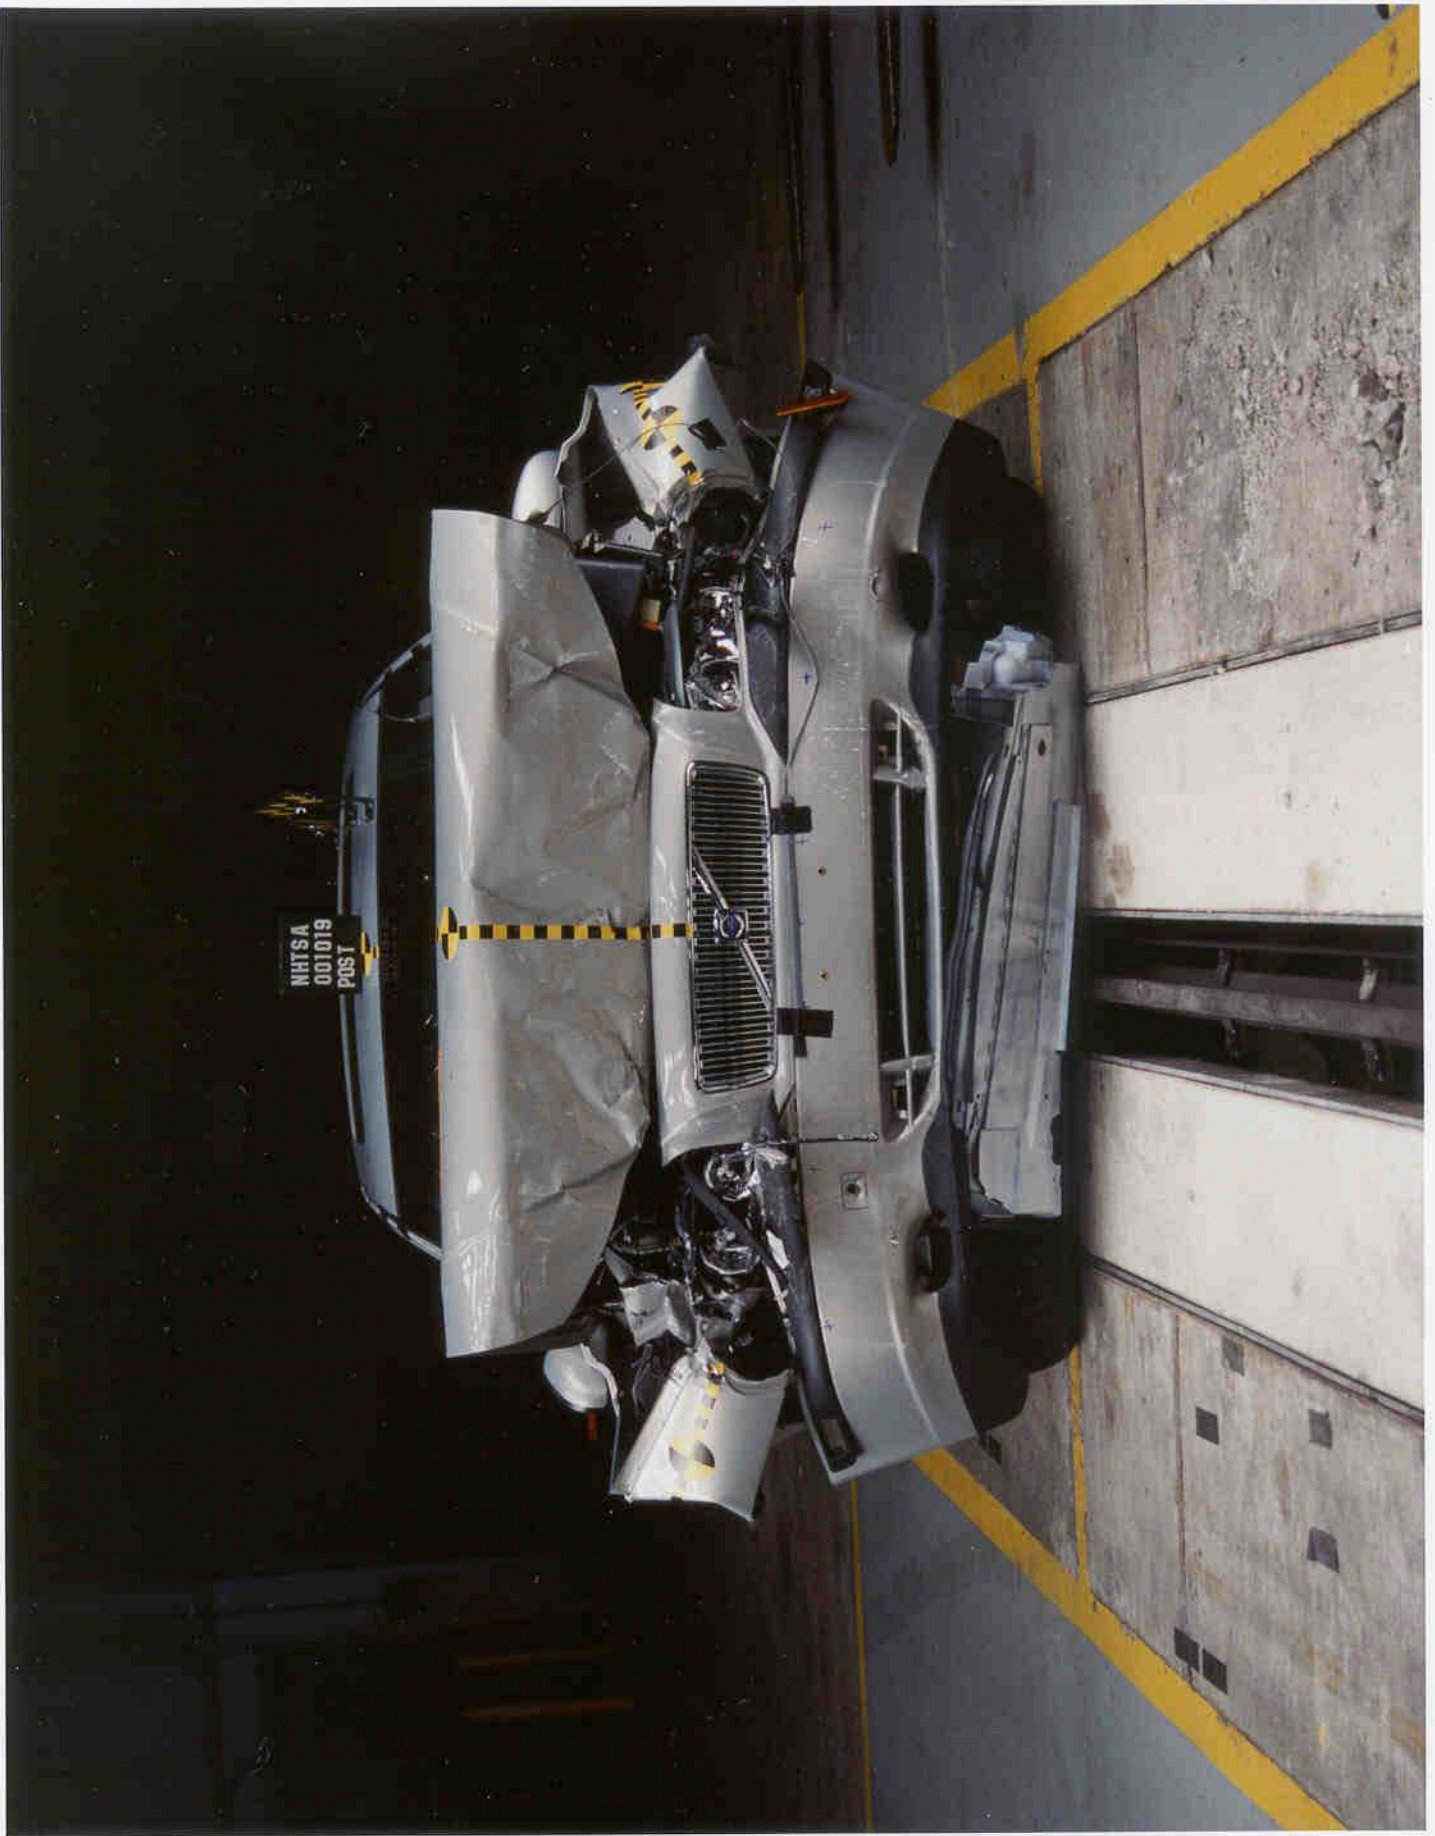
Figure A-2 Post-Test Front View  
A-3

Midpoint of damage: D: Vehicle Longitudinal Centerline

Length of damaged region: L: 1524 mm

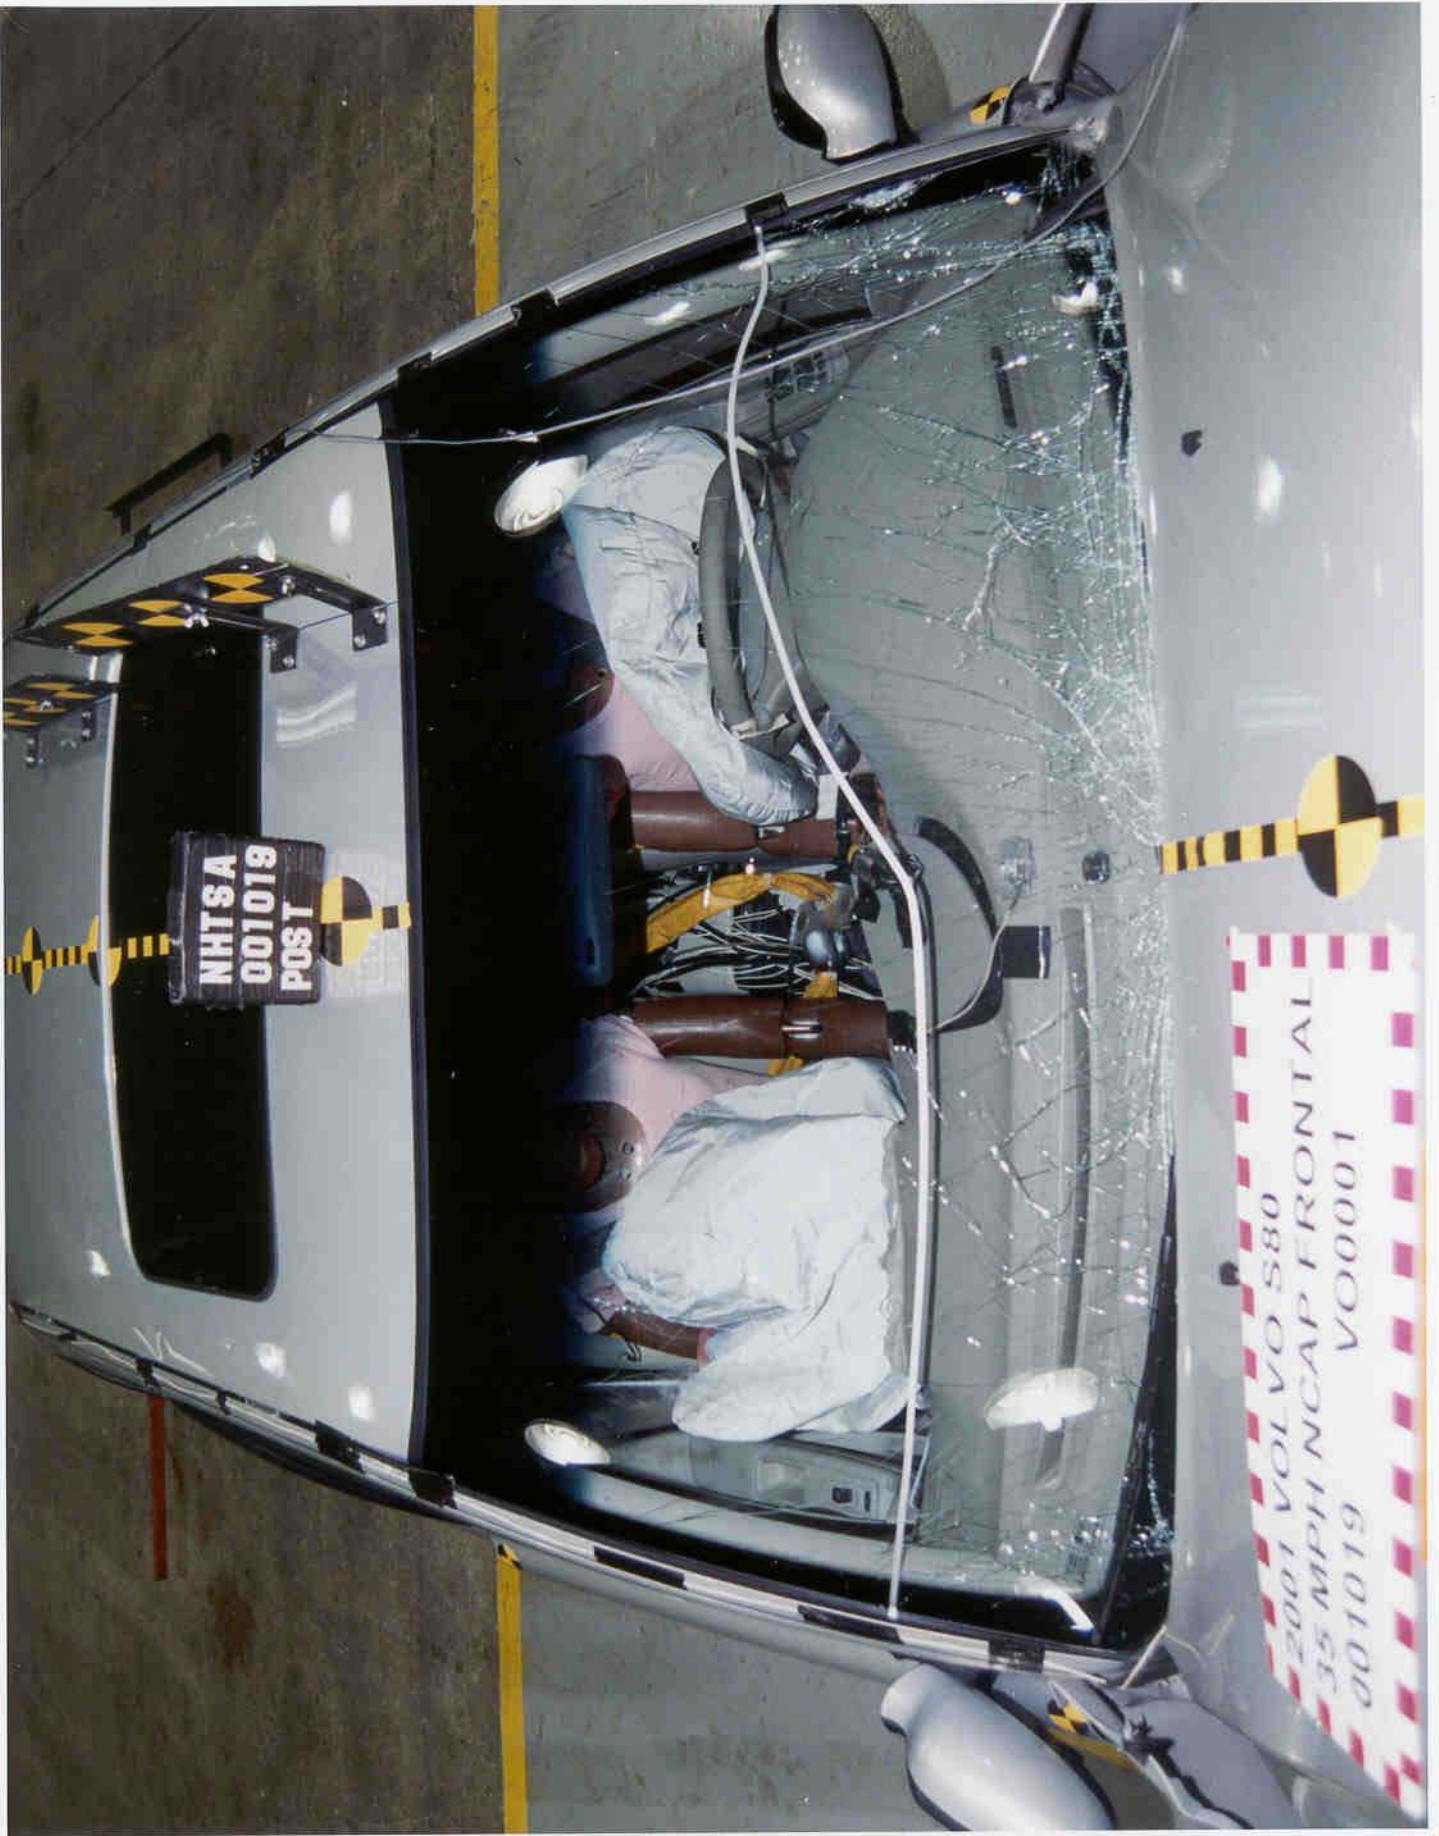
Figure A-16 Post-Test Windshield - View 1

Glazing Damage: Entire windshield cracked.

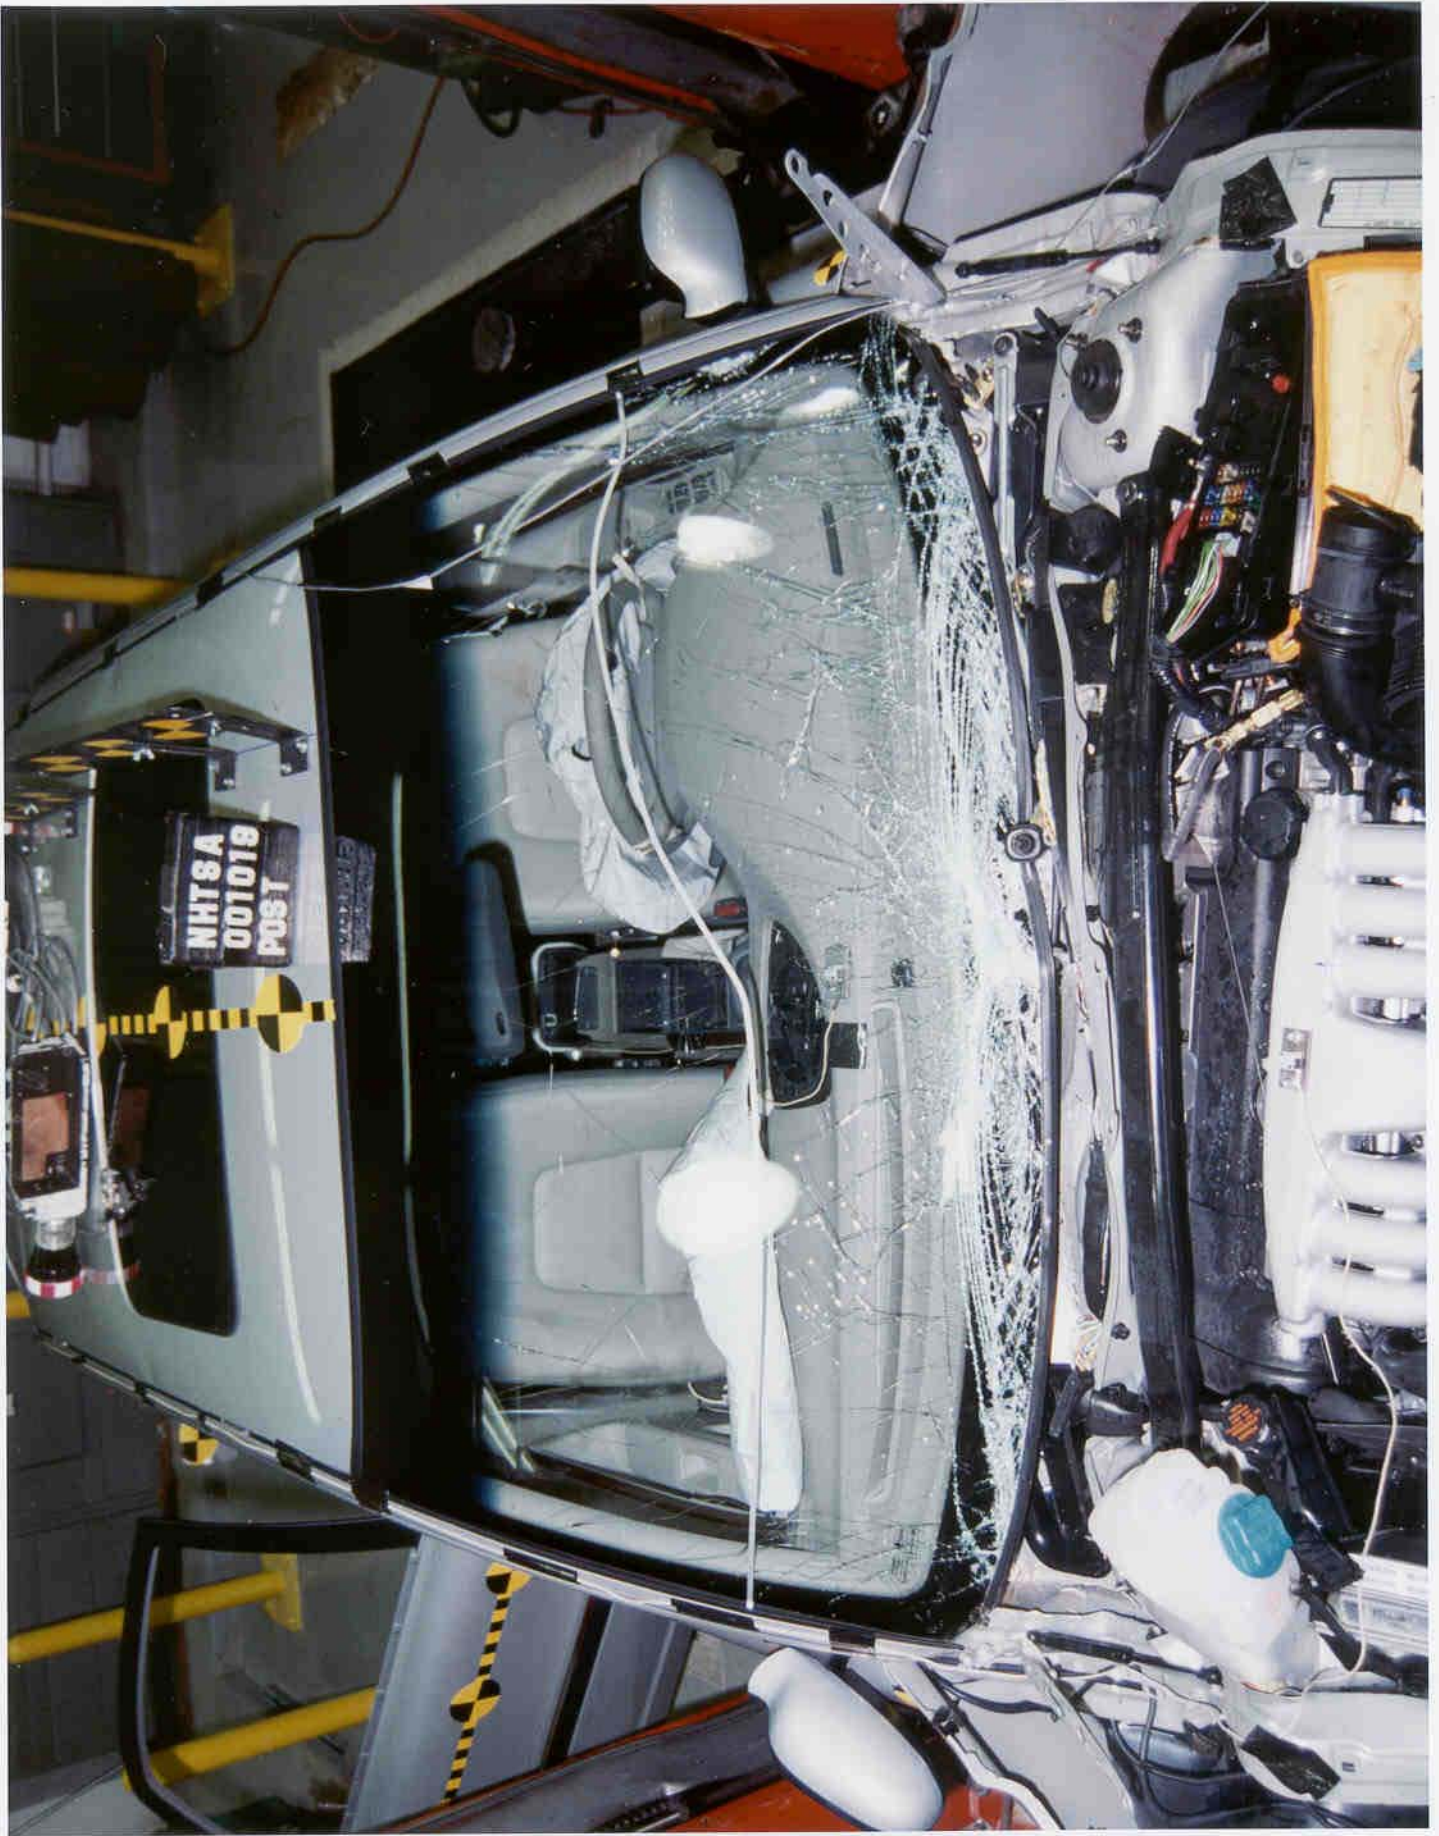
Figure A-17 Post-Test Windshield - View 2

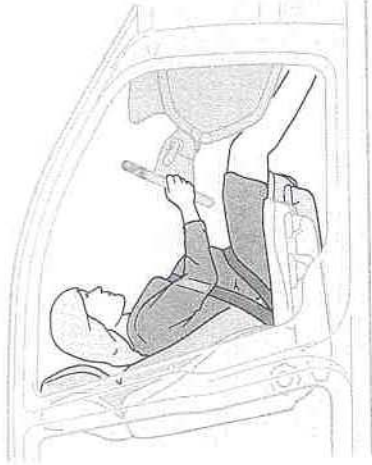
Pregnant women should always wear seat belts. Remember that the belt should always be positioned in such a way as to avoid any possible pressure on the abdomen. The lap portion of the belt should be located low, as shown in the above illustration.

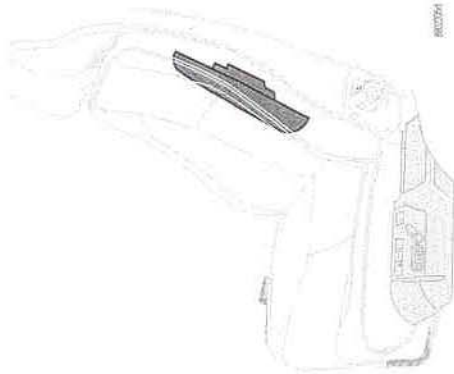
SIPS airbag \*

### SIPS airbag (front seats only)

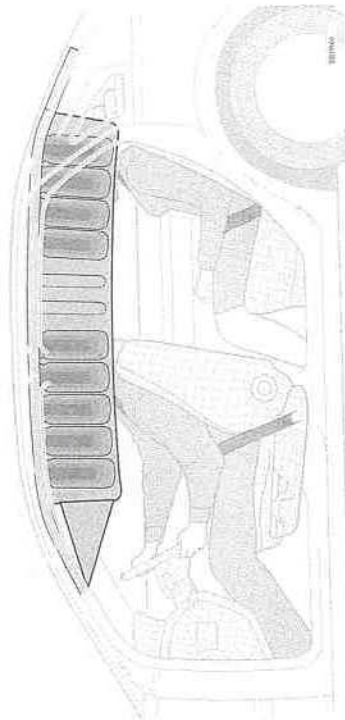
### Volvo Inflatable Curtain (VIC)

This system consists of inflatable curtains located along the sides of the roof liners, stretching from the center of both front side windows to the rear edge of the rear side door windows. It is designed to help protect the heads of the occupant of the front seat and the occupant of the outboard rear seat position in certain side impact collisions.

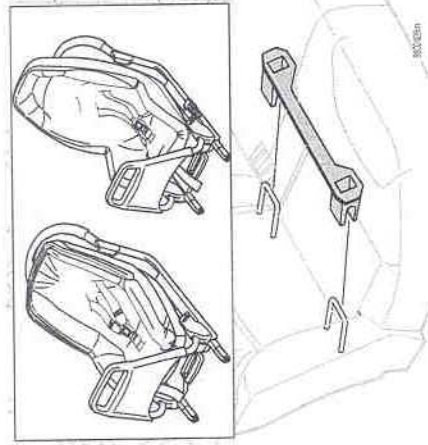
### Isofix fasteners and Seat guide

The Isofix fasteners are available as a retailer-installed option in the rear seat on the outboard positions. Consult your Volvo retailer for more information on child safety accessories.
