REPORT NUMBER: 214-CAL-01-03

**SAFETY COMPLIANCE TESTING FOR FMVSS 214
SIDE IMPACT PROTECTION
INDICANT**

GENERAL MOTORS OF CANADA LTD.
2001 CHEVROLET MONTE CARLO
2-DOOR

NHTSA NUMBER: C10103

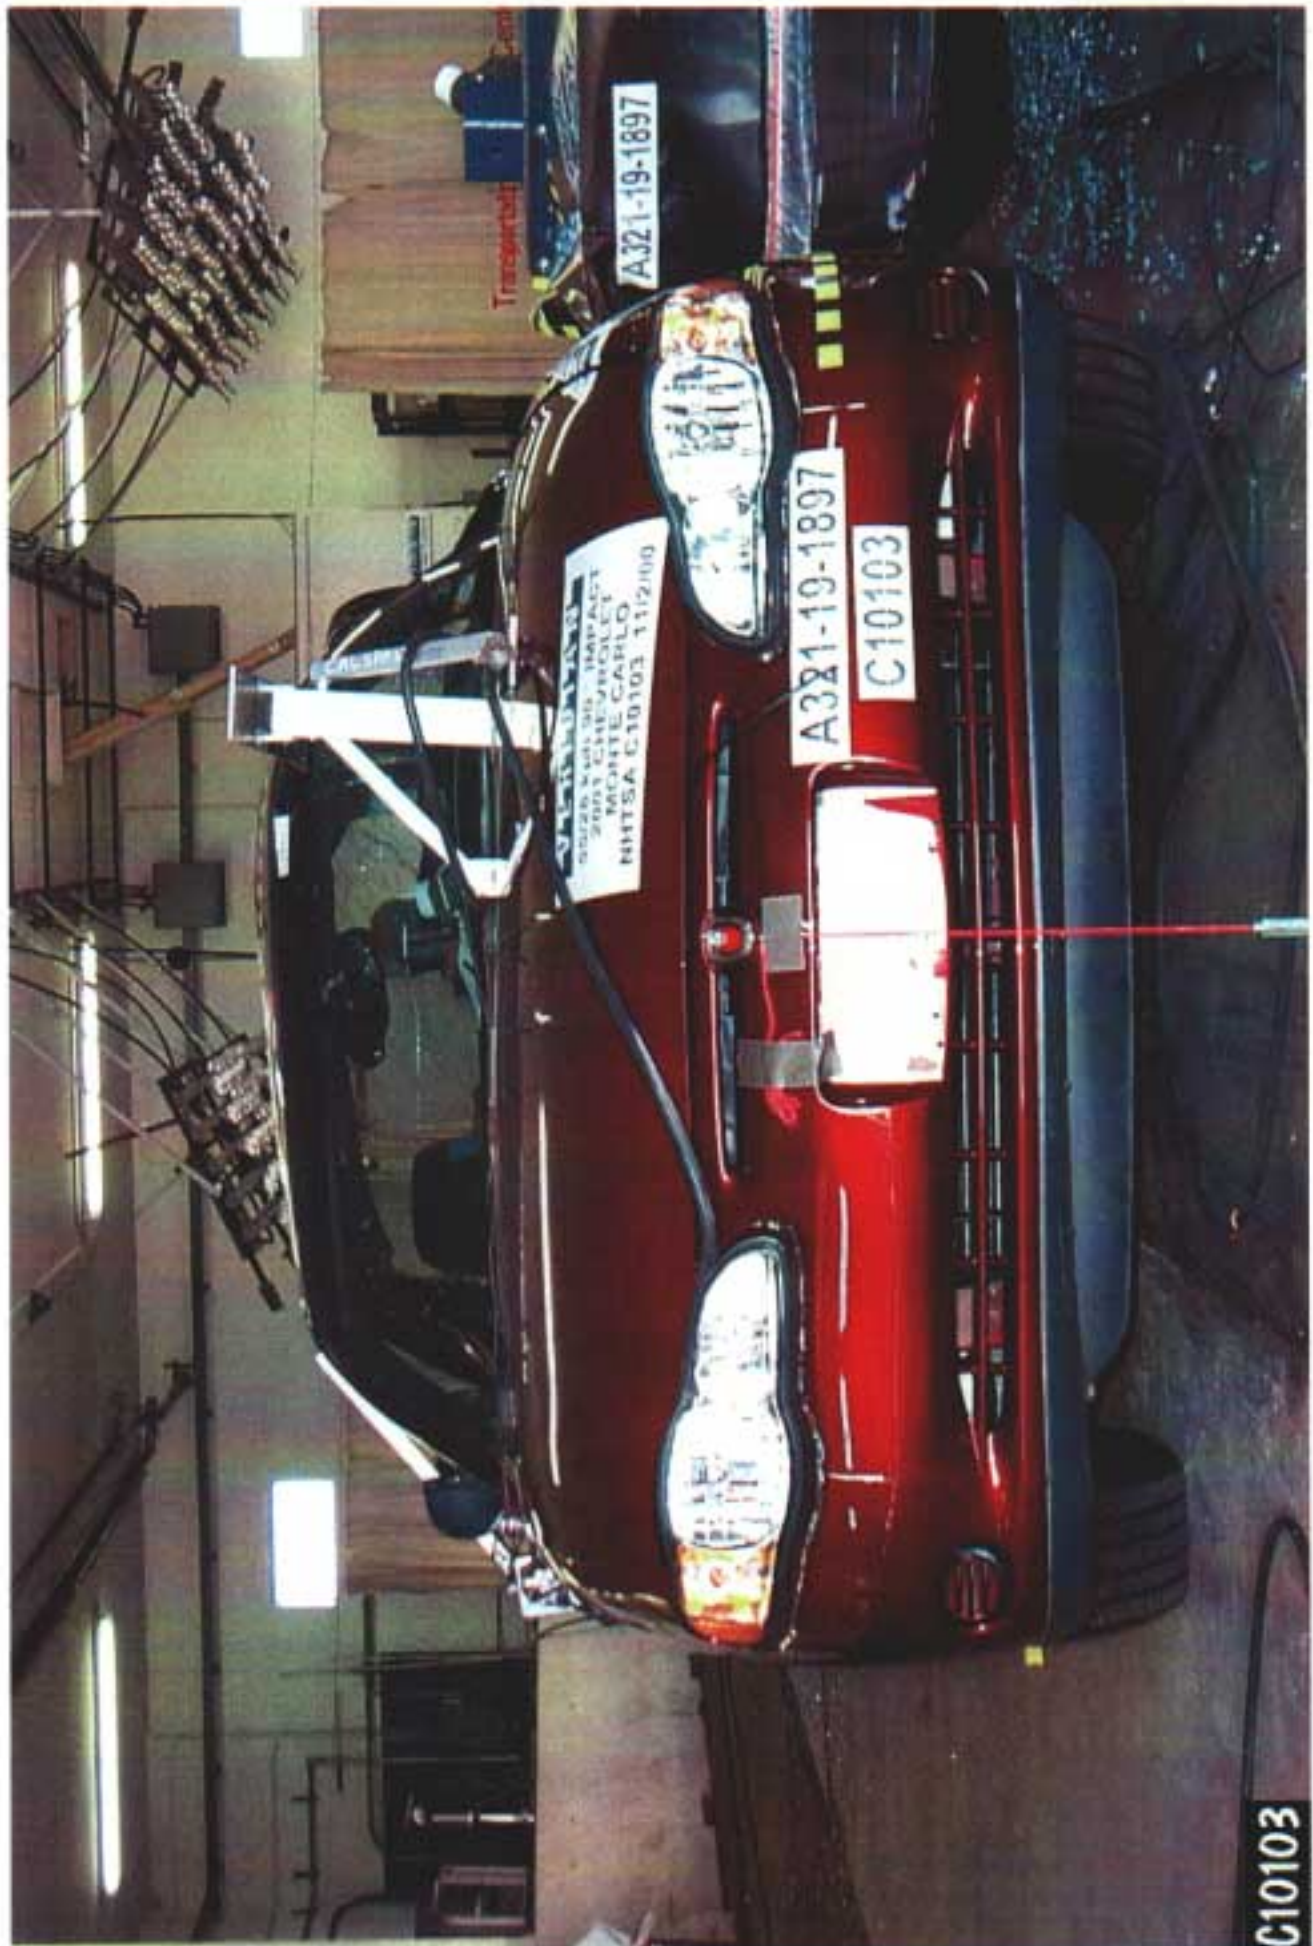
Figure A-2: POST-TEST FRONTAL VIEW OF TEST VEHICLE

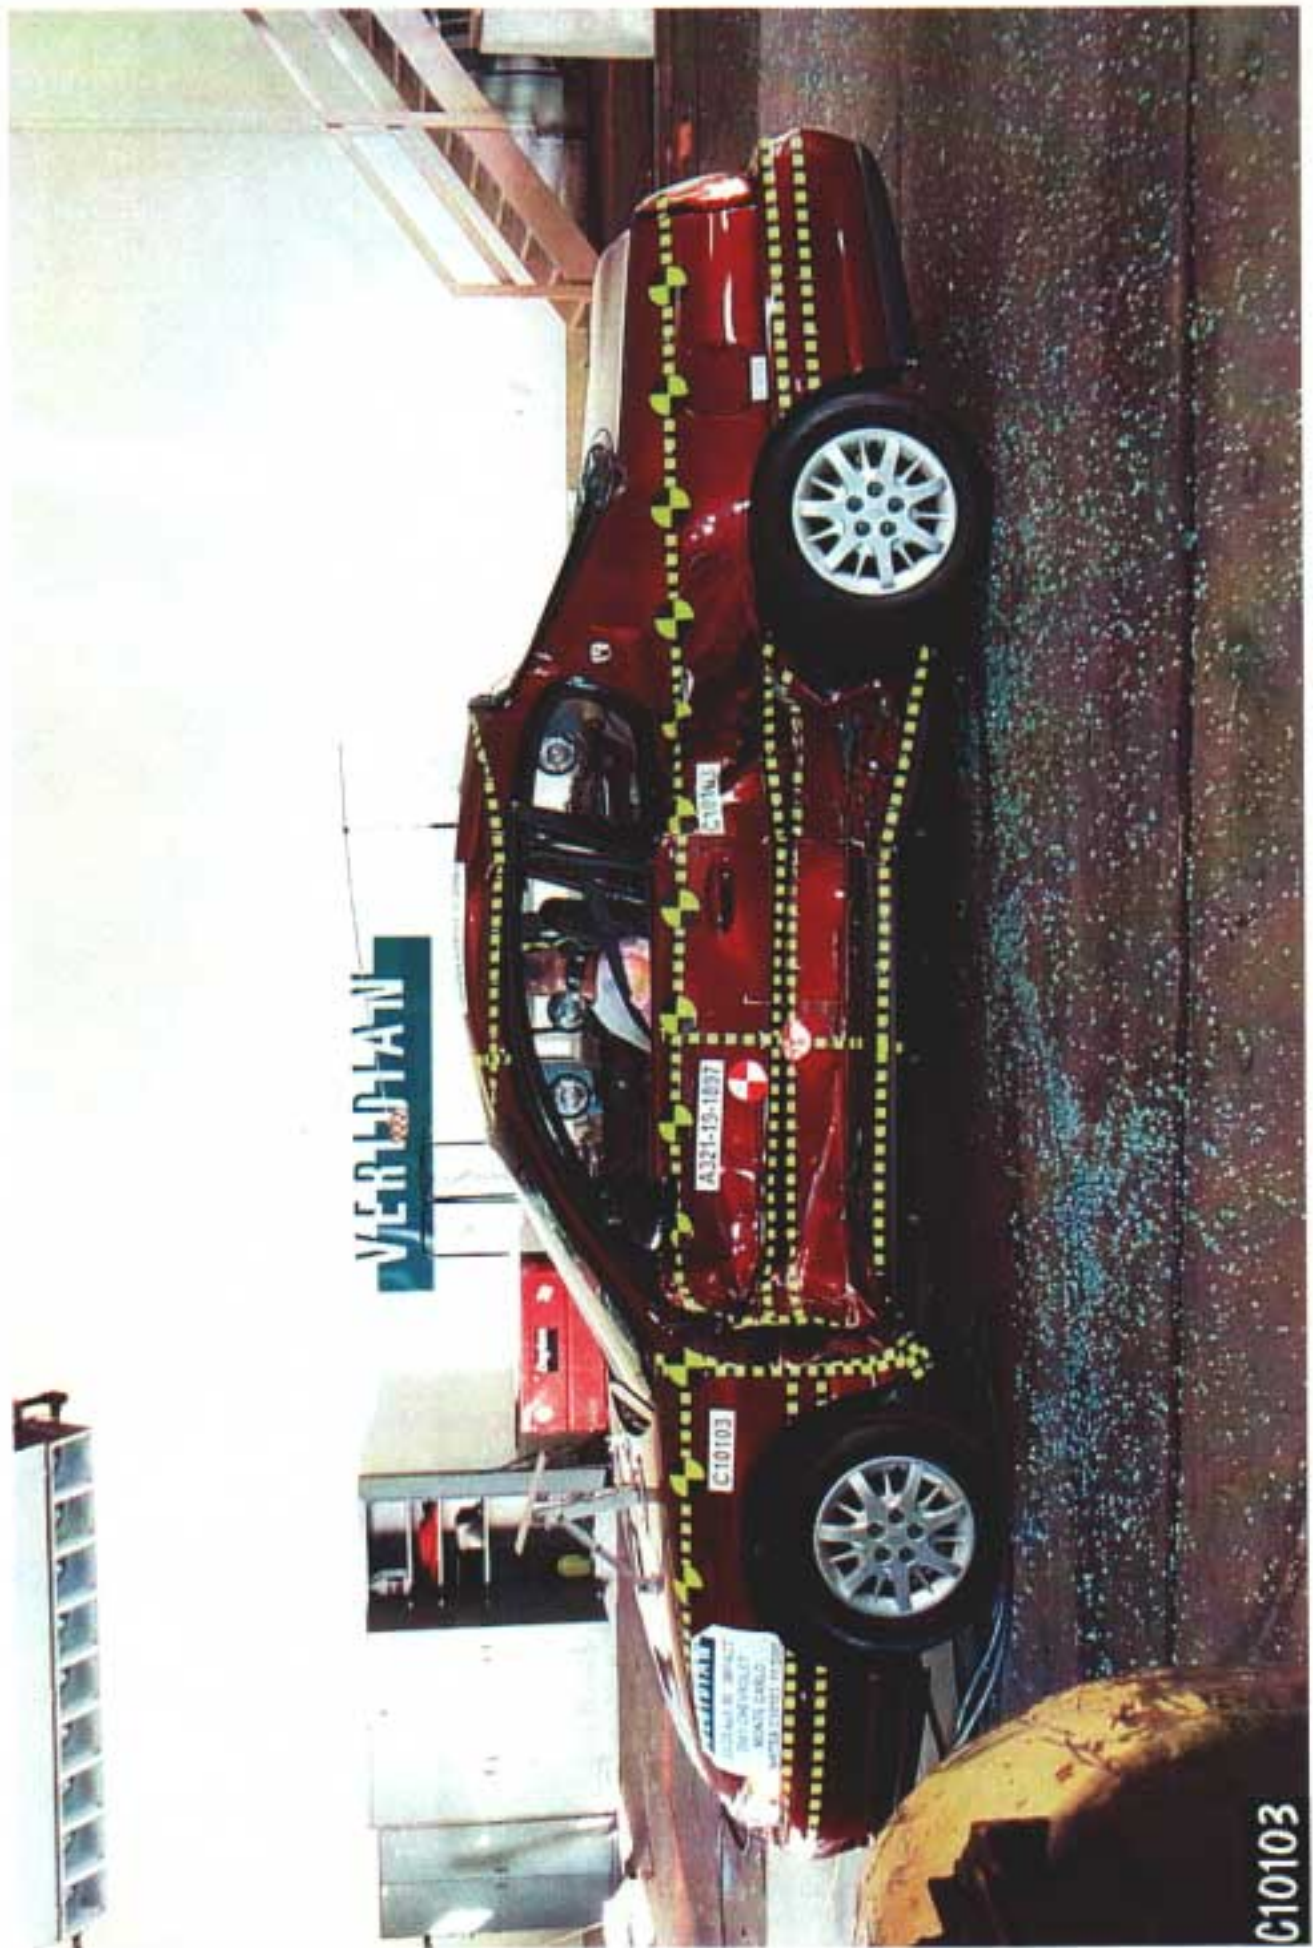
Figure A-6: POST-TEST IMPACTED SIDE VIEW OF TEST VEHICLE

Windshield:	<u>Windshield cracked at its top left edge</u>
Window:	<u>Left door window and rear window shattered during the impact</u>

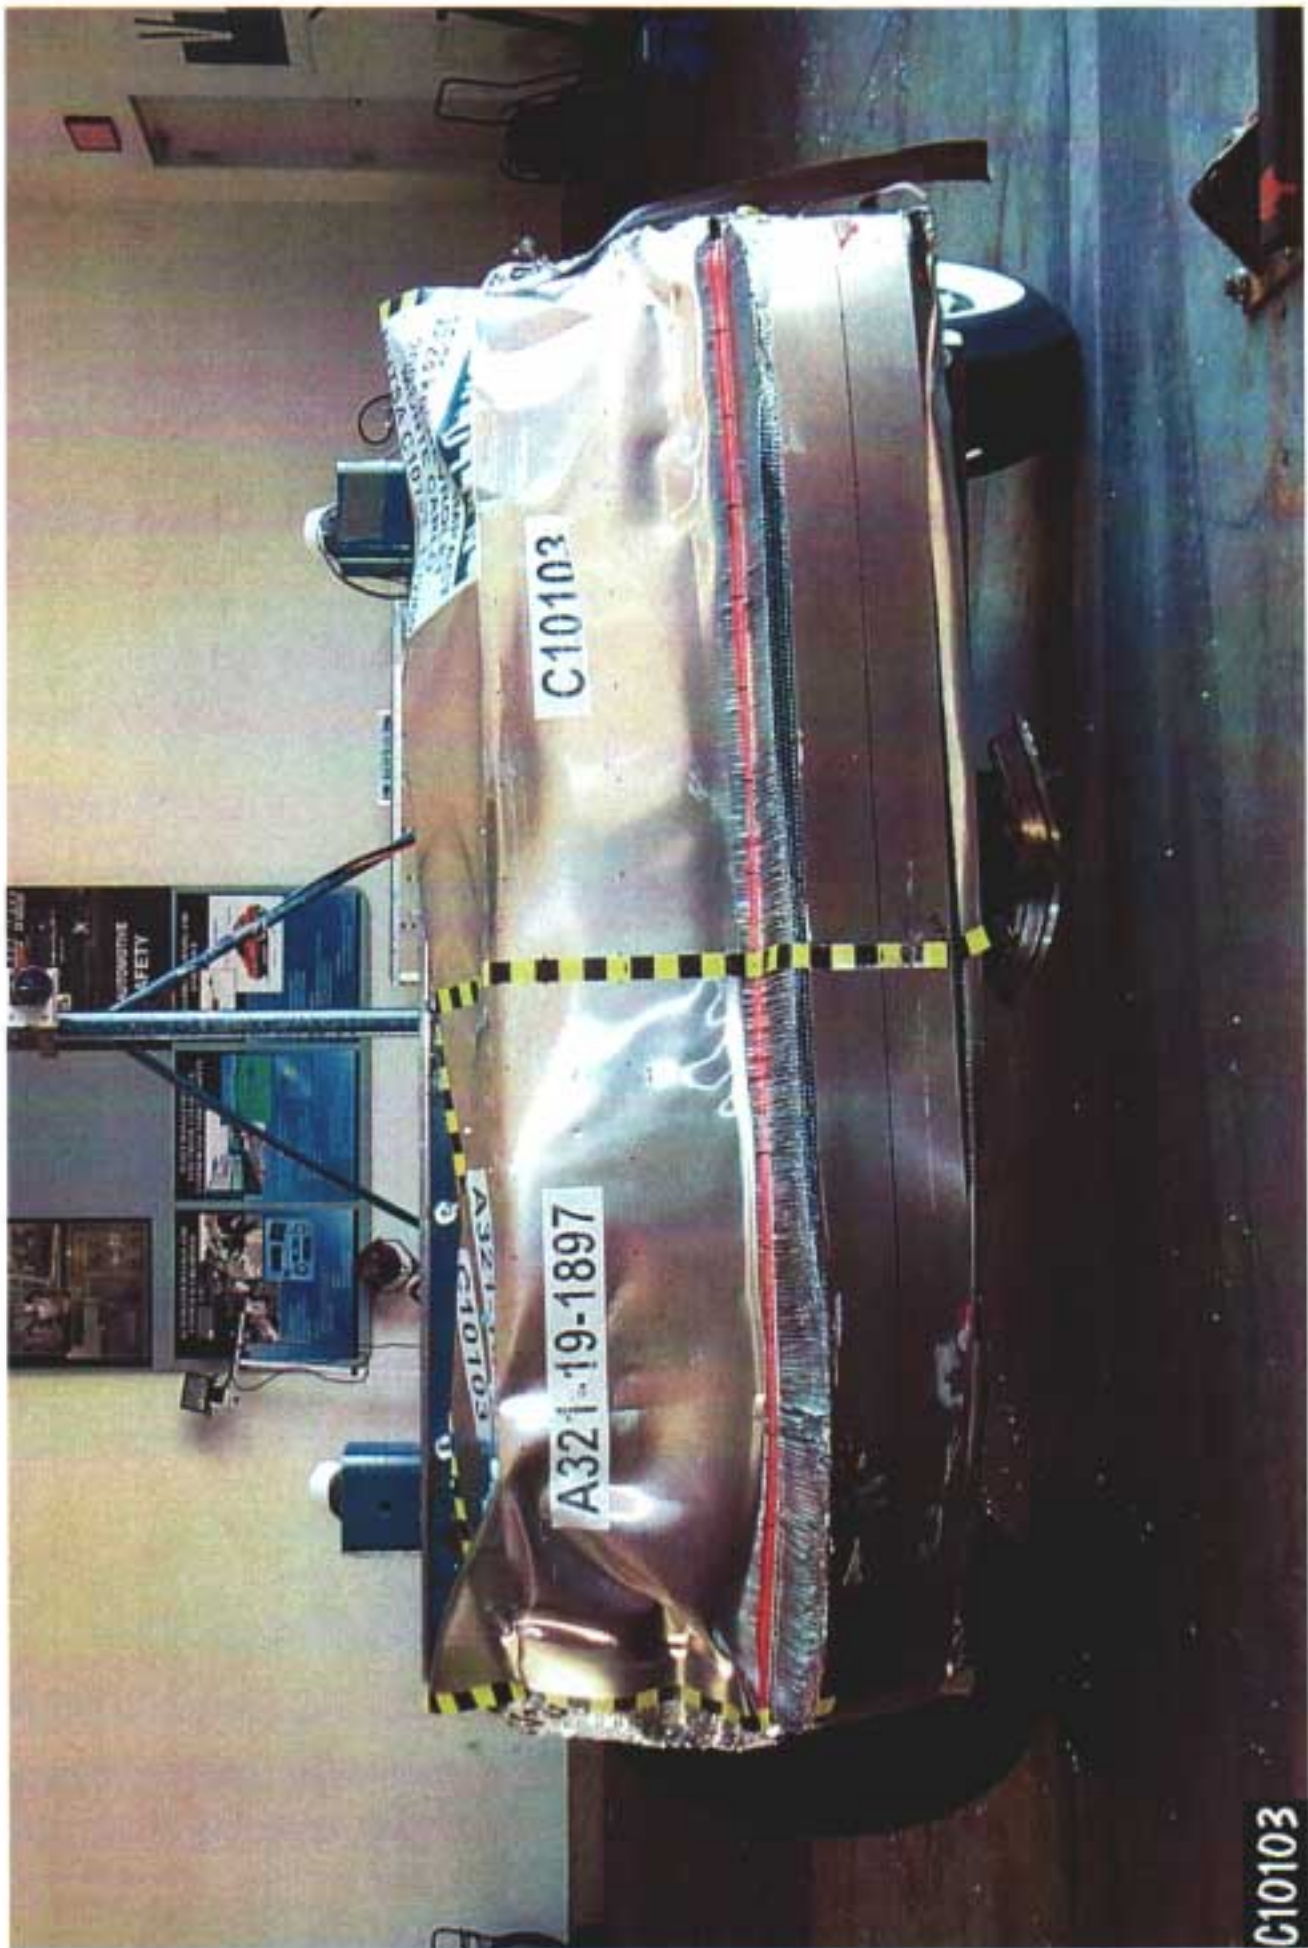
Figure A-8: POST-TEST FRONTAL VIEW OF IMPACTOR FACE

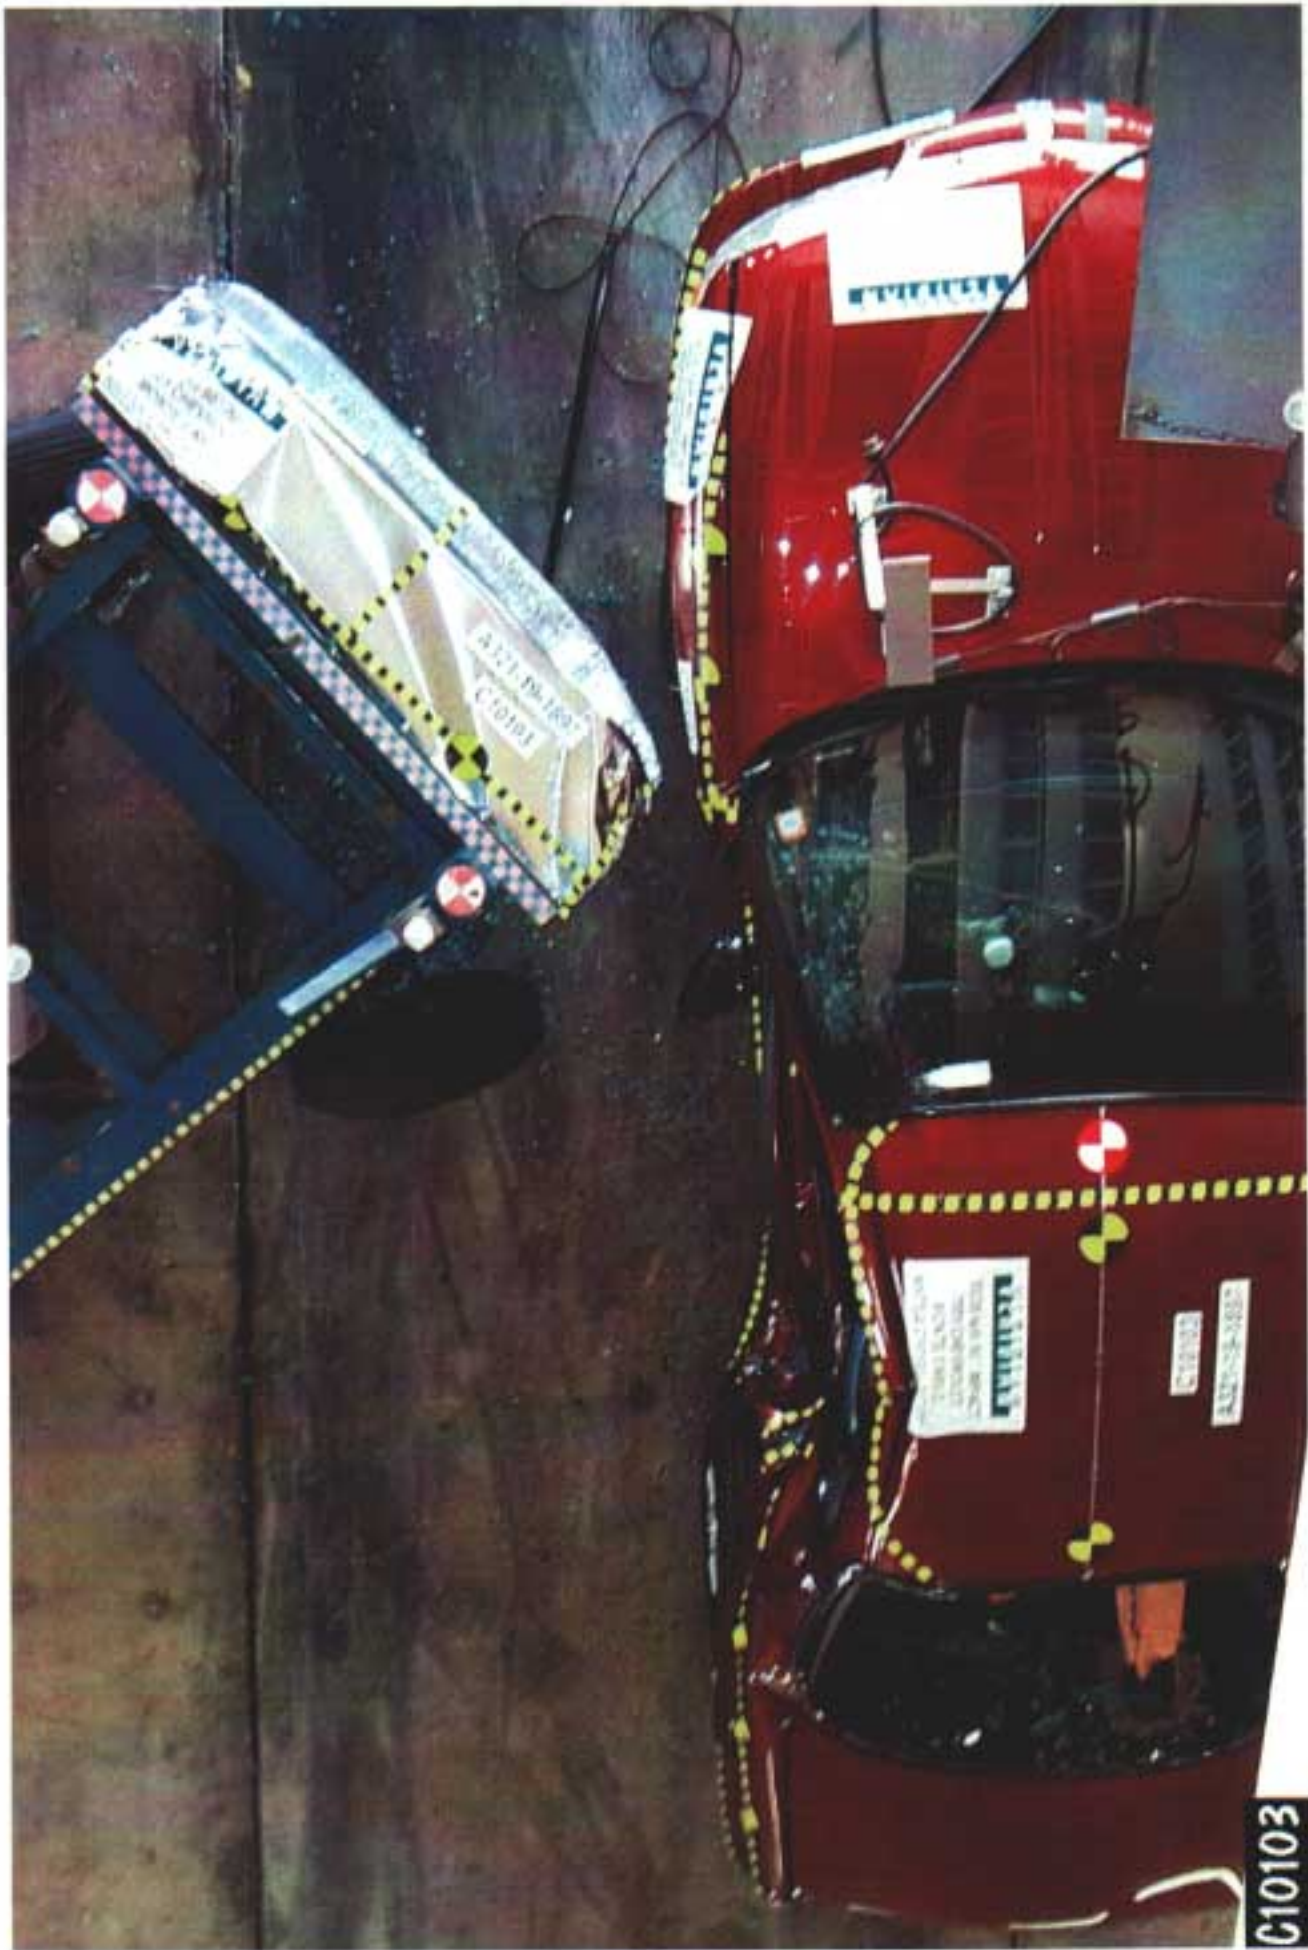
Figure A-16: POST-TEST OVERHEAD VIEW OF MDB AND VEHICLE

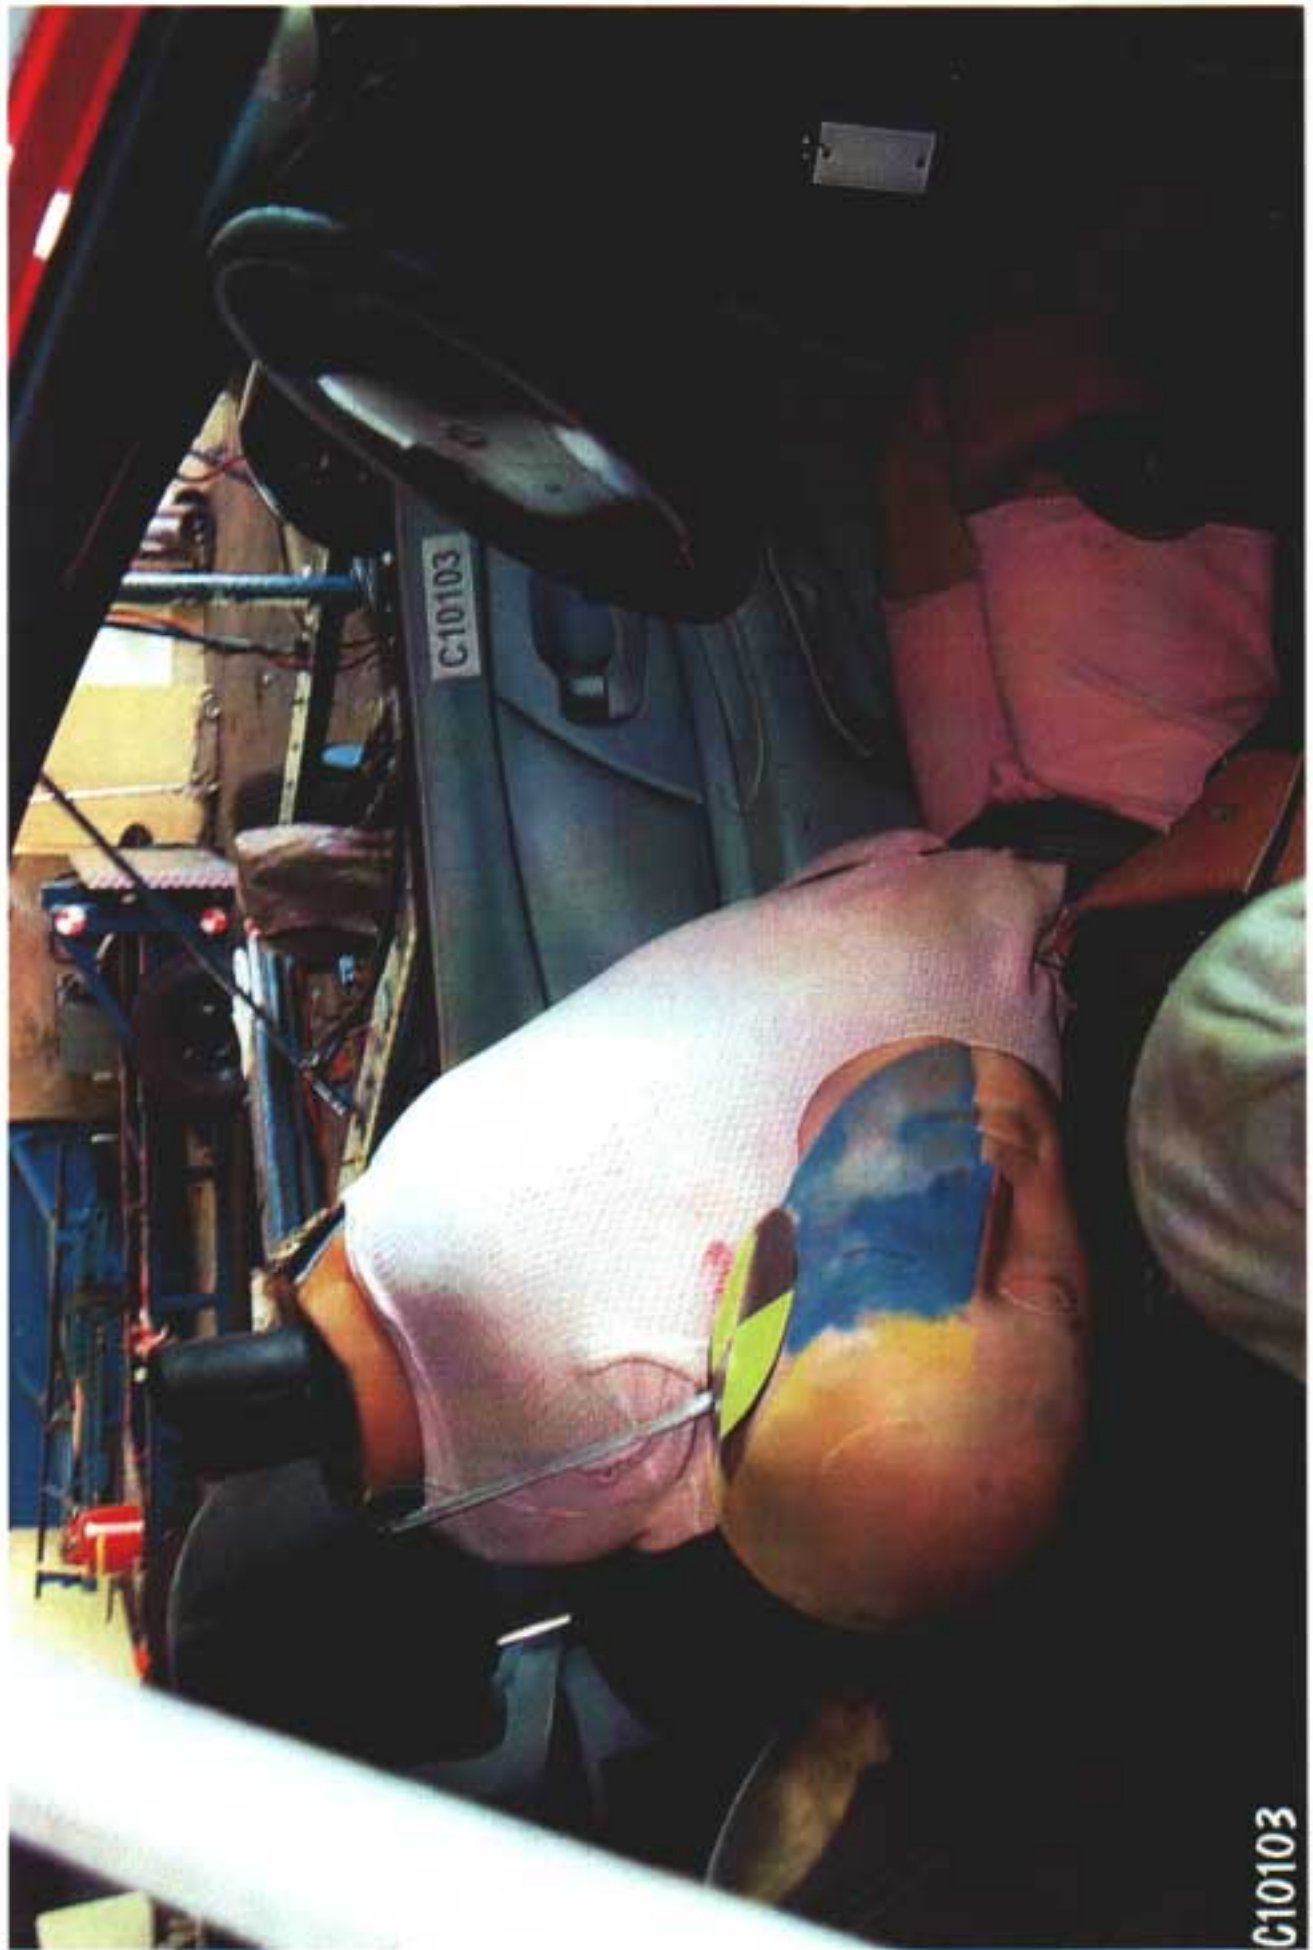
Figure A-18: POST-TEST RIGHT OCCUPANT COMPARTMENT VIEW OF FRONT SID

† The driver SID's neck upper surface sheared late in the impact event allowing the head to separate from the body.

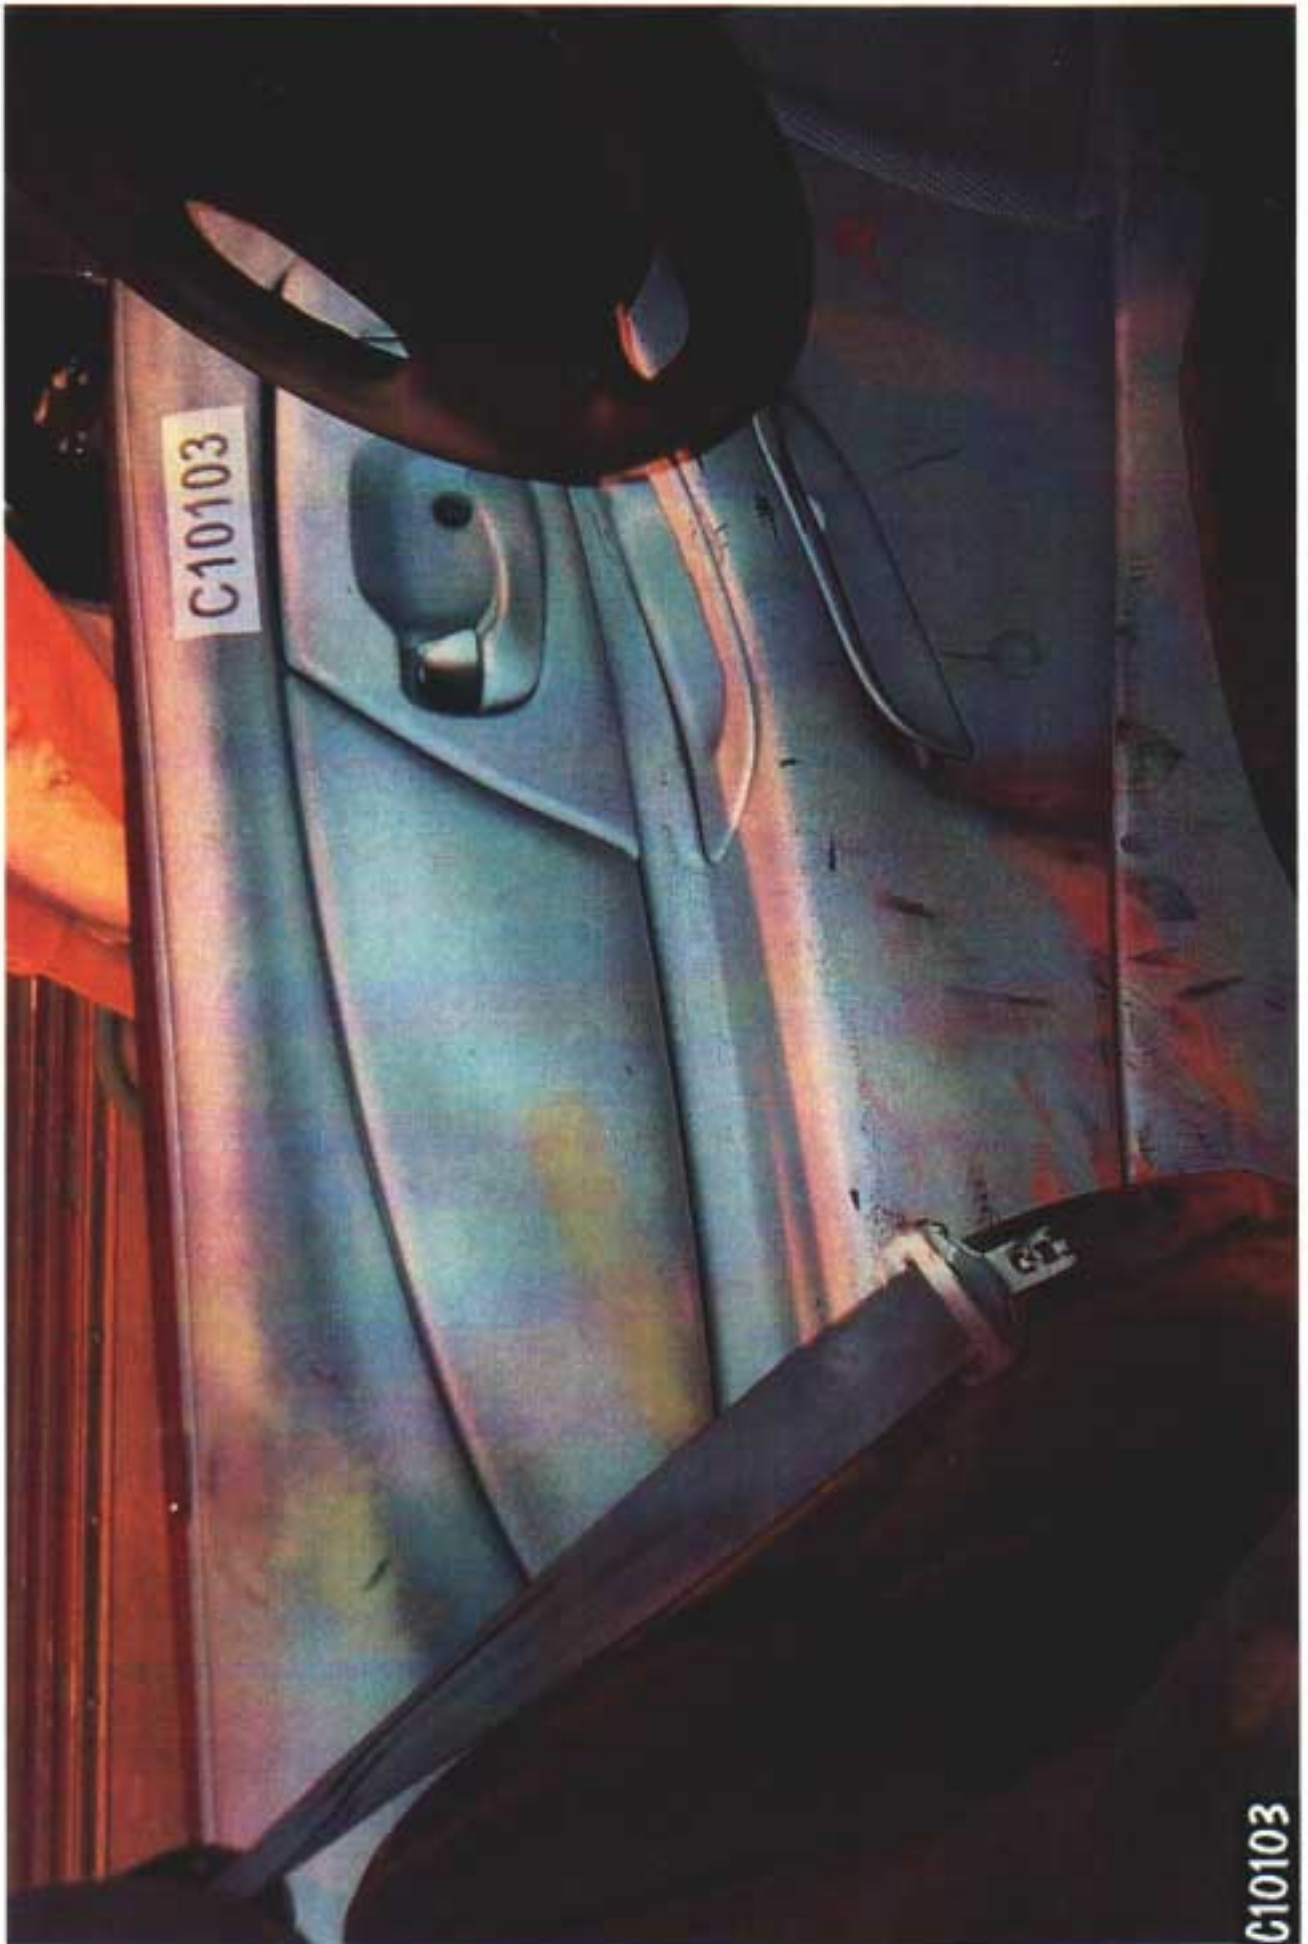
Figure A-26: POST-TEST FRONT INTERIOR TRIM SHOWING SID IMPACT LOCATIONS

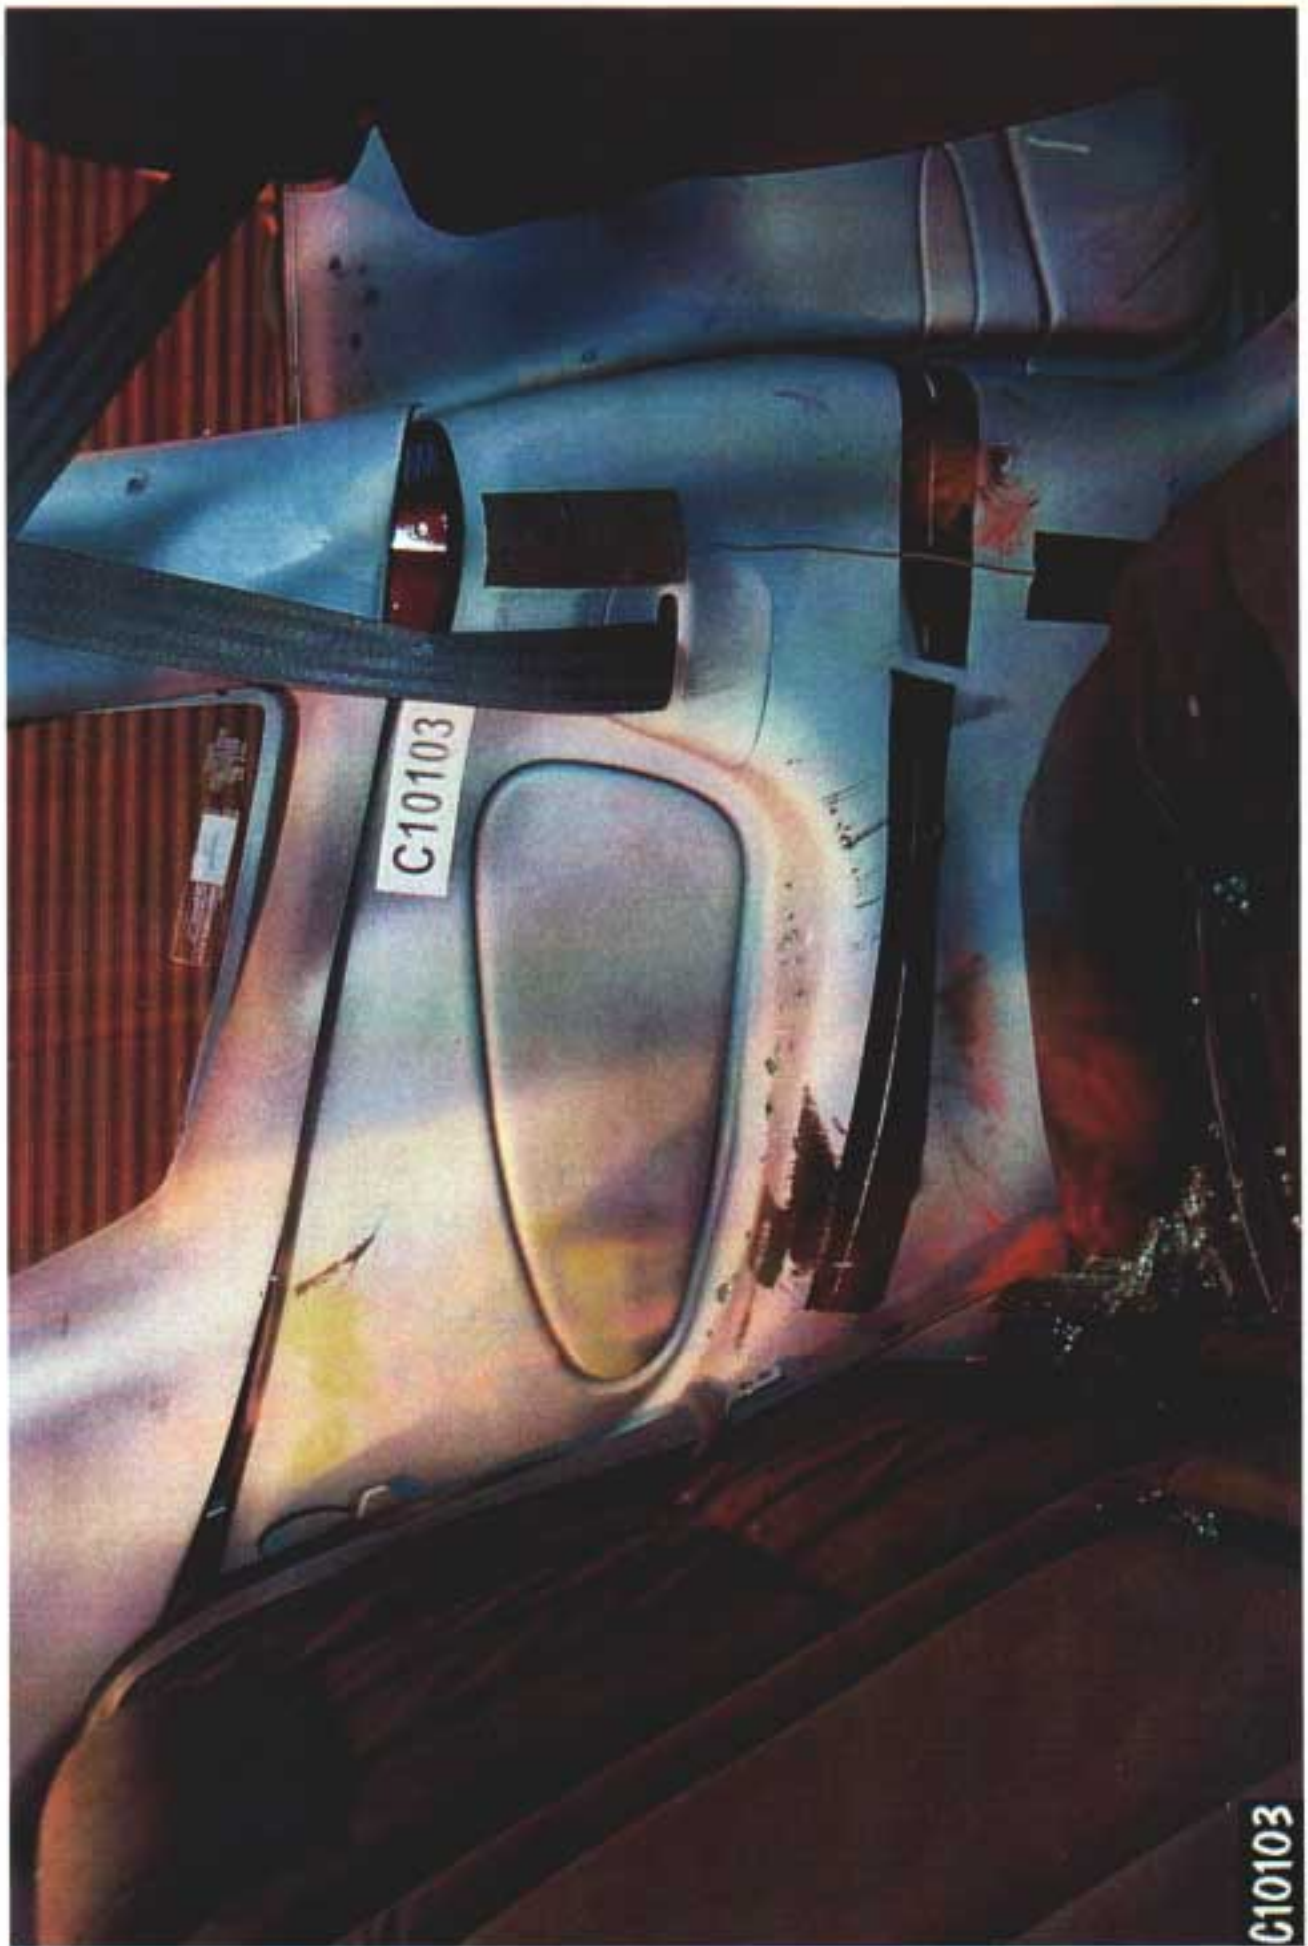
Figure A-28: POST-TEST REAR INTERIOR TRIM SHOWING SID IMPACT LOCATIONS

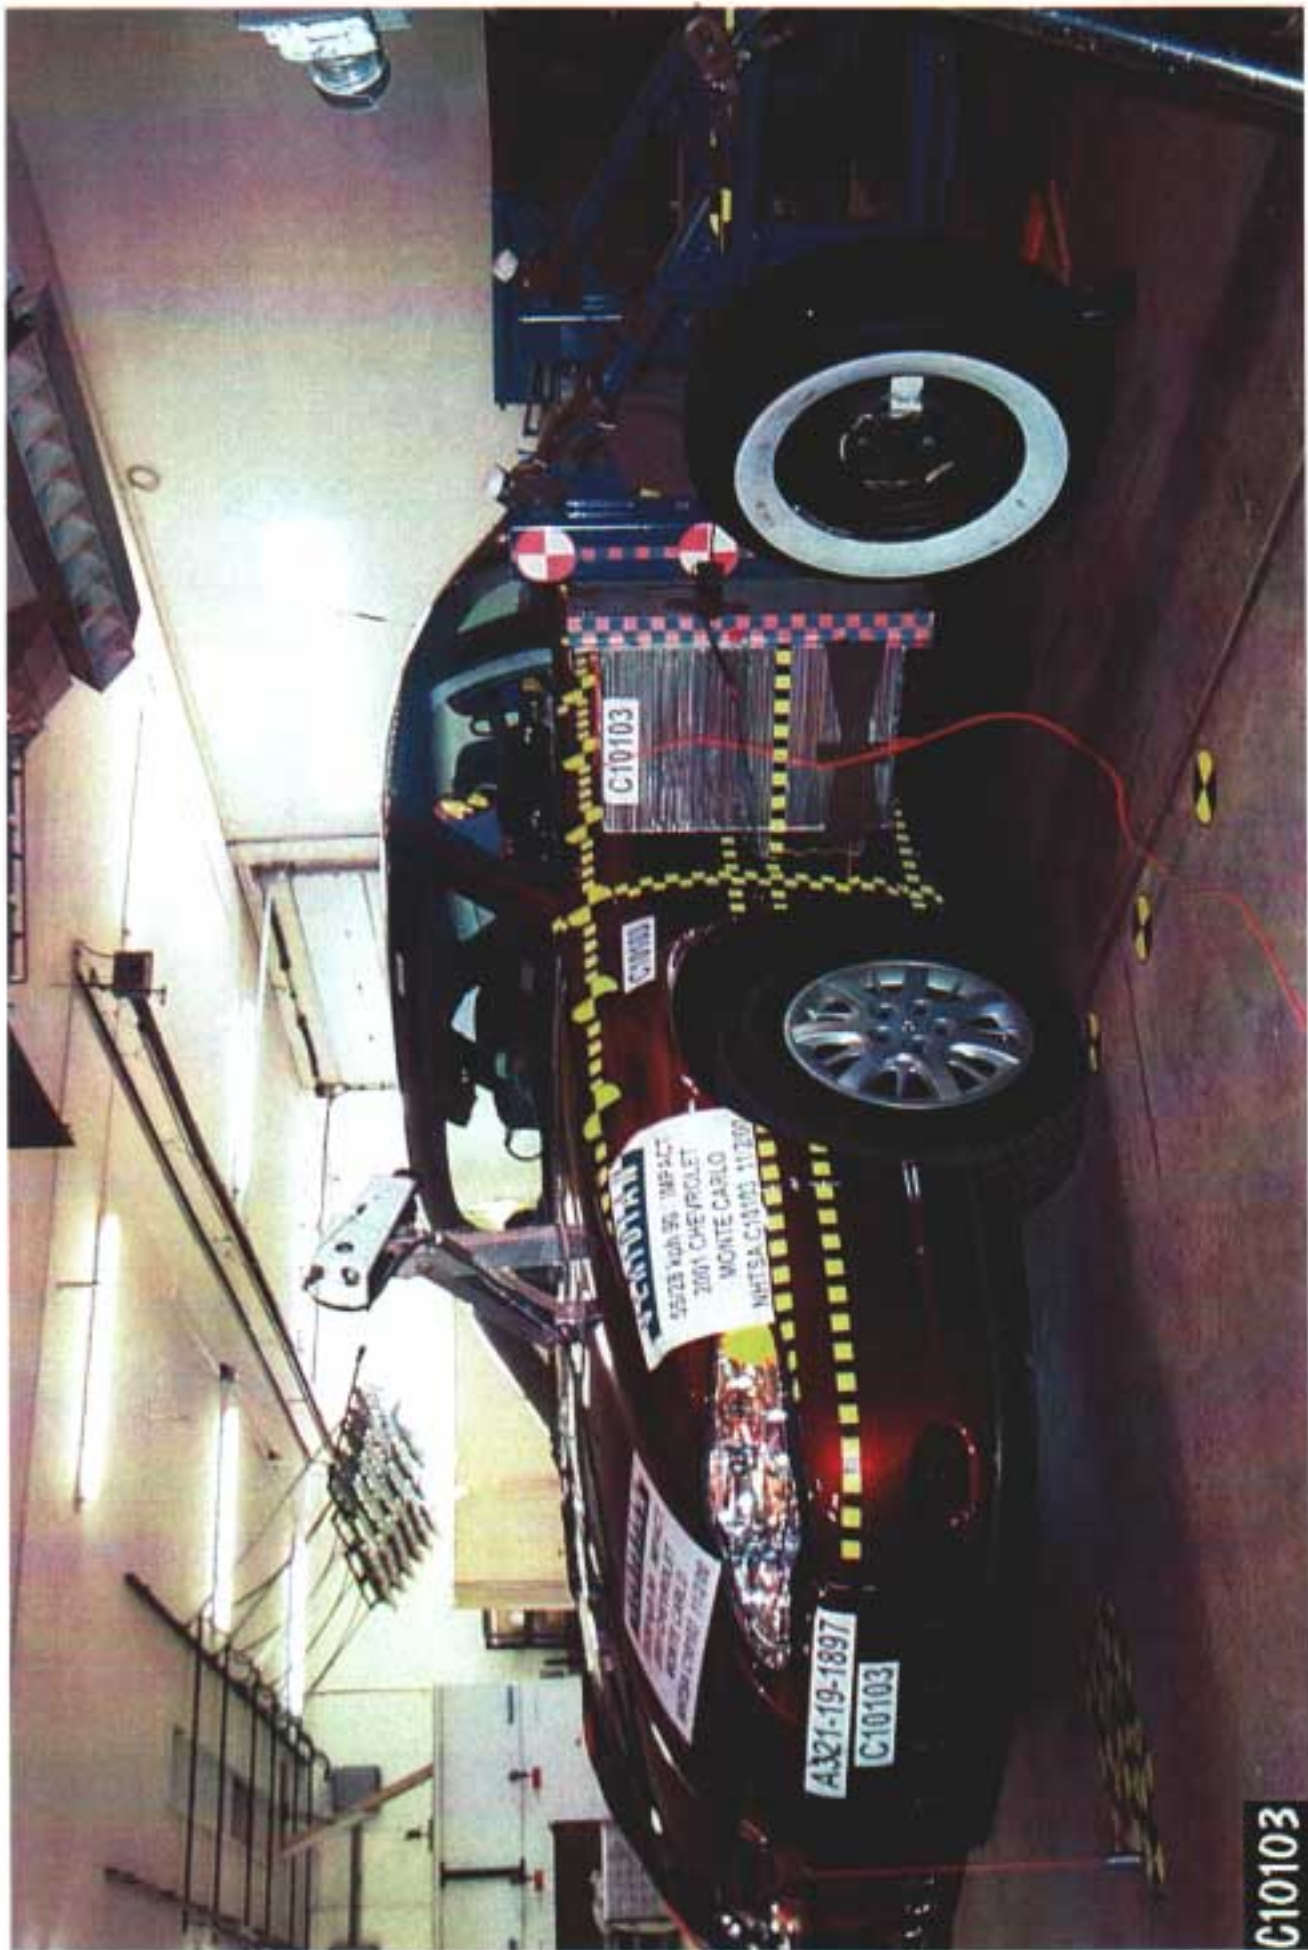
Figure A-29: PRE-TEST LEFT SIDE VIEW OF MDB WITH IMPACTOR FACE IN POSITION

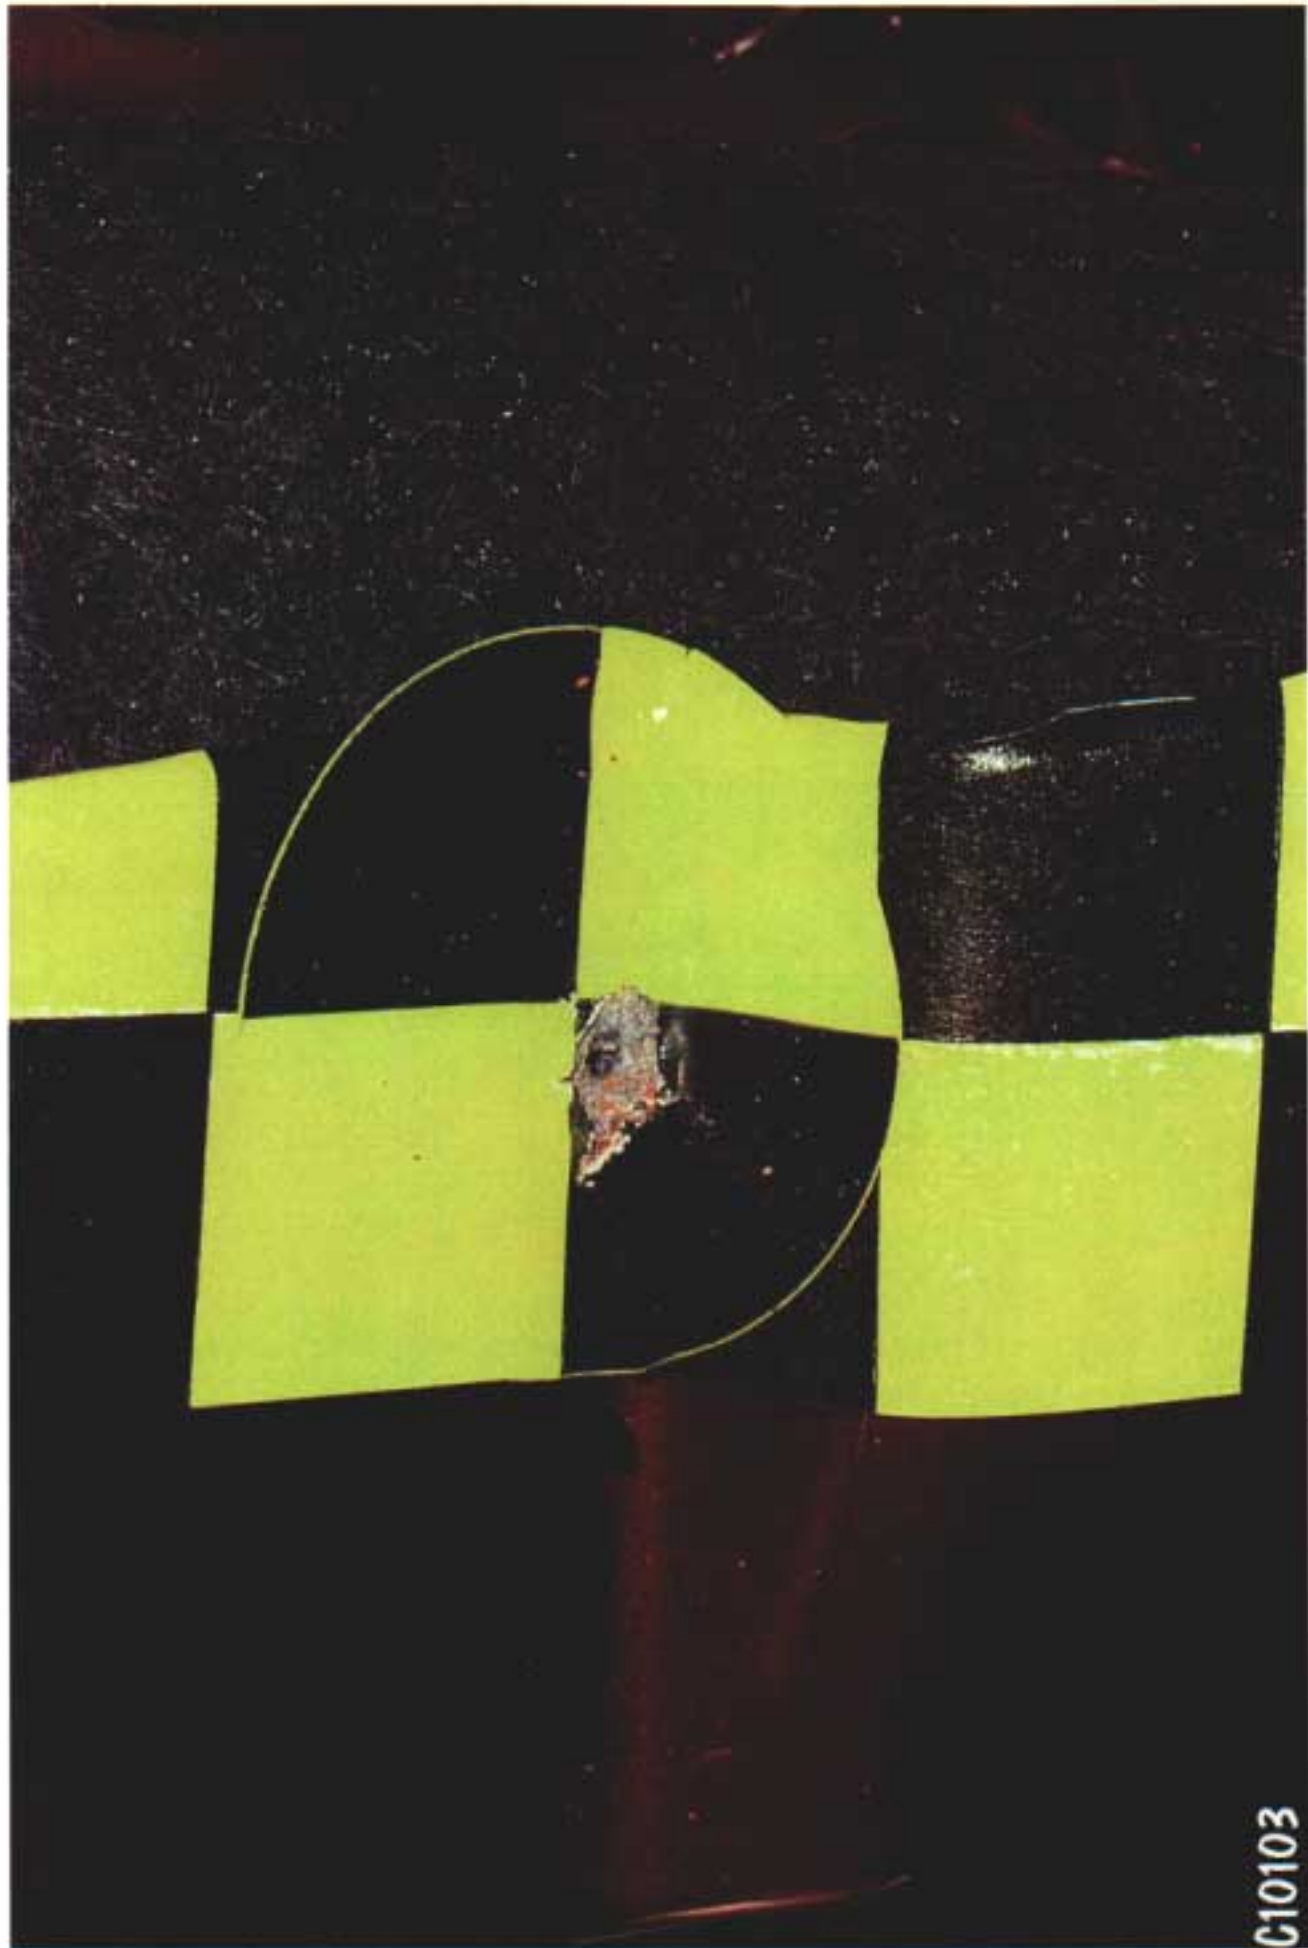
Figure A-31: POST-TEST CLOSE-UP VIEW OF IMPACT POINT TARGET
