REPORT NUMBER: CAL-01-01

**NEW CAR ASSESSMENT PROGRAM (NCAP)
FRONTAL BARRIER IMPACT TEST**

**GENERAL MOTORS OF CANADA LTD.
2001 CHEVROLET IMPALA
4-DOOR SEDAN**

NHTSA NUMBER: M10102

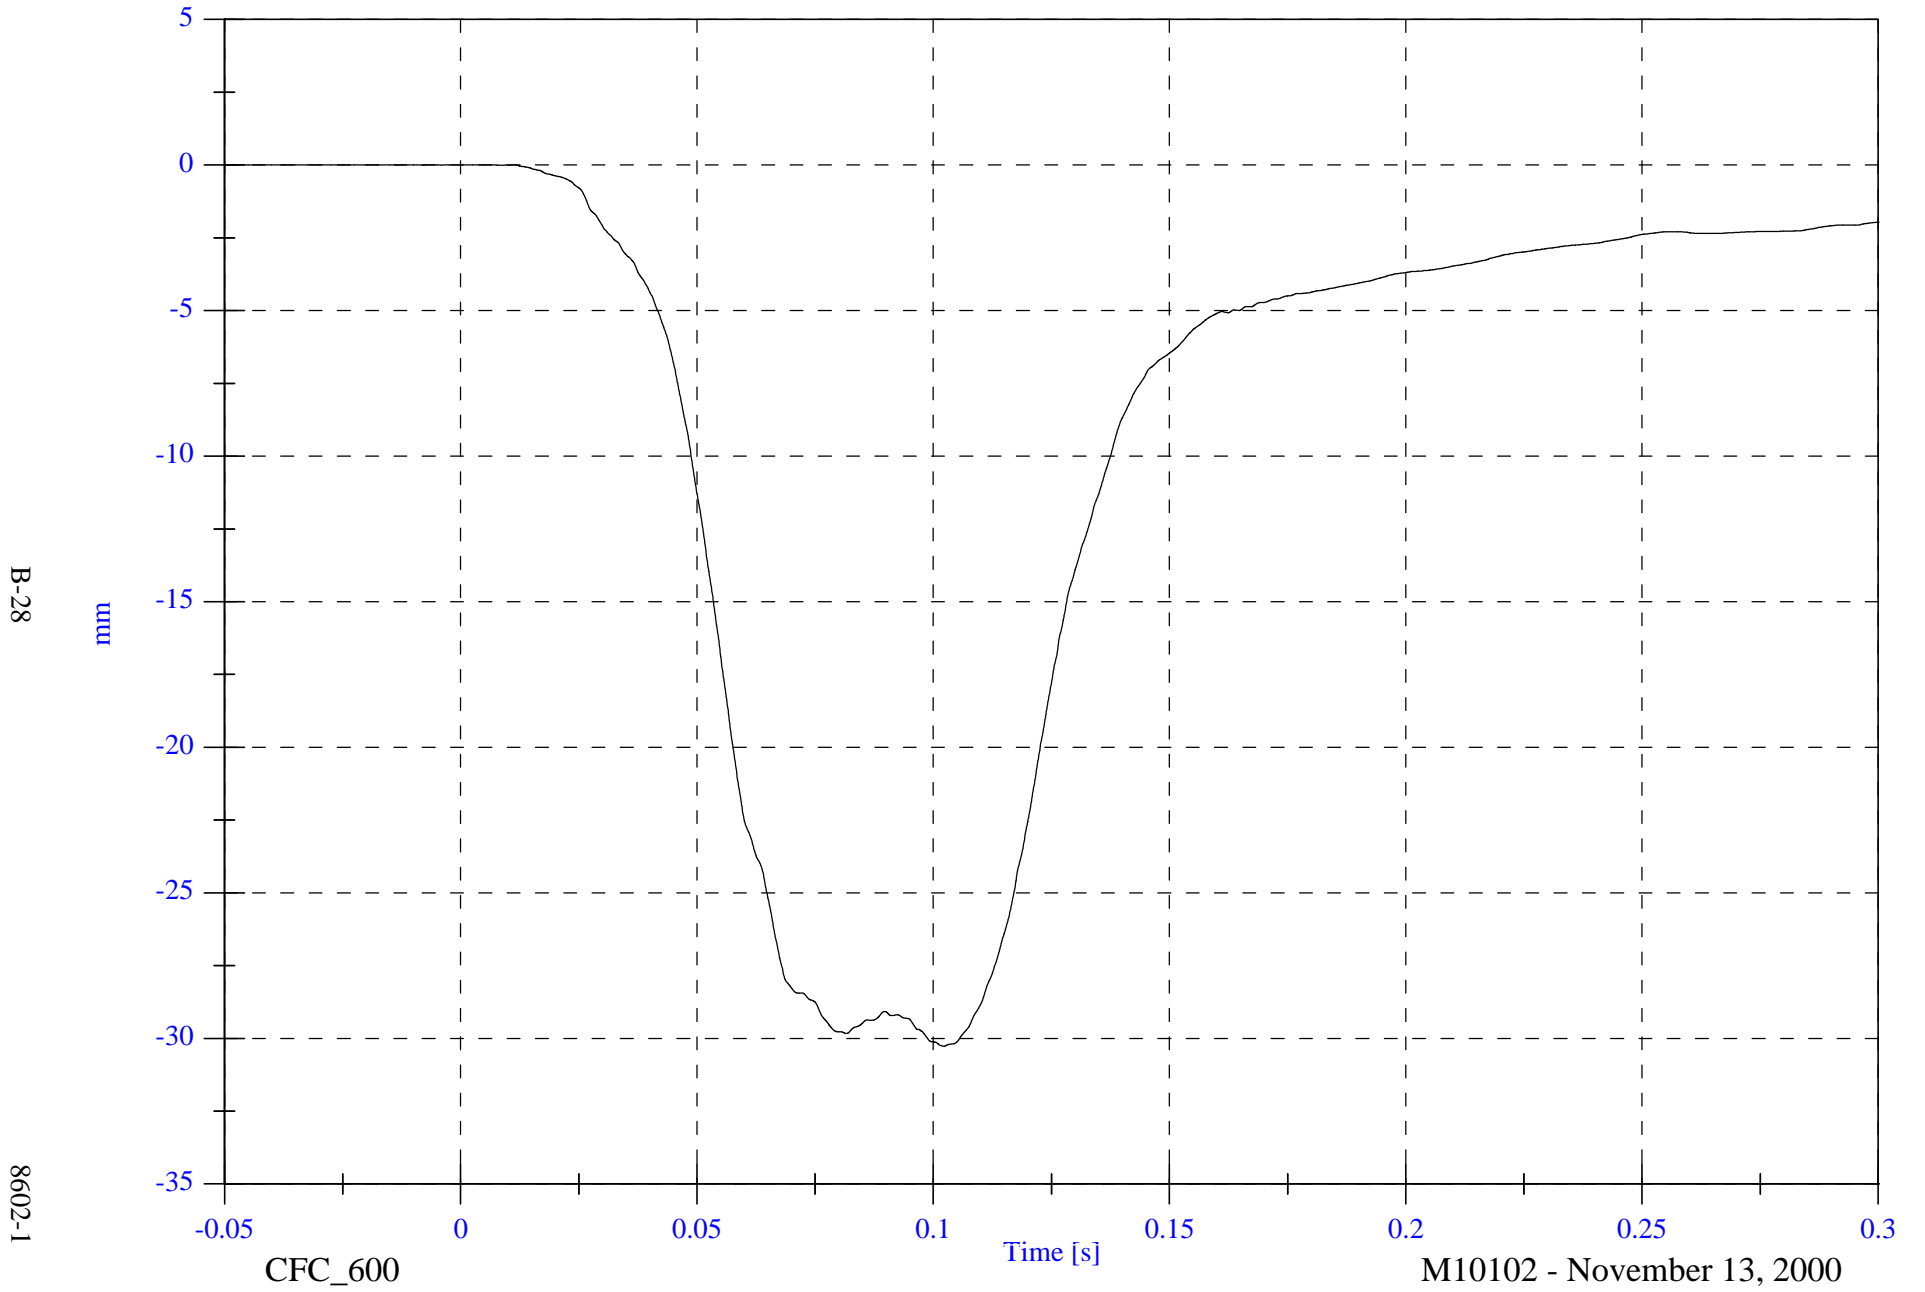
P1 Chest Compression x

Min: -30.3 [mm] at 0.102 [s]

The driver's HIC was 342.6. The maximum chest deceleration over 3 milliseconds was 34.5 g's and maximum chest deflection was 30.3 mm. Compressive femur loads were 5690.1 Newtons on the left and 6247.4 Newtons on the right.

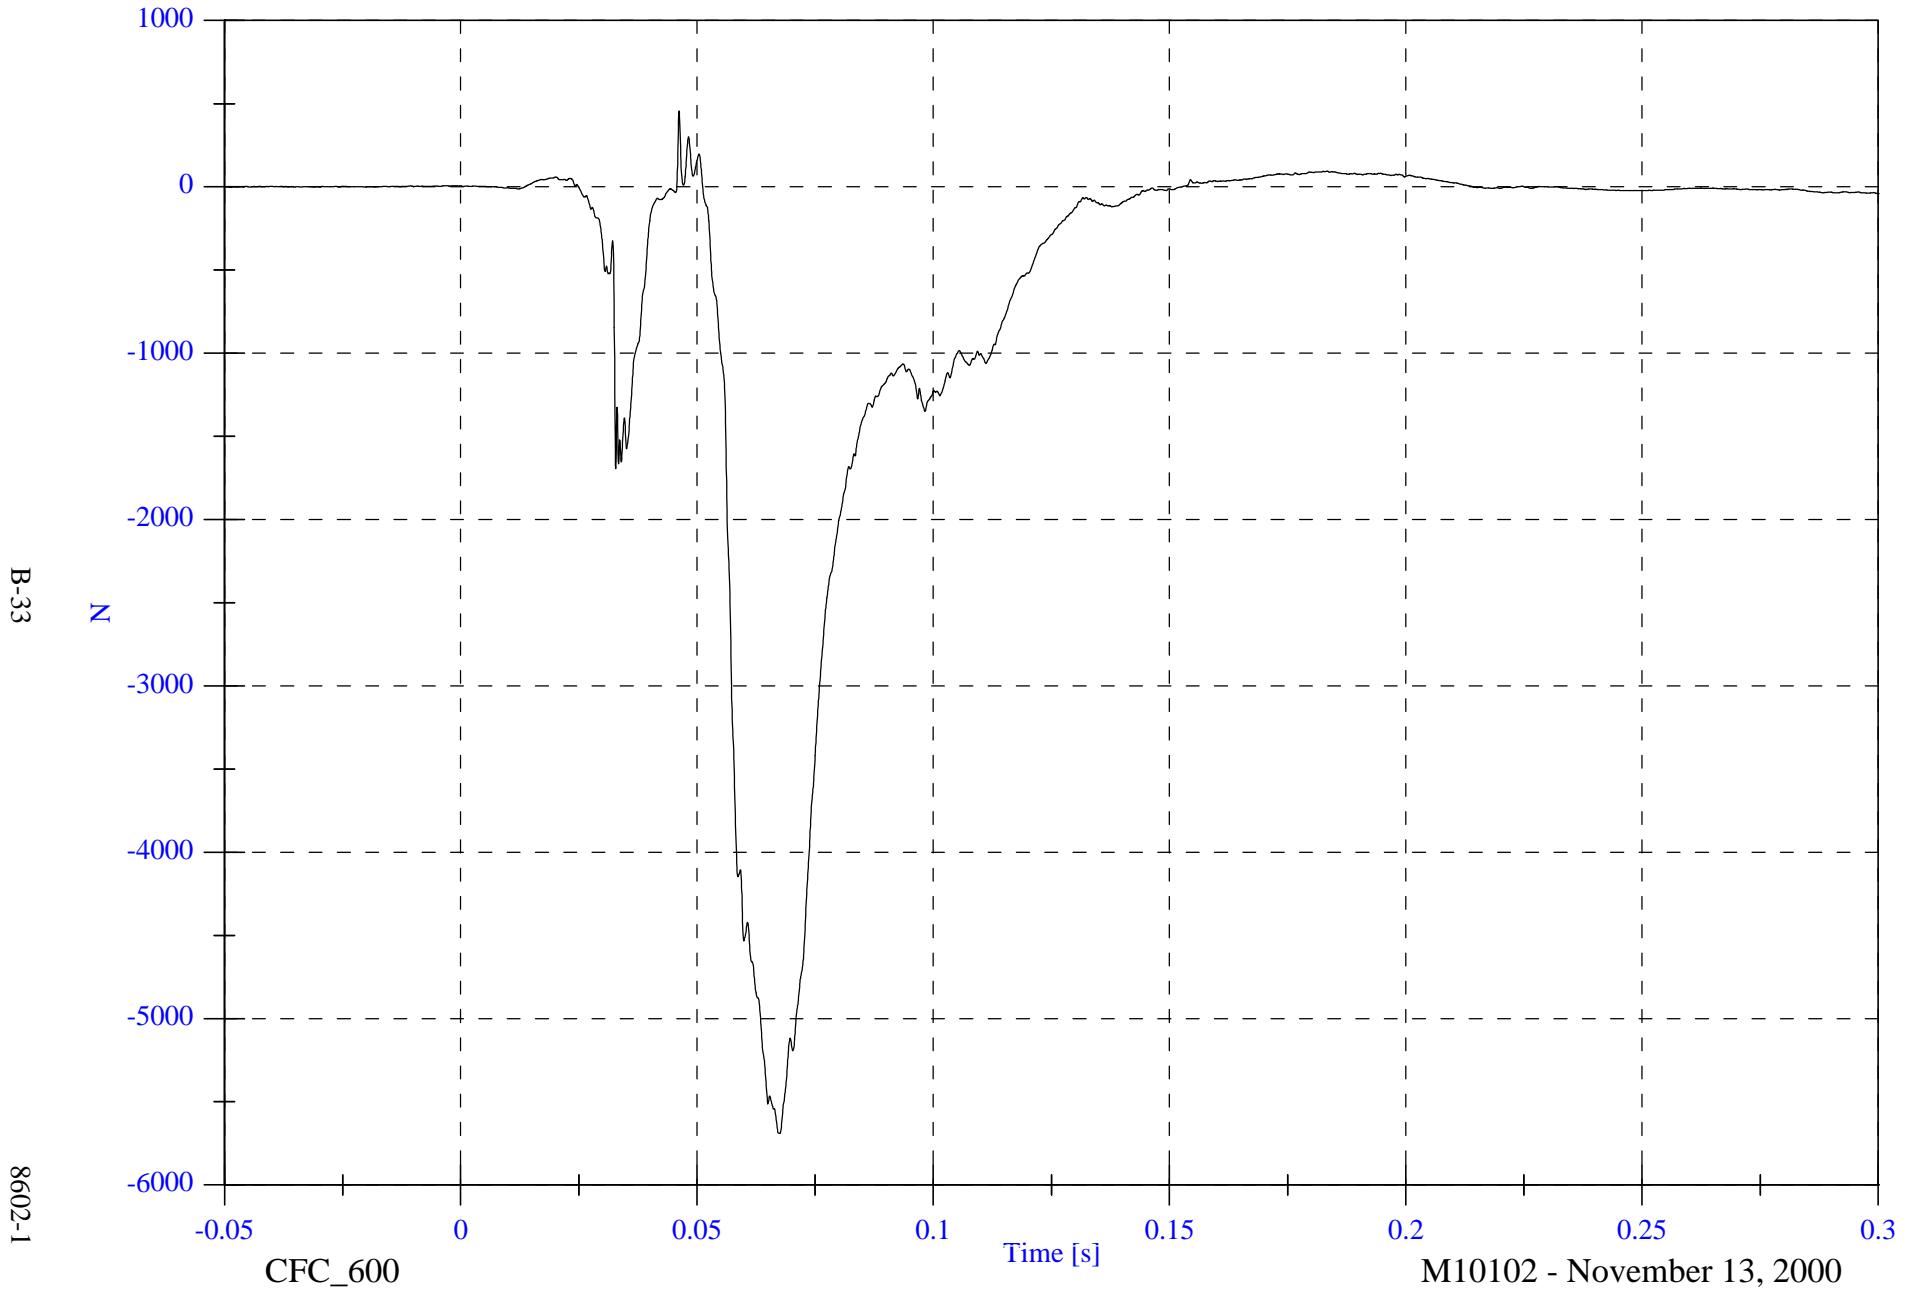
Max: 457.1 [N] at 0.046 [s]

Min: -5690.1 [N] at 0.068 [s]

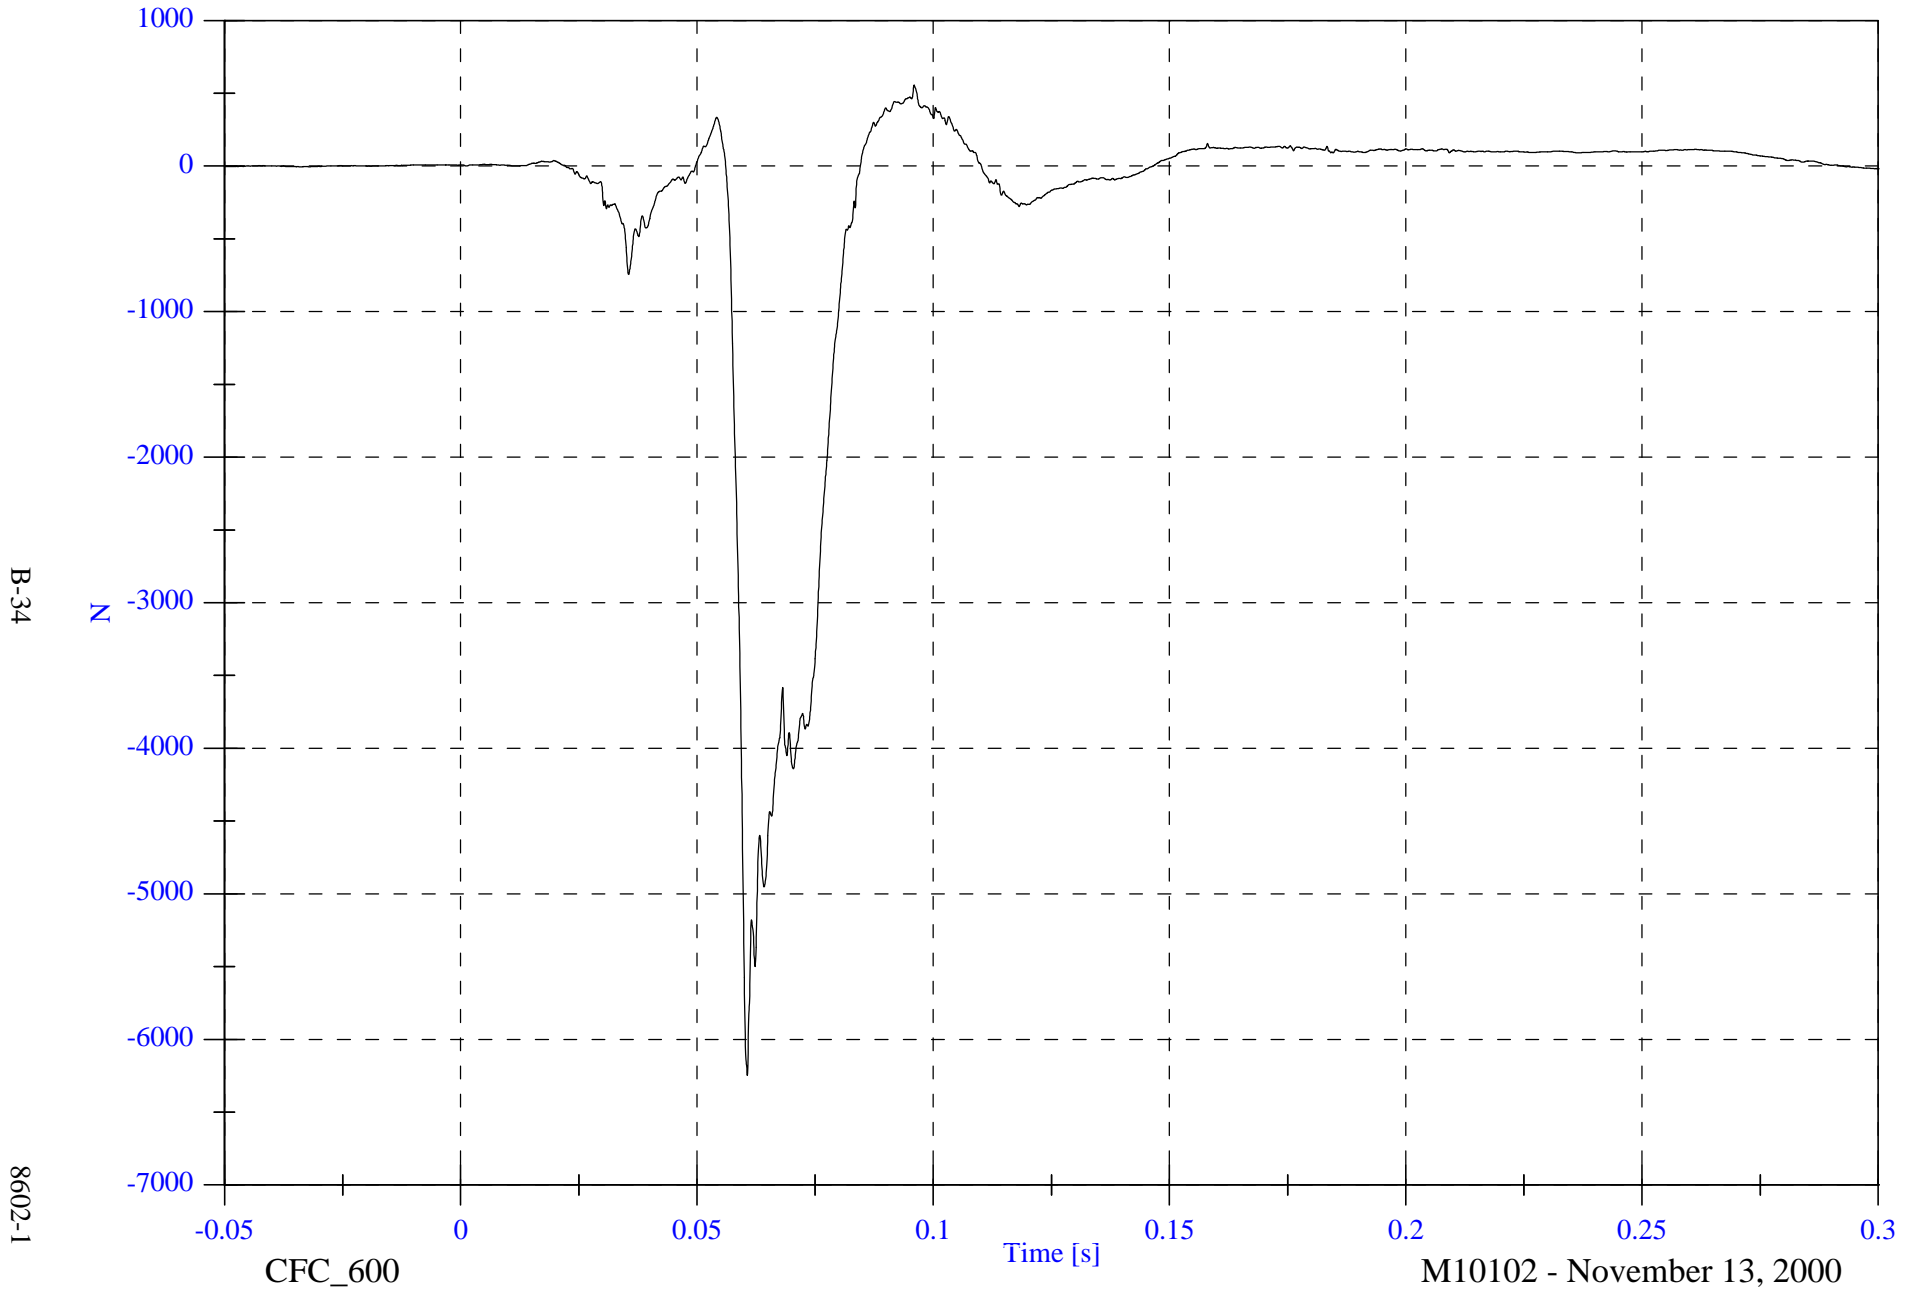
P1 Right Femur z

Max: 557.7 [N] at 0.096 [s]

Min: -6247.4 [N] at 0.061 [s]

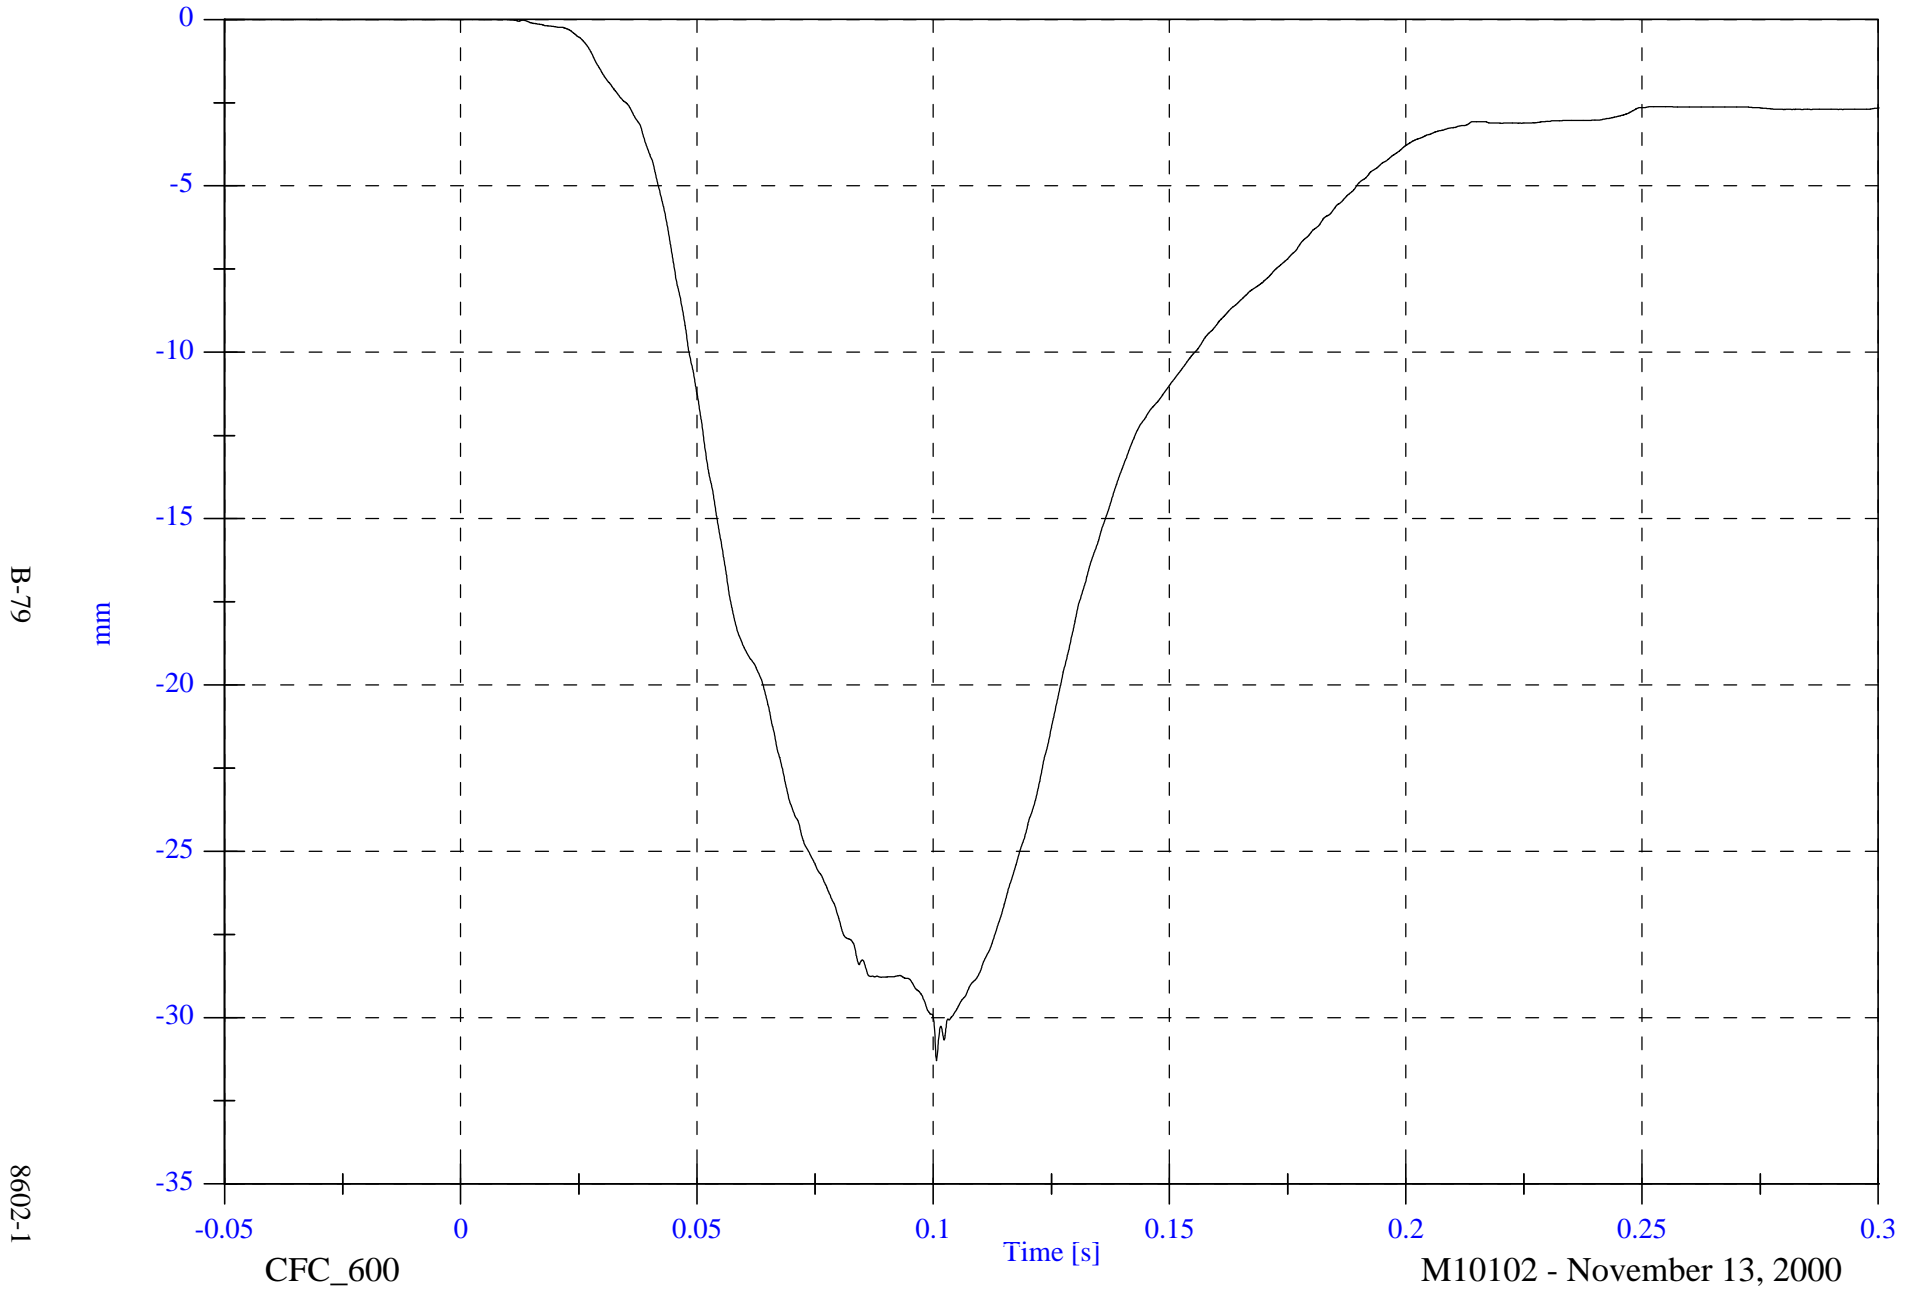
Max: 0.0 [mm] at -0.030 [s]

Min: -31.3 [mm] at 0.101 [s]

The right front passenger's HIC was 400.9. Maximum chest deceleration over 3 milliseconds was 39.7 g's and maximum chest deflection was 31.3 mm. Compressive femur loads were 3696.0 Newtons on the left and 4044.6 Newtons on the right.

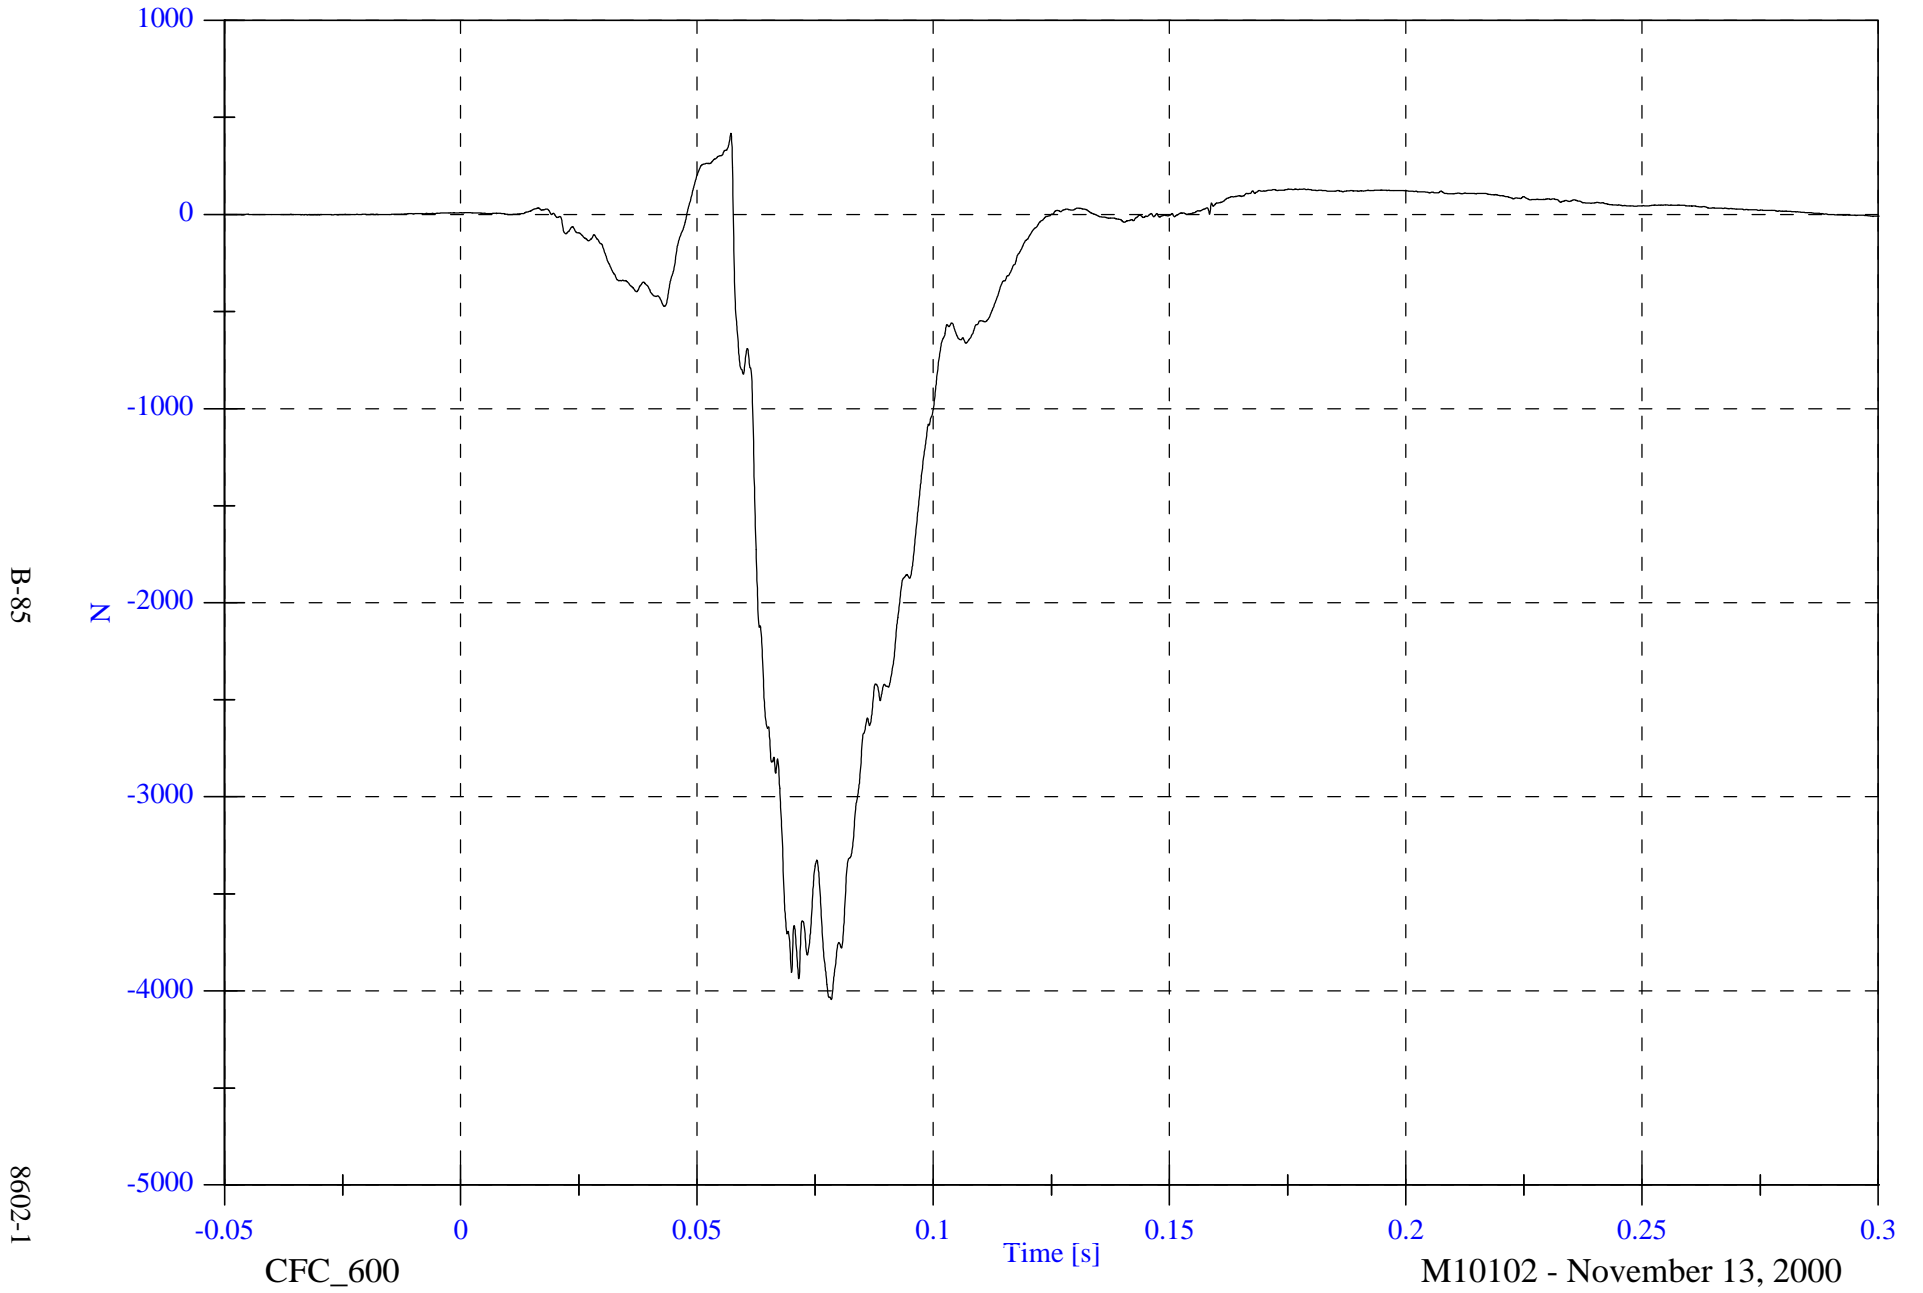
Max: 418.0 [N] at 0.057 [s]

Min: -4044.6 [N] at 0.078 [s]
