**REPORT NUMBER KAR20051-04**

**NEW CAR ASSESSMENT PROGRAM  
SIDE IMPACT TEST**

**HYUNDAI MOTOR CORPORATION  
2001 HYUNDAI ELANTRA  
4 DOOR SEDAN  
NHTSA NUMBER: HYU002**

**FINAL REPORT**

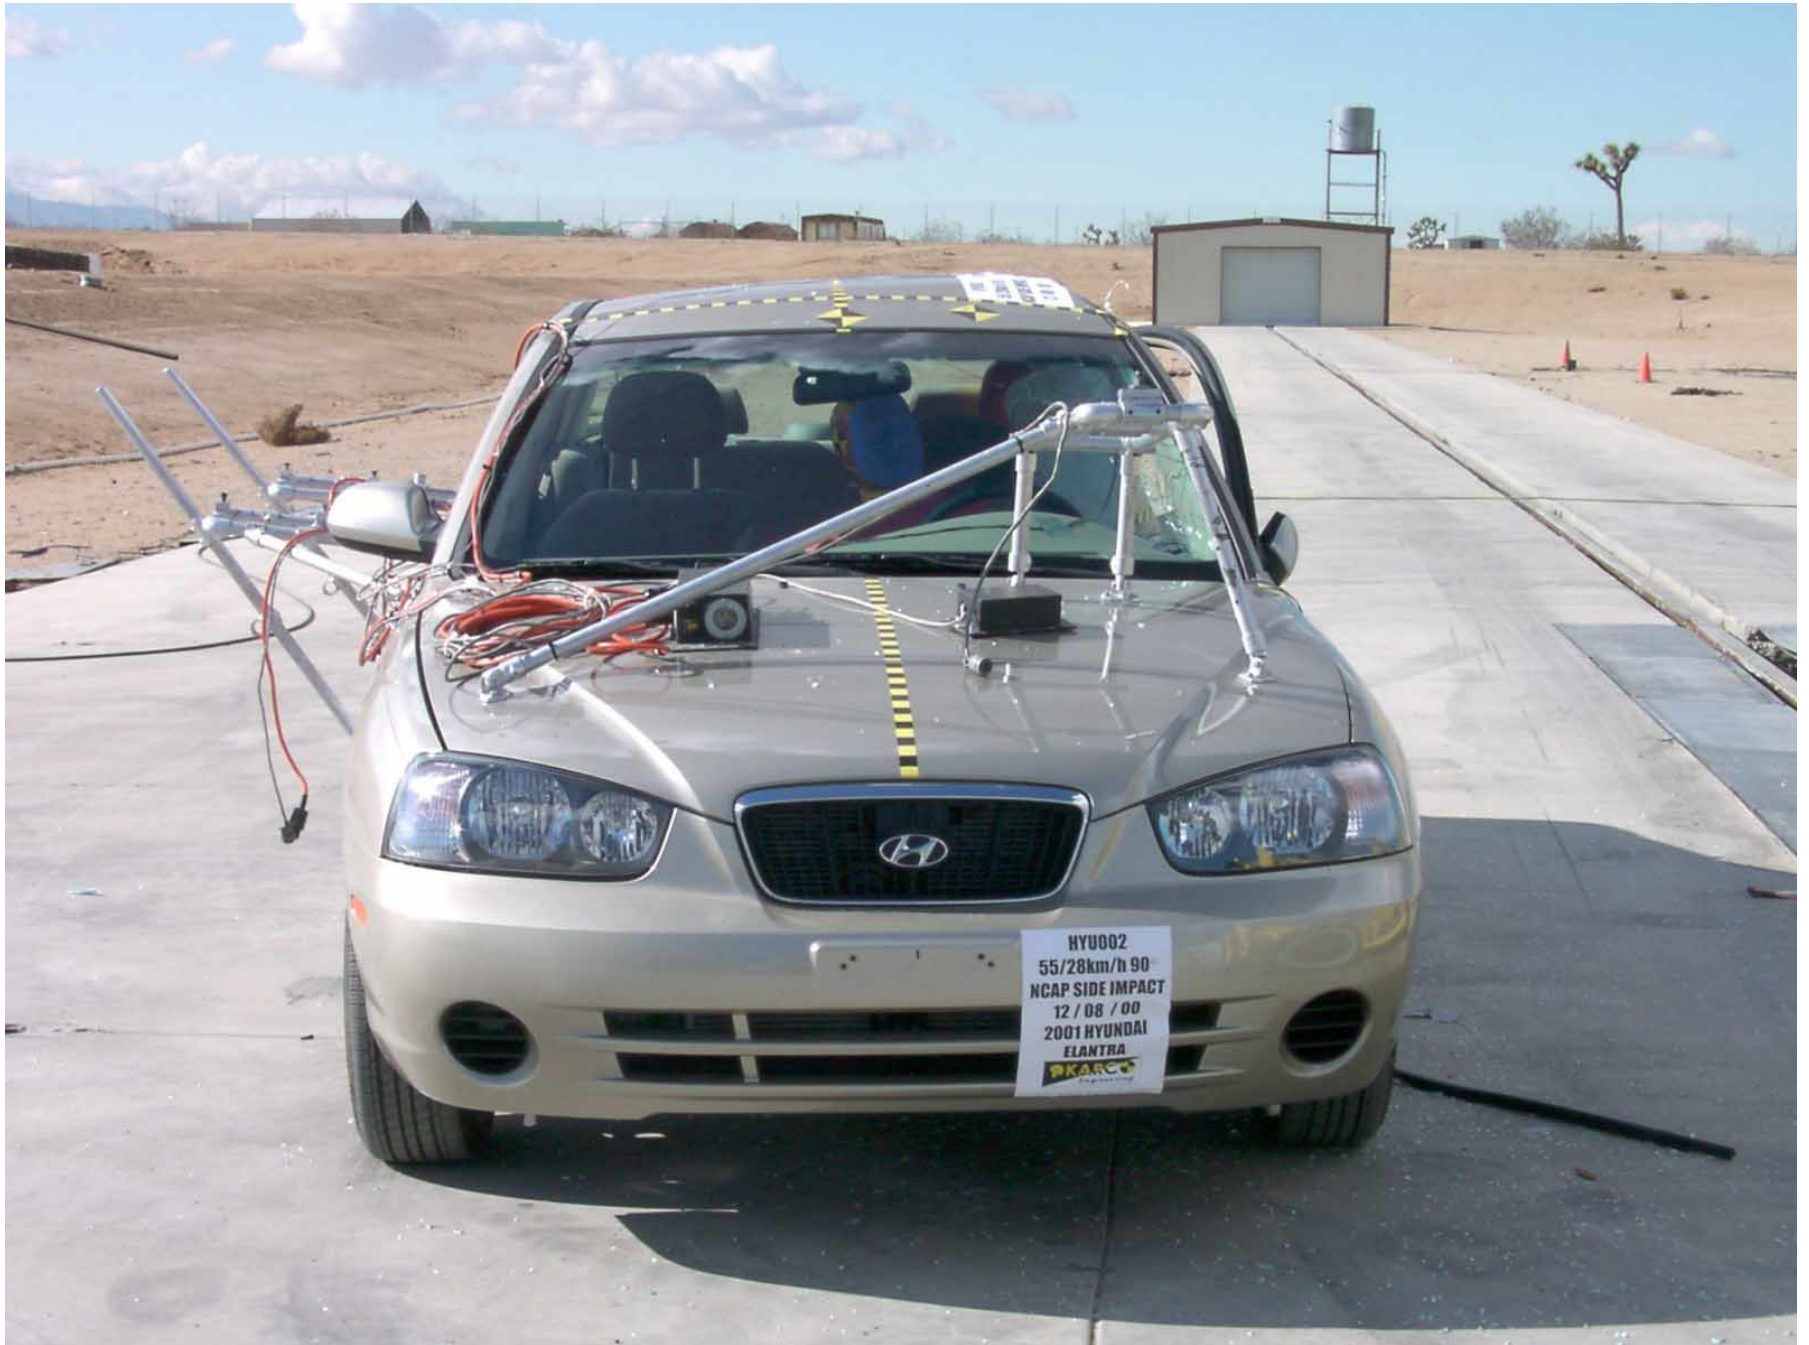
Figure A-6: Front View, Post-Test

| Critical Areas of Performance | Observations and Conclusions |
|---|---|
| Windshield Damage | Glazing Cracks on Struck Side Only |

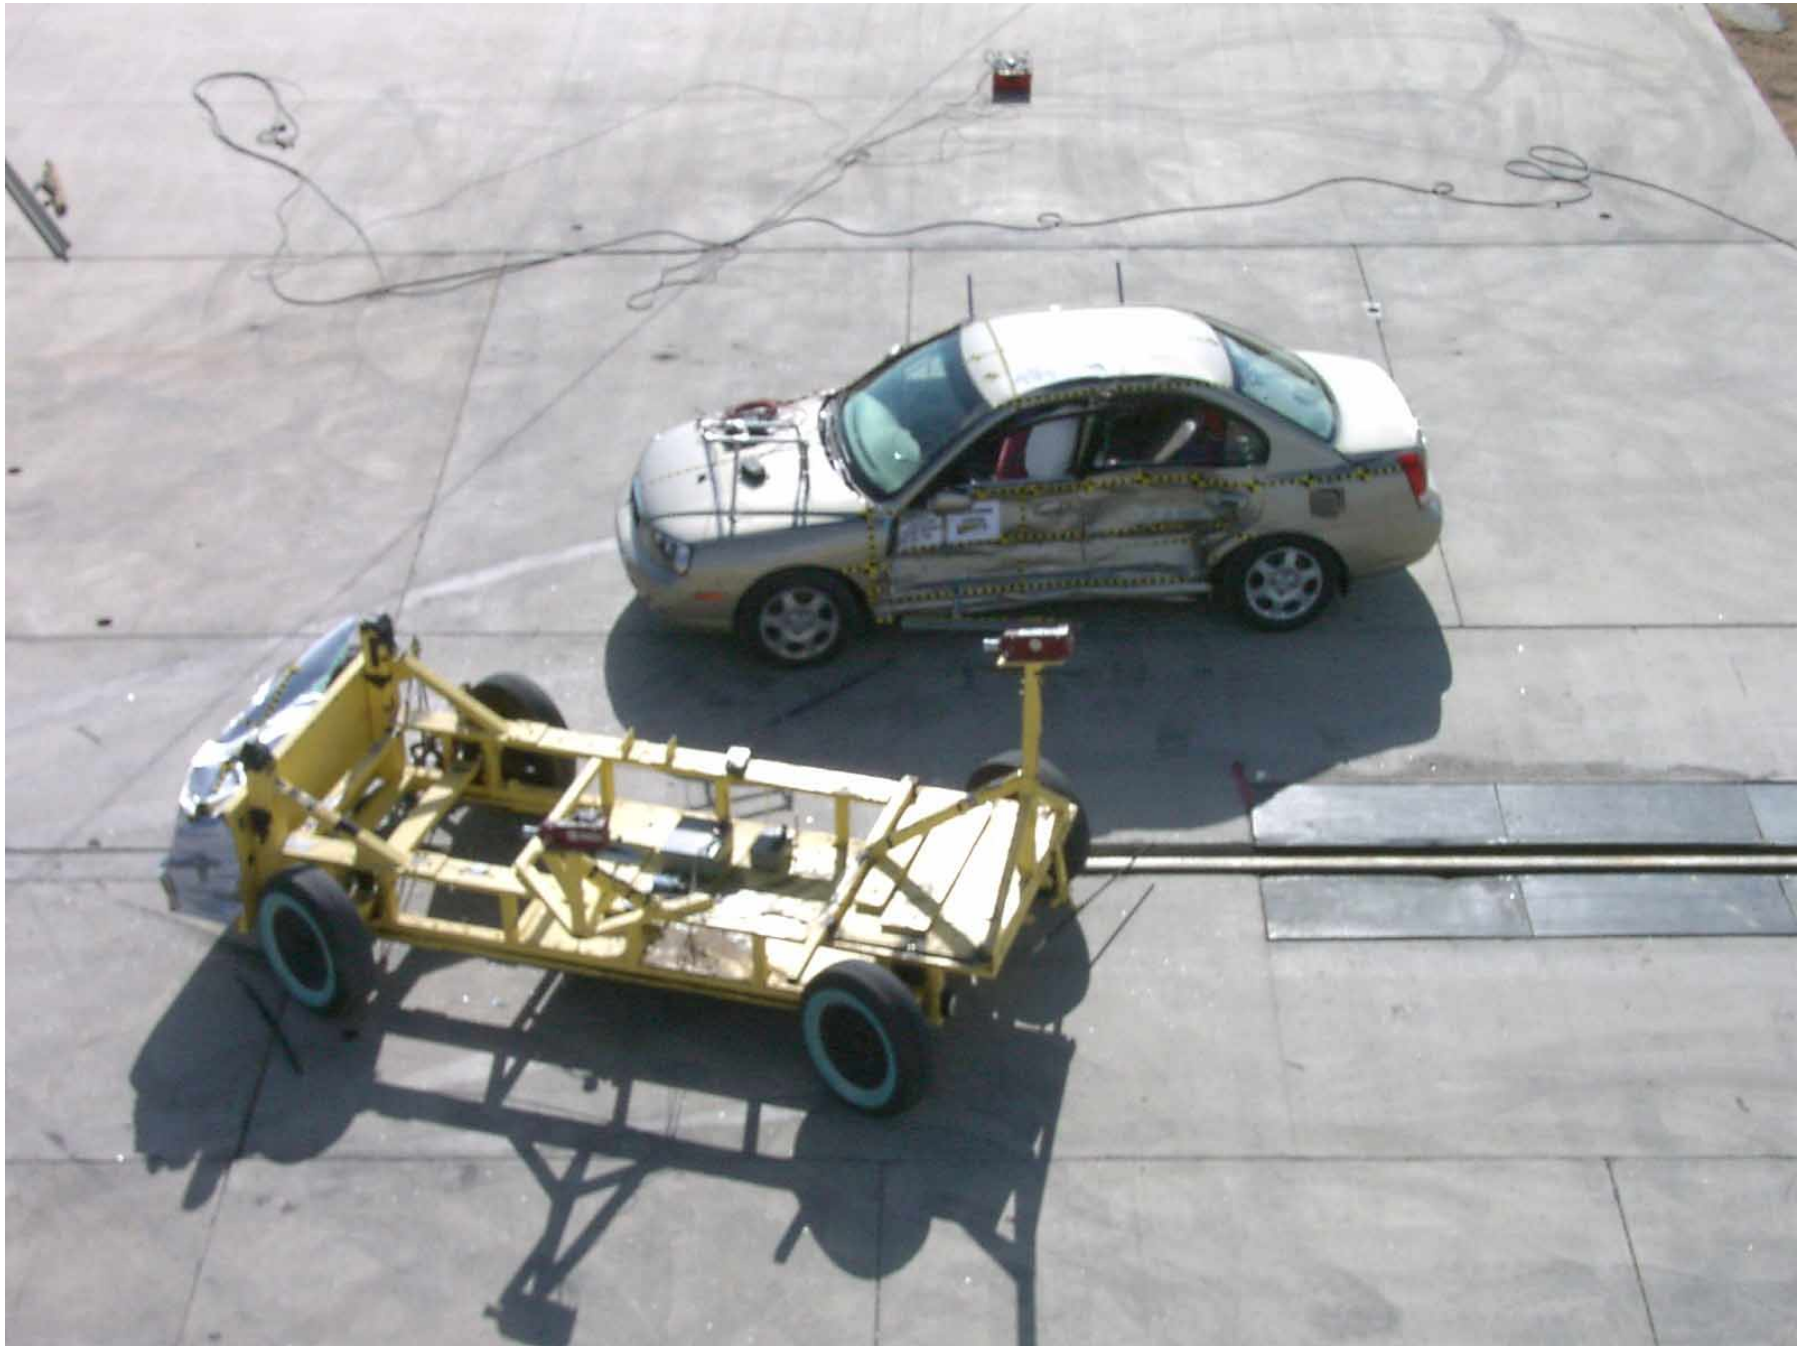
Figure A-13: Overhead Overall View, Post-Test

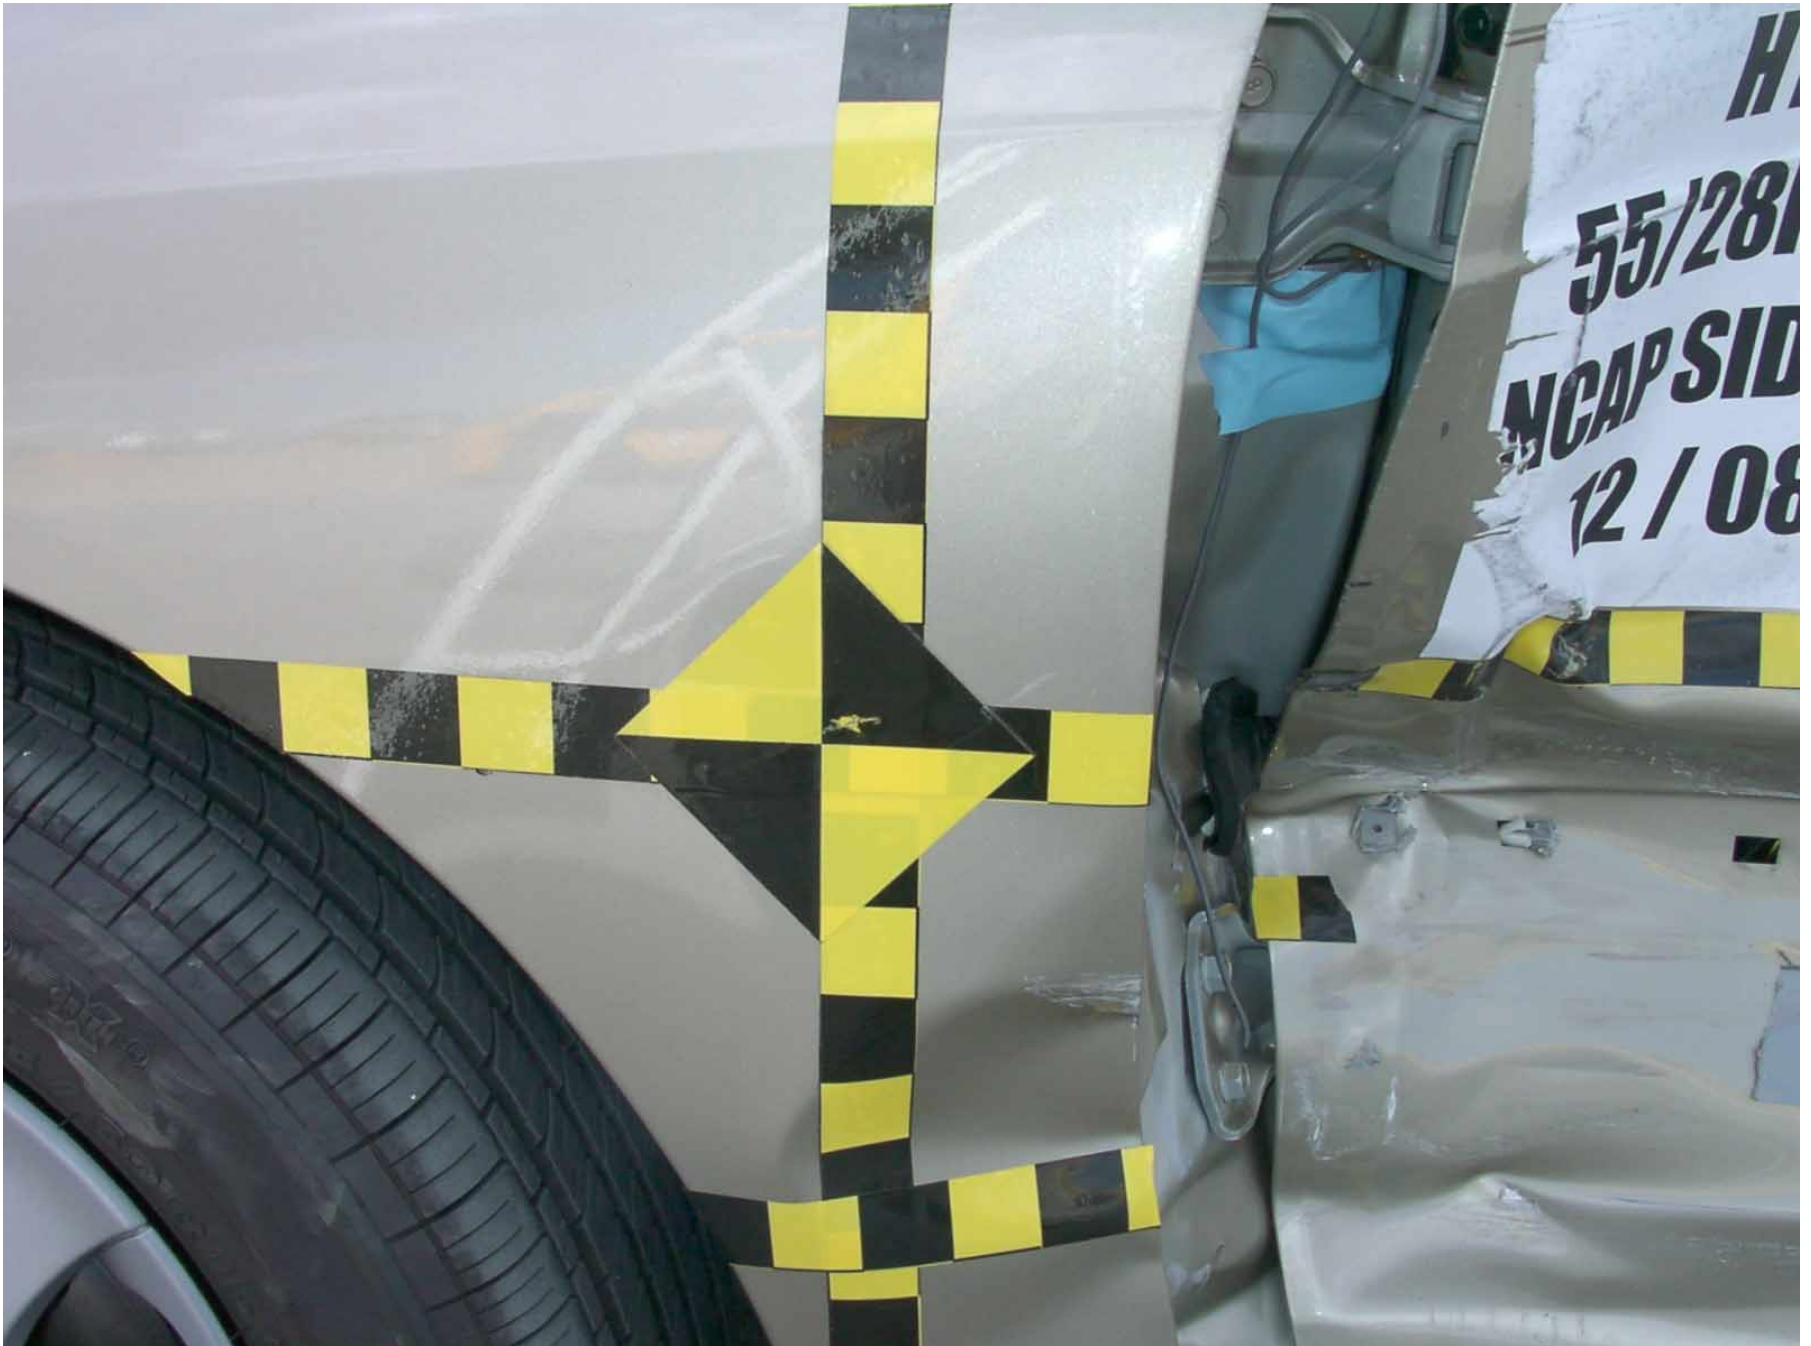
Figure A-17: Impact Point Target Close-up, Post-Test

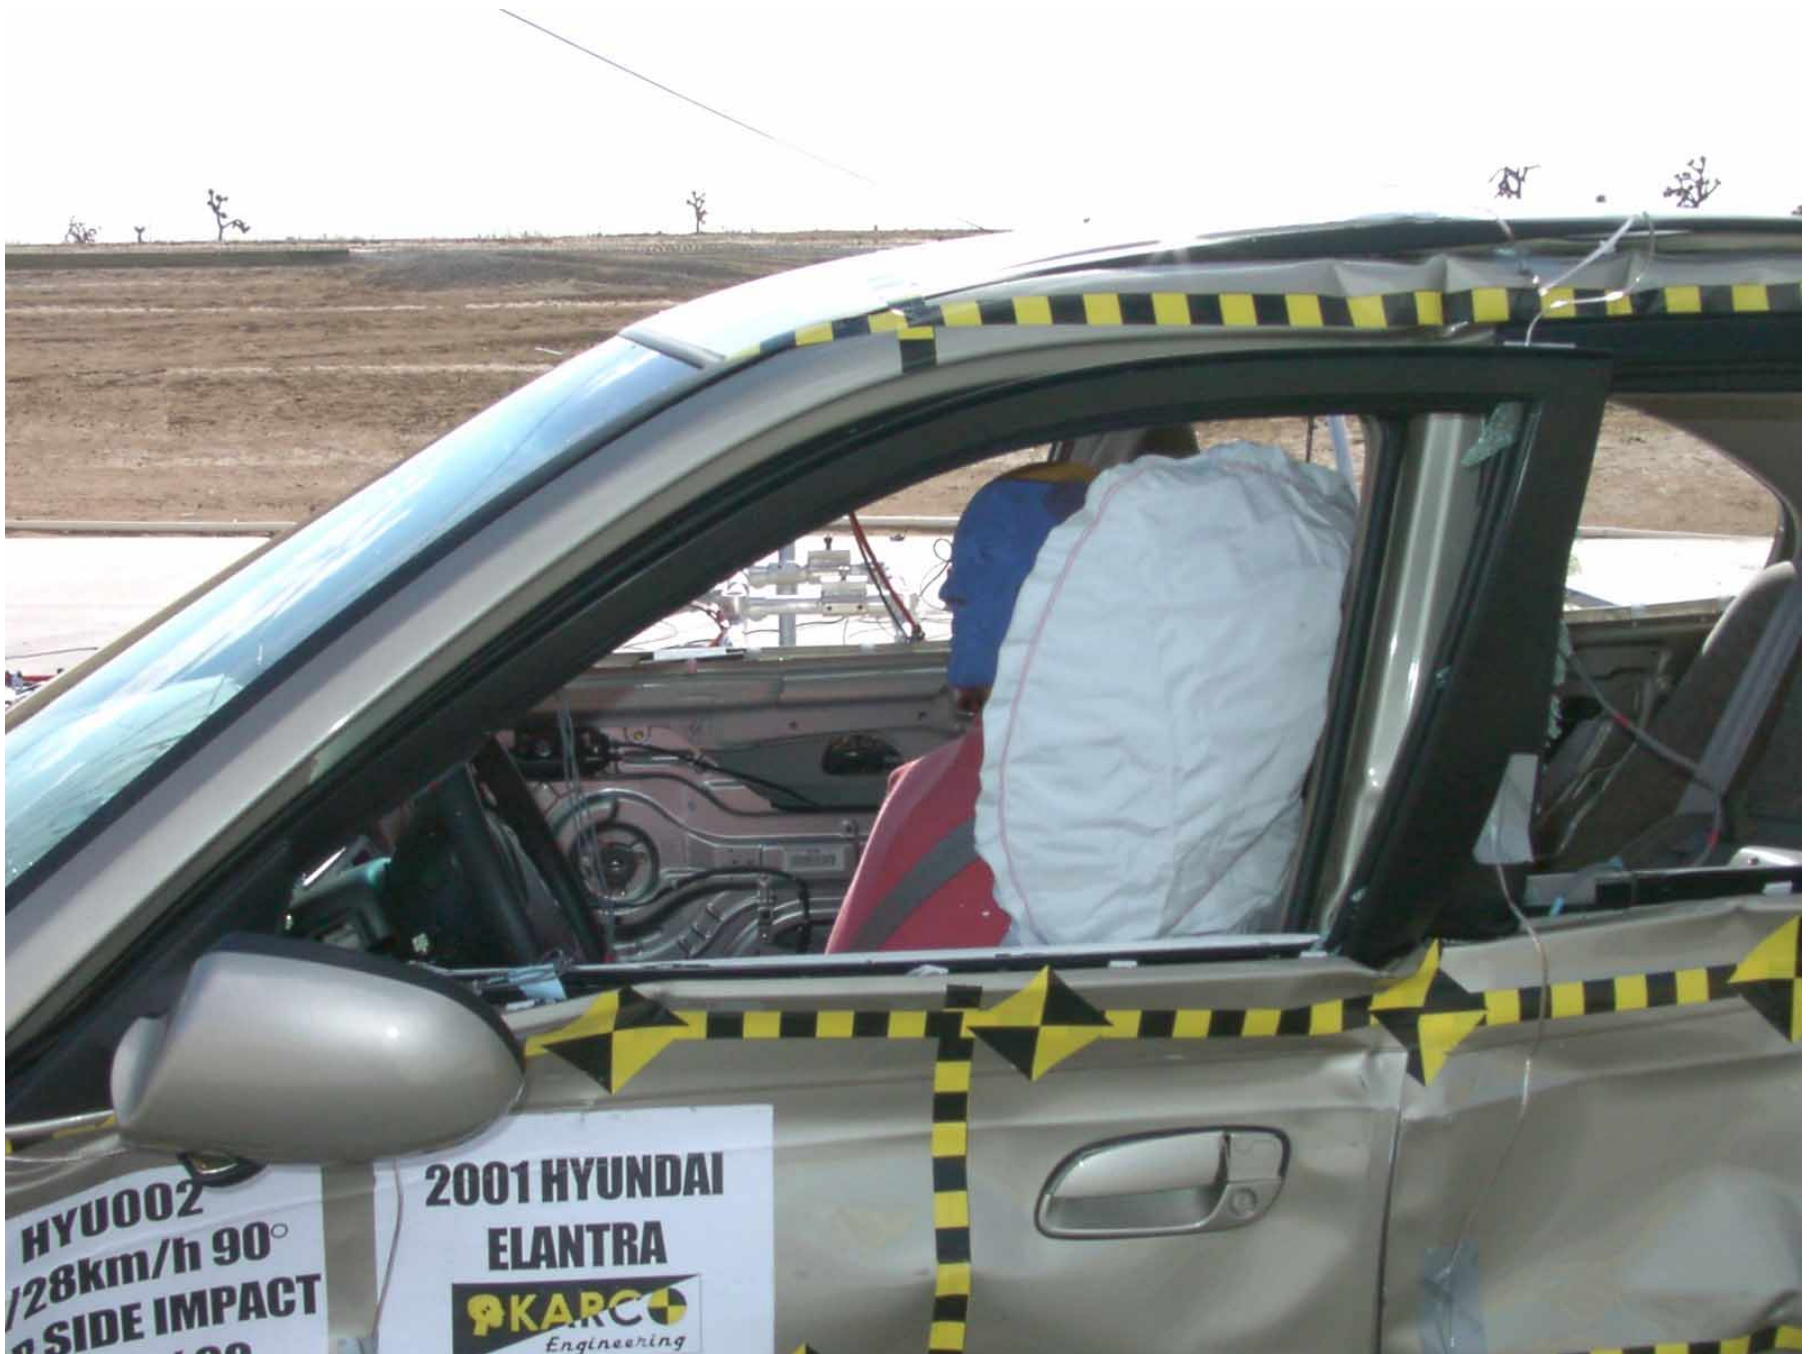
Figure A-20: Driver Dummy Left Side, Post-Test

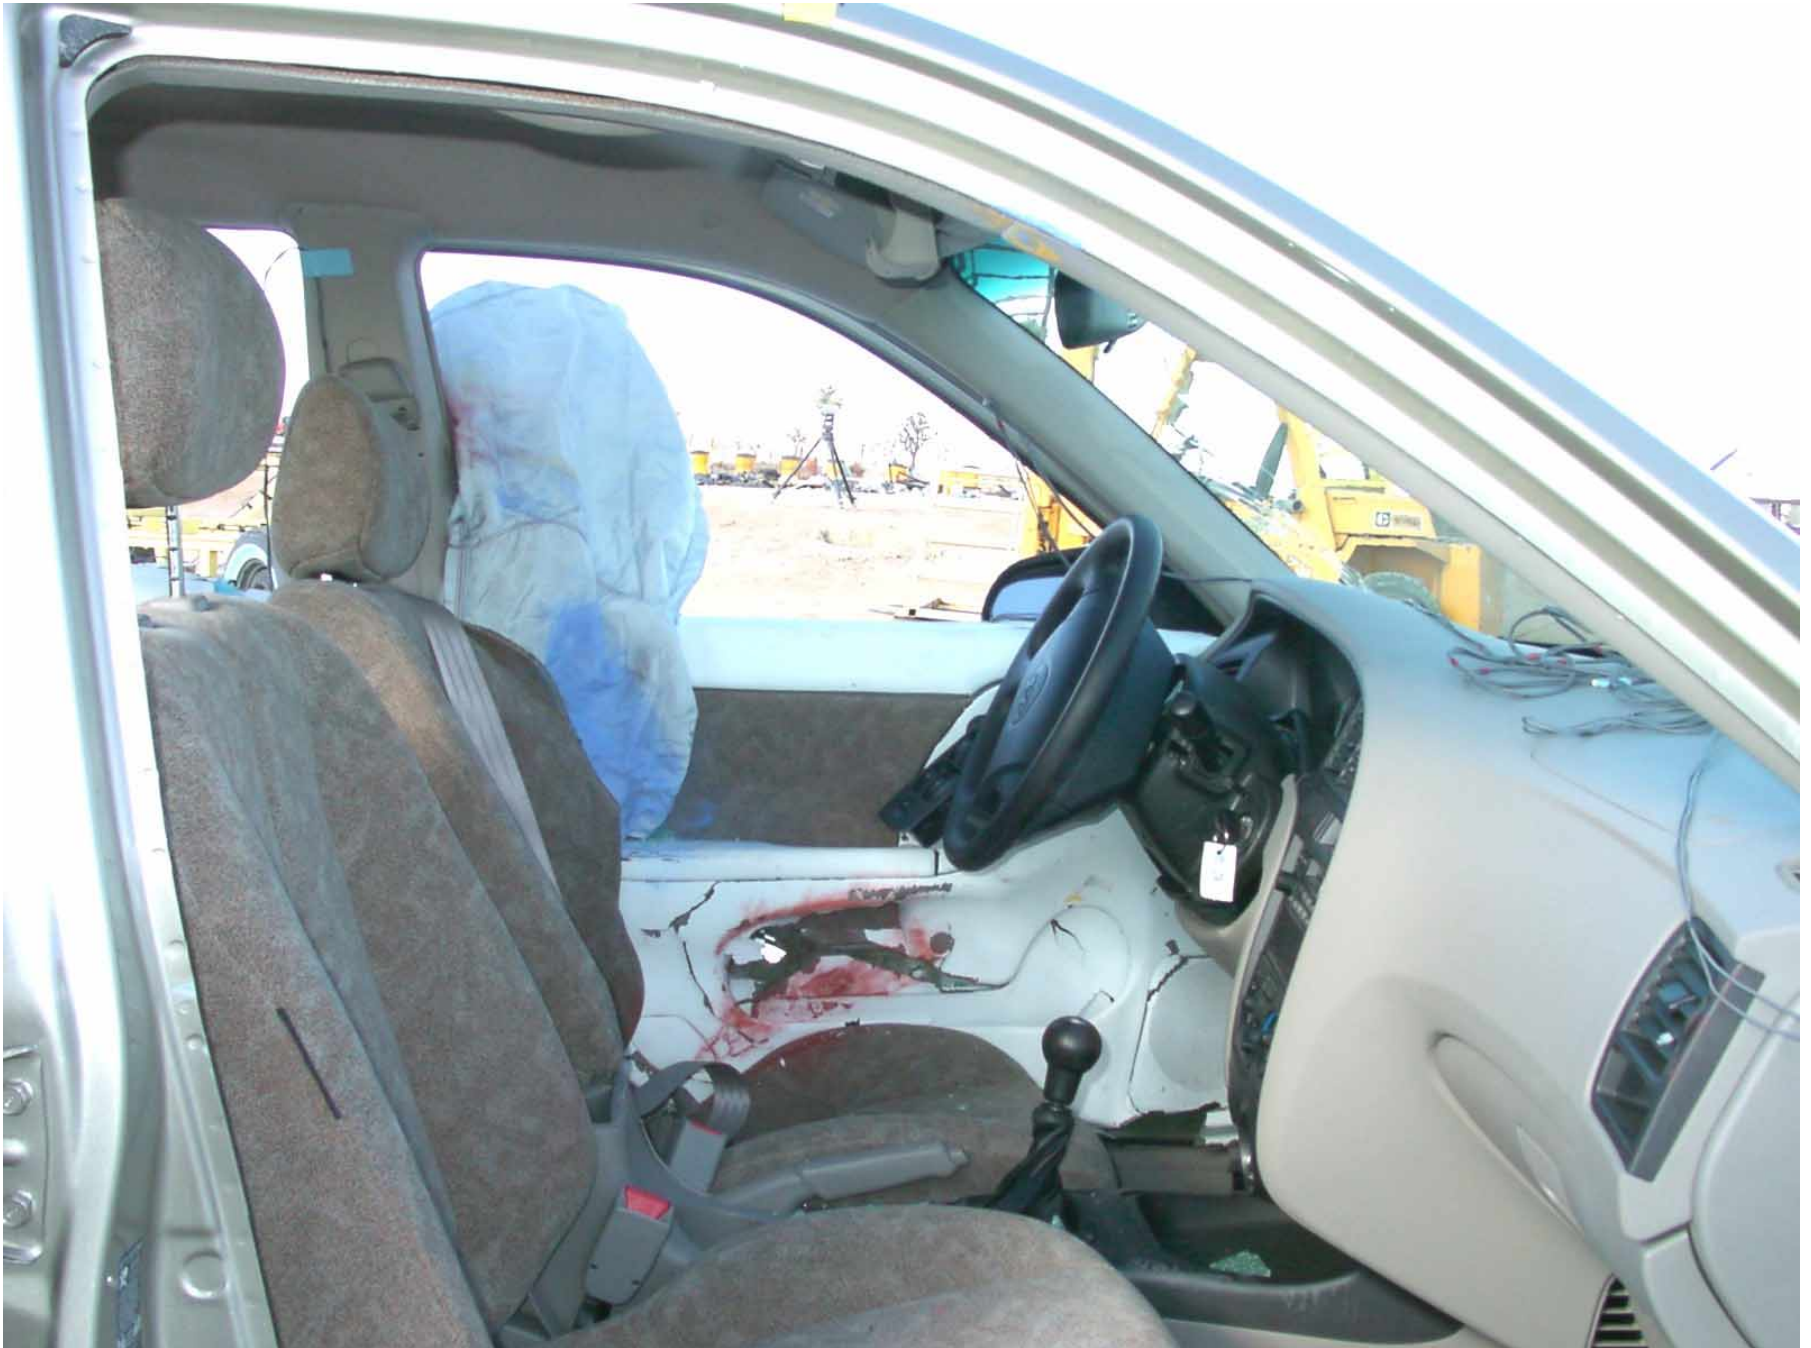
Figure A-26: Driver Dummy Contact Points Inside View, Post-Test

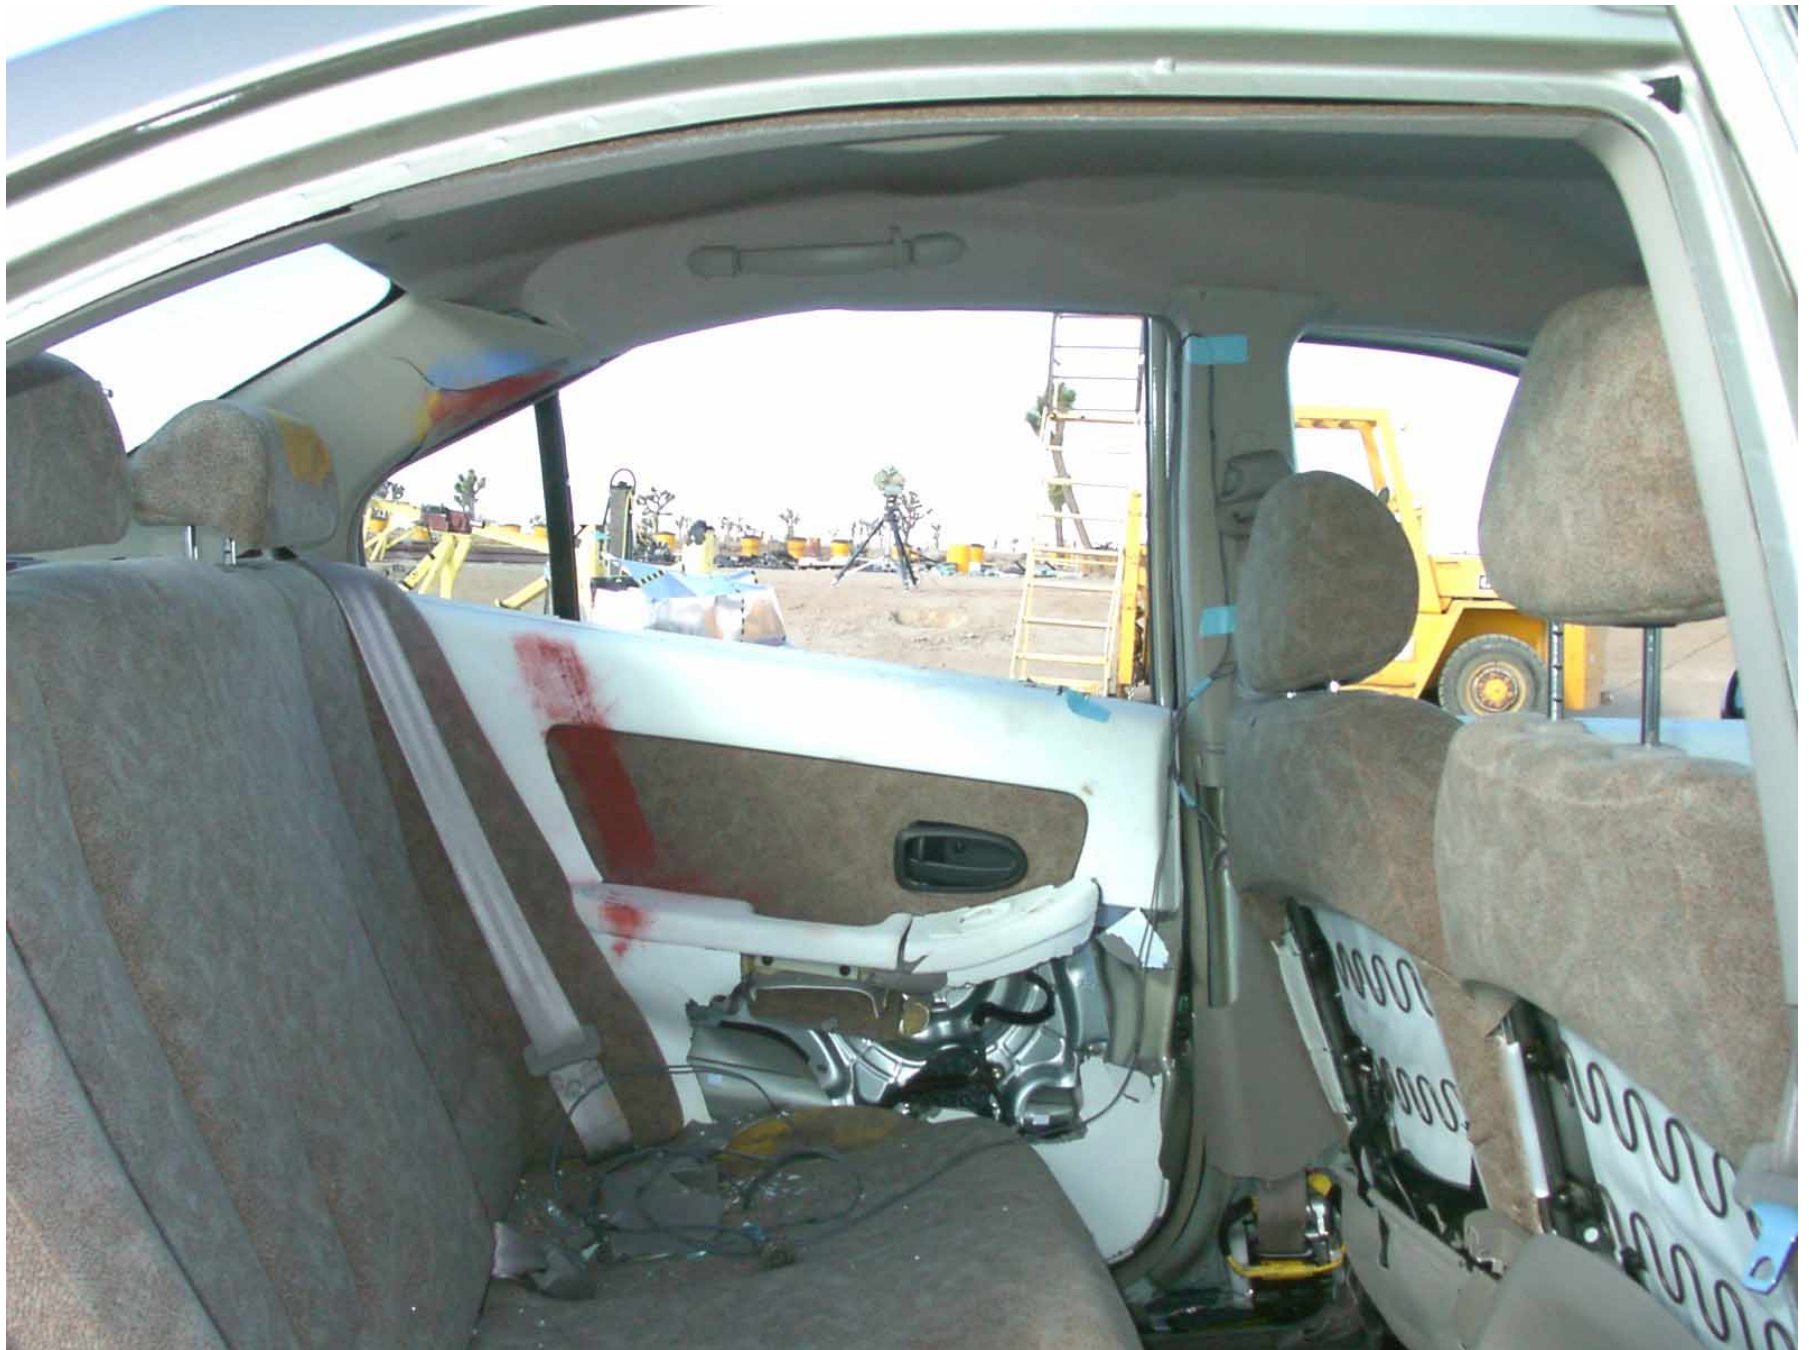
Figure A-35: Passenger Dummy Contact Points Inside View, Post-Test

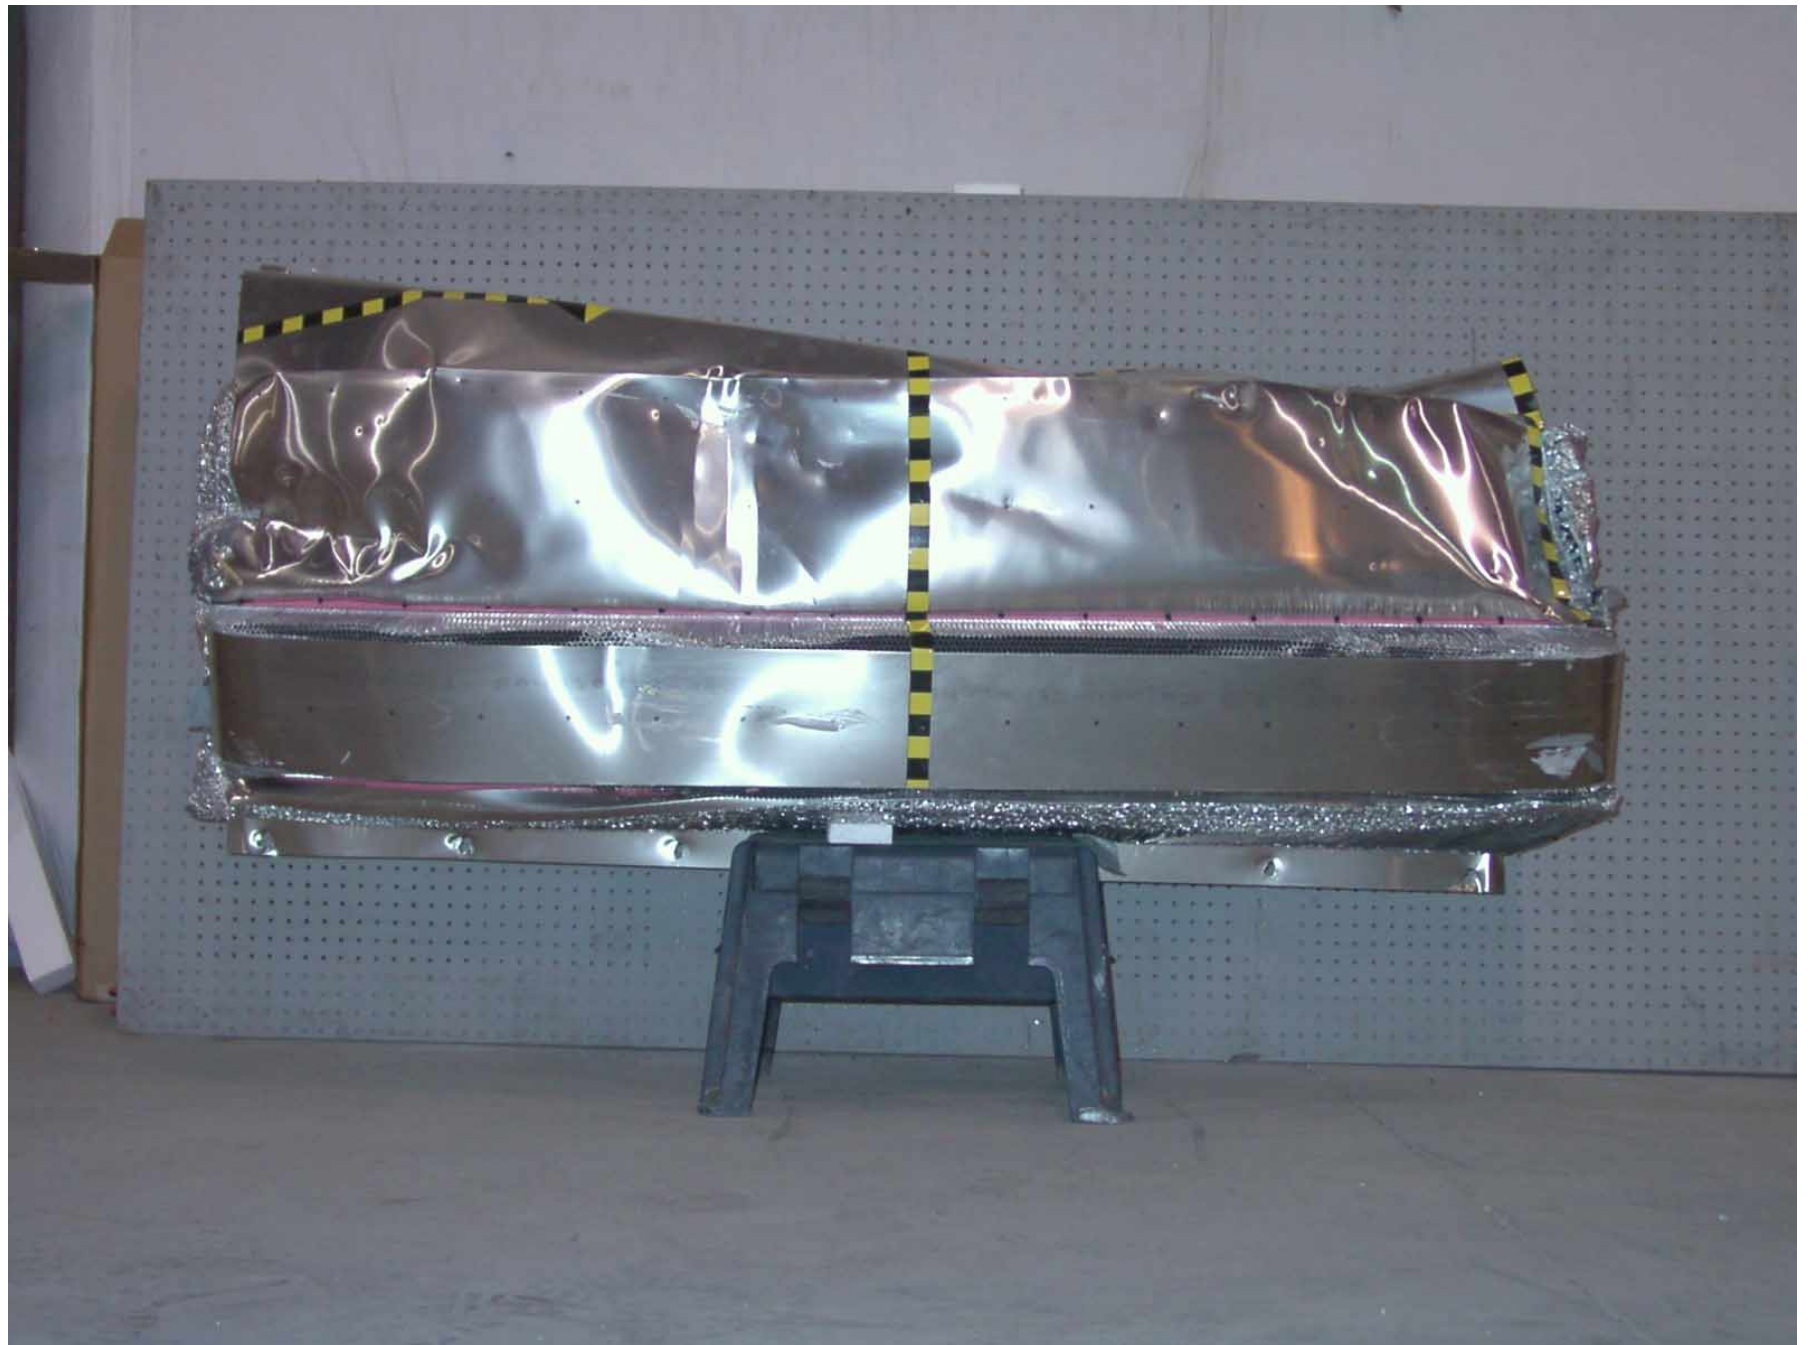
Figure A-37: Front View of Deformable Barrier, Post-Test

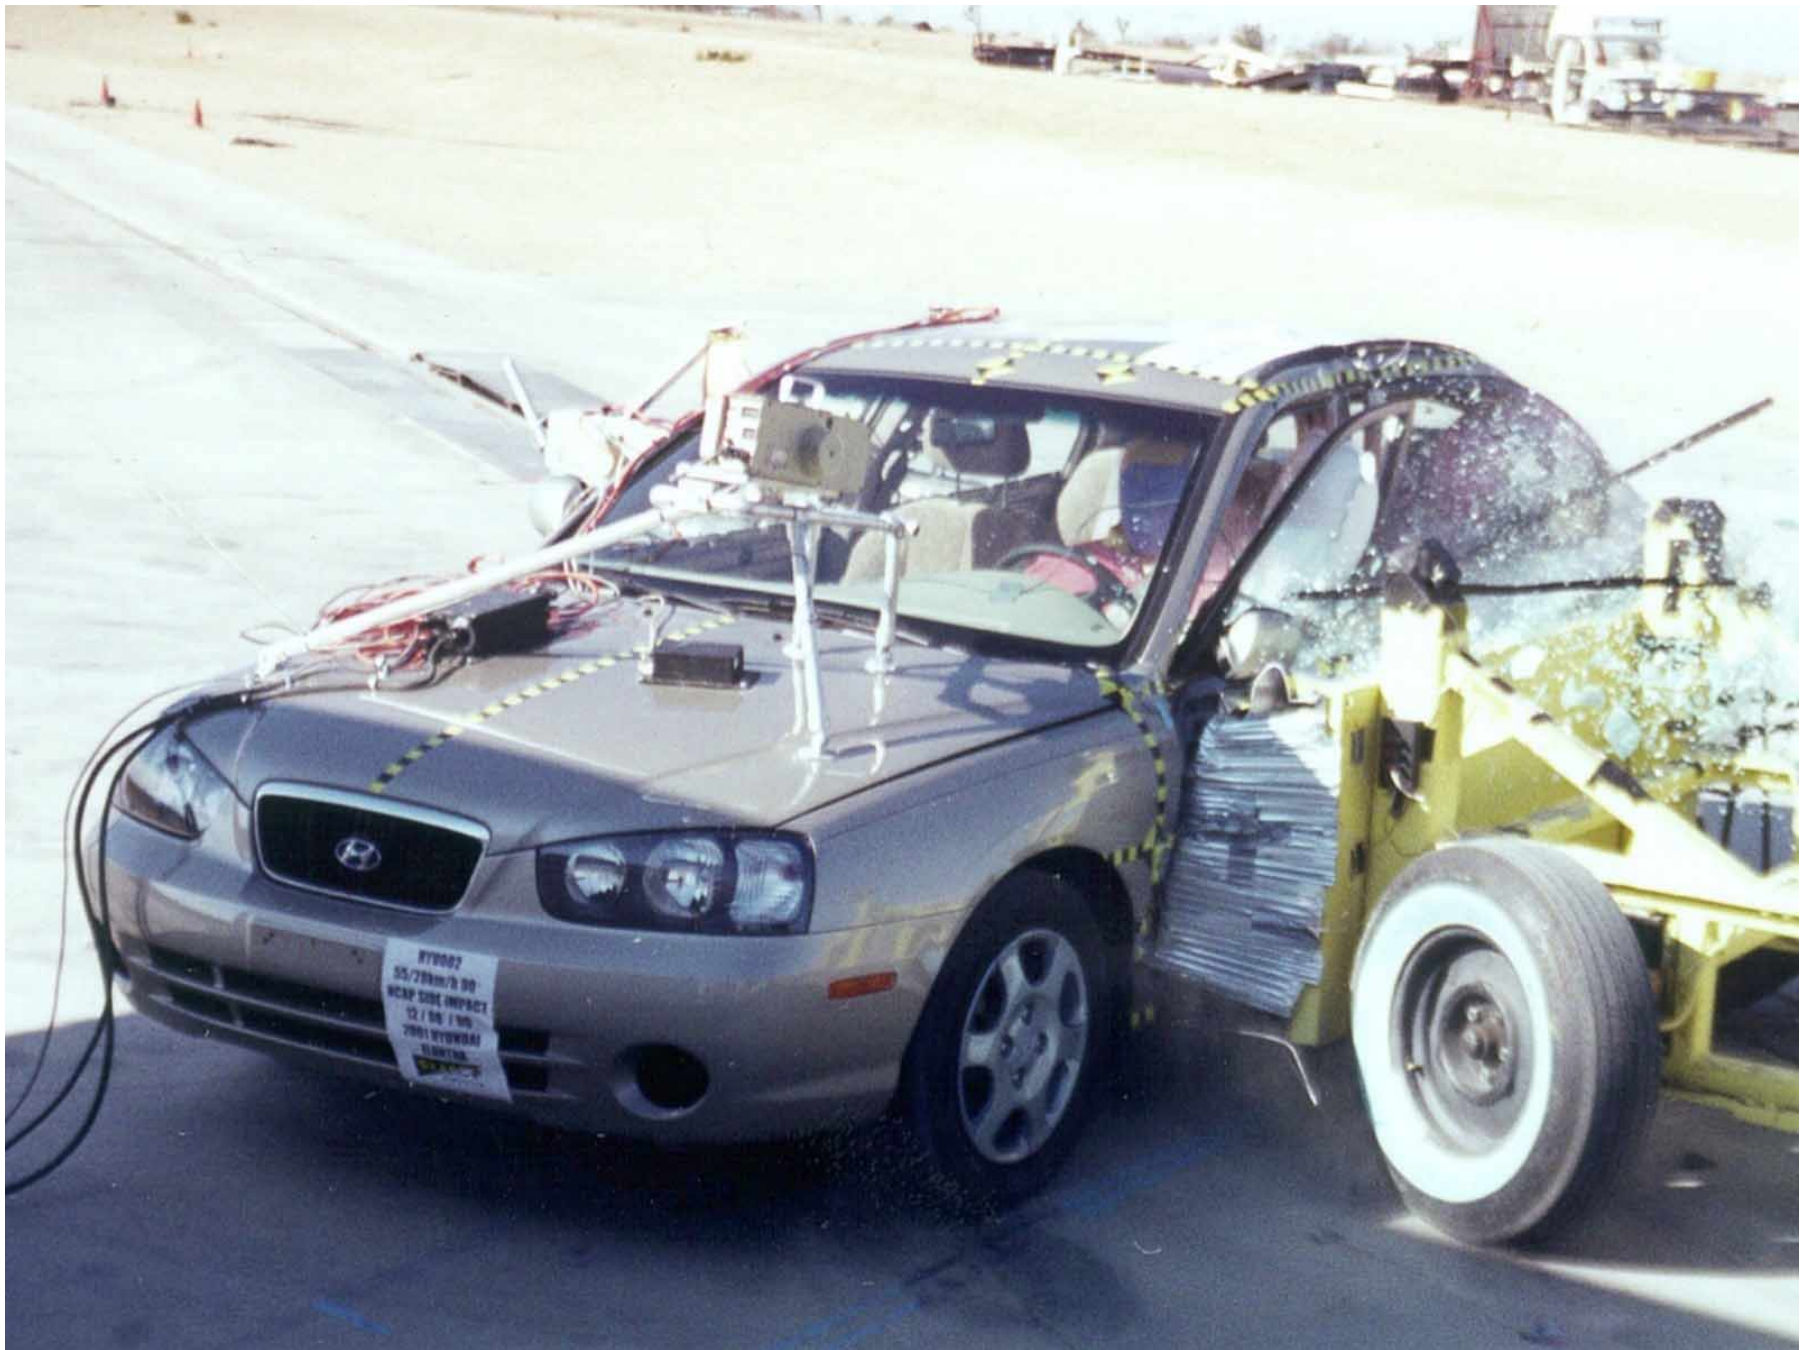
Figure A-45: Vehicle During Impact
