REPORT NUMBER KAR21003-01

**NEW CAR ASSESSMENT PROGRAM
SIDE IMPACT TEST**

**GENERAL MOTORS CORPORATION
2001 CHEVROLET VENTURE MINIVAN**

NHTSA NUMBER: M10110

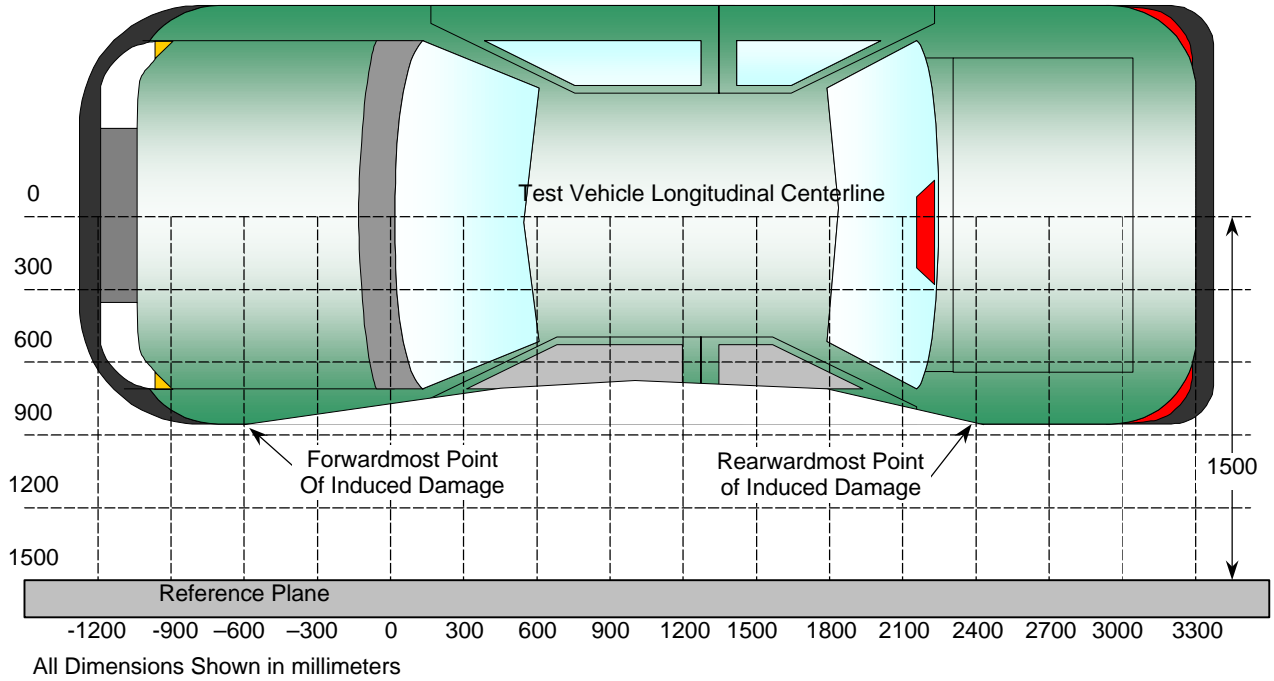
VEHICLE DAMAGE PROFILE DISTANCES

TOP VIEW

Damage Profile Distances

The test vehicle sustained a maximum static crush of 394 mm at level 2, 1050mm rearward of the left vertical impact point. The driver SID, Serial No. 274 and the passenger SID, Serial No. 275 were calibrated just prior to this test. The SID injury criteria is summarized as follows:

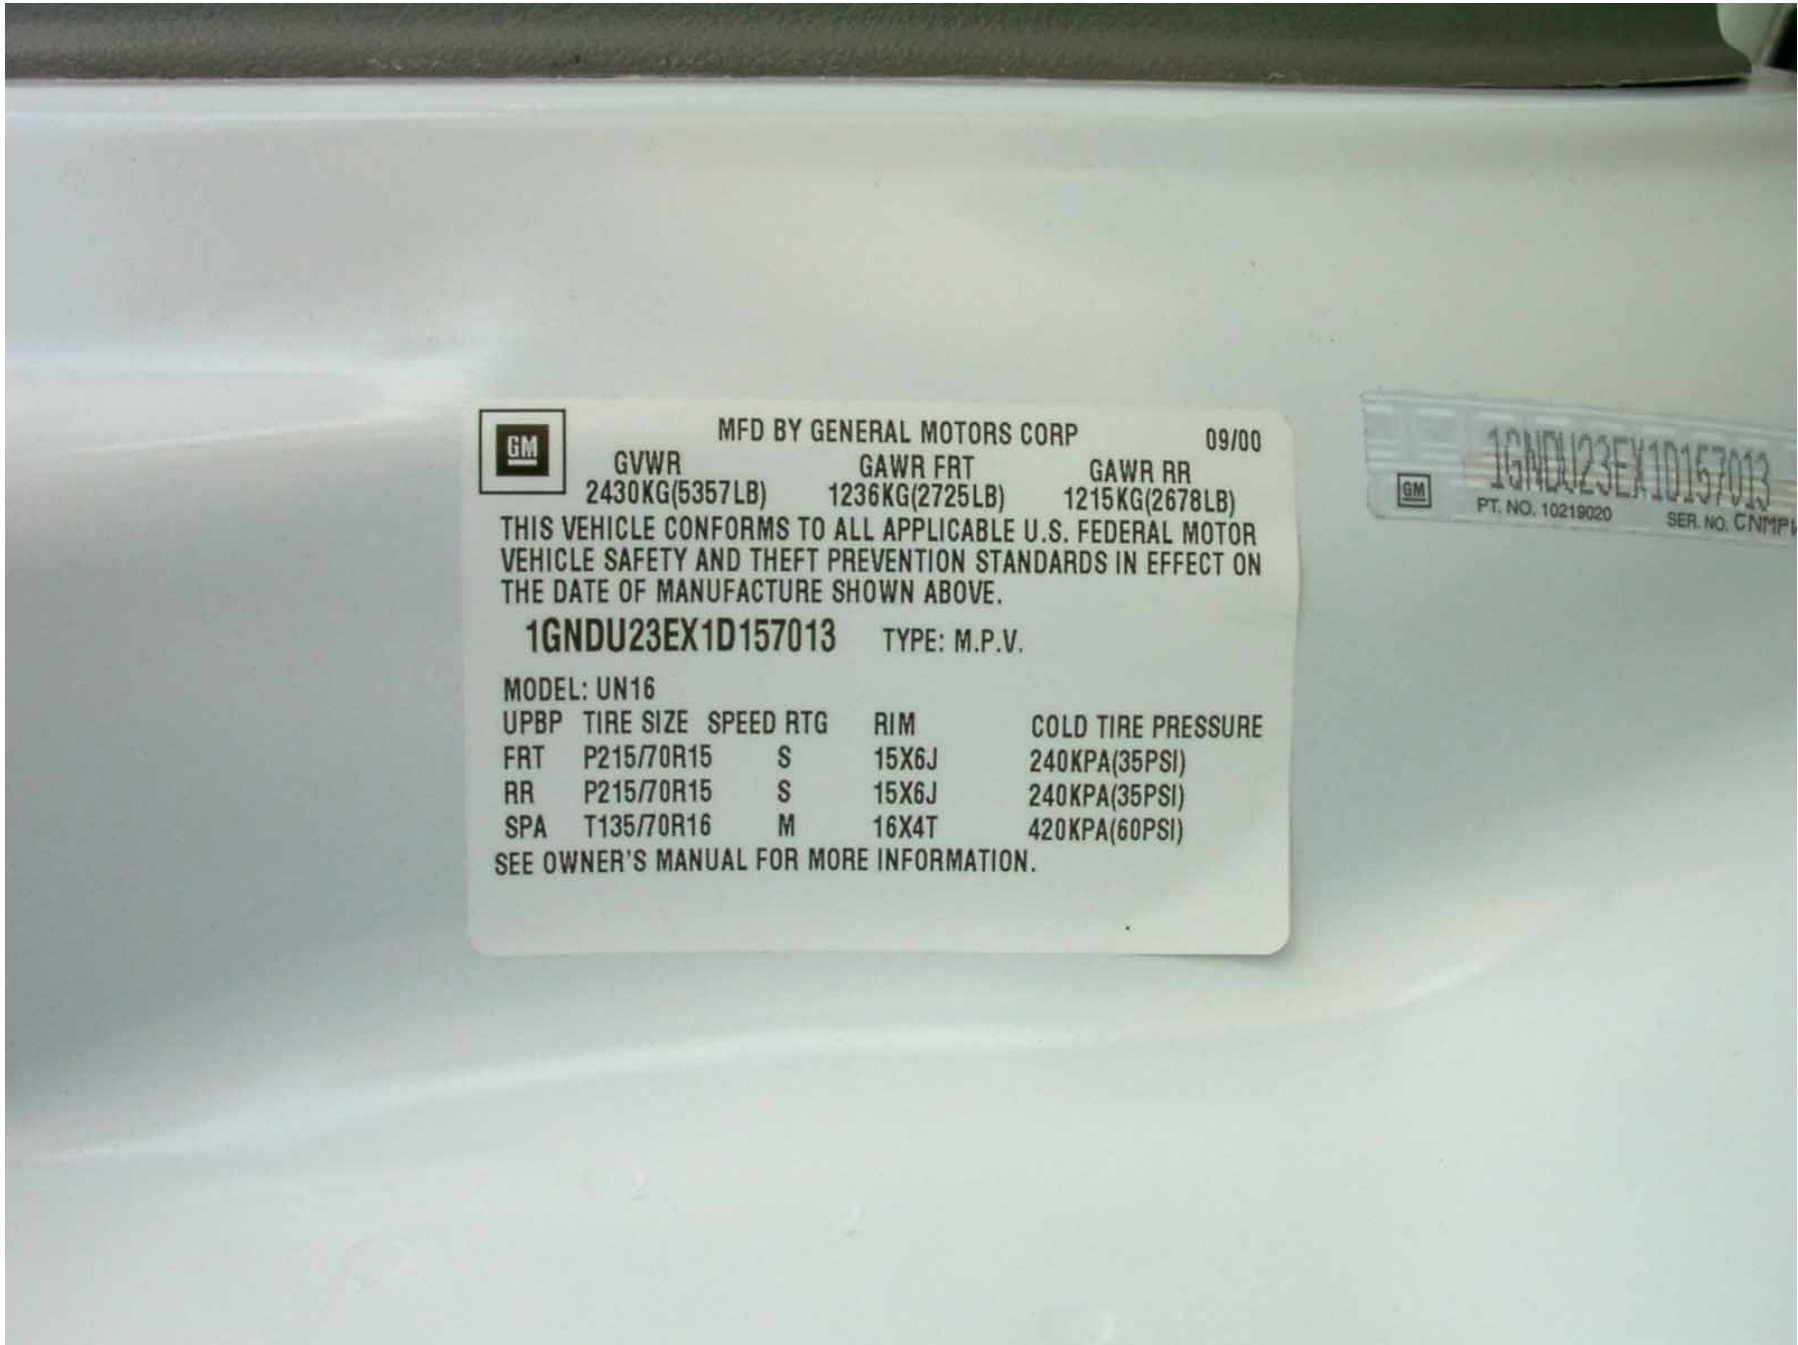
Figure A-4: Vehicle Tire Label

GM MFD BY GENERAL MOTORS CORP 09/00
 GVWR 2430KG(5357LB) GAWR FRT 1236KG(2725LB) GAWR RR 1215KG(2678LB)
 THIS VEHICLE CONFORMS TO ALL APPLICABLE U.S. FEDERAL MOTOR VEHICLE SAFETY AND THEFT PREVENTION STANDARDS IN EFFECT ON THE DATE OF MANUFACTURE SHOWN ABOVE.
1GNDU23EX1D157013 TYPE: M.P.V.
 MODEL: UN16

UPBP	TIRE SIZE	SPEED RTG	RIM	COLD TIRE PRESSURE
FRT	P215/70R15	S	15X6J	240KPA(35PSI)
RR	P215/70R15	S	15X6J	240KPA(35PSI)
SPA	T135/70R16	M	16X4T	420KPA(60PSI)

GM 1GNDU23EX1D157013
 PT. NO. 10219020 SER. NO. CNMP

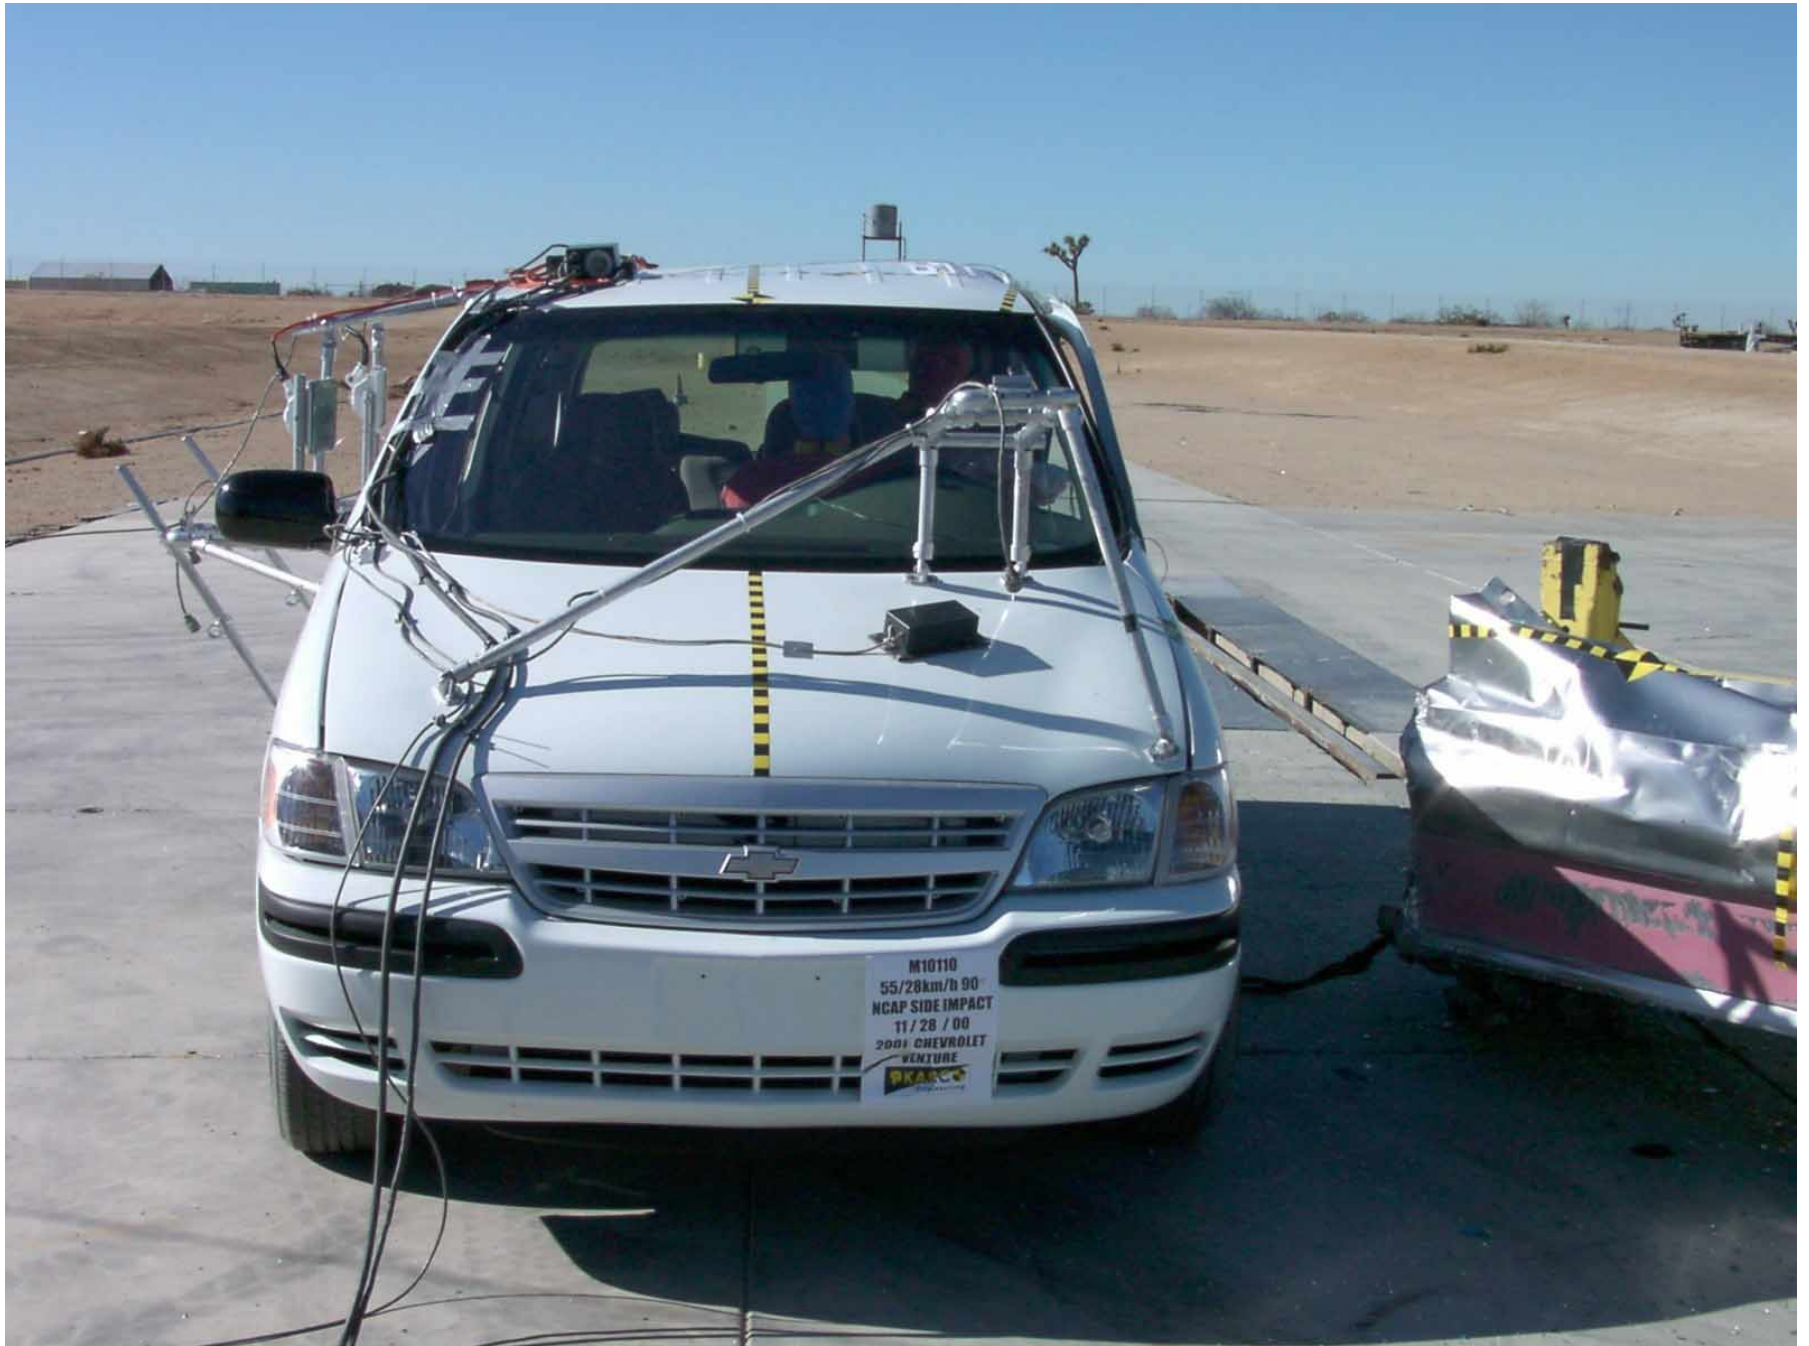
Figure A-6: Front View, Post-Test

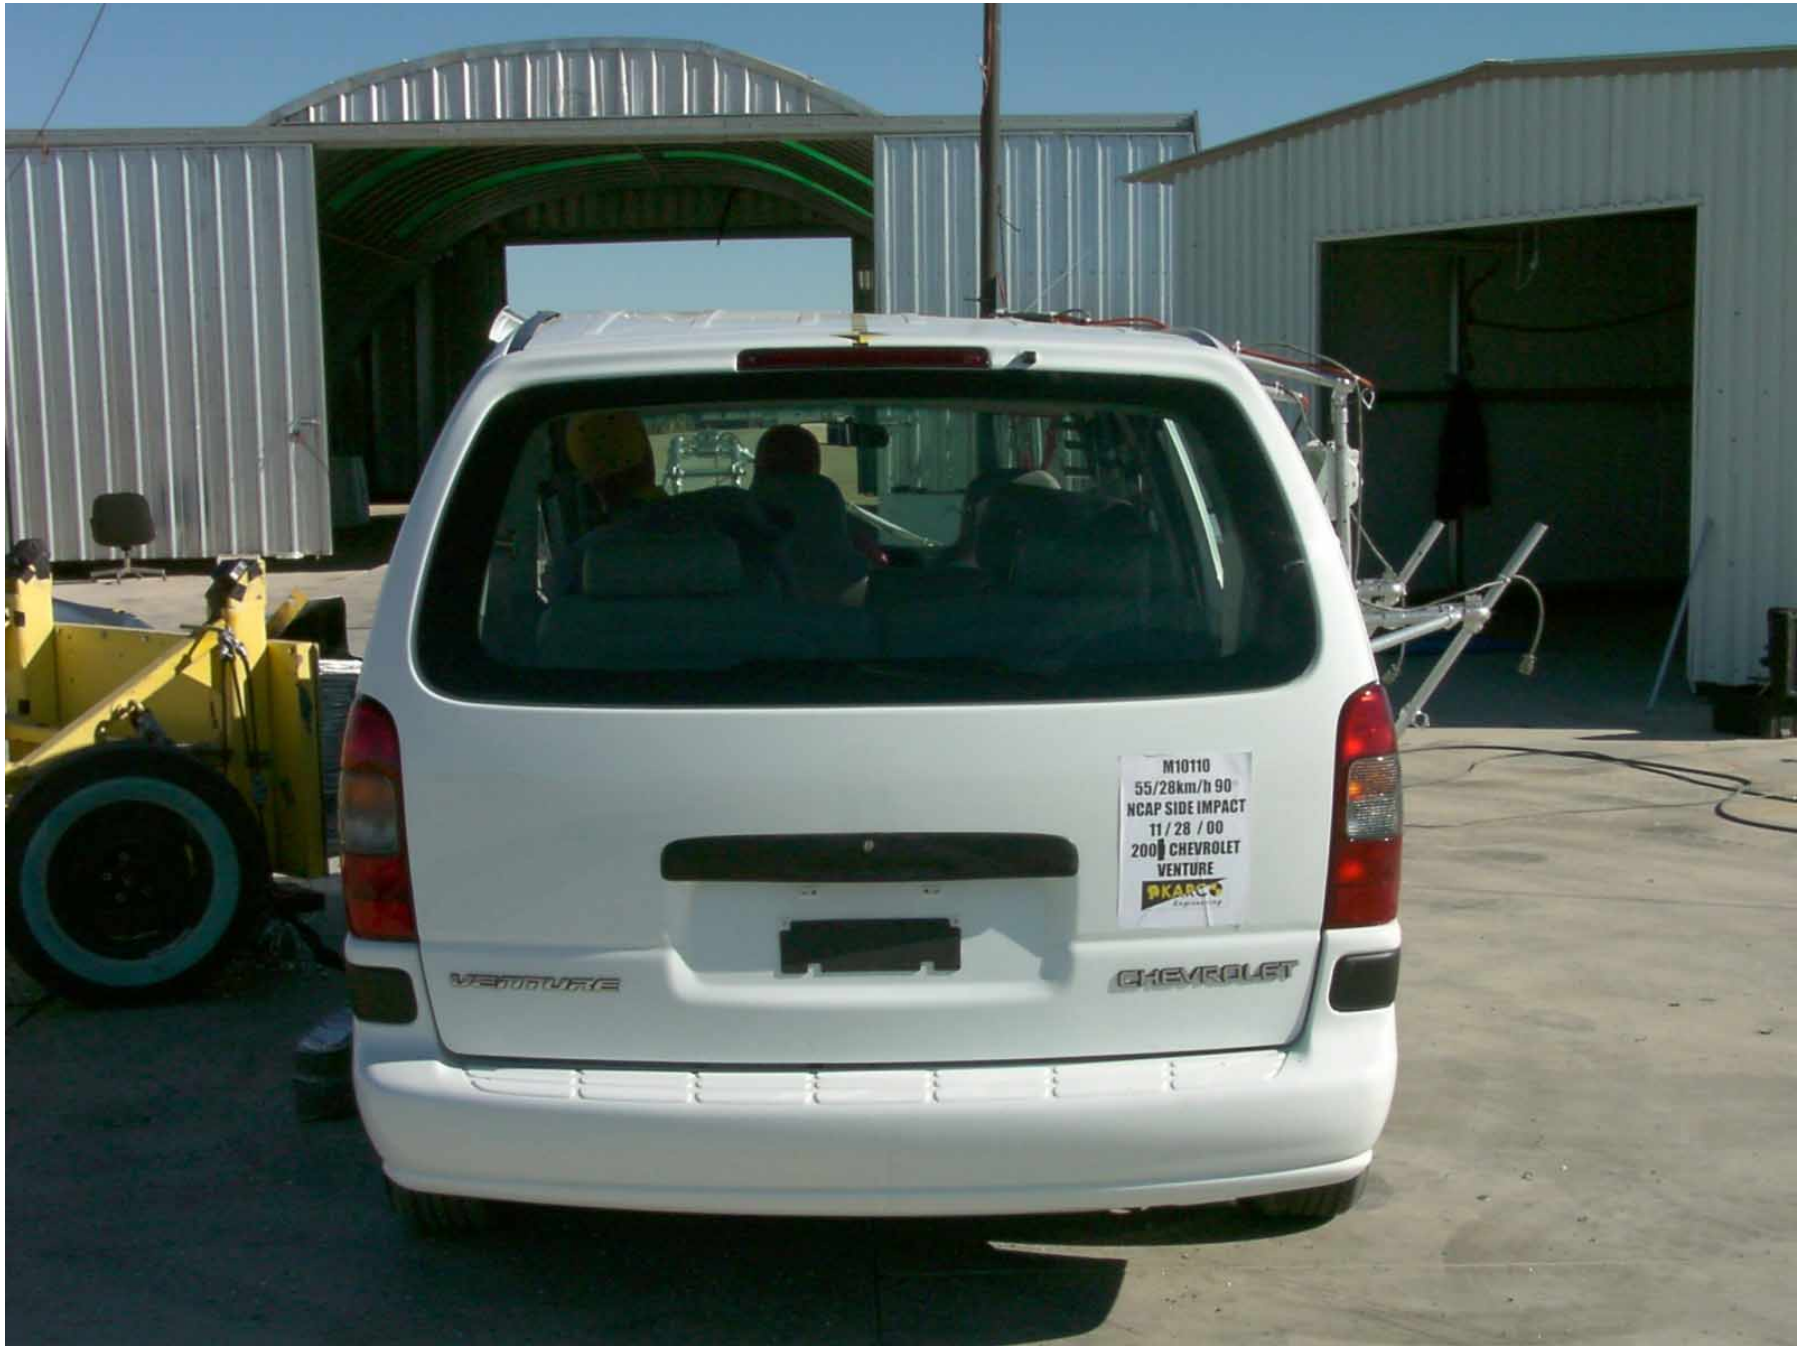
Figure A-8: Rear View, Post-Test

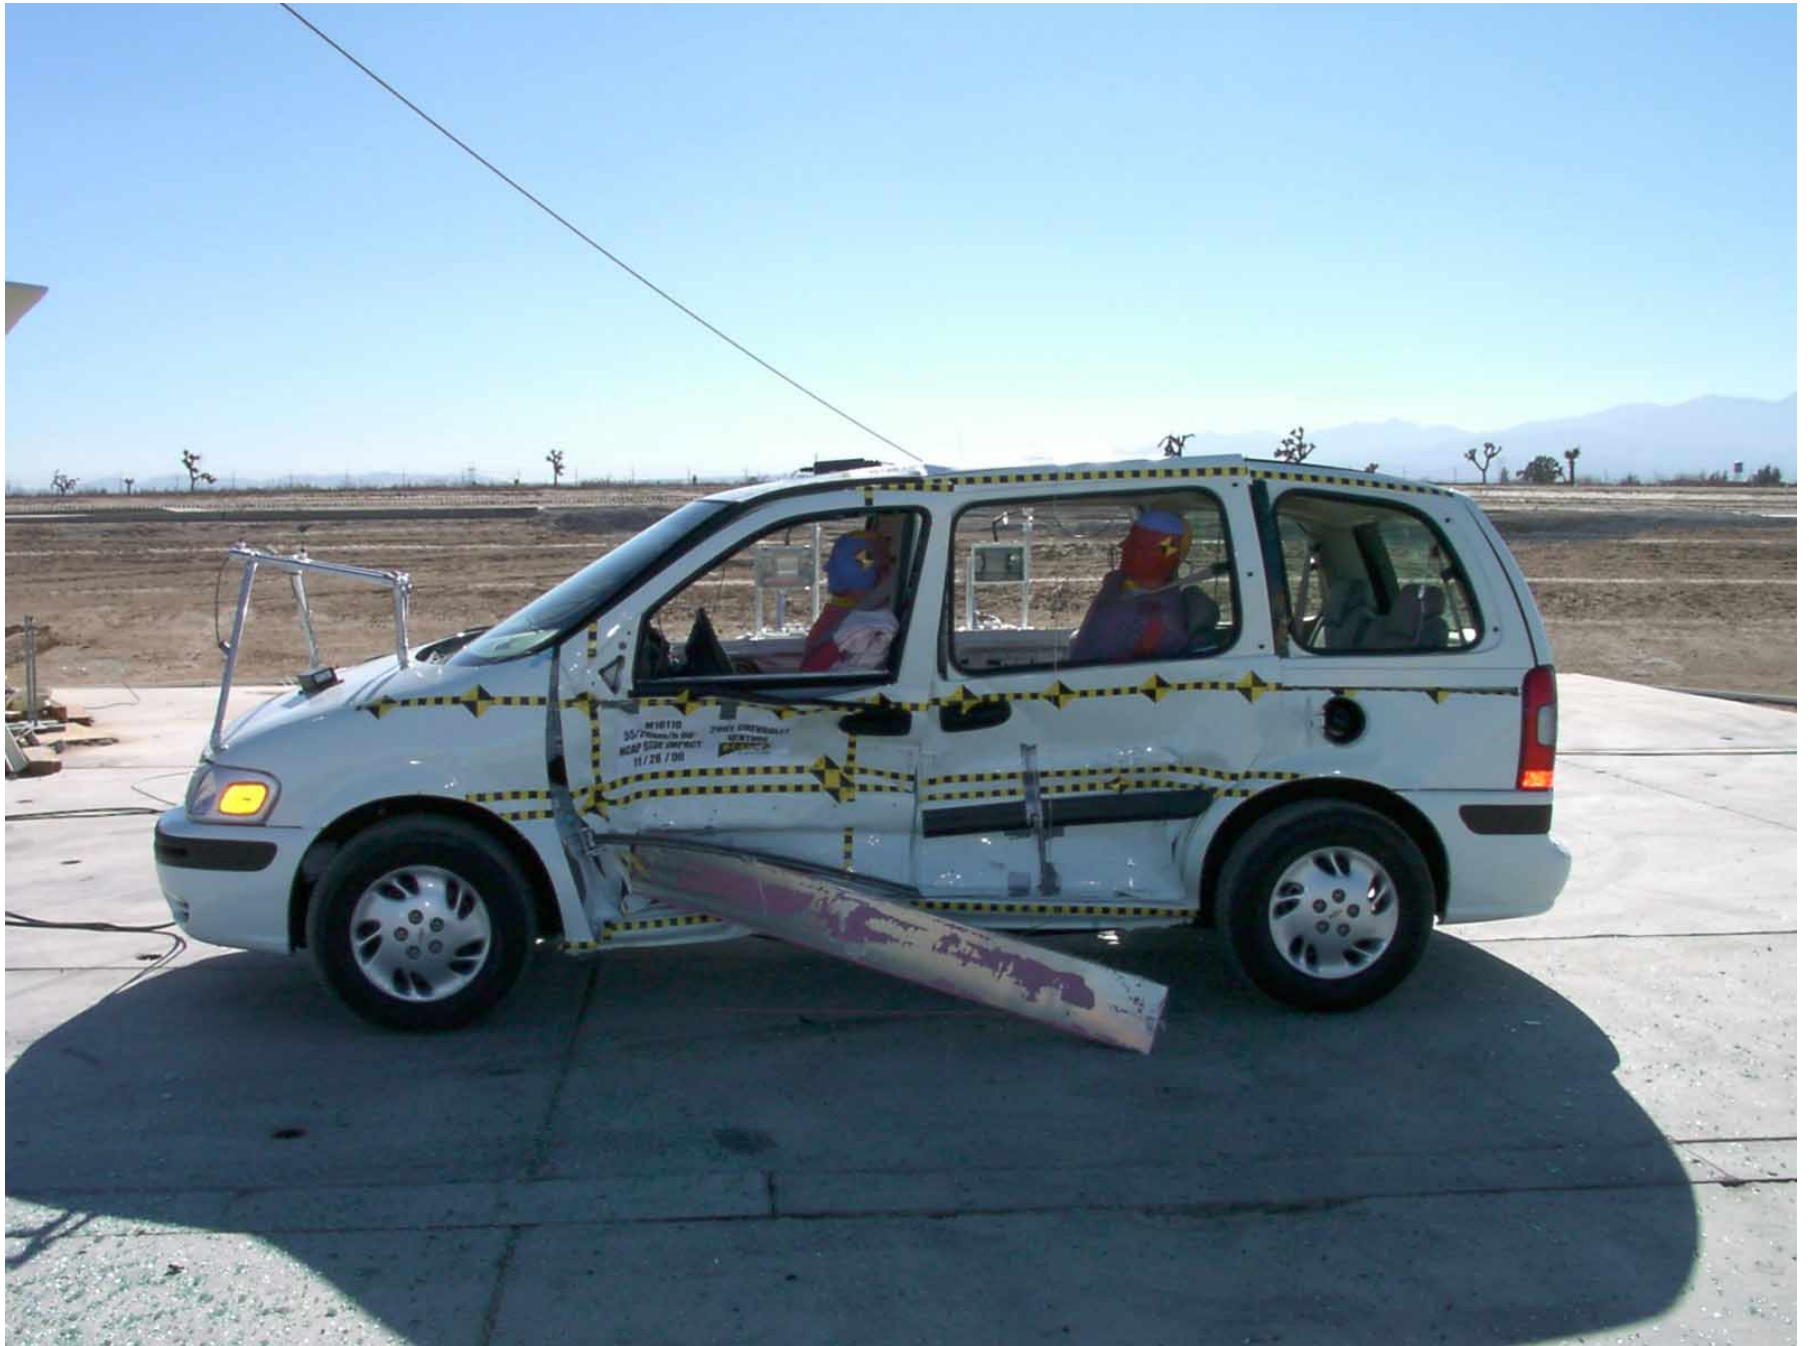
Figure A-10: Left (Impacted) Side View, Post-Test

Critical Areas of Performance	Observations and Conclusions
Pillar Performance	Pillars pushed inward with no apparent failure
Sill Separation	No Apparent Visible Failure
Windshield Damage	Glazing Cracks on Struck Side Only
Window Damage	Both left side windows broke
Other Notable Effects	No significant items to note.

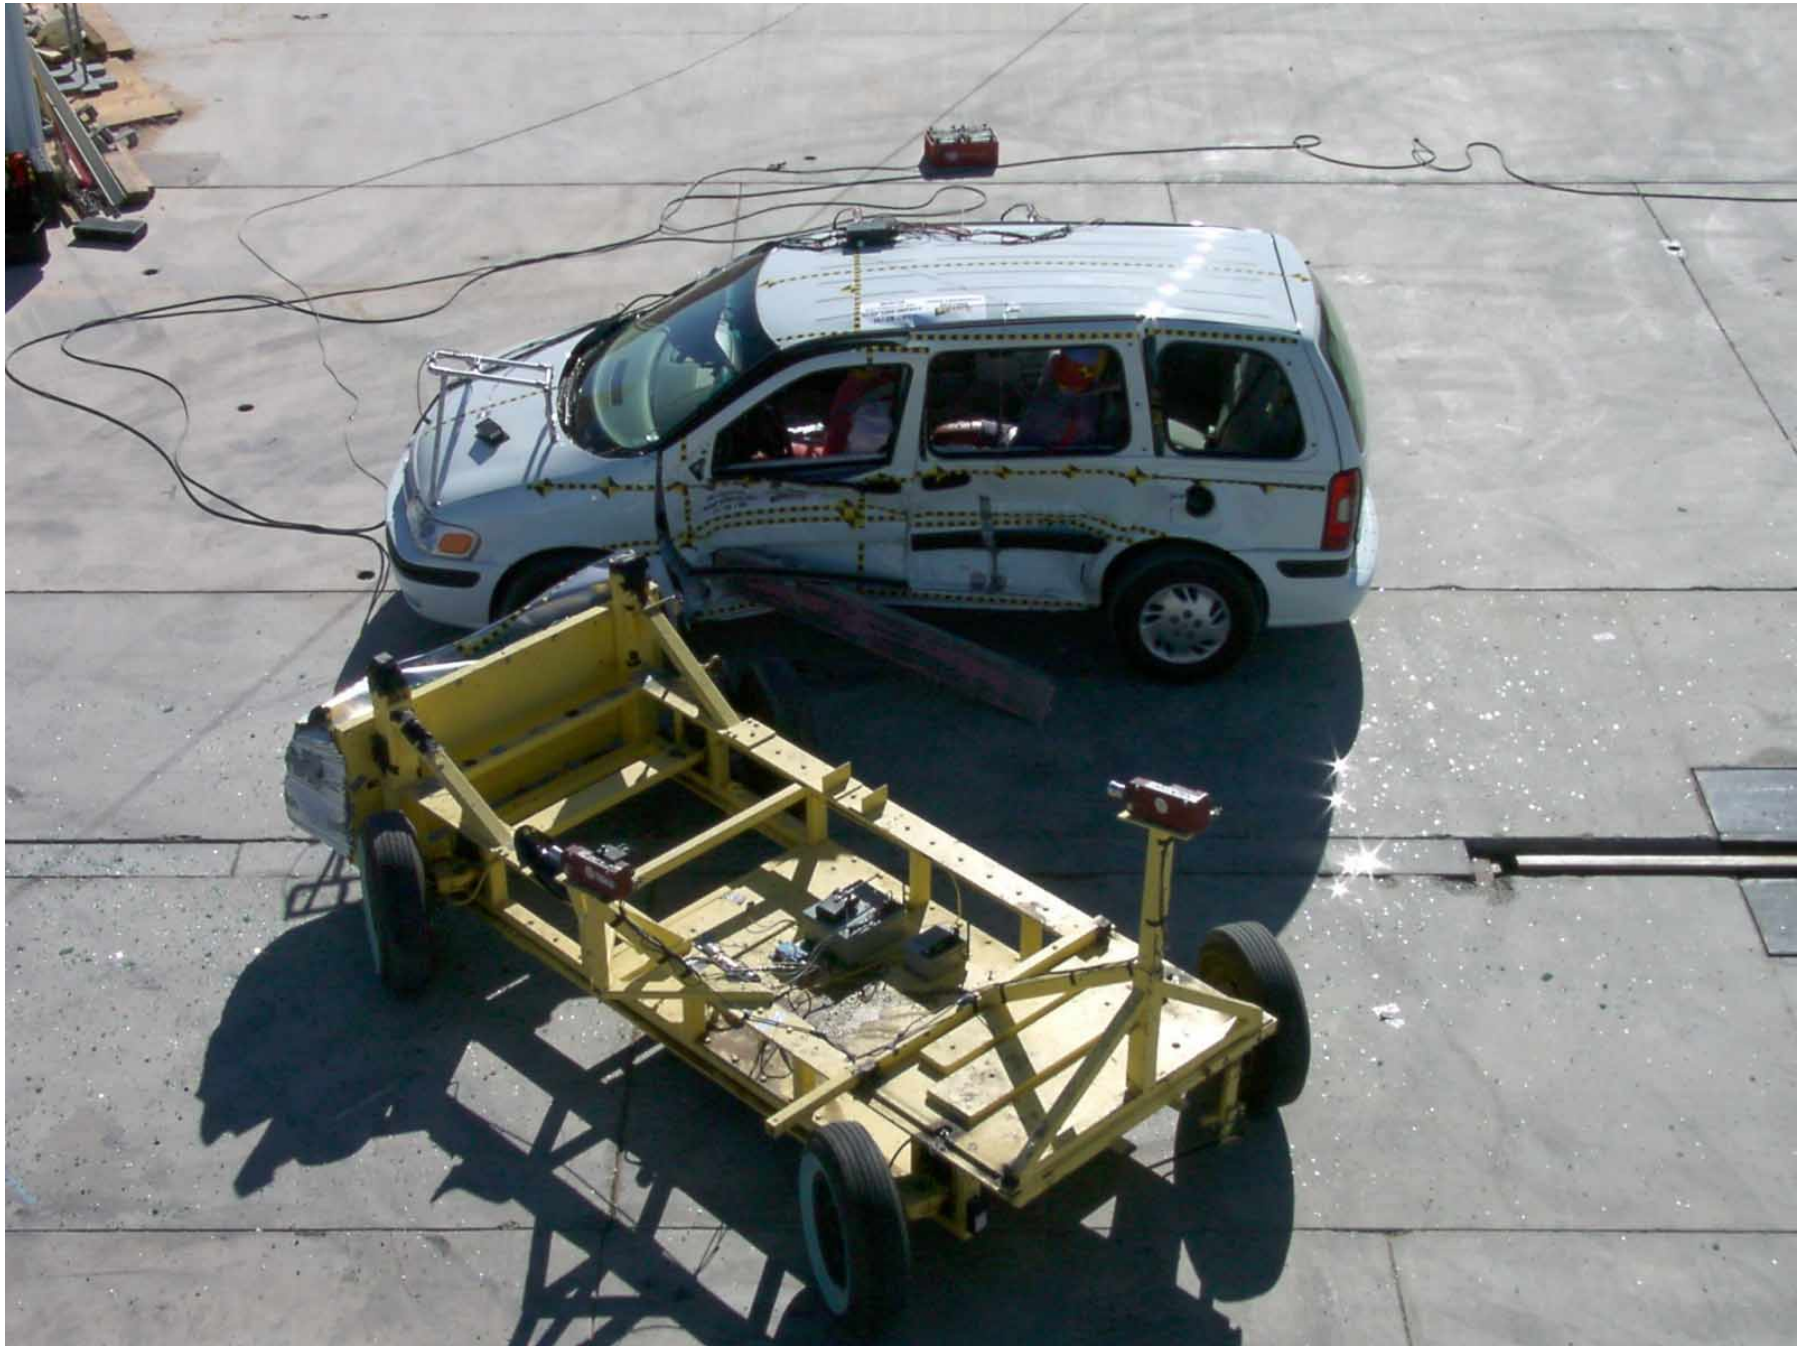
Figure A-13: Overhead Overall View, Post-Test

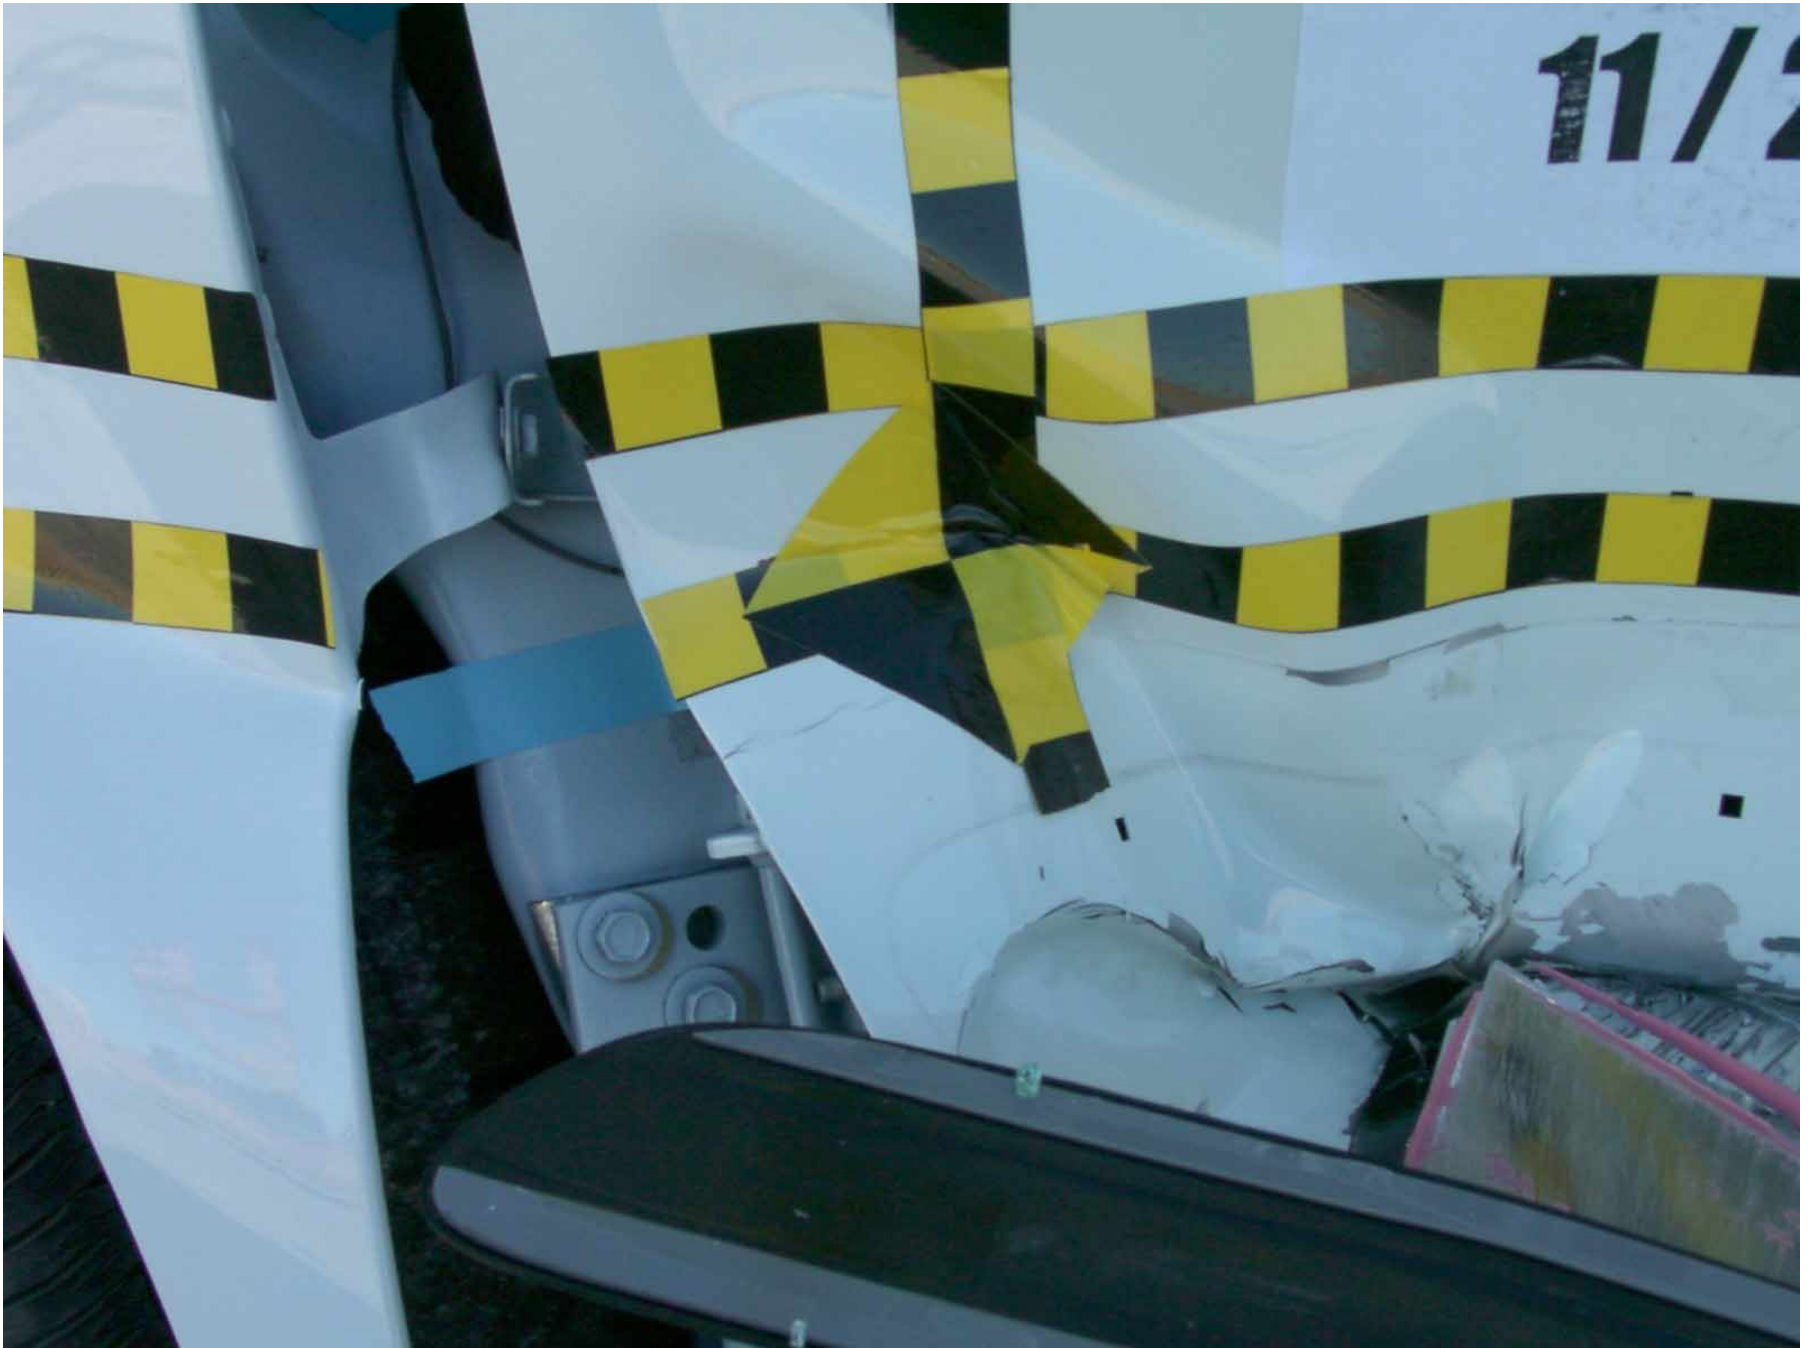
Figure A-17: Impact Point Target Close-up, Post-Test

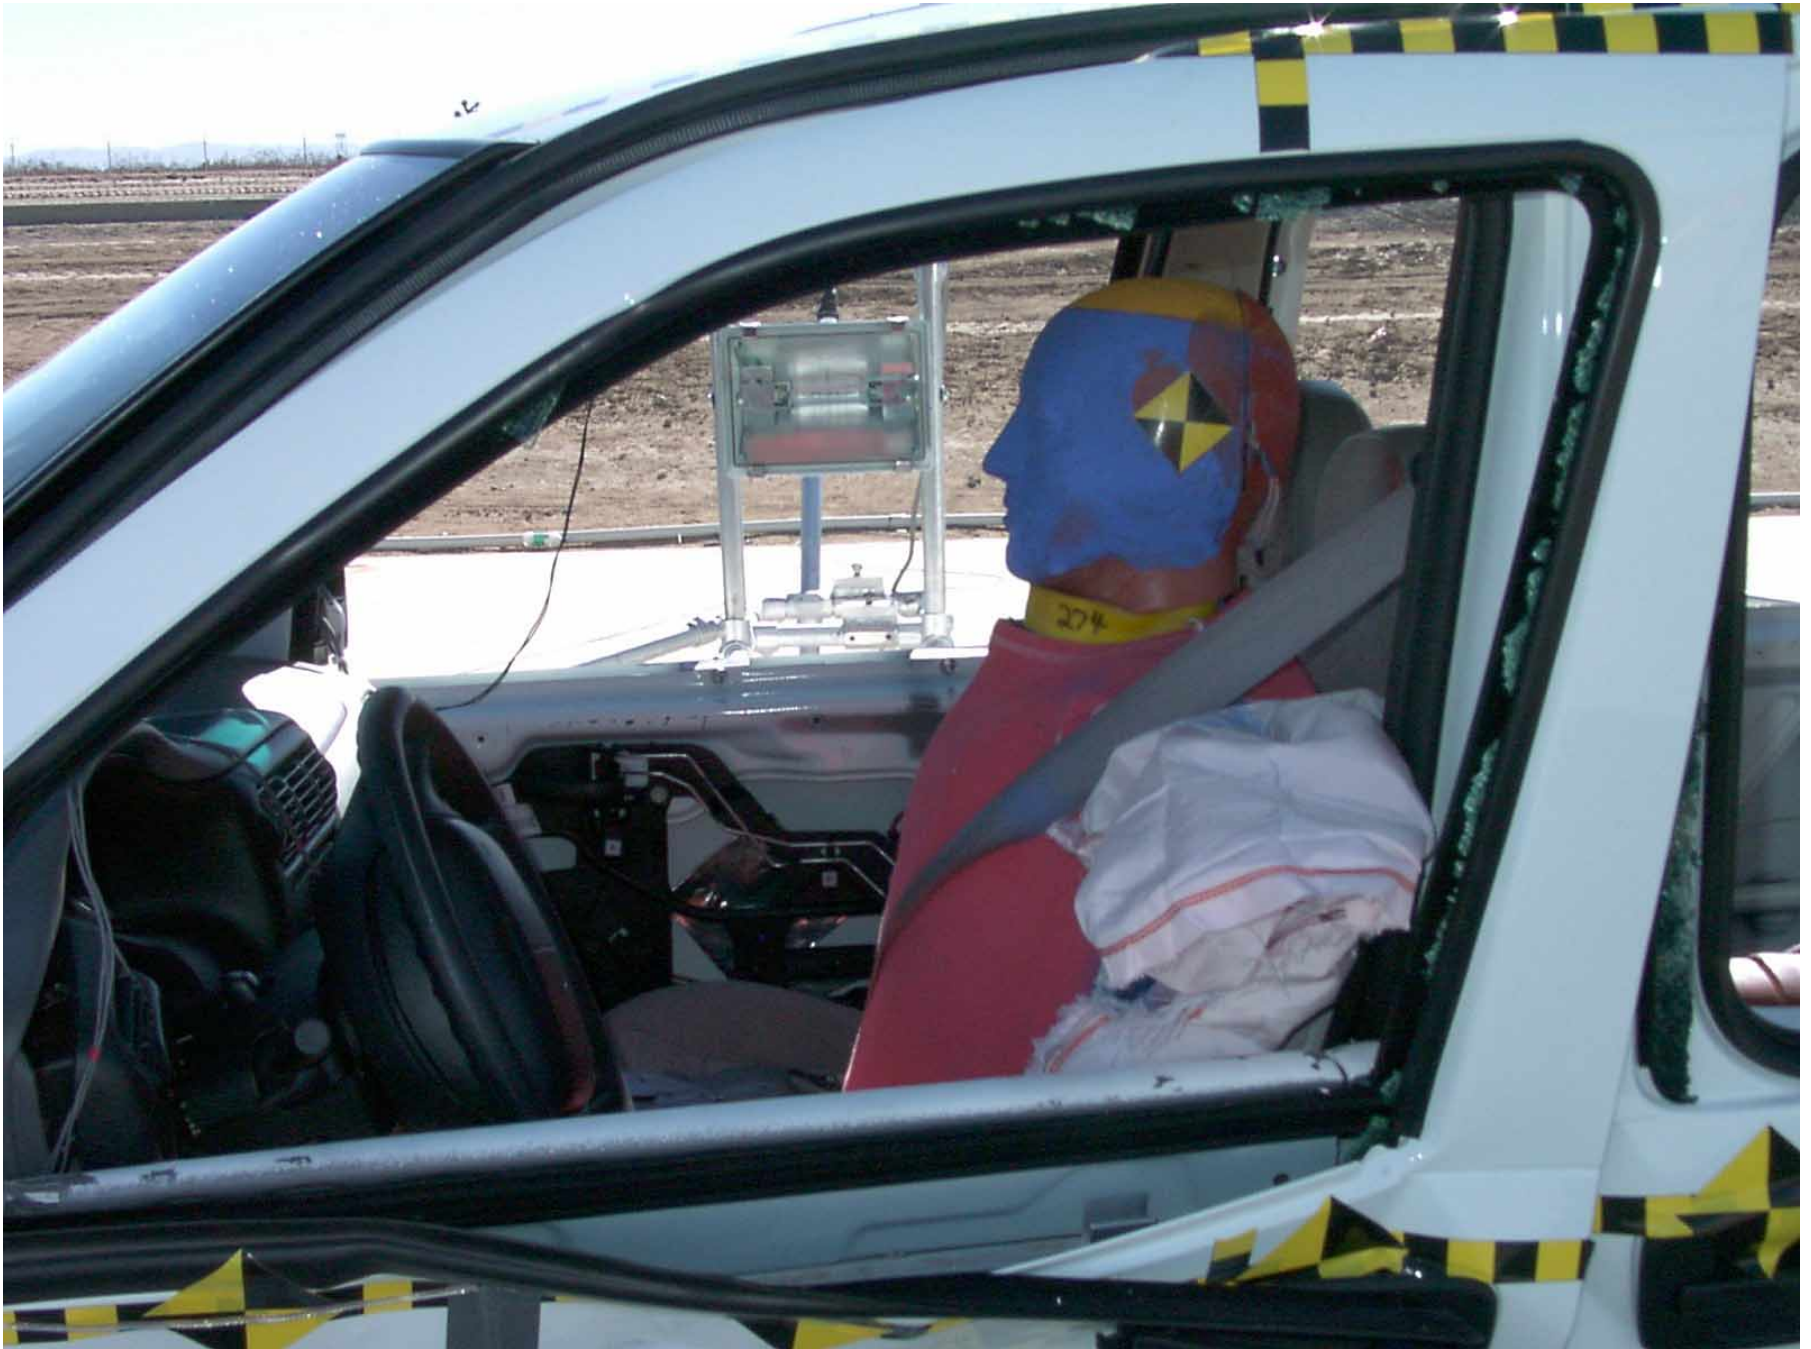
Figure A-20: Driver Dummy Left Side, Post-Test

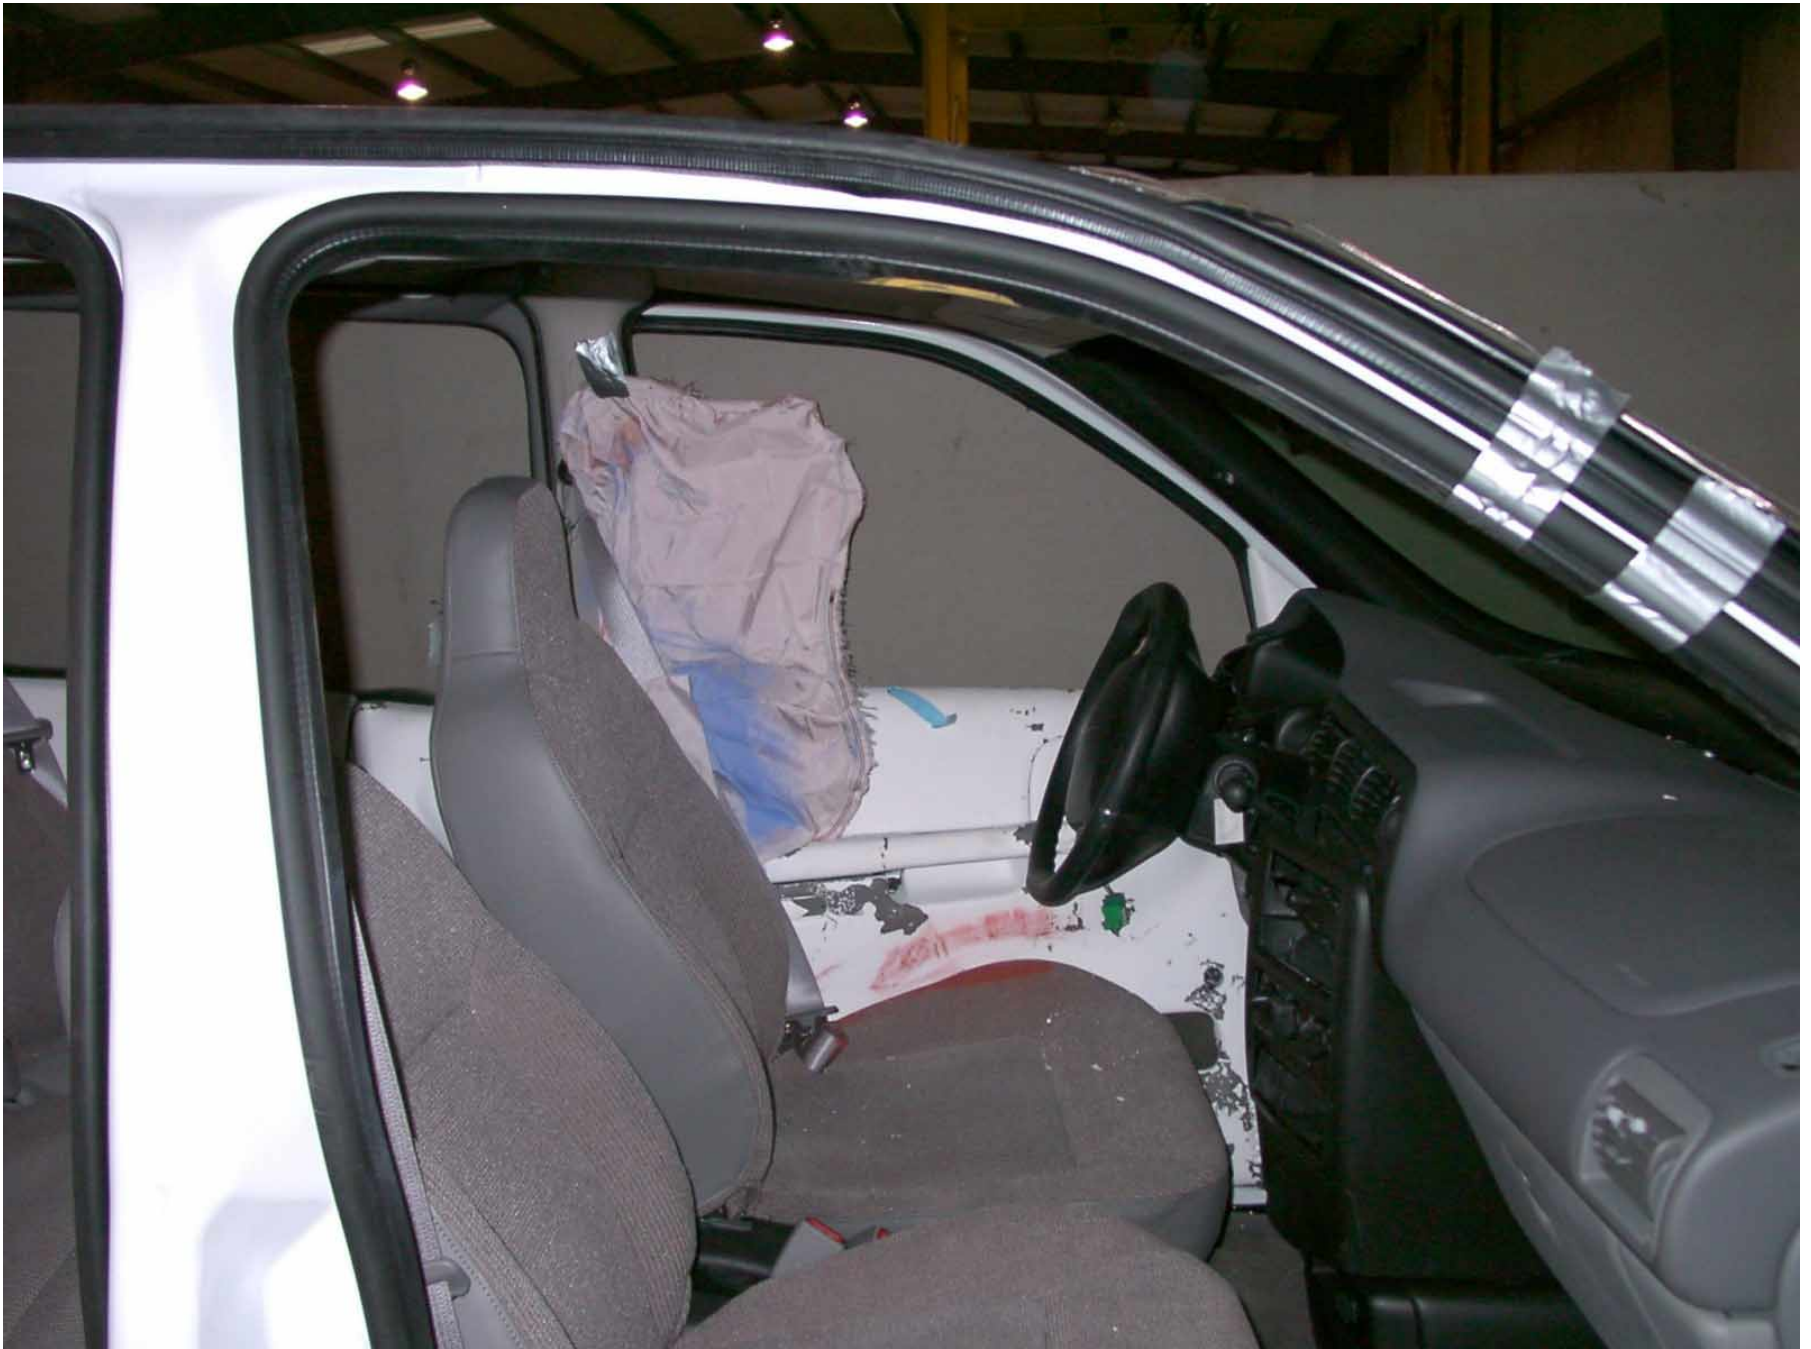
Figure A-26: Driver Dummy Contact Points Inside View, Post-Test

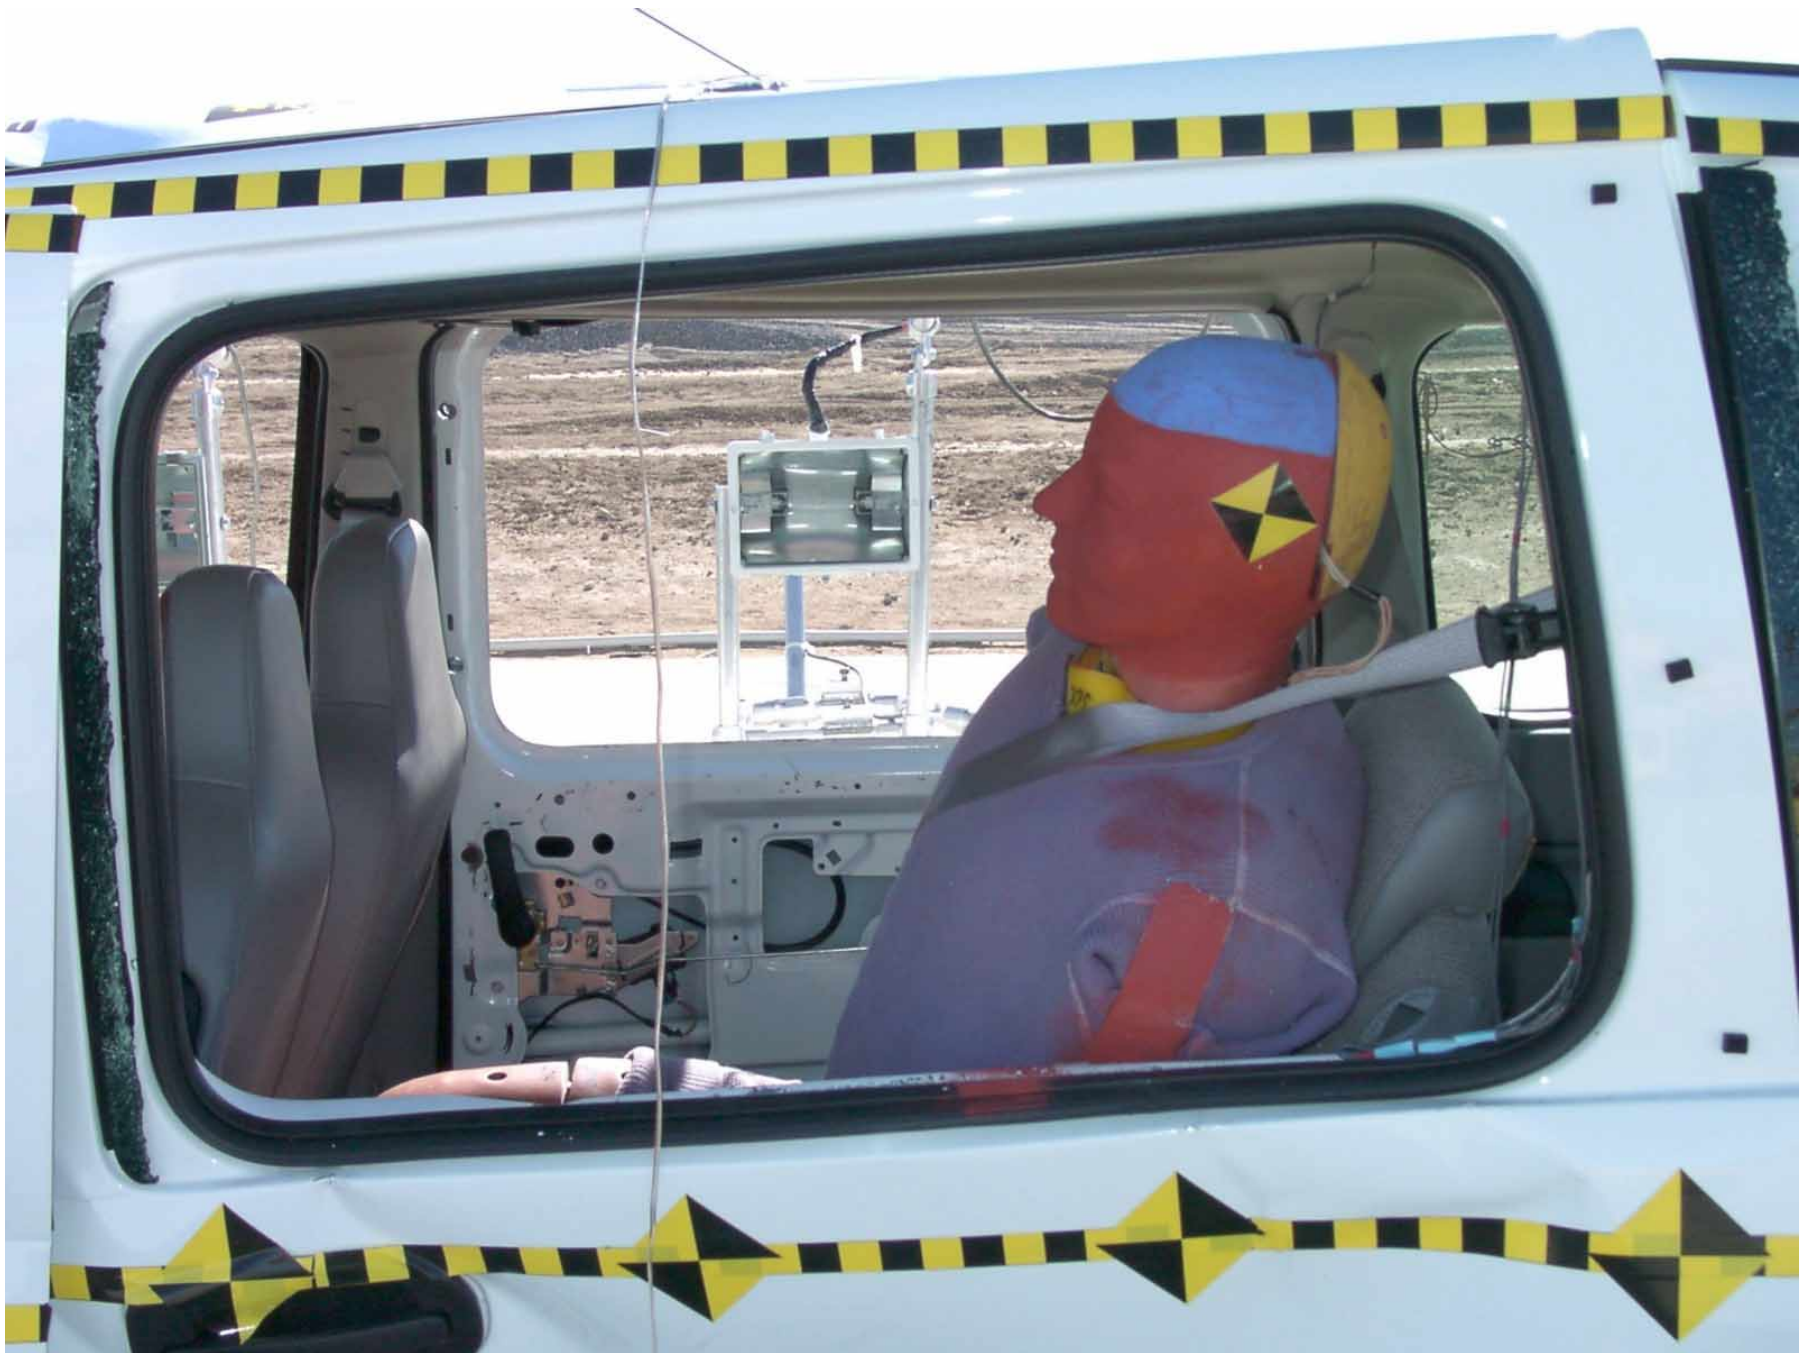
Figure A-29: Passenger Dummy Left Side, Post-Test
