REPORT NUMBER KAR21003-01

**NEW CAR ASSESSMENT PROGRAM
SIDE IMPACT TEST**

**GENERAL MOTORS CORPORATION
2001 CHEVROLET VENTURE MINIVAN**

NHTSA NUMBER: M10110

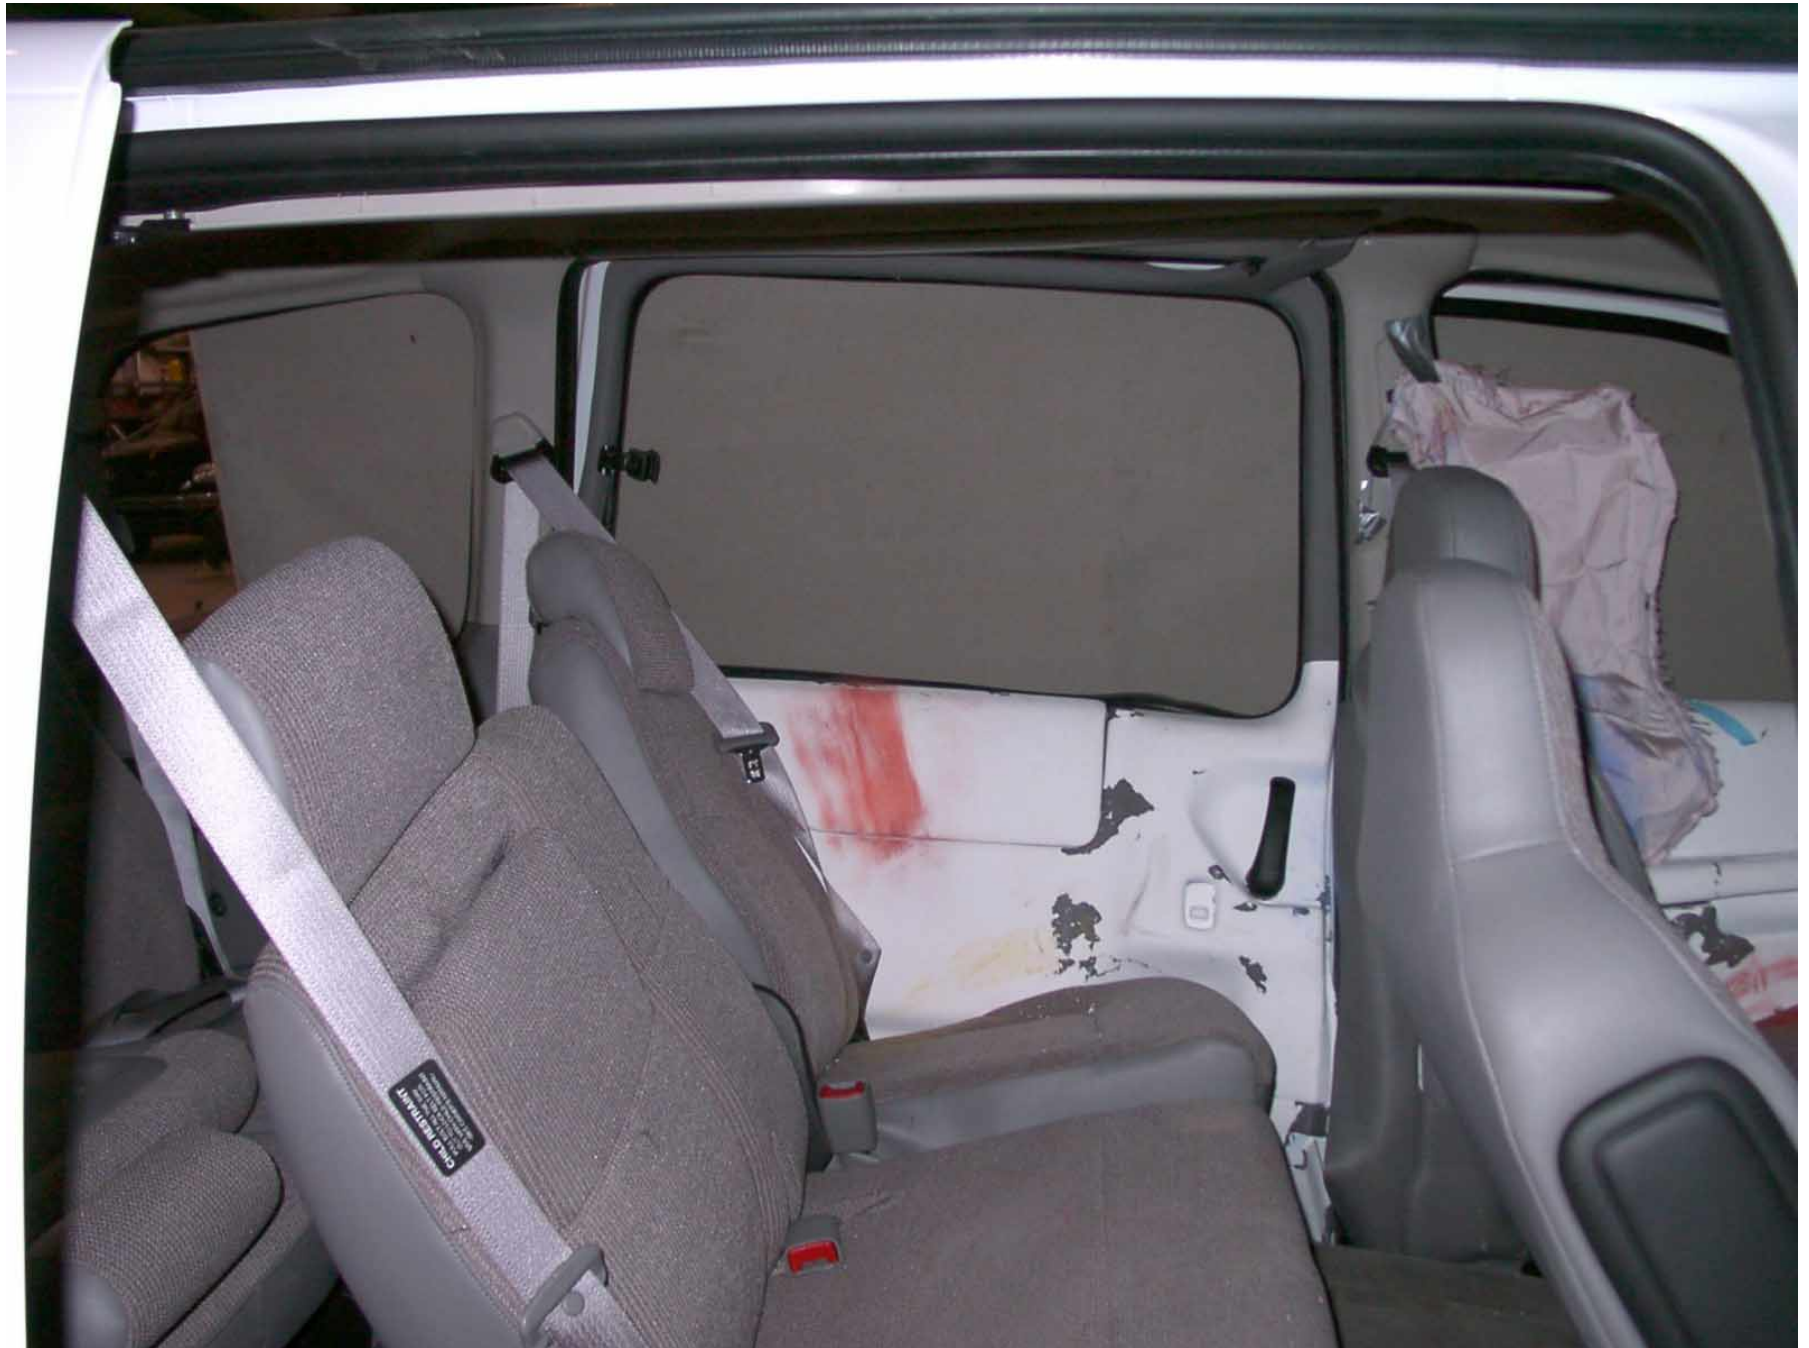
Figure A-35: Passenger Dummy Contact Points Inside View, Post-Test

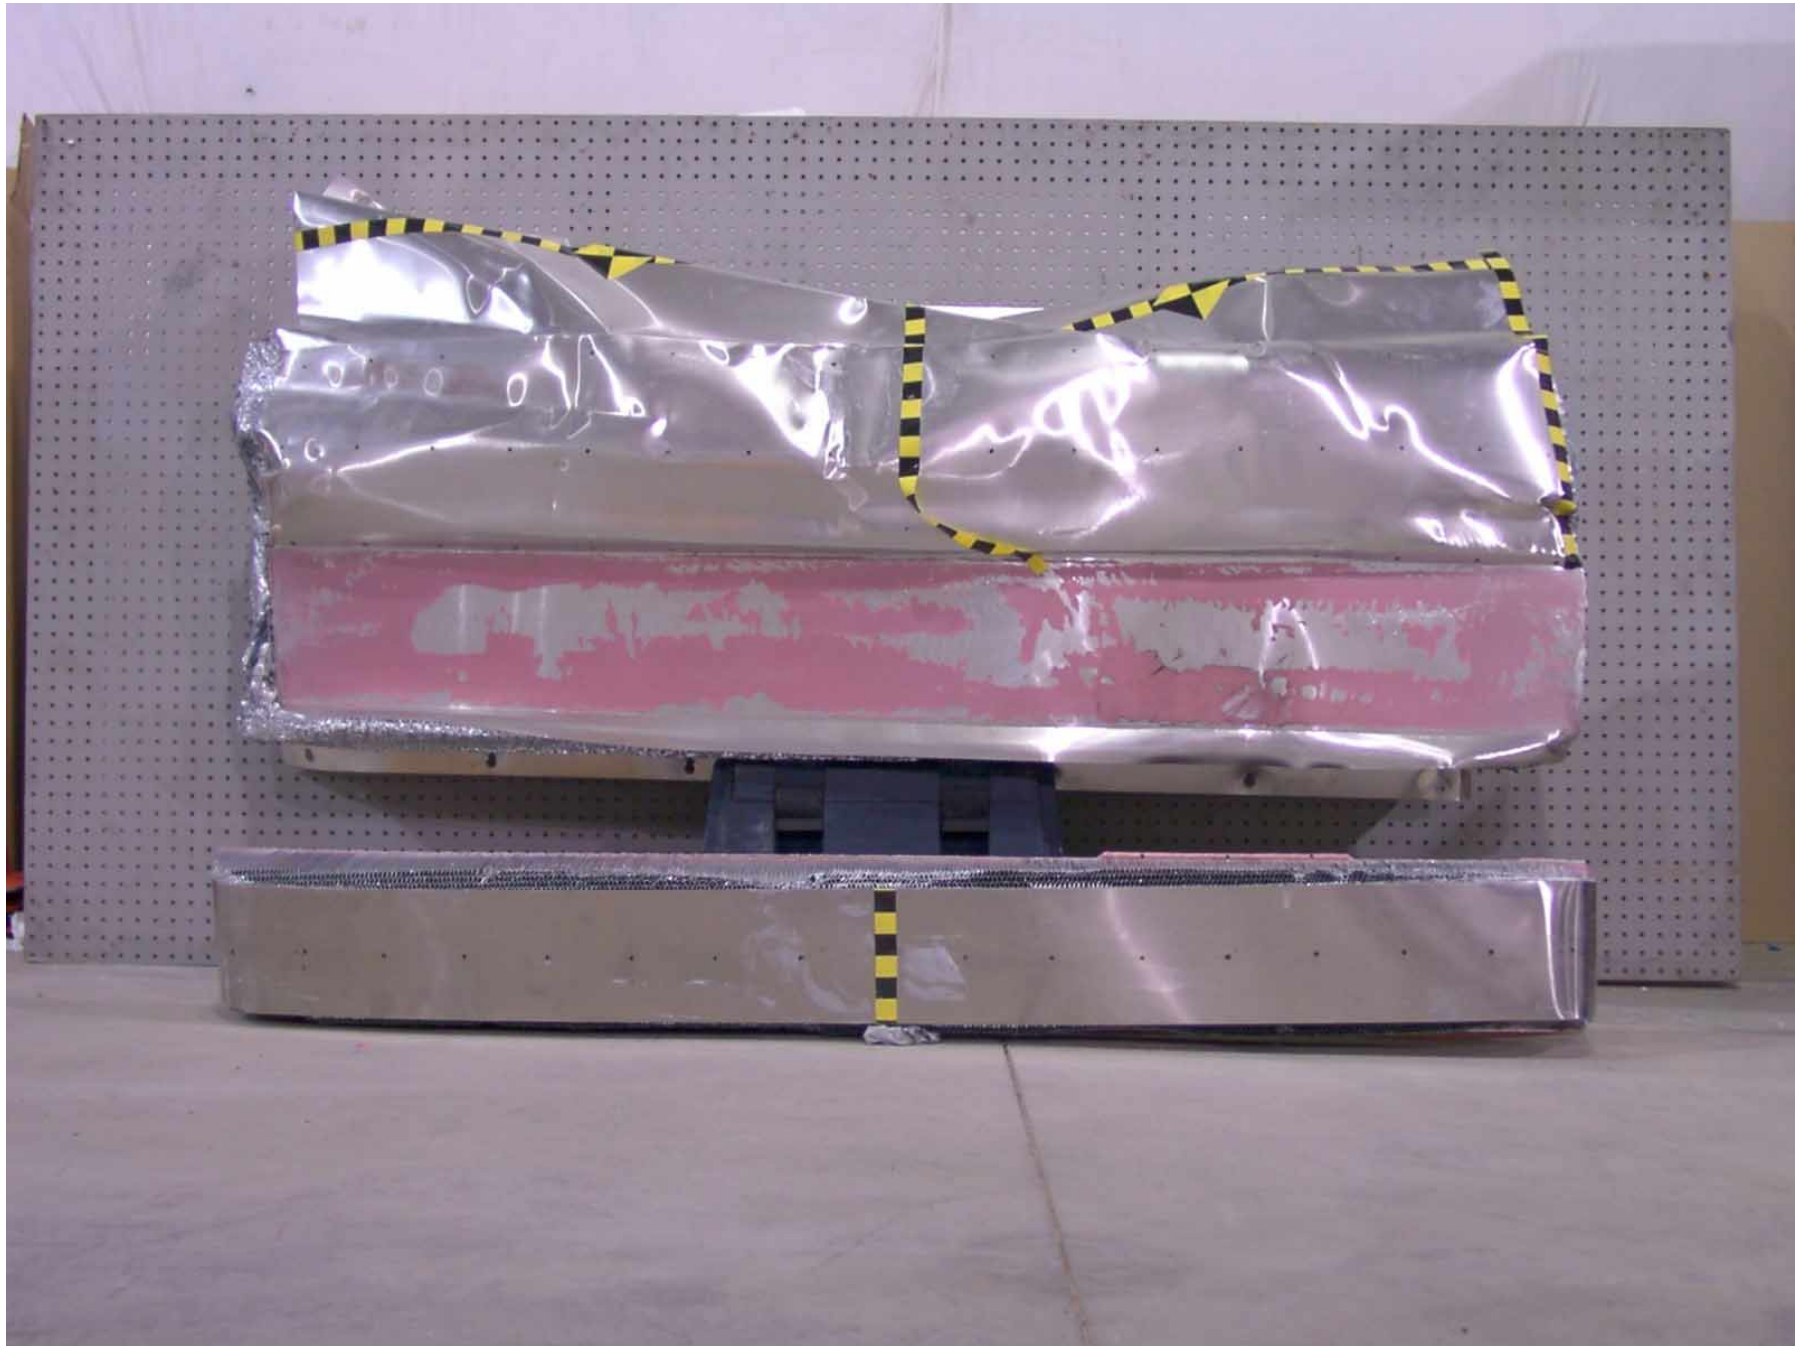
Figure A-37: Front View of Deformable Barrier, Post-Test

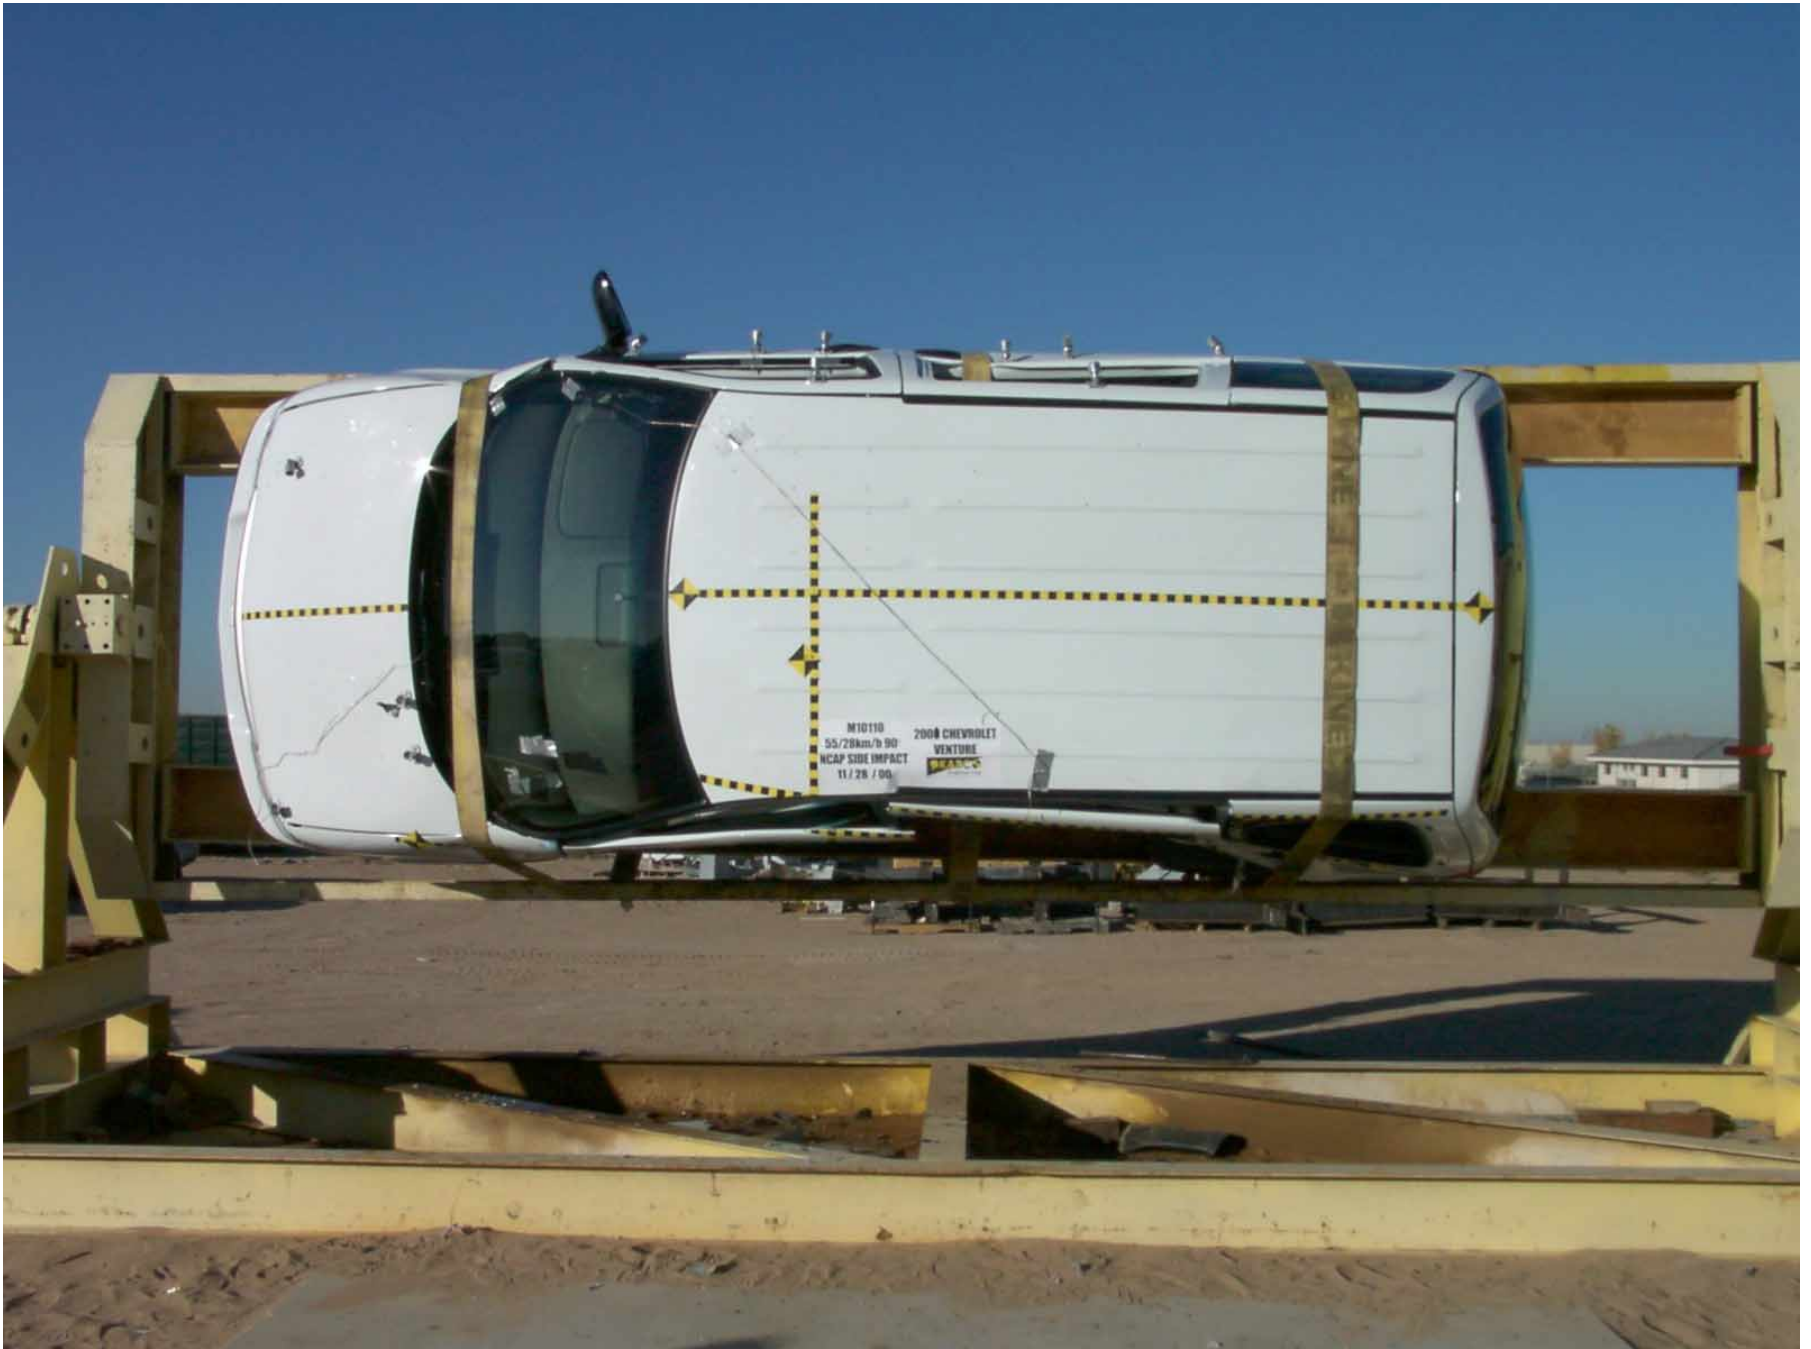
Figure A-44: Vehicle on Rollover Device, Top View

No solvent leakage occurred during static rollover testing.

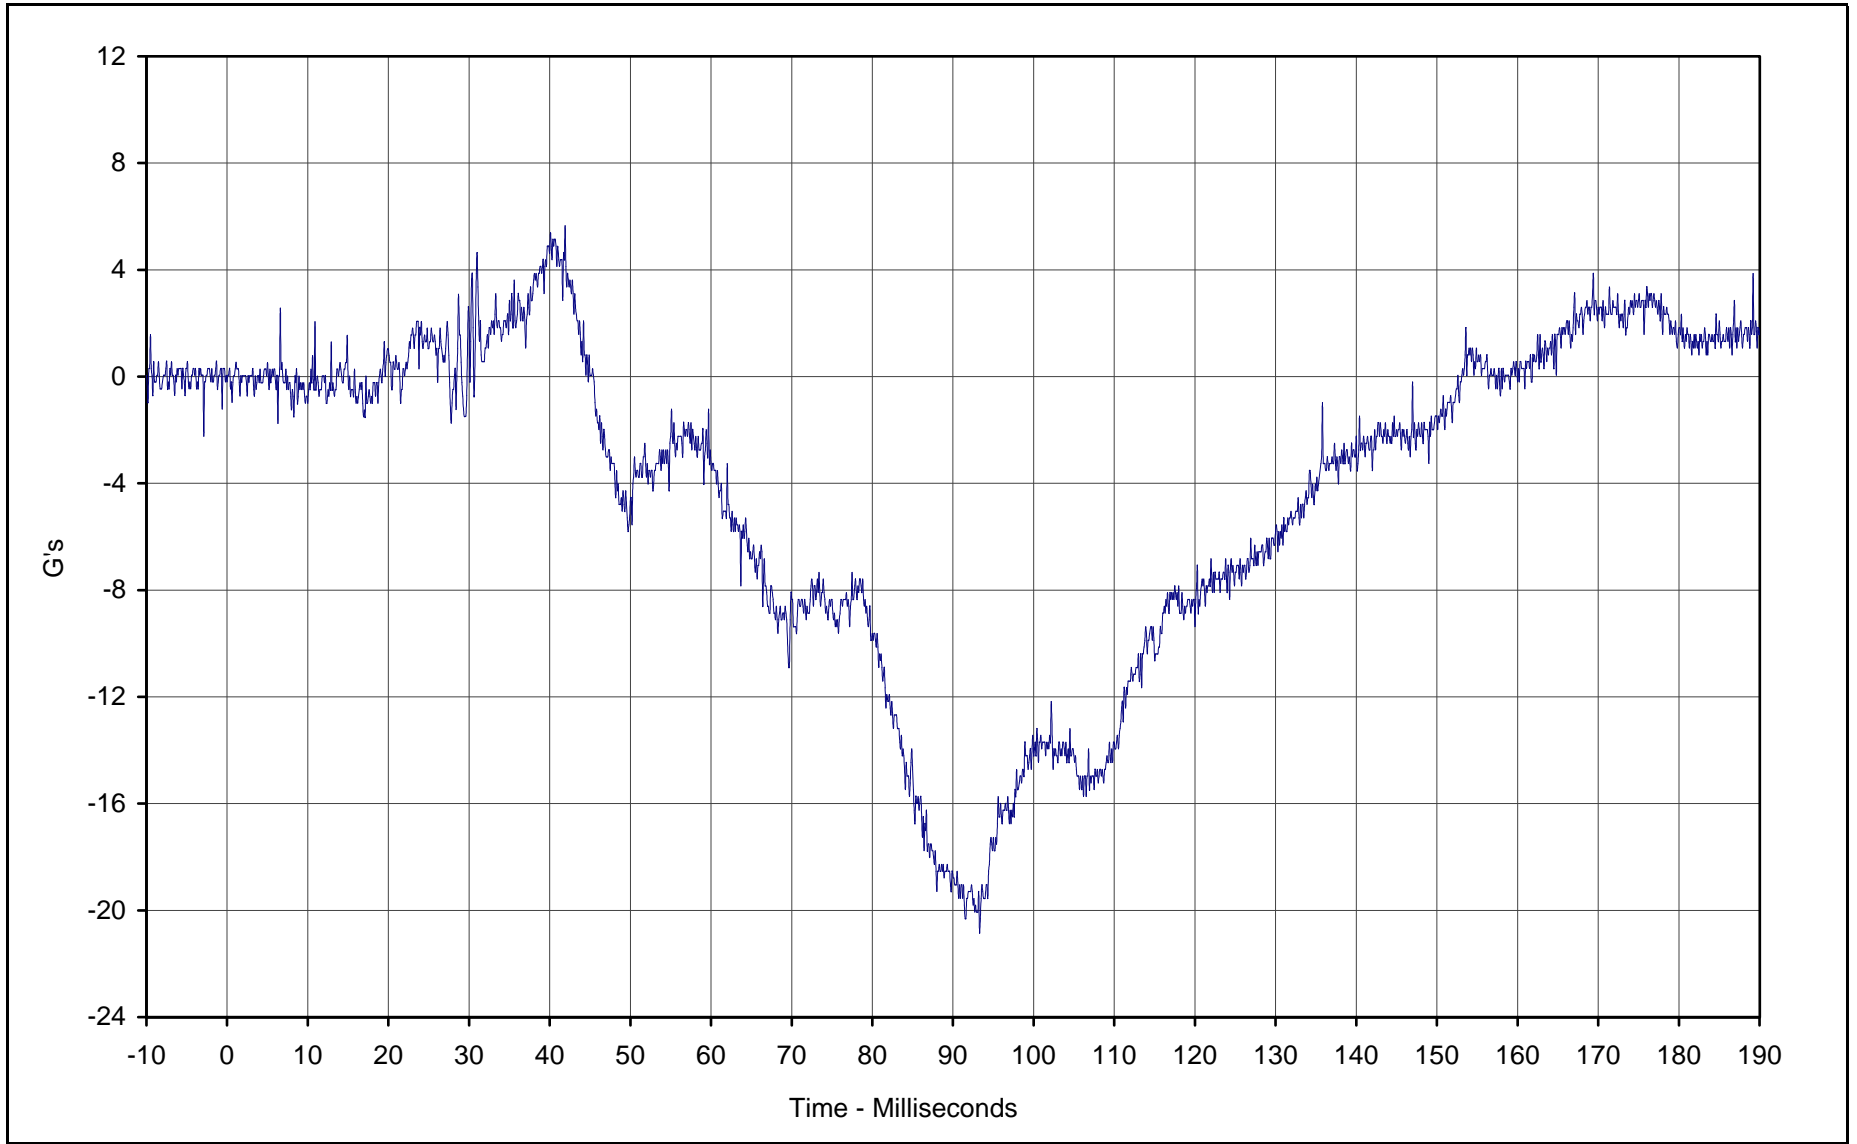
Curve Description: Driver Head CG X
Maximum Value: 5.7 at 41.9 Milliseconds
Minimum Value: -20.8 at 93.3 Milliseconds
SAE Filter Class: 1000
Date of Test: 11/28/00
Curve Number: FIL-001

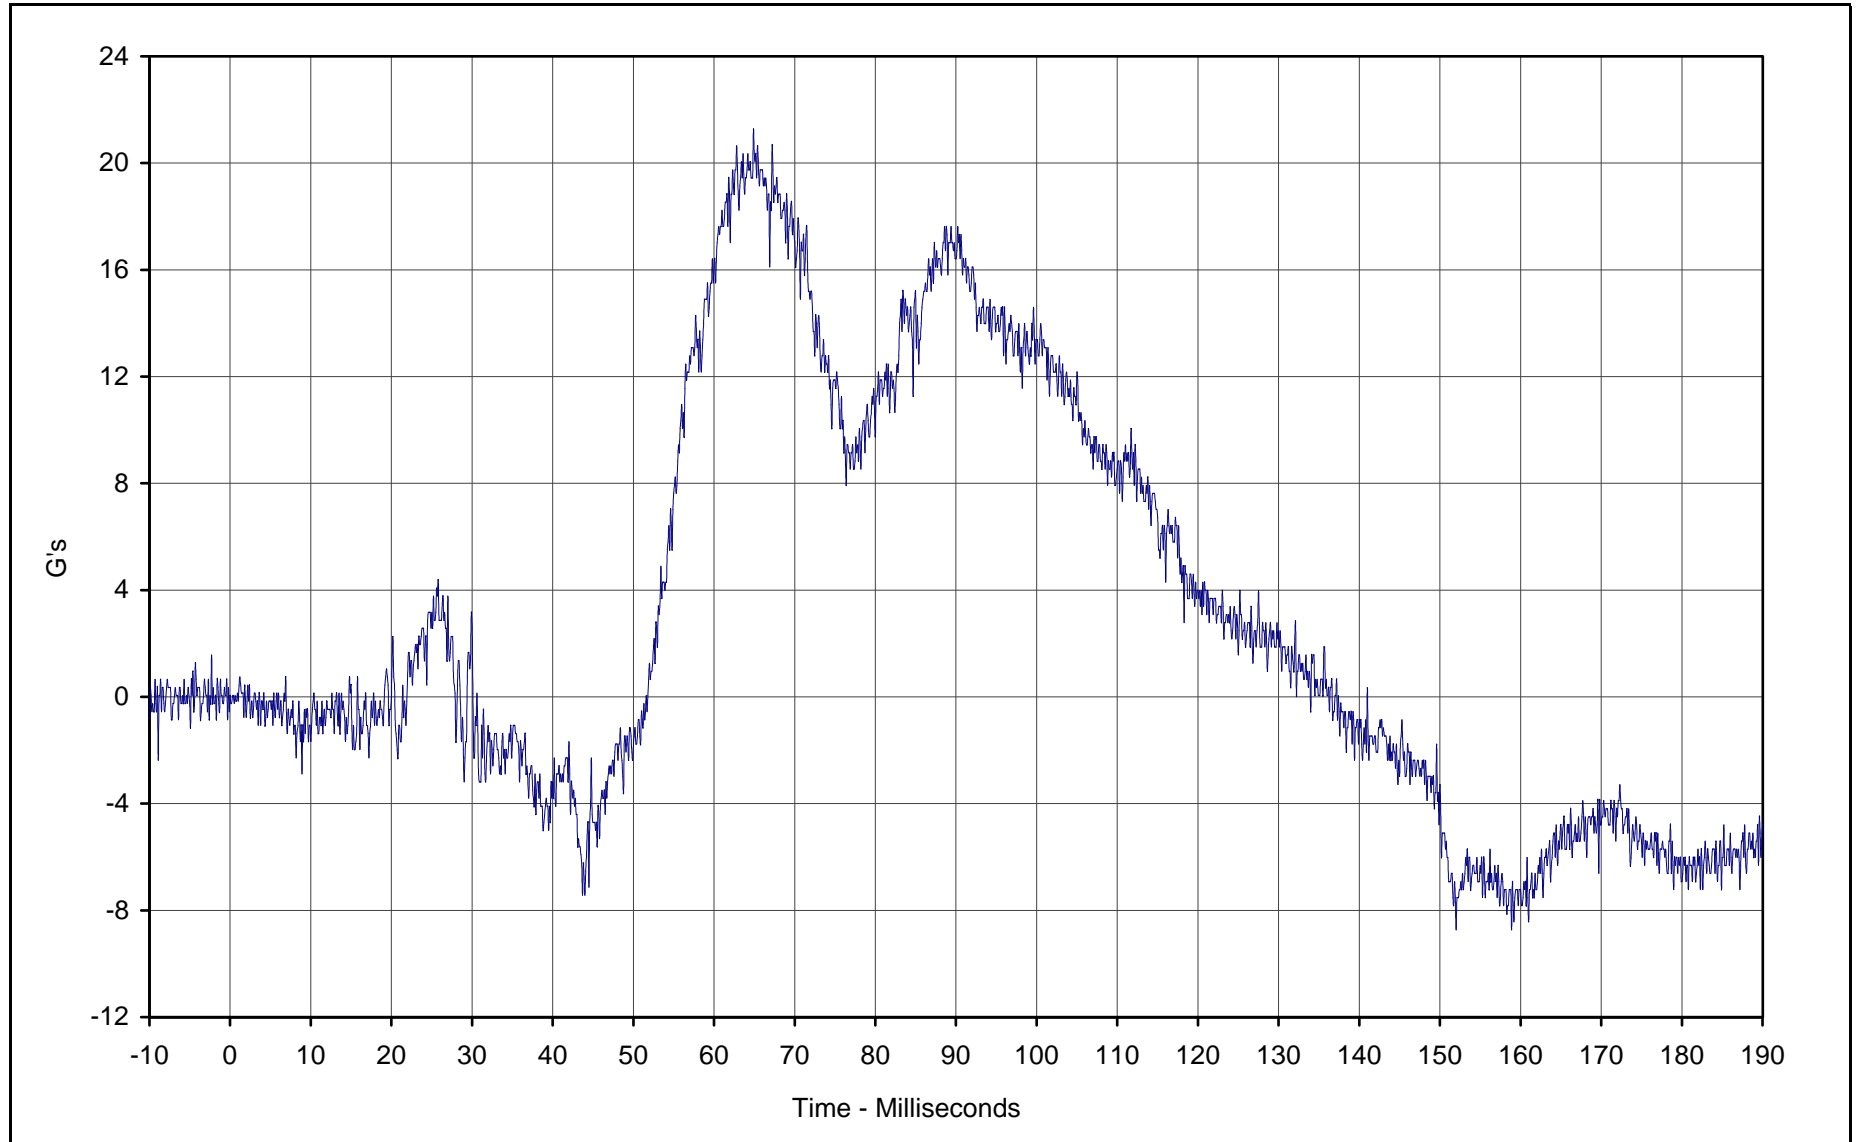
Curve Description: Driver Head CG Y
 Maximum Value: 21.3 at 64.9 Milliseconds
 Minimum Value: -8.7 at 152.0 Milliseconds
 SAE Filter Class: 1000
 Date of Test: 11/28/00
 Curve Number: FIL-002

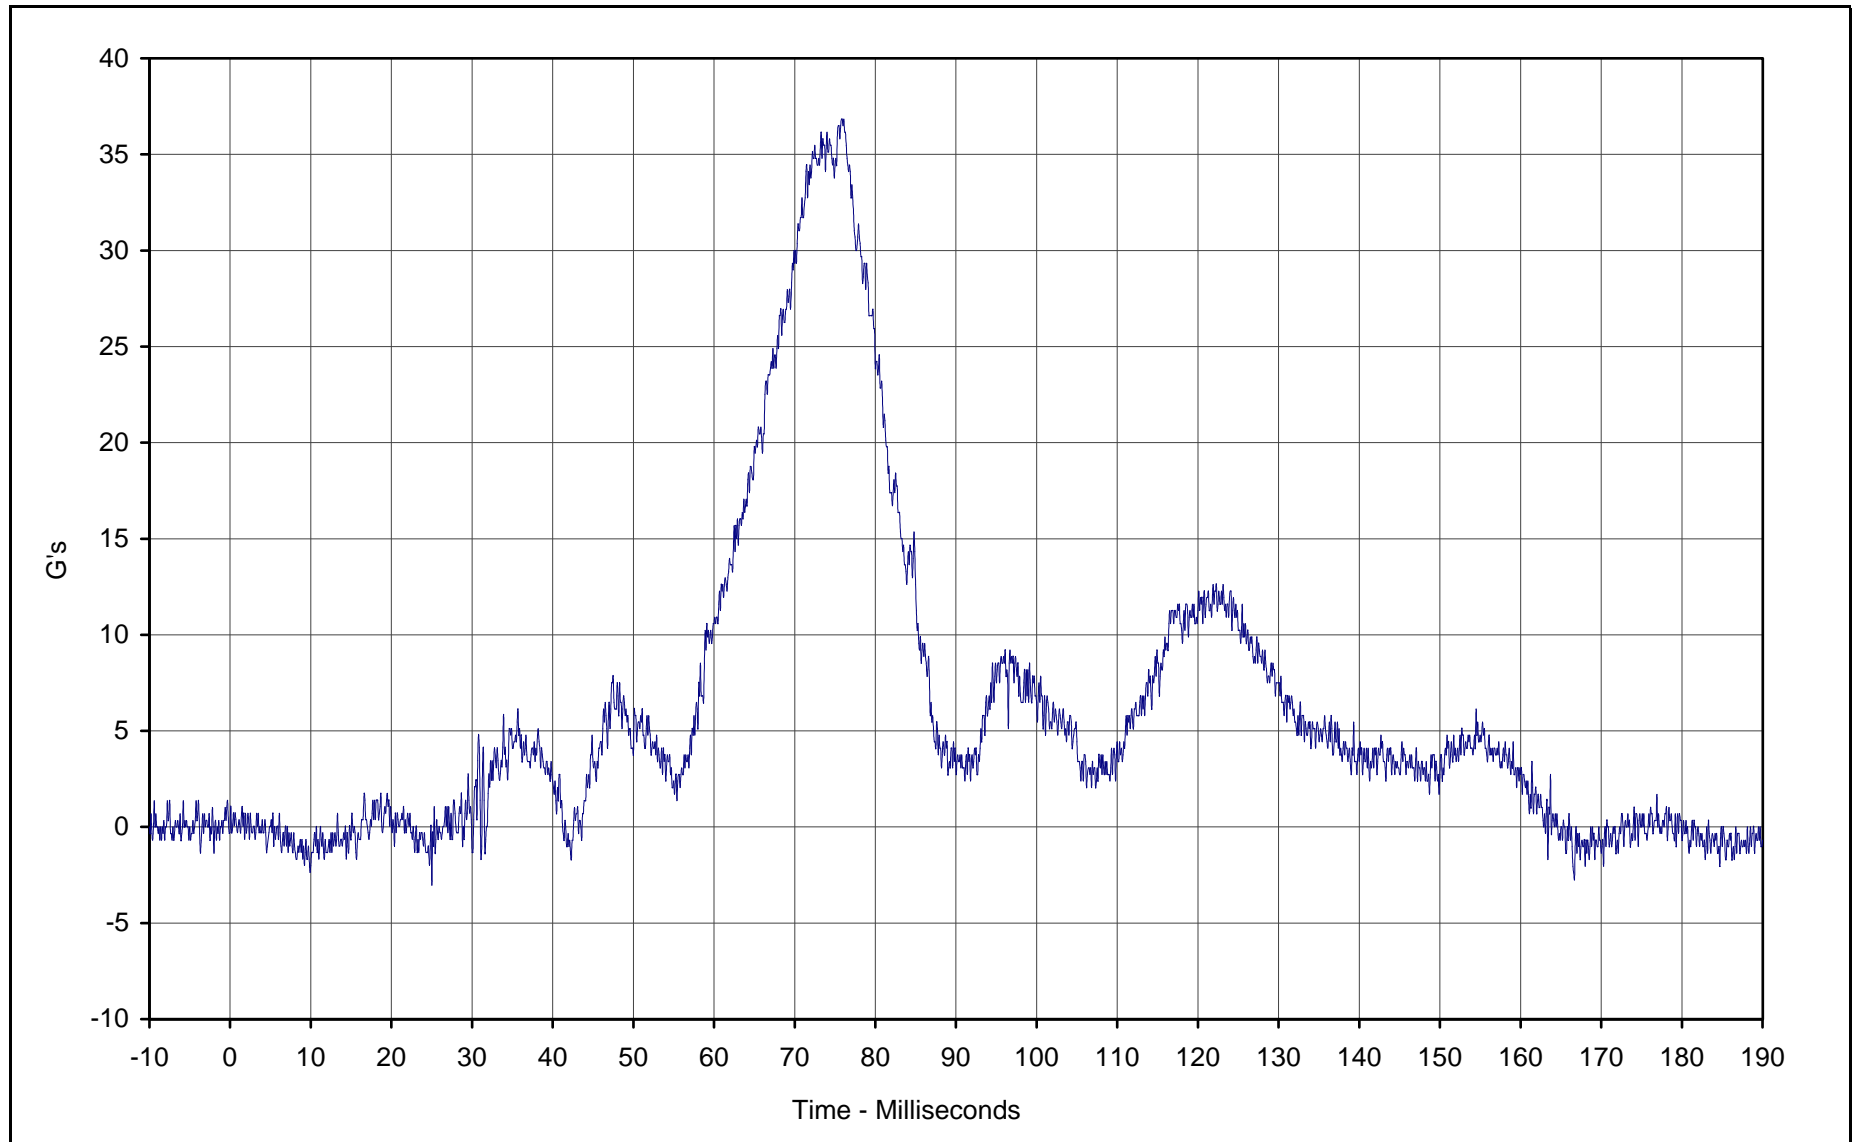
Curve Description: Driver Head CG Z
 Maximum Value: 36.8 at 75.8 Milliseconds
 Minimum Value: -3.0 at 25.0 Milliseconds
 SAE Filter Class: 1000
 Date of Test: 11/28/00
 Curve Number: FIL-003

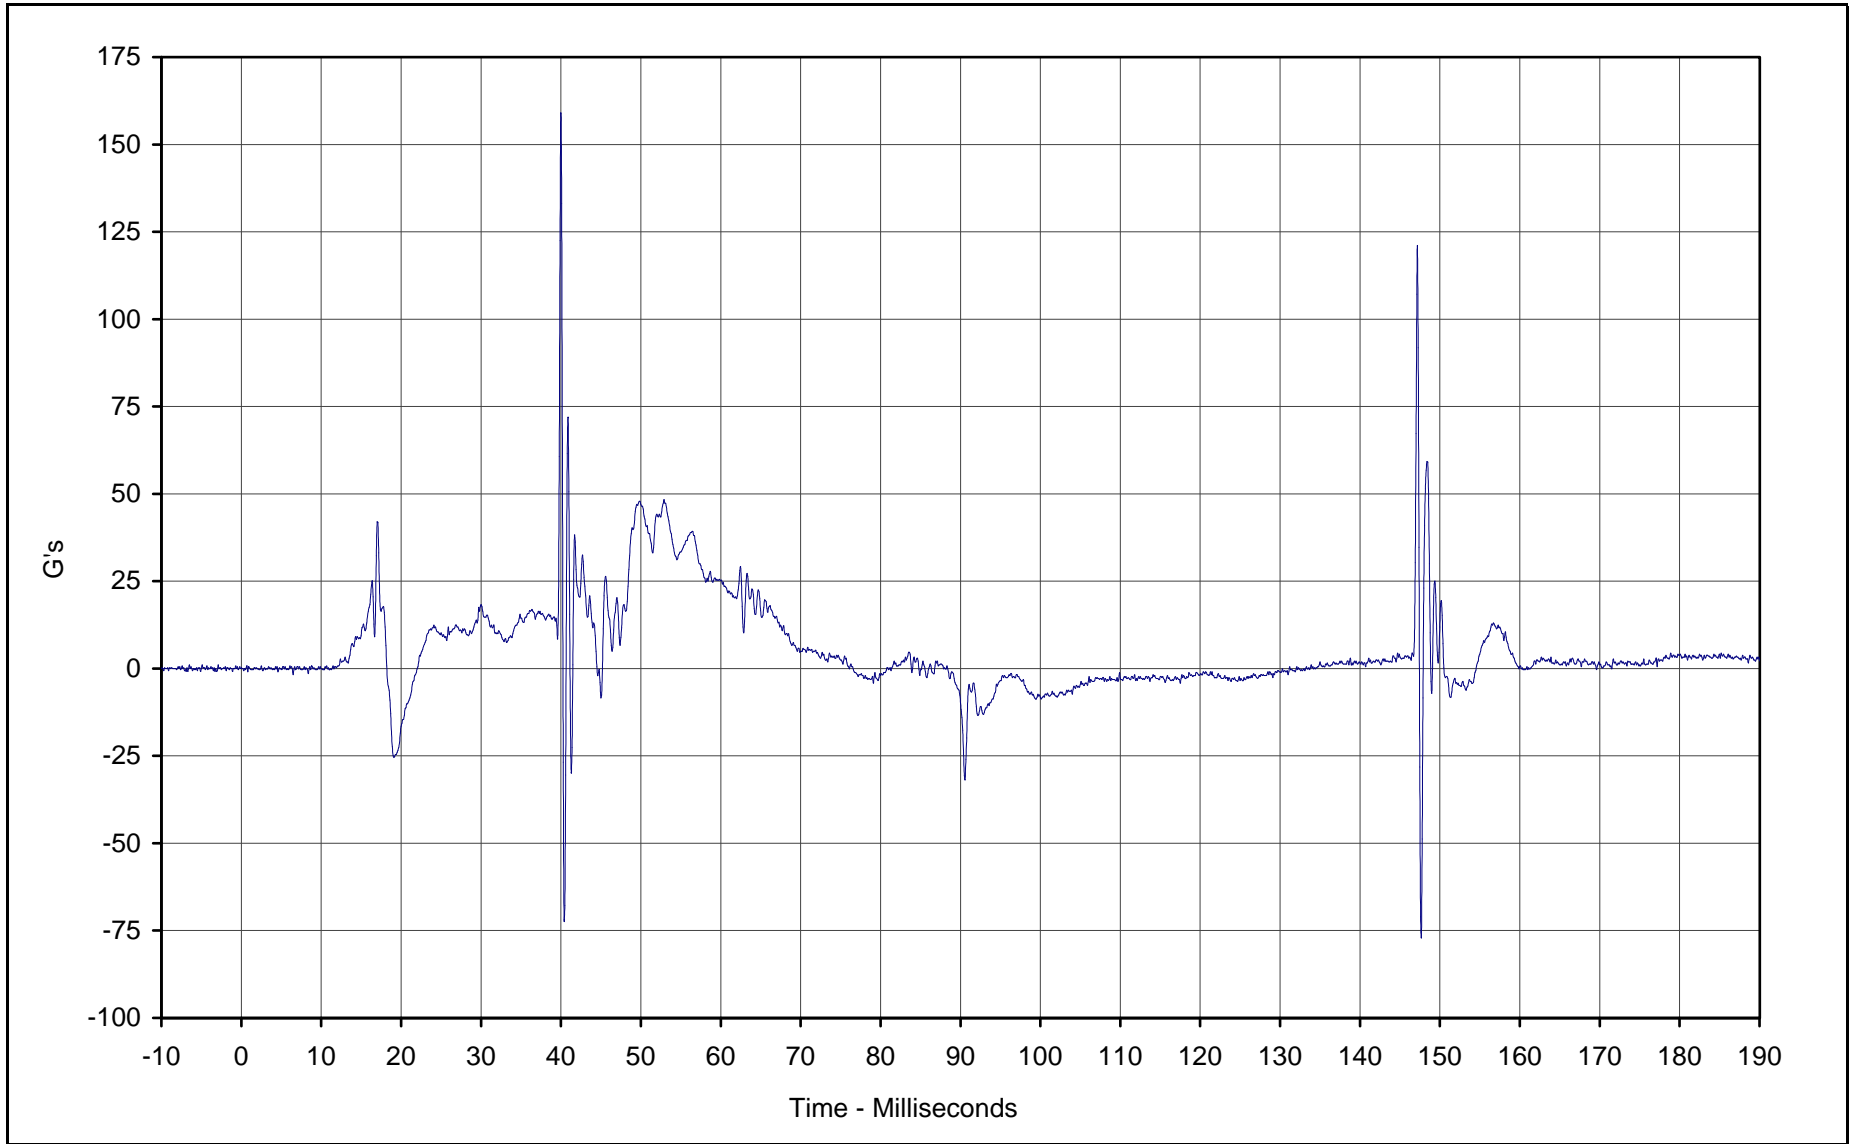
Curve Description: Driver Upper Rib Primary Y
Maximum Value: 159.0 at 40.0 Milliseconds
Minimum Value: -76.9 at 147.7 Milliseconds
SAE Filter Class: 1000
Date of Test: 11/28/00
Curve Number: FIL-004

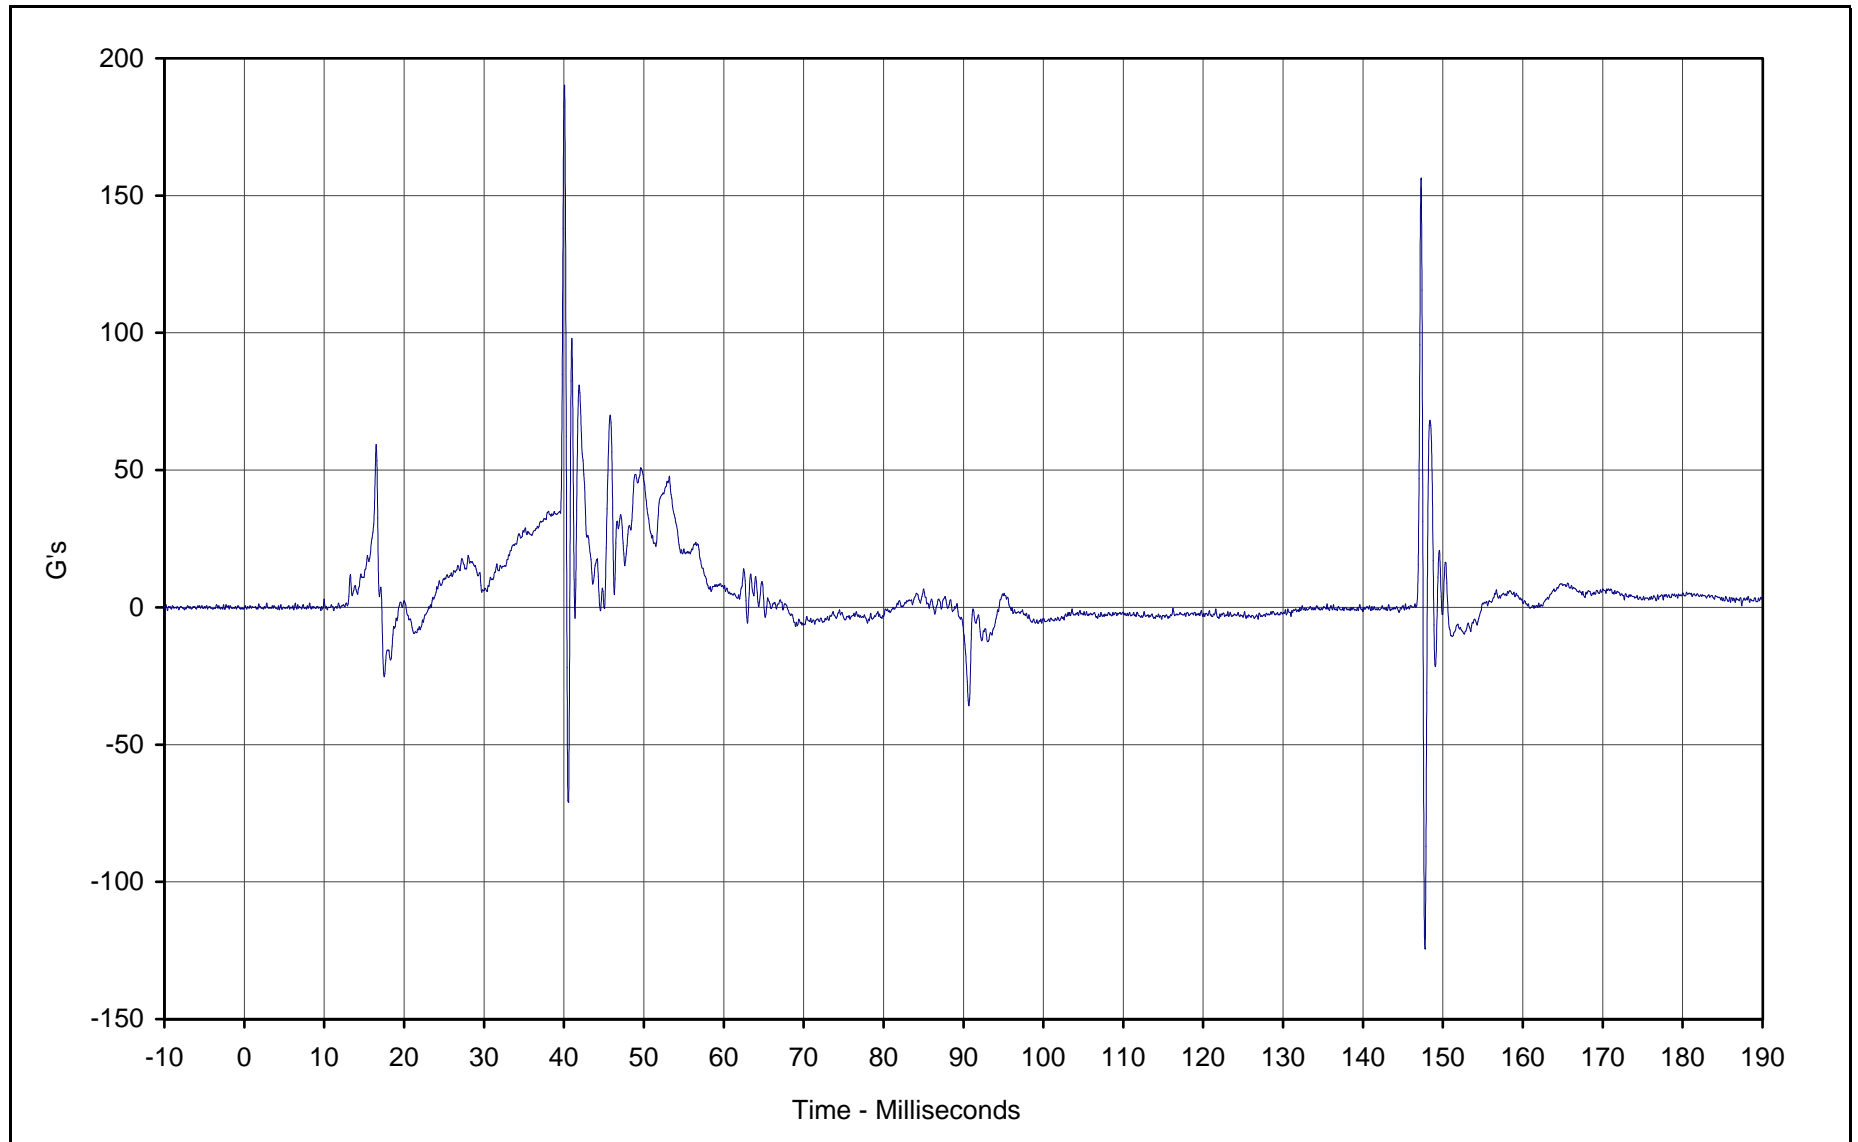
Curve Description: Driver Lower Rib Redundant Y
 Maximum Value: 189.6 at 40.1 Milliseconds
 Minimum Value: -124.1 at 147.8 Milliseconds
 SAE Filter Class: 1000
 Date of Test: 11/28/00
 Curve Number: FIL-009

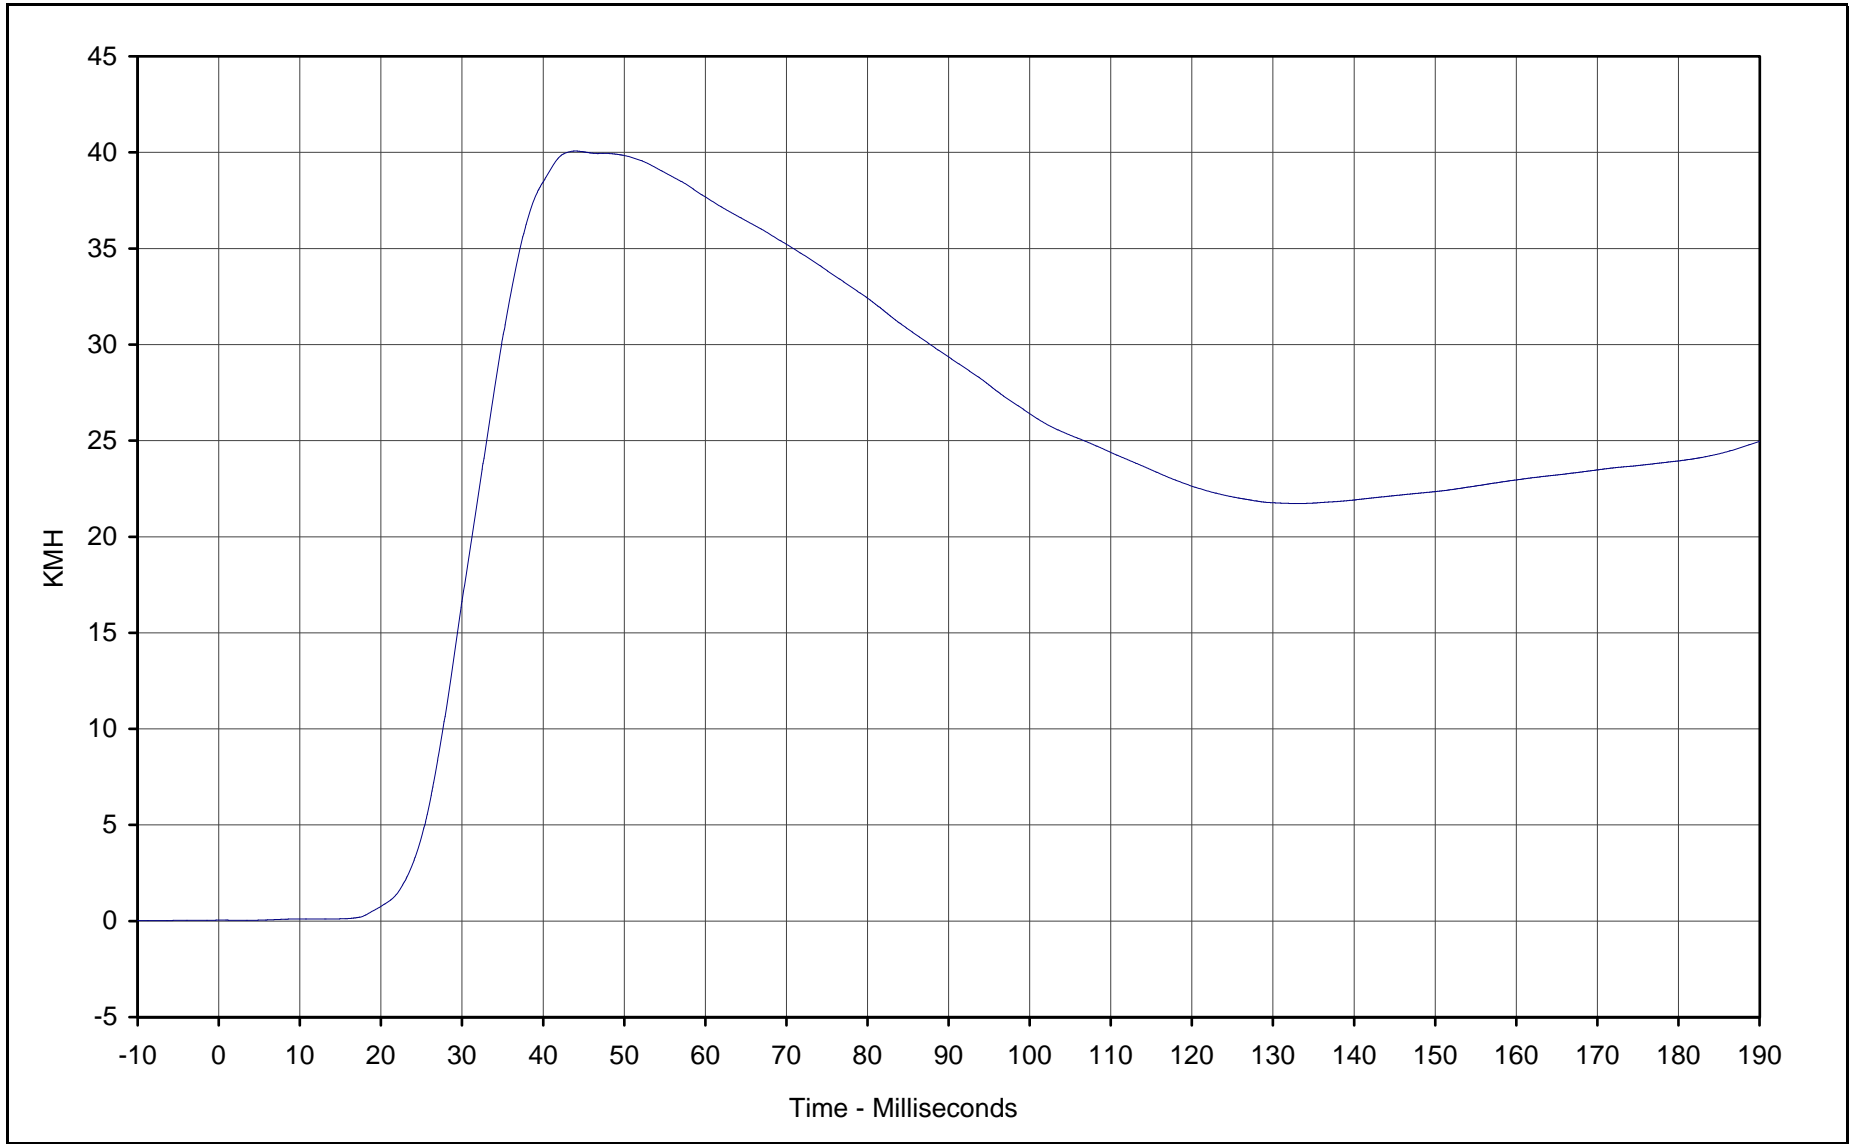
Curve Description: Pass. Pelvis Primary Y Velocity
Maximum Value: 40.1 at 44.0 Milliseconds
Minimum Value: 0.0 at 3.4 Milliseconds
SAE Filter Class: 180
Date of Test: 11/28/00
Curve Number: IN1-020

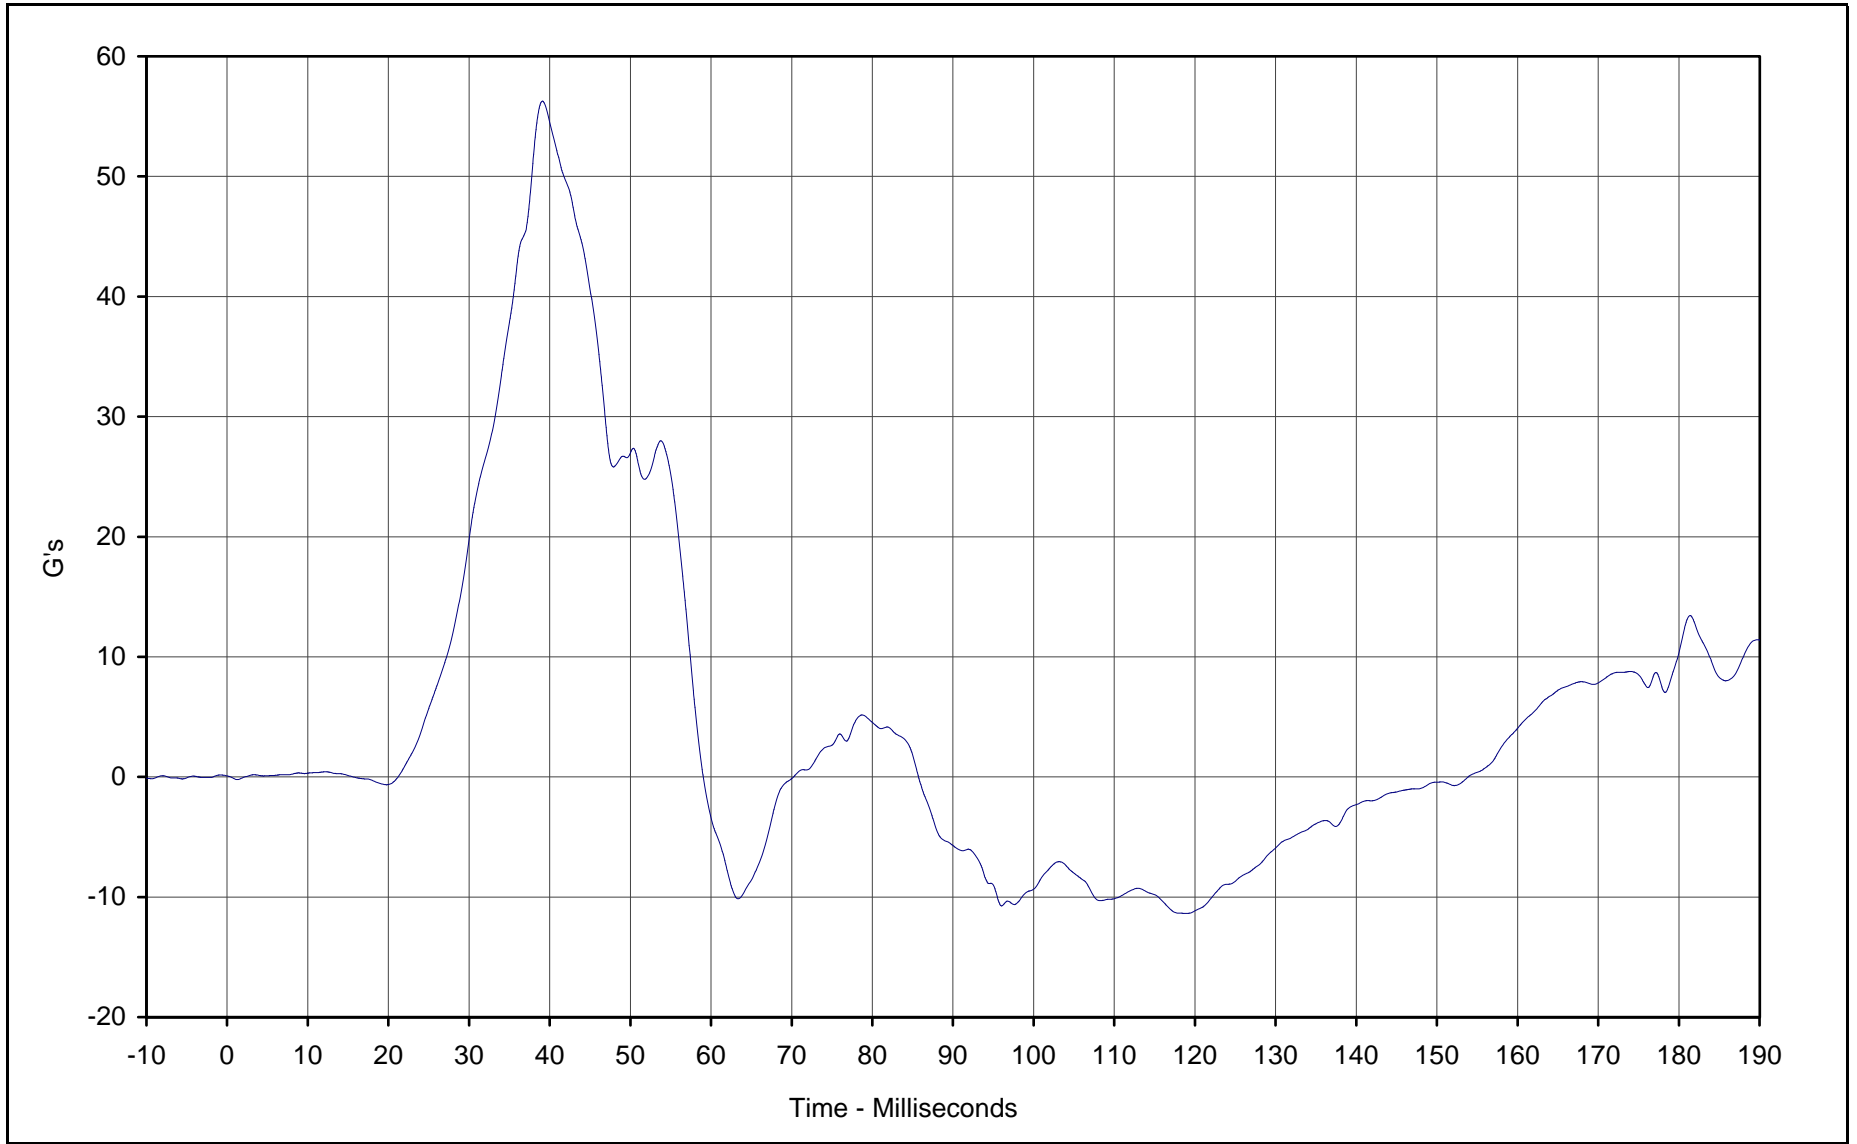
Curve Description: Pass. Lower Spine Redundant Y
Maximum Value: 56.3 at 39.1 Milliseconds
Minimum Value: -11.4 at 118.9 Milliseconds
SAE Filter Class: 180
Date of Test: 11/28/00
Curve Number: FIL-023
