REPORT NUMBER KAR21003-01

**NEW CAR ASSESSMENT PROGRAM
SIDE IMPACT TEST**

**GENERAL MOTORS CORPORATION
2001 CHEVROLET VENTURE MINIVAN**

NHTSA NUMBER: M10110

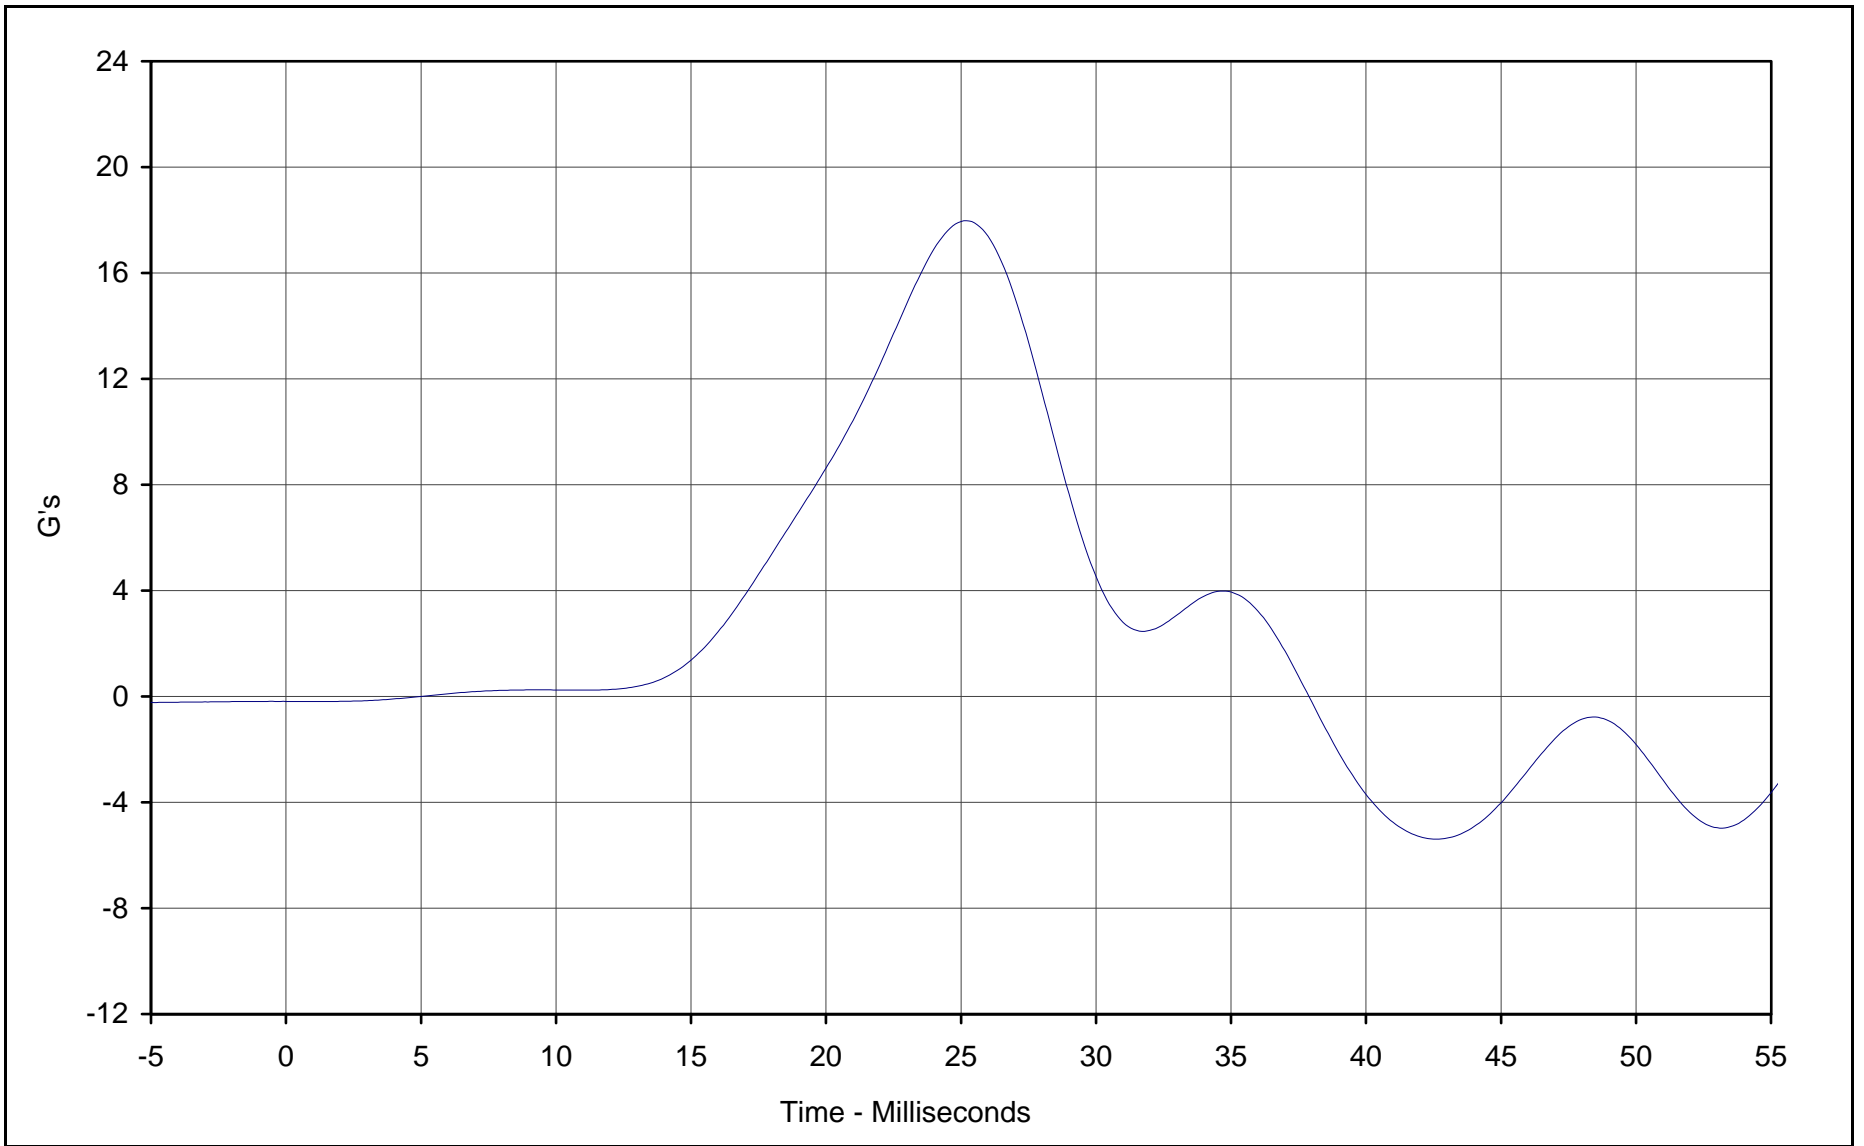
Curve Description: Lower Spine Y Acceleration
Maximum Value: 18.0 at 25.2 Milliseconds
Minimum Value: -5.4 at 42.6 Milliseconds
SAE Filter Class: FIR 100
Date of Test: 11/29/00

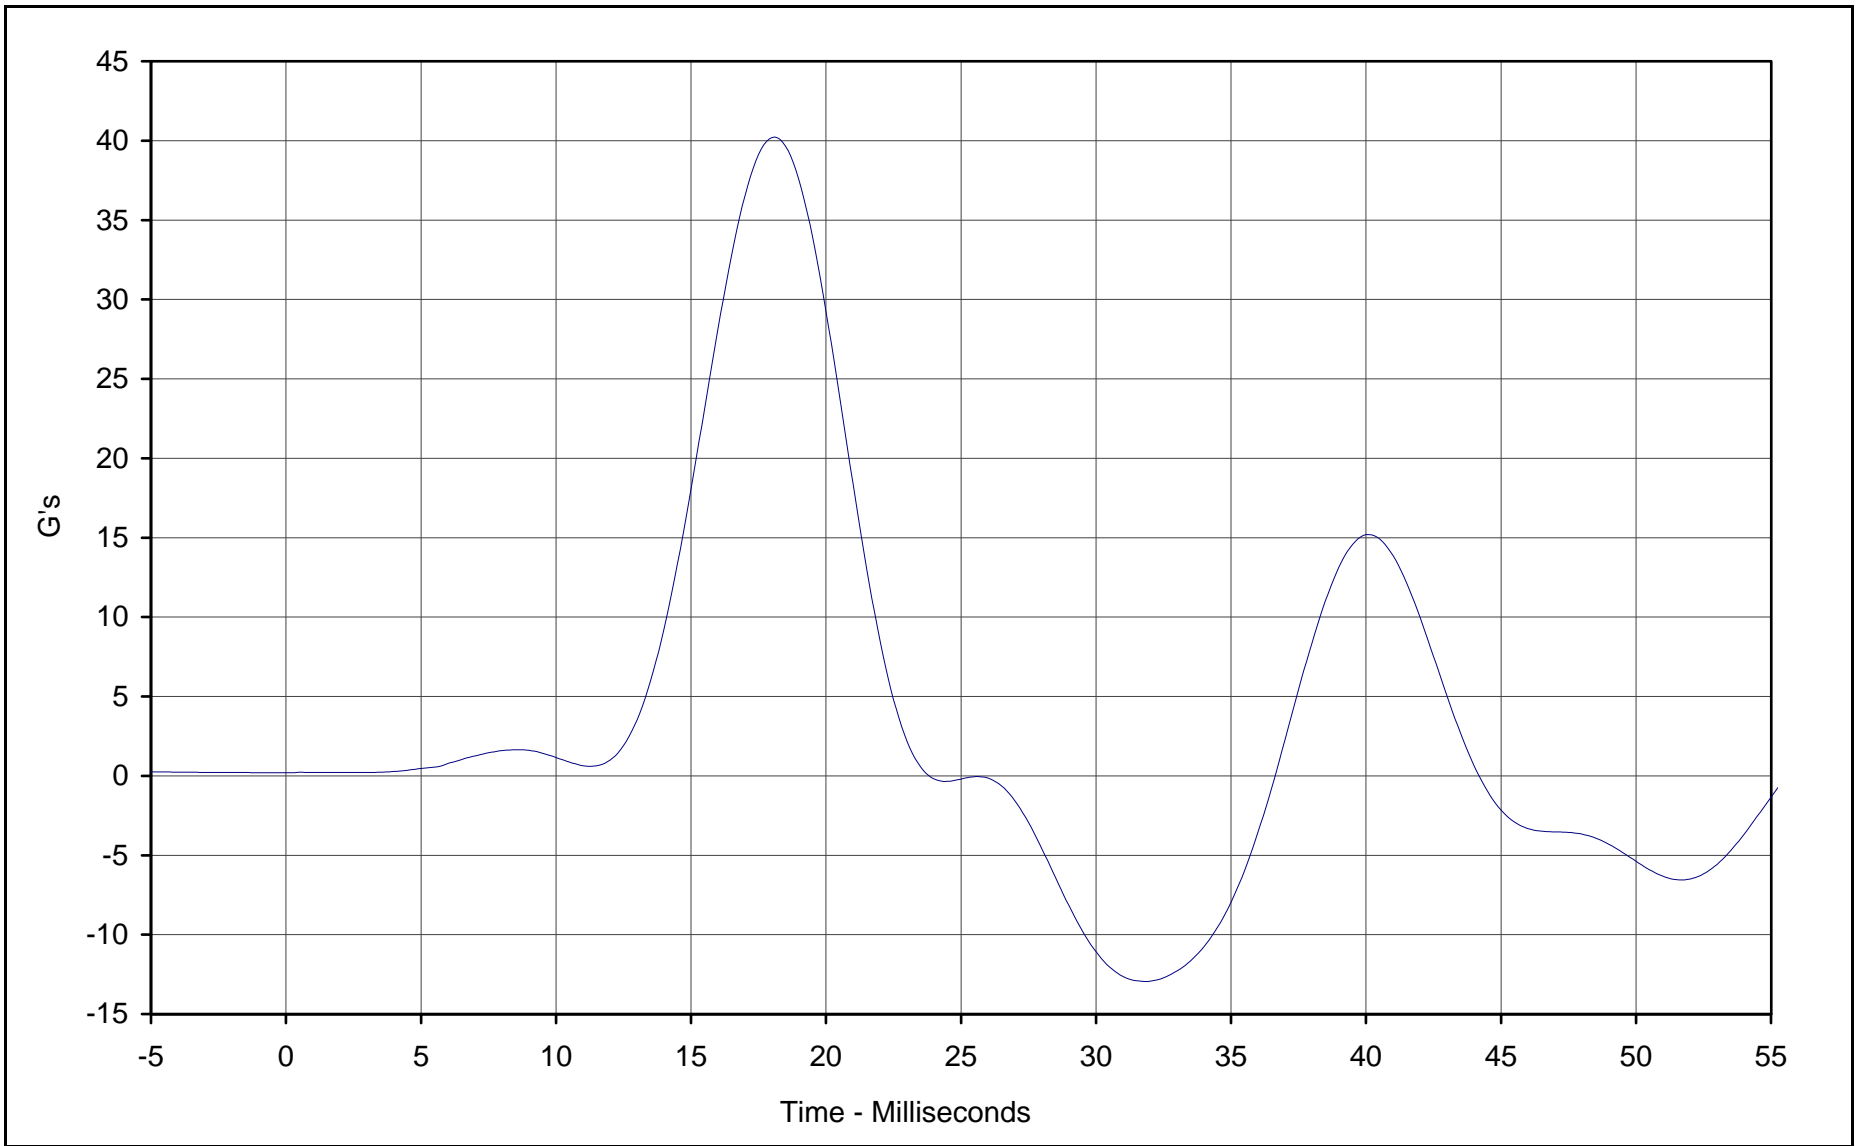
Curve Description: Left Upper Rib Y Acceleration
Maximum Value: 40.2 at 18.1 Milliseconds
Minimum Value: -13.0 at 31.8 Milliseconds
SAE Filter Class: FIR 100
Date of Test: 11/29/00

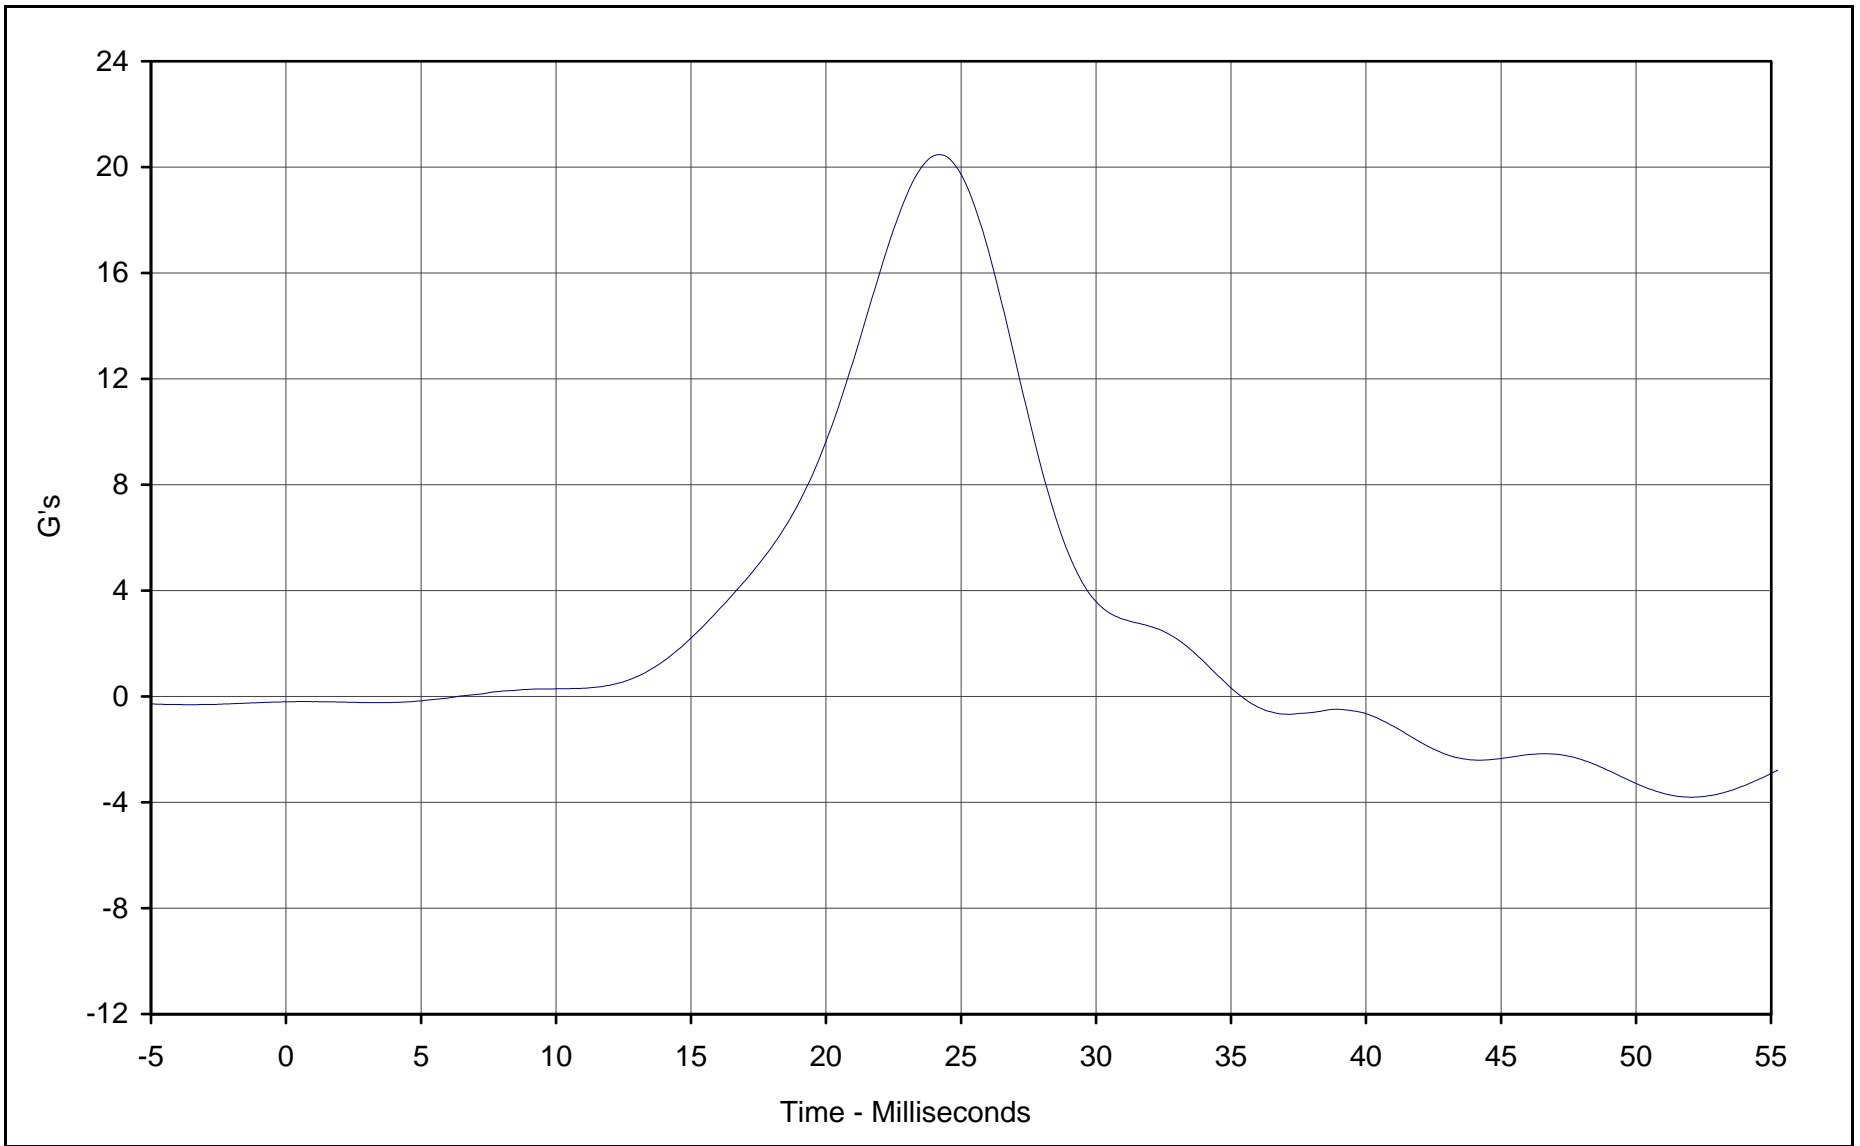
Curve Description: Lower Spine Y Acceleration
Maximum Value: 20.5 at 24.2 Milliseconds
Minimum Value: -3.8 at 52.1 Milliseconds
SAE Filter Class: FIR 100
Date of Test: 11/29/00
