Insurance Institute for Highway Safety Crashworthiness Evaluation

Crash Test Report 2000 Nissan Xterra (CF00020)

Vehicle identification number: 5N1ED28Y4YC588507
Body style: Midsize 4-door utility vehicle
Engine/transmission: Longitudinal 3.3-liter V6, 4-speed automatic,
4-wheel drive

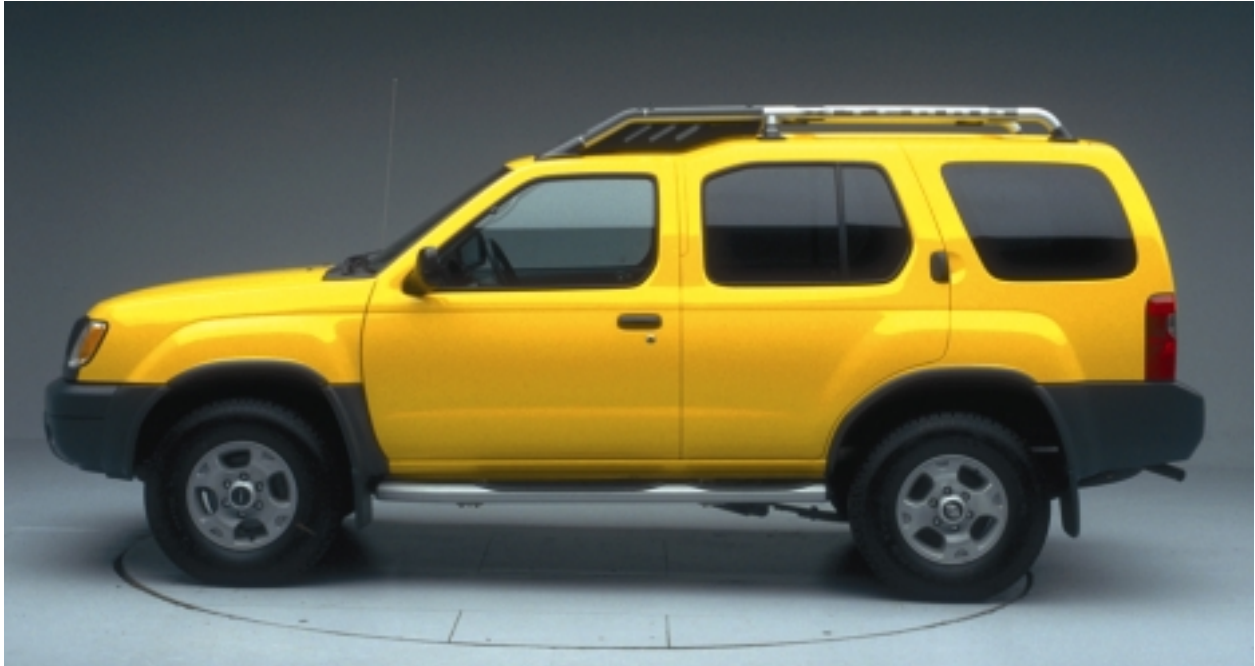
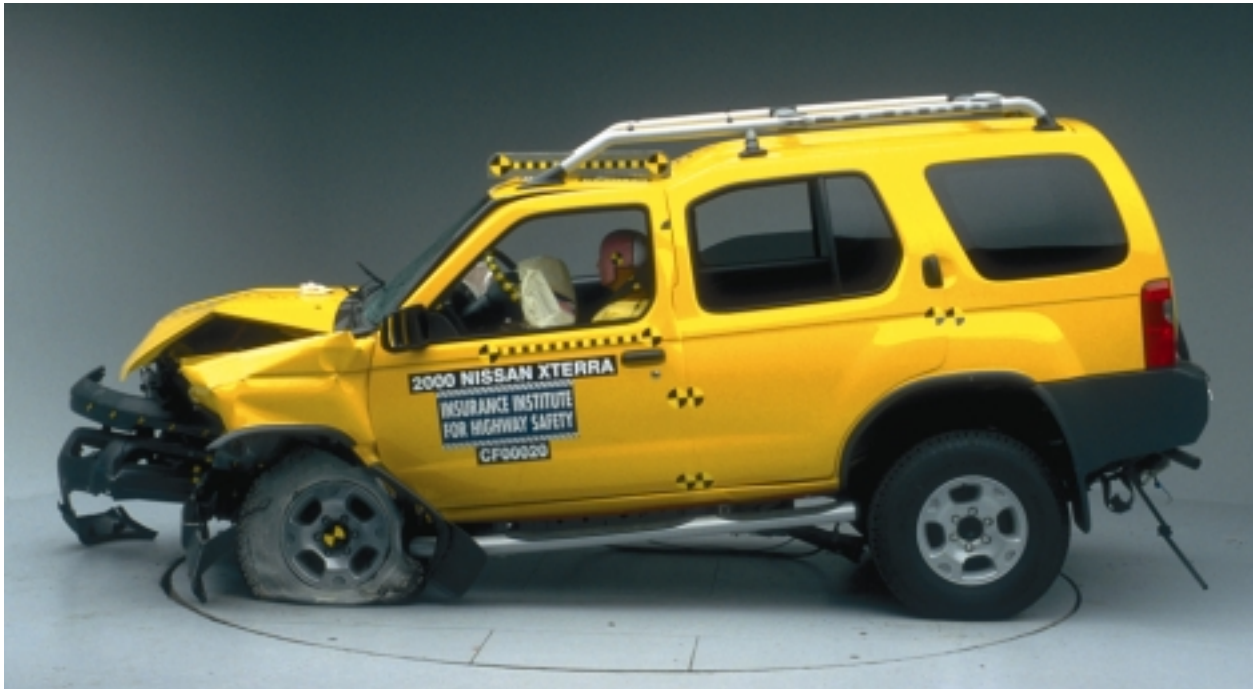
Figure 1
Pre-crash and Post-crash Side Views — 2000 Nissan Xterra

A 2000 Nissan Xterra was crash tested on June 20, 2000 into a fixed deformable barrier at 40.1 mi/h (64.6 km/h) and a 40 percent overlap on the driver side. A Hybrid III 50th percentile male dummy was positioned in the driver seat with the lap/shoulder belt fastened.

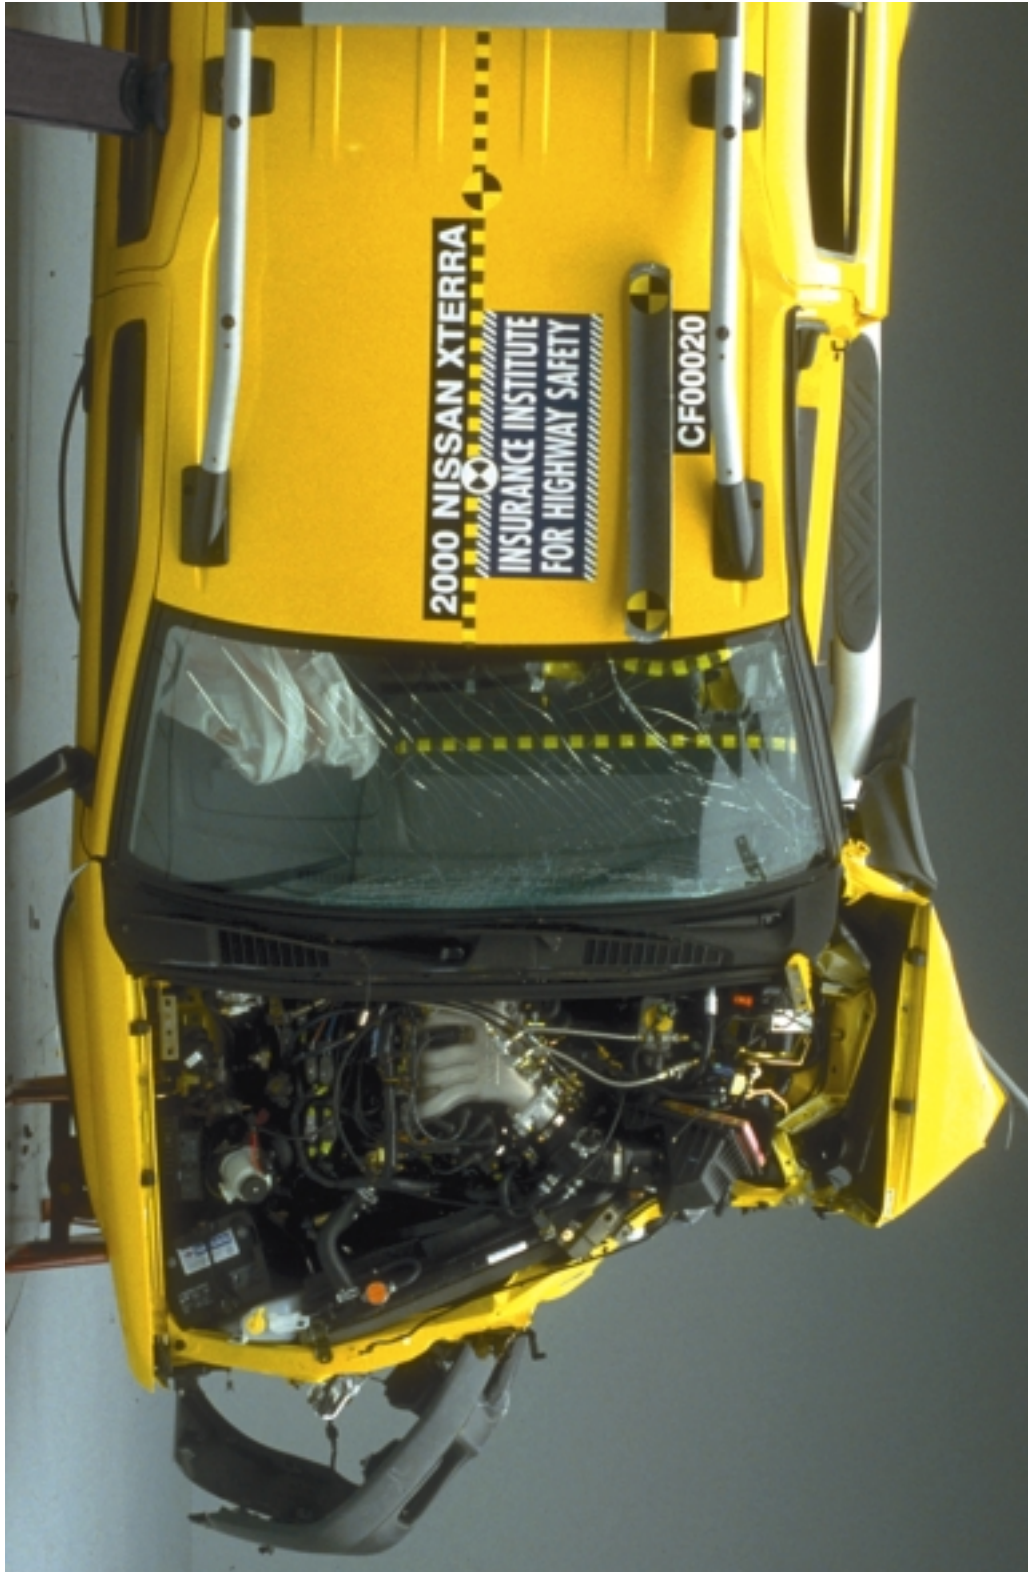
Figure 2
Overhead View of Crash Deformation — 2000 Nissan Xterra

Figure 2 shows the overhead view of the crash deformation. Figure 3 illustrates the precrash and postcrash contour measures of the front bumper face bar profile and the resulting permanent crush. Figure 4 shows the precrash and postcrash views from below. Figure 5 illustrates the deformation of the frame rails, door sills, and crossmembers, which are visible in Figure 4.

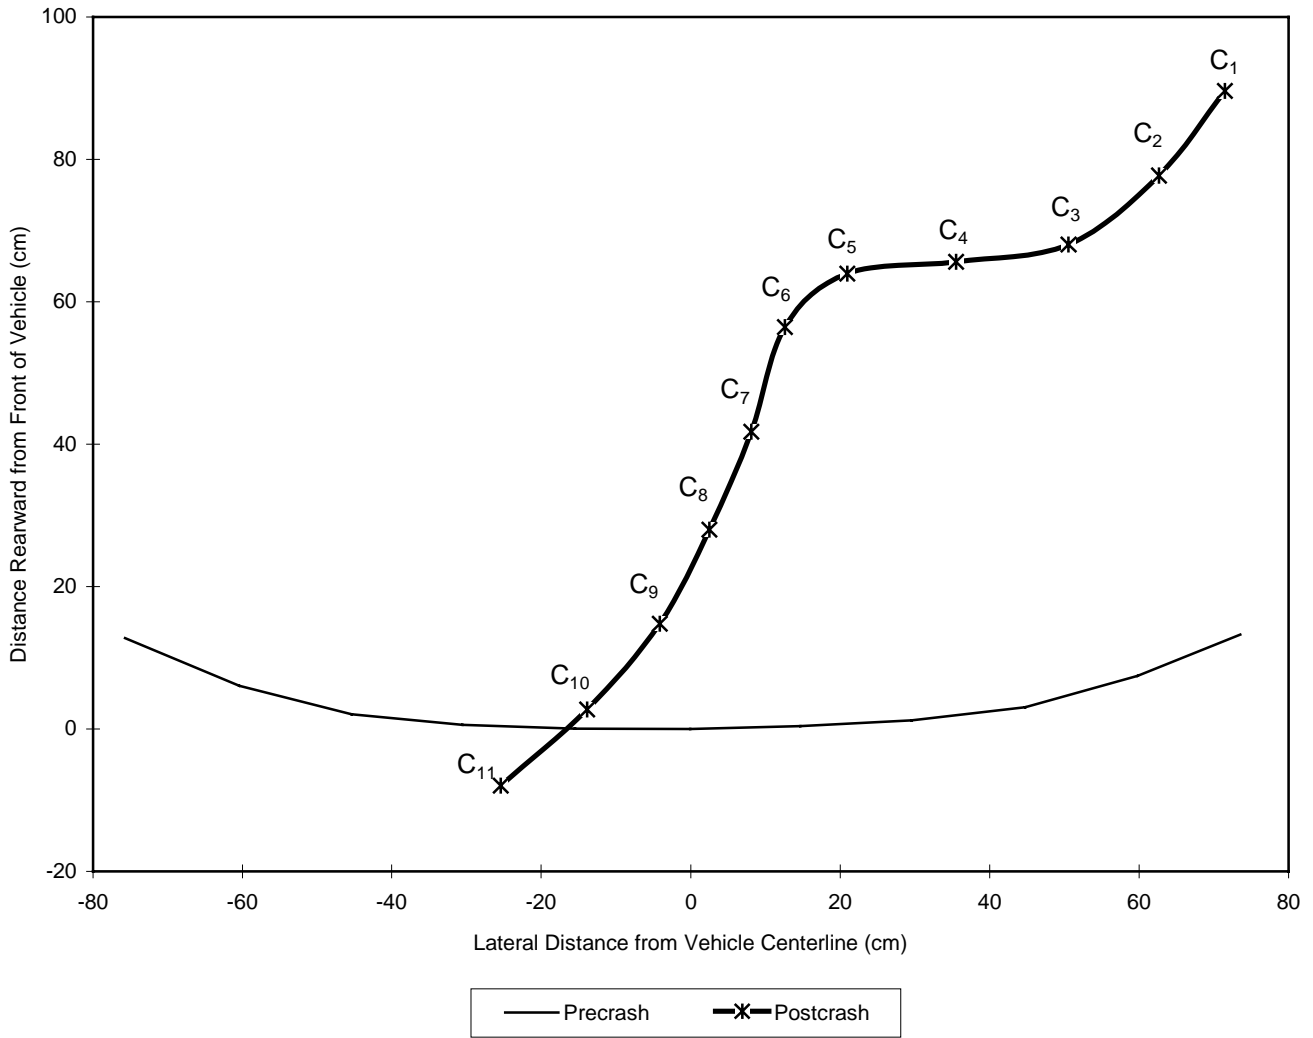
Figure 3
Front Bumper Face Bar Crush Contour — 2000 Nissan Xterra

C ₁	C ₂	C ₃	C ₄	C ₅	C ₆	C ₇	C ₈	C ₉	C ₁₀	C ₁₁
Postcrash Contour (cm)	90	78	68	66	64	56	42	28	15	3	-8
Precrash Contour (cm)	13	7	3	1	0	0	0	1	2	6	13
Resulting Crush (cm)	77	71	65	65	64	56	42	27	13	-3	-21

The length of the reference line was 149 cm precrash and 97 cm postcrash.

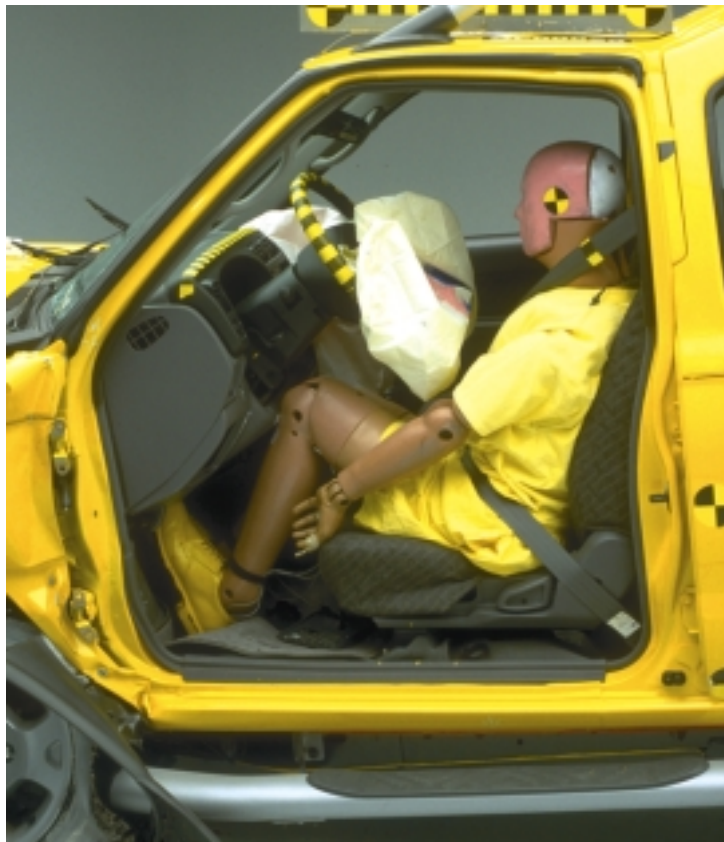
**Figure 6
Dummy and Vehicle Interior, Postcrash — 2000 Nissan Xterra**

Postcrash examination of the driver seat rails indicated no discernible movement of the seat in its tracks during the crash. Deformation of the floor under the driver seat caused the seat to tip slightly outward and pitch slightly forward.

The upper end of the steering column moved upward 15 cm and rearward 2 cm relative to the driver seat.

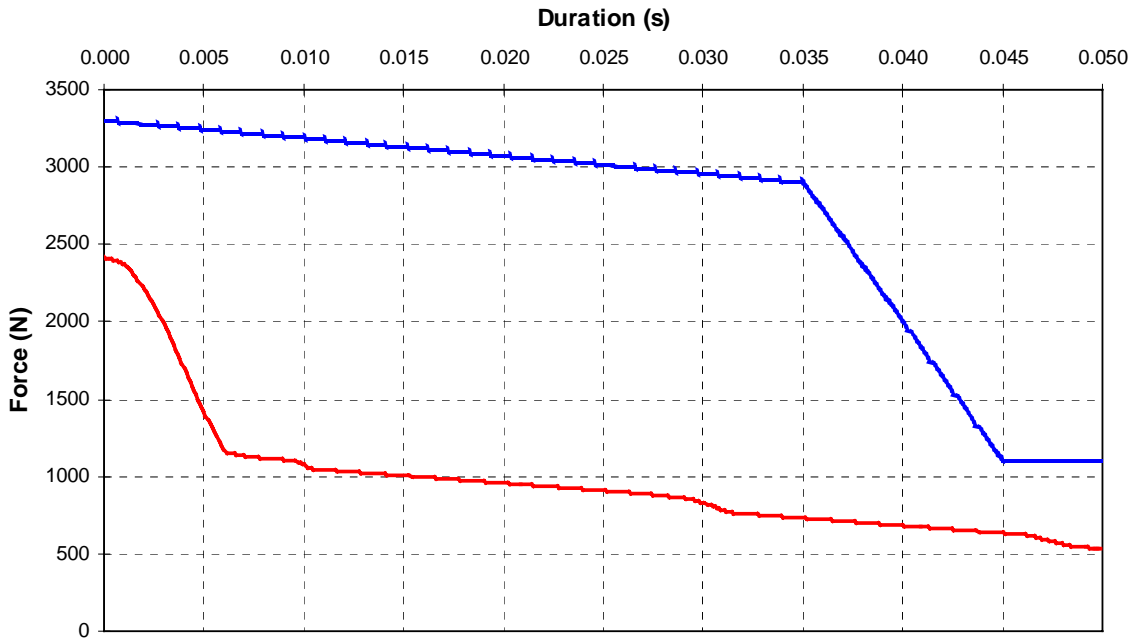
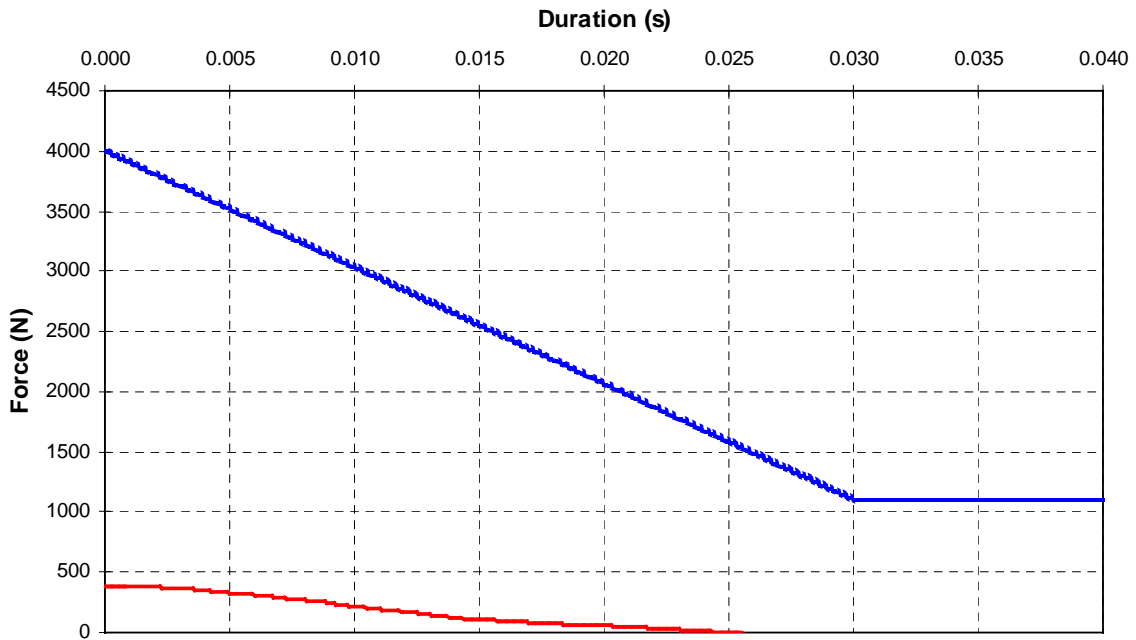
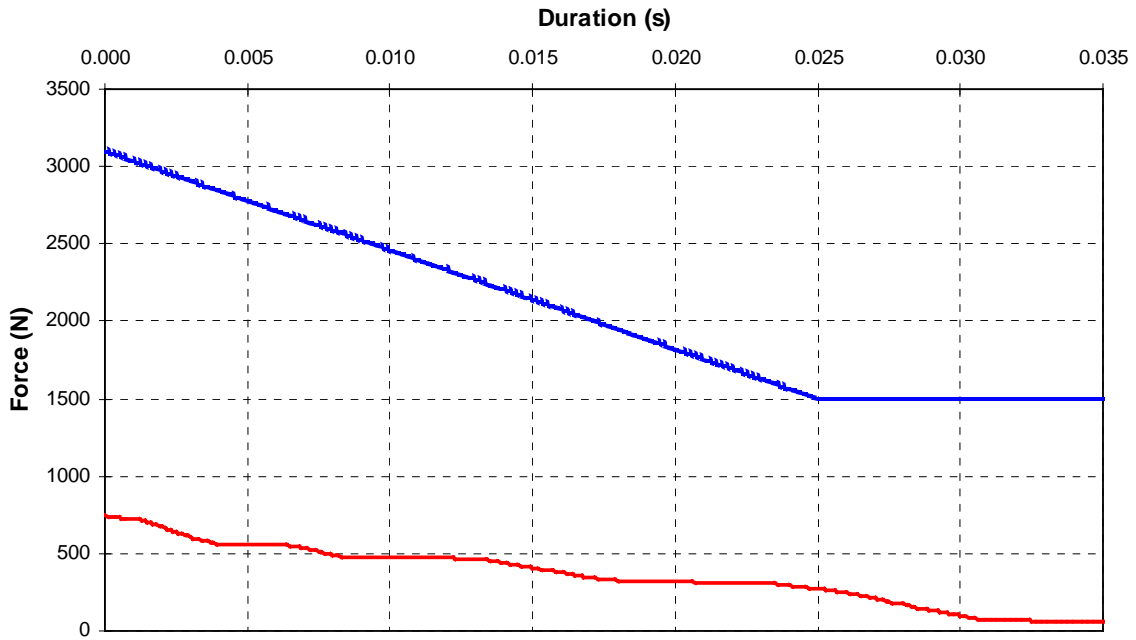
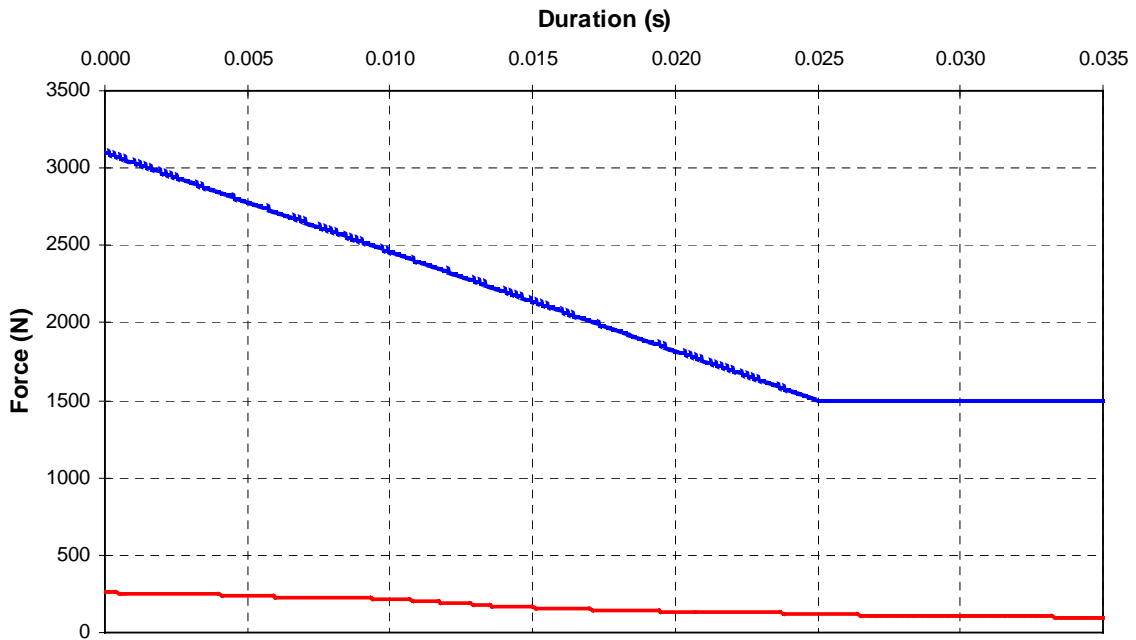
Table 4 provides a summary of the maximum neck injury measurements recorded during the crash. None of the recorded neck force measures exceeded the magnitude-duration injury criteria (Figures A-13 to A-16).

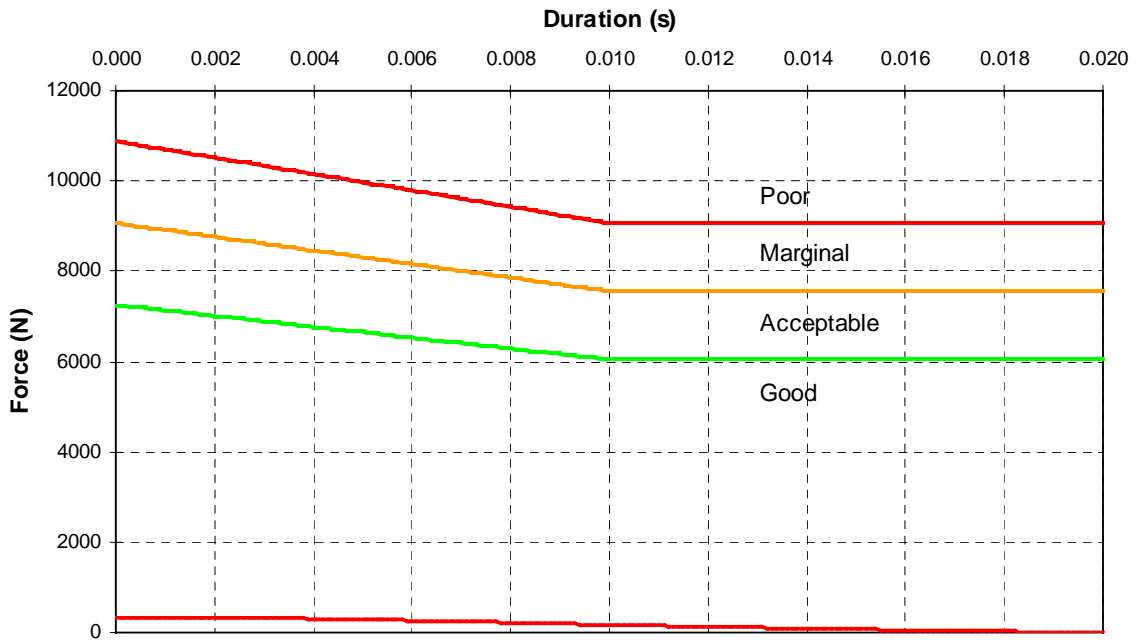
A- 24 CF00020 2000 Nissan Xterra Left Femur Axial Force Analysis

* This critical value is for instantaneous loading. Femur loads are compared with magnitude-duration injury criteria in Figures A-24 and A-37.

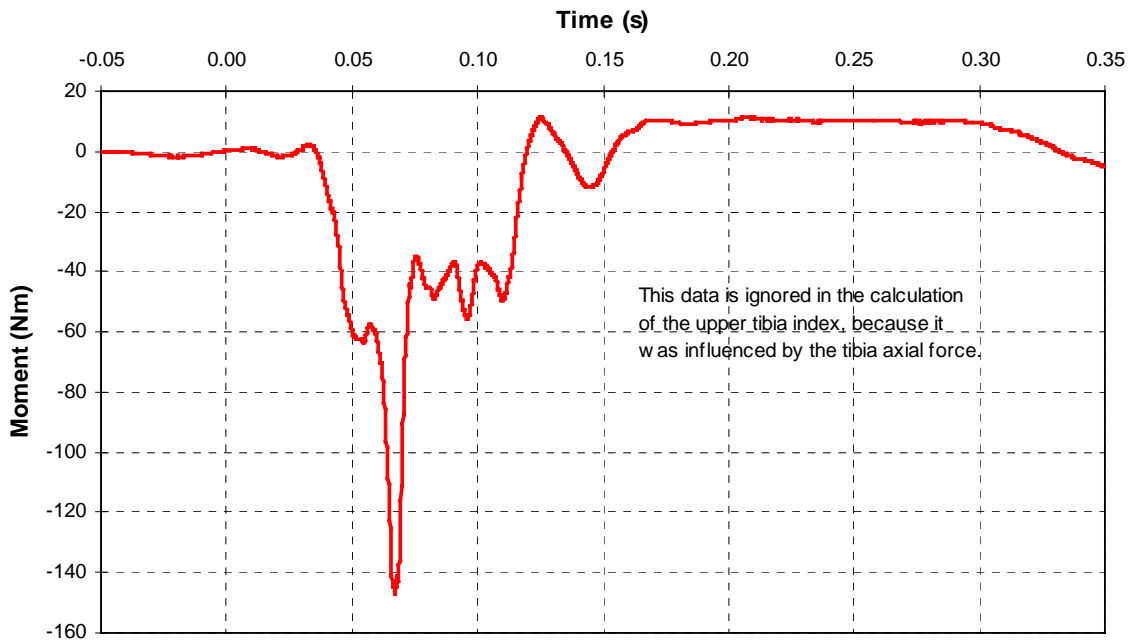
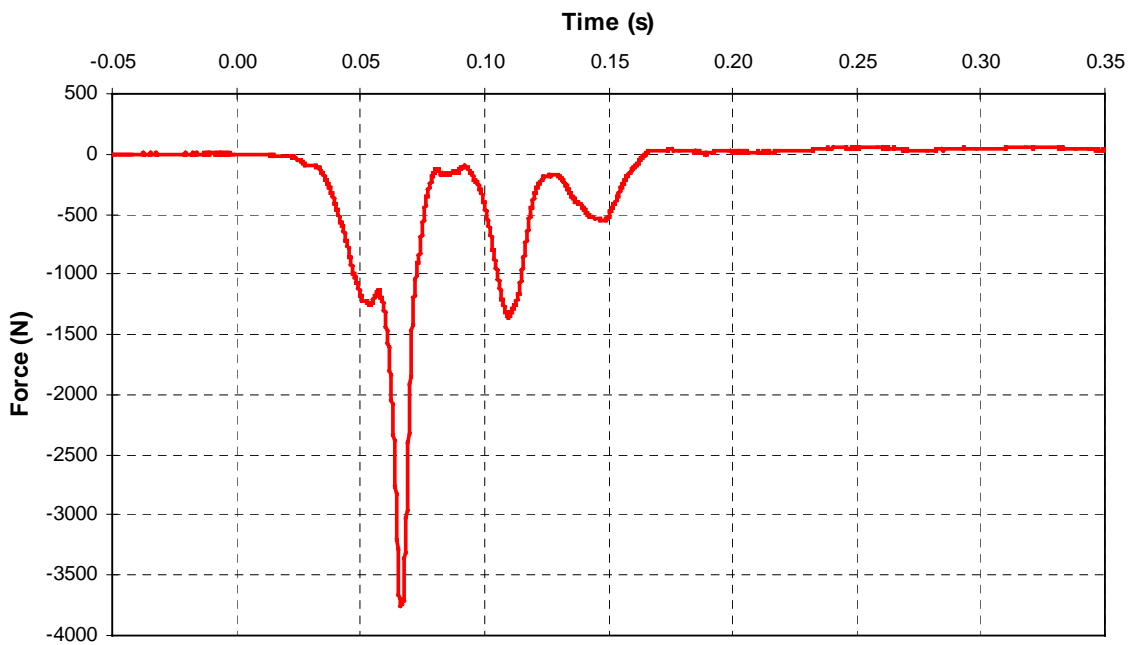
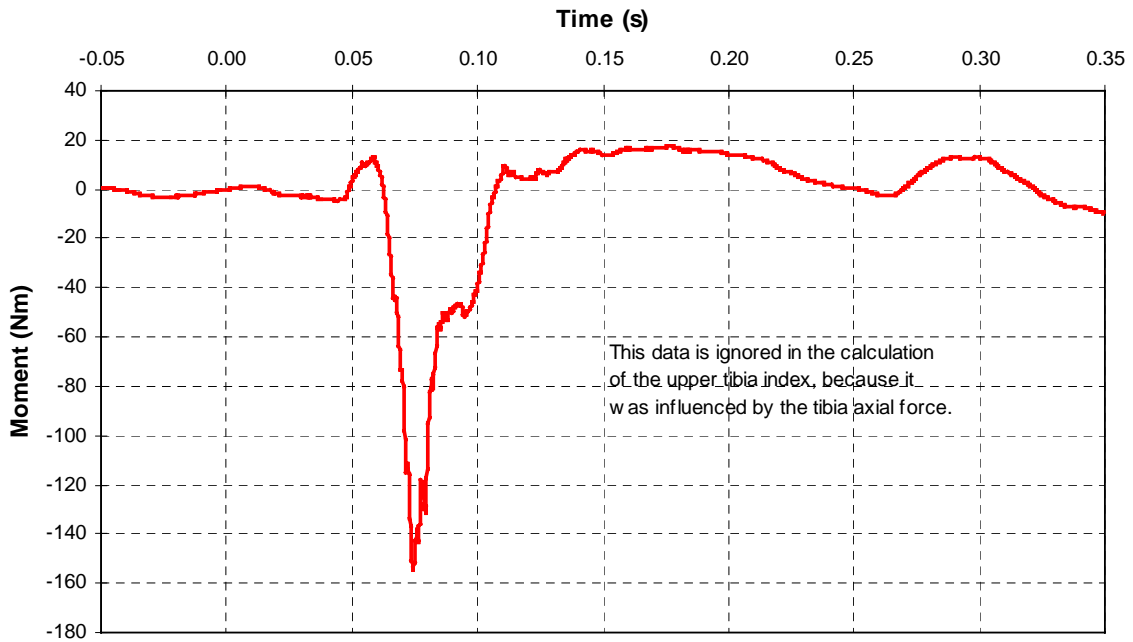
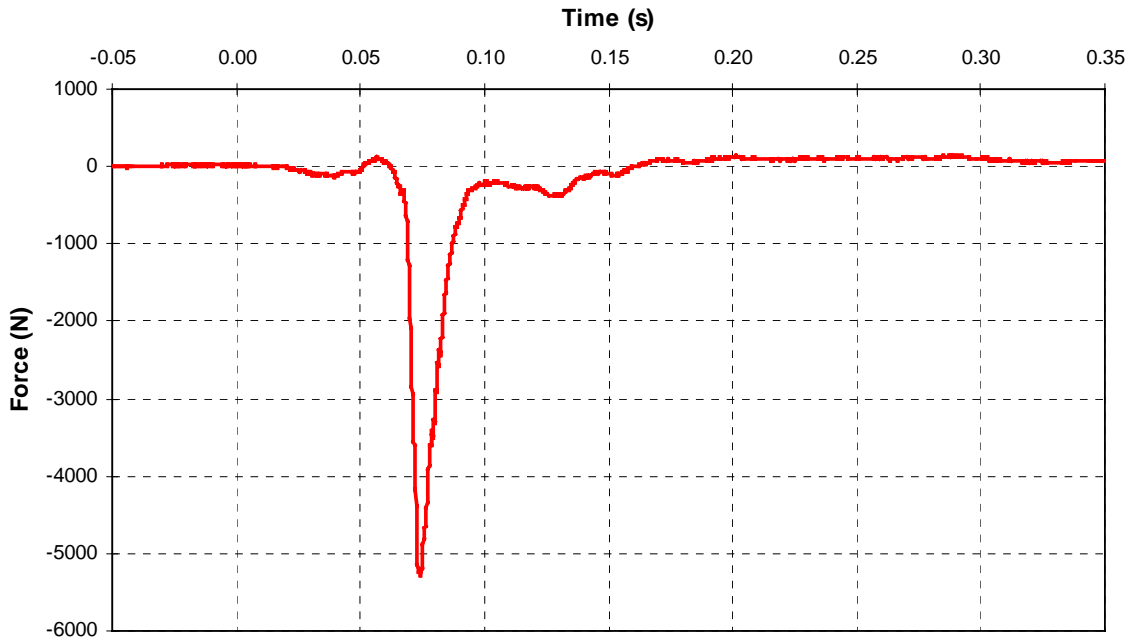
Both the left and right upper tibia A-P bending moments had time signatures similar to the tibia axial force (Figures A-27 and A-32 and Figures A-40 and A-45). The ratio of the left A-P bending moment to the left tibia axial force (approximately 0.038 m) from 64 to 66 ms into the crash is about the same as the distance (in meters) between a line through the knee and ankle joints and the upper load cell midline due to the bent shape of the dummy's tibia. The ratio of the right A-P bending moment to the right tibia axial force was approximately 0.029 m from 72 to 75 ms into the crash. Therefore, the upper tibia bending could have resulted from the foot force acting through the moment arm of the tibia bend rather than from transverse forces applied by contact with the knee bolster and, as a result, no upper tibia A-P or resultant moments are reported for either leg. The reported maximum left and right upper tibia indices were calculated from only the upper tibia L-M moments and the corresponding tibia axial force.

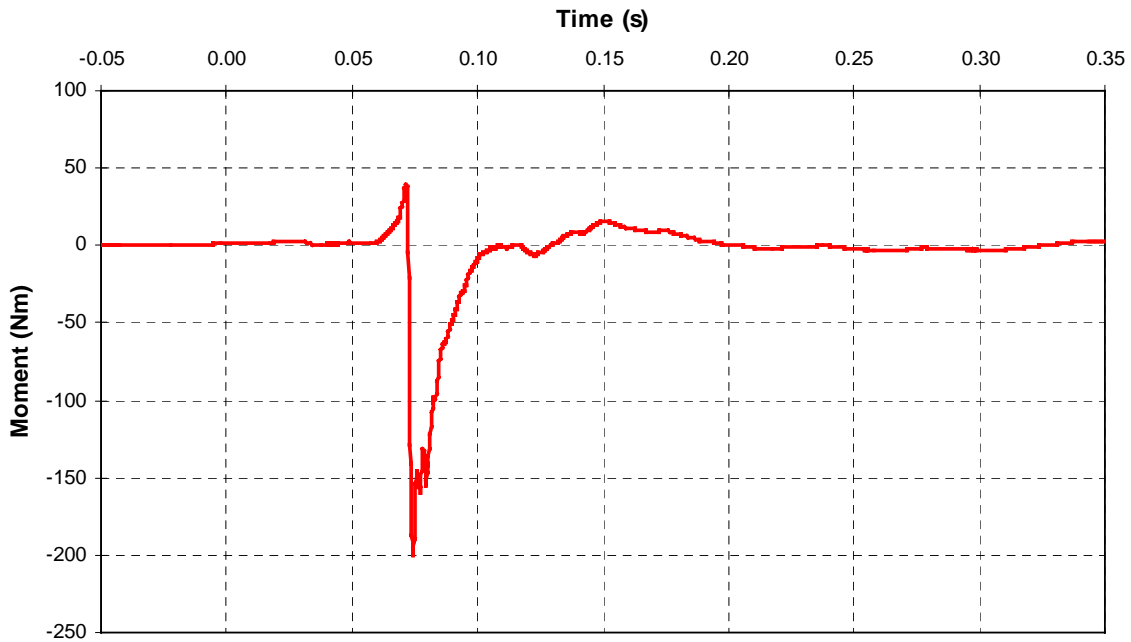
A- 42 CF00020 2000 Nissan Xterra Right Lower Tibia L-M Moment

Right leg and foot: The maximum right lower tibia L-M moment was -200 Nm at 74 ms, significantly contributing to the right lower tibia index of 1.05 at 74 ms. The maximum right tibia axial force was -5.3 kN at 74 ms. The maximum resultant right foot acceleration was 165 g at 71 ms.
