Insurance Institute for Highway Safety Crashworthiness Evaluation

Crash Test Report 2001 Isuzu Trooper (CF00029)

Vehicle identification number: JACDJ58X617J04920
Body style: Midsize 4-door utility vehicle
Engine/transmission: Longitudinal 3.5-liter V6, 4-speed automatic,
4-wheel drive

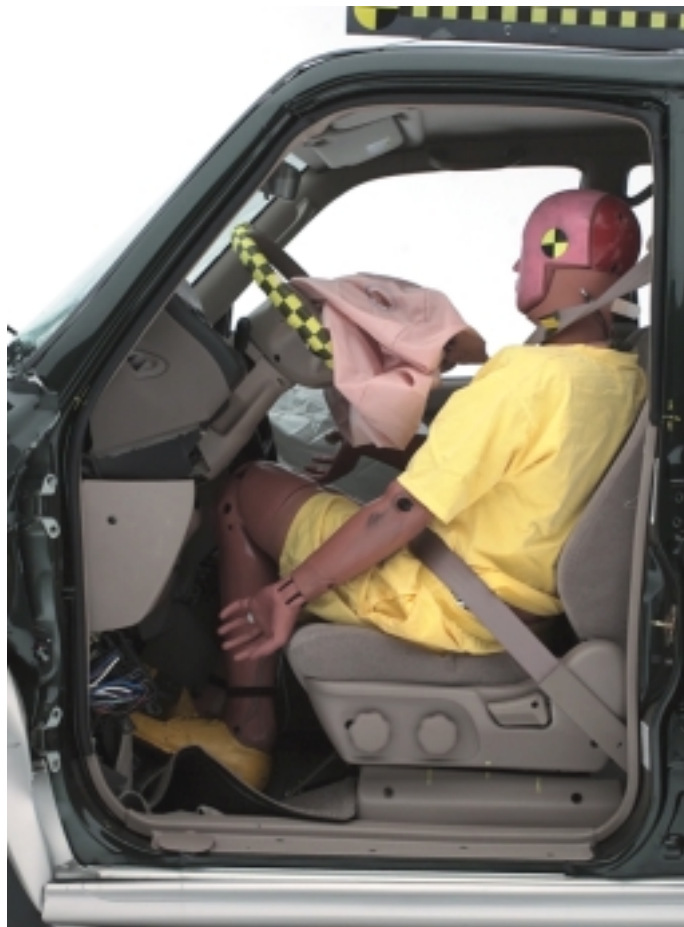
Figure 6
Dummy and Vehicle Interior, Postcrash — 2001 Isuzu Trooper

Analysis of the high-speed film taken from camera position D indicated the deploying airbag contacted the dummy's chin at 52 ms into the crash and then receded by 60 ms. The face began to load the airbag at 70 ms (2 ms after full inflation). Paint transferred from the dummy's face indicated the nose loaded the airbag 5 cm above and 1 cm to the left of its center. As the dummy's face continued to move forward, the steering column tilted upward, causing the lower end of the steering wheel rim to move close to the dummy's chin. Although the airbag fabric obscured the dummy's face and steering wheel, the dummy's chin appeared to approach the lower center (6 o'clock) portion of the steering wheel. Sudden increases in the rearward and upward head accelerations and neck tension and a decrease in the neck A-P bending moment, all occurring at the same time (98 ms), were consistent with contact between the dummy's chin and the steering wheel. A subsequent decrease in the neck A-P shear force suggested that the rim then contacted the dummy's neck. On rebound from the steering wheel, the head moved upward and rearward, and the left upper rear side of the head grazed the B-pillar trim above the shoulder belt upper anchorage D-ring at about 326 ms. At about the same time, the right rear of the head contacted the upper outboard corner of the head restraint. Table 2 provides the timing of these events.
