**REPORT NUMBER KAR21003-06**

**NEW CAR ASSESSMENT PROGRAM  
SIDE IMPACT TEST**

**FORD MOTOR COMPANY  
2001 LINCOLN LS  
4 DOOR SEDAN  
NHTSA NUMBER: M10210**

**FINAL REPORT**

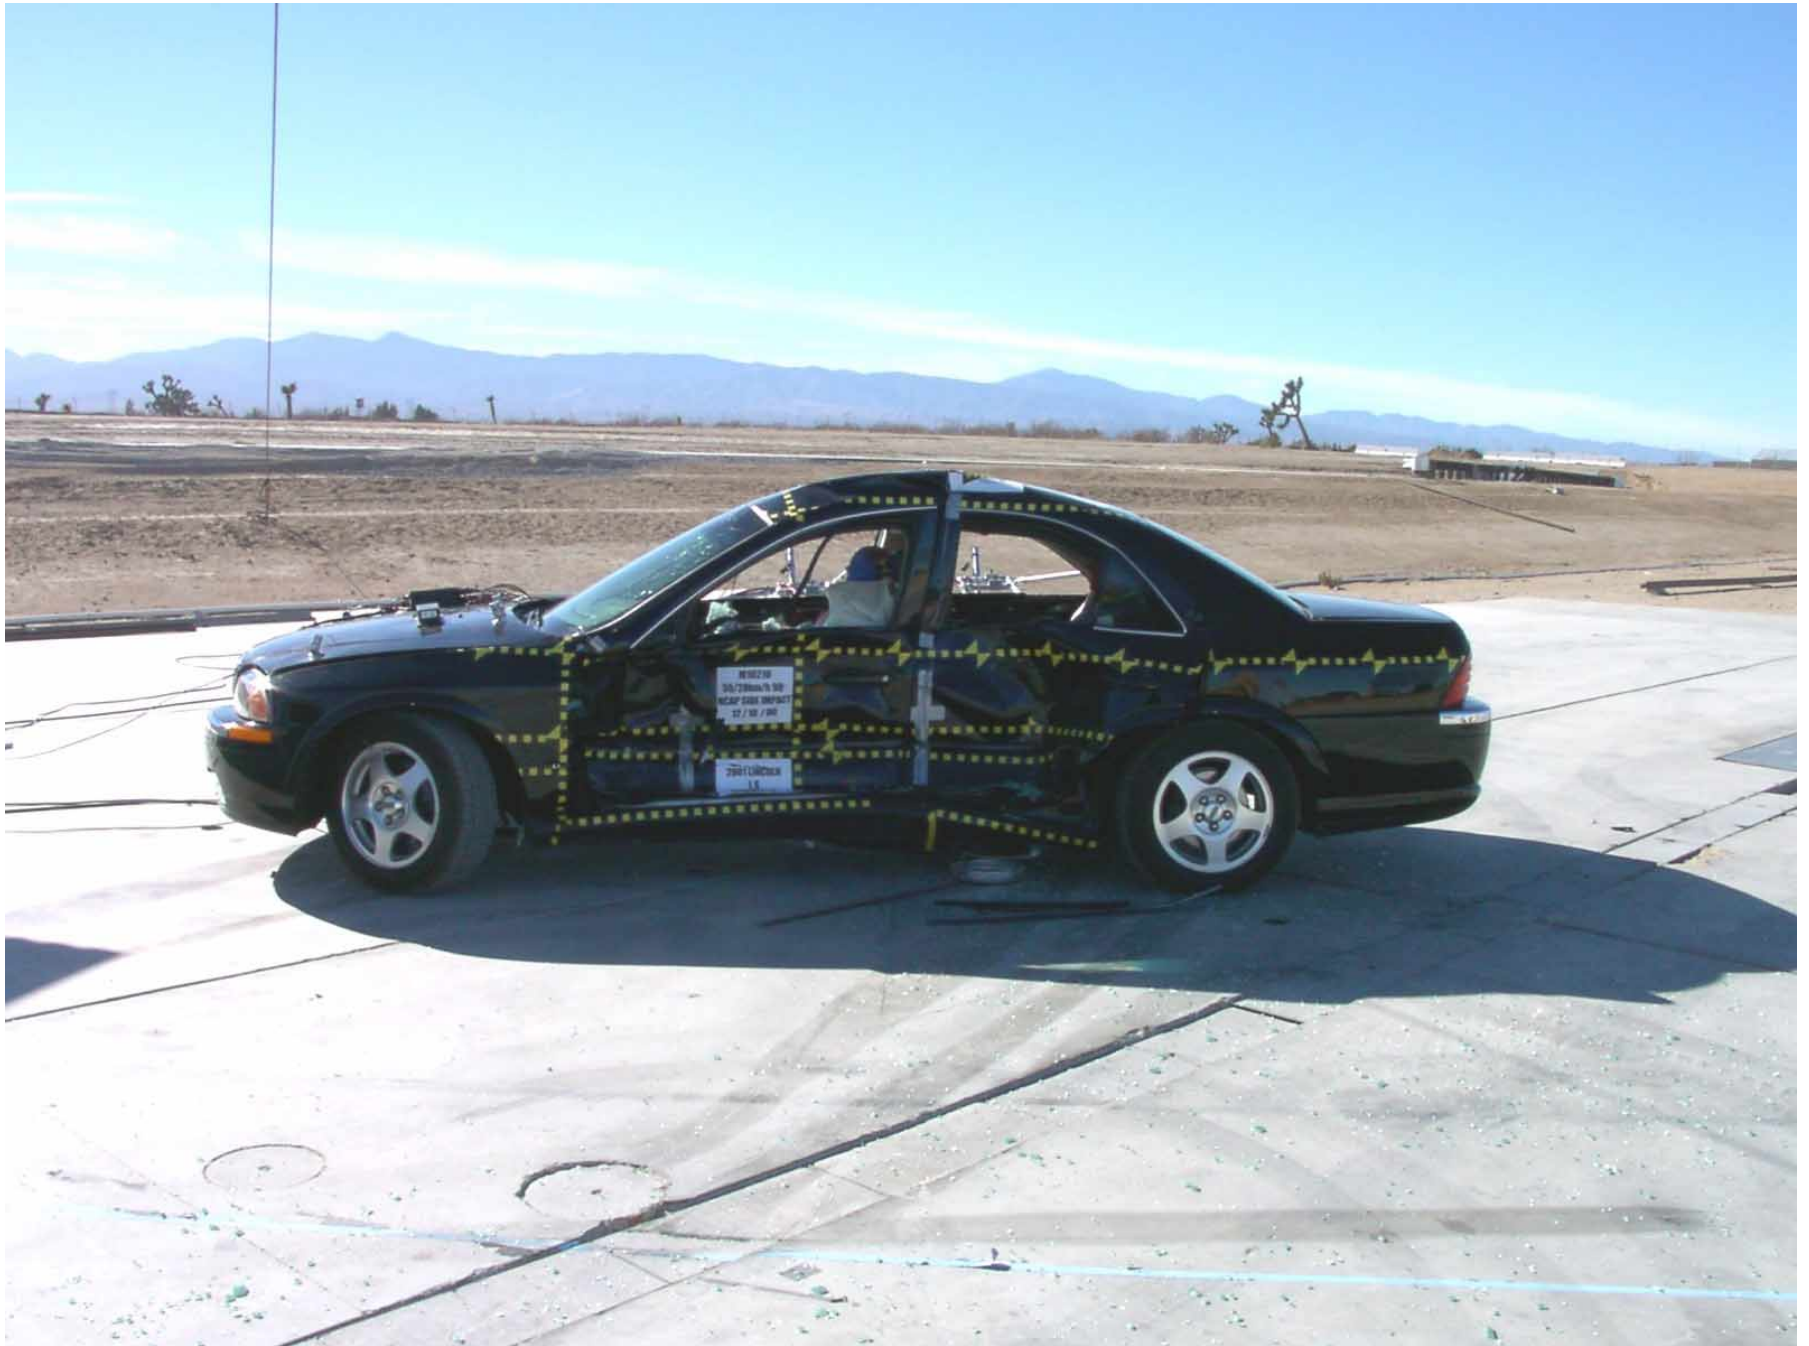
Figure A-10: Left (Impacted) Side View, Post-Test

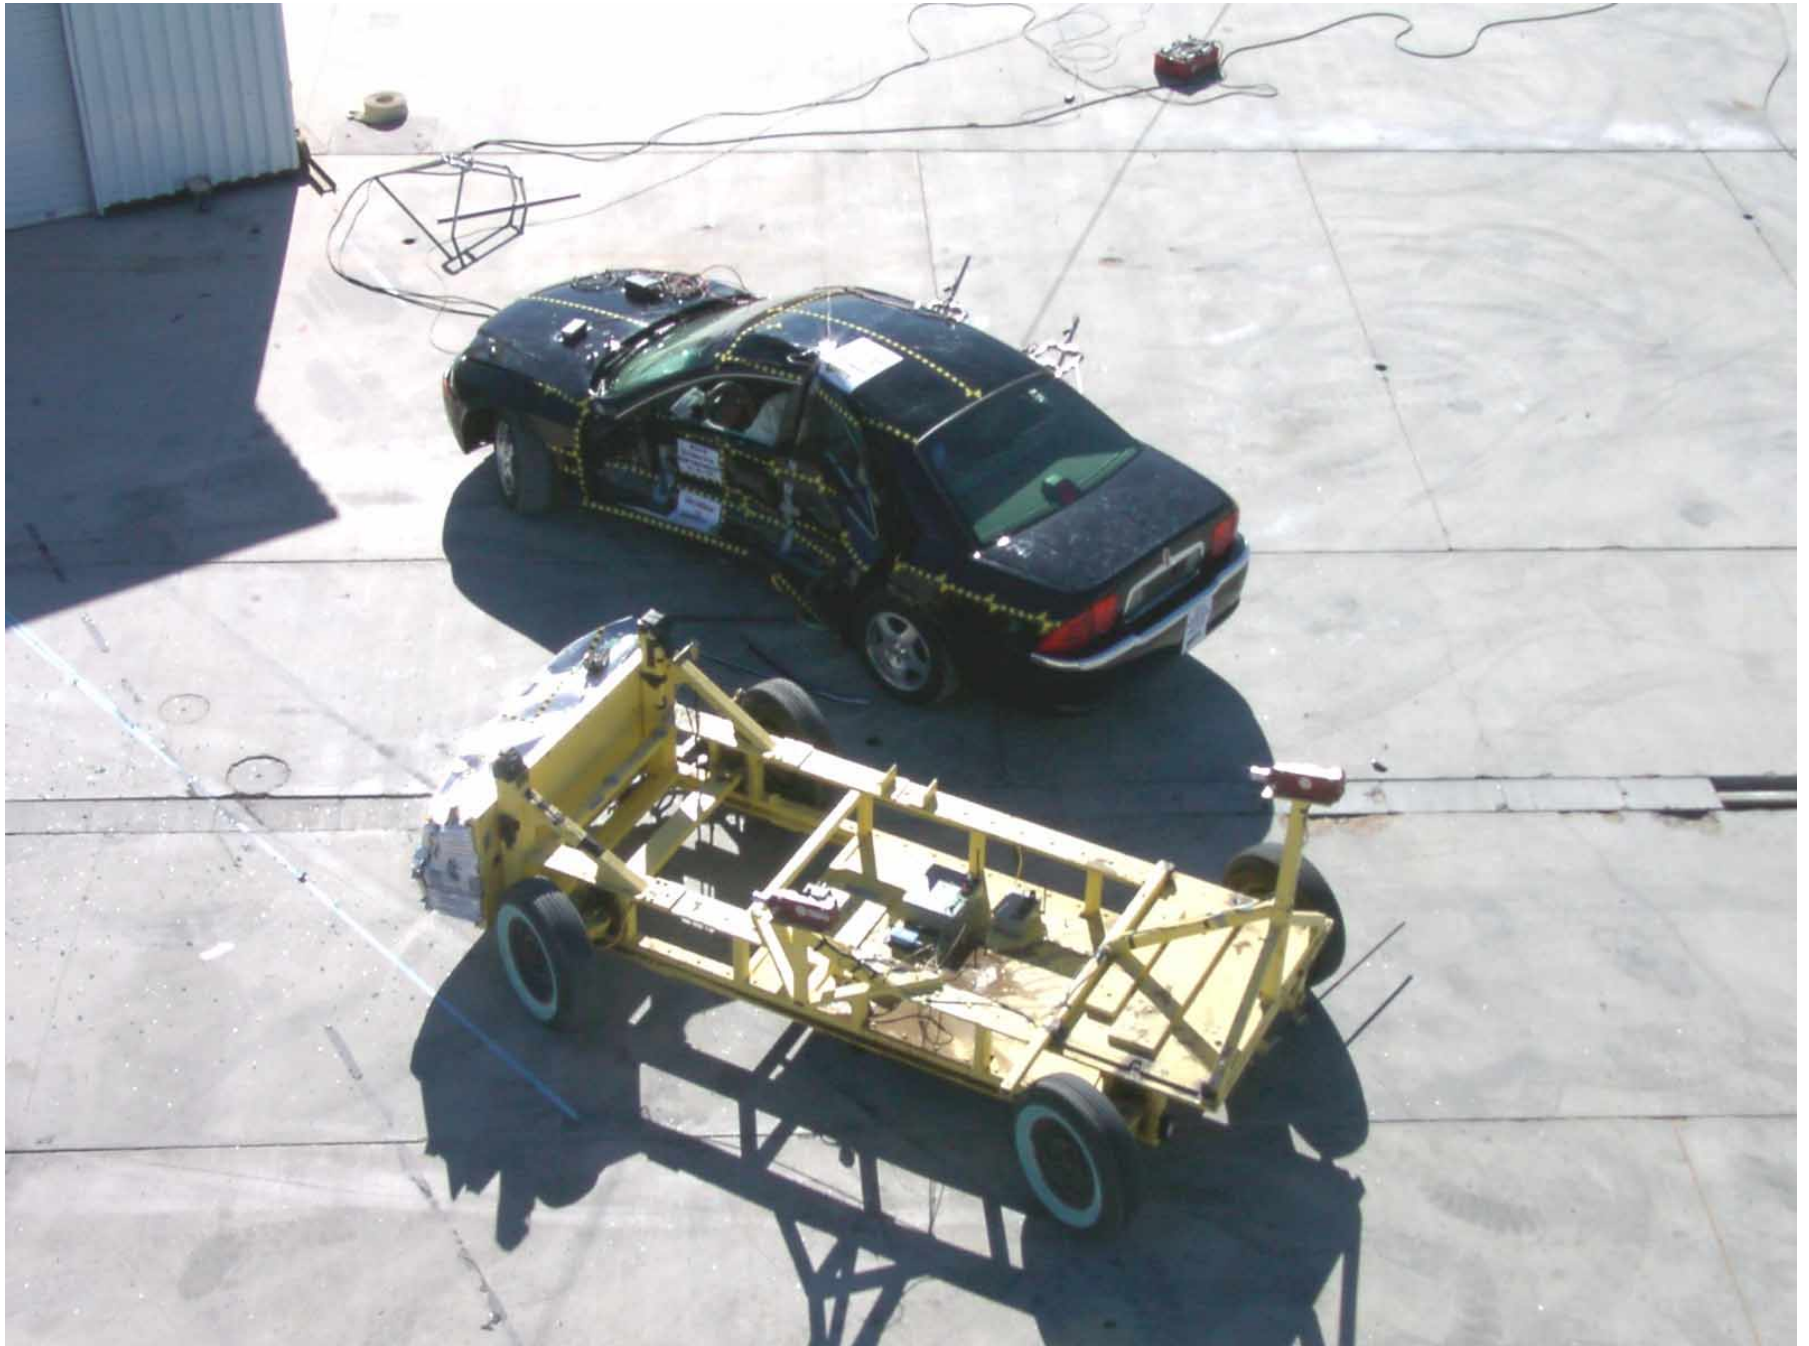
Figure A-13: Overhead Overall View, Post-Test

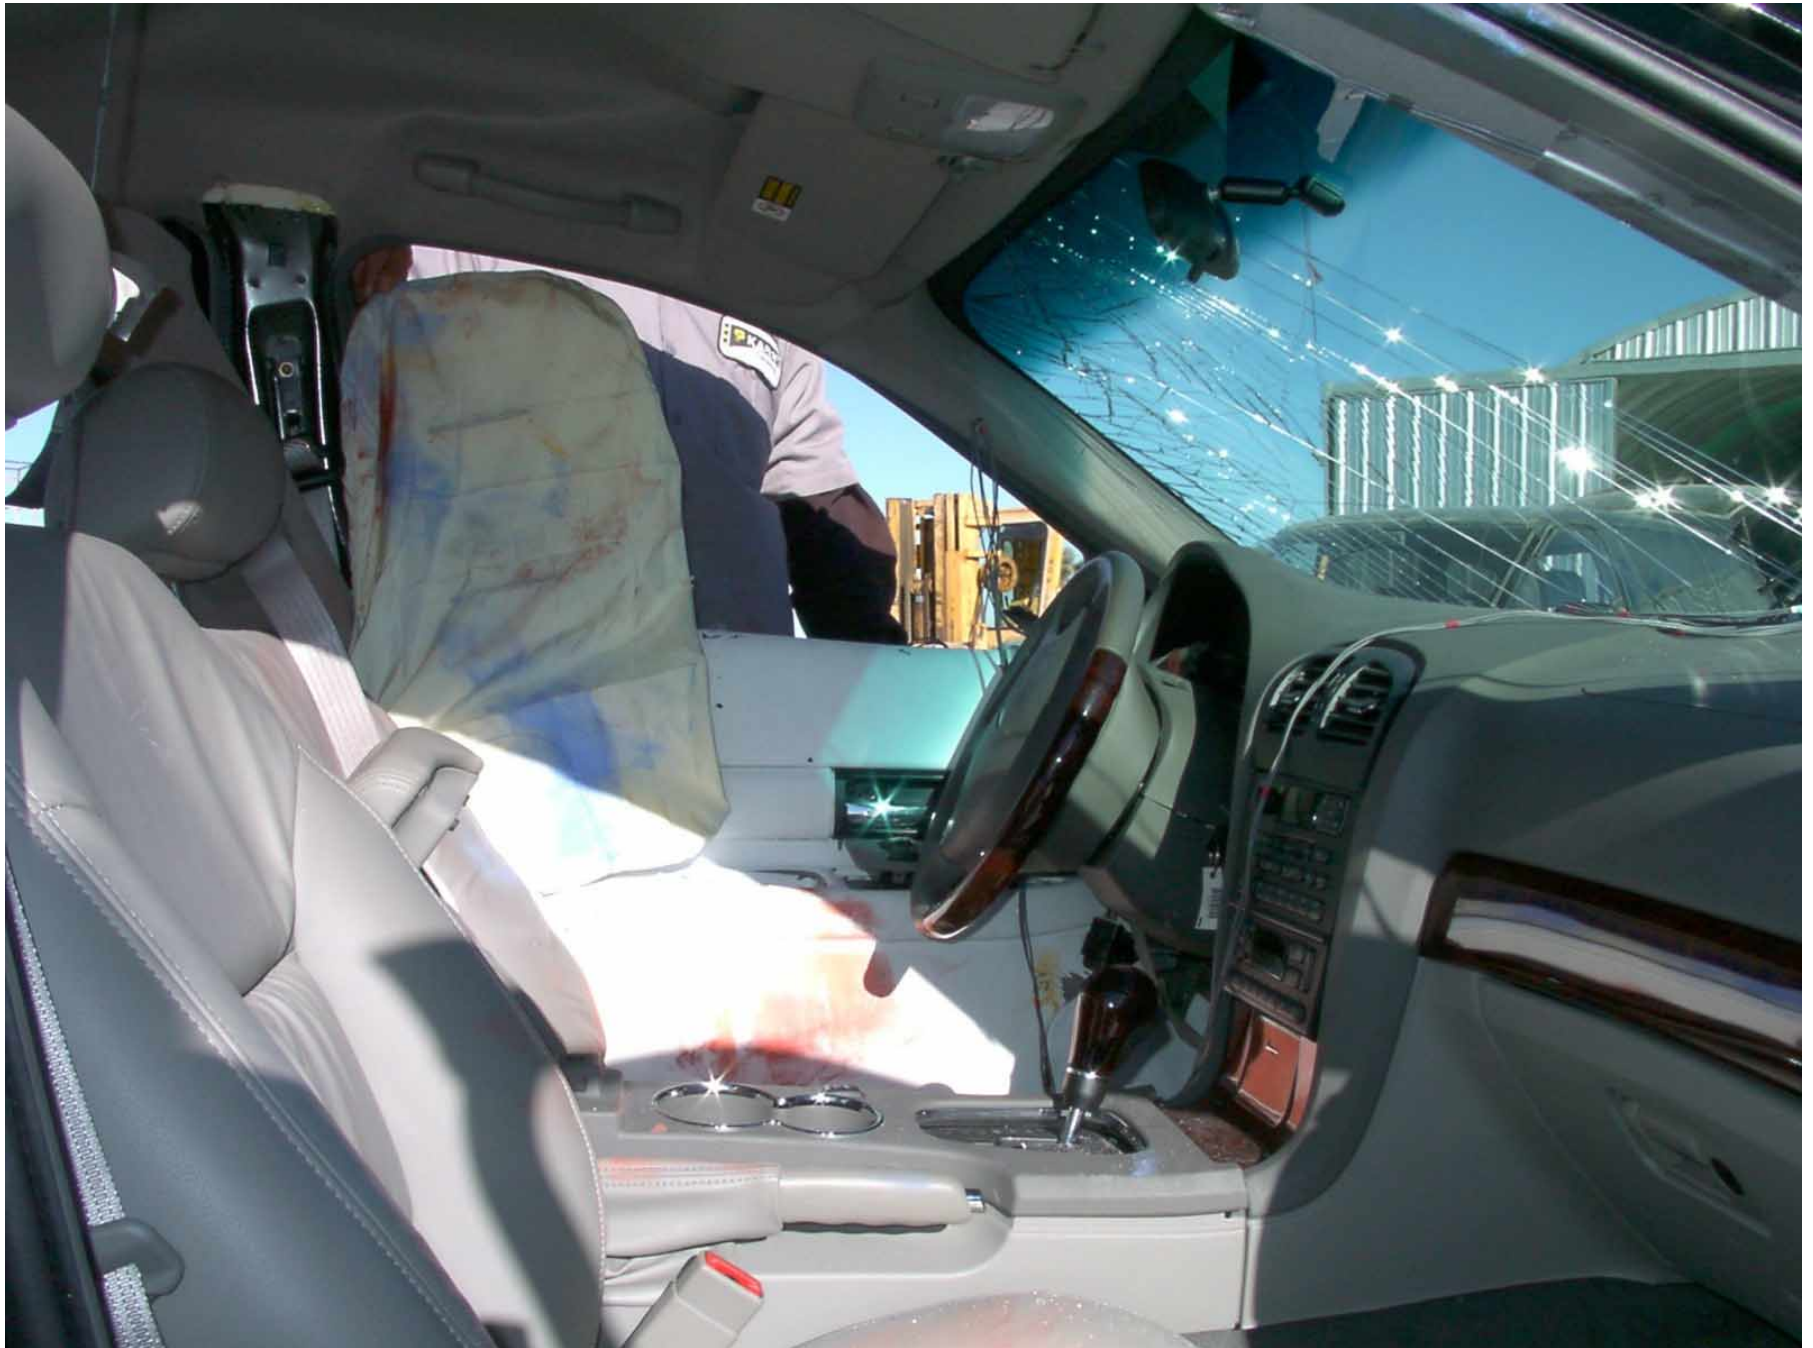
Figure A-26: Driver Dummy Contact Points Inside View, Post-Test

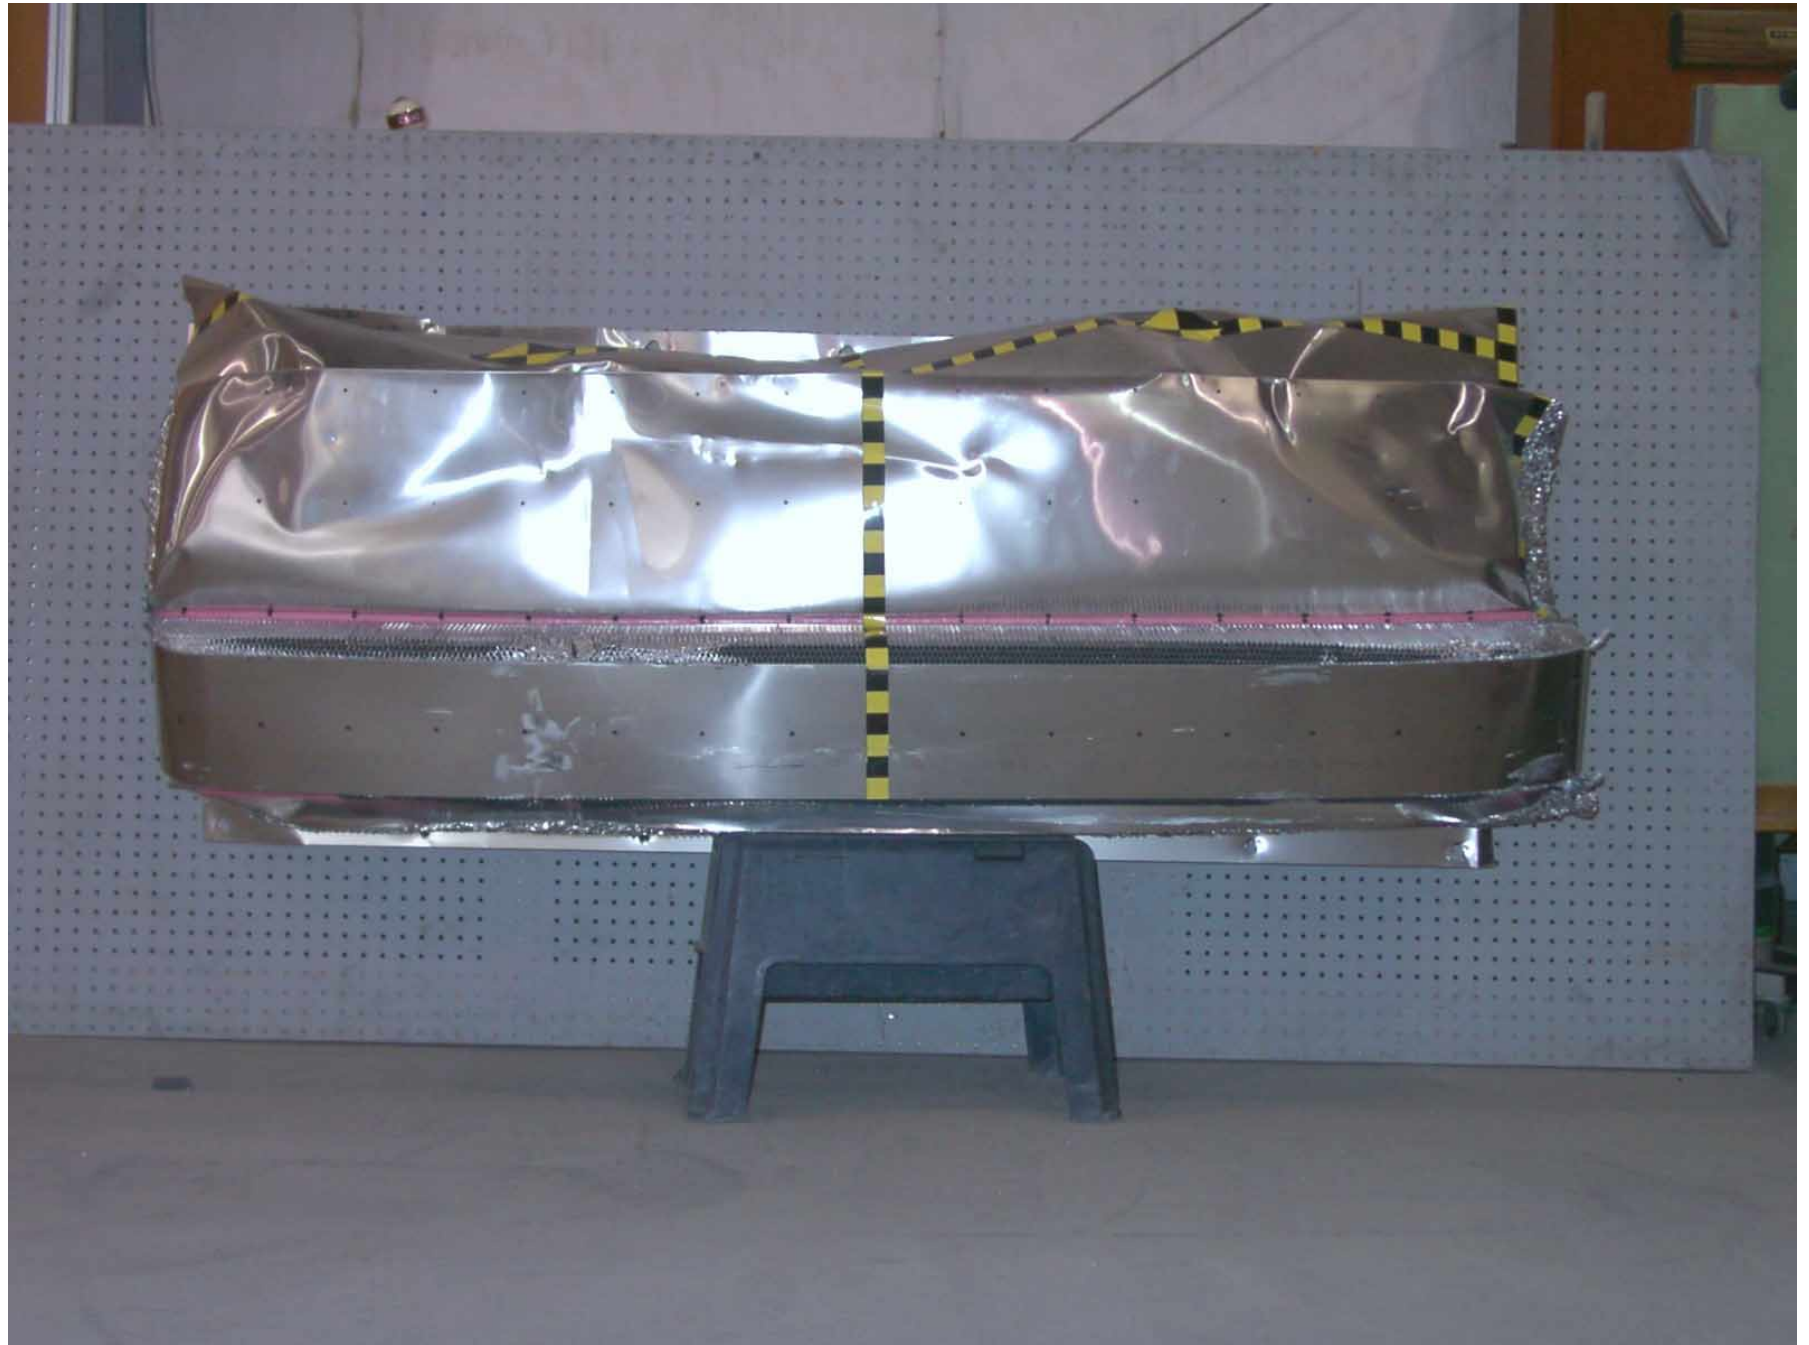
Figure A-37: Front View of Deformable Barrier, Post-Test
