REPORT NUMBER: CAL-01-09

**NEW CAR ASSESSMENT PROGRAM (NCAP)  
FRONTAL BARRIER IMPACT TEST**

**GENERAL MOTORS CORP.  
2001 BUICK LESABRE  
4-DOOR SEDAN**

FINAL REPORT

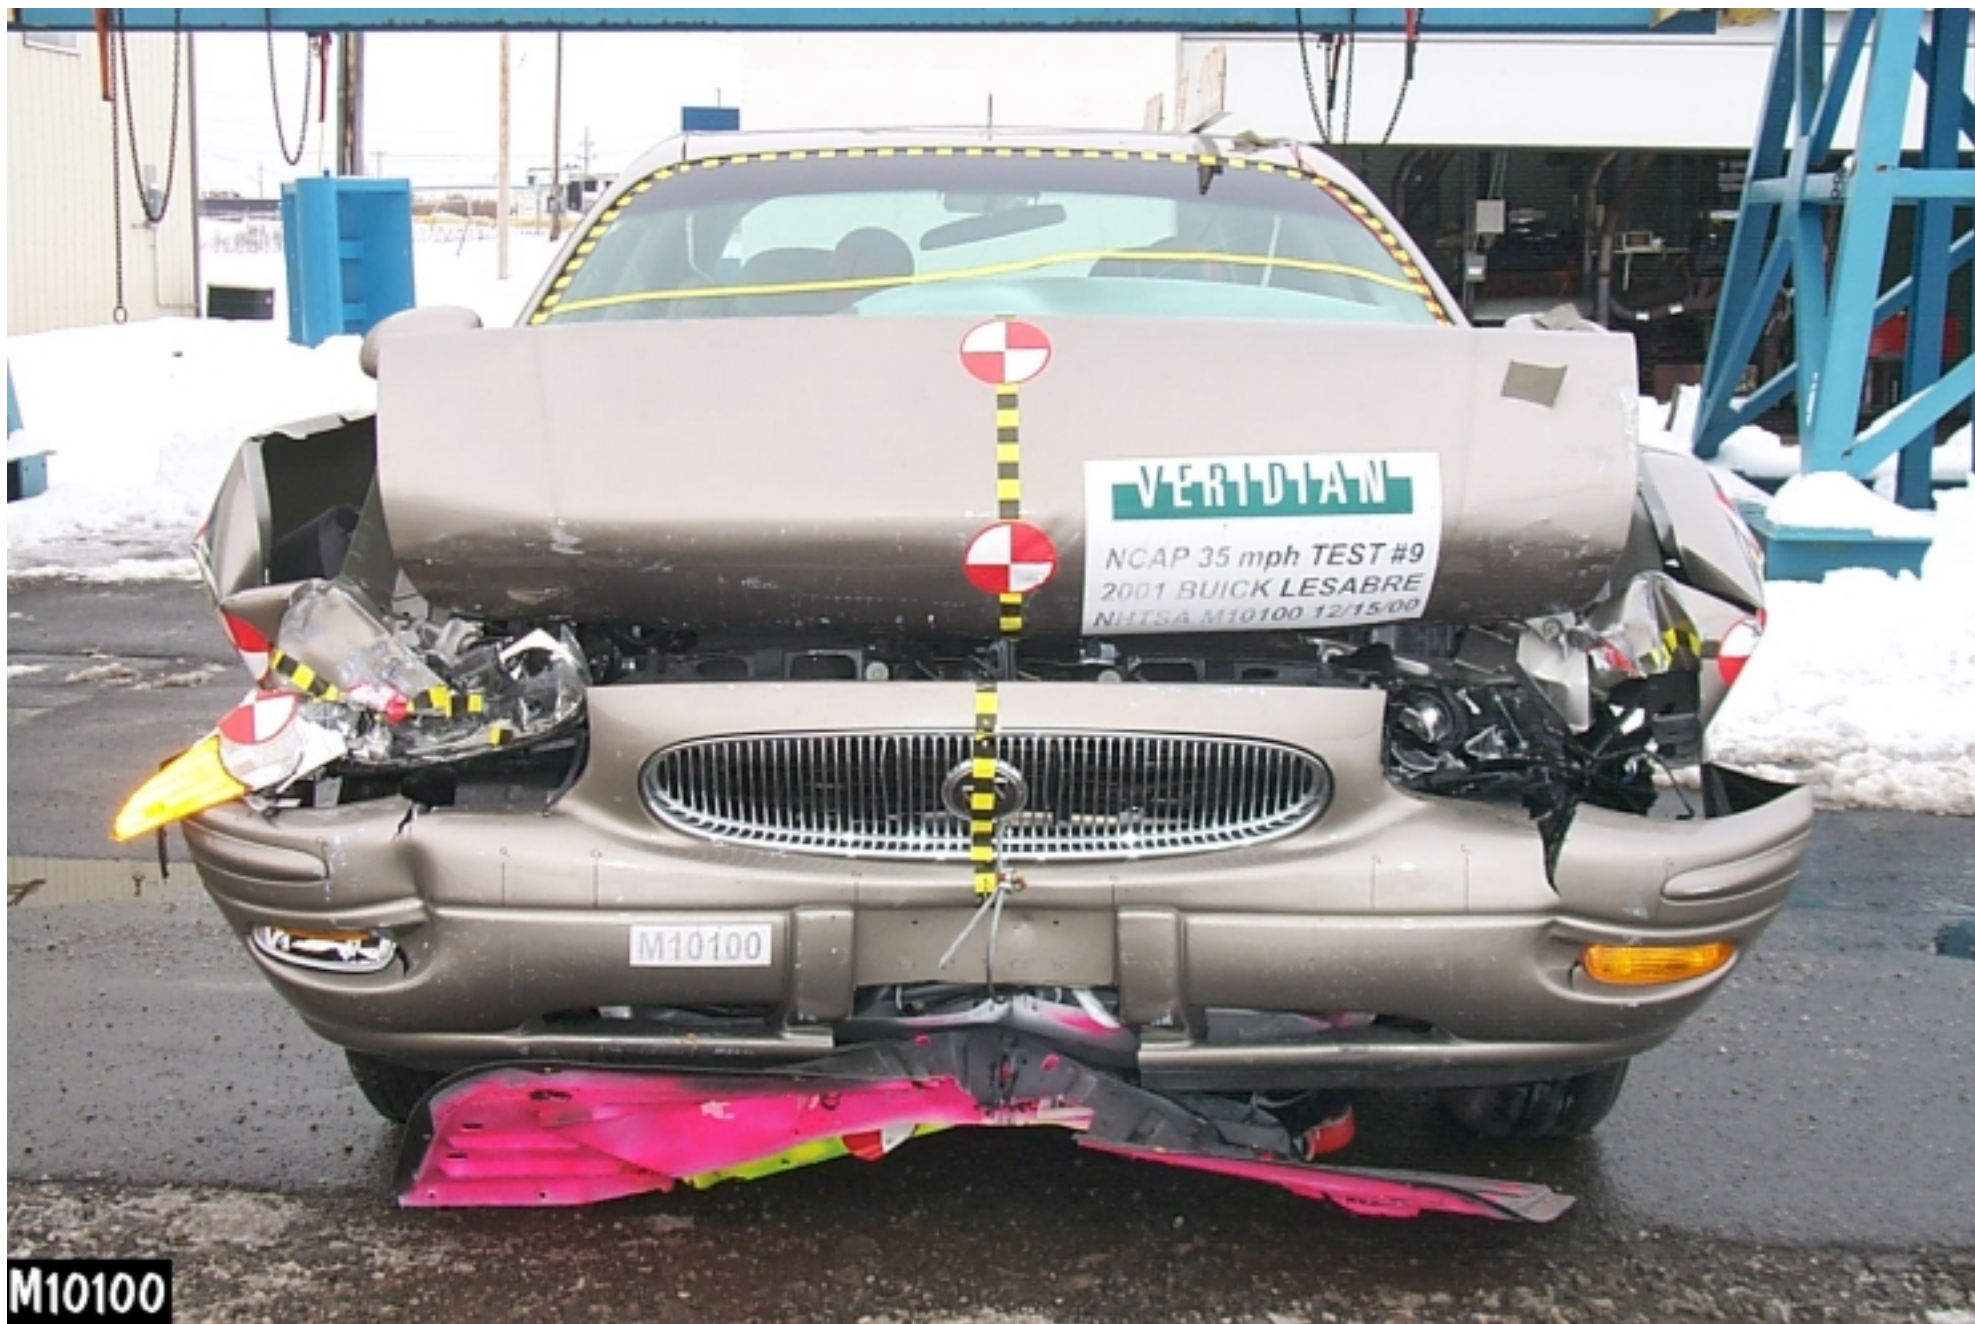
Figure A-3: POST-TEST FRONT VIEW.

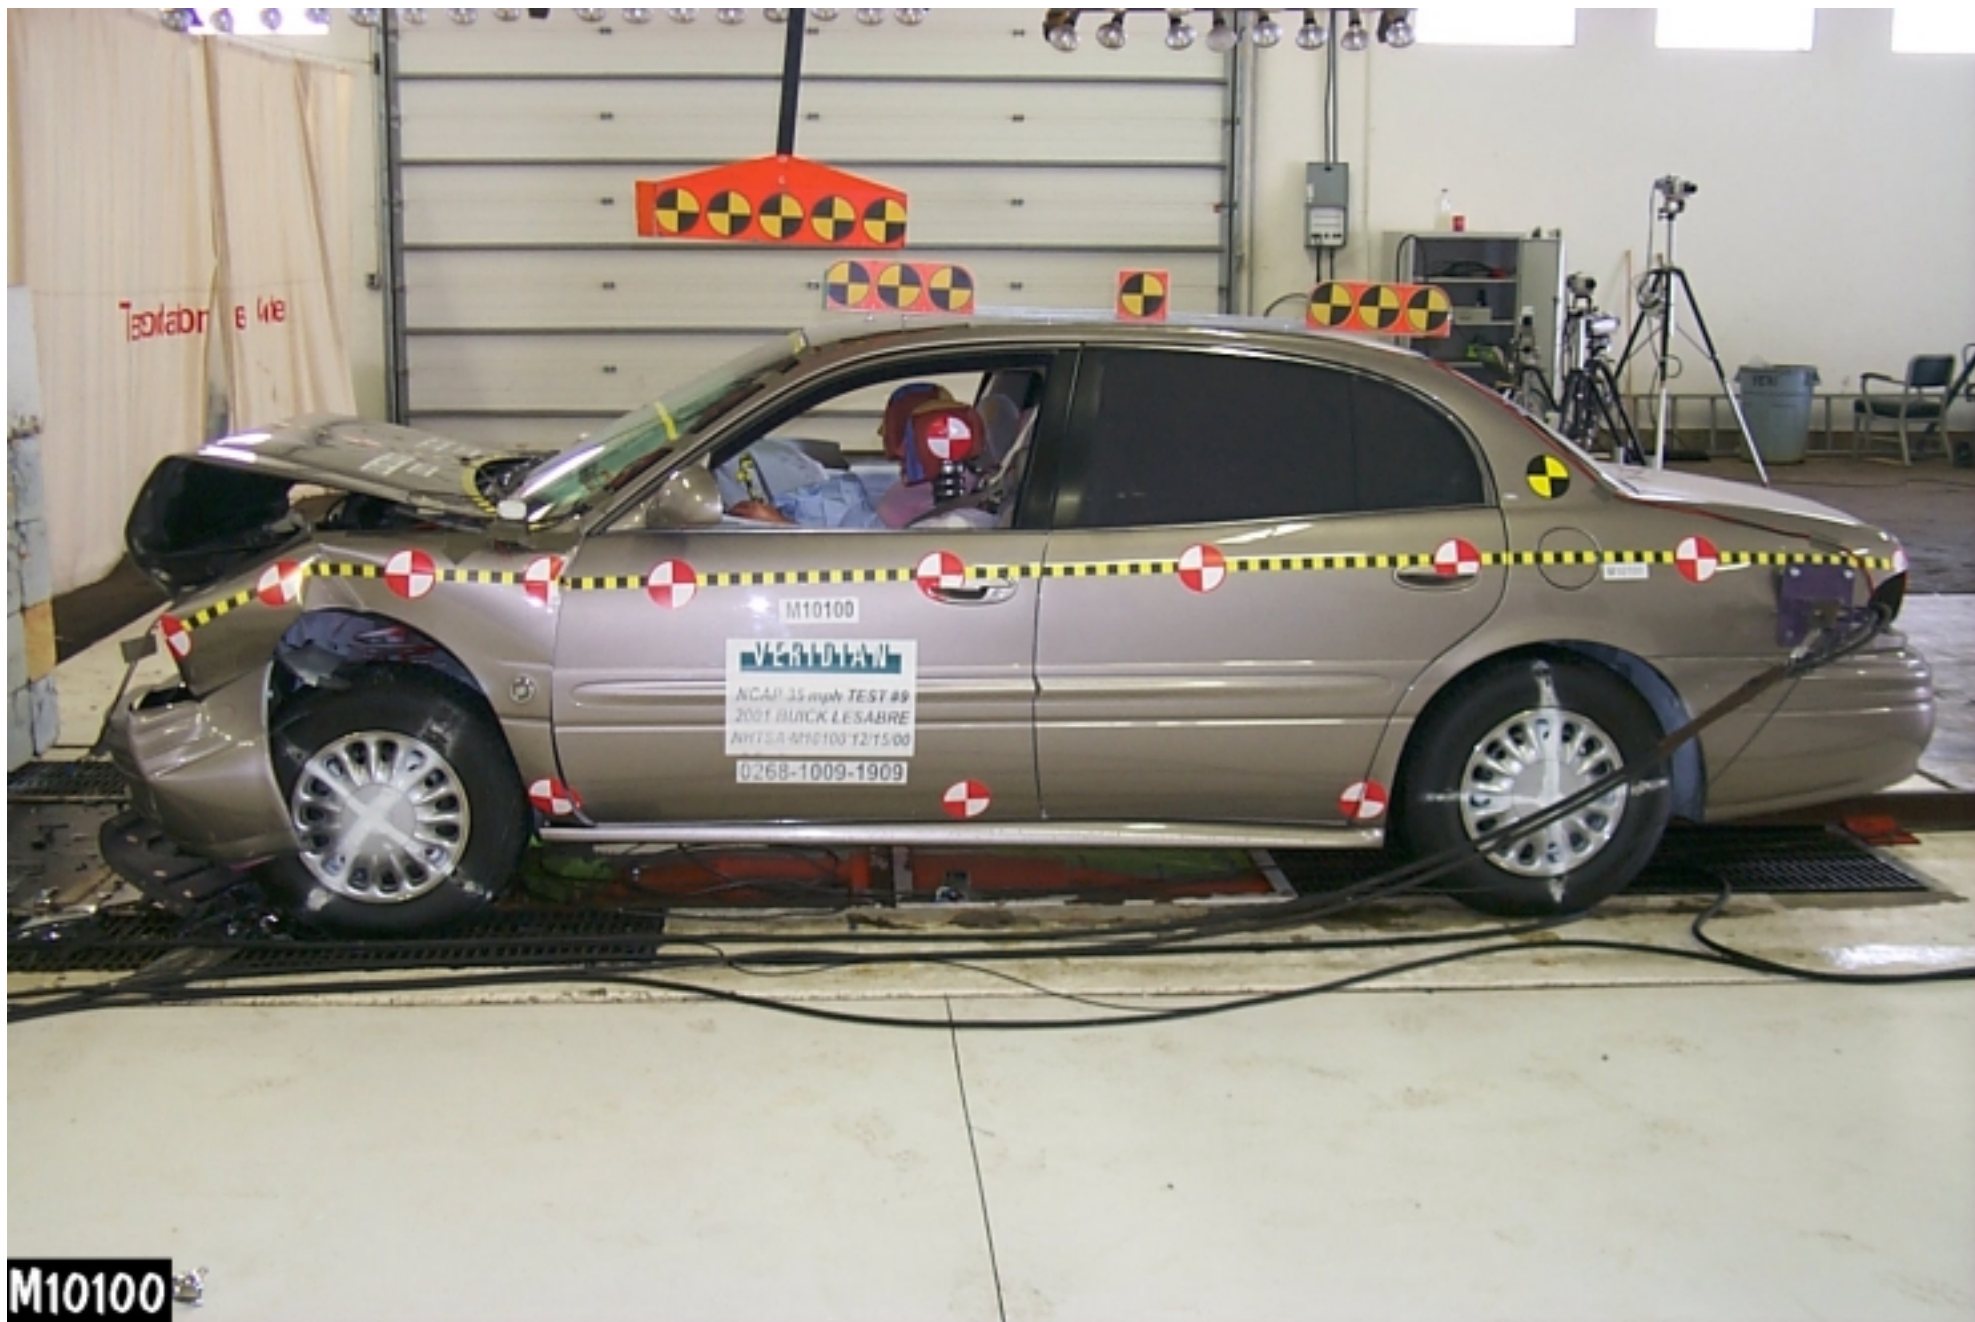
Figure A-5: POST-TEST LEFT SIDE VIEW

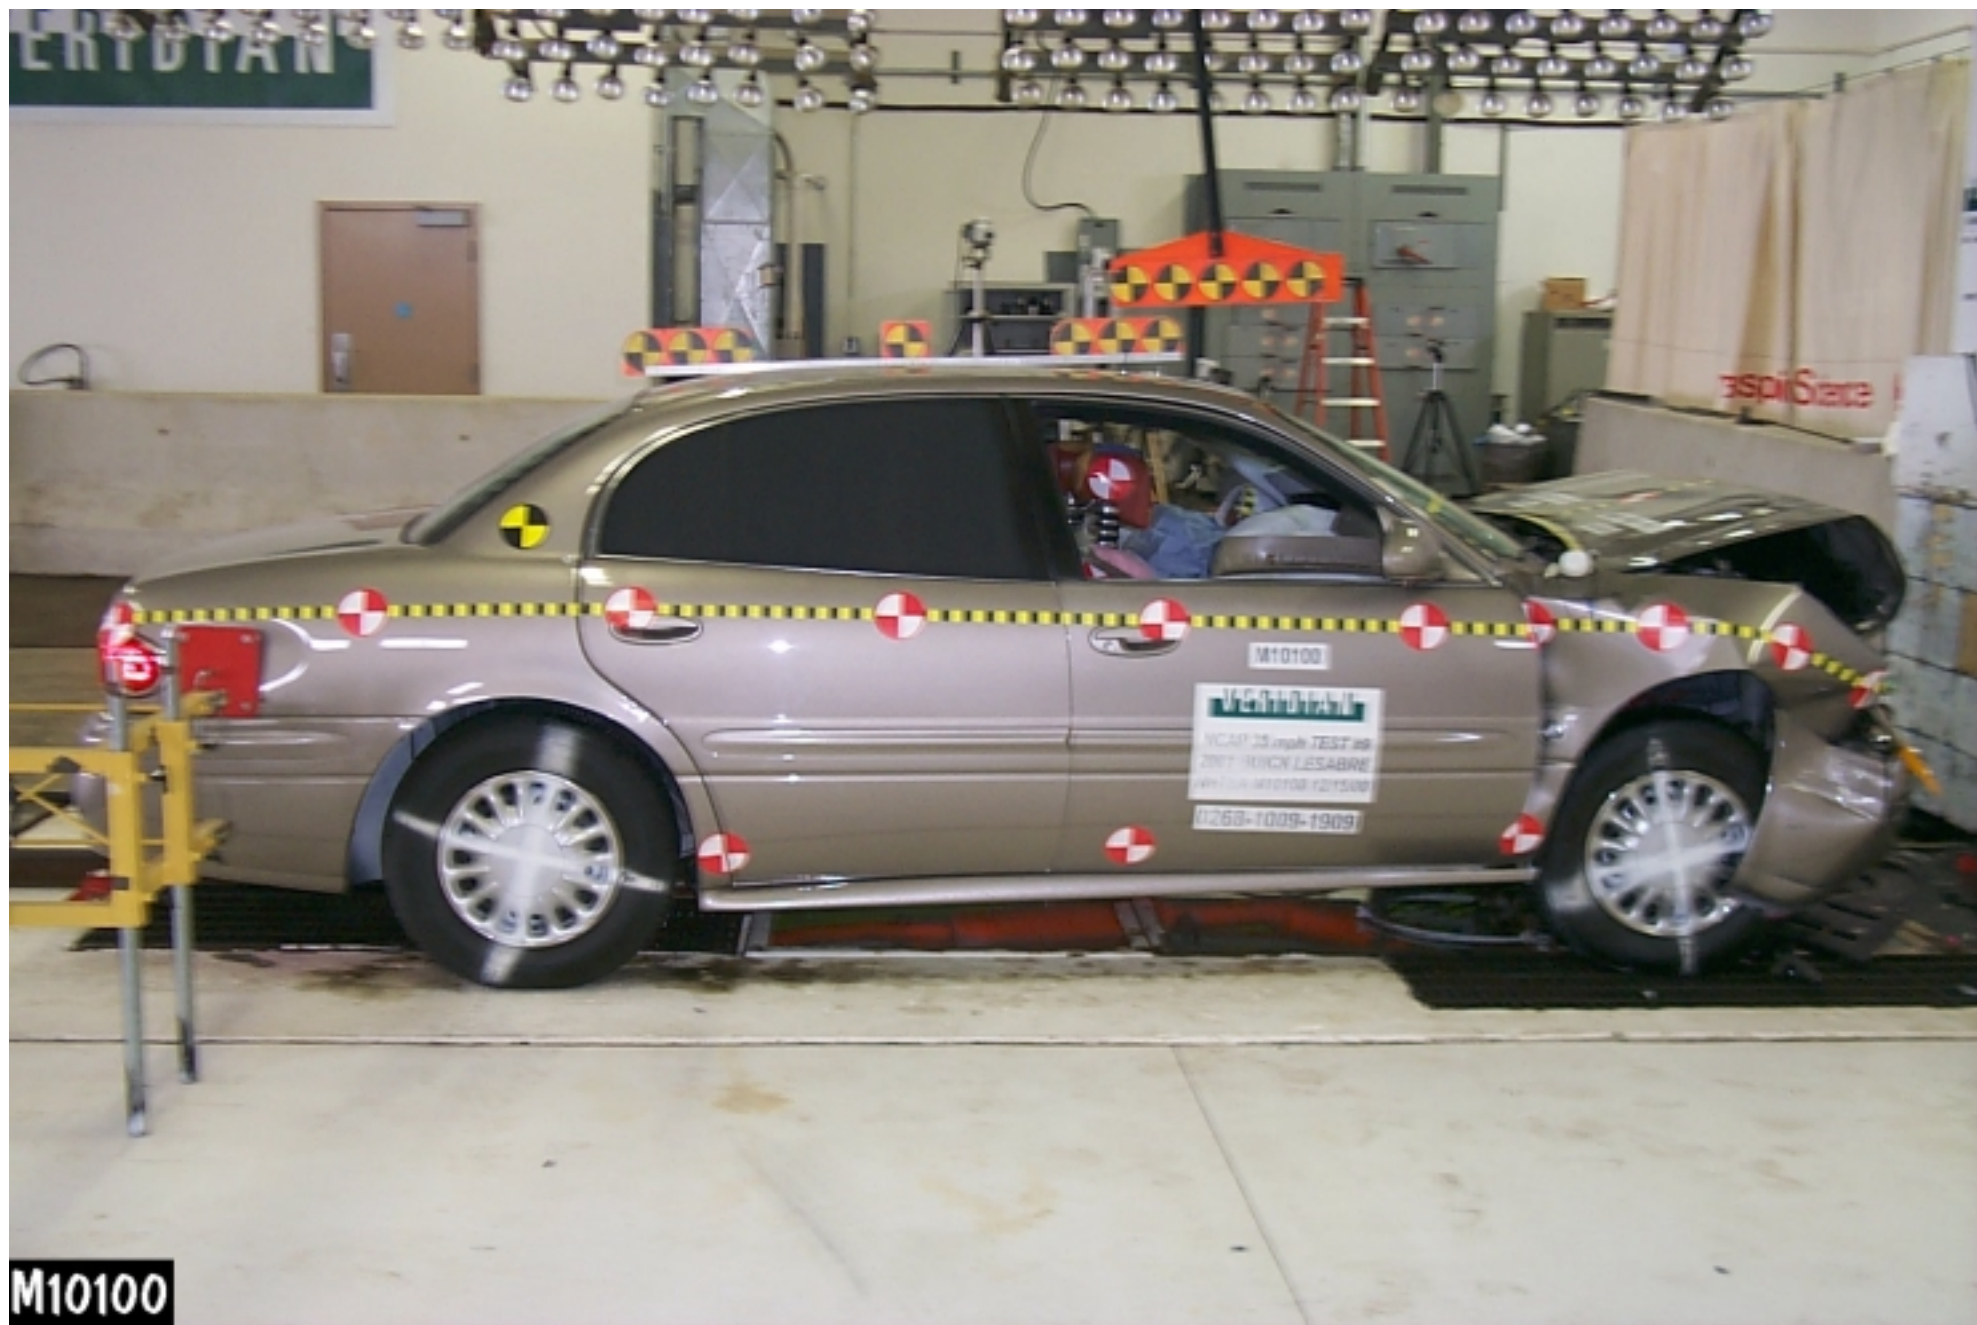
Figure A-7: POST-TEST RIGHT SIDE VIEW

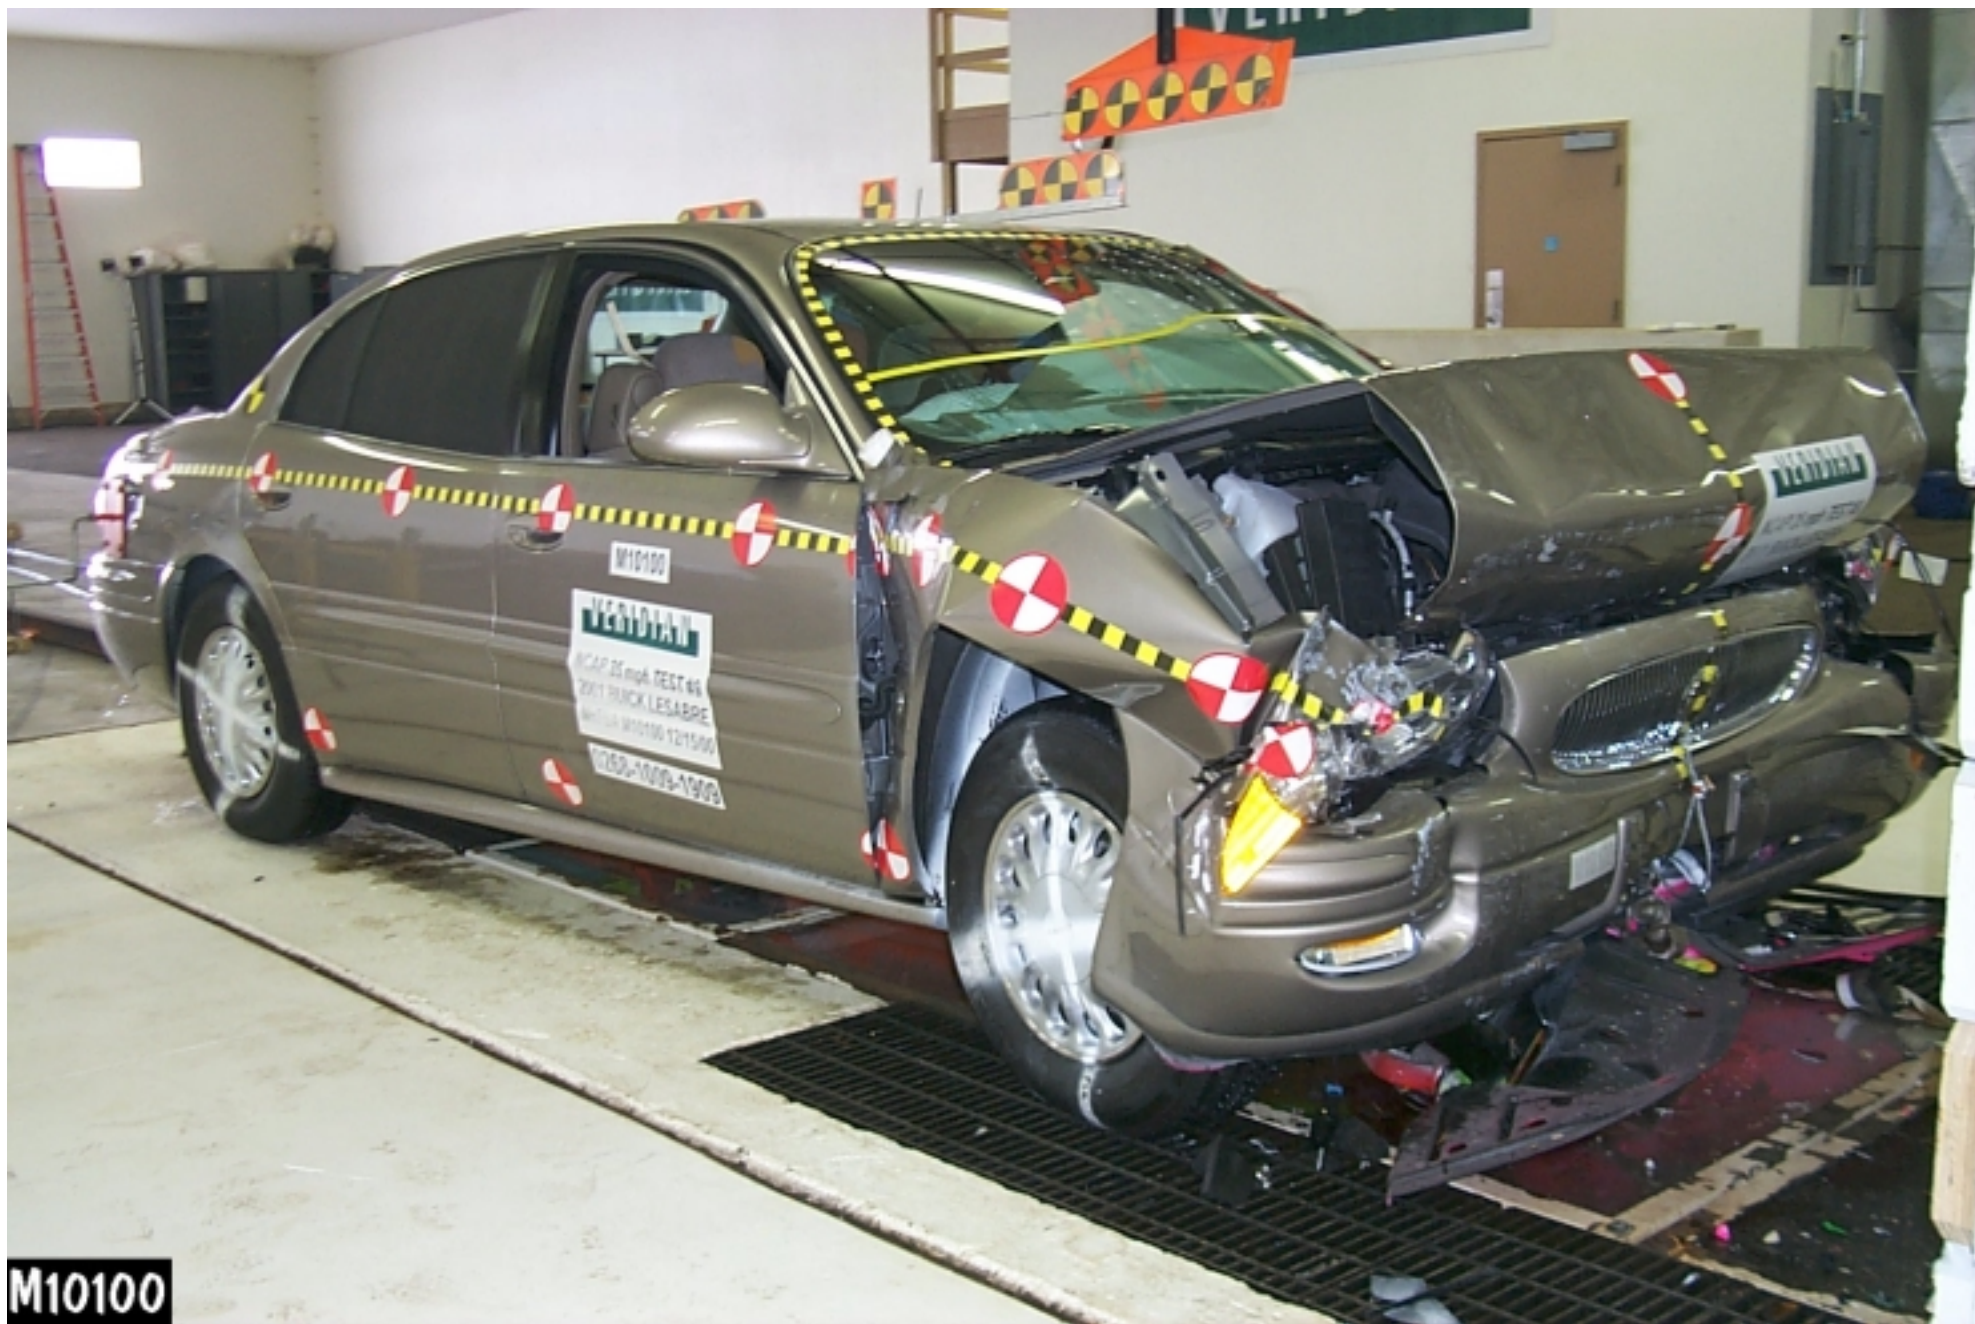
Figure A-9: POST-TEST RIGHT FRONT THREE-QUARTER VIEW

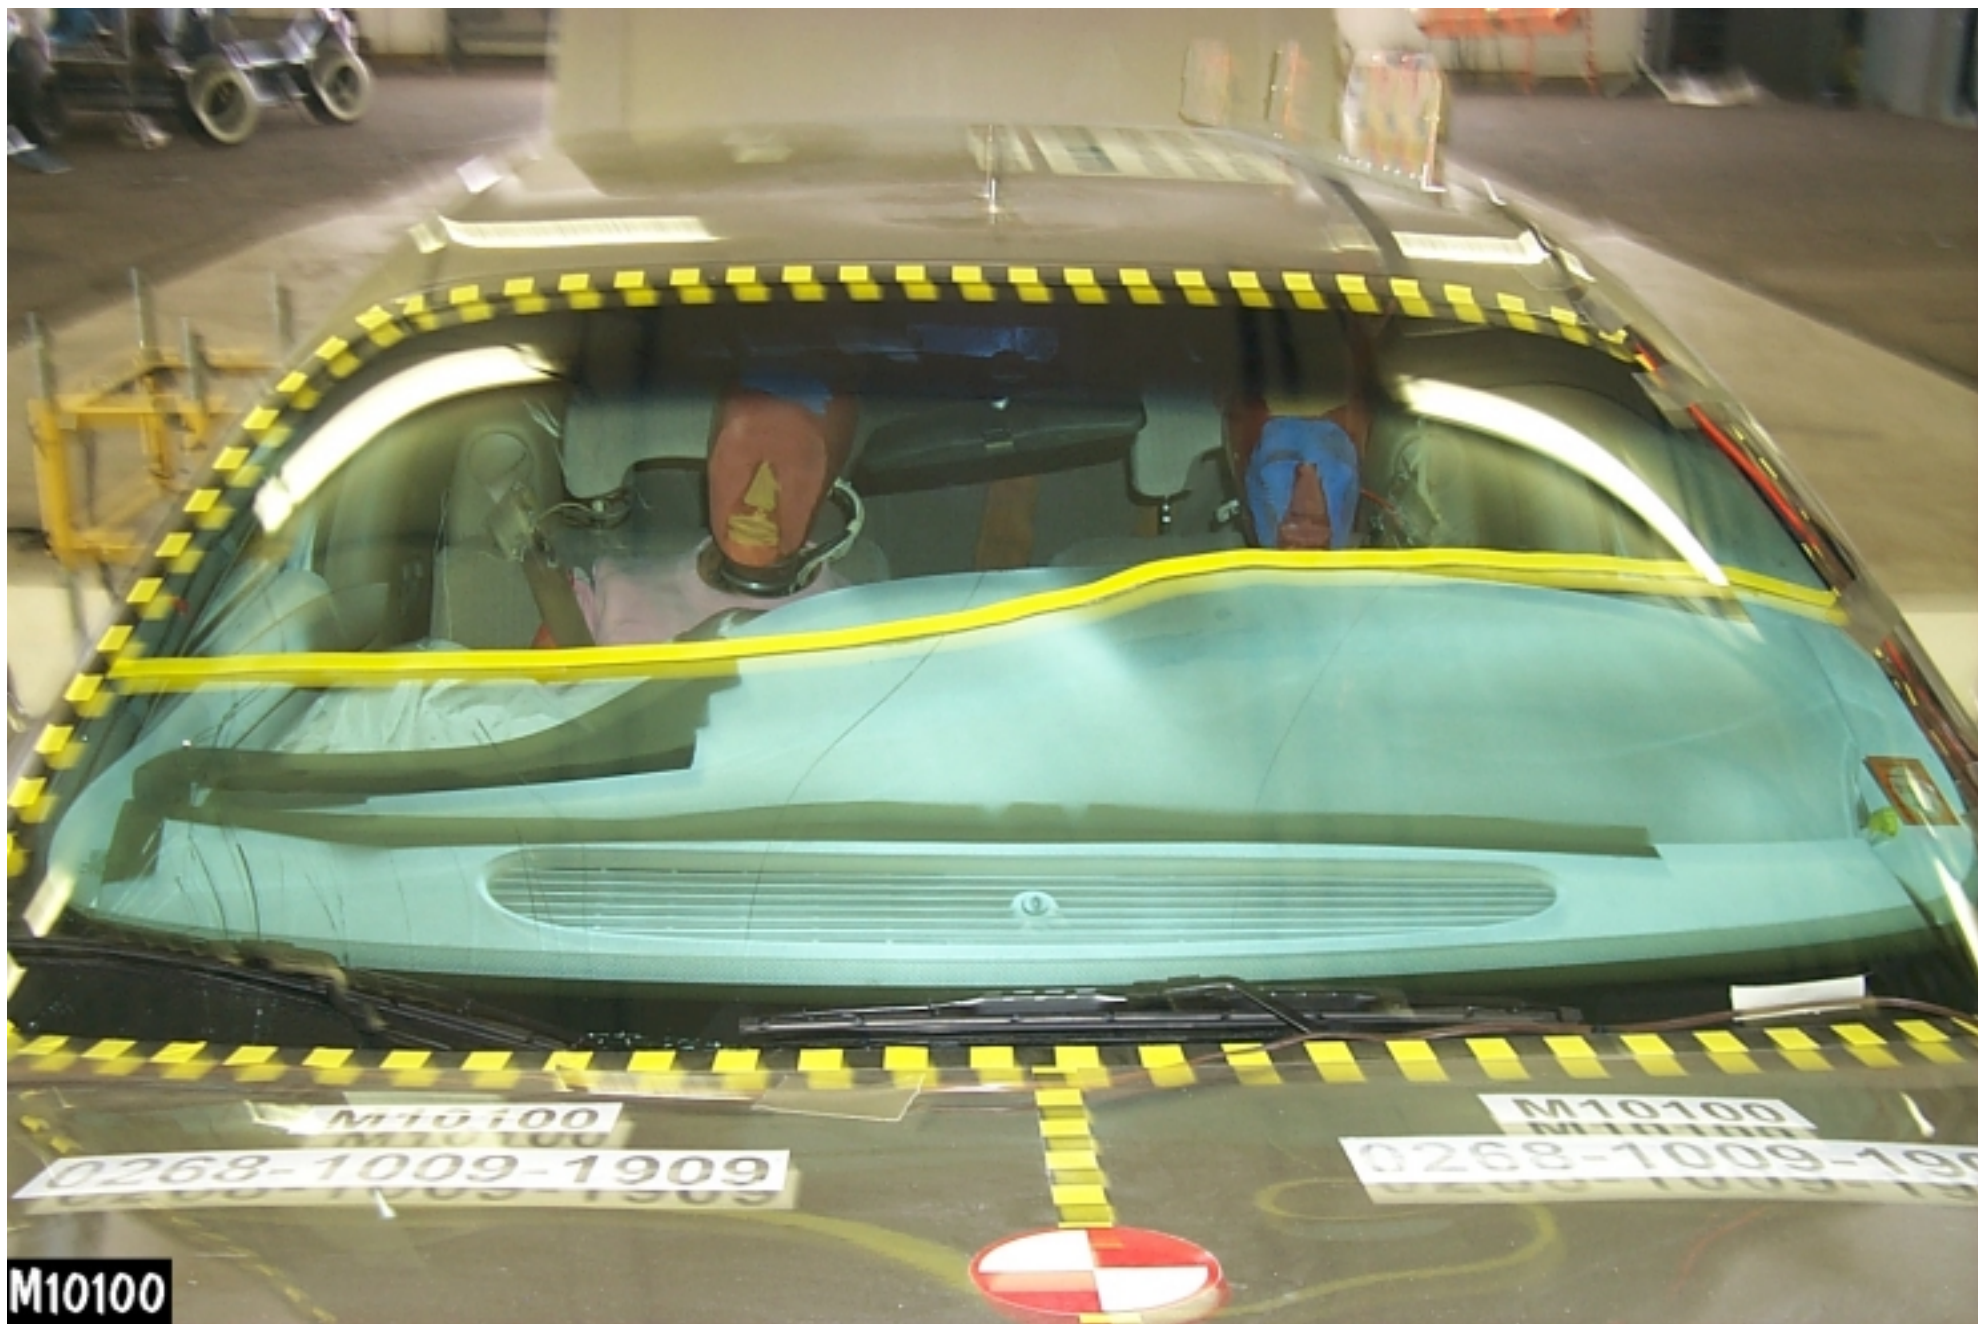
Figure A-13: POST-TEST WINDSHIELD VIEW

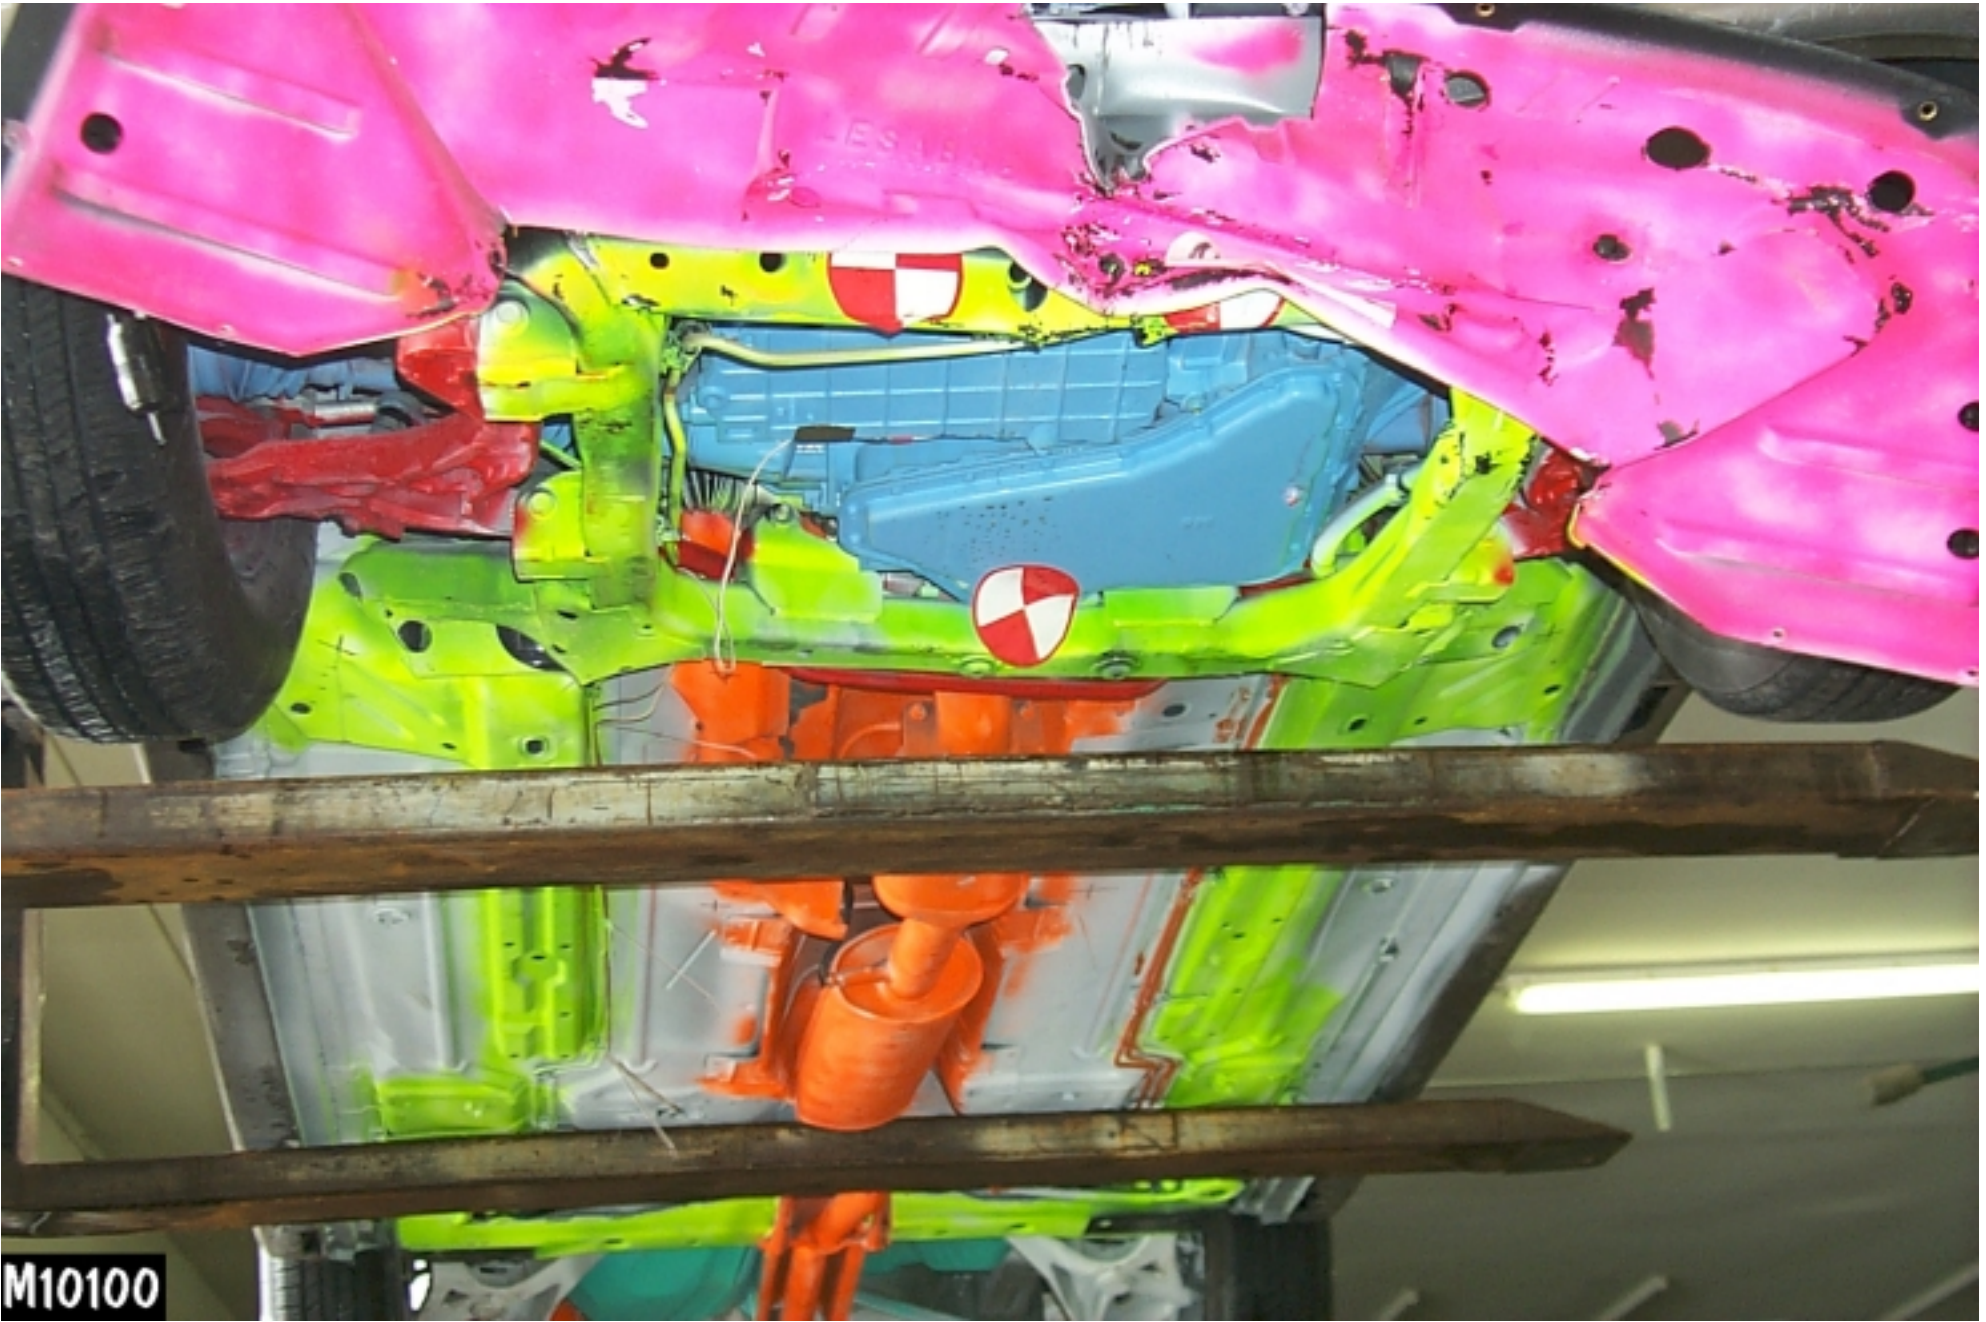
Figure A-17: POST-TEST FRONT UNDERBODY VIEW

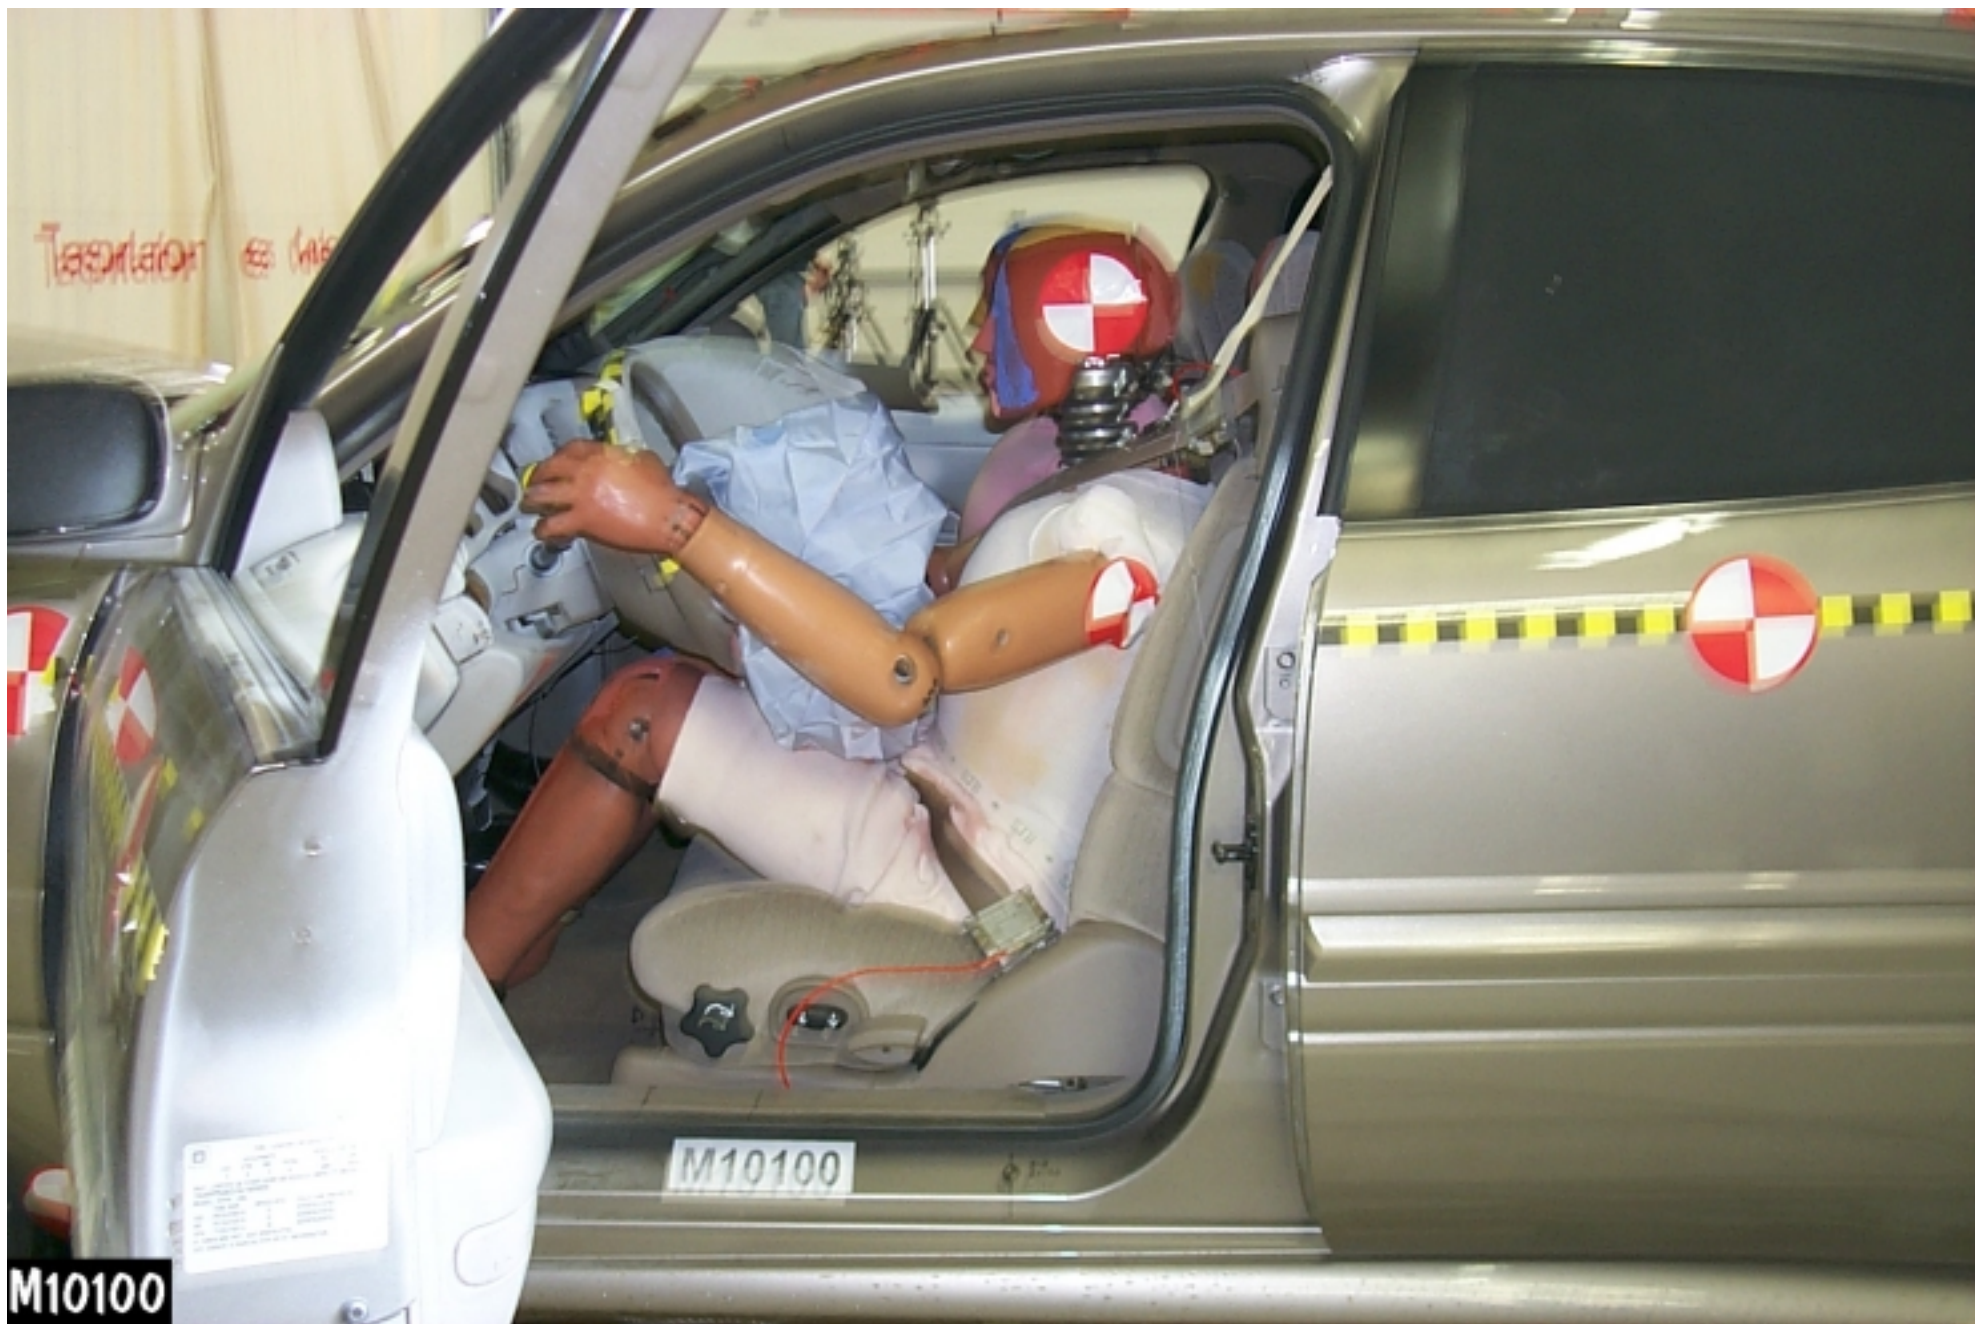
Figure A-23: POST-TEST DRIVER POSITION VIEW

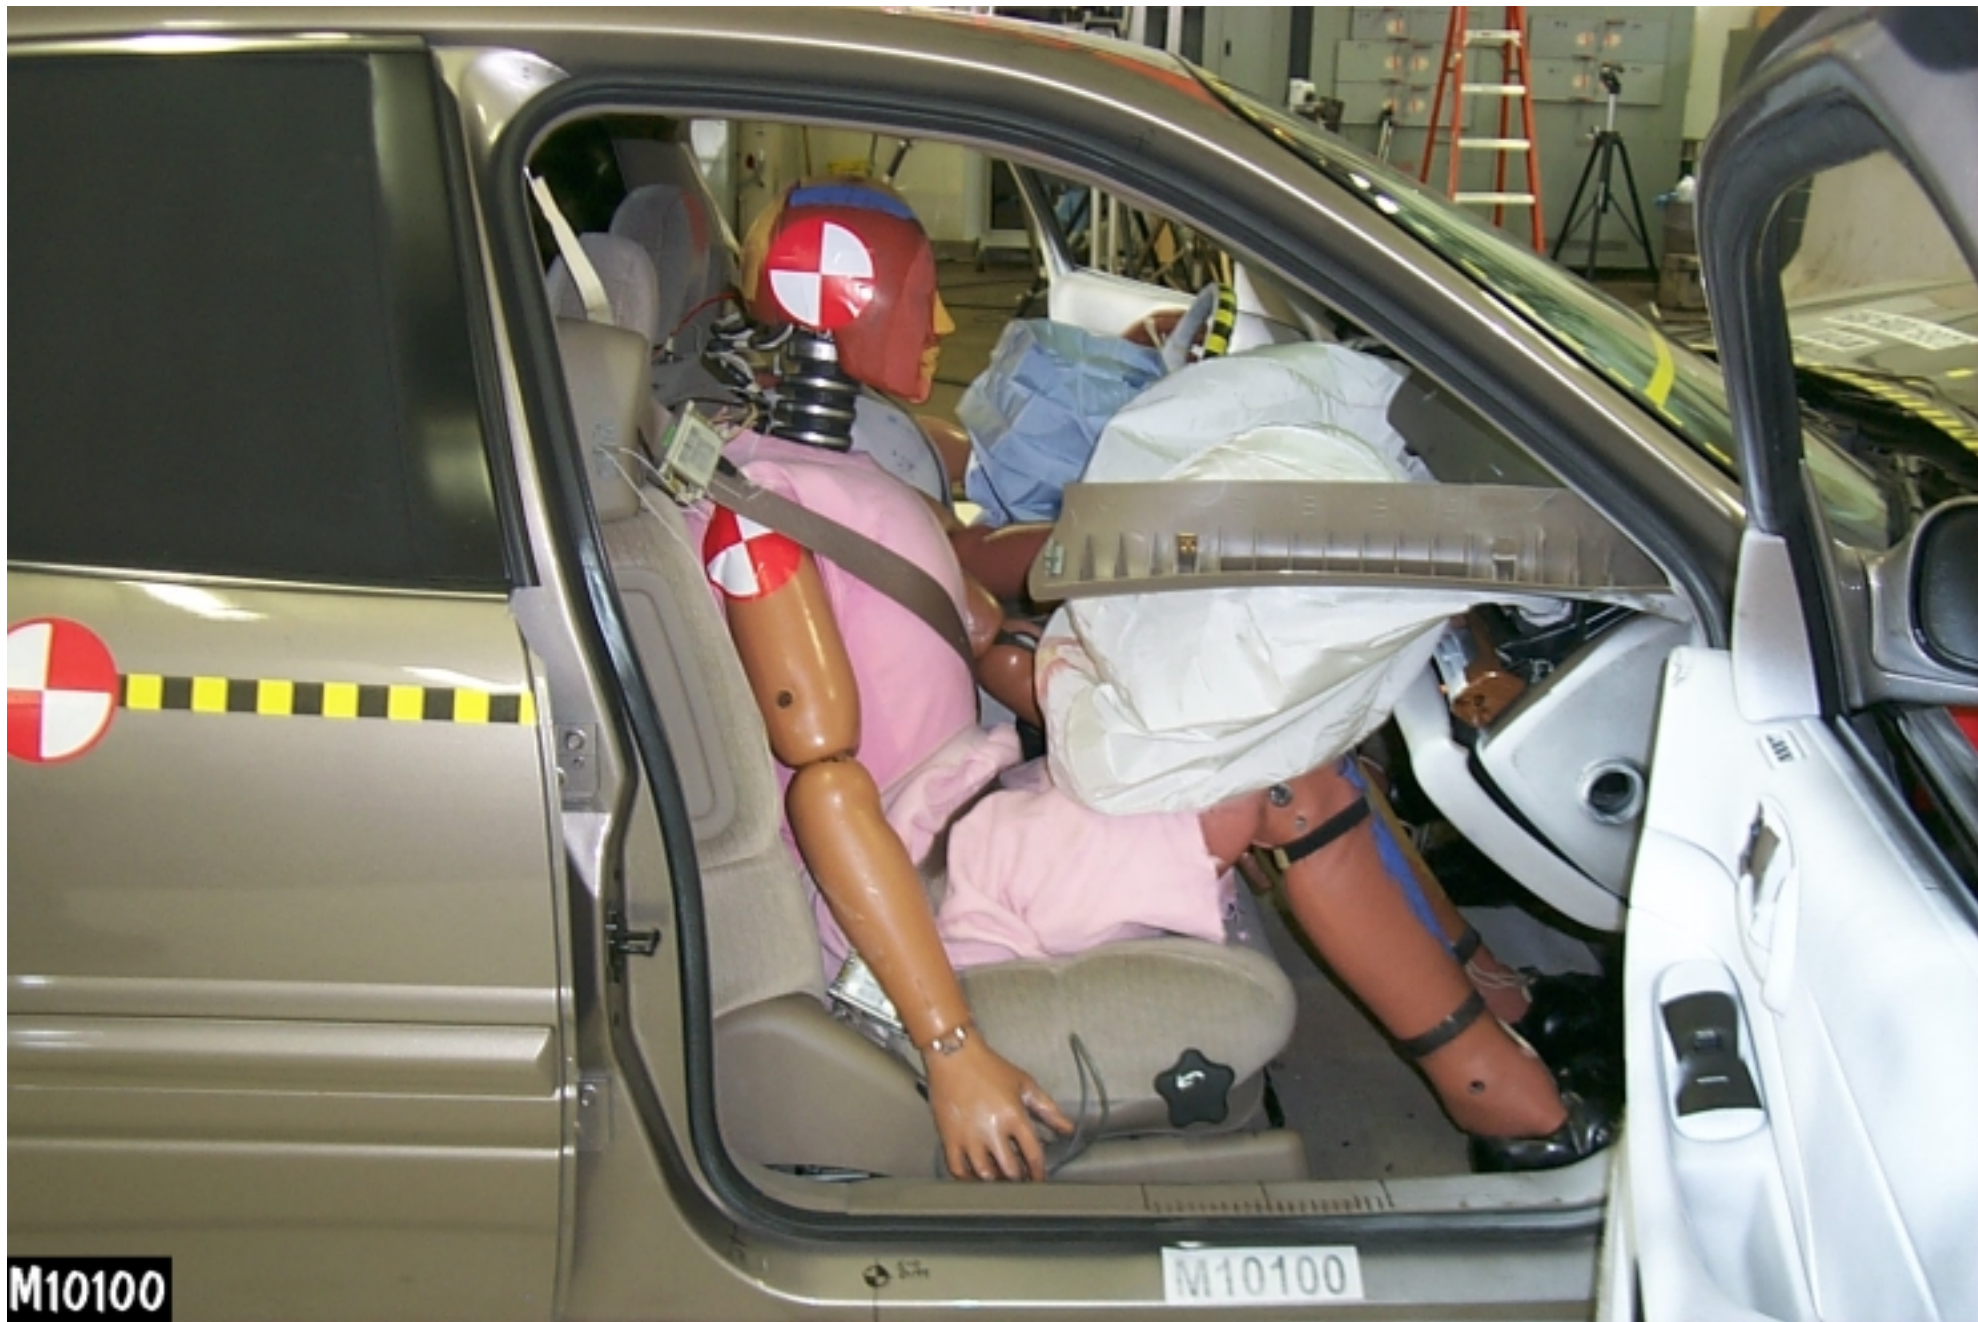
Figure A-25: POST-TEST PASSENGER POSITION VIEW
