**REPORT NUMBER: 214D-MGA-2001-006**

**SAFETY COMPLIANCE TESTING FOR FMVSS 214  
SIDE IMPACT PROTECTION  
INDICANT**

**Hyundai Motor Company  
2001 Hyundai Accent GL 4 door  
NHTSA NUMBER:C10515**

**PREPARED BY:  
MGA RESEARCH CORPORATION  
5000 WARREN ROAD  
BURLINGTON, WI 53105**

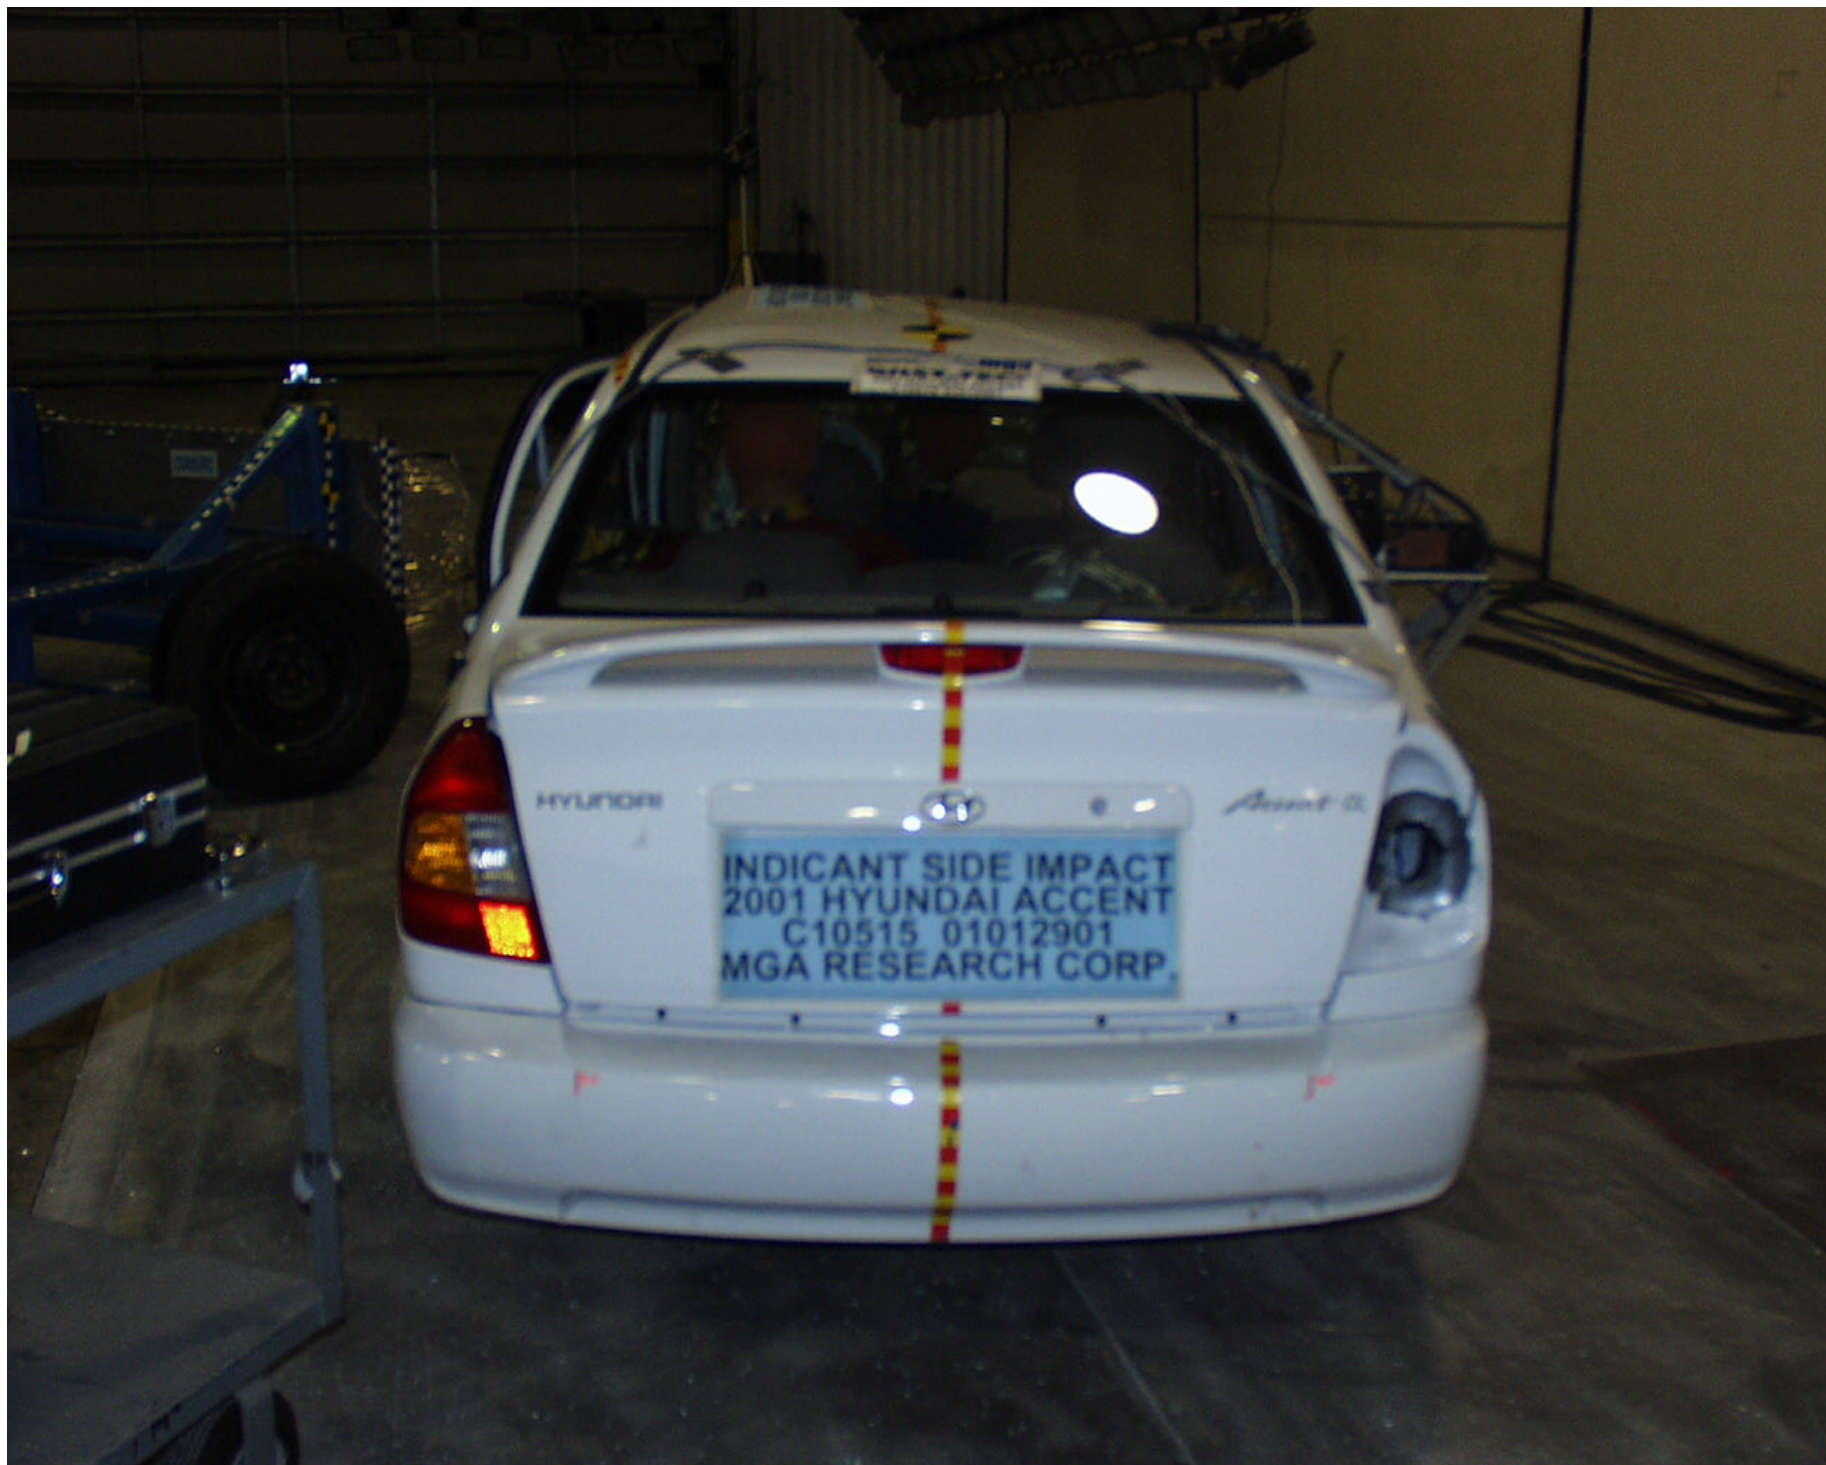
Photo No. A-4 - Post-Test Rear View of Test Vehicle

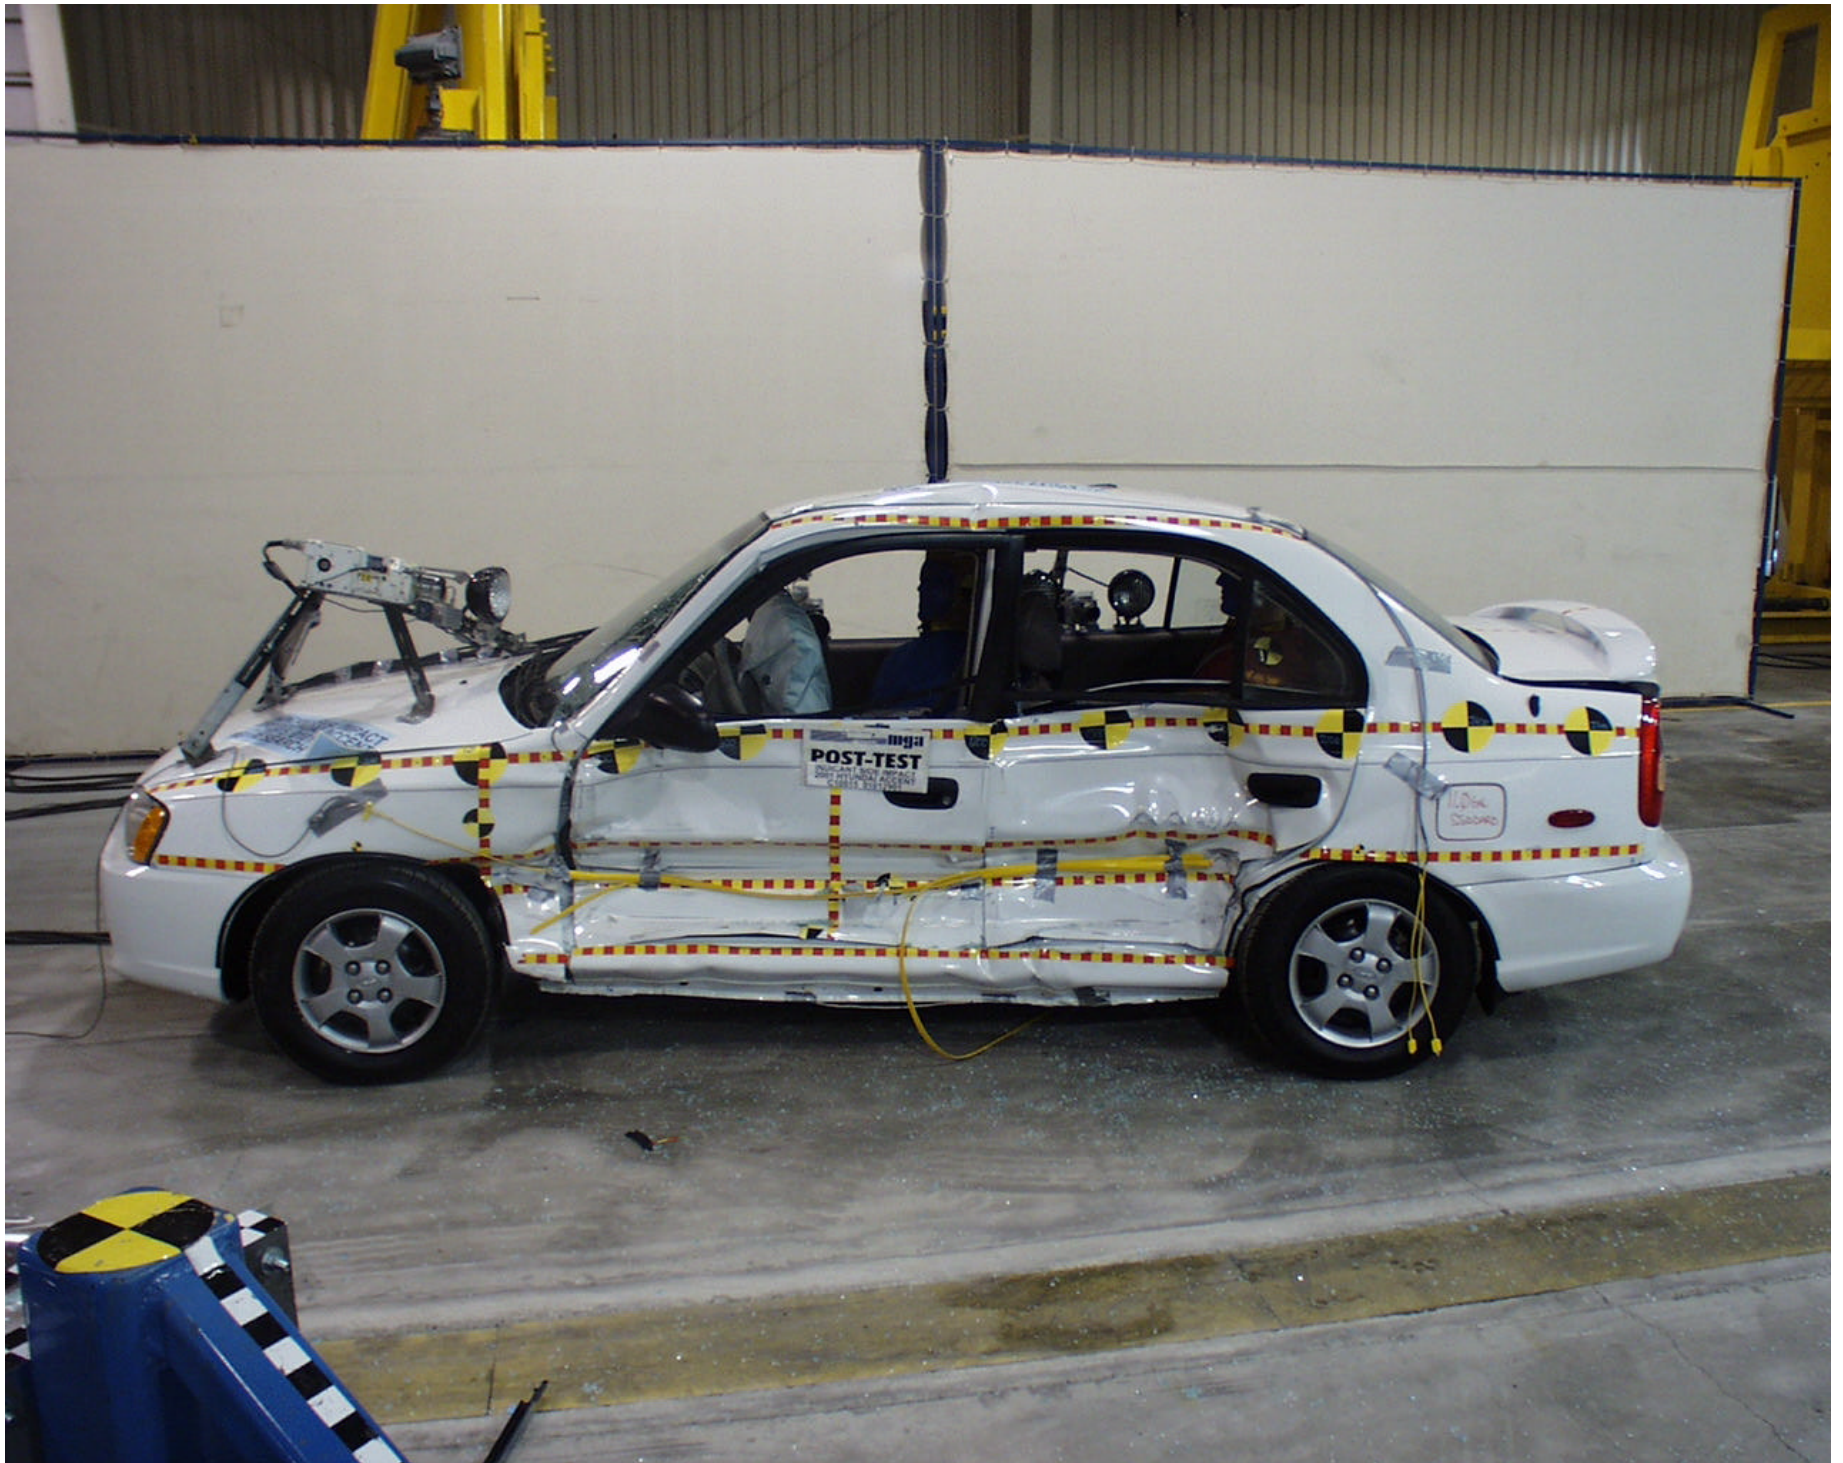
Photo No. A-6 - Post-Test Left Side View of Test Vehicle

The test vehicle sustained a maximum static crush of 331 mm at level 2, 1200 mm rearward of the left vertical impact point. The driver and passenger SID's, Serial Nos. 036 and 037 respectively, were calibrated just prior to this test. The SID's injury criteria is summarized as follows:

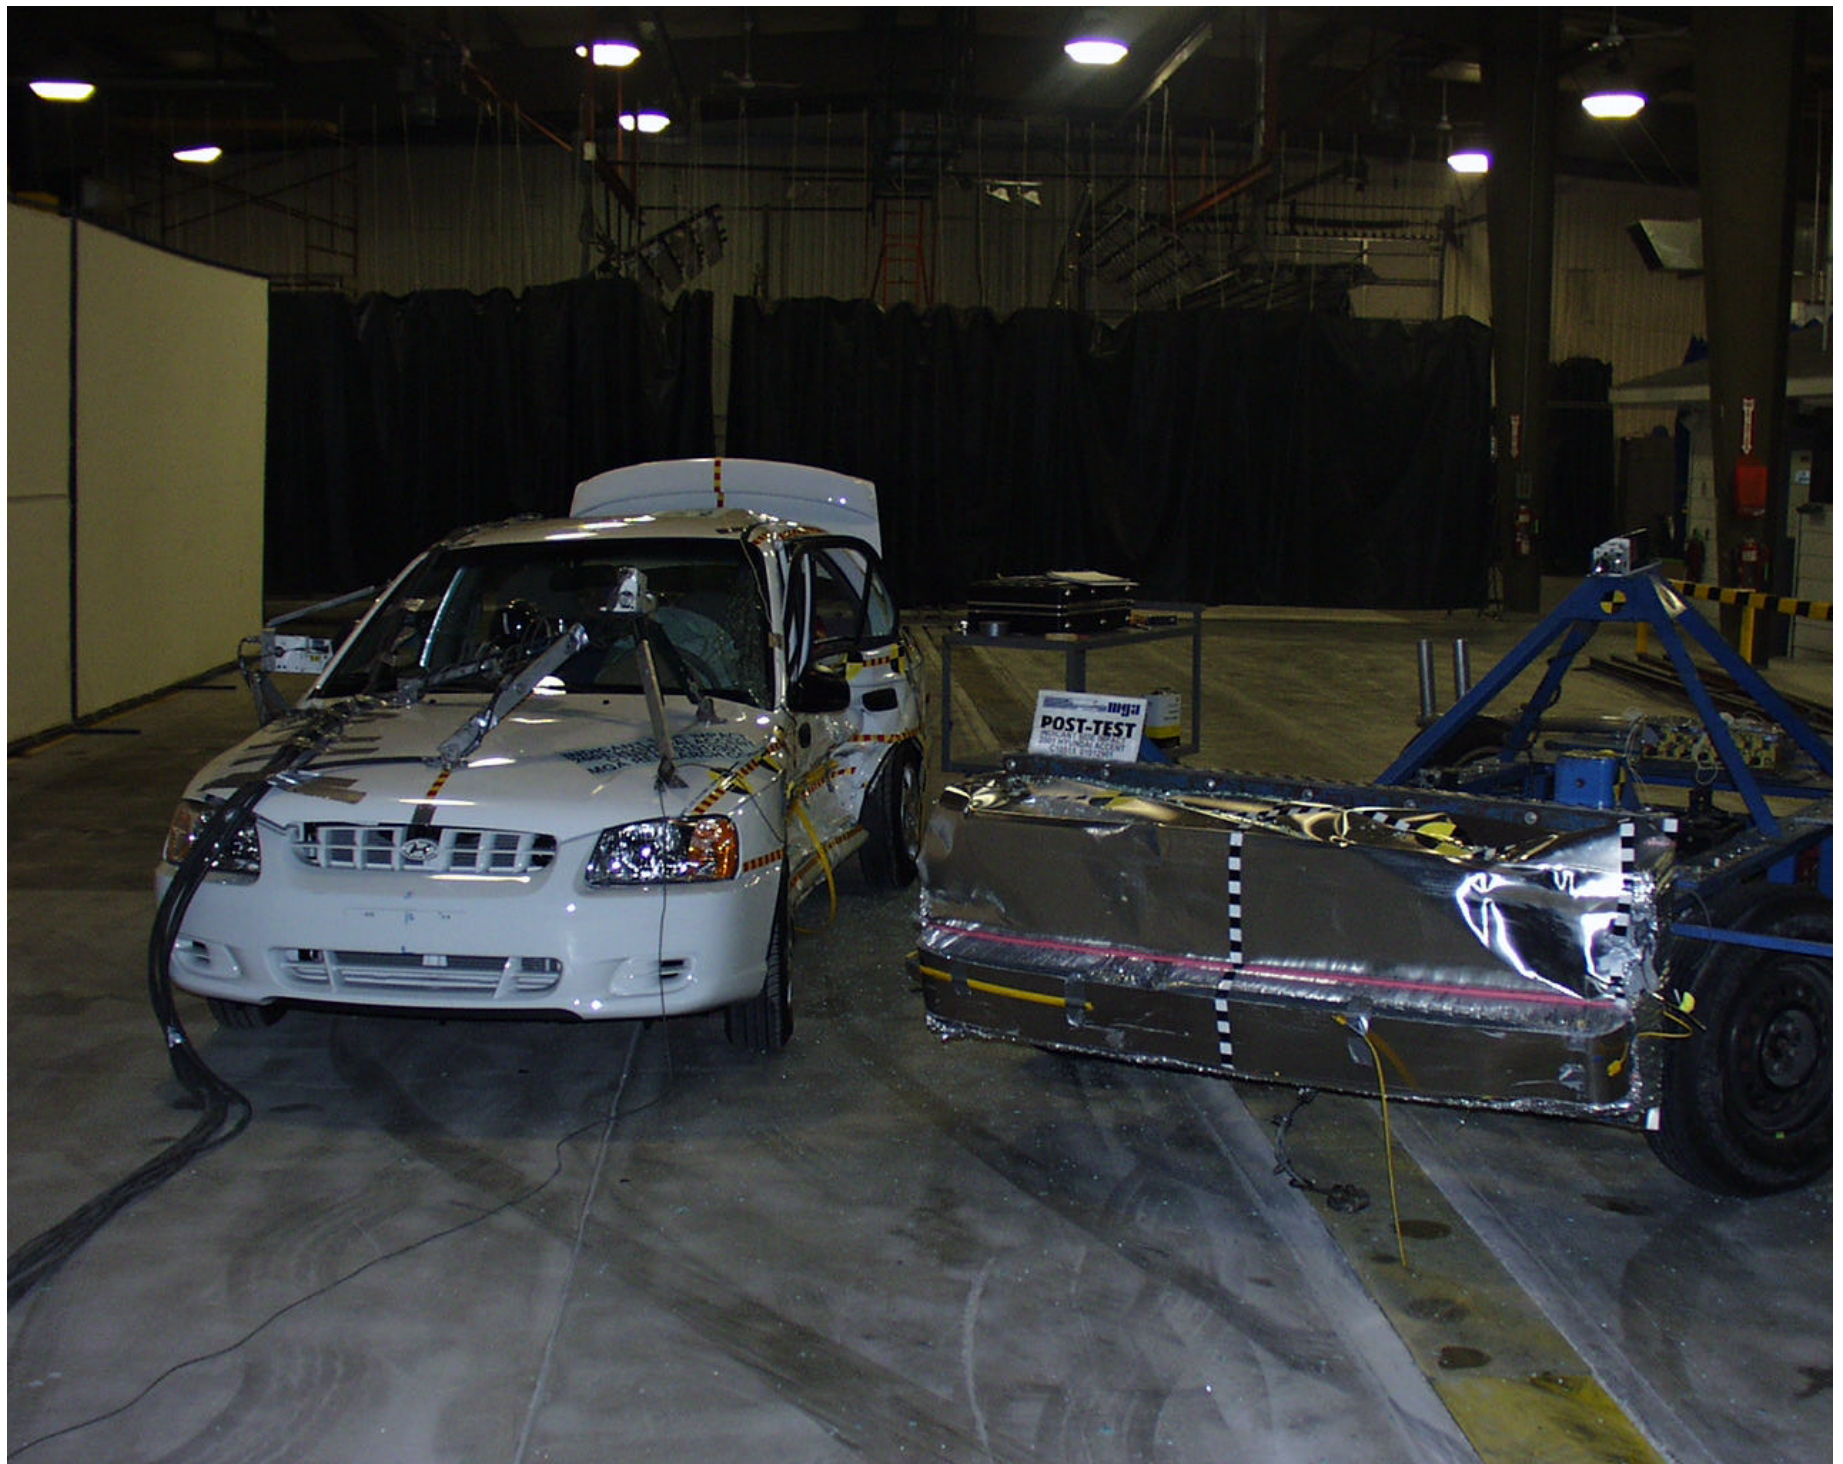
Photo No. A-10 - Post-Test MDB and Vehicle (left side)

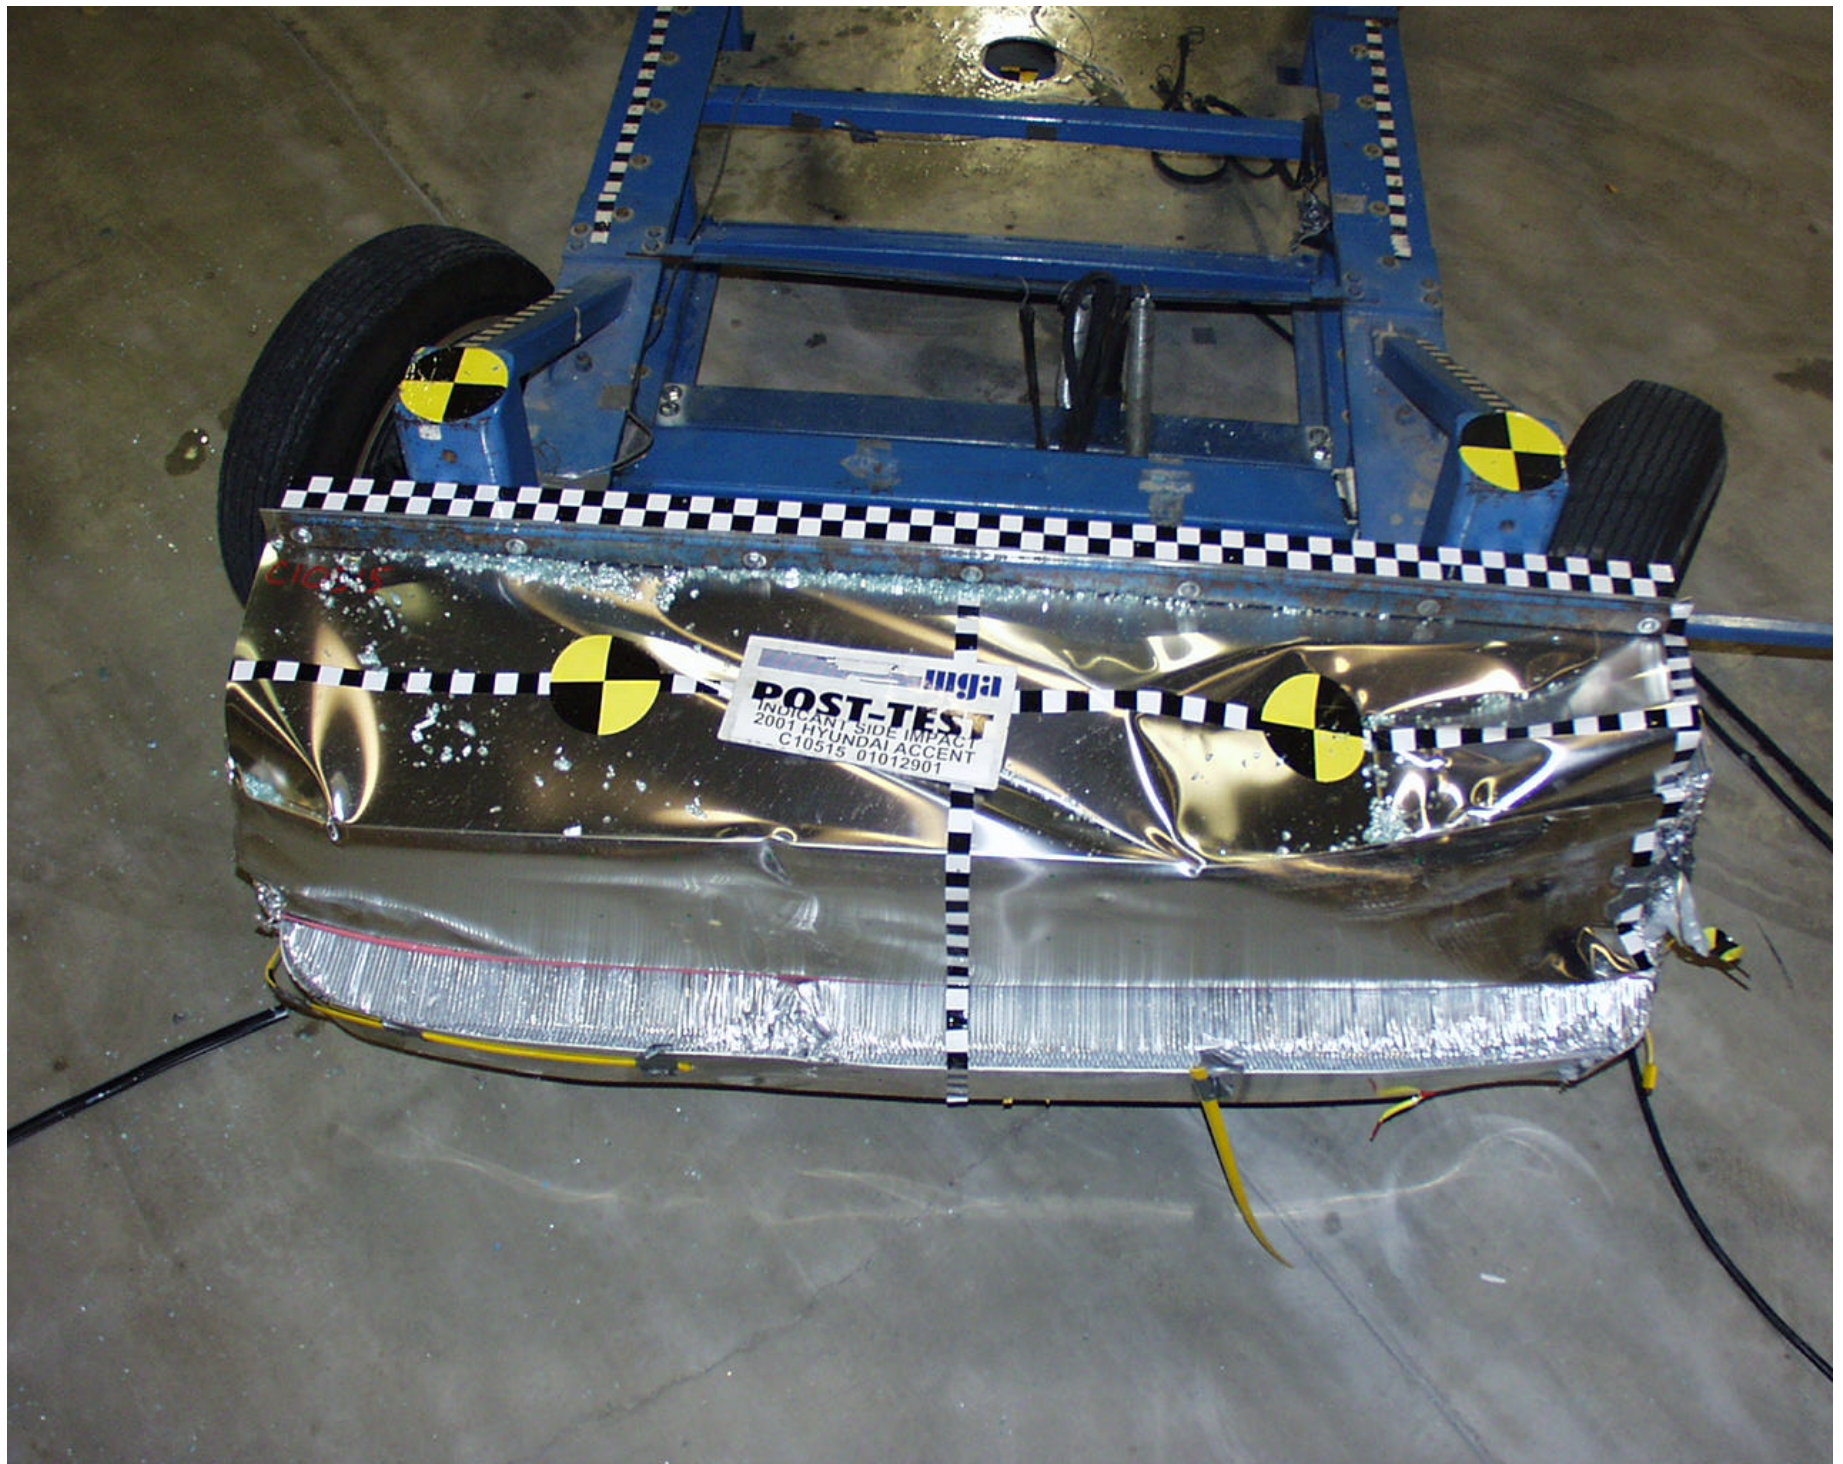
Photo No. A-13 - Post-Test MDB Top View

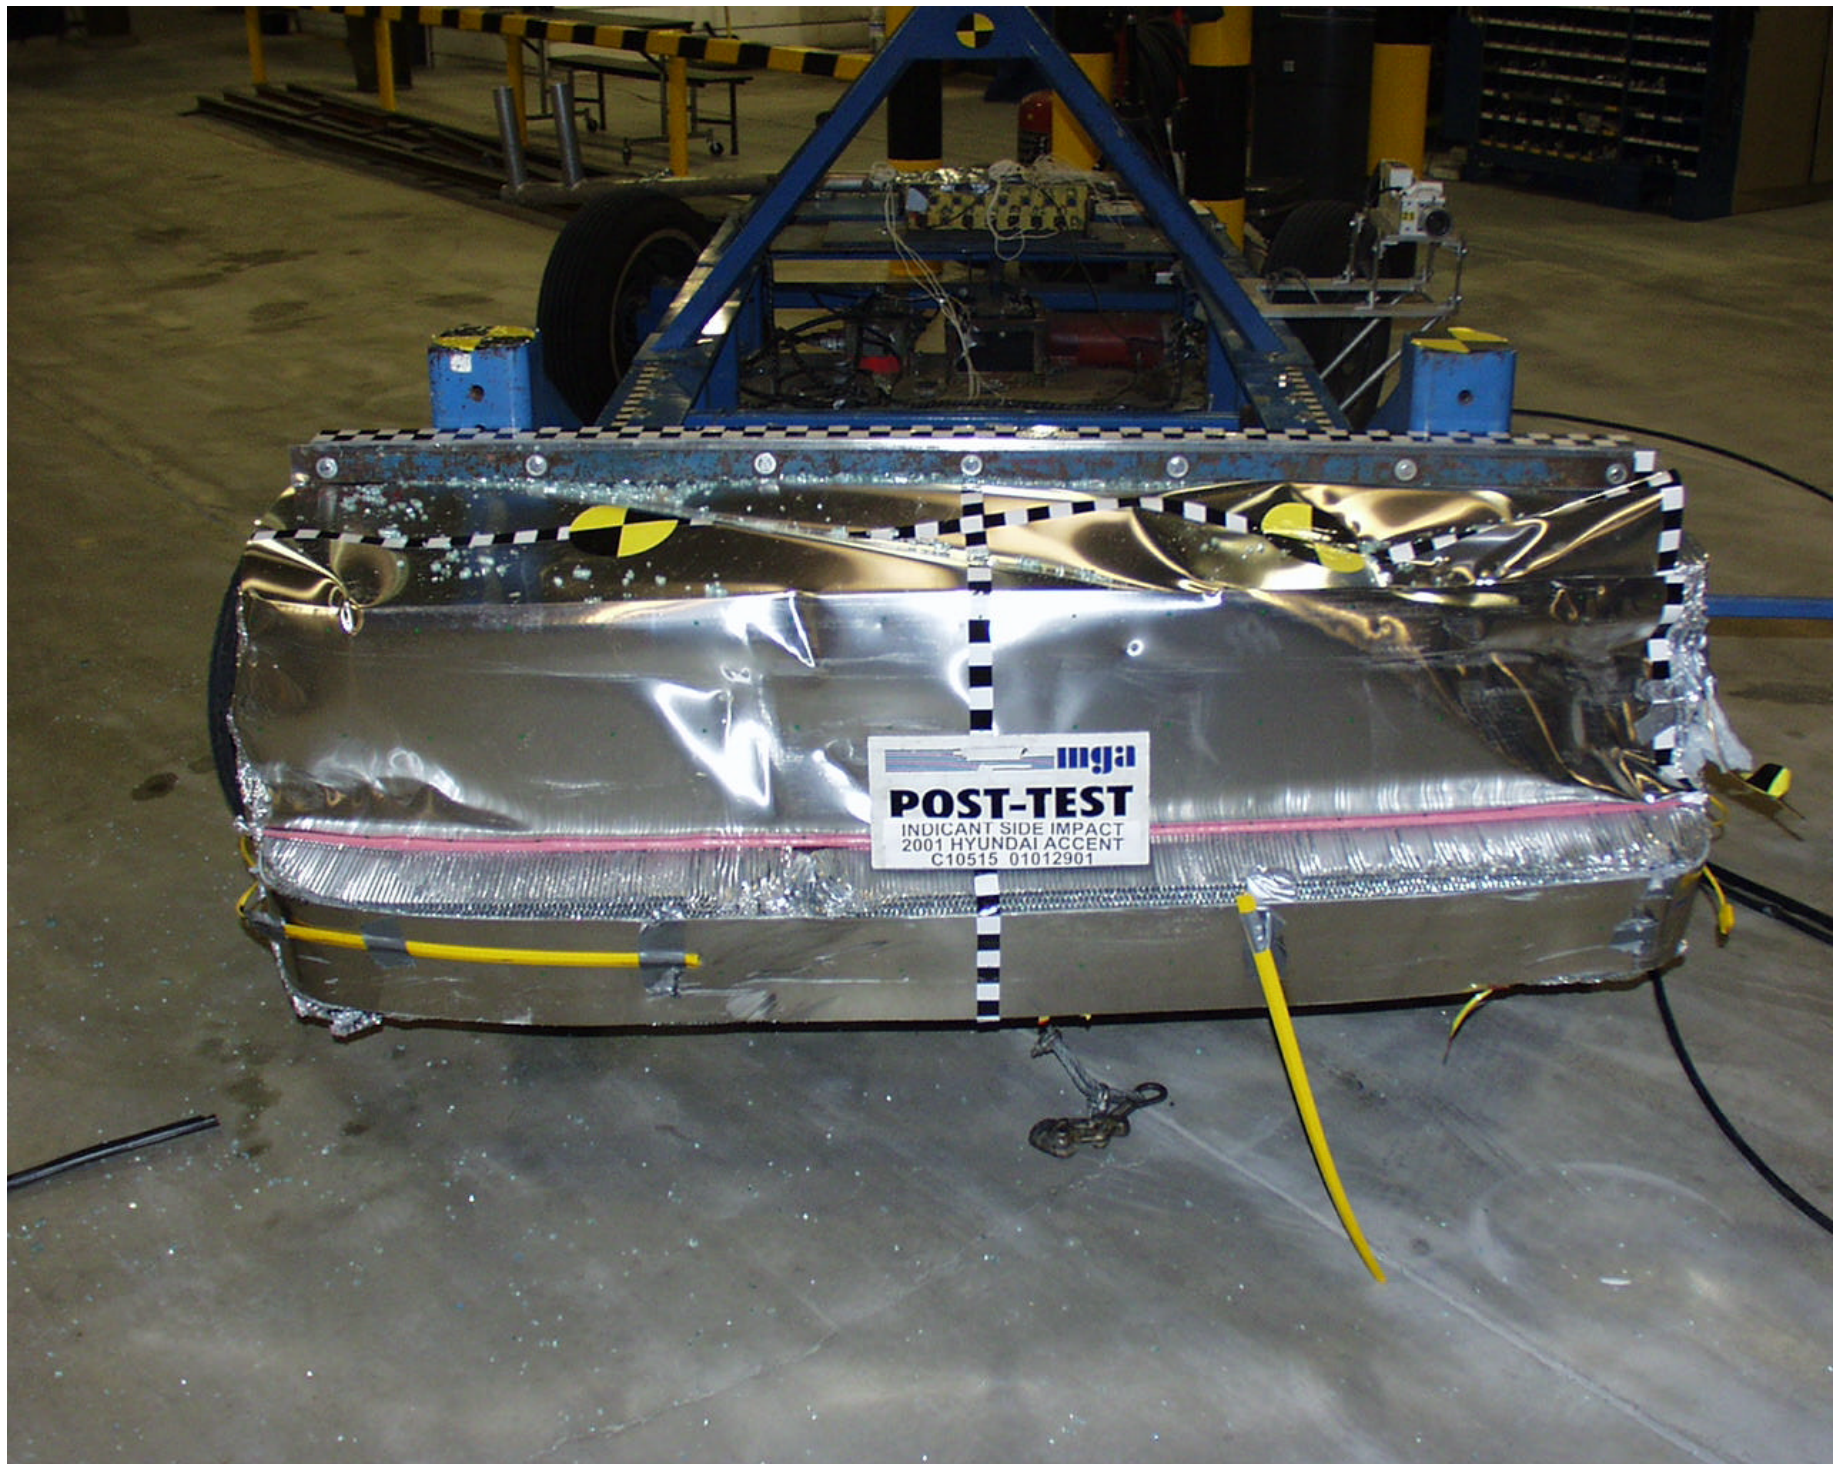
Photo No. A-15 - Post-Test MDB Front View

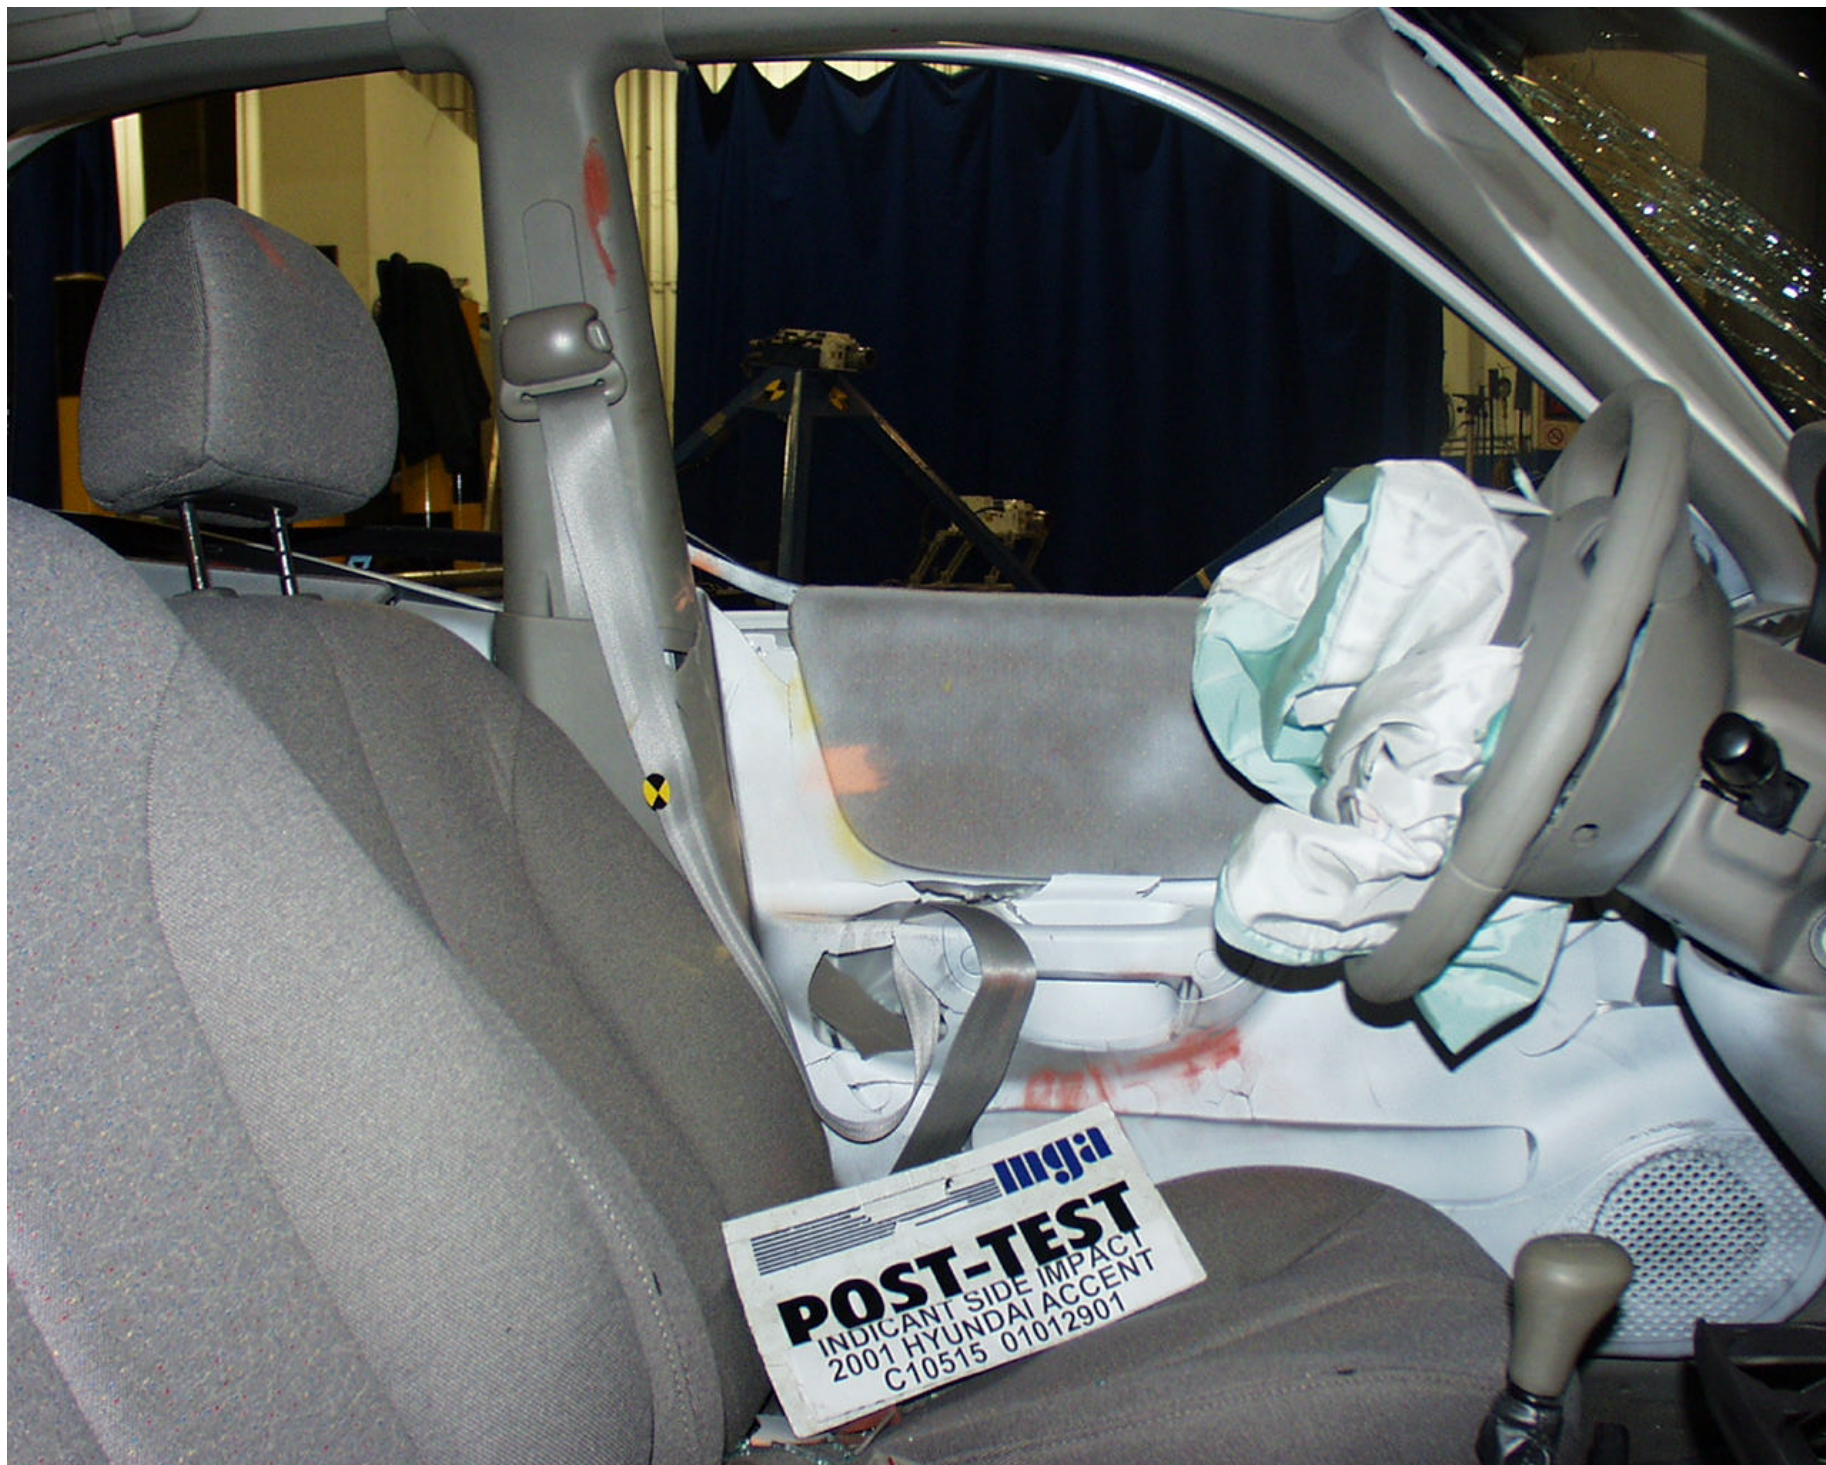
Photo No. A-27 - Post-Test Driver Dummy Contact

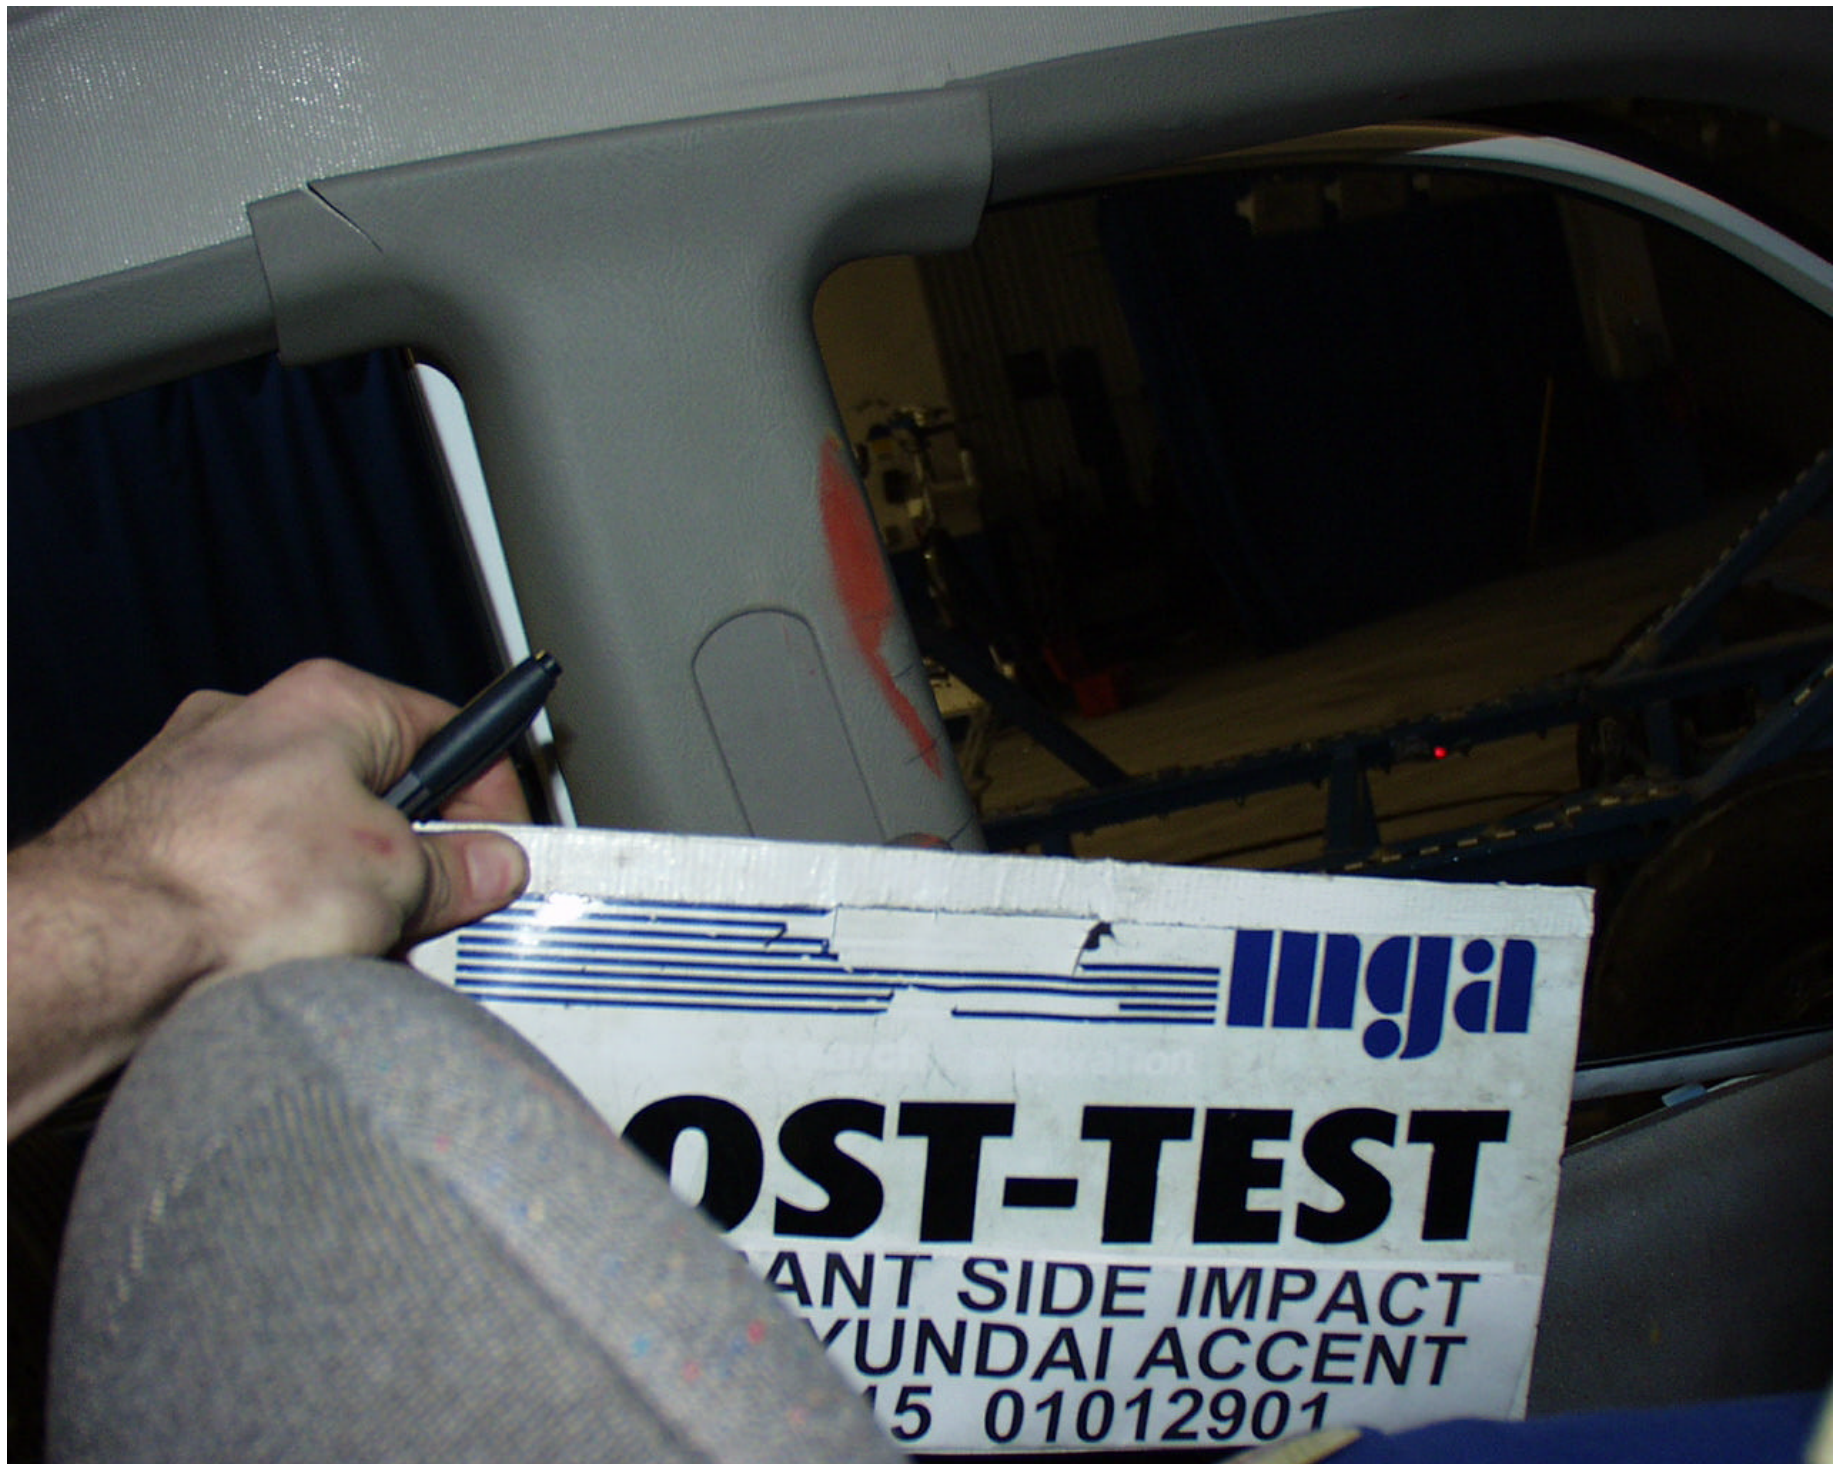
Photo No. A-28 - Post-Test Driver Dummy Head Contact

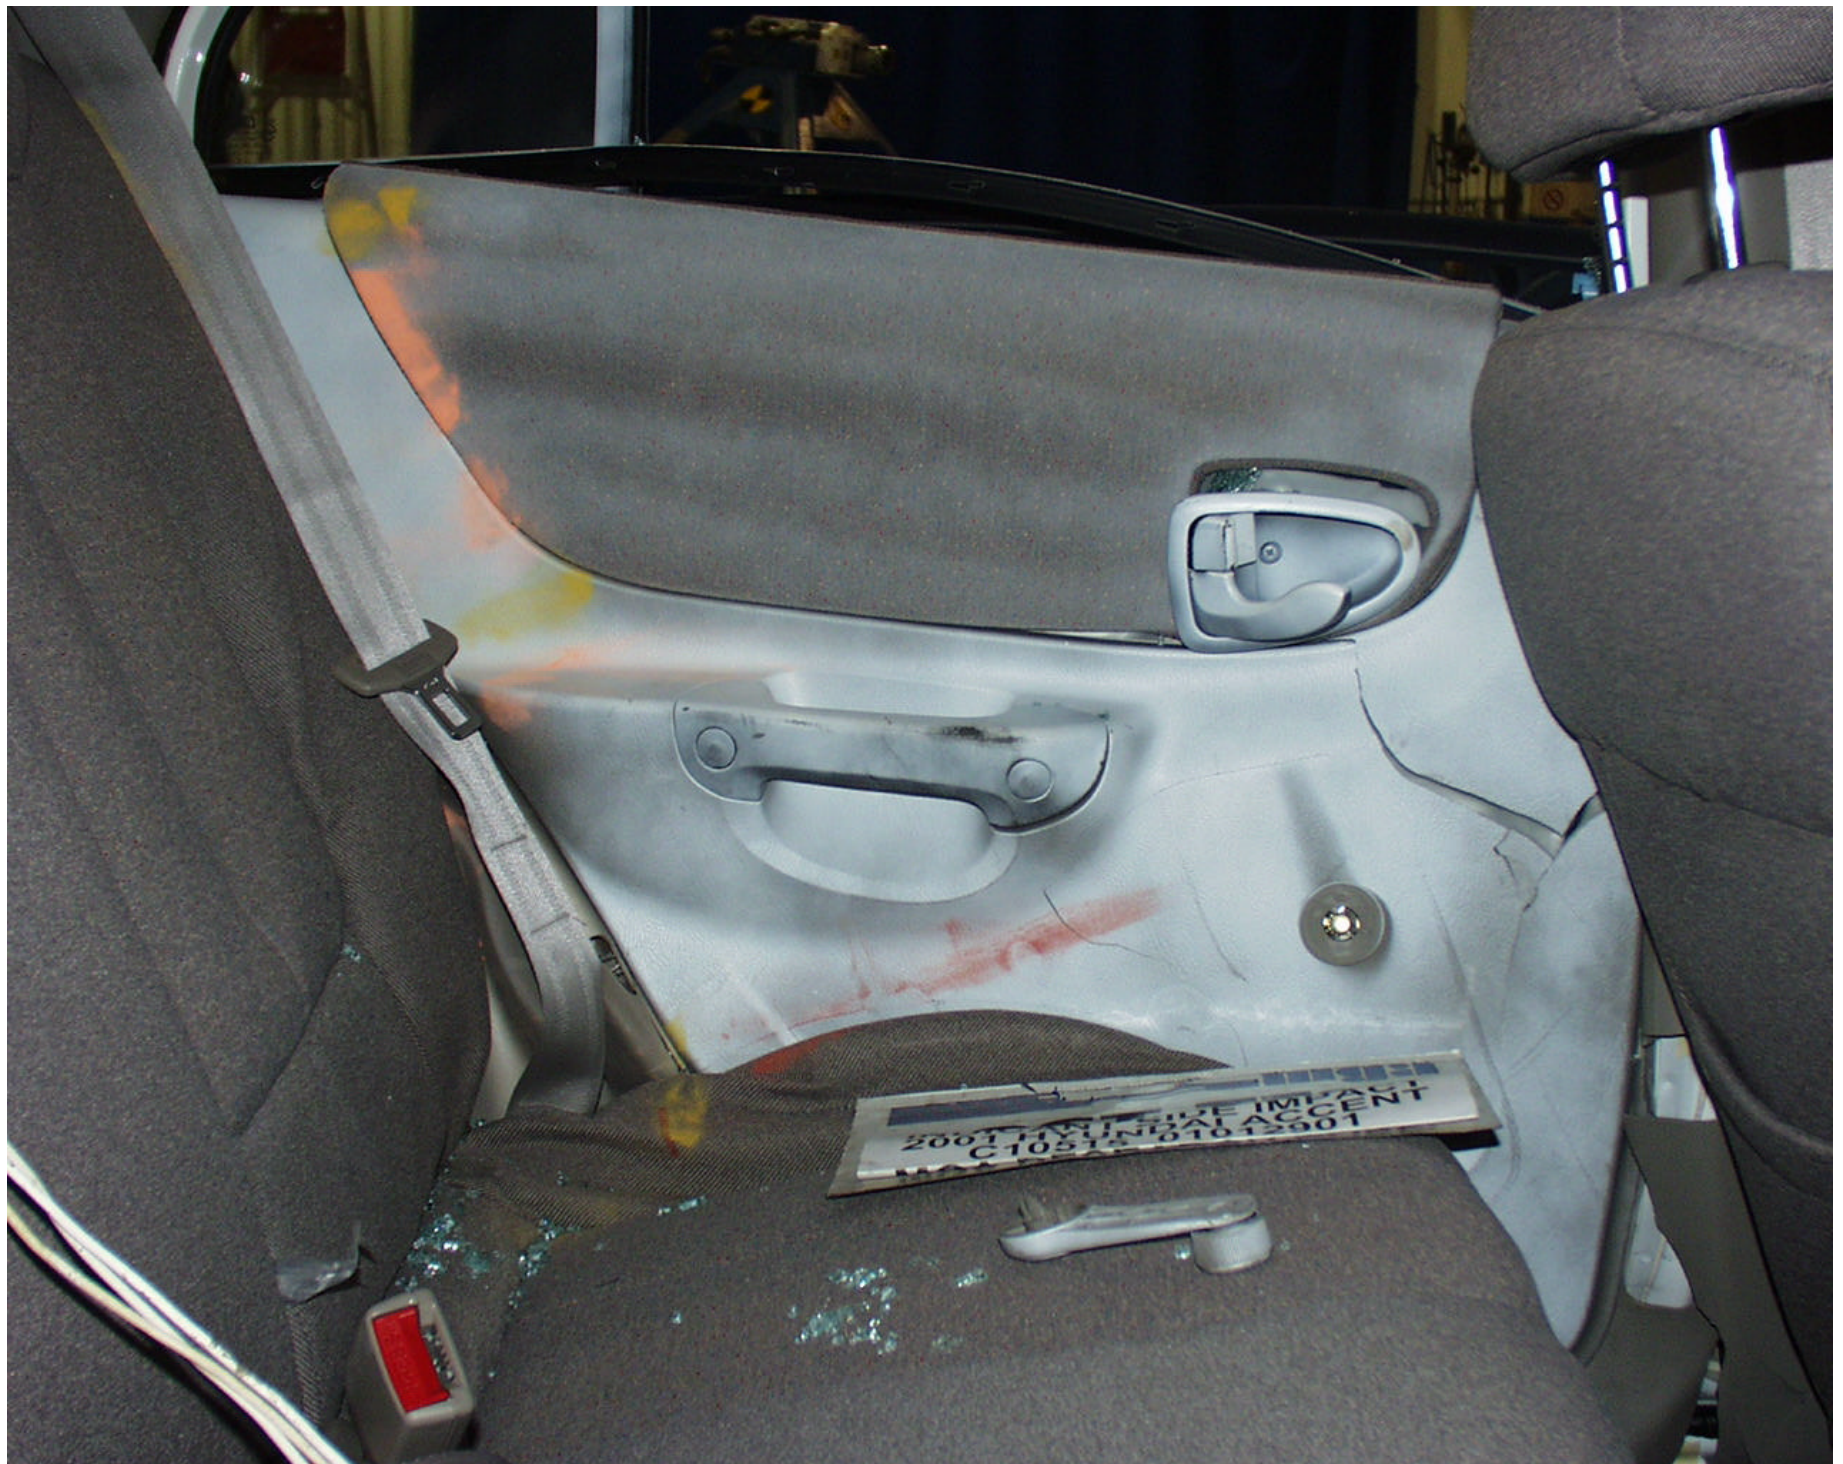
Photo No. A-36 - Post-Test Passenger Dummy Contact
