**REPORT NUMBER: 214D-MGA-2001-006**

**SAFETY COMPLIANCE TESTING FOR FMVSS 214  
SIDE IMPACT PROTECTION  
INDICANT**

**Hyundai Motor Company  
2001 Hyundai Accent GL 4 door  
NHTSA NUMBER:C10515**

**PREPARED BY:  
MGA RESEARCH CORPORATION  
5000 WARREN ROAD  
BURLINGTON, WI 53105**

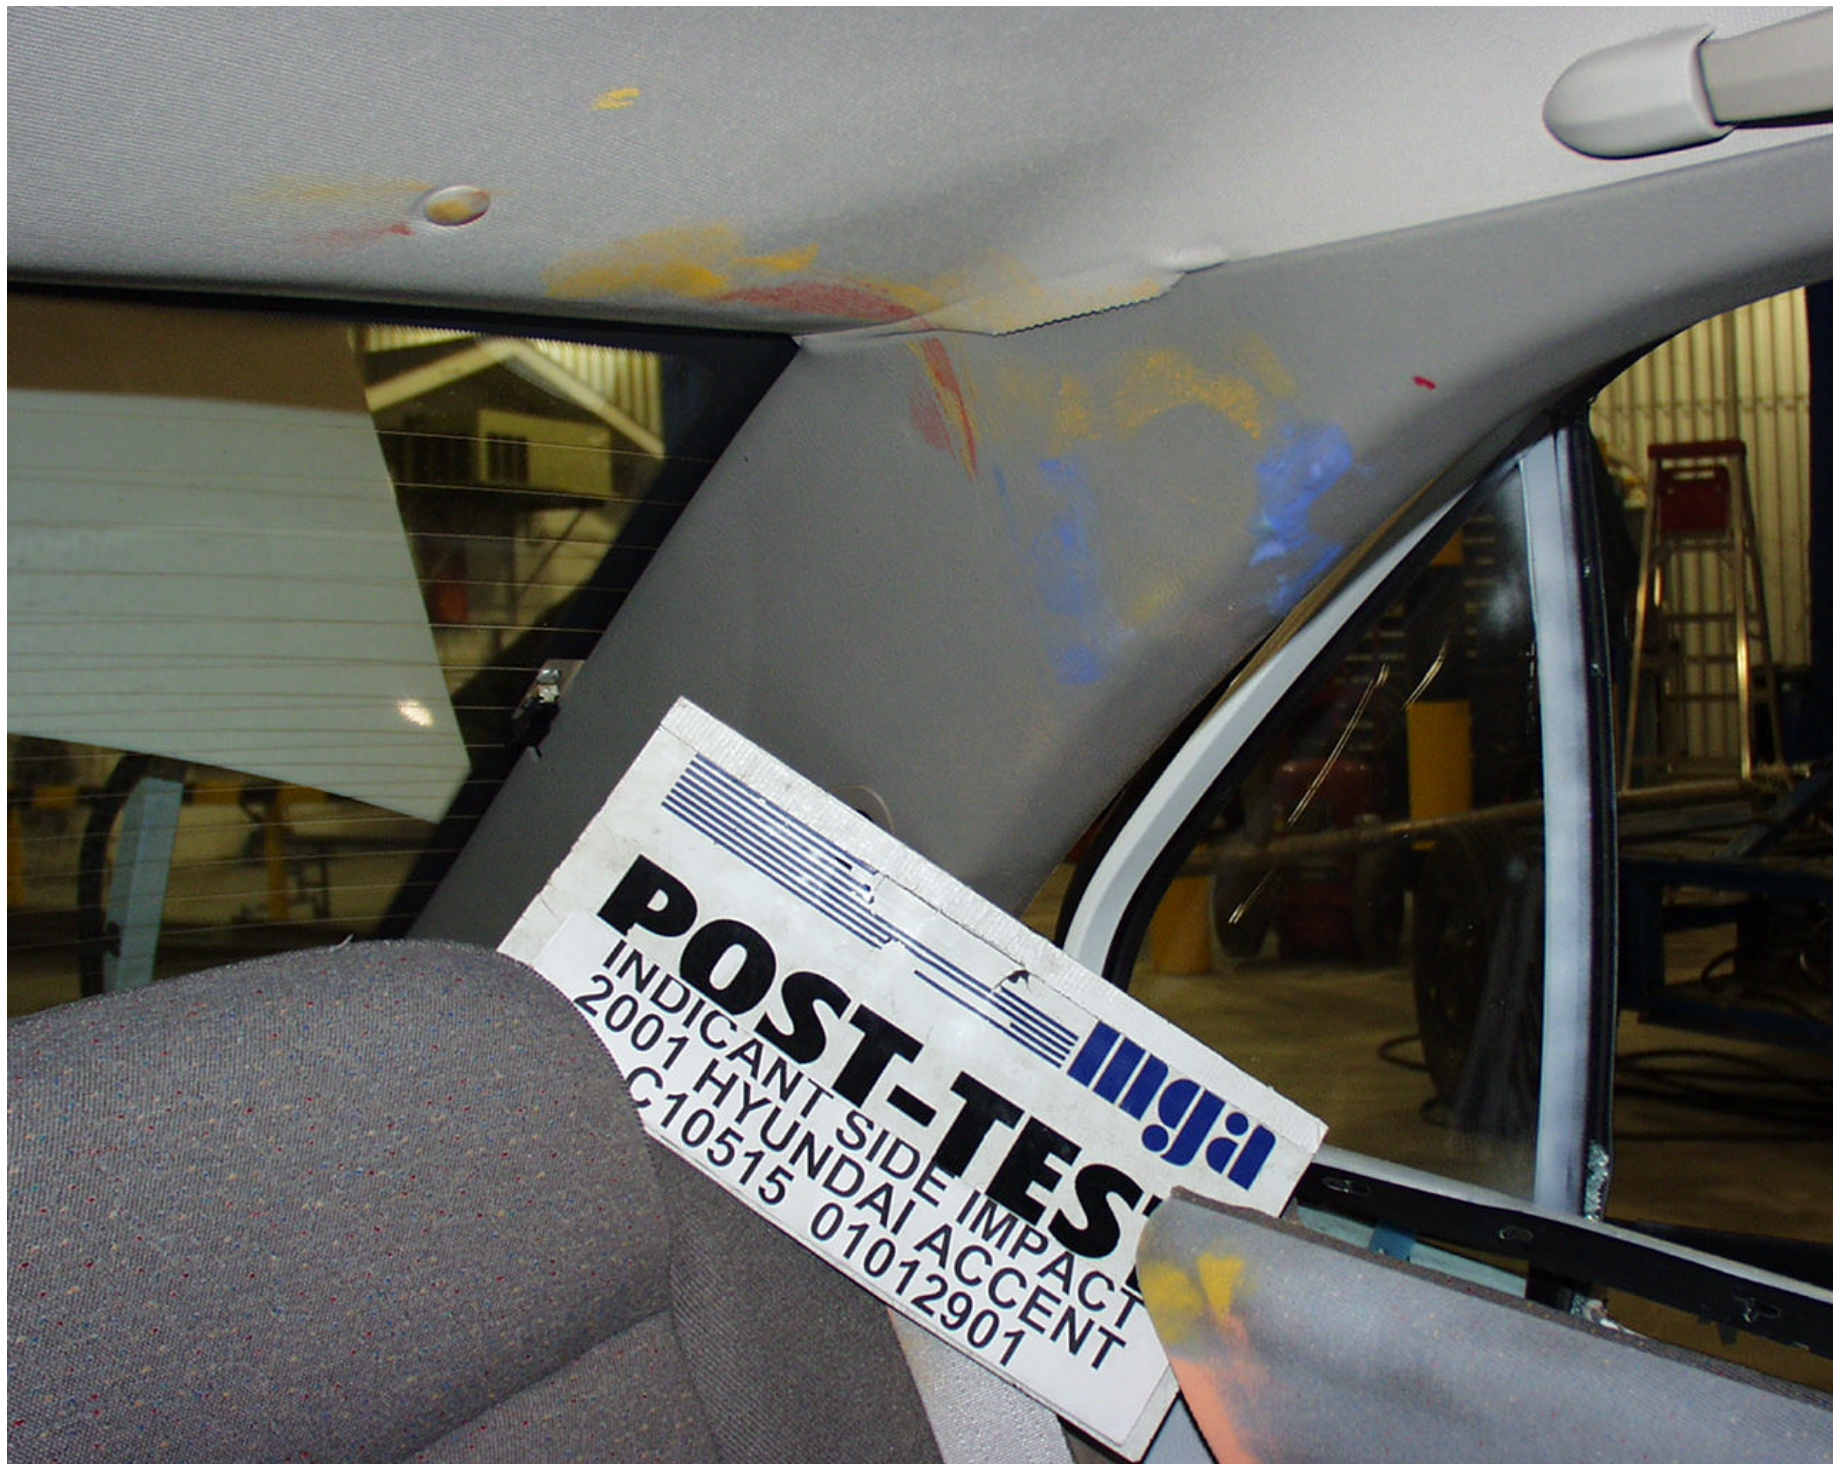
Photo No. A-37 - Post-Test Passenger Dummy Head Contact

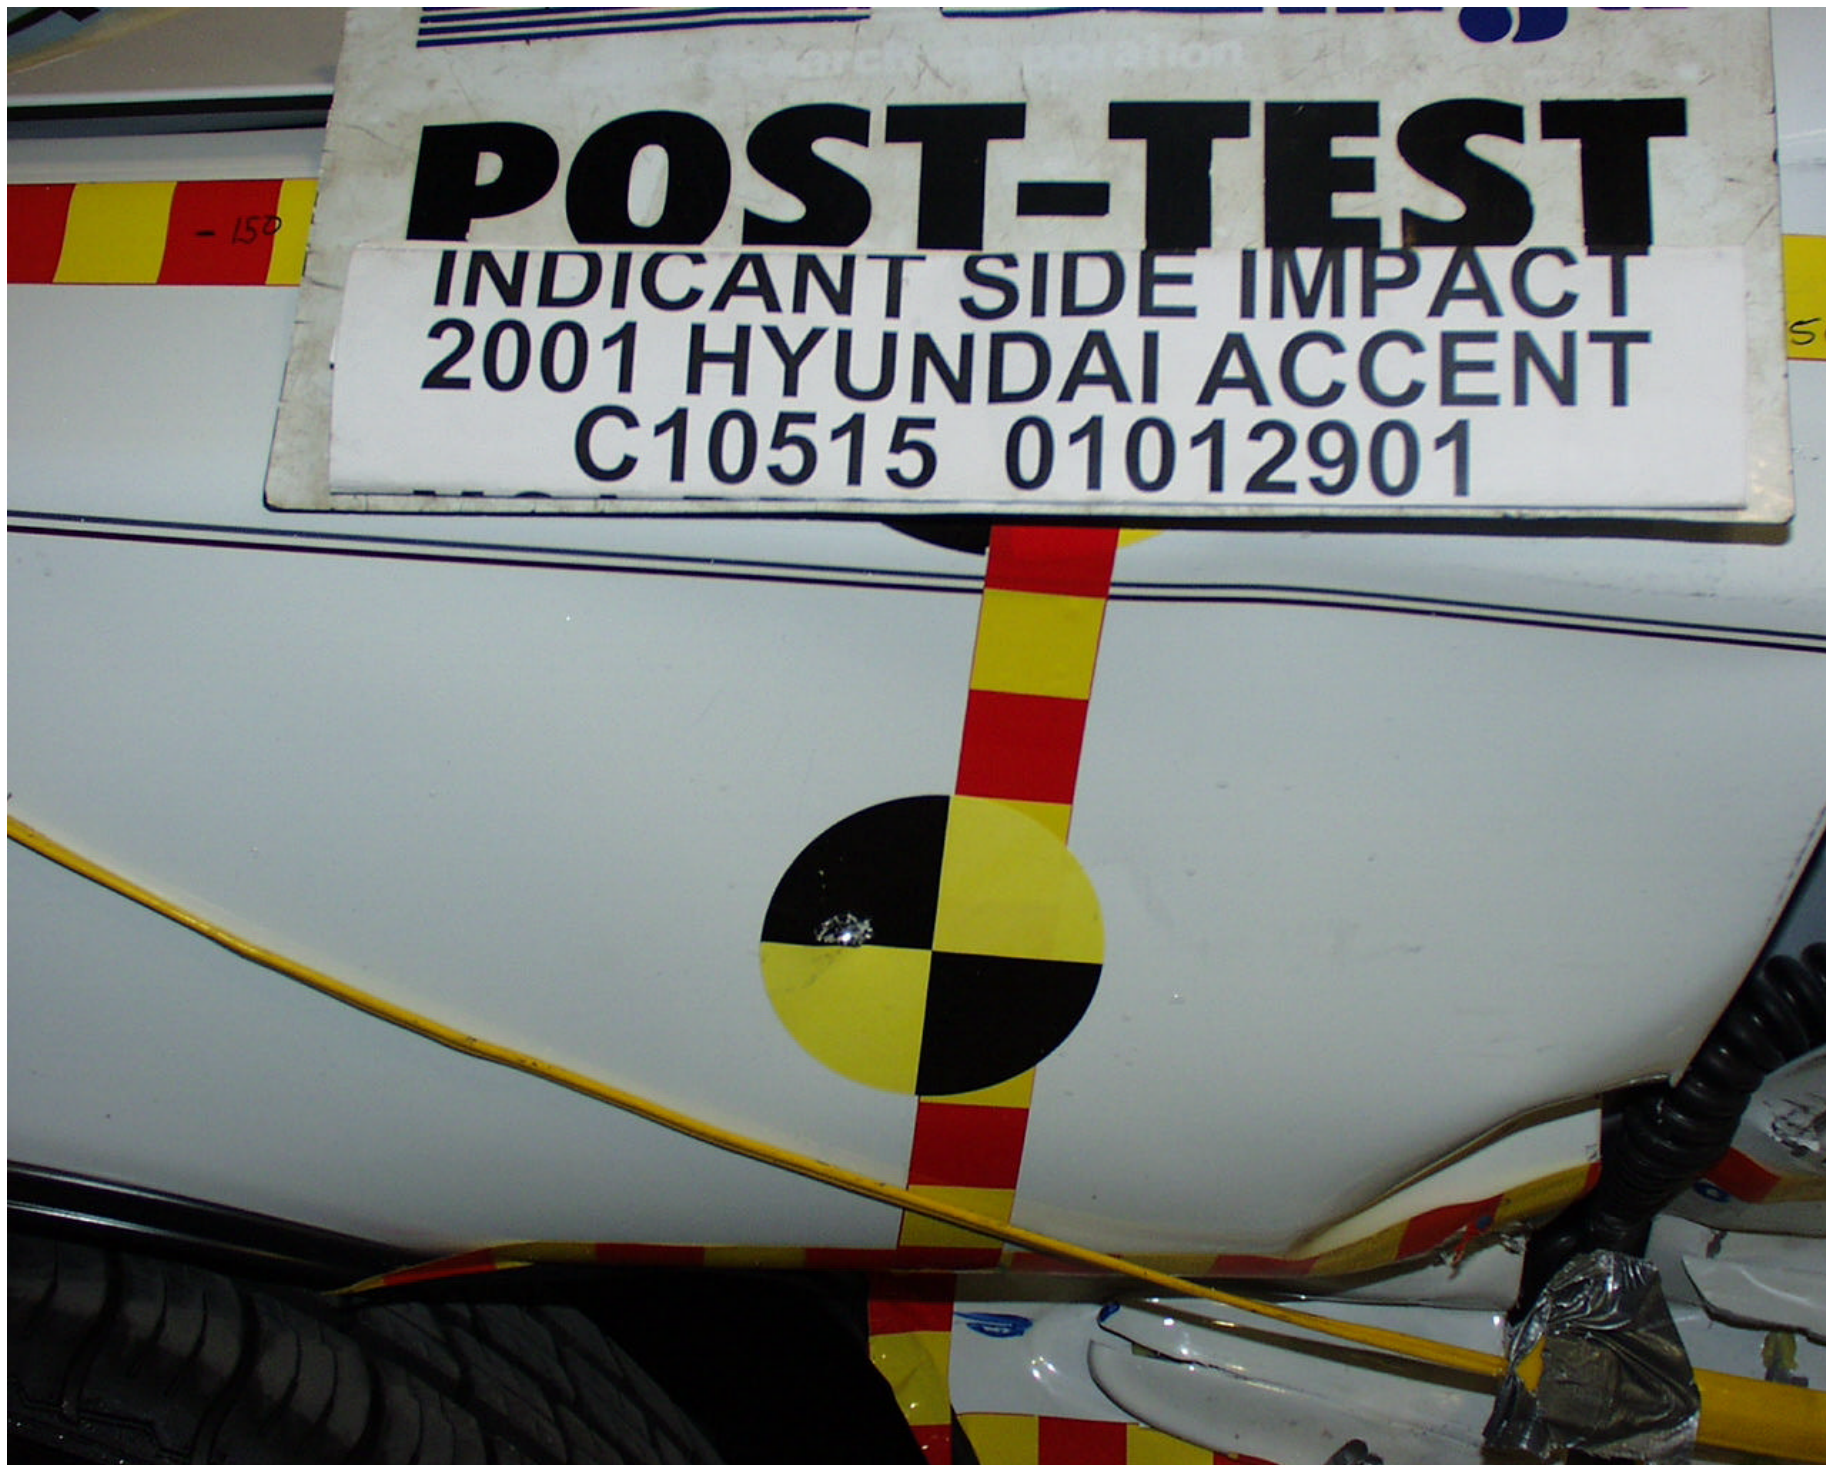
Photo No. A-39 - Post-Test Left Front Impact Point on Vehicle

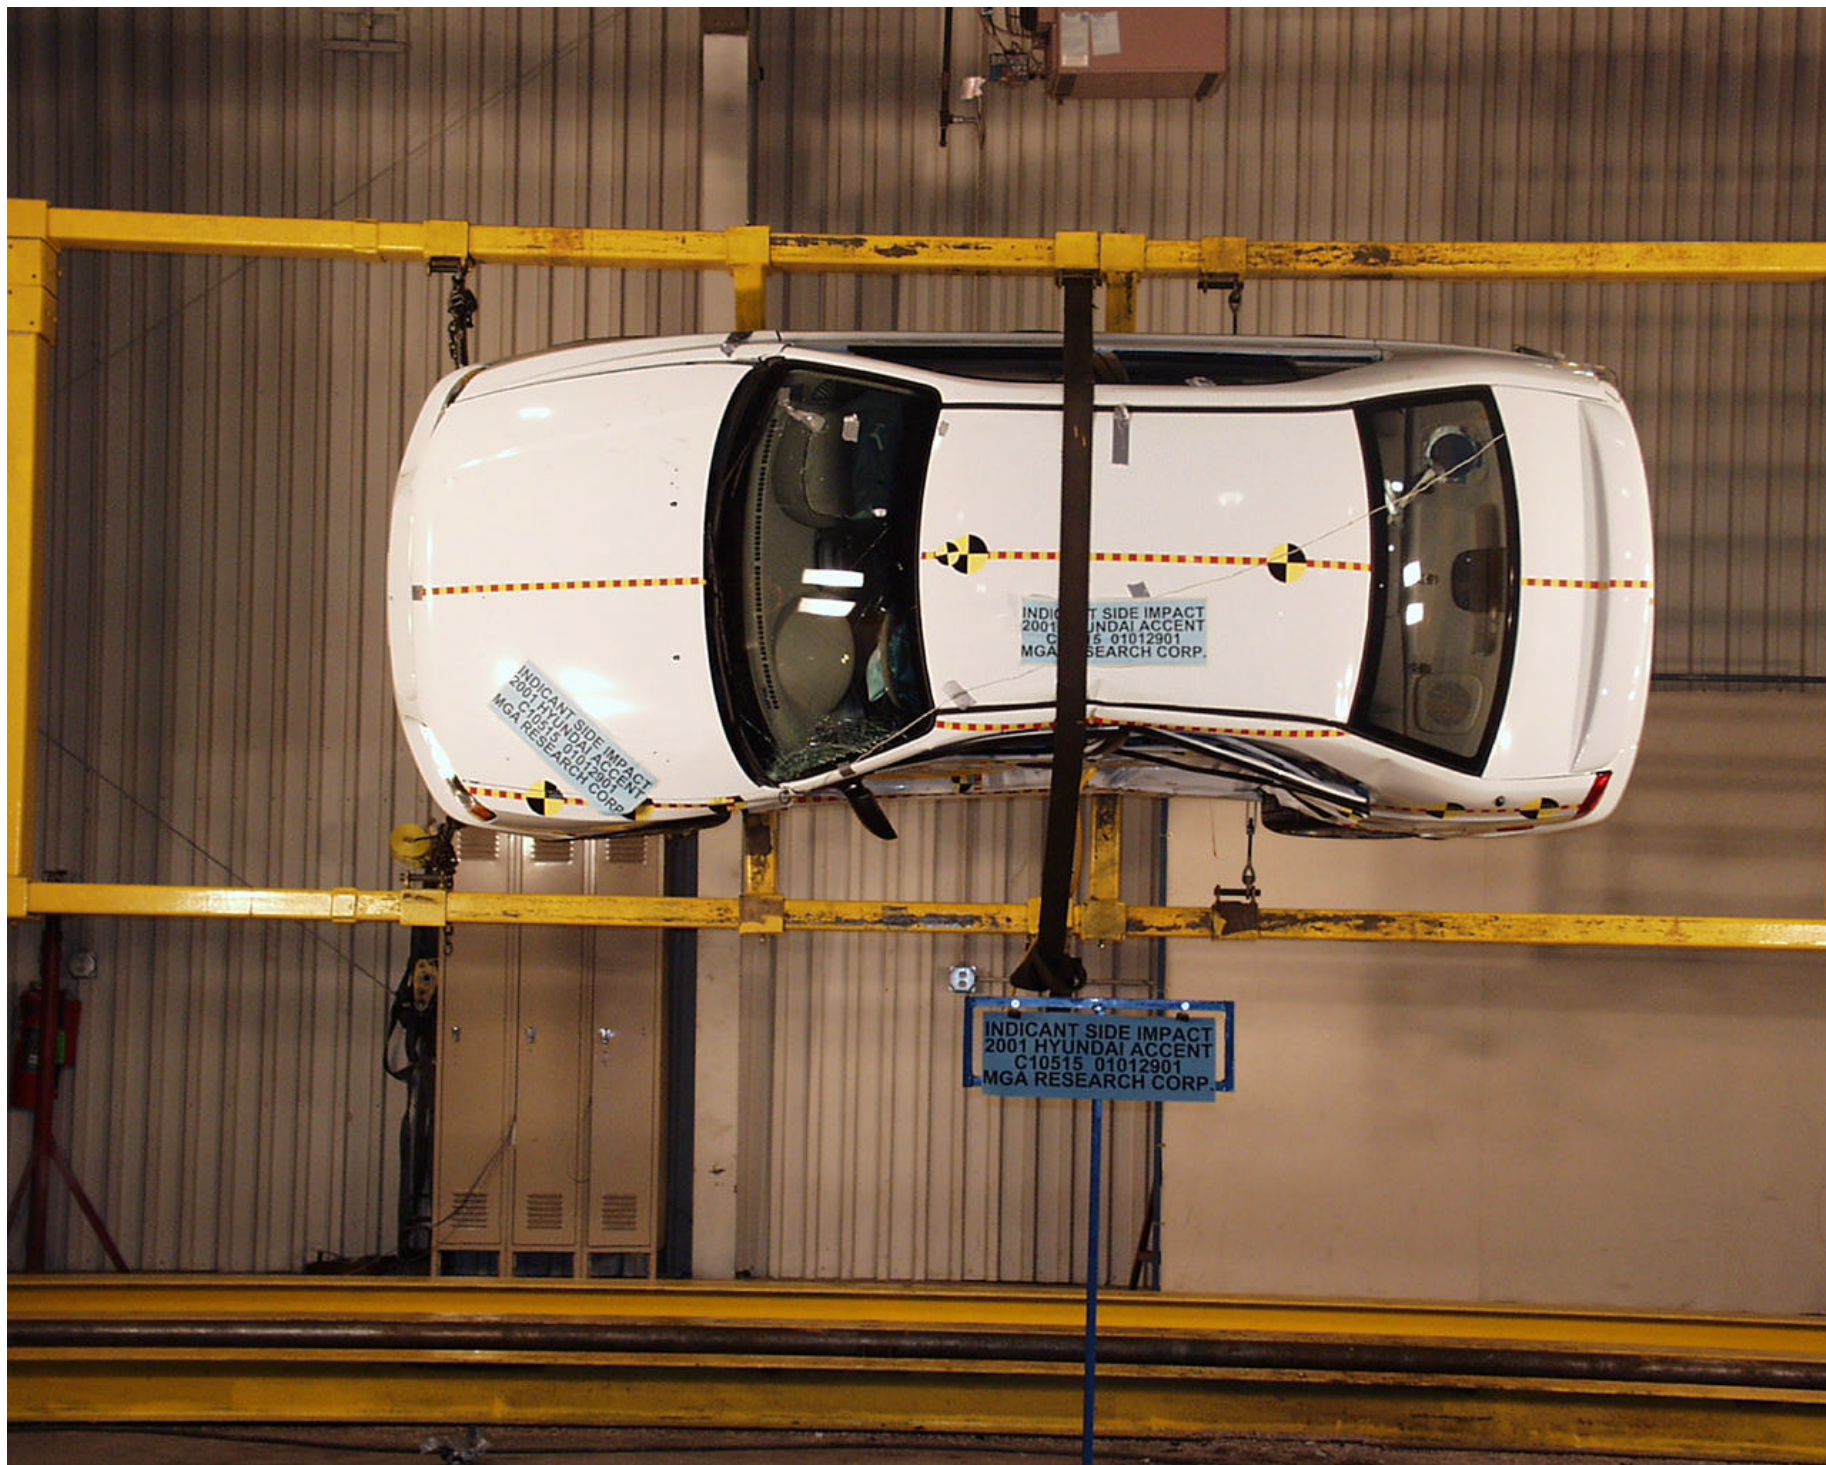
Photo No. A-43 - Rollover 90°
