REPORT NO. MCW-DOT-214-D3

**NEW CAR ASSESSMENT PROGRAM
SIDE IMPACT TESTING**

DAIMLERCHRYSLER CORPORATION
2001 DODGE DAKOTA SPORT
QUAD CAB PICKUP TRUCK

NHTSA NUMBER: M1 0304

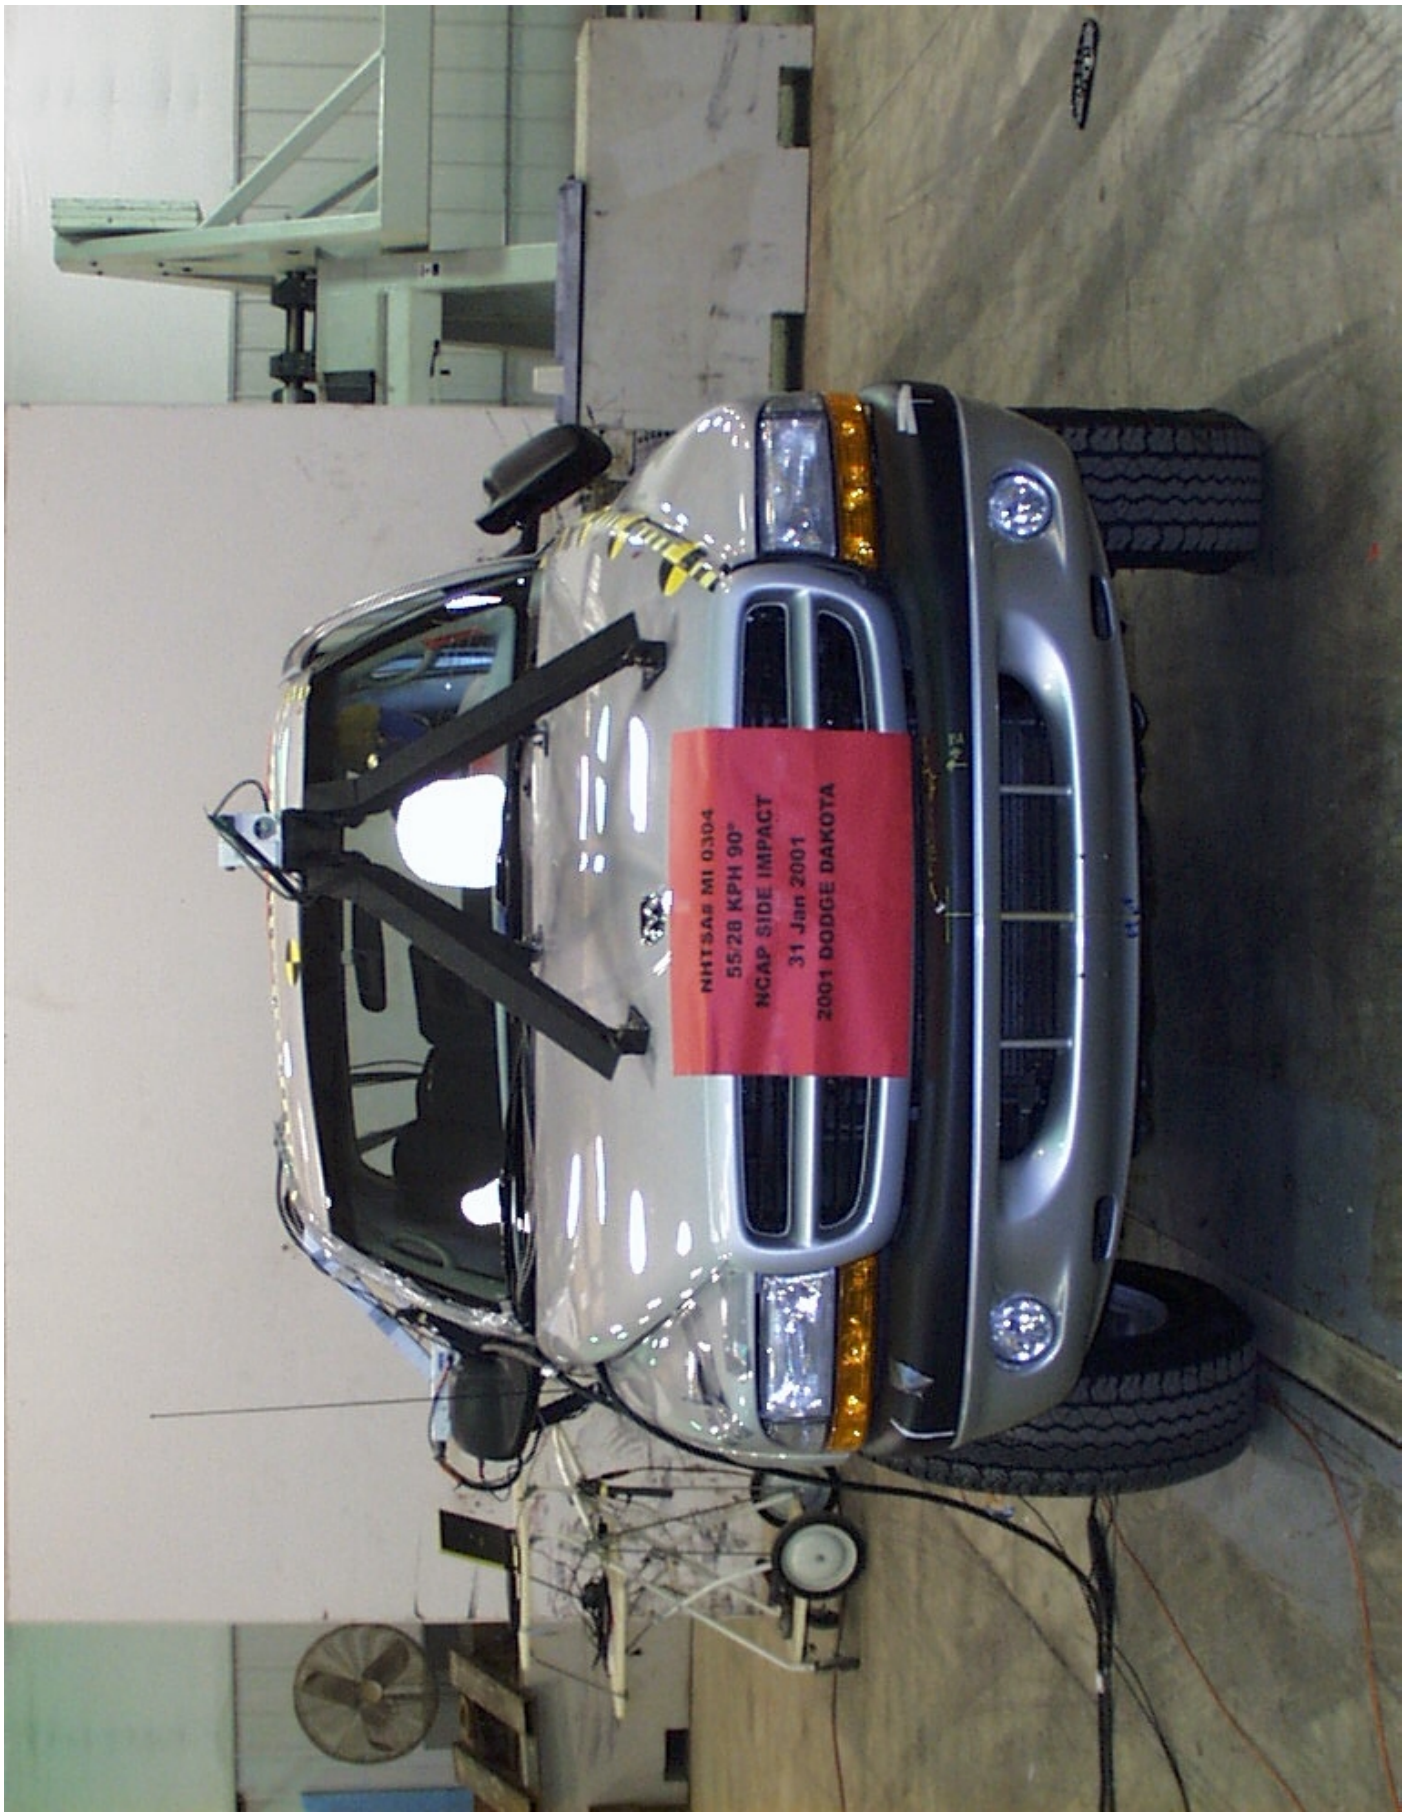
Figure A-2: POST-TEST FRONTAL VIEW OF TEST VEHICLE

Windshield	<u>Lower left side of windshield cracked during impact</u>
Window	<u>None</u>

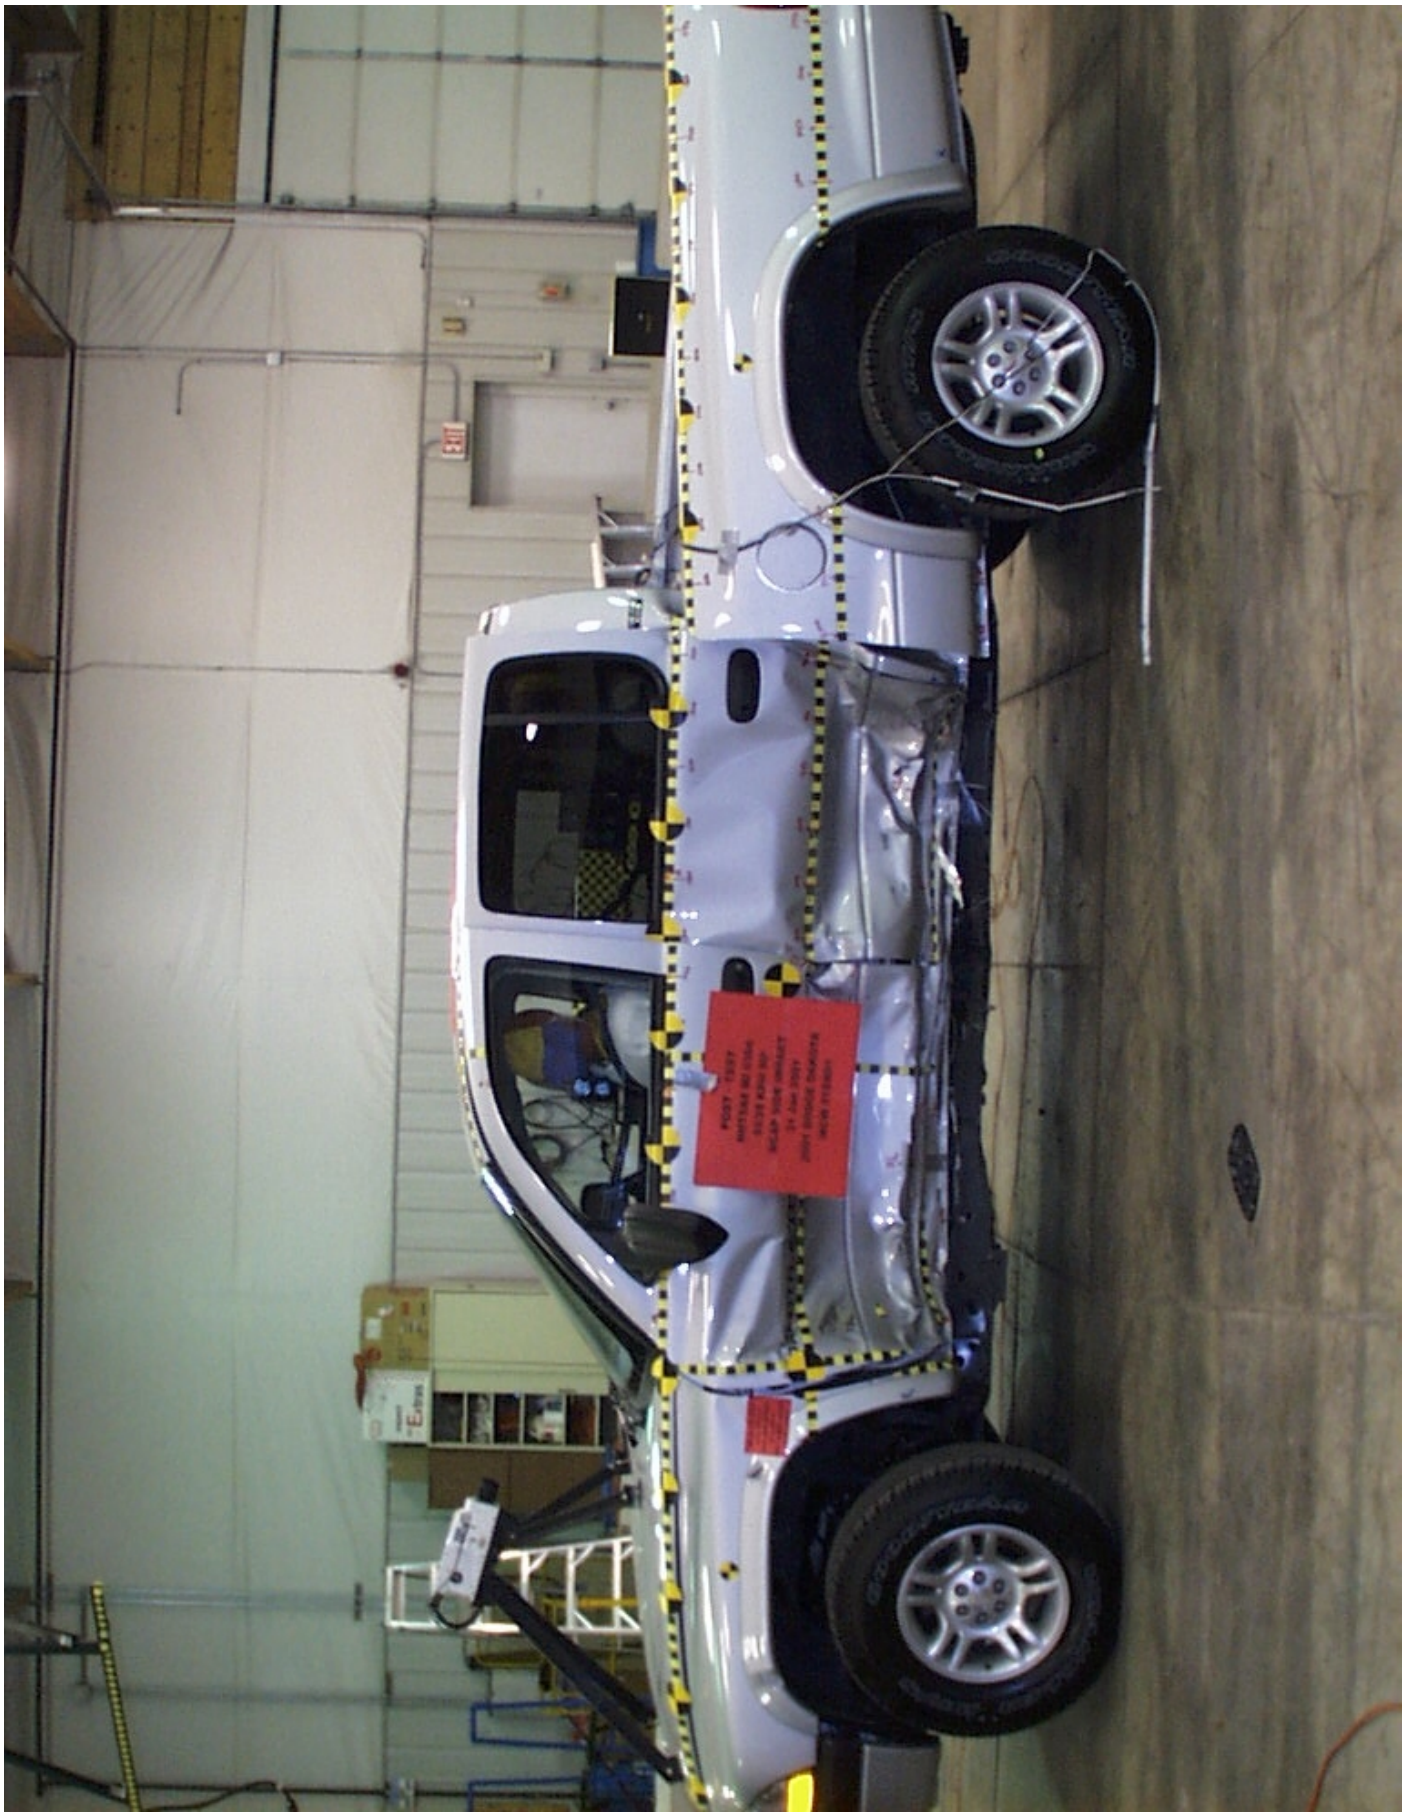
Figure A-6 POST-TEST IMPACTED SIDE VIEW OF TEST VEHICLE

1. LEVEL 1	(453 mm above ground)	=	243	mm
2. LEVEL 2	(same as Level 3)	=	N/a	mm
3. LEVEL 3	(834 mm above ground)	=	165	mm
4. LEVEL 4	(1210 mm above ground)	=	73	mm
5. LEVEL 5	(1676 mm above ground)	=	46	mm

Maximum Post-Test intrusion at Level 1 is 243 mm

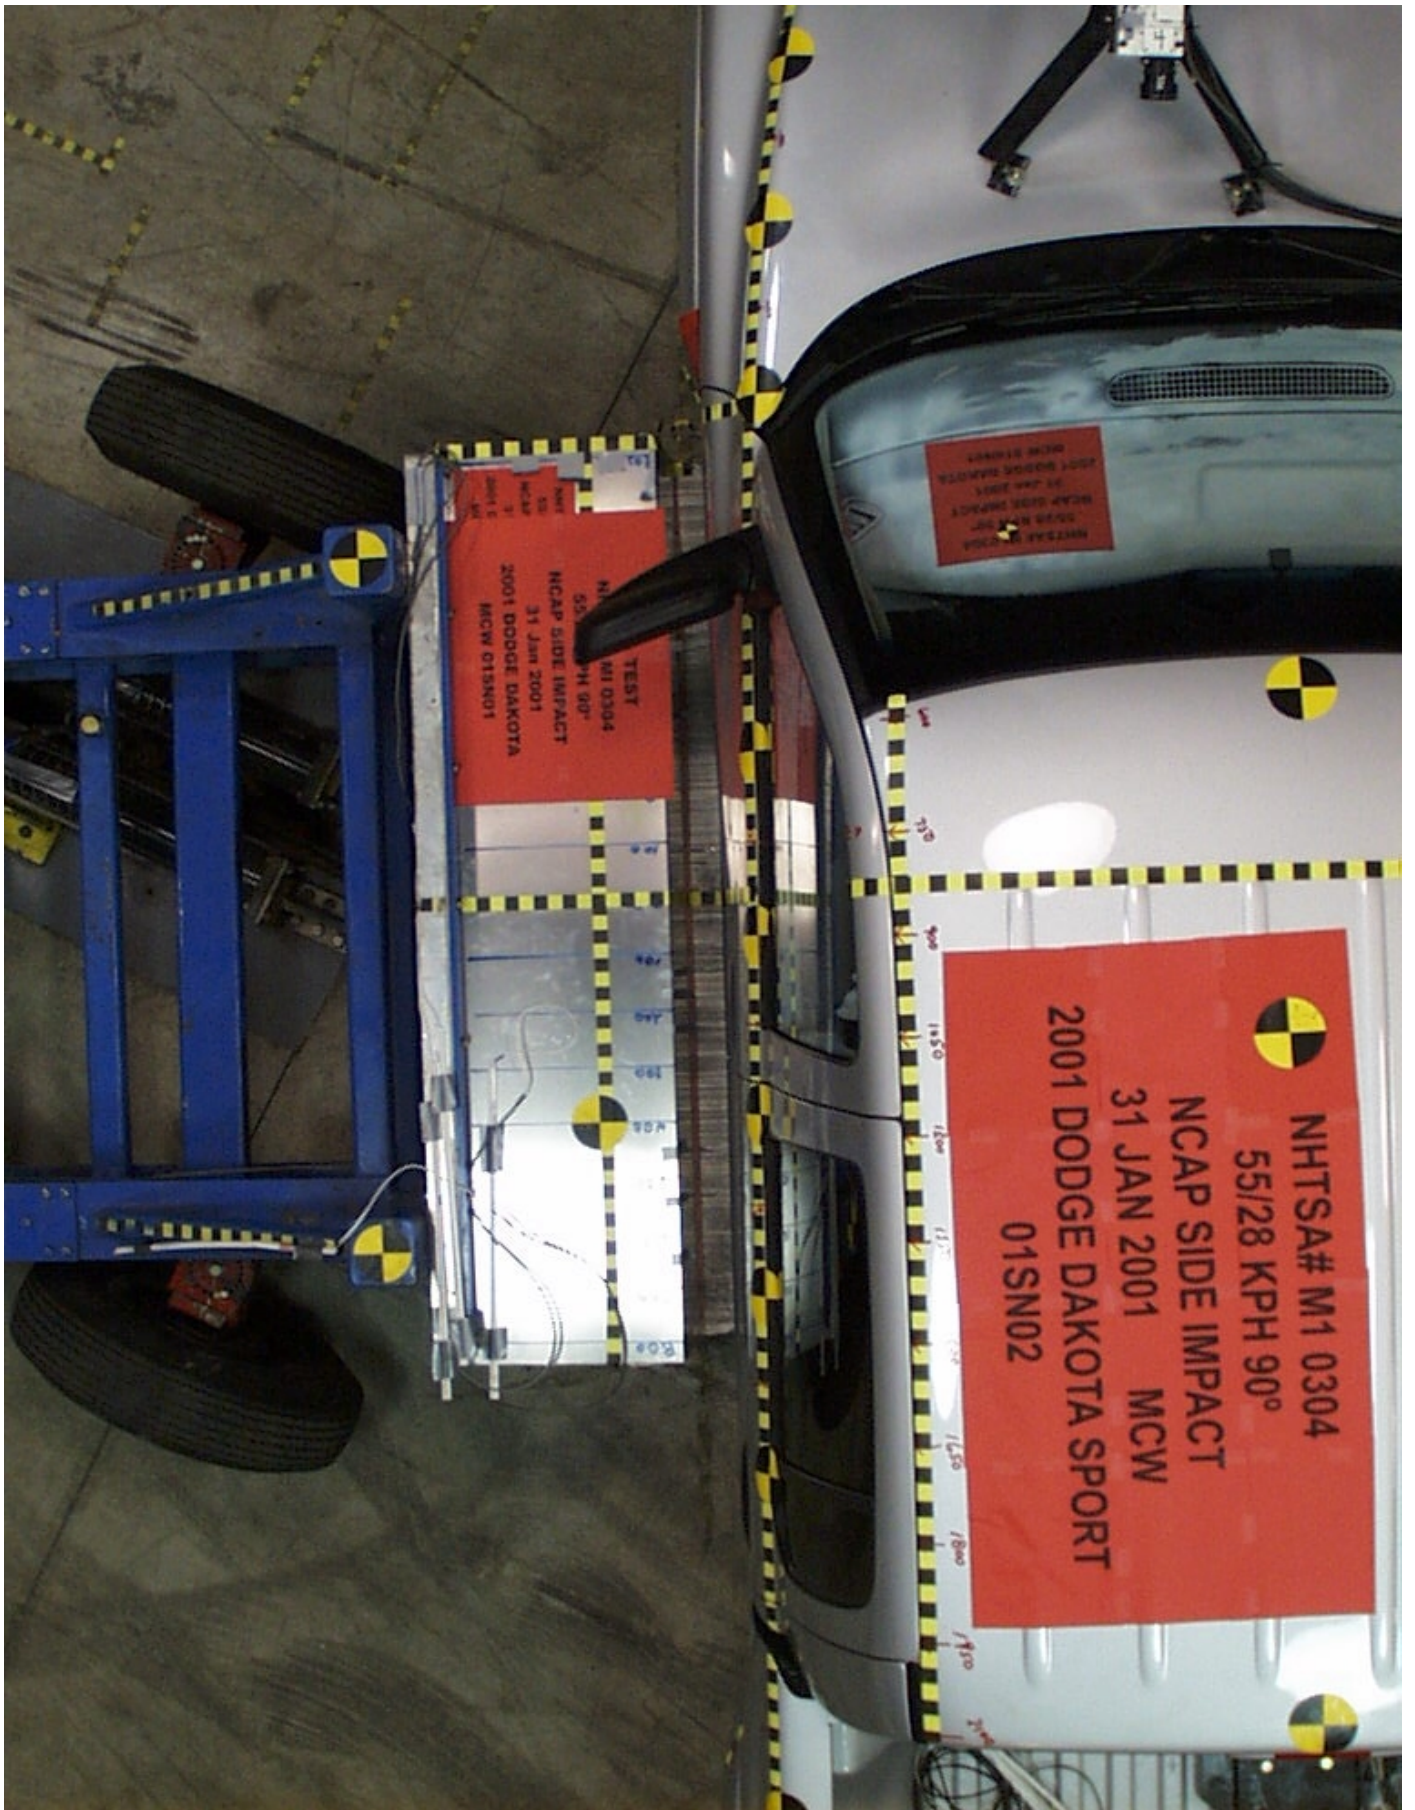
Figure A-13 PRE-TEST OVERHEAD VIEW OF ALIGNED MDB AND VEHICLE

Crabbed 27° to the left

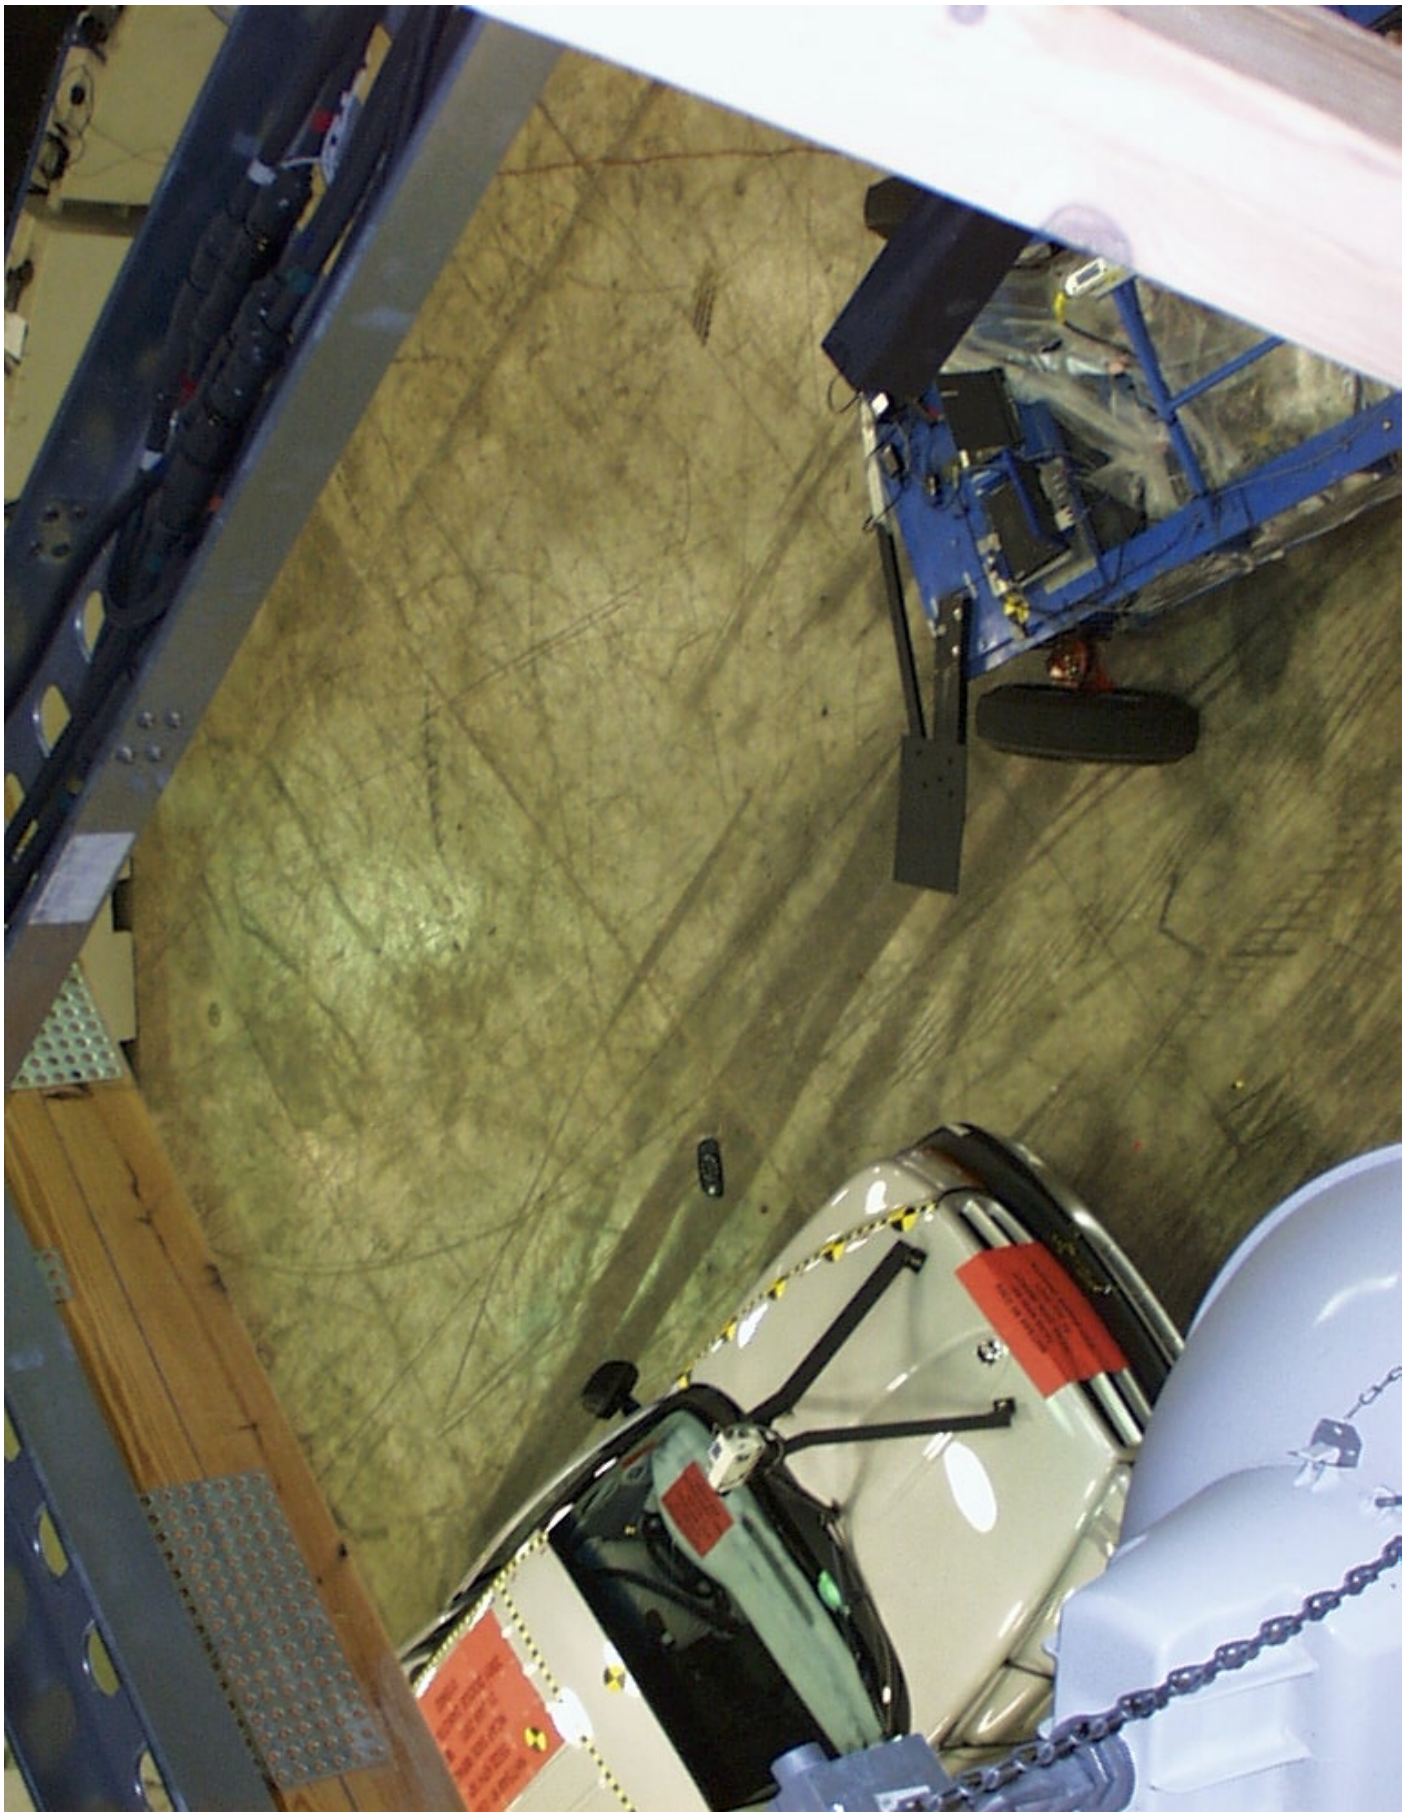
Figure A-14 POST-TEST OVERHEAD VIEW OF MDB AND VEHICLE

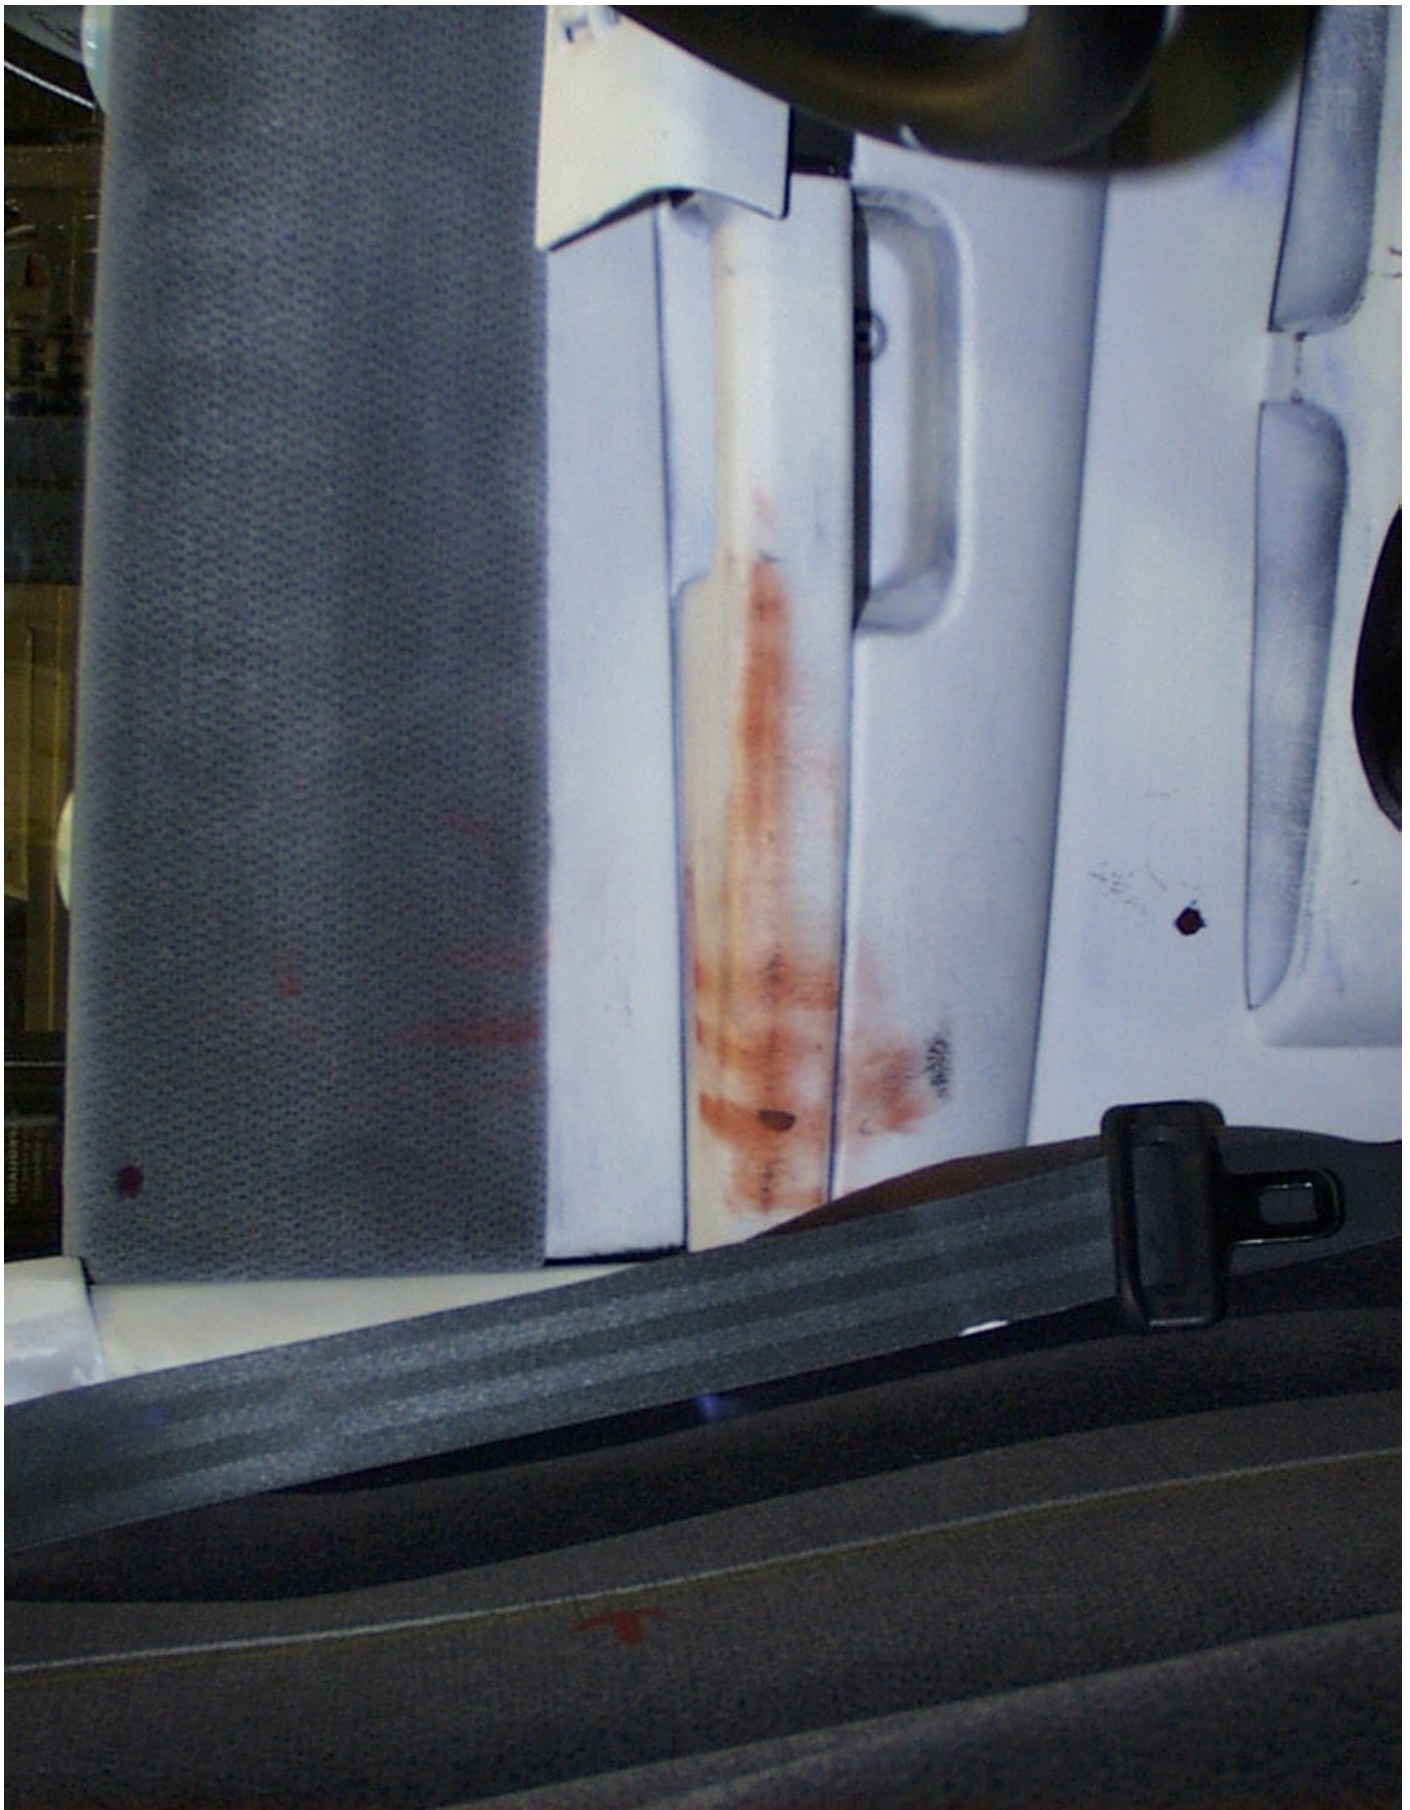
Figure A-26 POST-TEST INTERIOR OF REAR DOOR SHOWING SID IMPACT LOCATIONS

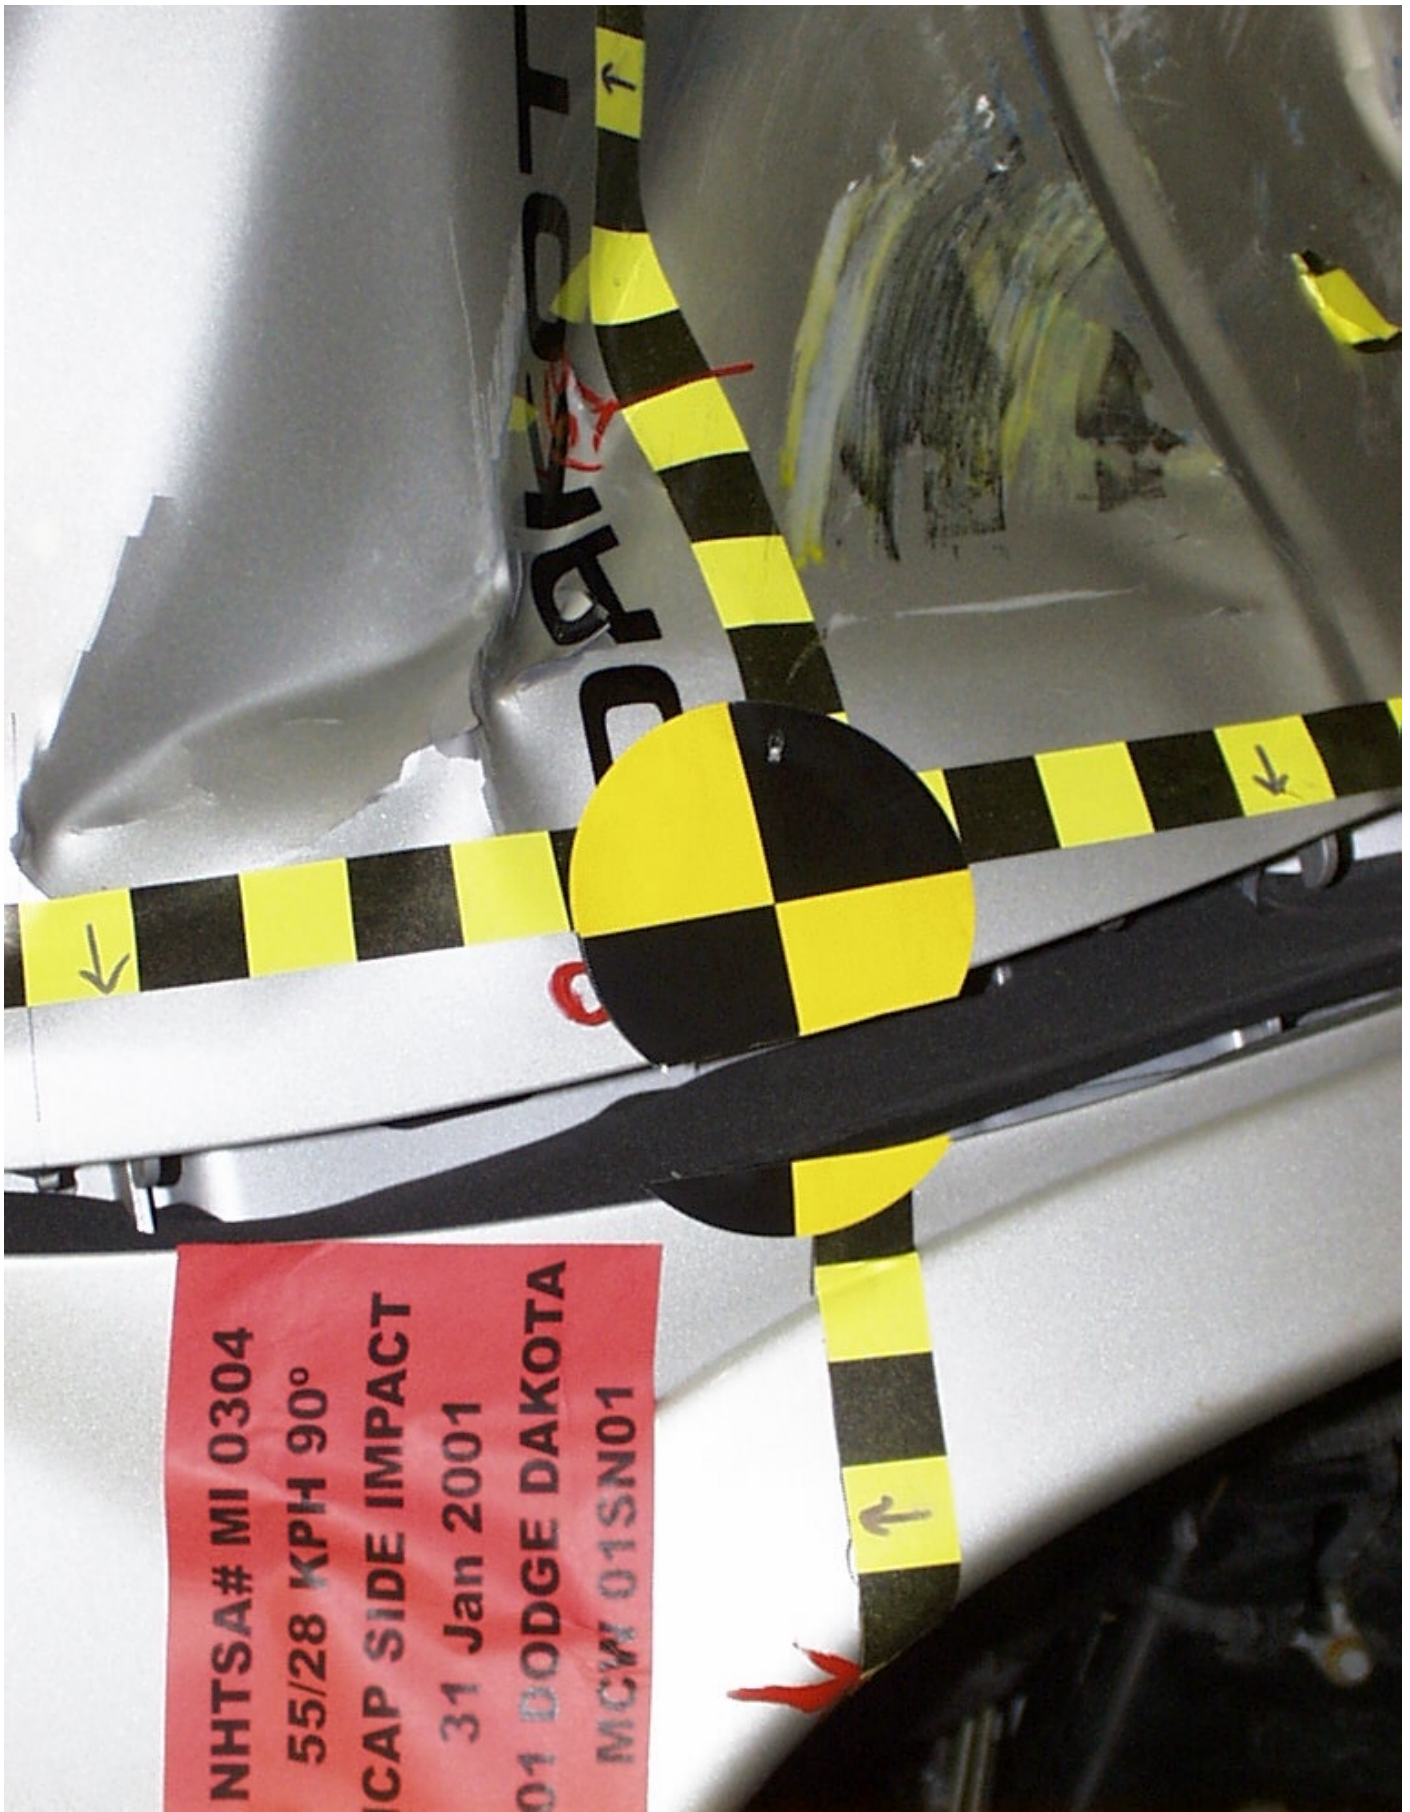
Figure A-29 POST-TEST CLOSE-UP VIEW OF IMPACT POINT TARGET

Actual Impact Point is 37 mm rearward of nominal impact reference line (lateral)

Actual Impact Point is 8 mm below nominal impact line (vertical)
