REPORT NUMBER: SNCAP-CAL-01-2

**NEW CAR ASSESSMENT PROGRAM  
SIDE IMPACT TEST**

**TOYOTA MOTOR CORPORATION  
2001 LEXUS RX300  
4-DOOR MPV**

FINAL REPORT

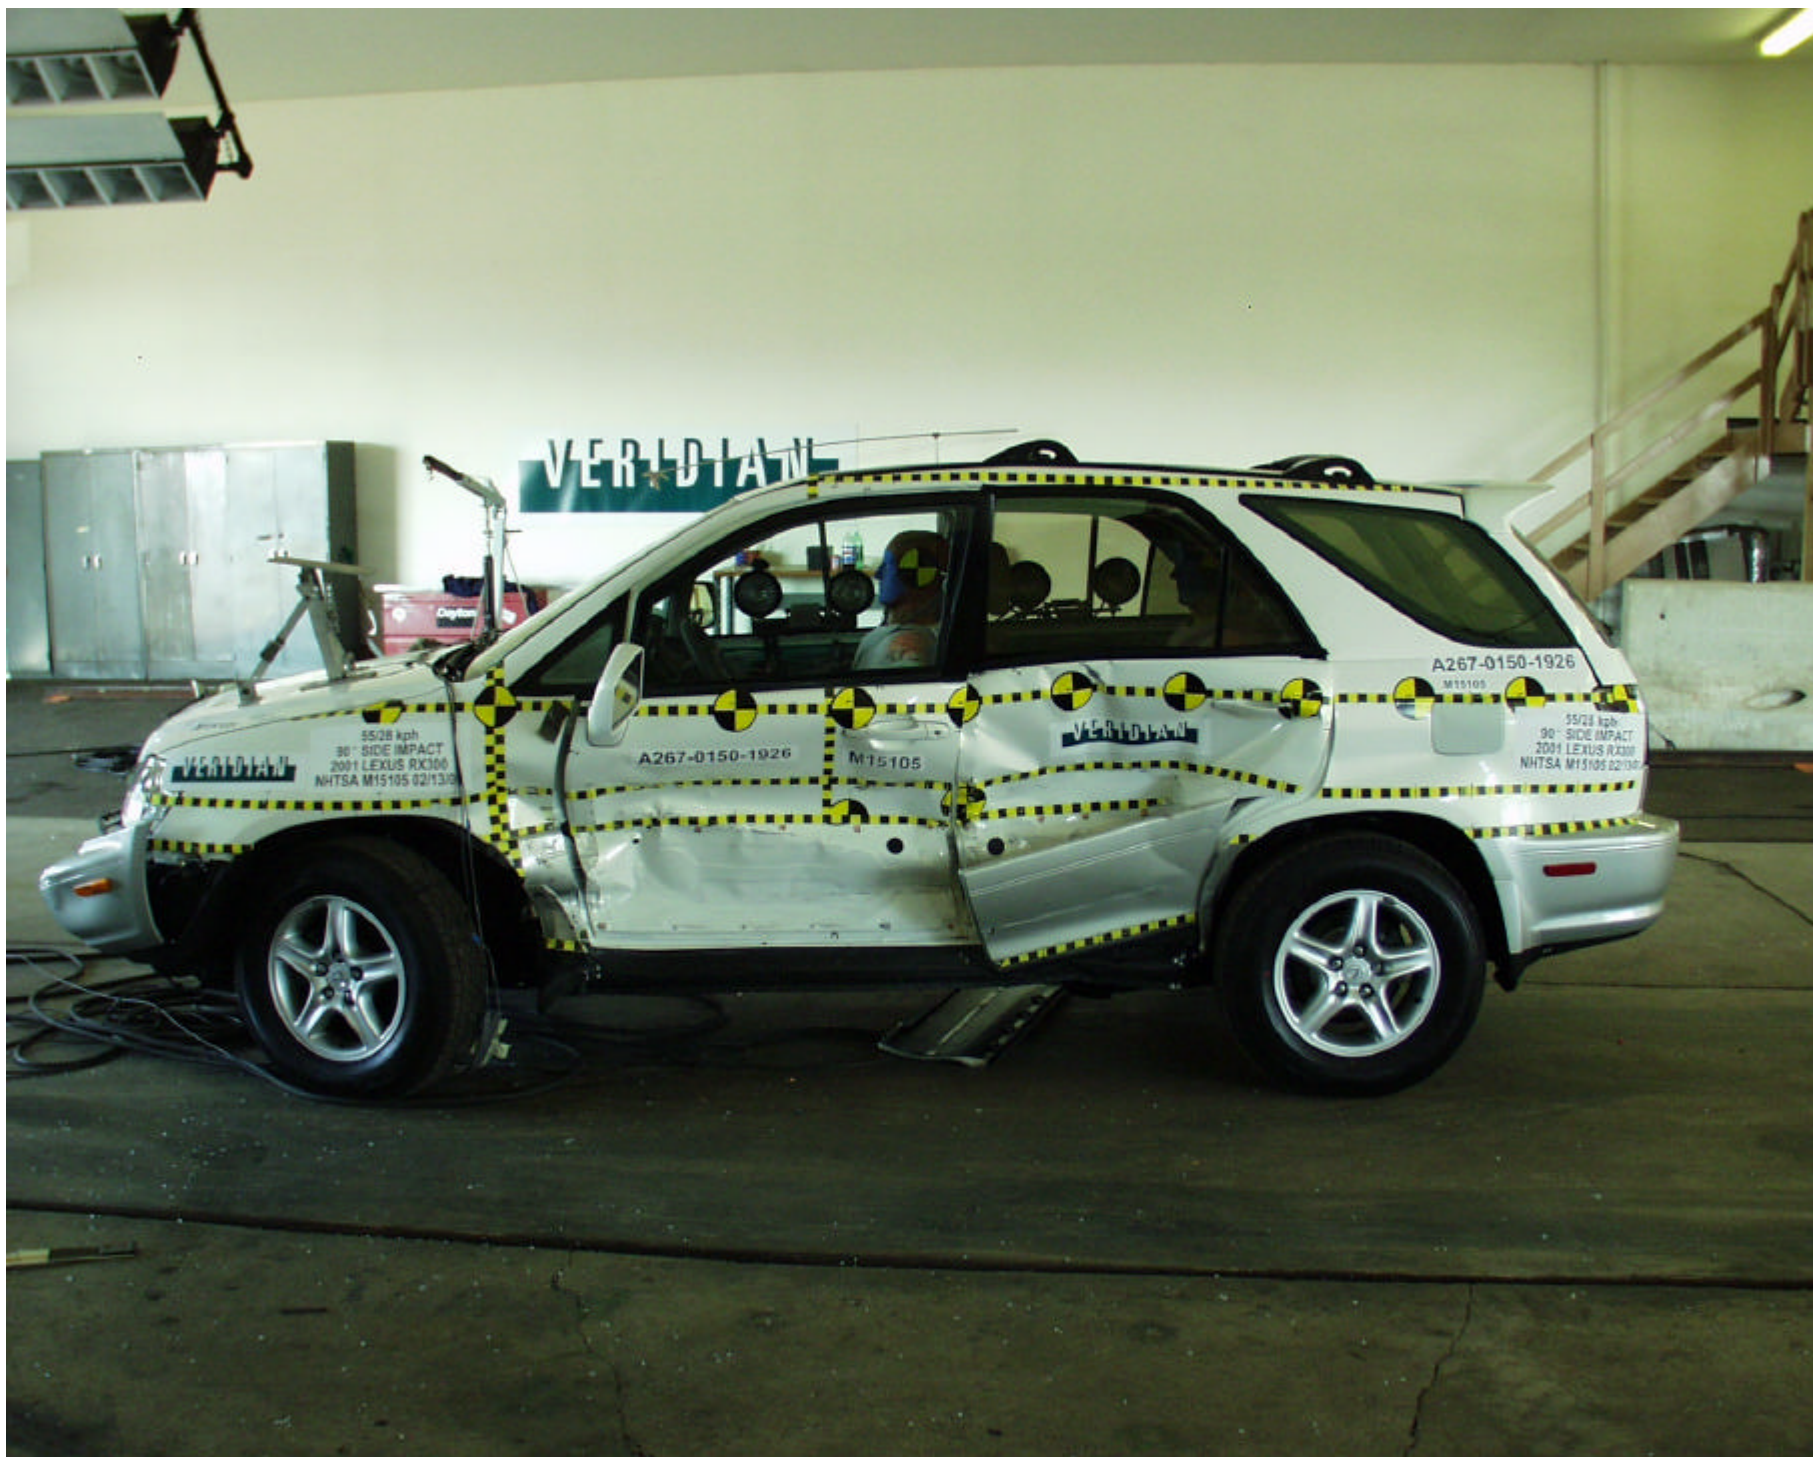
Figure A-6 POST-TEST IMPACTED SIDE VIEW OF TEST VEHICLE

#### MAXIMUM EXTERIOR STATIC CRUSH:

1. LEVEL 1 ( 399 mm above ground) = 172 millimeters

2. LEVEL 2 ( 712 mm above ground) = 282 millimeters

3. LEVEL 3 ( 821 mm above ground) = 290 millimeters

4. LEVEL 4 ( 1061 mm above ground) = 141 millimeters

5. LEVEL 5 ( 1598 mm above ground) = 10 millimeters

Maximum Post-Test Intrusion = 290 millimeters

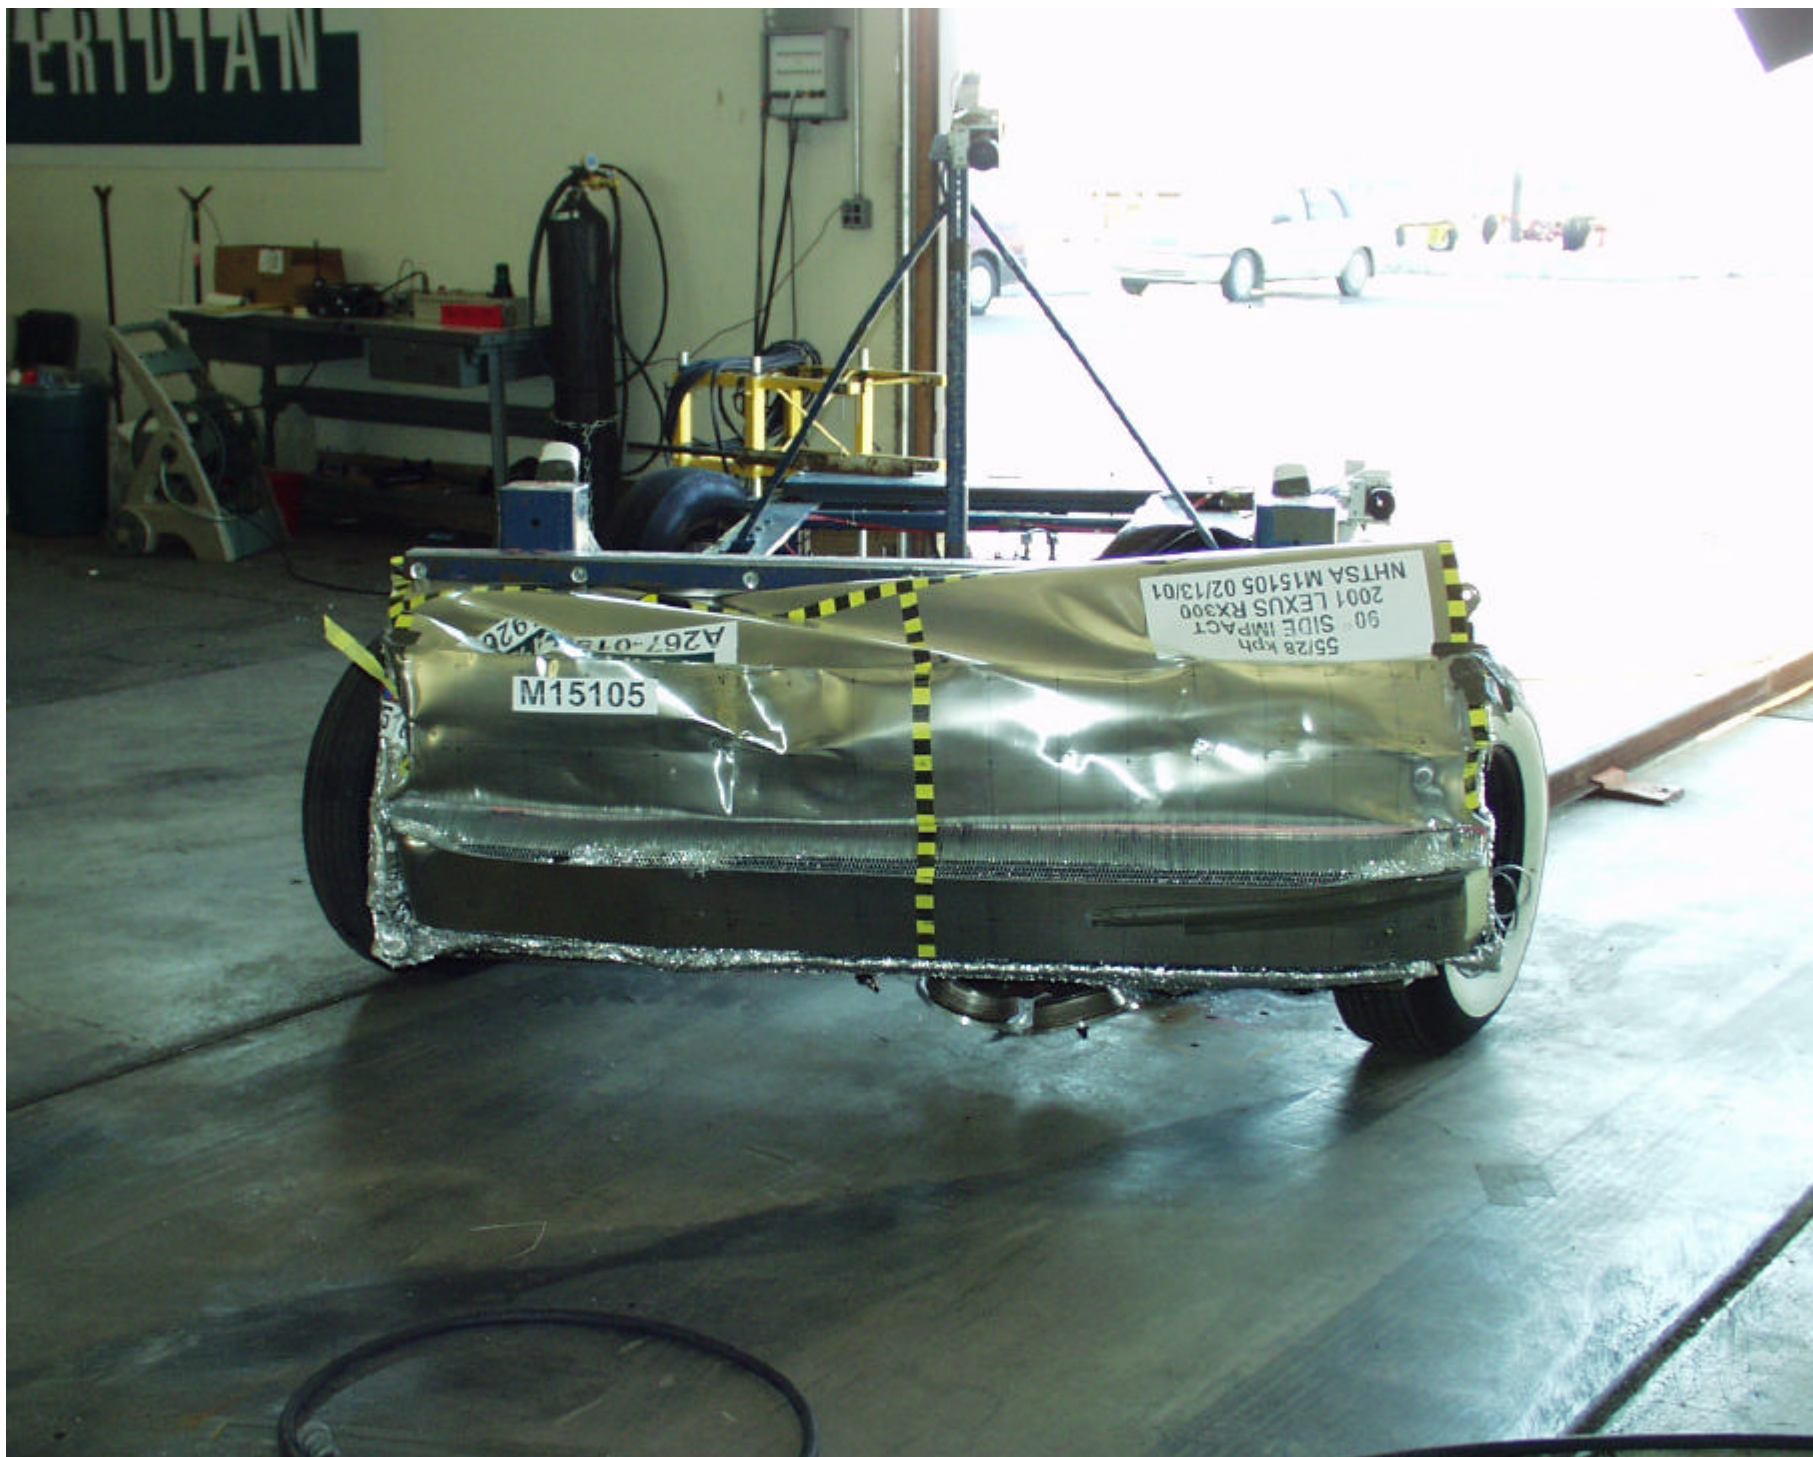
Figure A-8 POST-TEST FRONTAL VIEW OF IMPACTOR FACE

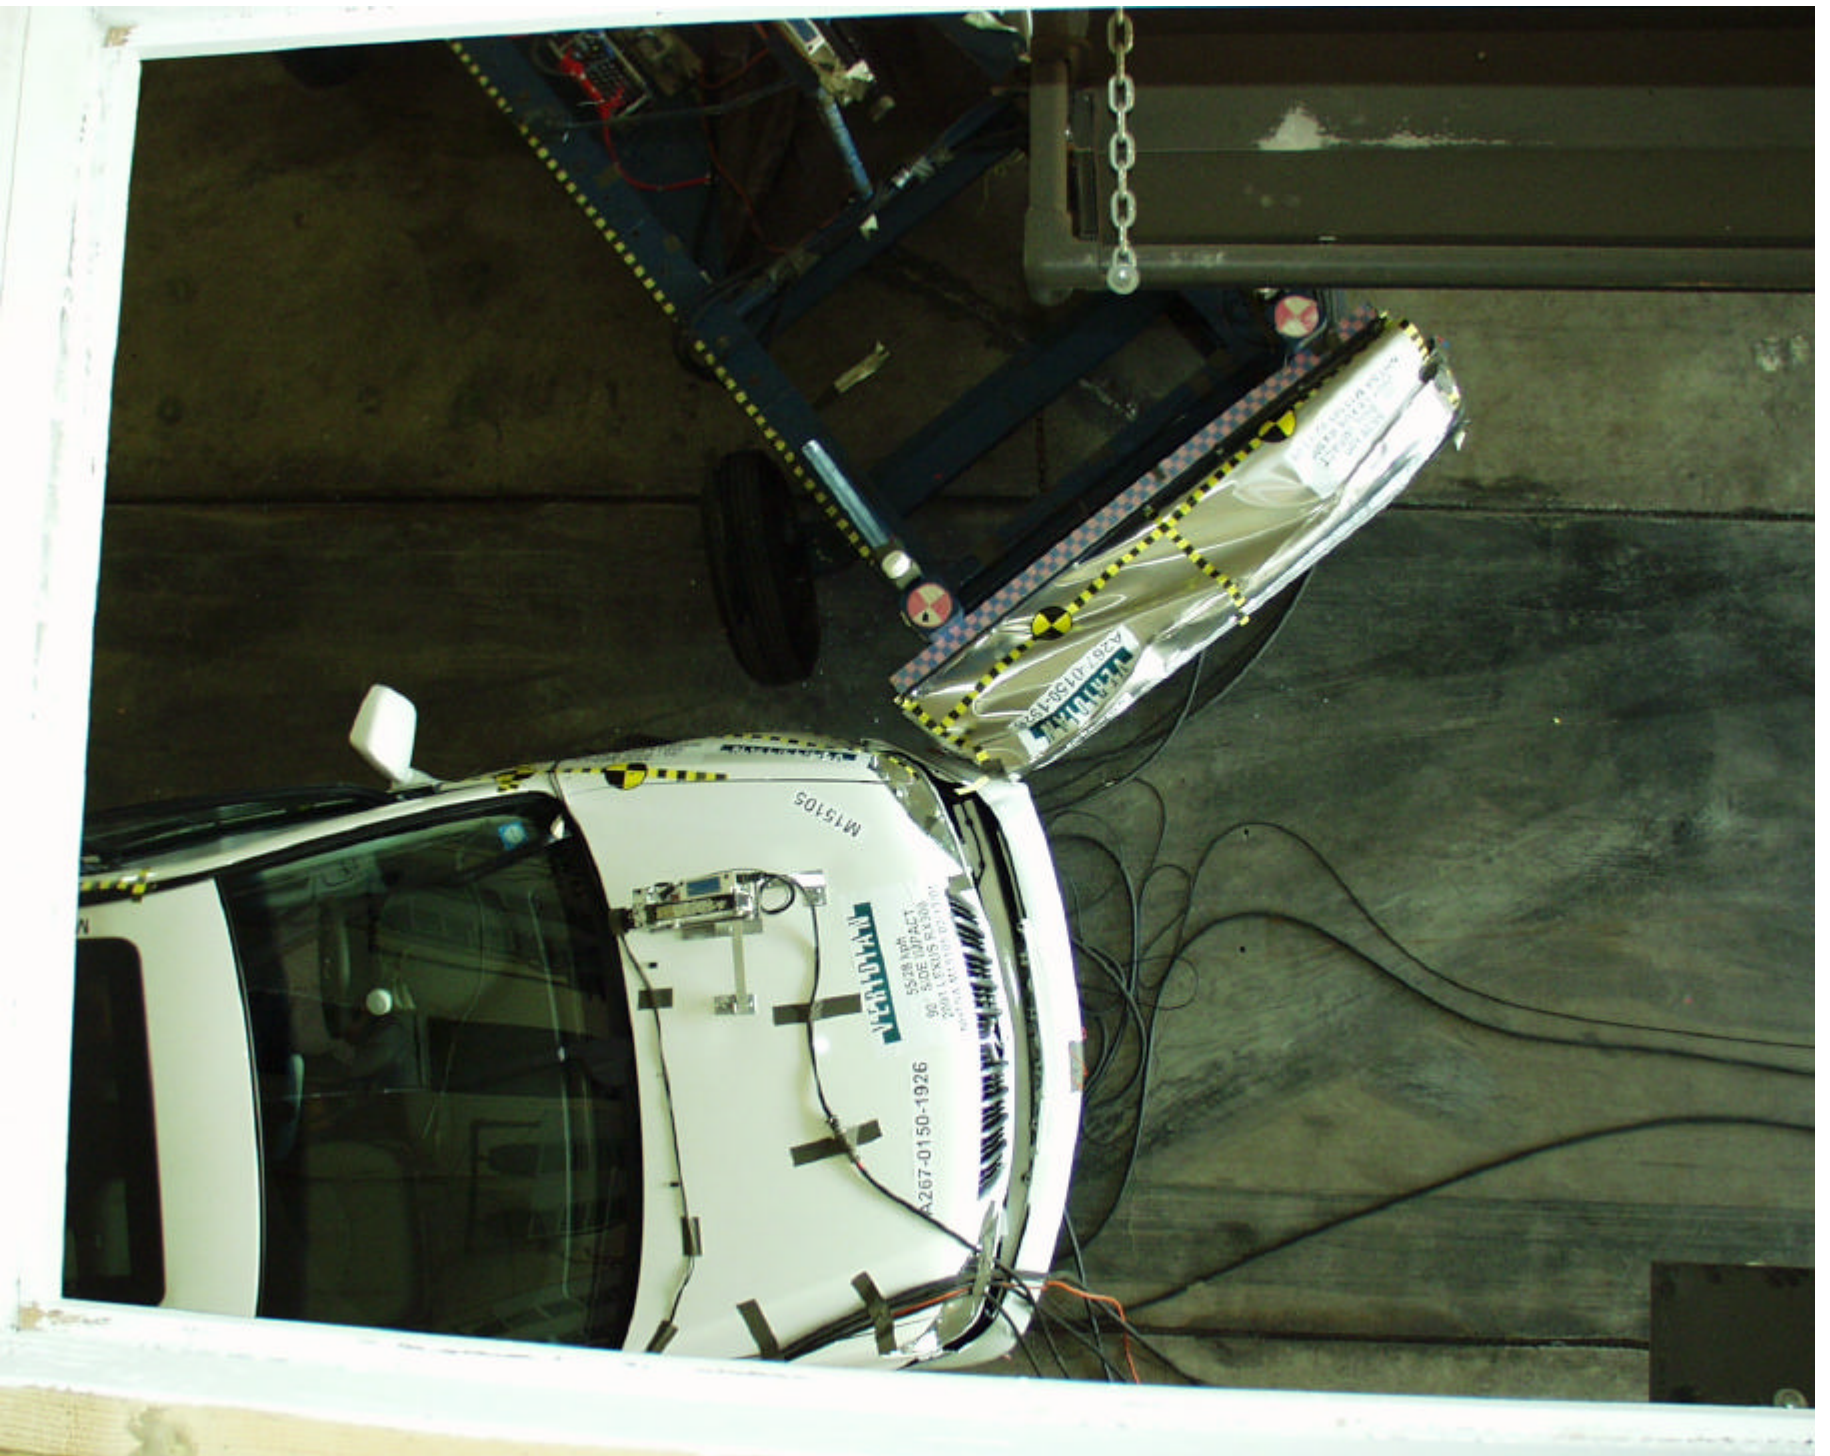
Figure A-16 POST-TEST OVERHEAD VIEW OF MDB AND VEHICLE

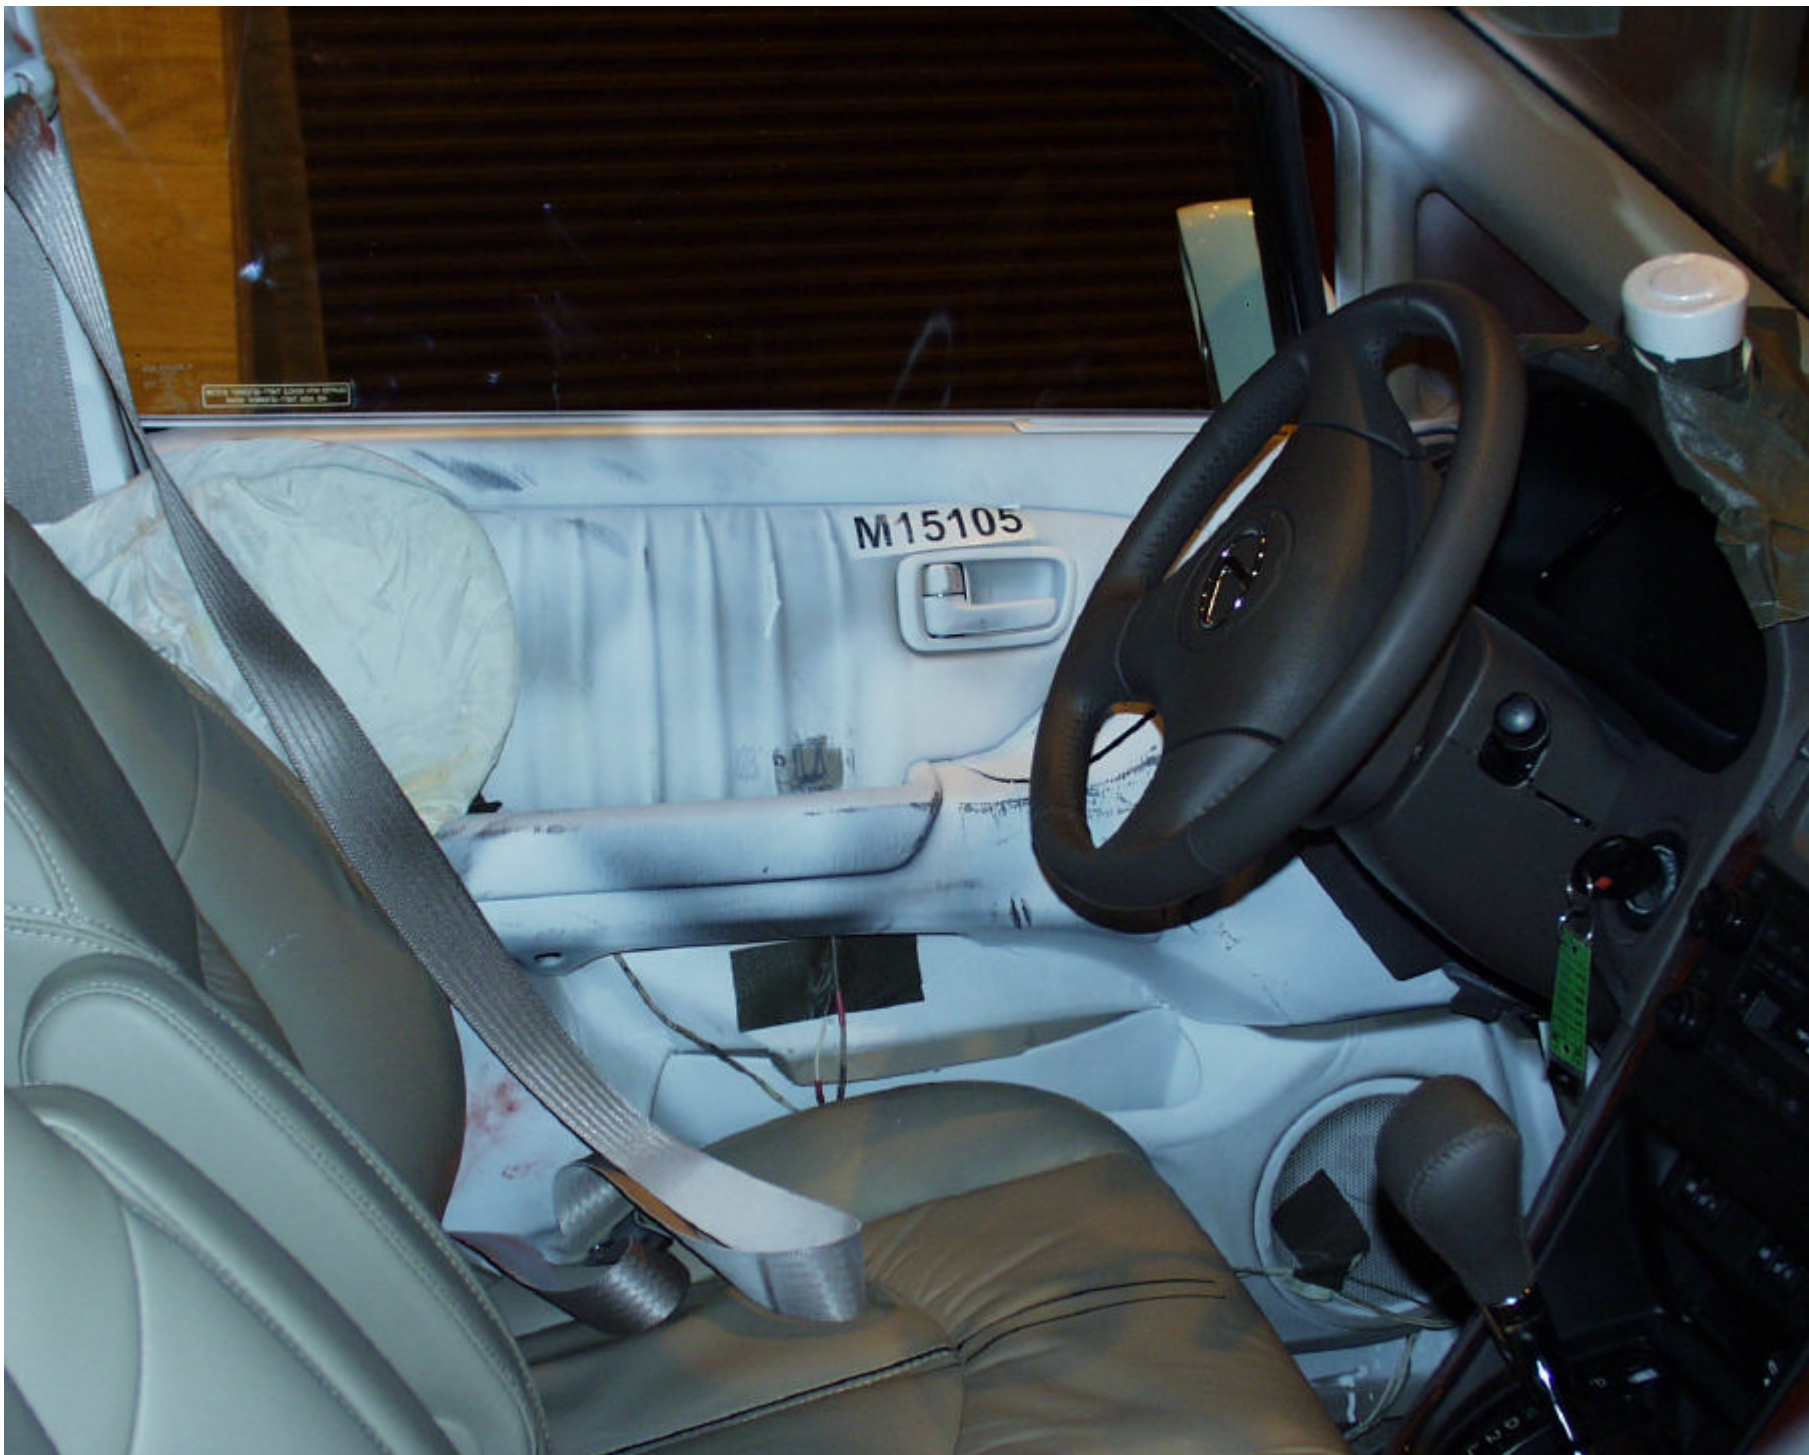
Figure A-26 POST-TEST INTERIOR OF FRONT DOOR SHOWING SID IMPACT LOCATIONS

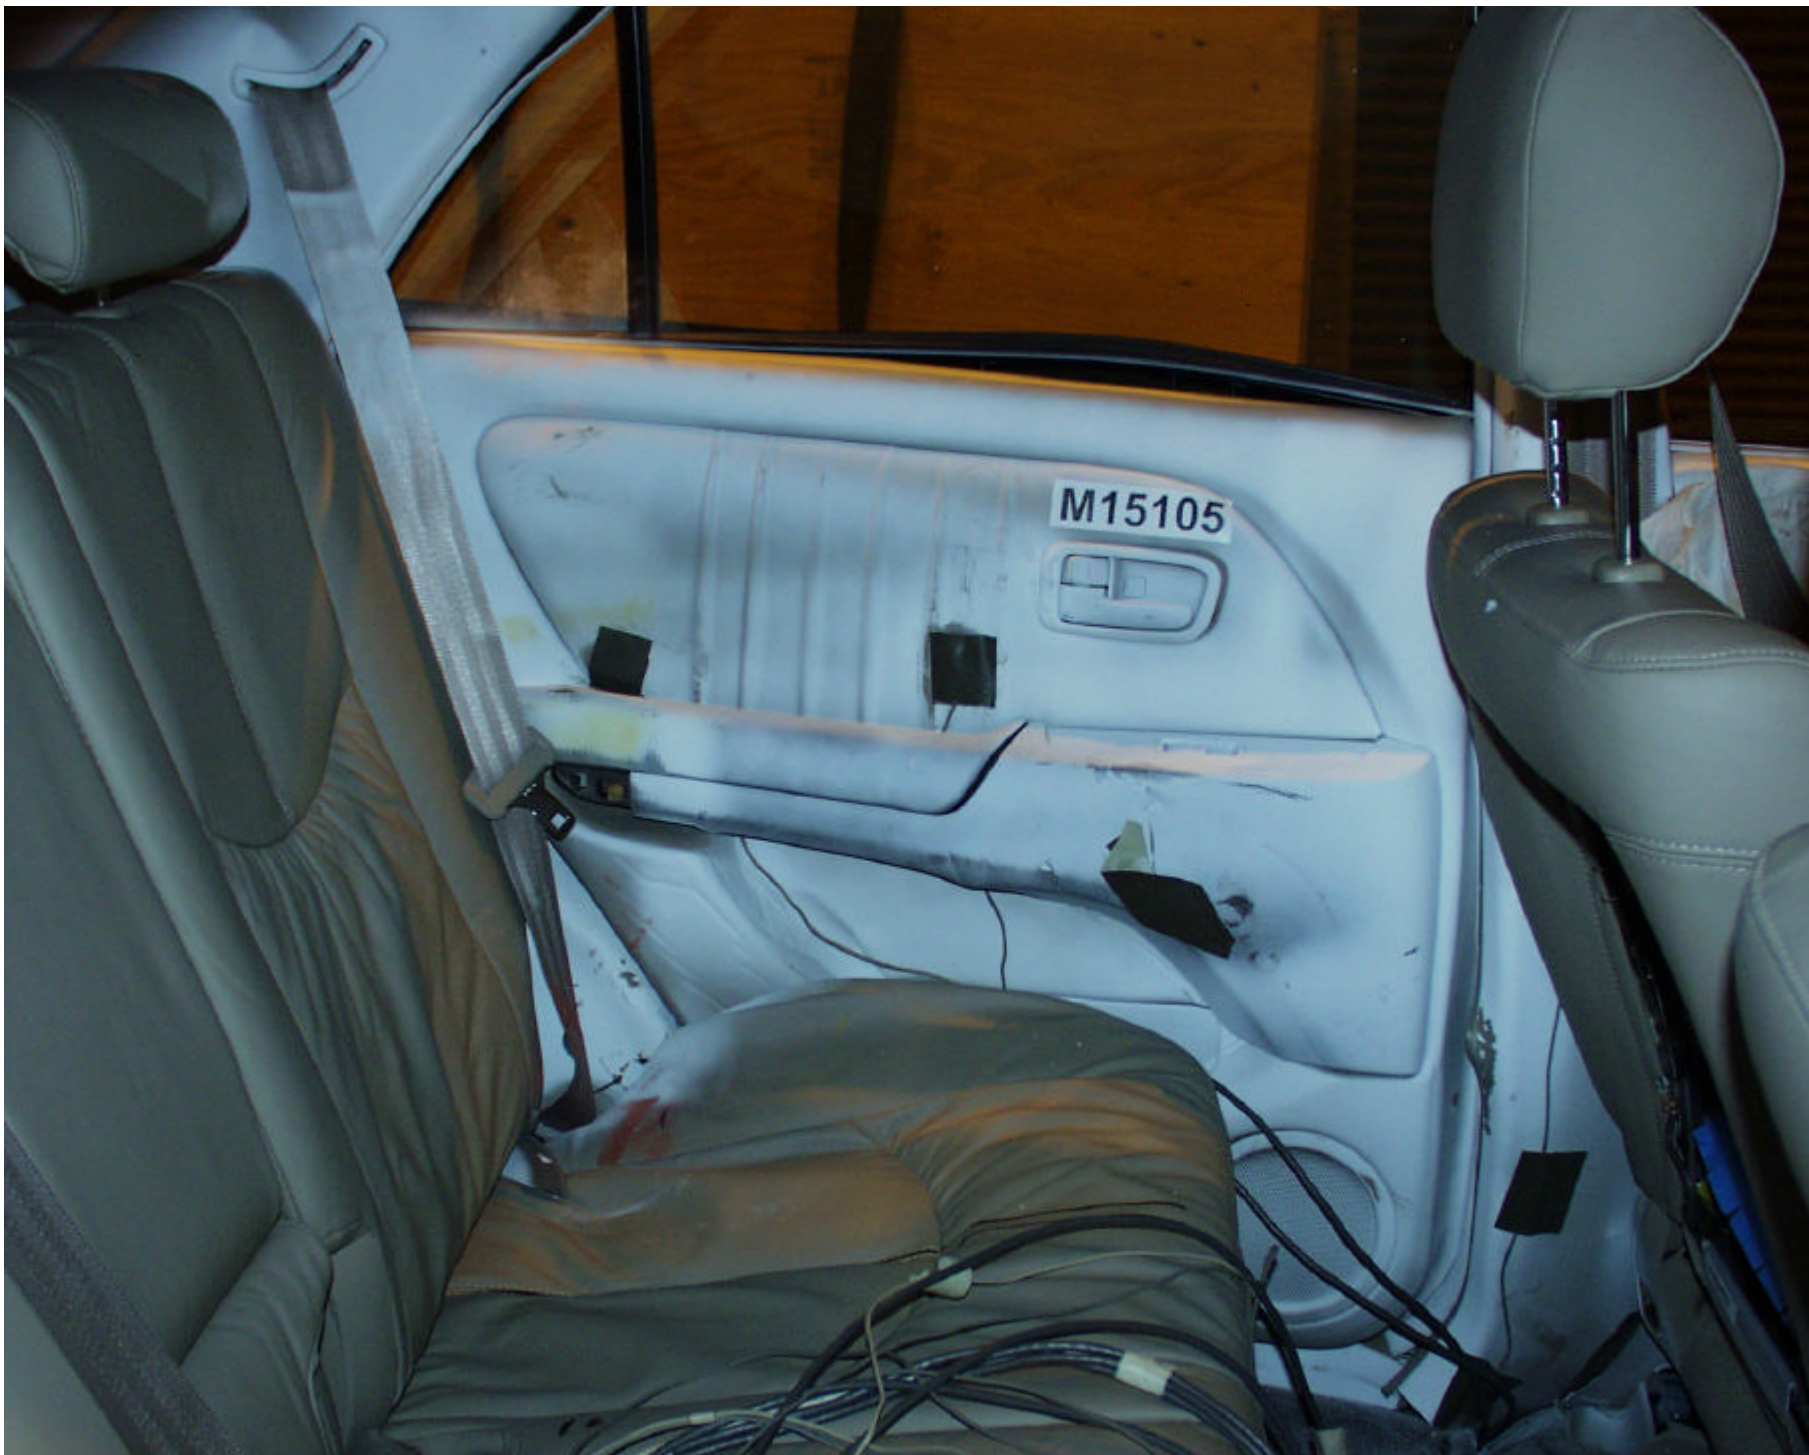
Figure A-28 POST-TEST INTERIOR OF REAR DOOR SHOWING SID IMPACT LOCATIONS

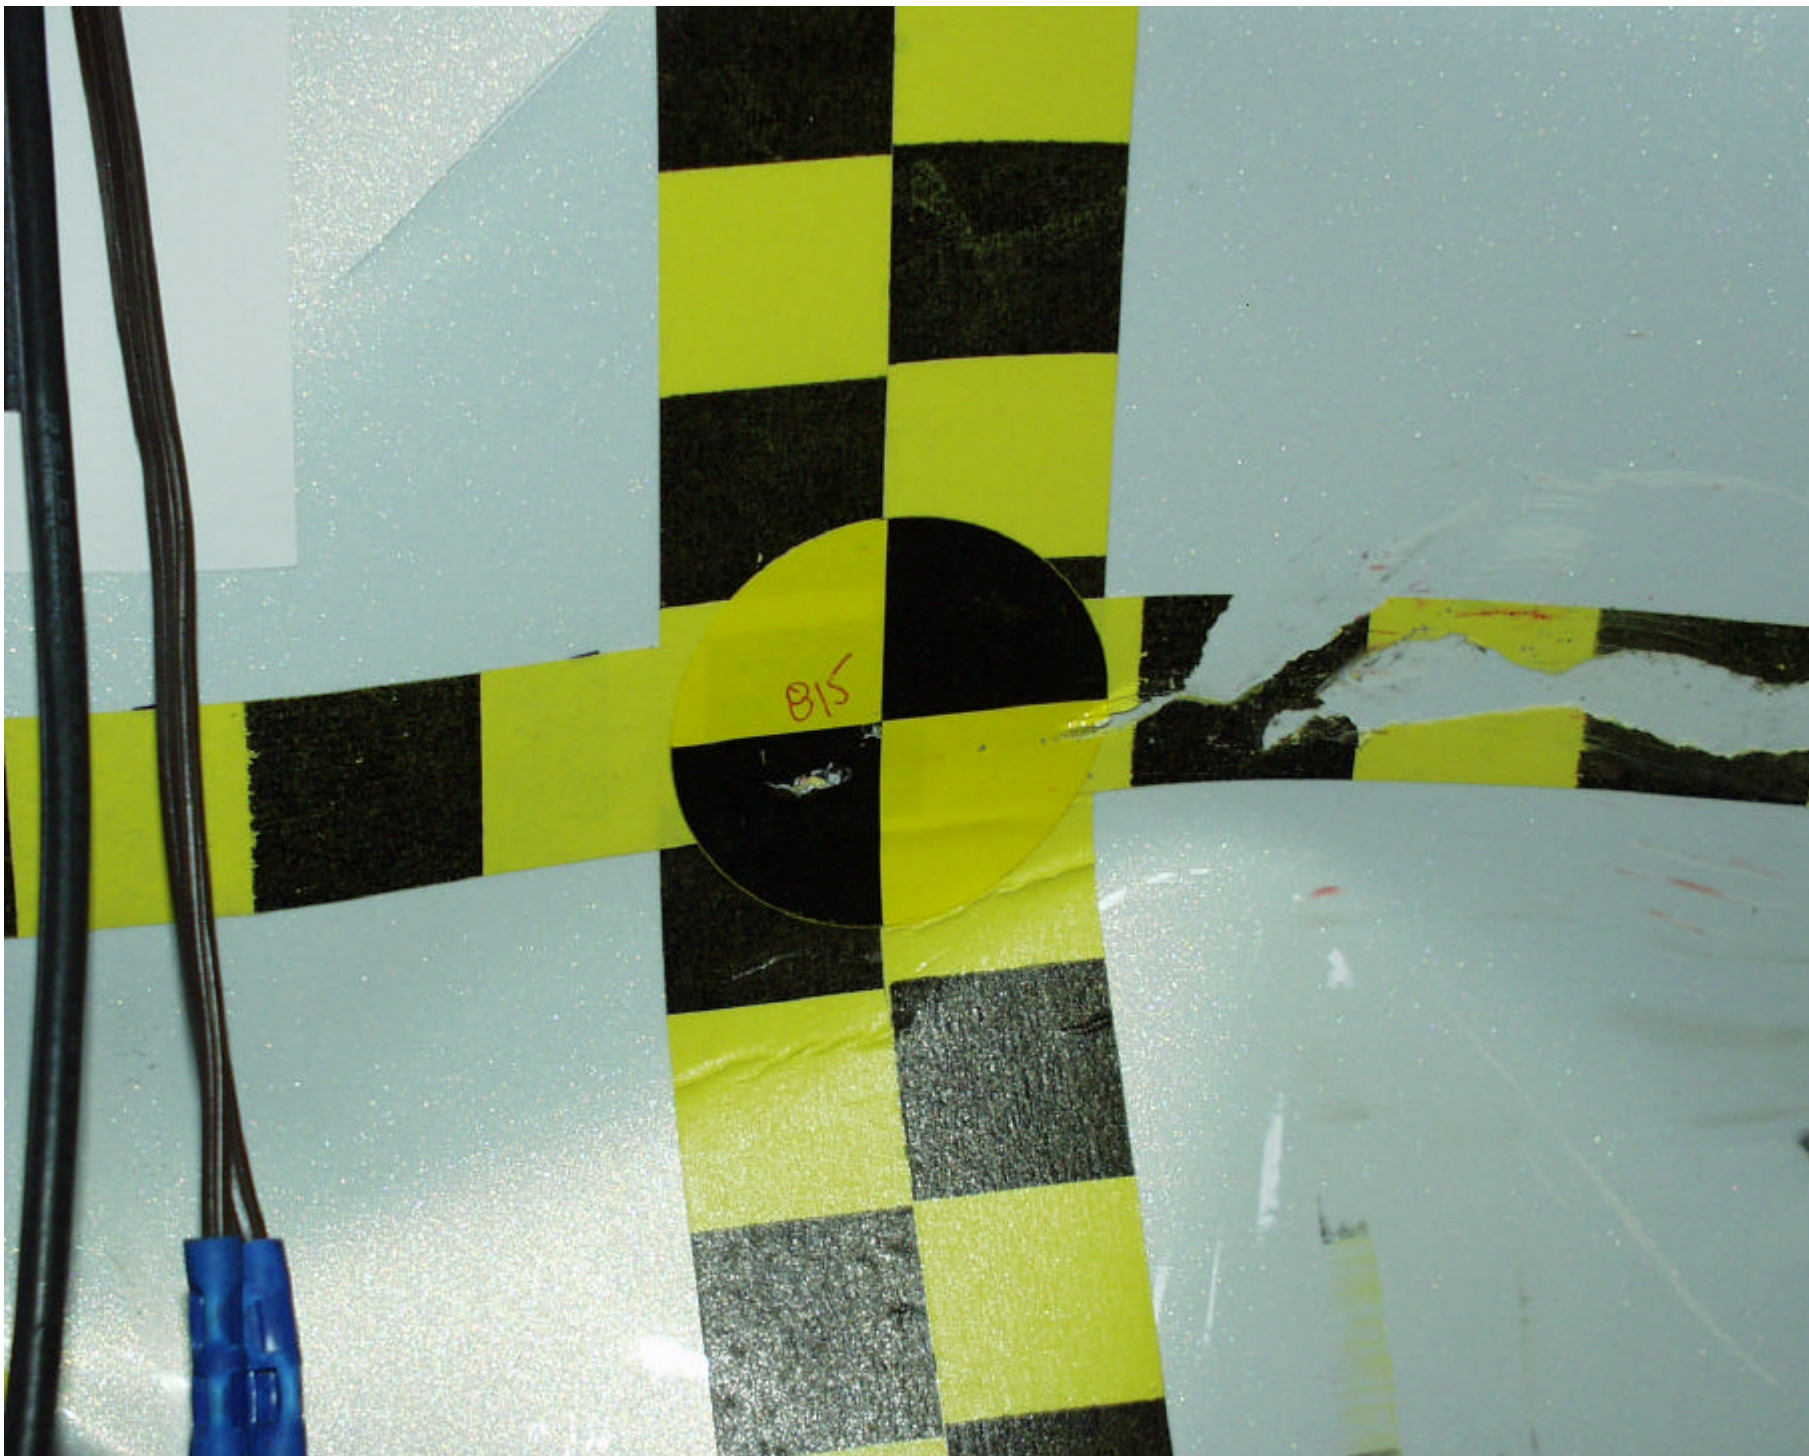
Figure A-31 POST-TEST CLOSE-UP VIEW OF IMPACT POINT TARGET

#### ACTUAL IMPACT POINT

Actual Impact Point is 4 mm forward of nominal impact ref. line (Lateral)

Actual Impact Point is 5 mm below nominal impact point (Vertical)
