REPORT NUMBER: SNCAP-CAL-01-4

**NEW CAR ASSESSMENT PROGRAM  
SIDE IMPACT TEST**

DAIMLERCHRYSLER  
2001 DODGE CARAVAN  
MPV

FINAL REPORT

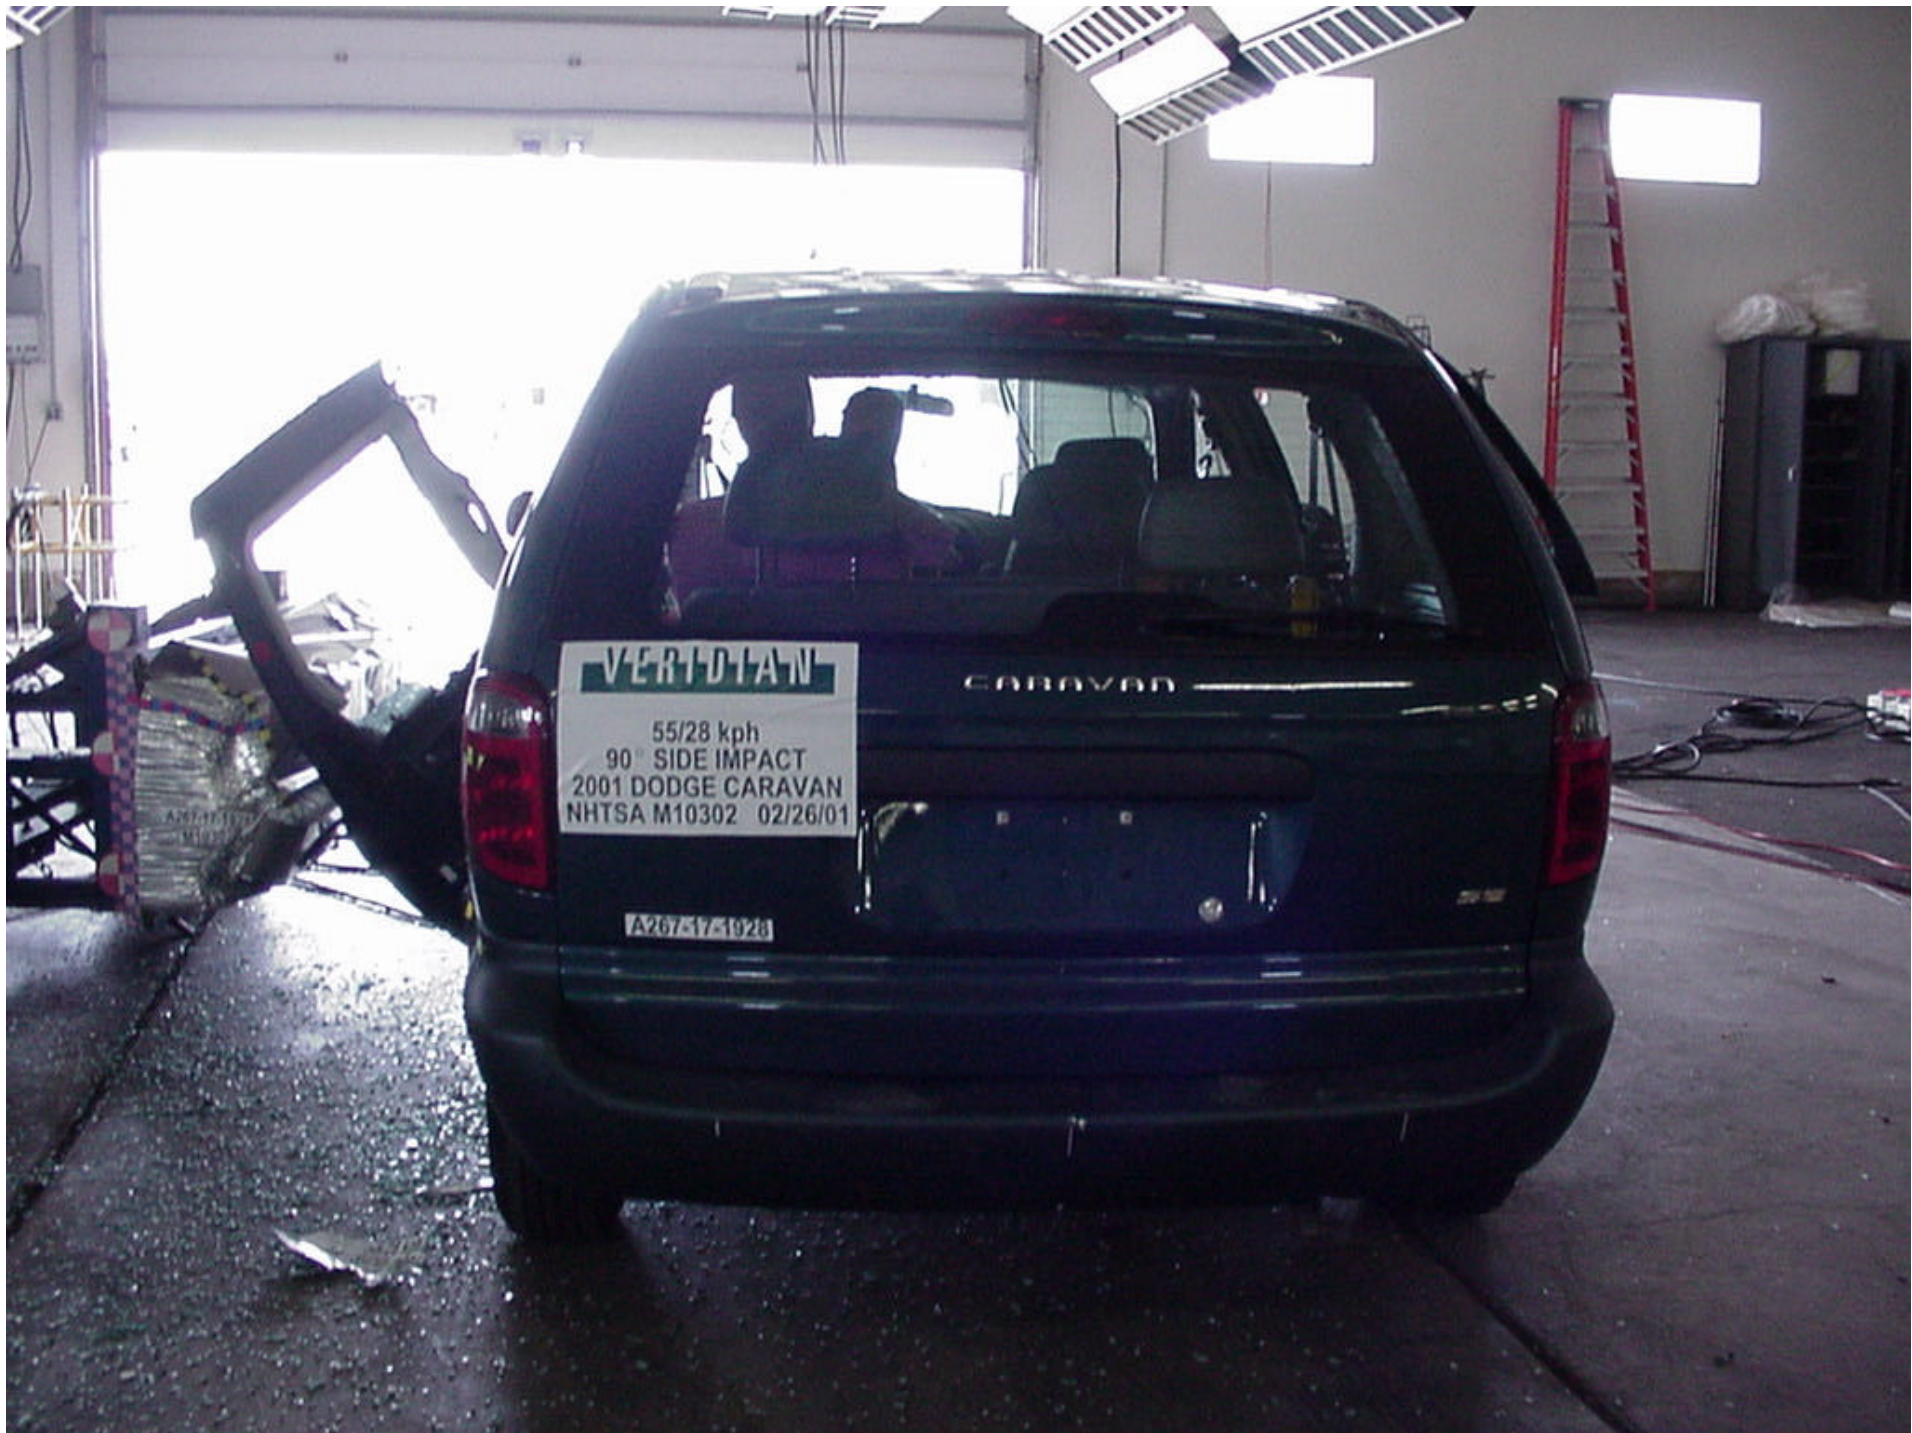
Figure A-4 POST-TEST REAR VIEW OF TEST VEHICLE

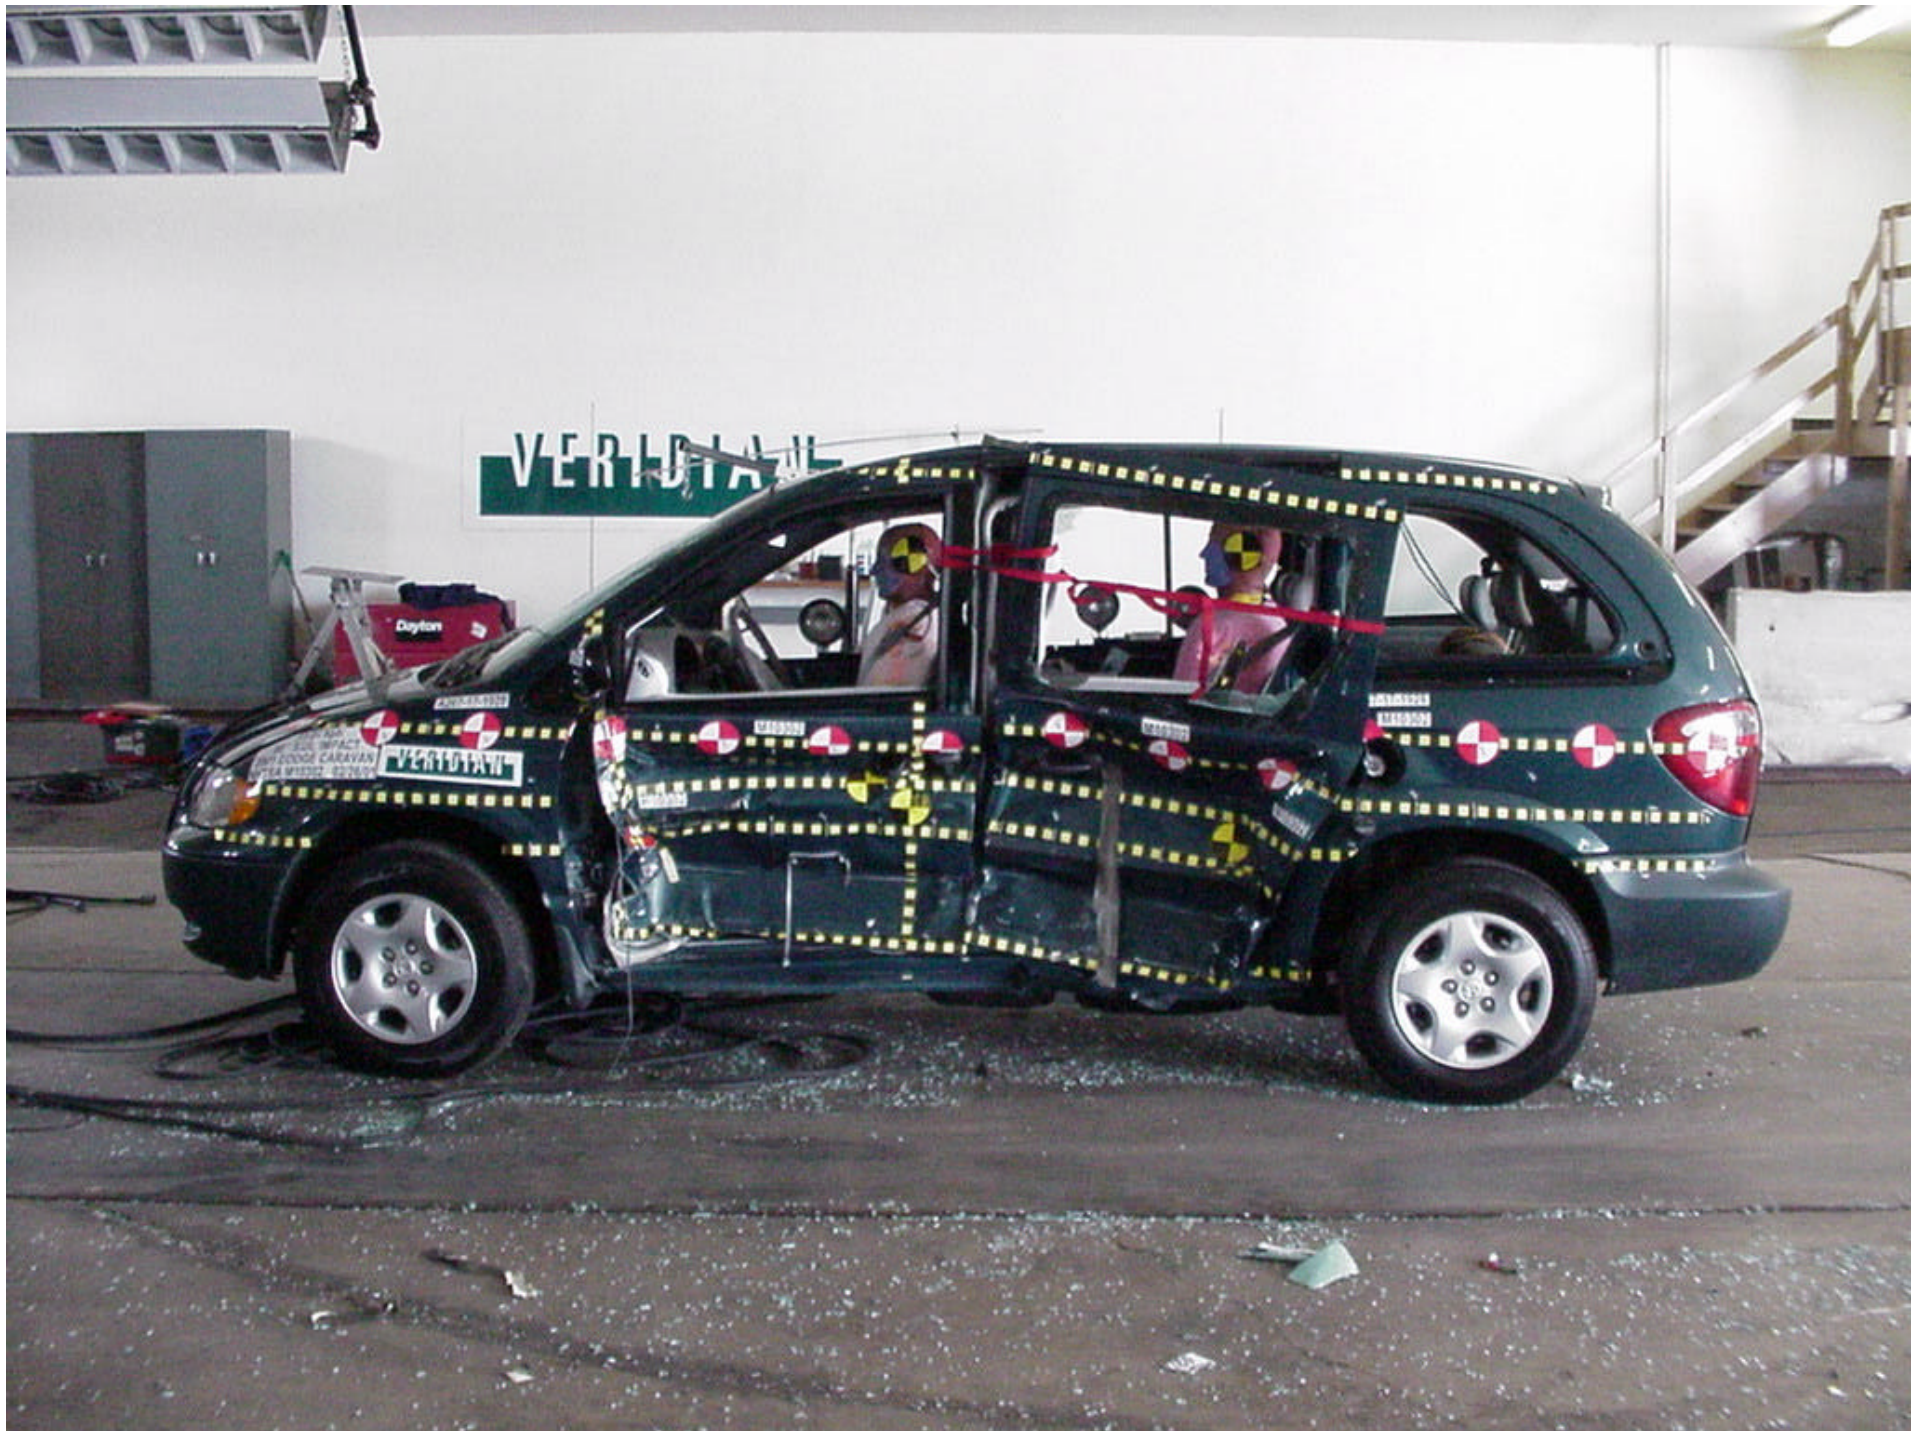
Figure A-6 POST-TEST IMPACTED SIDE VIEW OF TEST VEHICLE

#### MAXIMUM EXTERIOR STATIC CRUSH:

1. LEVEL 1 ( 305 mm above ground) = 229 millimeters

2. LEVEL 2 ( 776 mm above ground) = 383 millimeters

3. LEVEL 3 ( 643 mm above ground) = 350 millimeters

4. LEVEL 4 ( 957 mm above ground) = 298 millimeters

5. LEVEL 5 ( 1634 mm above ground) = 19 millimeters

Maximum Post-Test Intrusion = 383 millimeters

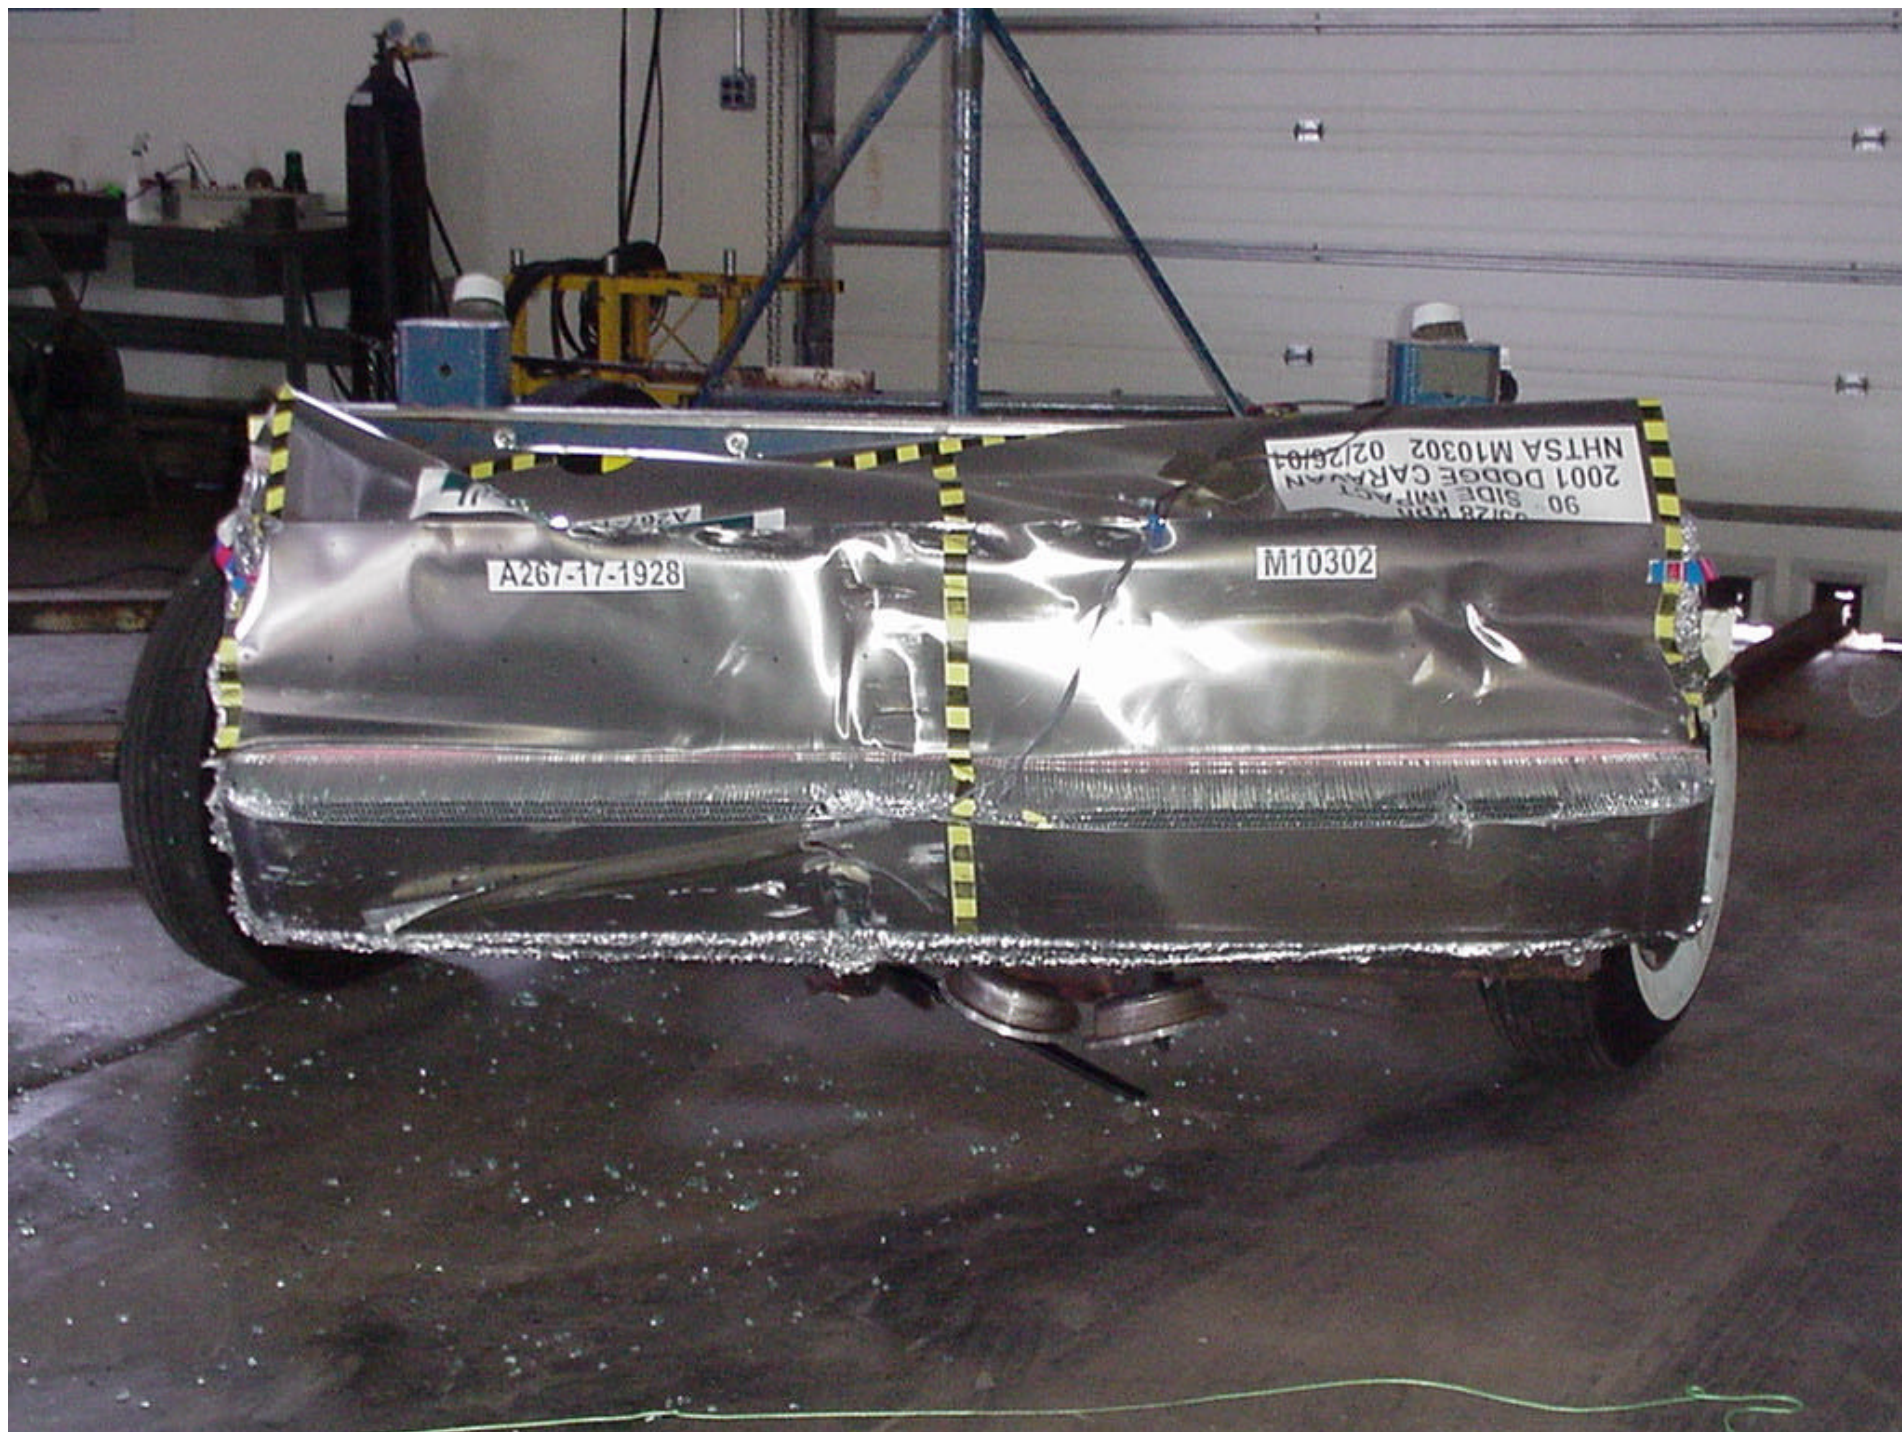
Figure A-8 POST-TEST FRONTAL VIEW OF IMPACTOR FACE

MAXIMUM STATIC CRUSH OF HONEYCOMB IMPACT FACE:

| 1. Row A at Center of Bumper Level | = | <u>127</u> | millimeters |
| 2. Row B at Top of Bumper Level | = | <u>65</u> | millimeters |
| 3. Row C at Mid Level | = | <u>111</u> | millimeters |
| 4. Row D at Top of Stack Level | = | <u>135</u> | millimeters |

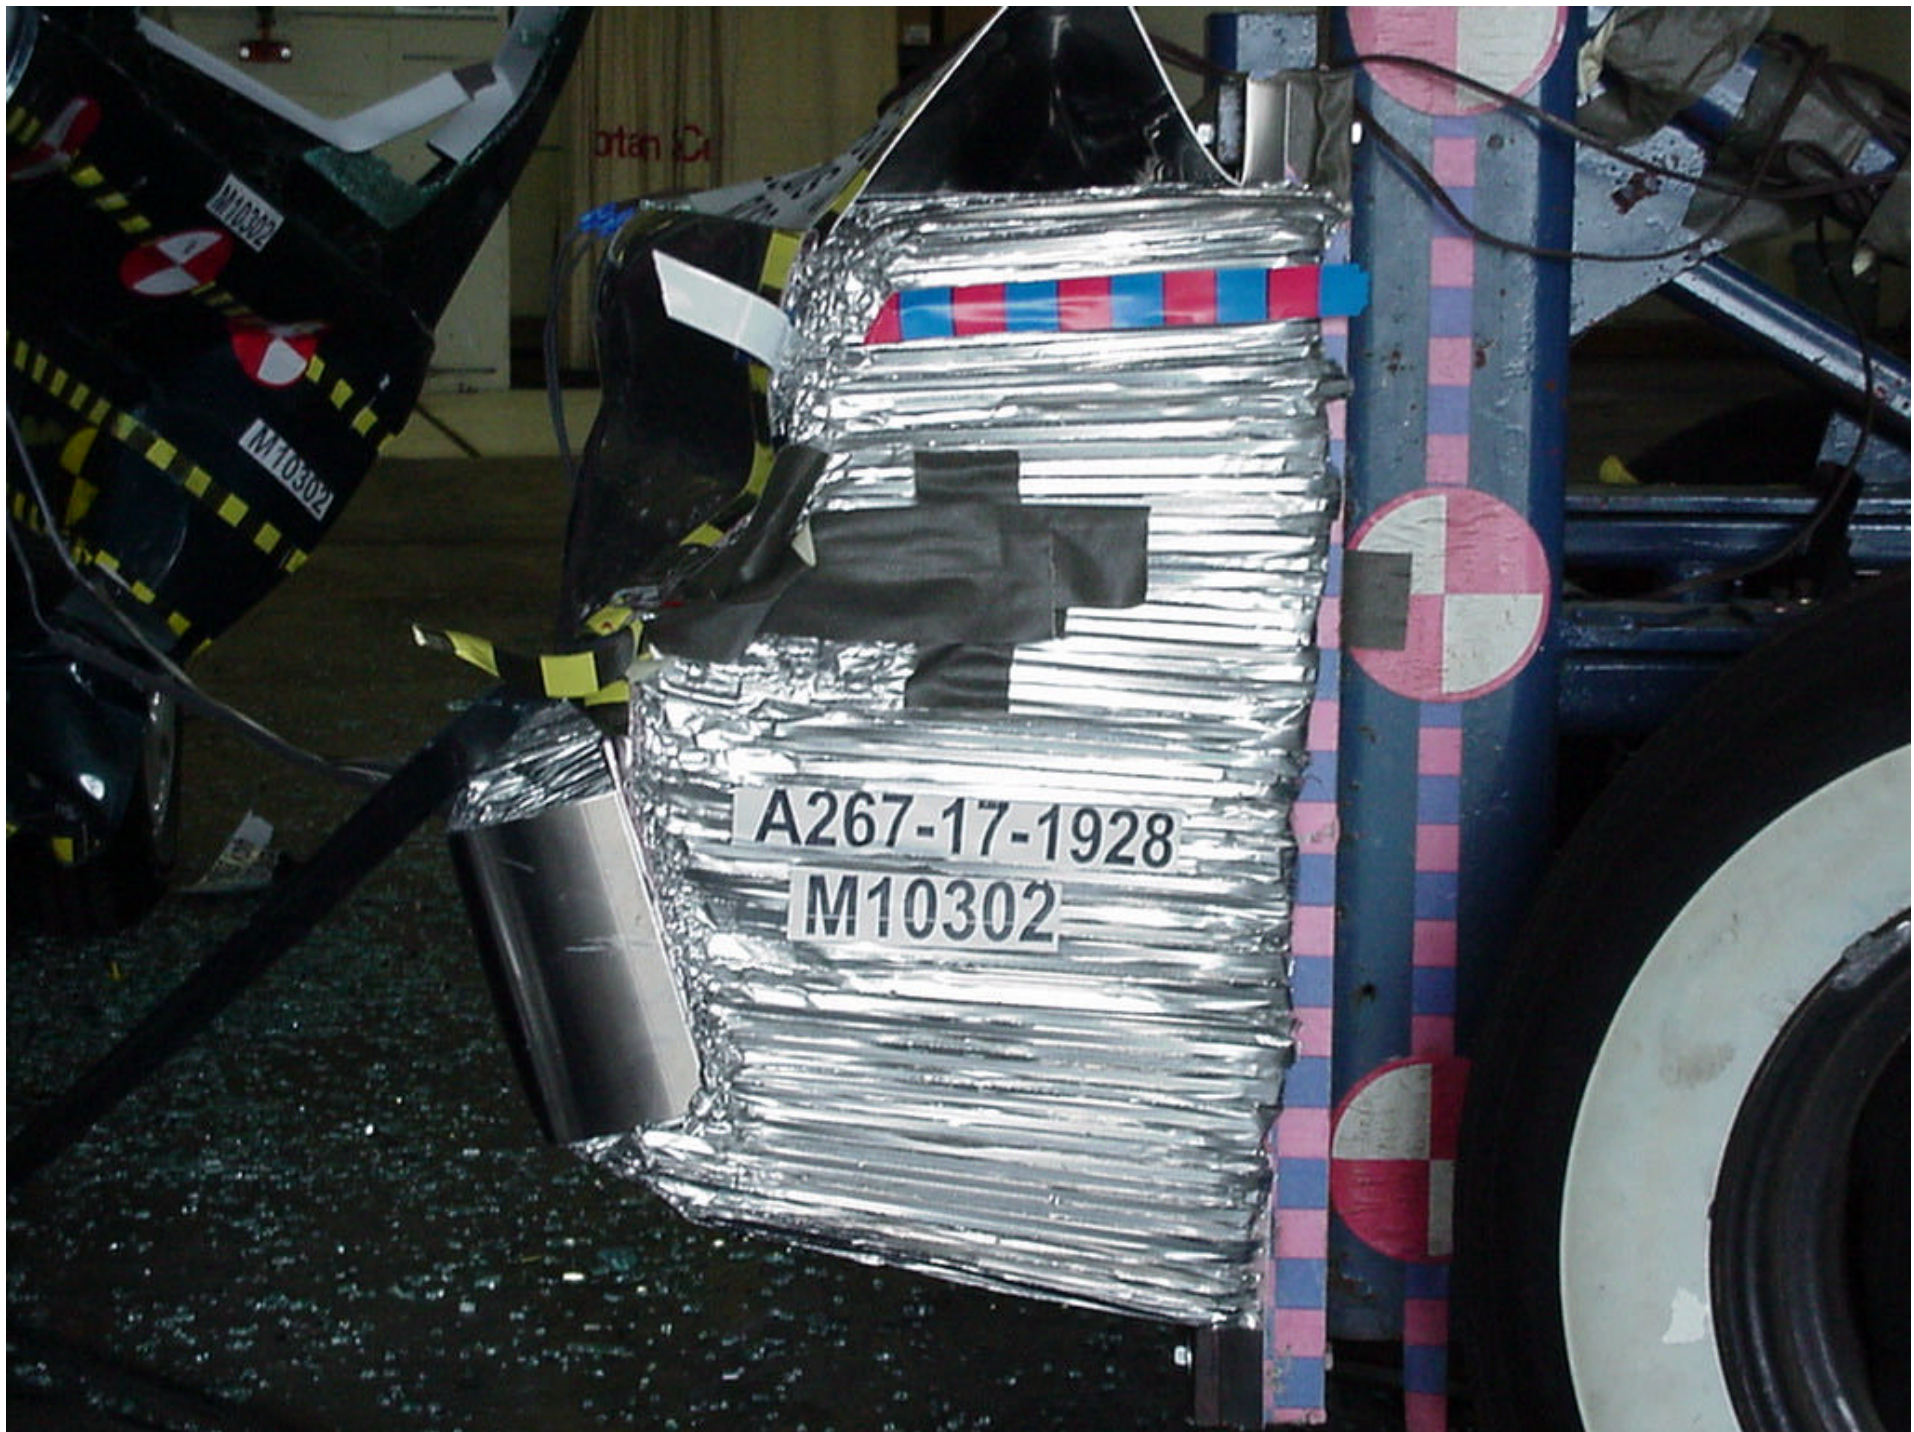
Figure A-10 POST-TEST LEFT SIDE VIEW OF IMPACTOR FACE

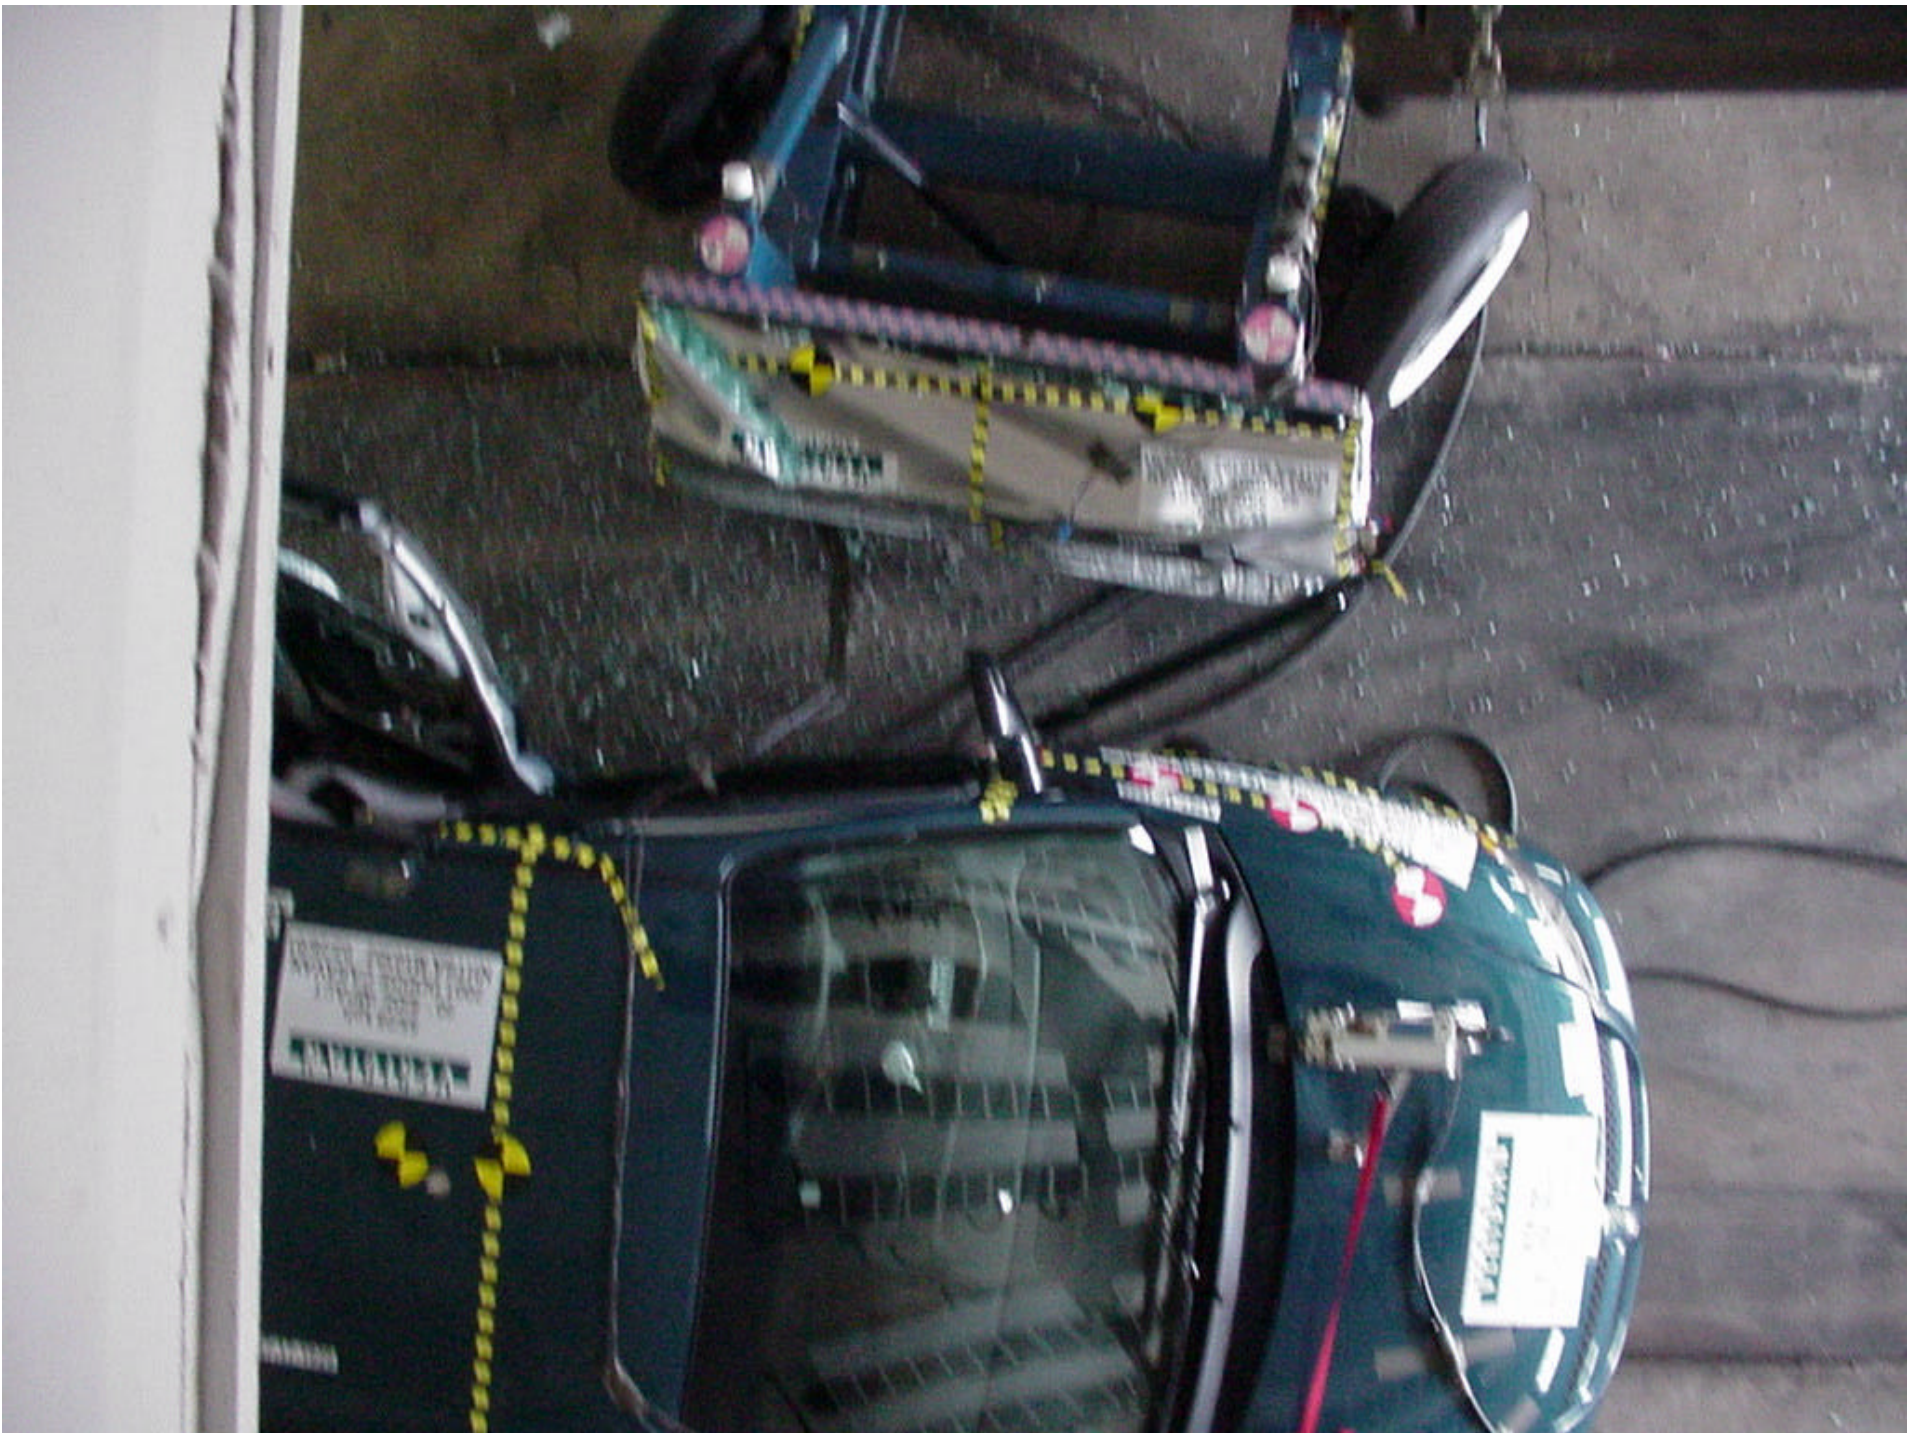
Figure A-16 POST-TEST OVERHEAD VIEW OF MDB AND VEHICLE

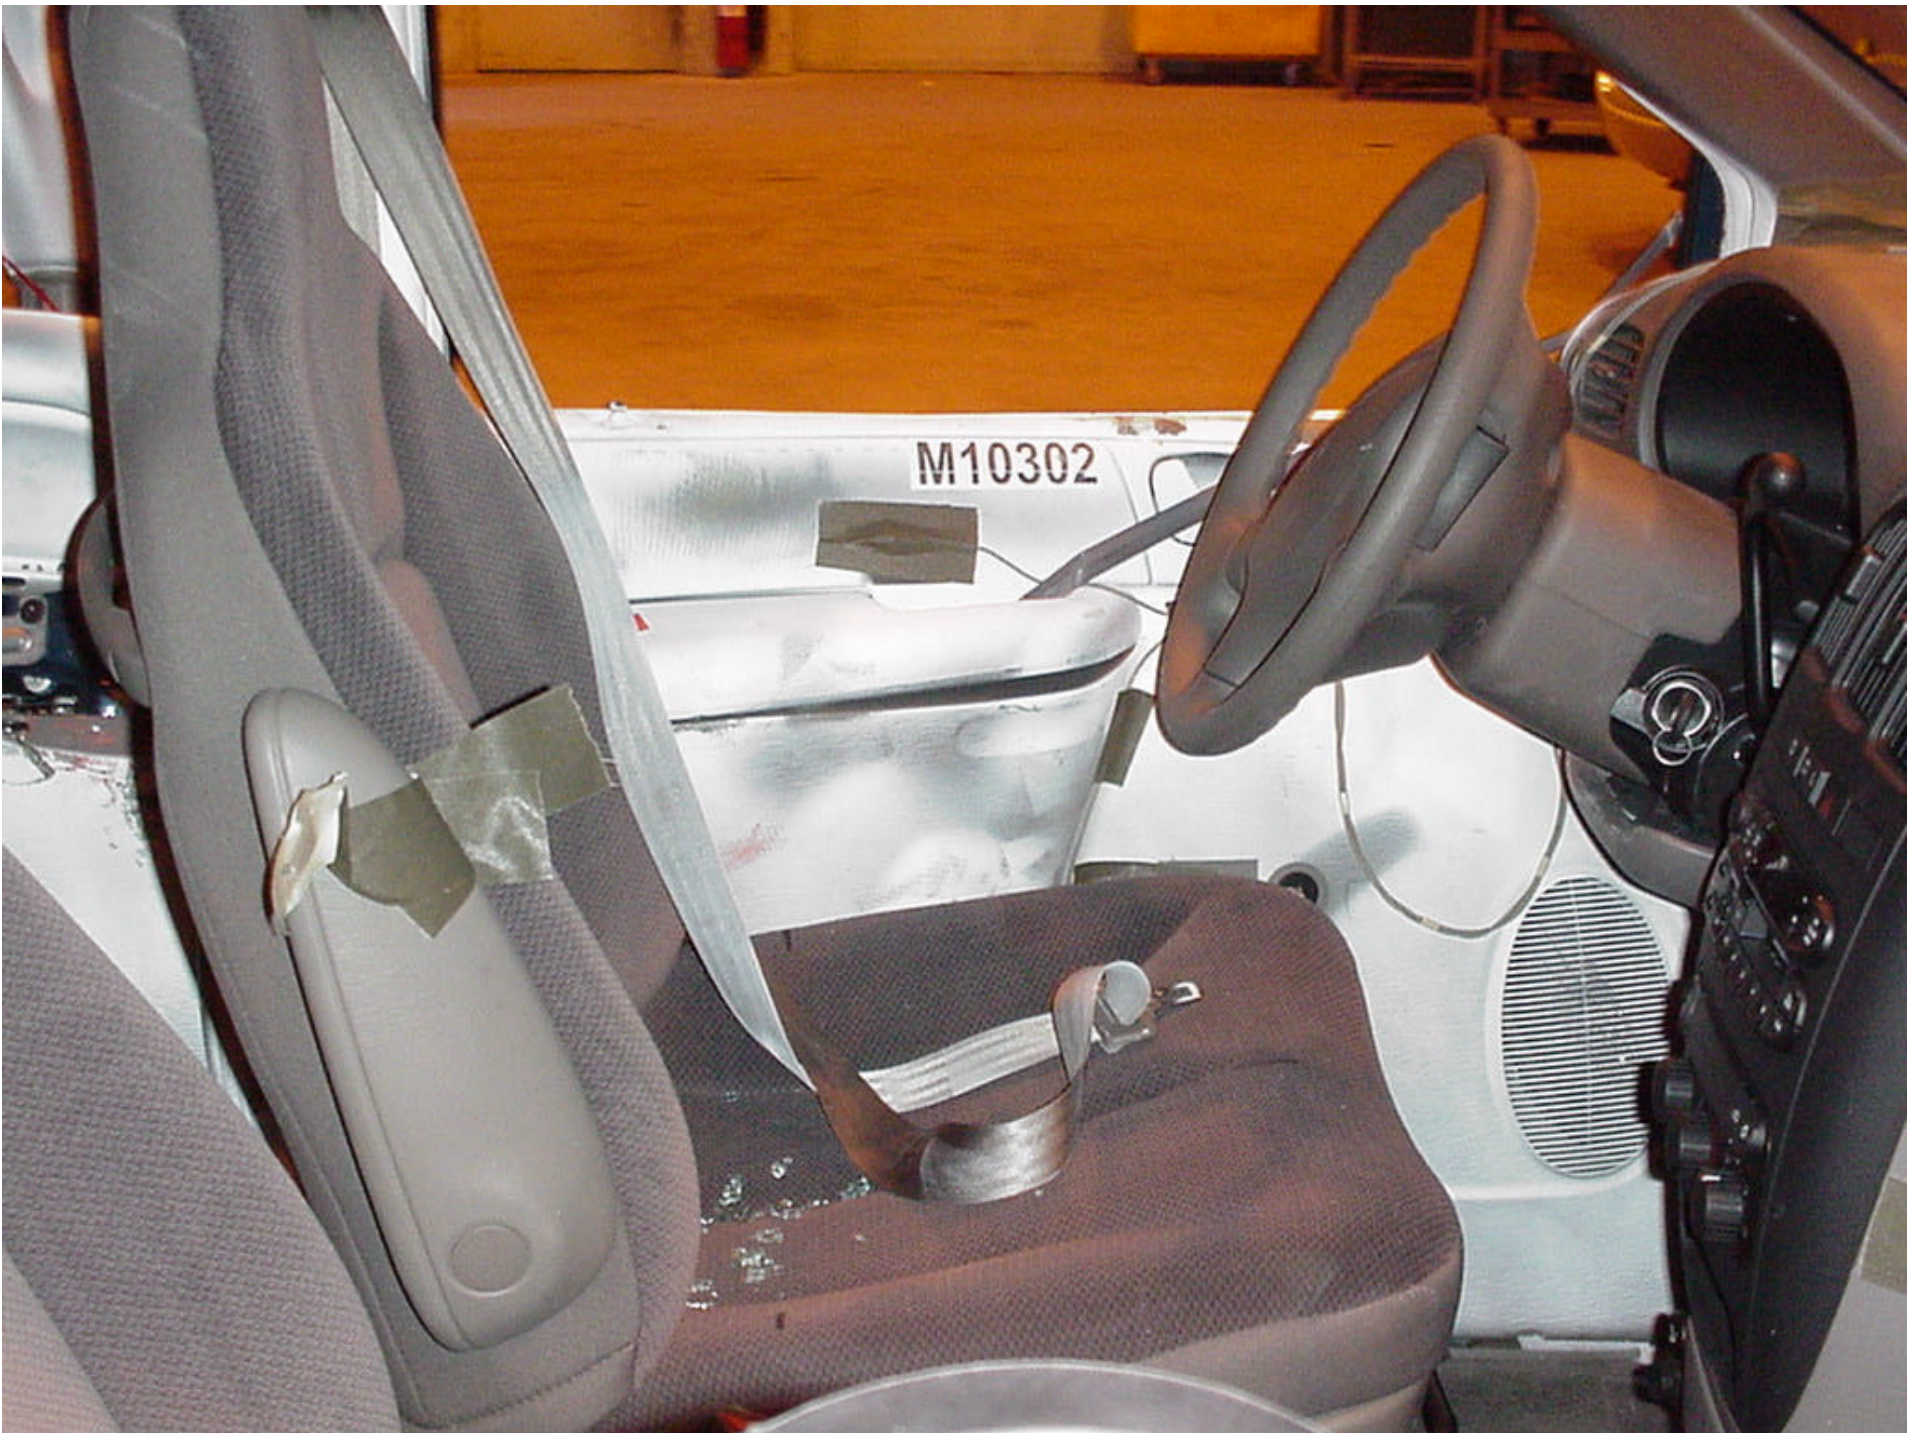
Figure A-26 POST-TEST INTERIOR OF FRONT DOOR SHOWING SID IMPACT LOCATIONS

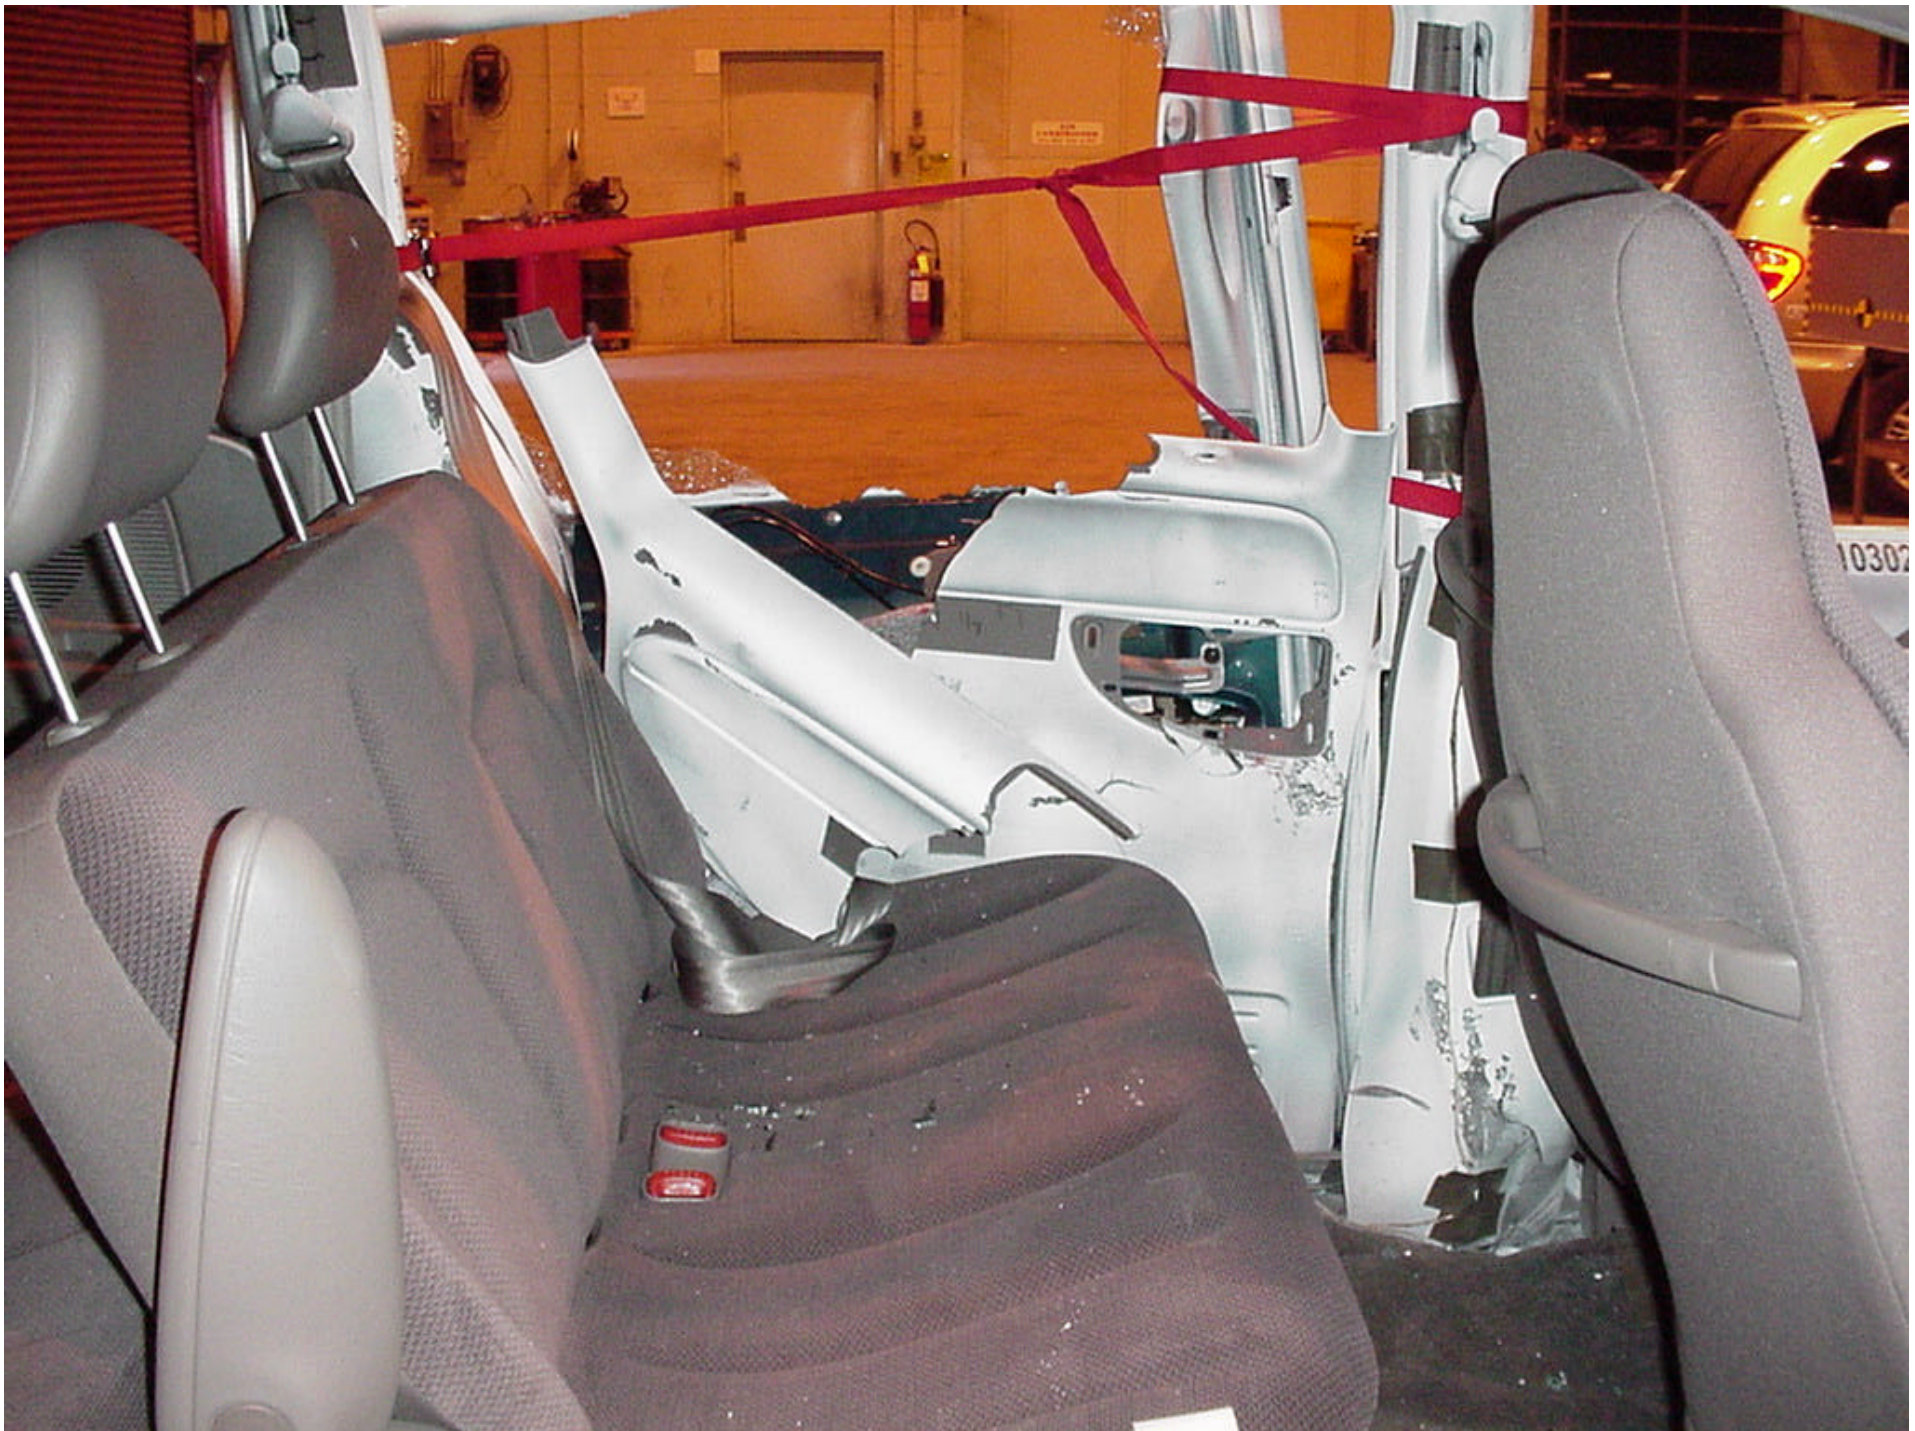
Figure A-28 POST-TEST INTERIOR OF REAR DOOR SHOWING SID IMPACT LOCATIONS

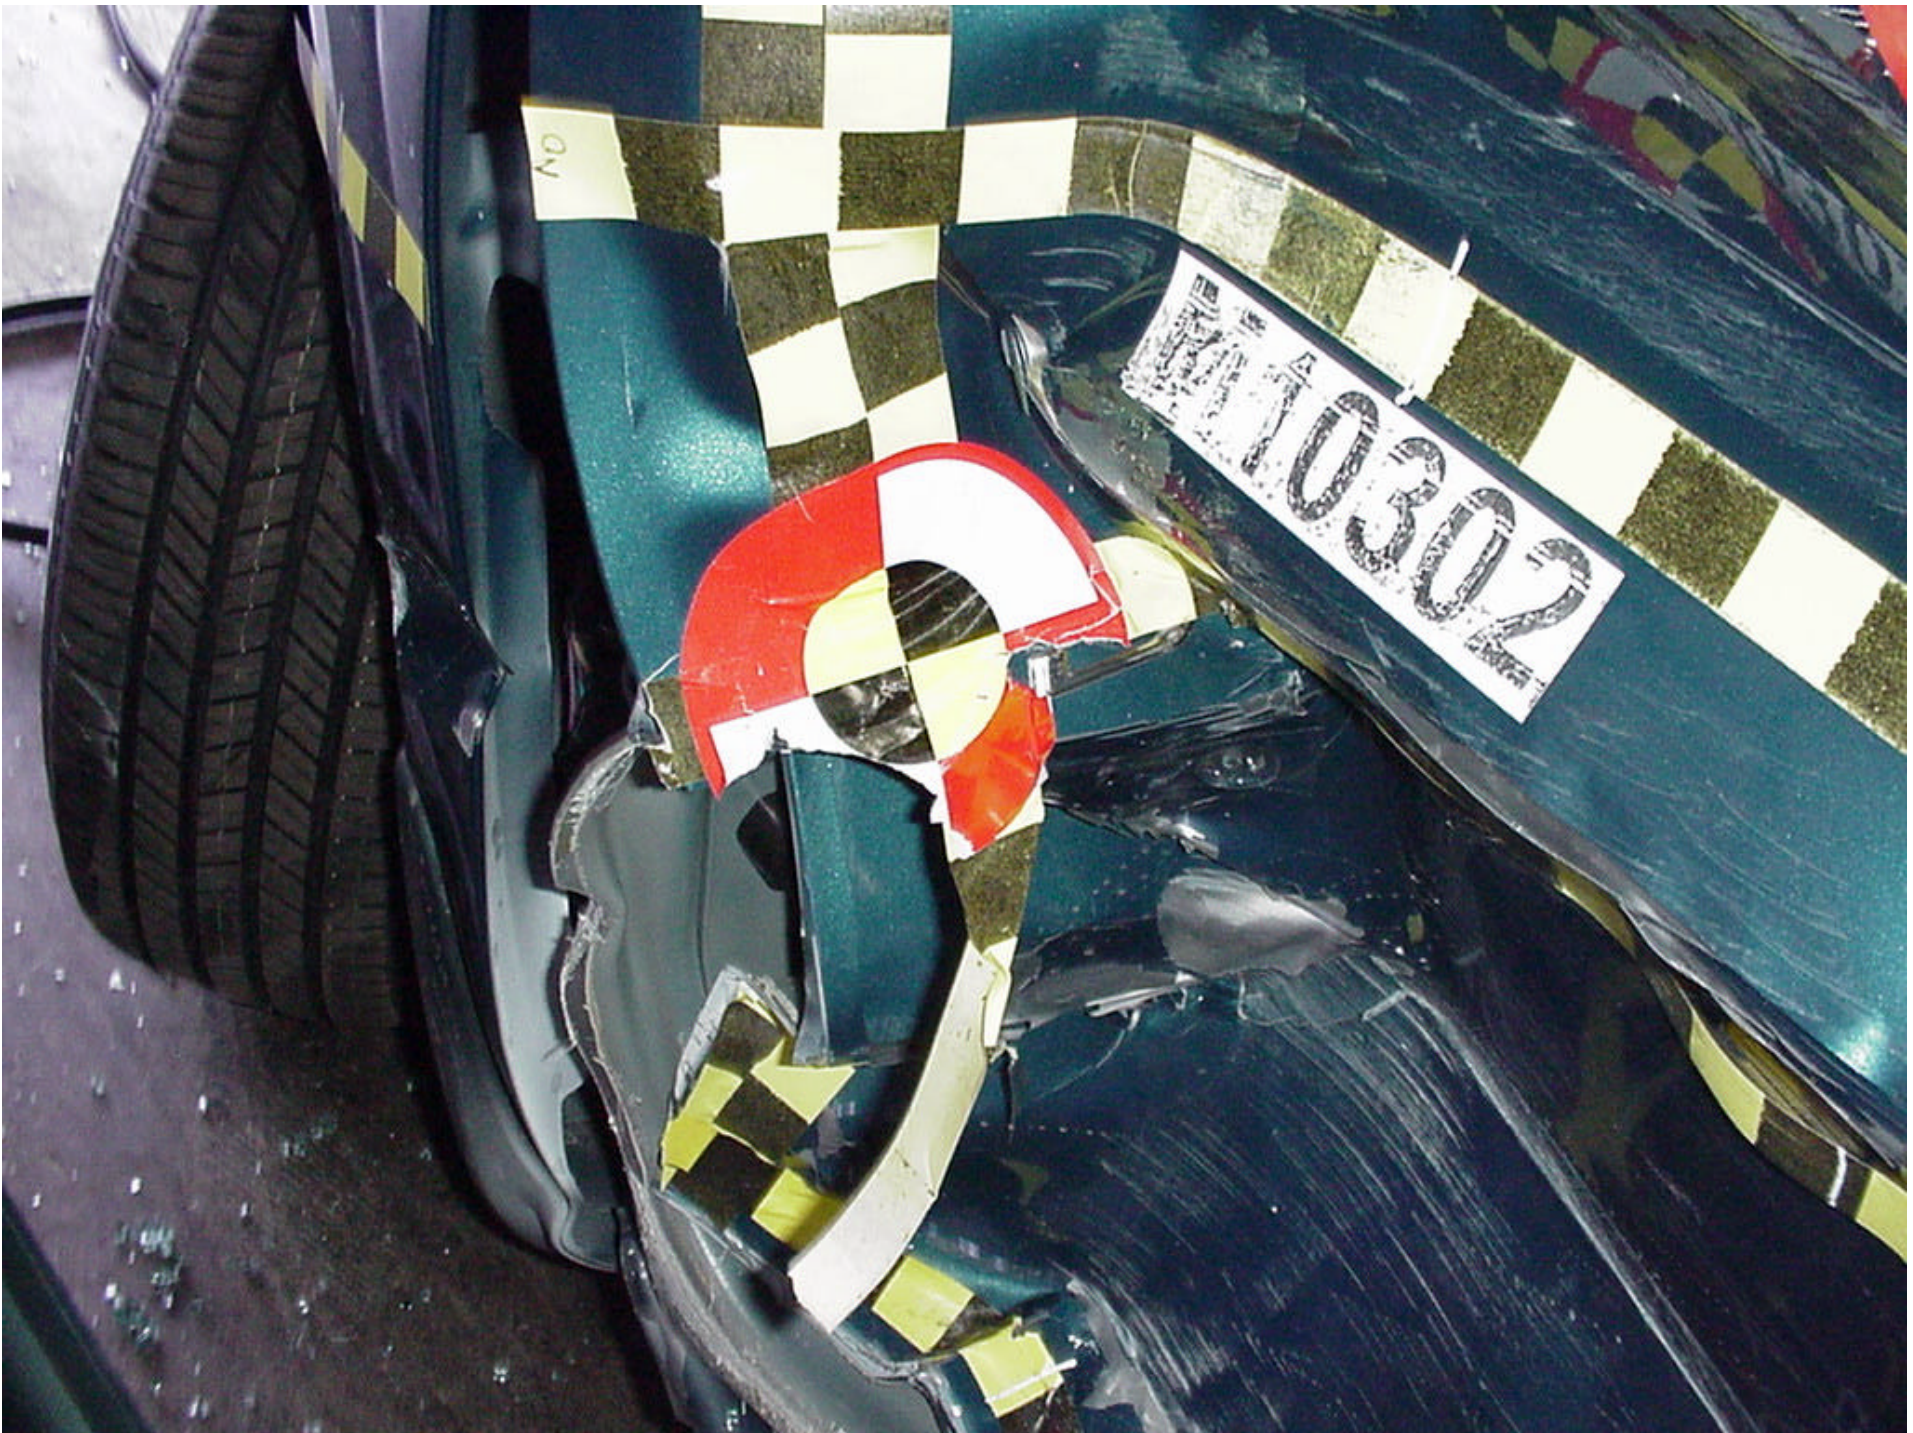
Figure A-31 POST-TEST CLOSE-UP VIEW OF IMPACT POINT TARGET

#### ACTUAL IMPACT POINT

Actual Impact Point is 5 mm forward of nominal impact ref. line (Lateral)

Actual Impact Point is 5 mm below nominal impact point (Vertical)
