REPORT NUMBER: SNCAP-CAL-01-4

**NEW CAR ASSESSMENT PROGRAM  
SIDE IMPACT TEST**

DAIMLERCHRYSLER  
2001 DODGE CARAVAN  
MPV

FINAL REPORT

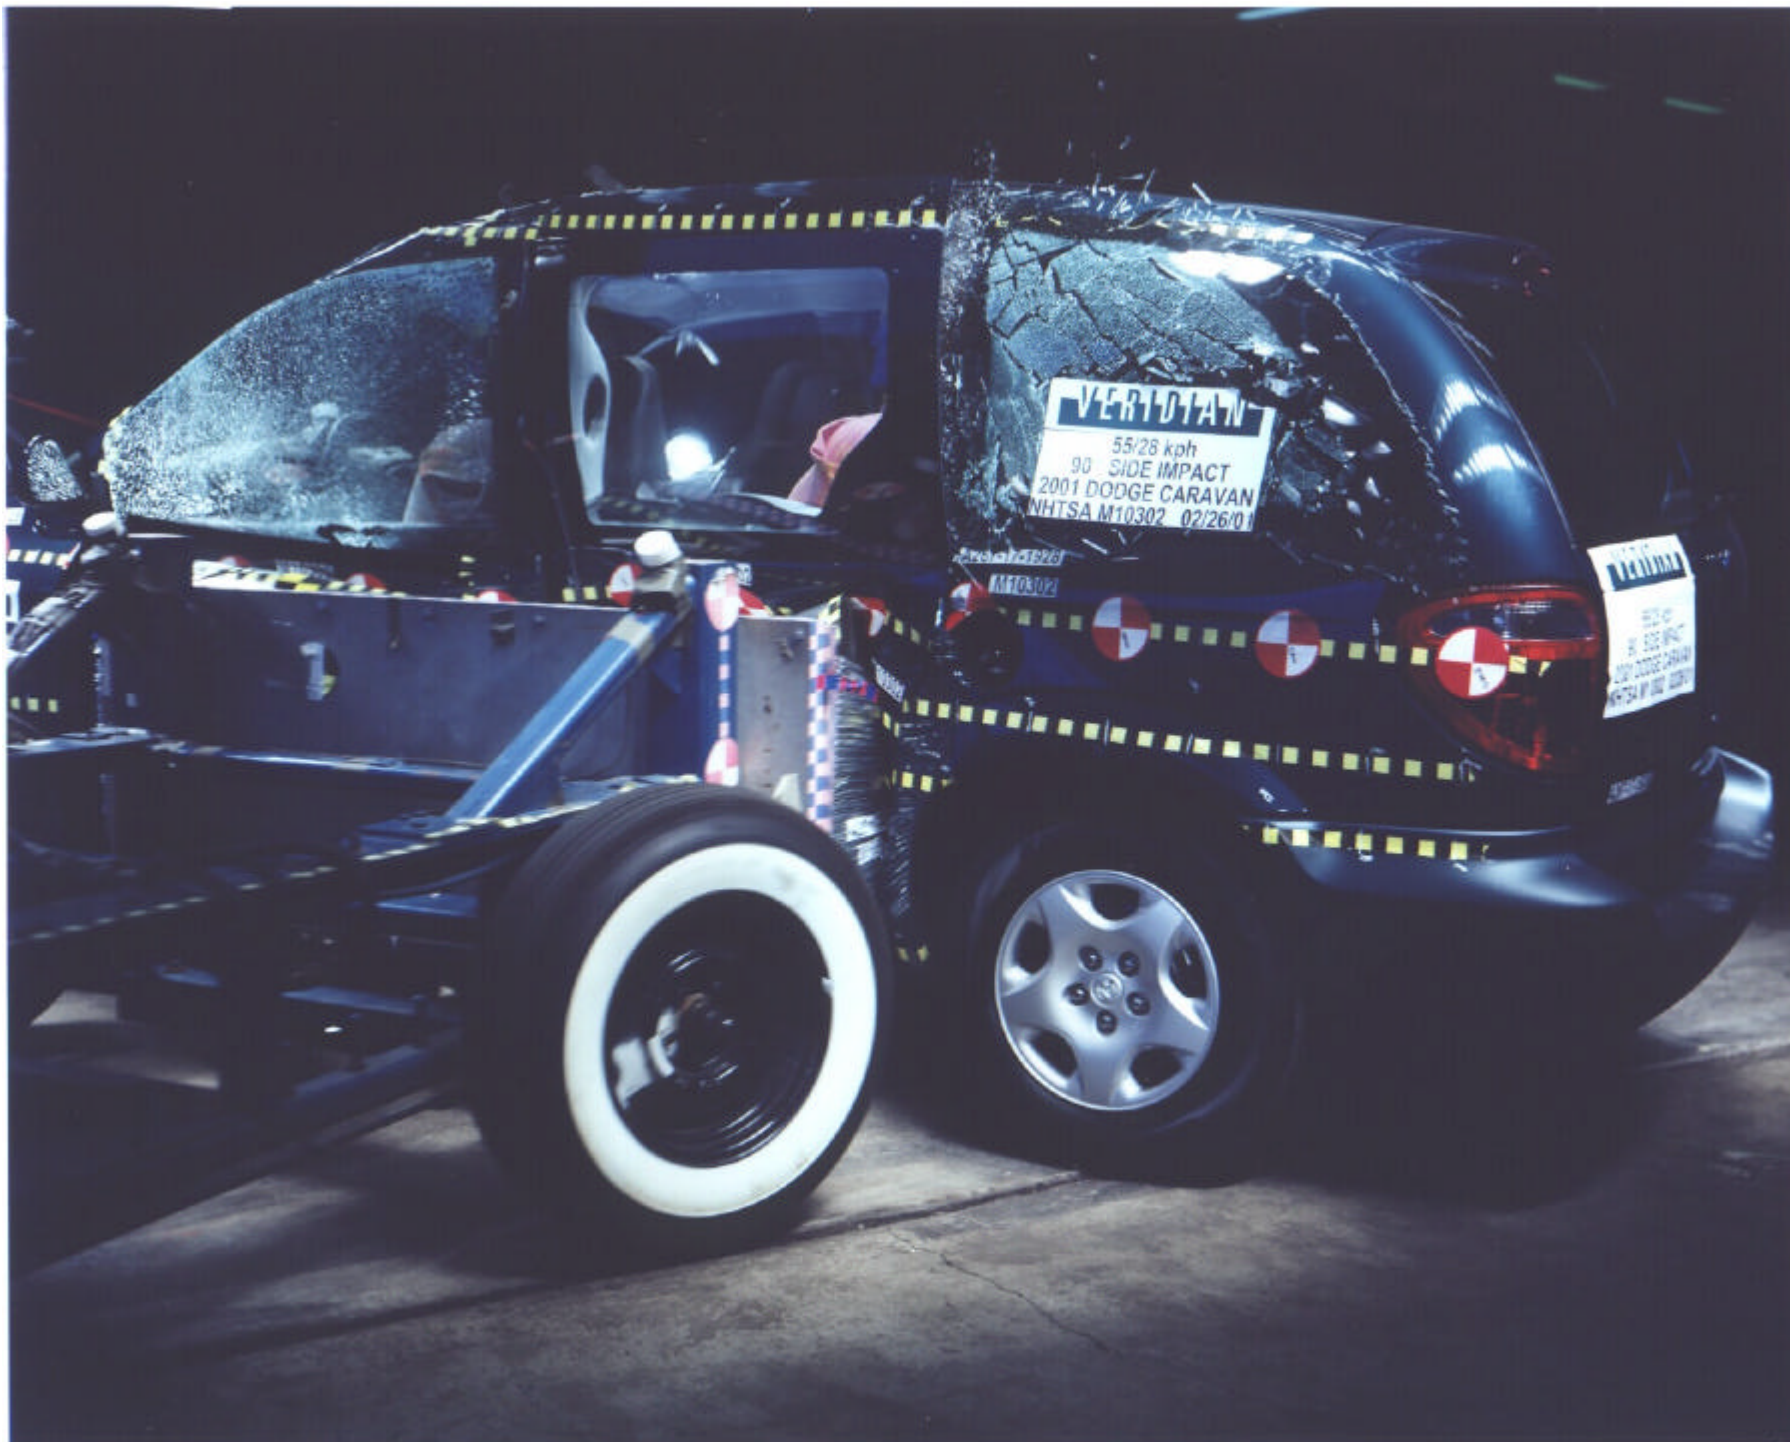
Figure A-34 IMPACT PHOTO

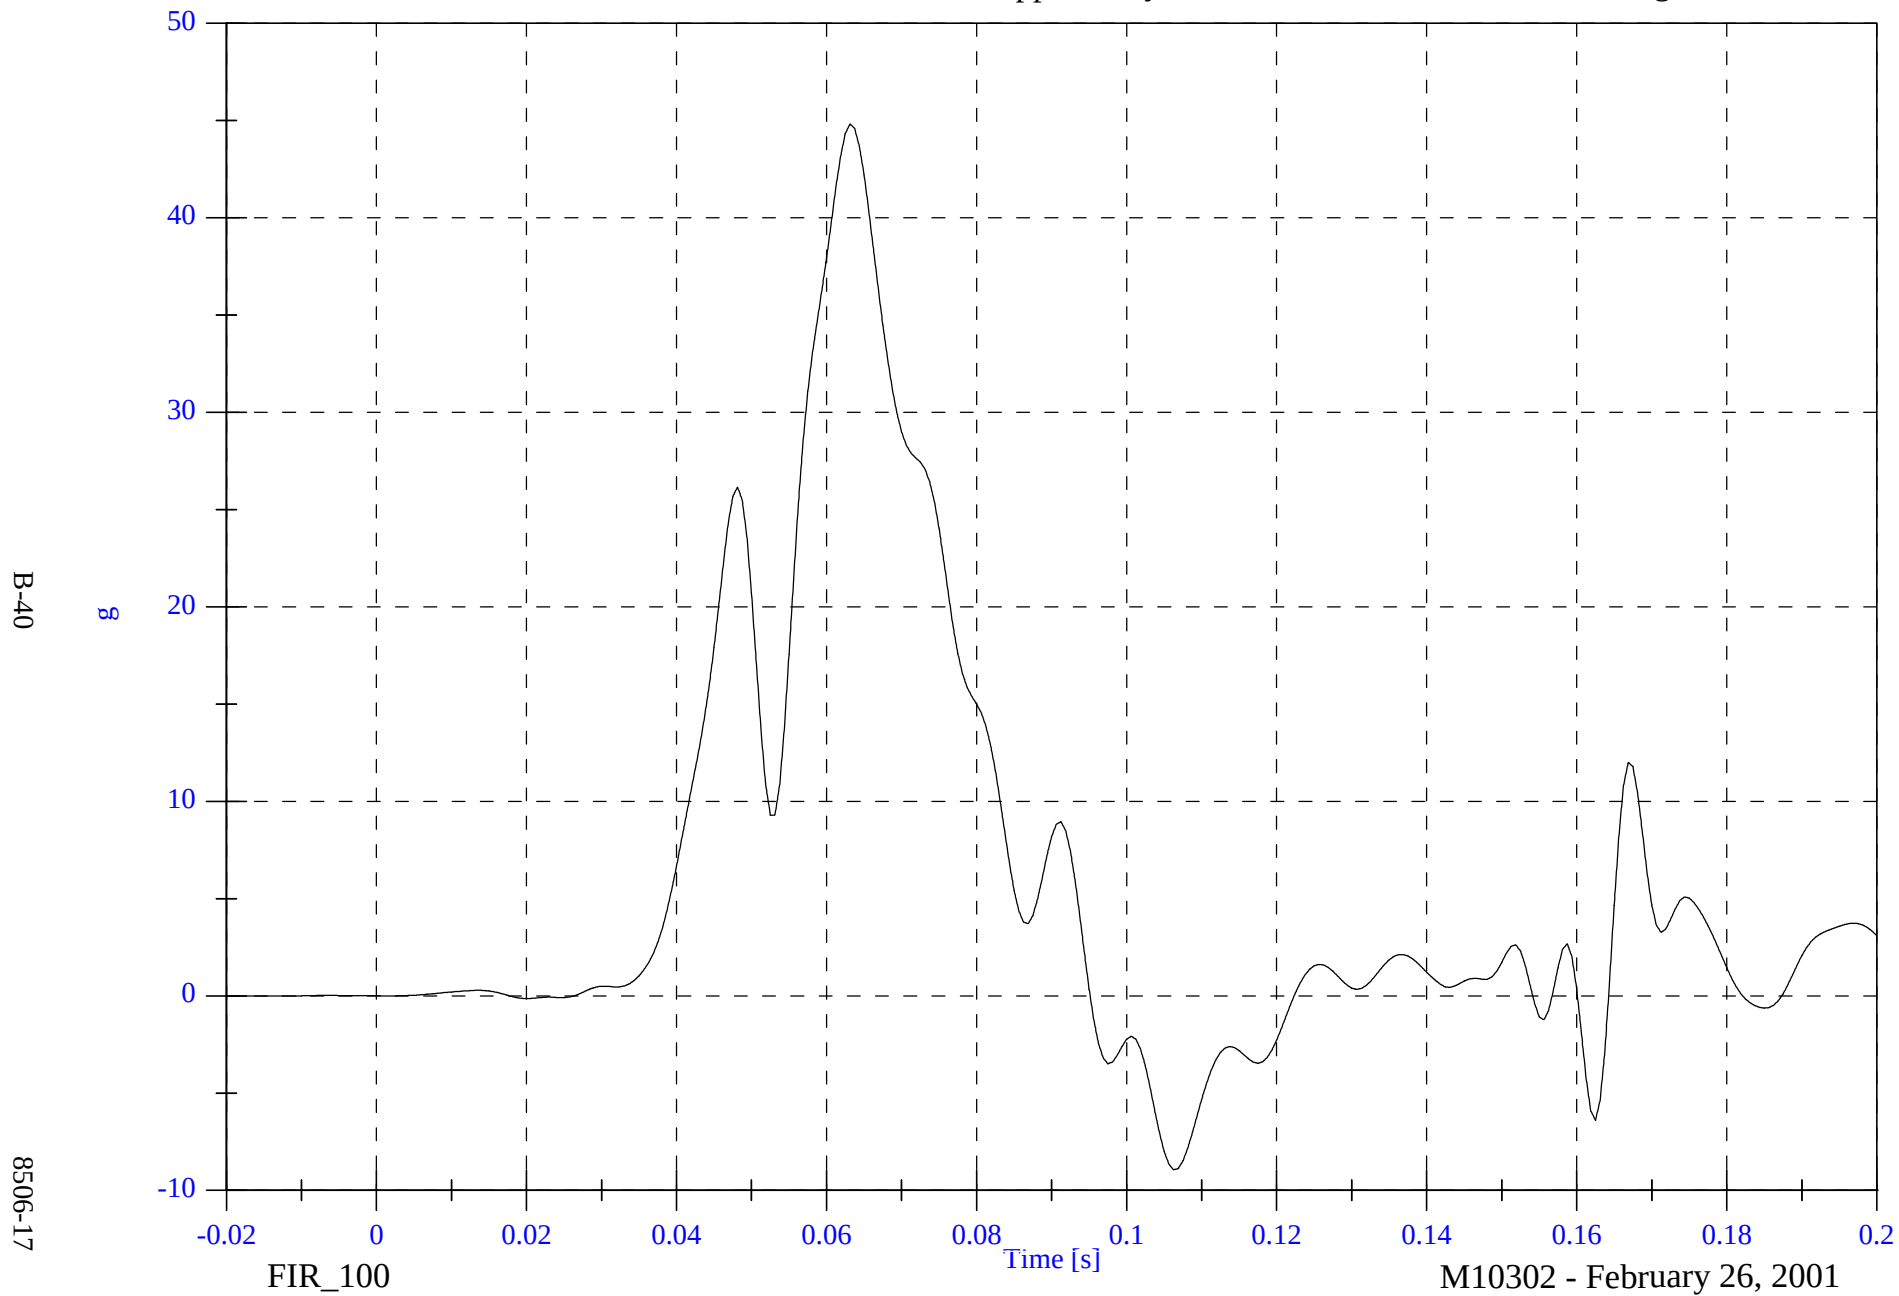
P4 Lower Rib y
