REPORT NUMBER: SNCAP-CAL-01-5

**NEW CAR ASSESSMENT PROGRAM  
SIDE IMPACT TEST**

DAIMLERCHRYSLER  
2001 DODGE GRAND CARAVAN  
MPV

FINAL REPORT

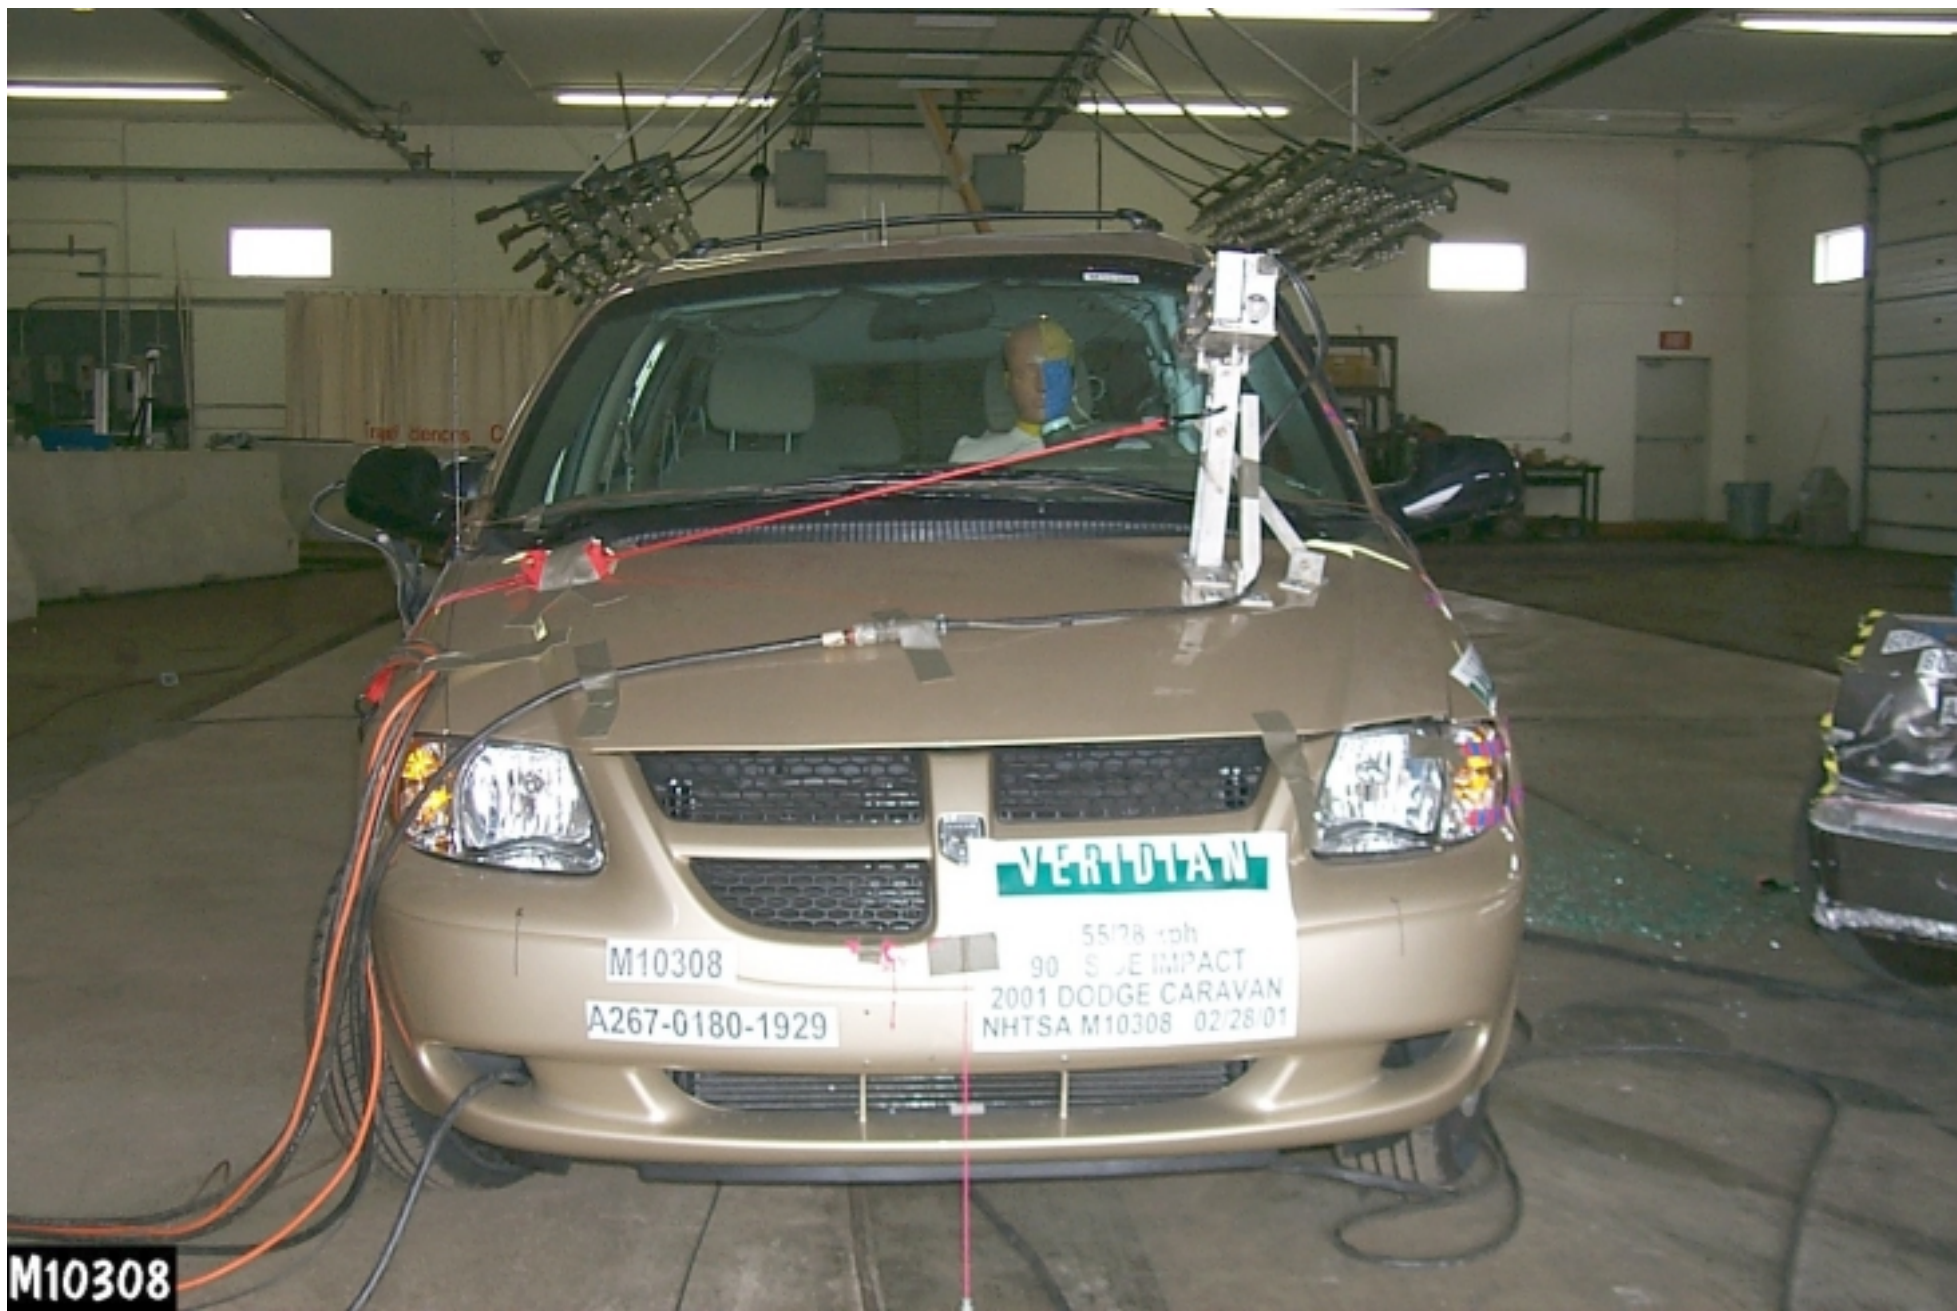
Figure A-2: POST-TEST FRONTAL VIEW OF TEST VEHICLE

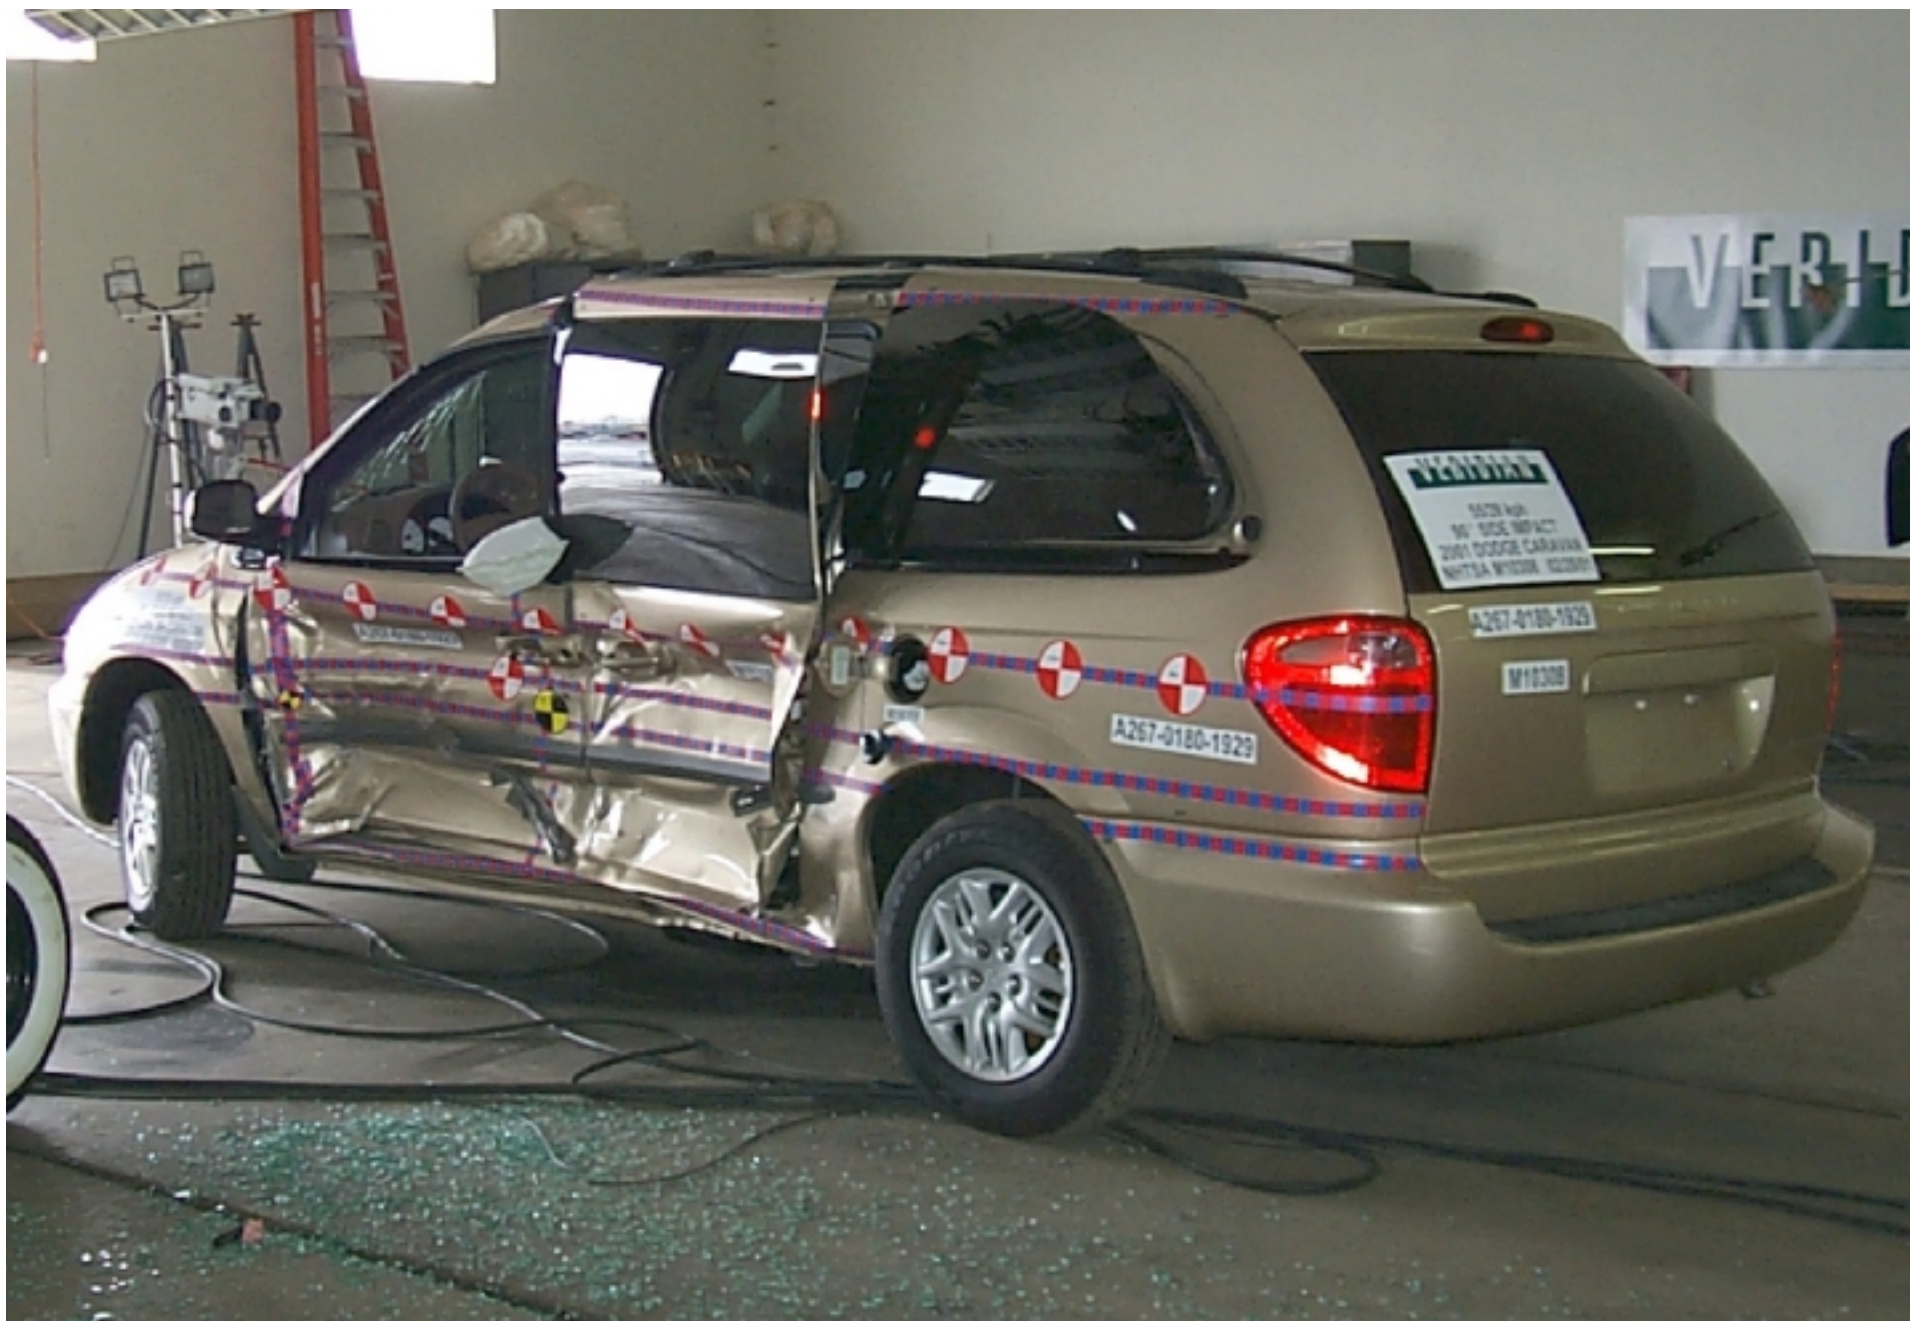
Figure A-6: POST-TEST IMPACTED SIDE VIEW OF TEST VEHICLE

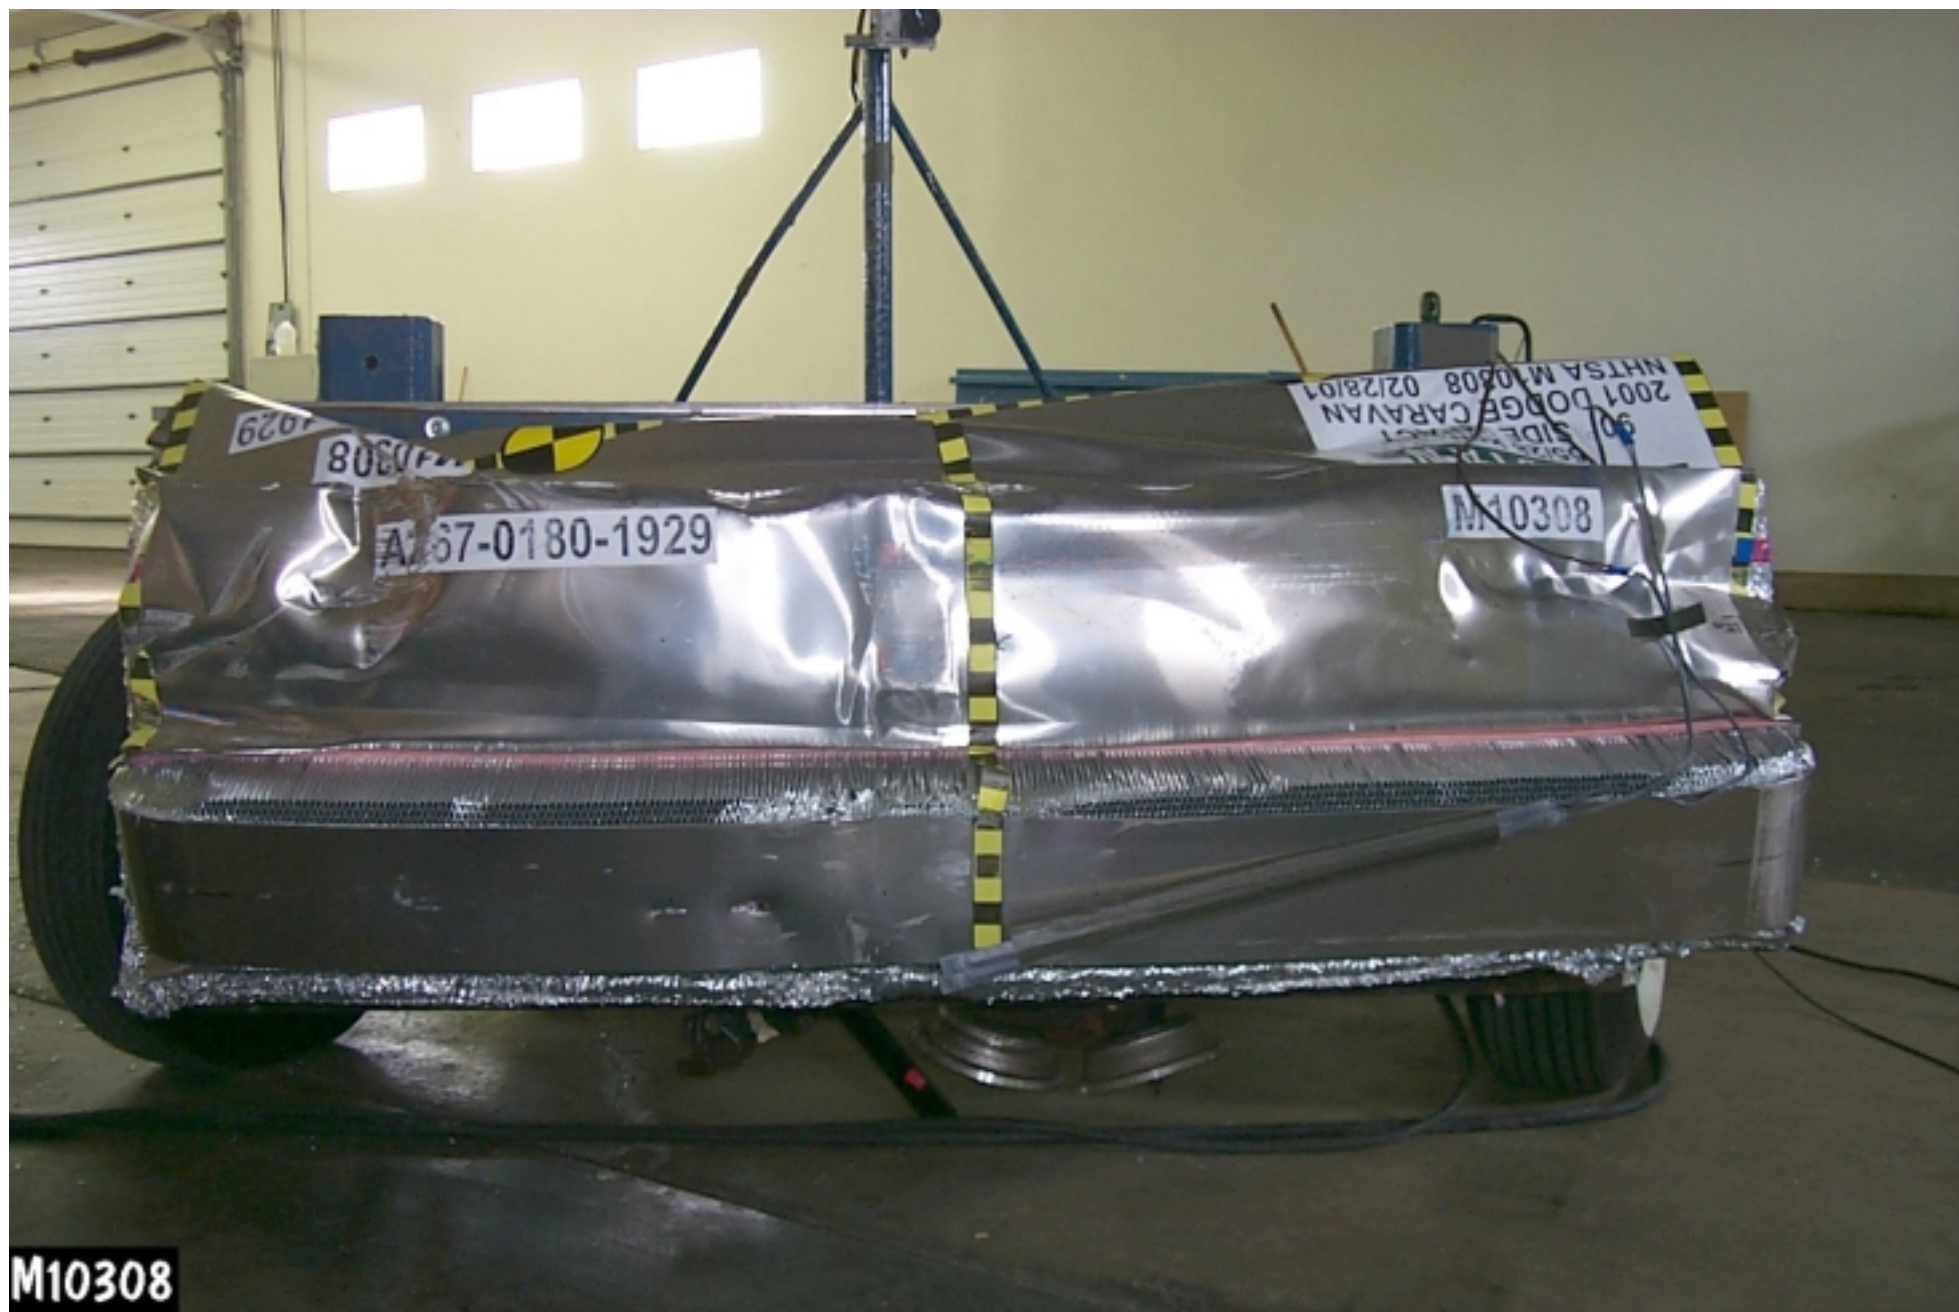
Figure A-8: POST-TEST FRONTAL VIEW OF IMPACTOR FACE

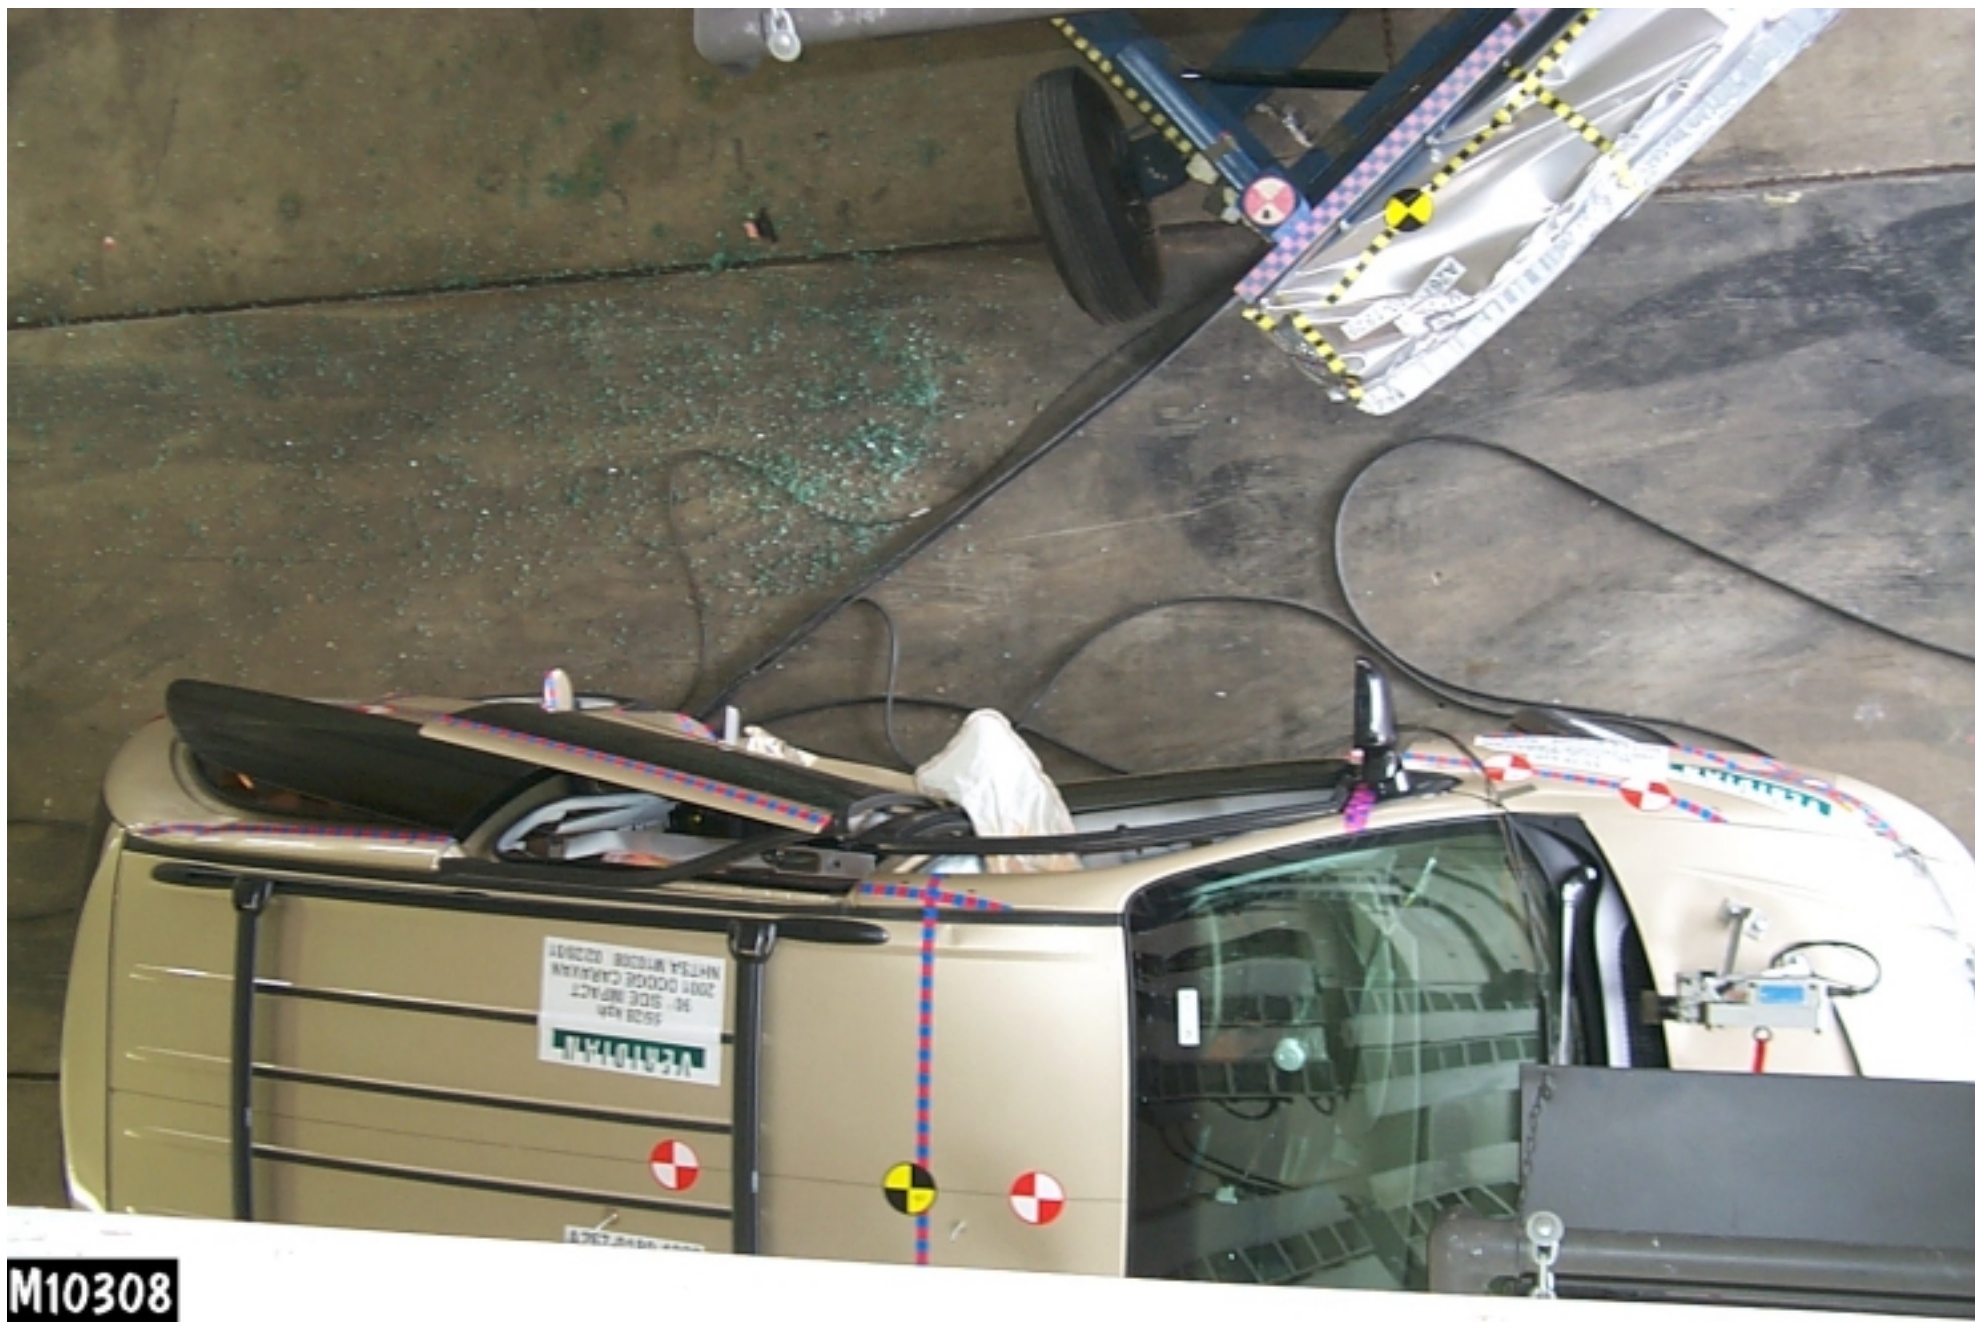
Figure A-16: POST-TEST OVERHEAD VIEW OF MDB AND VEHICLE

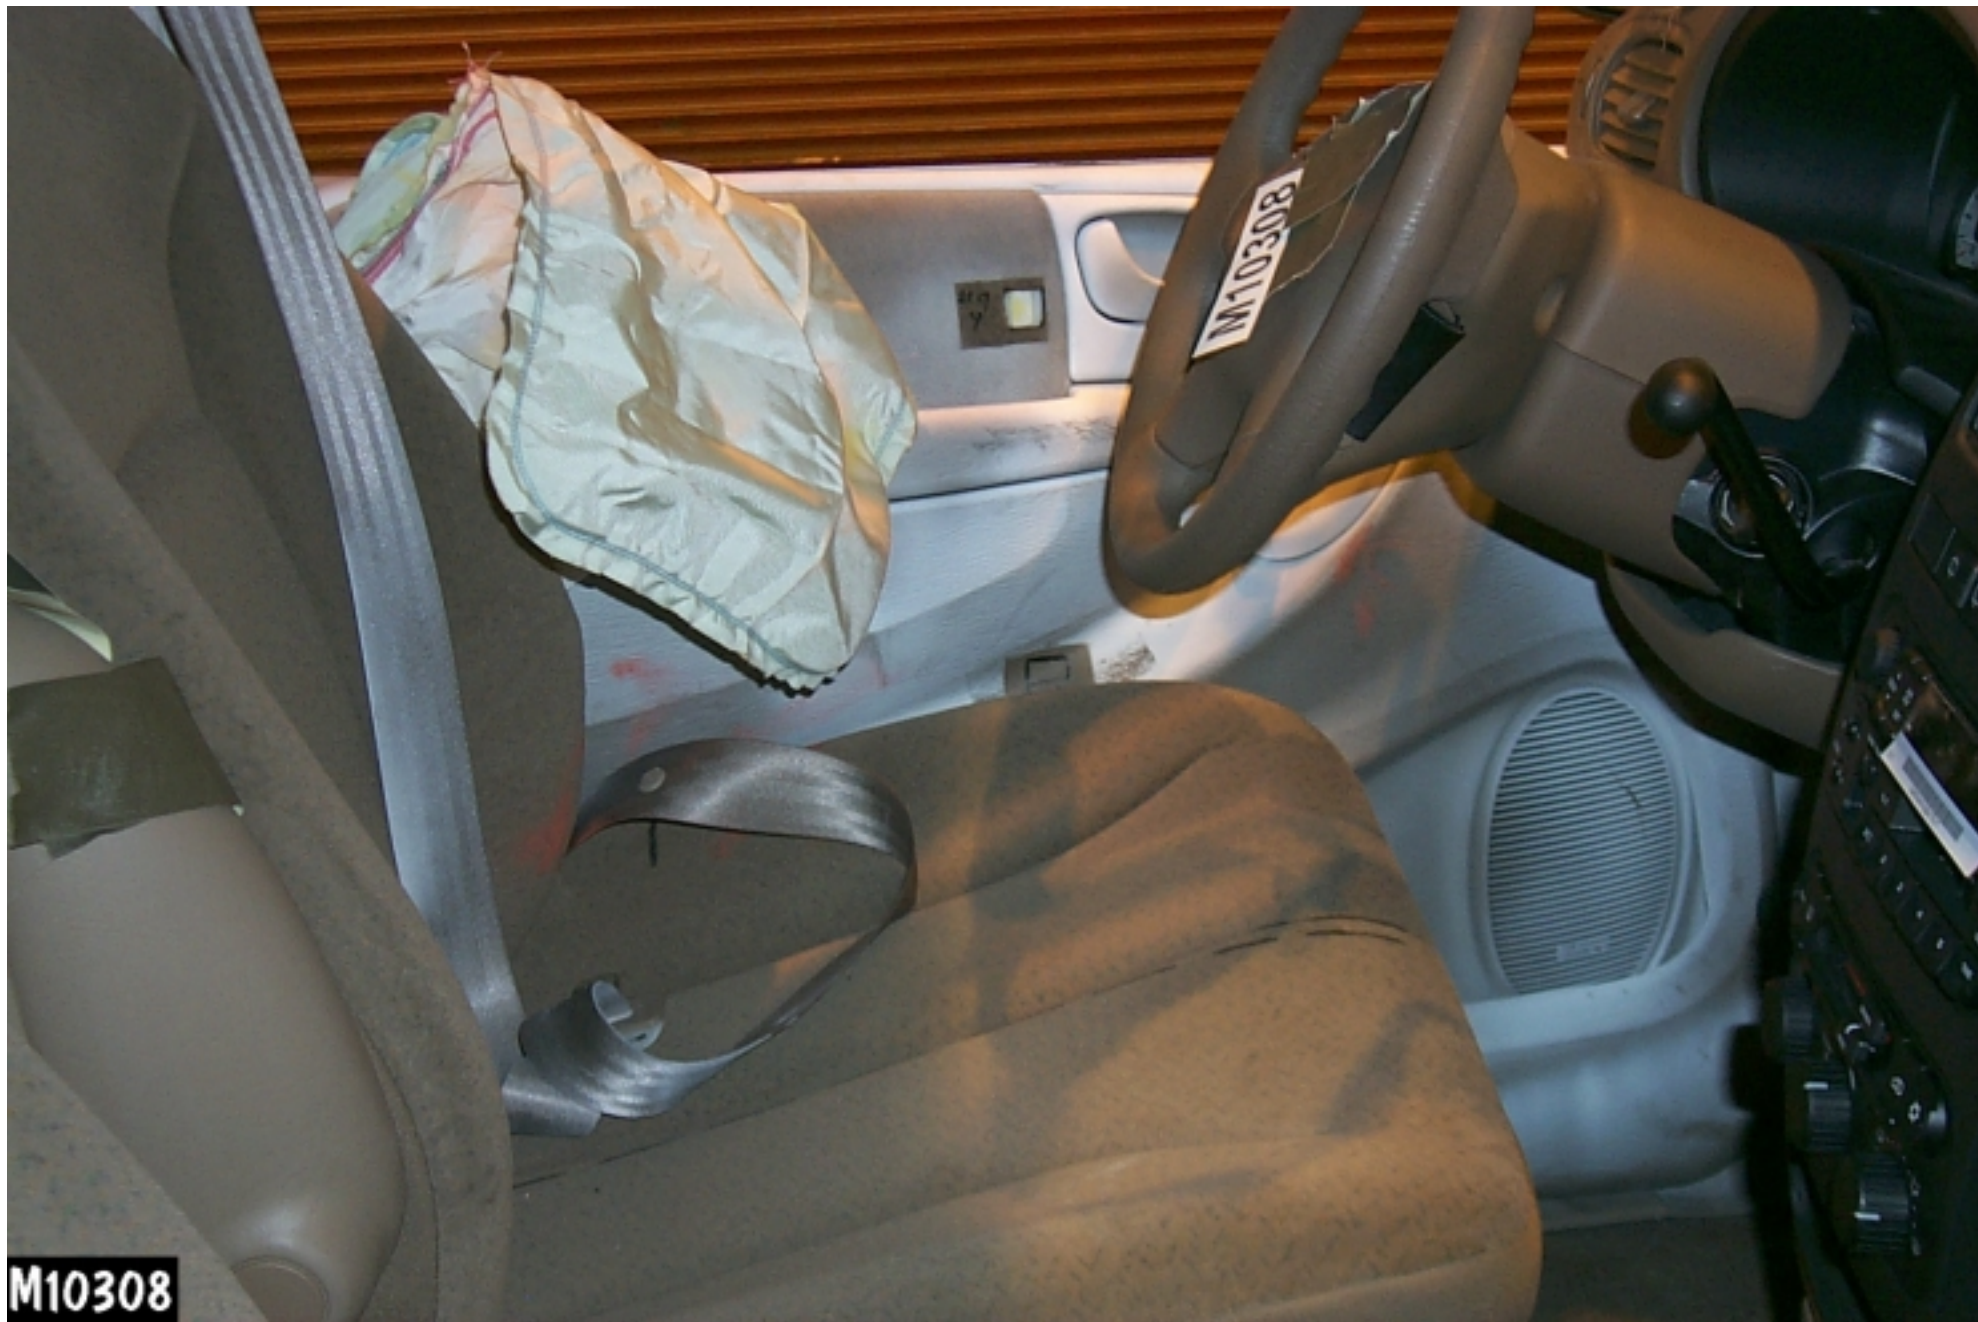
Figure A-26: POST-TEST FRONT INTERIOR TRIM SHOWING SID IMPACT LOCATIONS

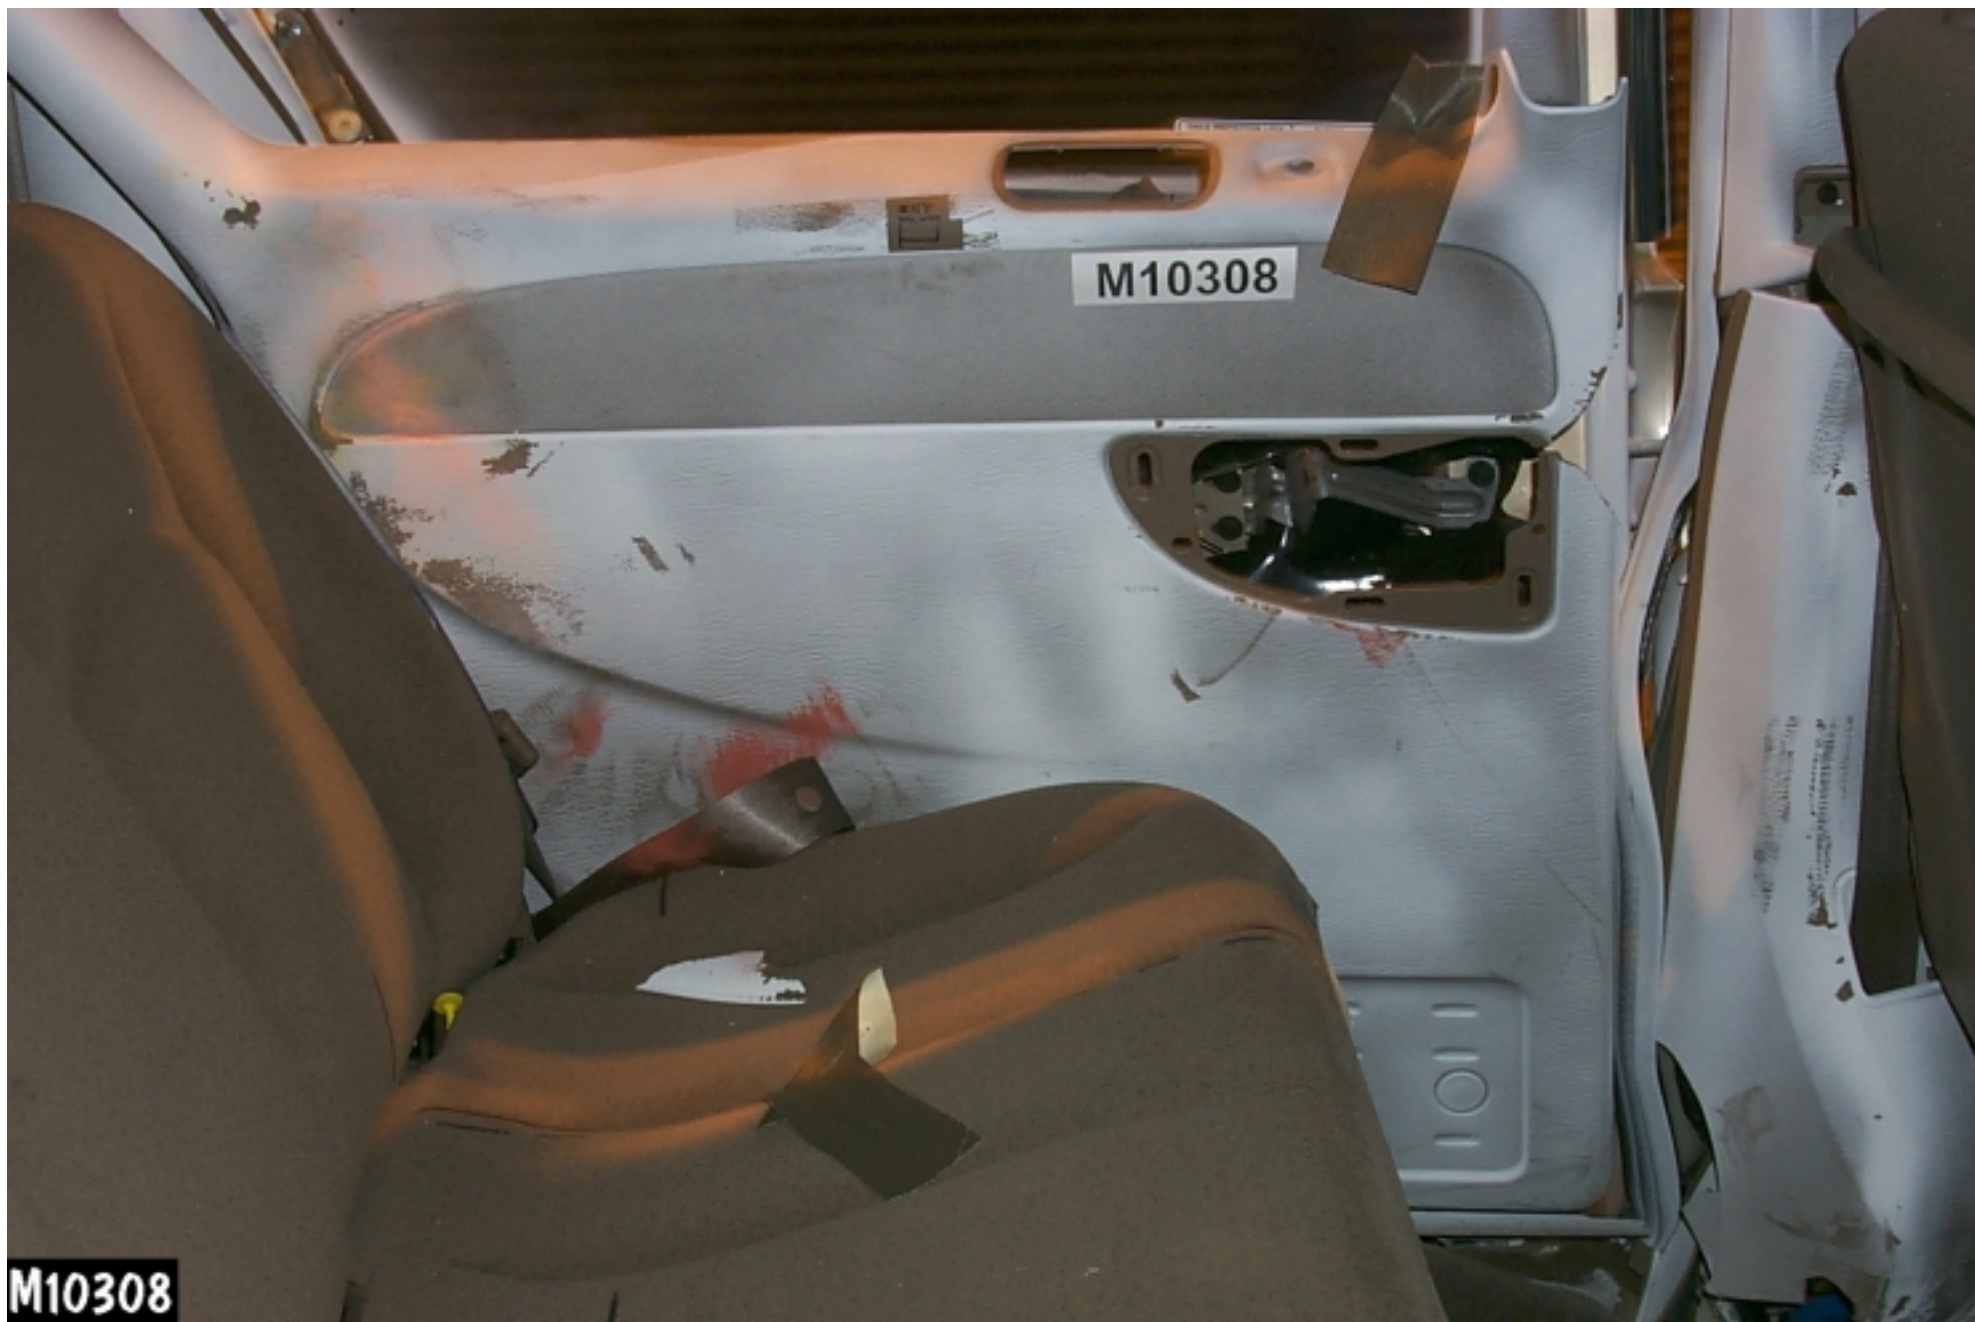
Figure A-28: POST-TEST REAR INTERIOR TRIM SHOWING SID IMPACT LOCATIONS
